Concrete Cloth™

Geosynthetic Cementitious Composite Mat (GCCM)

CASE STUDY:

Toledo, OH
Slope Protection

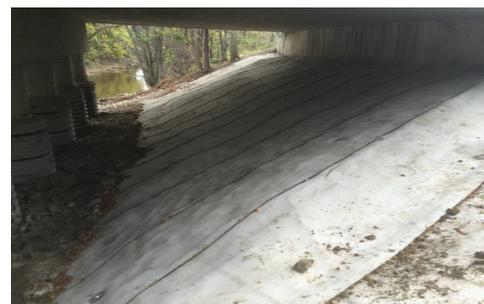
Completed Concrete Cloth GCCM installation.

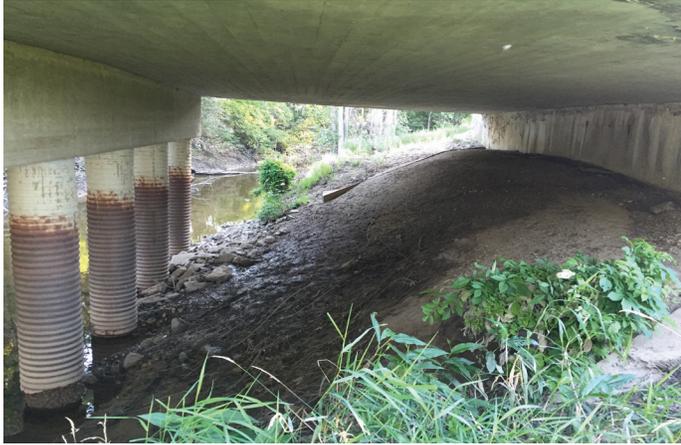
In September 2015, the Ohio Department of Transportation (ODOT) found that flood flows were causing erosion of the foundation slope near the columns below a two-lane roadway bridge on Ohio State Route 579 in Toledo, Ohio. This area was also exposed to runoff from bridge drainage. The ODOT considered lining the slope with riprap, but access to the slope was limited and the department did not want to disrupt traffic on the two-lane road. The option to add vegetation to the slope was also considered, but it was deemed impractical because of the excessive shade under the slope that could prevent it from growing and would ultimately require continued maintenance.

Initial slope conditions with erosion near columns.

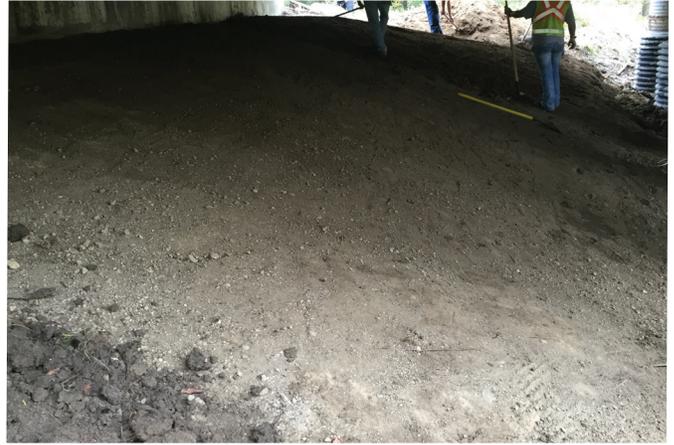
Surface restoration prior to Concrete Cloth GCCM installation.

The surface underneath the overpass was restored prior to the GCCM's installation by smoothing out the repair area and removing any large rocks and clumps of earth that would inhibit the GCCM from being able to lay flat on the slope. The maintenance crew hand-prepared the slope by raking it, and once the surface was ready, the rolls of material were cut in an area near the bridge, carried underneath the overpass and laid in strips down longitudinally on the slope. The only part of the project that required lane closure was when a water tank was brought in to hydrate the material, which closed one lane of the bridge.

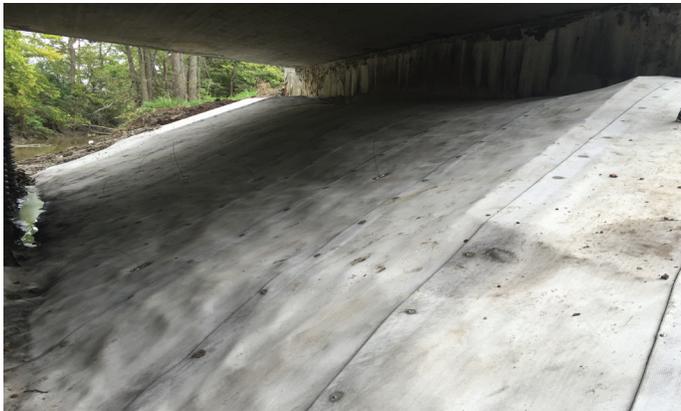
Completed installation.

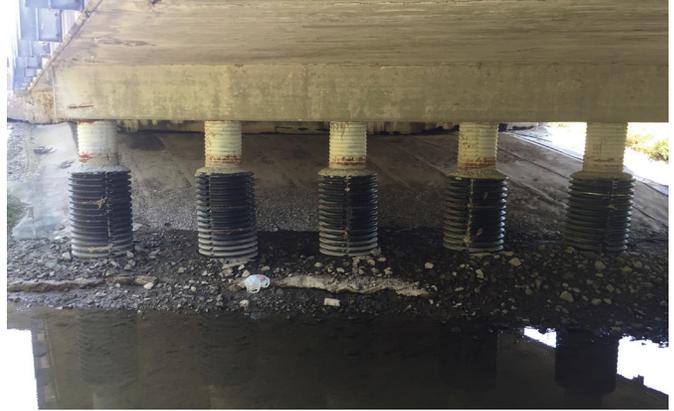
This project was a trial run for the ODOT's use of Concrete Cloth GCCM to see if the material would fit the department's needs, and since its completion, the department has used the material to repair other slopes under bridges throughout the state, specifically on I-77 in Guernsey County, and to line culvert inverts for protection as well. Almost three years after the repair, the Concrete Cloth GCCM underneath this specific bridge is holding up well and protecting the slope from erosion as it was designed to do.

Completed installation three years later, view from opposite bank.

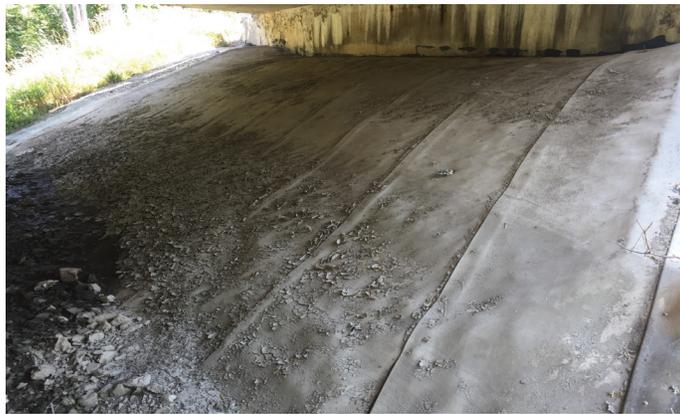
Completed installation three years later.
