Owen M, McNamara A and Panchal J  
The risk of unexploded ordnance on construction sites in London, UK.  
*Environmental Geotechnics*,  
<https://doi.org/10.1680/jenge.18.00049>

## Research Article

# The risk of unexploded ordnance on construction sites in London, UK

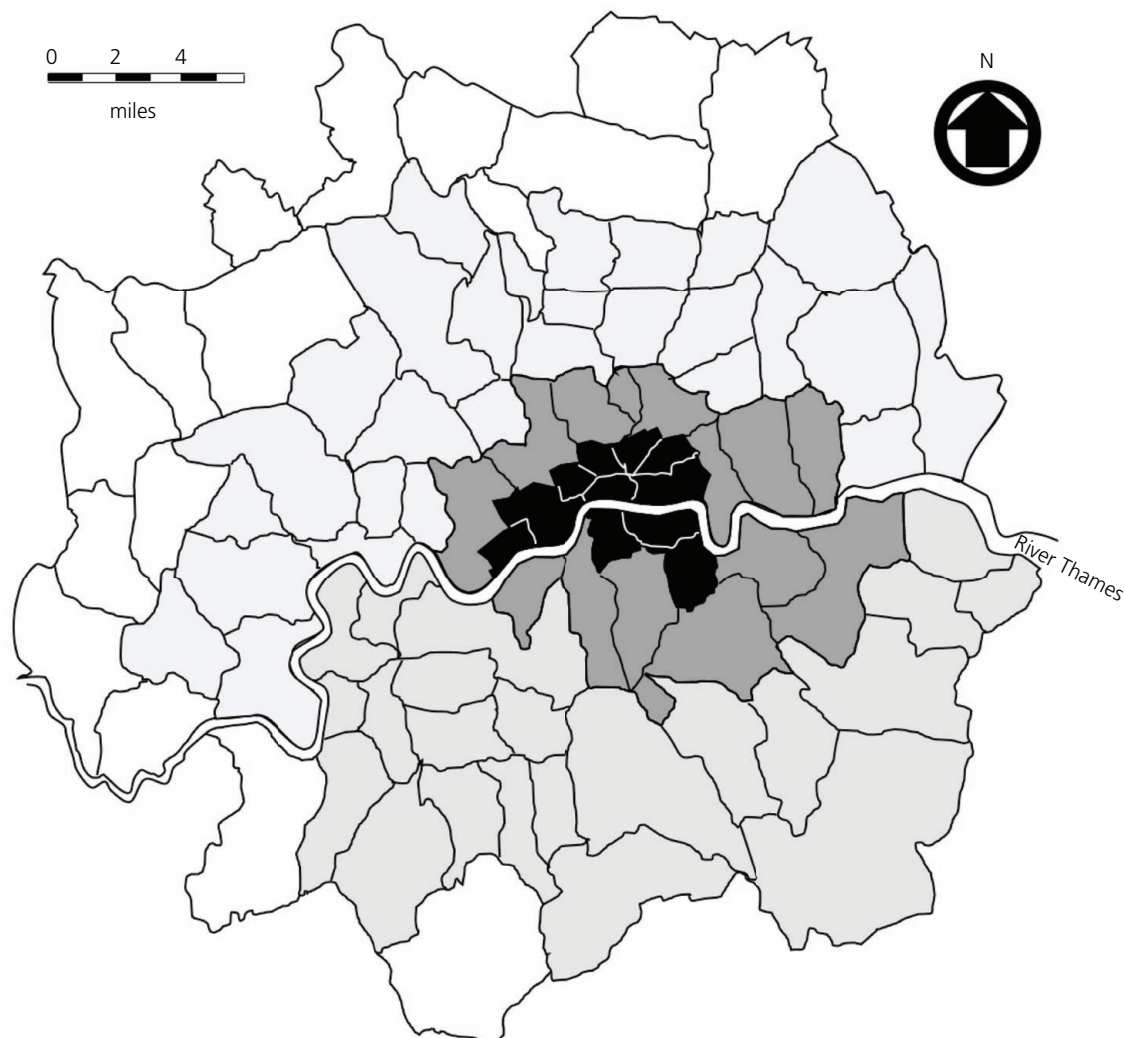
Figure 1. Greater London, with darker areas showing higher-density bombing (Saunders, 2005). 1 mile = 1.61 km

The geographical area considered within this paper has been limited to Greater London (defined in Figure 1), which suffered considerable bomb damage during WW2. This area has since undergone widespread redevelopment, and historical information on the discovery of UXO is widely available from public bodies. The Ciria guide (Stone *et al.*, 2009: p. 9) reports that ‘unexploded ordnance resulting from aerial bombardment continues to be encountered [in] ... London in particular, especially during construction and redevelopment works’.

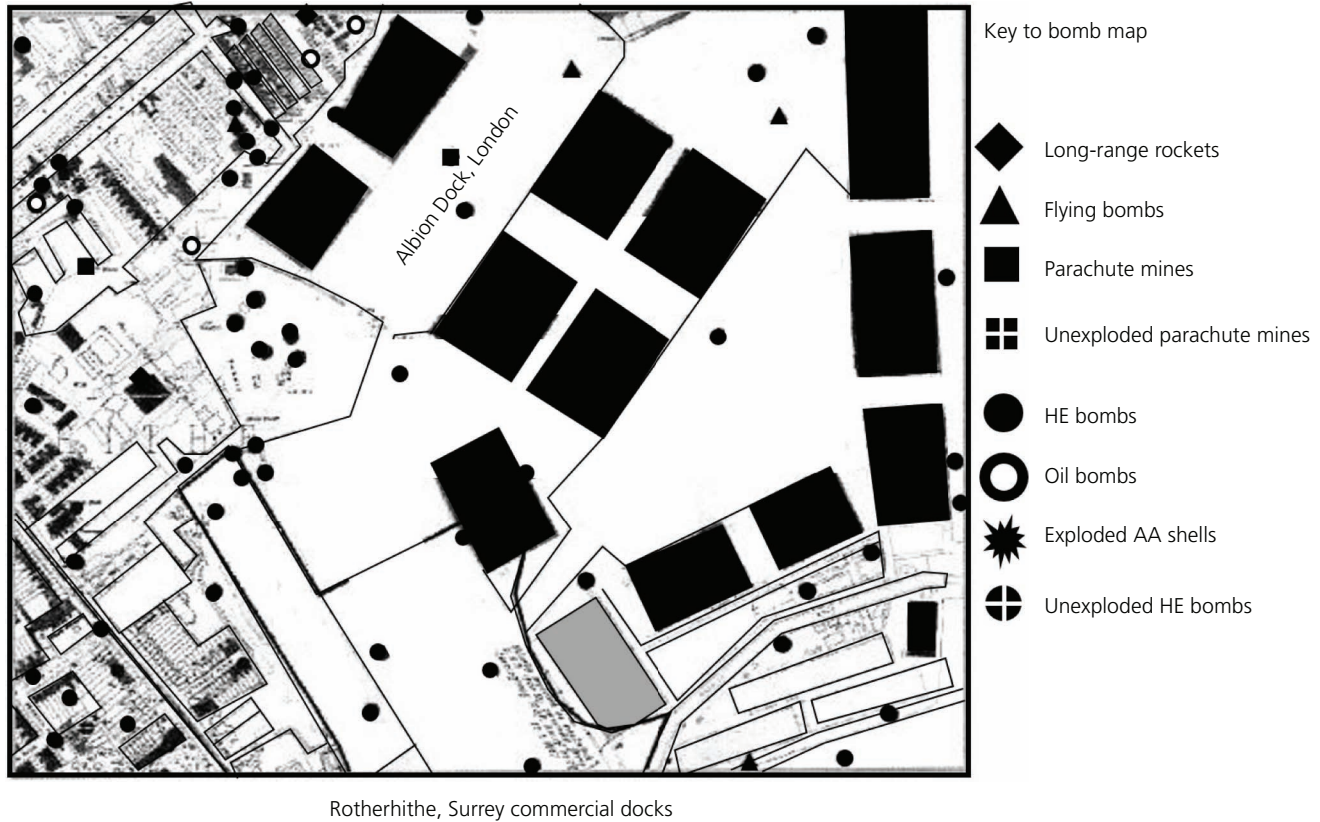
Figure 2. Diagram of bomb site from a sample risk assessment (Stone *et al.*, 2009). AA, anti-aircraft

The sample report suggested that the density of UXBs remaining in Rotherhithe, London, was either one, two or three 50 kg bombs per hectare. There is, however, no justification for these values, except to advise that it is prudent to assume that there is at least

one UXB per hectare. The density of remaining UXBs greater than 50 kg is not postulated. London County Council (LCC) bomb damage maps (Saunders, 2005), referenced in this particular risk assessment, suggests that between 200 and 300 bombs were dropped for every 1000 acres (405 ha) in Greenwich, London, which equates to 0.49–0.74 bombs per hectare. On the basis that approximately 90% of these bombs exploded, the assumption that one UXB per hectare remains appears to be implausibly high without additional justification.
