Inspection Report

Provided by:
Neckar Valley

123 Your Street
Your Town
Your Province
1A2 B3C

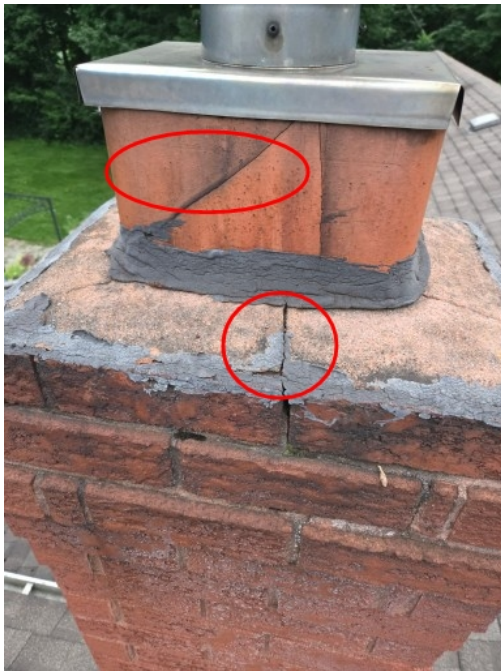
1.2 Chimney (Repair)

missing mortar between bricks, as well as damage to other masonry components, repair by qualified contractor recommended.

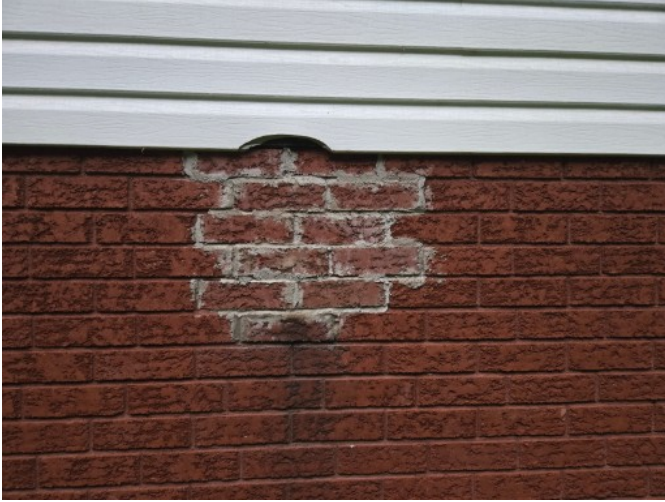
2.3 Exterior Wall Conditions (Appears Serviceable)

Previous repairs to brickwork

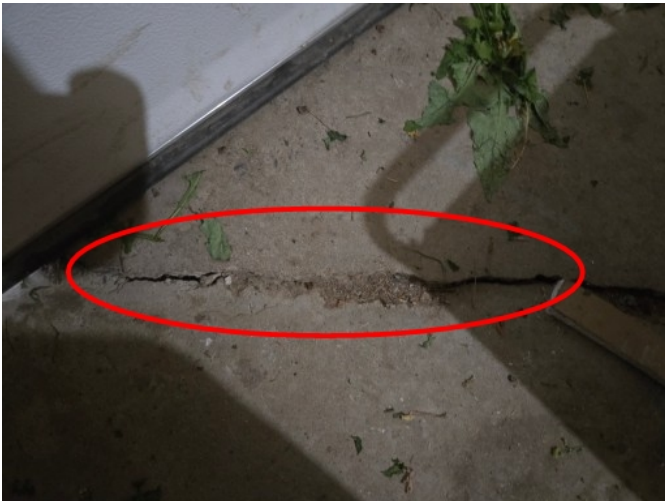
3.3 Floor Conditions (Repair)

Minor cracking and/or settlement noted at the garage concrete floor surface. No immediate concern noted at this time. Suggest sealing cracks to reduce potential moisture penetrations.

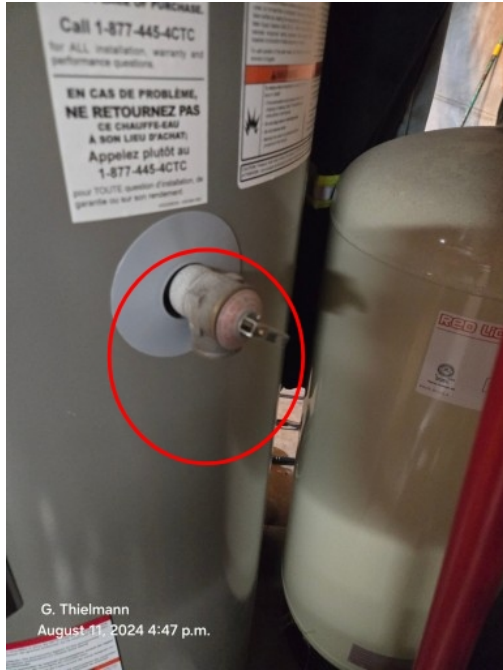
7.4 Water Heater Conditions (Repair)

T P R (temperature pressure relief) valve overflow pipe was missing at the time of the inspection. Recommend installation of an extension pipe for increased safety. consult a licensed plumber for additional information.

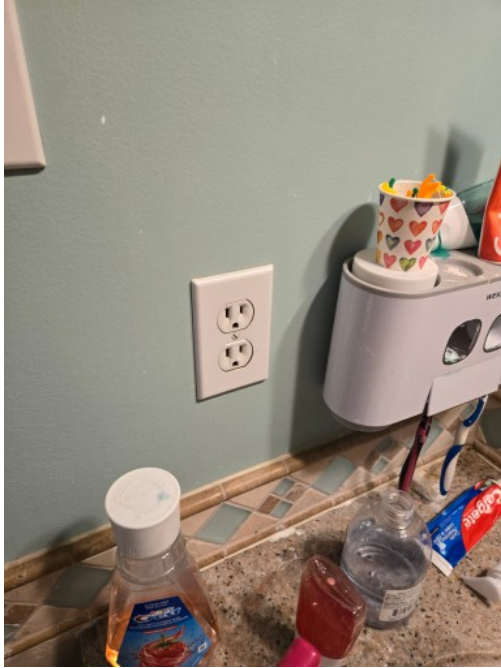
10.7 Electrical Conditions (Safety)

GFIC (Ground Fault Interrupter Circuit) receptacle circuit (a safety device for outlets near water) recommended.

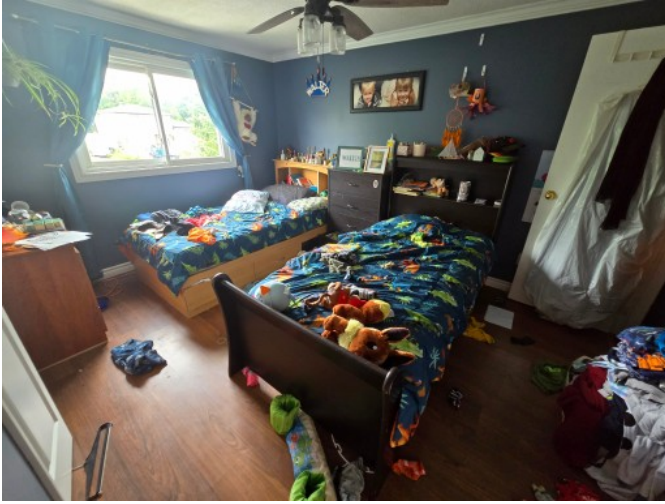
11.7 Electrical Conditions (Appears Serviceable)

not all outlets were accessible for testing due to occupants belongings. the accessible outlets tested were in satisfactory condition

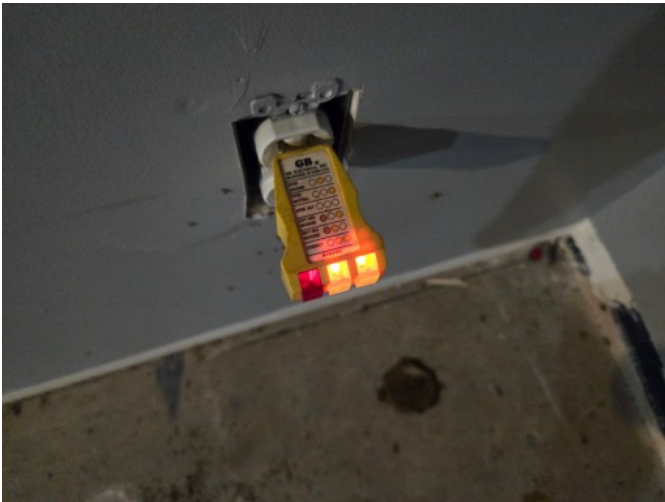
12.7 Electrical Conditions (Safety)

Missing receptacle or switch covers were observed . Recommend covers be installed for safety.

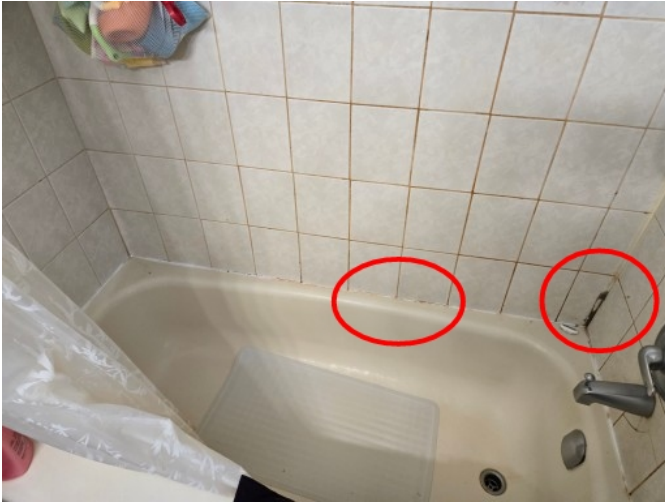
13.12 Shower - Tub Conditions (Repair)

Caulking is recommended at the tub walls and or floors in bath . Conditions behind wall or under floor were concealed and not visible or accessible for inspection.

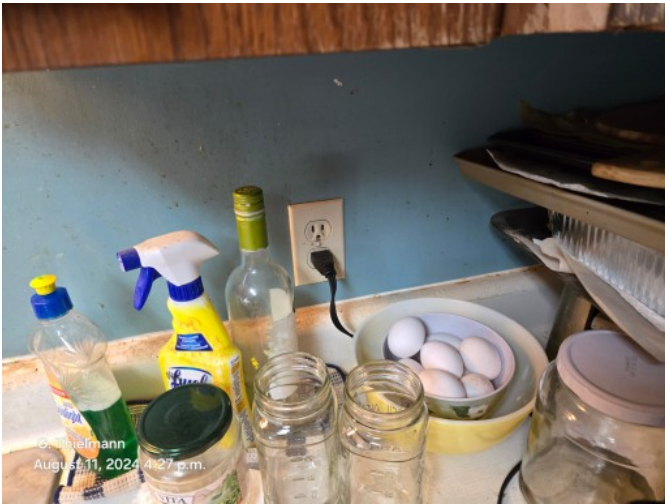
14.7 Electrical Conditions (Safety)

missing GFCI, GFCI protection is needed in potentially wet areas. consult a licensed and qualified electrical contractor.

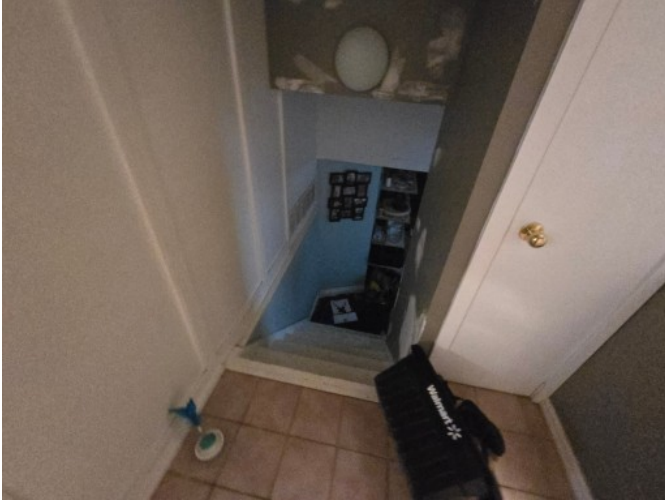
16.1 Basement Stair Conditions (Safety)

Missing or broken railing

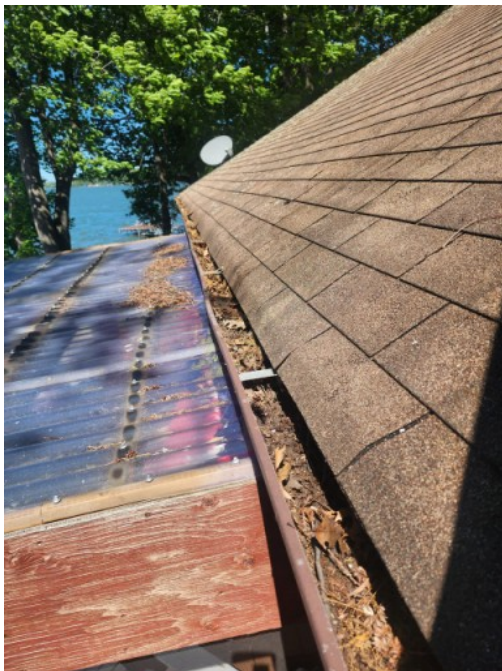
1.4) Gutter & Downspout Conditions

The gutters were filled with leaves and debris at the time of the inspection. Suggest cleaning and removal of debris on a regular basis. This condition can cause water penetration at the eave area.

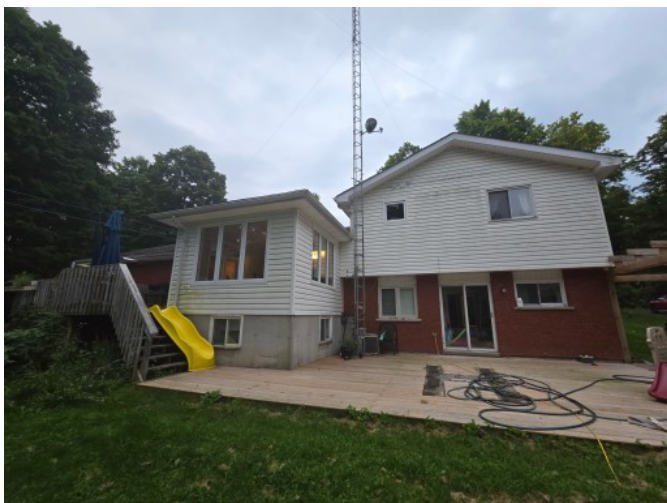
2.2) Back Entrance Conditions

The visible and accessible areas of the deck appeared to be in serviceable condition at the time of the inspection.

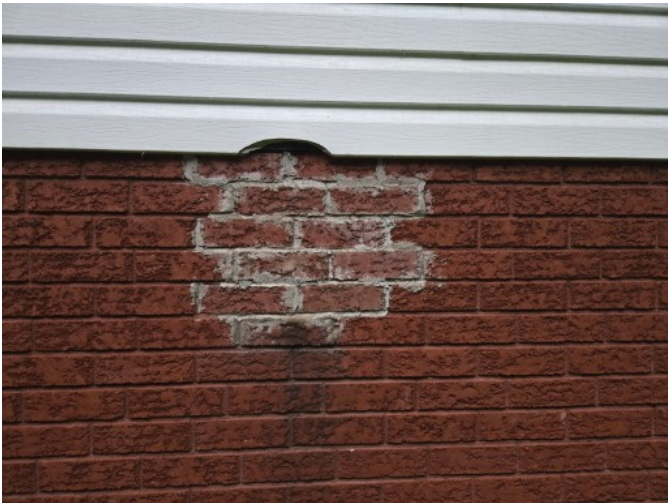
2.3) Exterior Wall Conditions

Previous repairs to brickwork

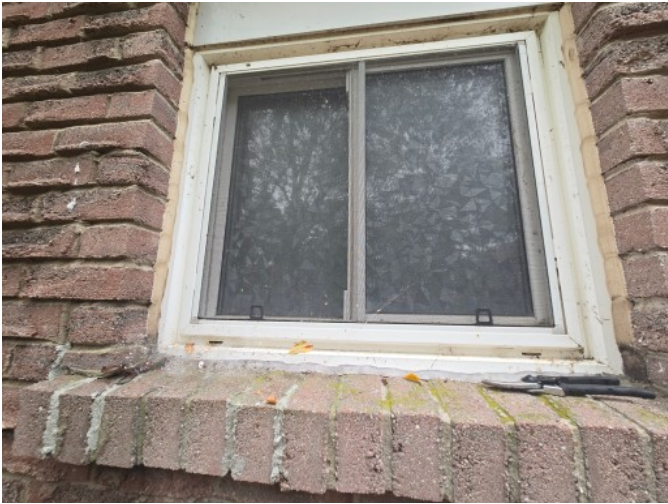
2.4) Window Conditions R

Exterior frame weathering and some deterioration was observed. Recommend repairs / maintenance as needed. Water penetration may have occurred.

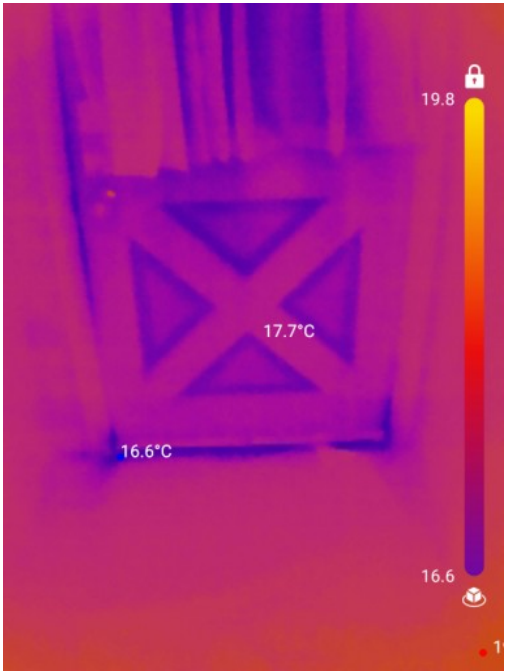
Thermal image of back entry door, showing signs of heat escaping around the bottom of the door

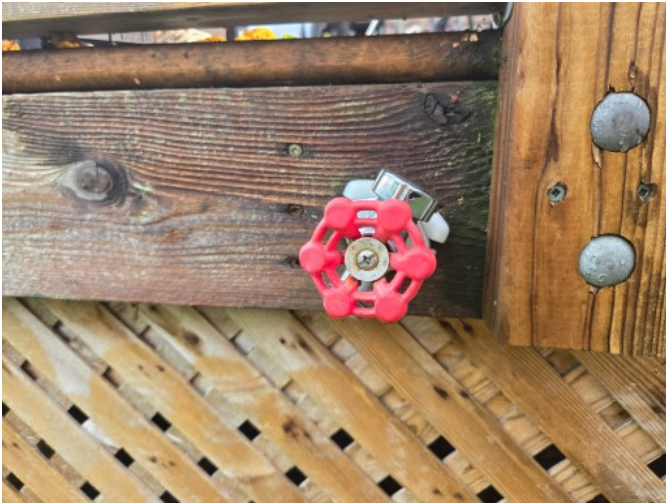
2.6) Faucet Conditions

The Hose Handle Leaked-Recommend Repairing or Replacing

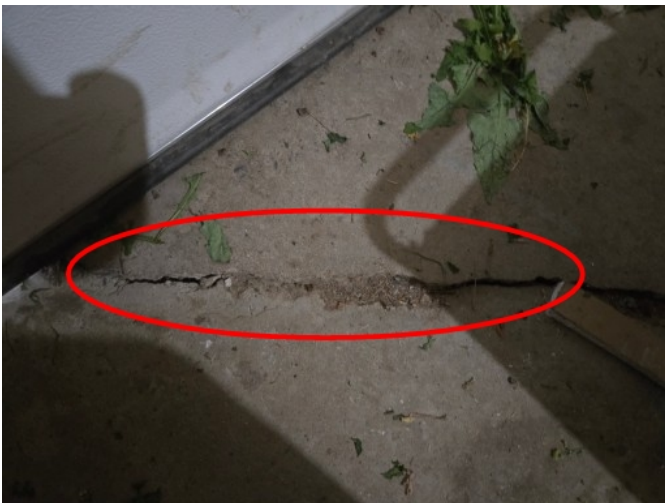
3.3) Floor Conditions

Minor cracking and/or settlement noted at the garage concrete floor surface. No immediate concern noted at this time. Suggest sealing cracks to reduce potential moisture penetrations.

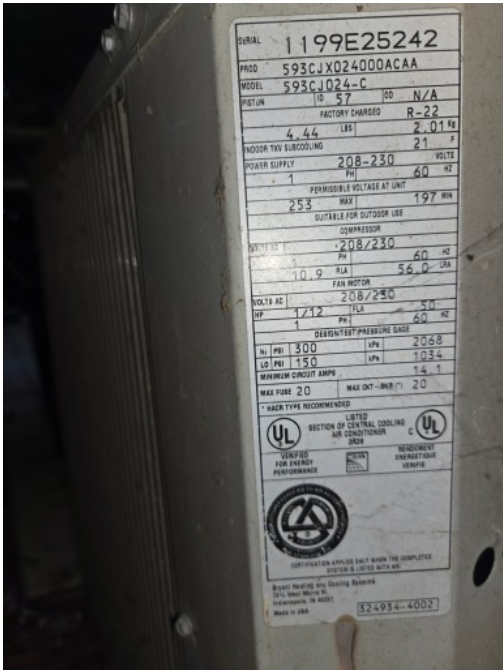
5.5) AC Unit Conditions

Appears to be in normal working order at the time of inspection. unit is charged with r-22, which may be difficult to find today as well as costly

Air conditioner unit label

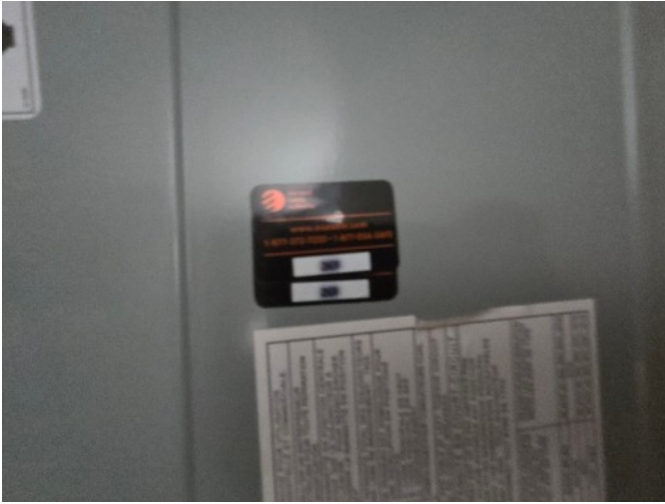
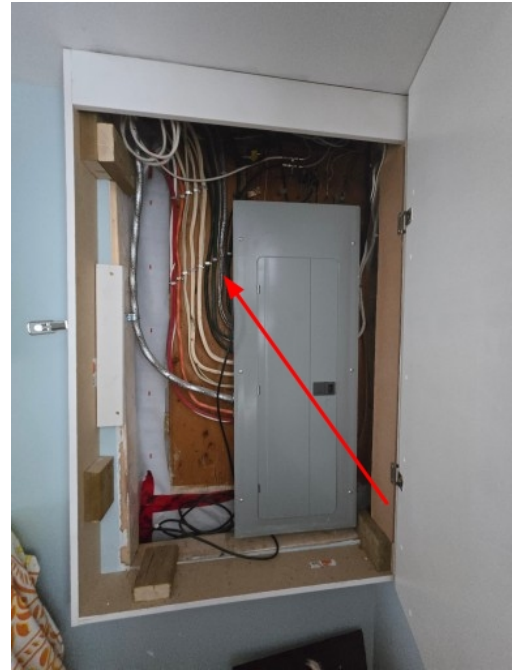
Aluminum branch circuit wiring

The main power cable is aluminum. The branch cables are copper. With the exception of some aluminum branch circuit wiring. It is suggested that a "Licensed Electrical Contractor" be contacted for further evaluation and repair.

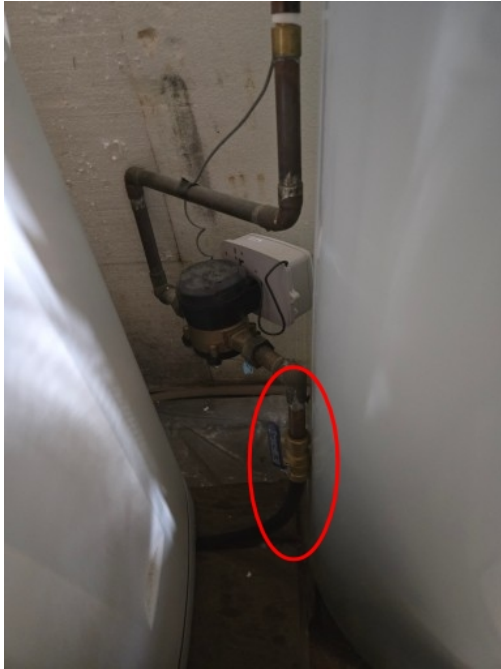
Main Service shutoff

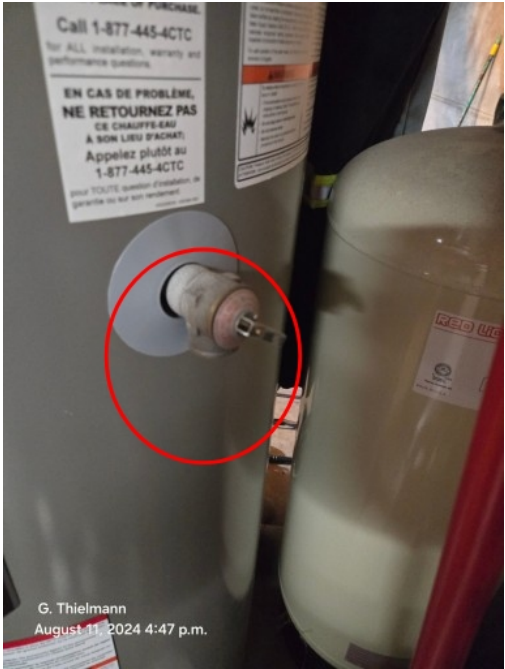
7.4) Water Heater Conditions R

T P R (temperature pressure relief) valve overflow pipe was missing at the time of the inspection. Recommend installation of an extension pipe for increased safety. consult a licensed plumber for additional information.

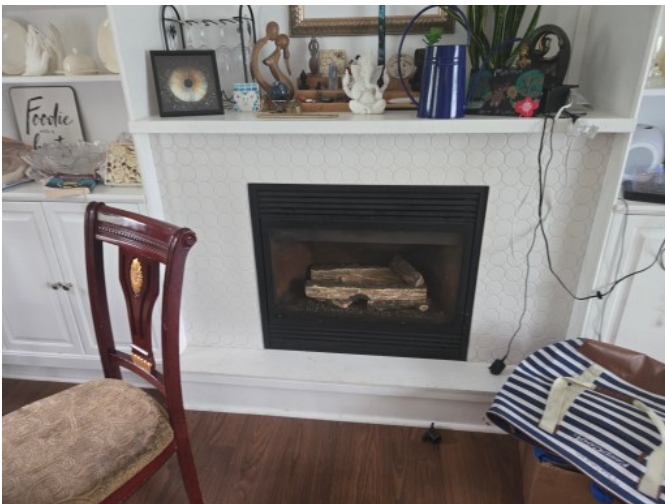
Fireplace**Fireplace Location**

A fireplace is located at the living room.

The fireplace is metal/pre-fabricated.

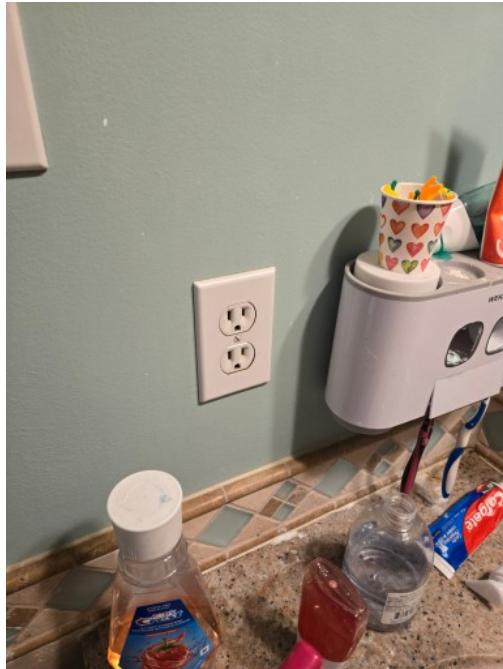
10.7) Electrical Conditions

GFIC (Ground Fault Interrupter Circuit) receptacle circuit (a safety device for outlets near water) recommended.

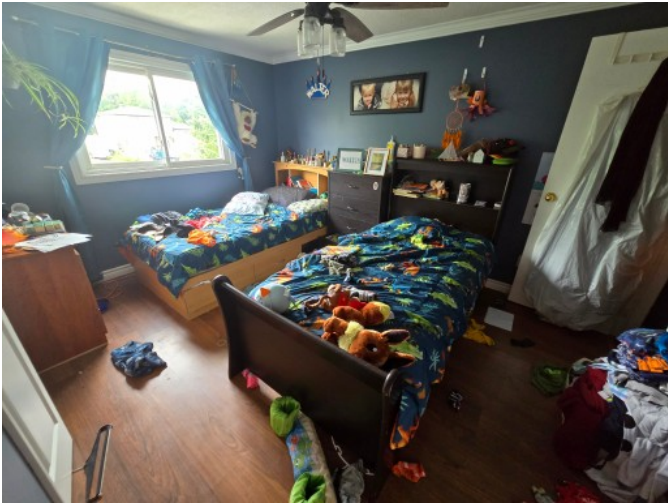
not all outlets were accessible for testing due to occupants belongings. the accessible outlets tested were in satisfactory condition

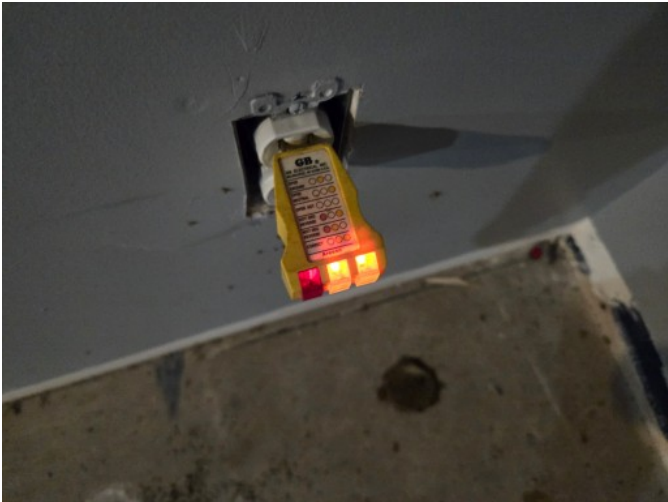
Missing receptacle or switch covers were observed . Recommend covers be installed for safety.

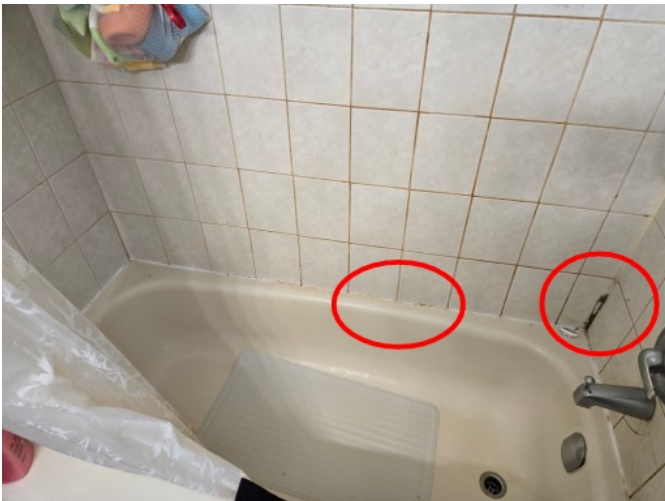
Caulking is recommended at the tub walls and or floors in bath . Conditions behind wall or under floor were concealed and not visible or accessible for inspection.

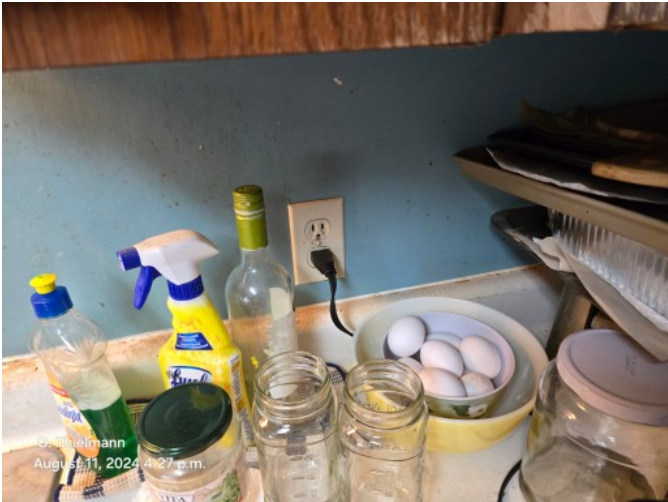
missing GFCI, GFCI protection is needed in potentially wet areas. consult a licensed and qualified electrical contractor.

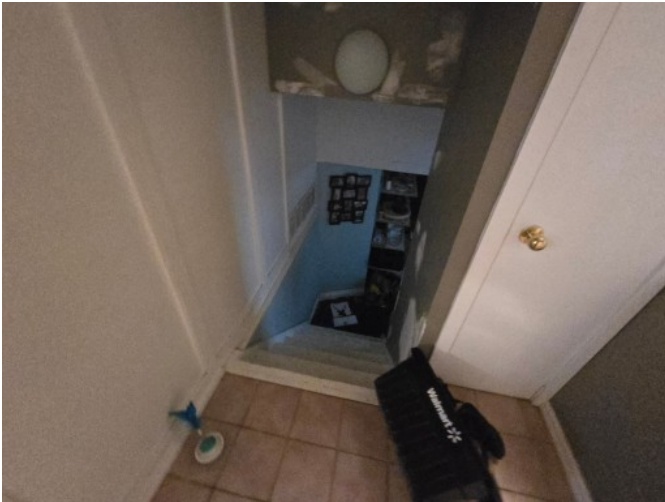
16 Basement**Walls - Ceilings - Floors****16.1) Basement Stair Conditions****S**

Missing or broken railing
