Inspection Report

Property Address:

1234 Street name
Anytown MN 55555

Lakeland Home Inspections

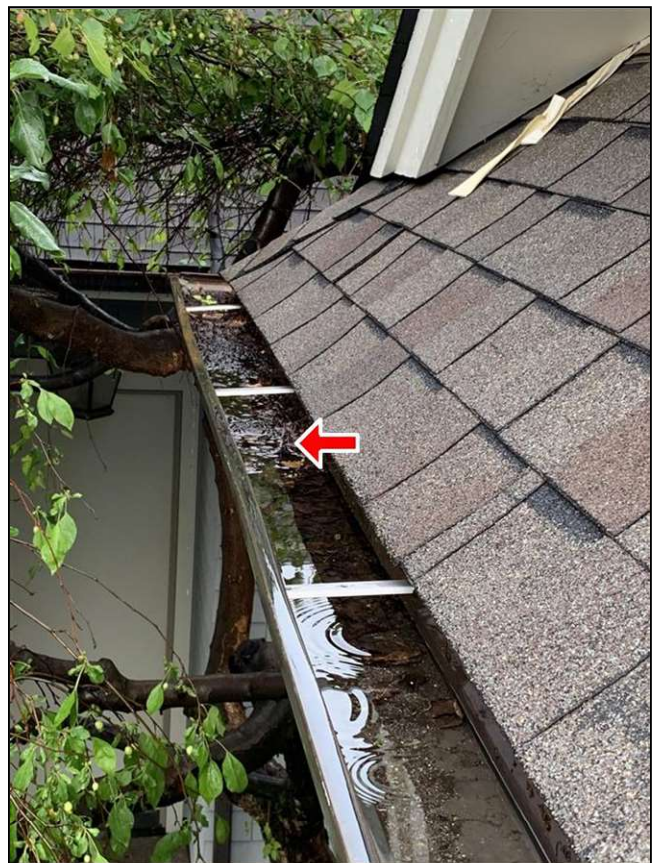
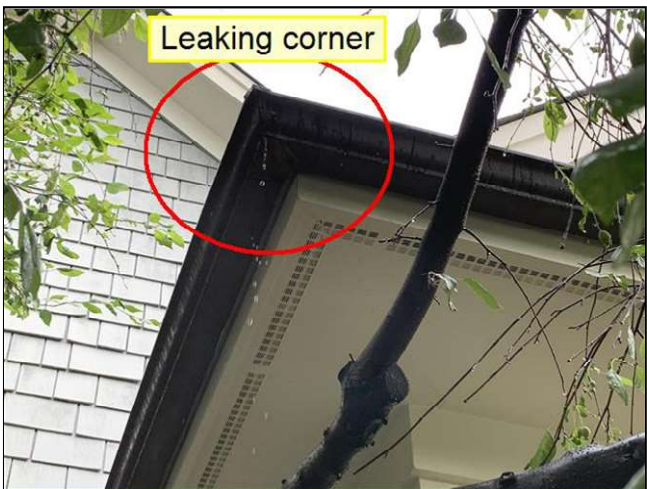
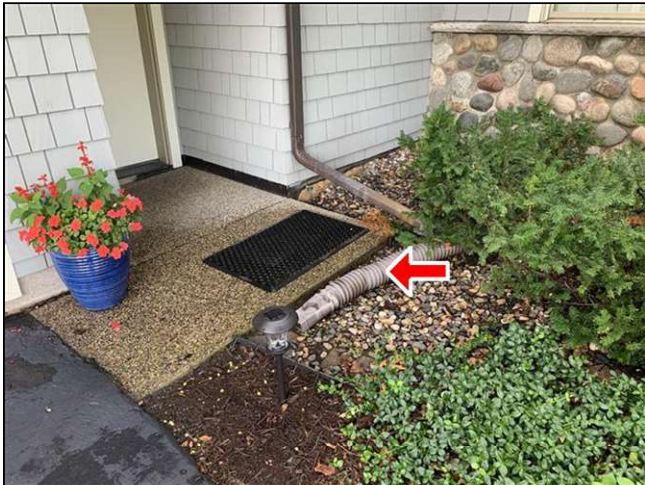
1.4 The gutters on the front of home are clogged and needs cleaning. Leaking corners were evident. The downspout in the front should be routed to another location.

- 1.4 Roof Drainage Systems (Gutters/Downspouts)
 Inspected, Repair or Replace
 The gutters on the front of home are clogged and needs cleaning. Leaking corners were evident. The downspout in the front should be routed to another location.
- 1.5 Roof Structure and Attic (report leak signs or condensation)
 Inspected, Repair or Replace
 The chimney has some rotted trim resulting in leaks around the chimney chase and on the roof sheathing.

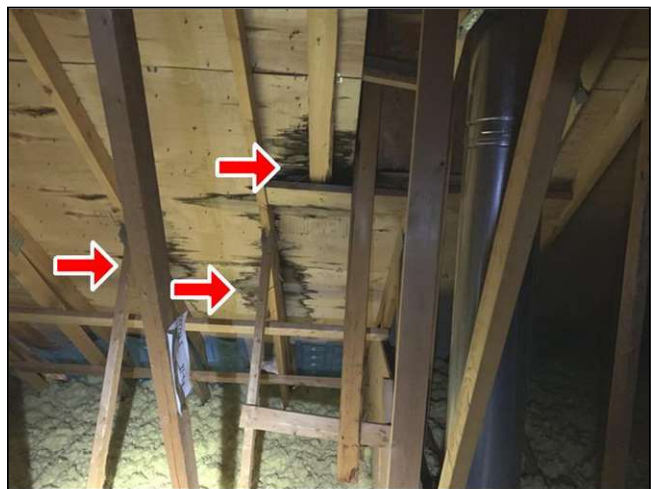
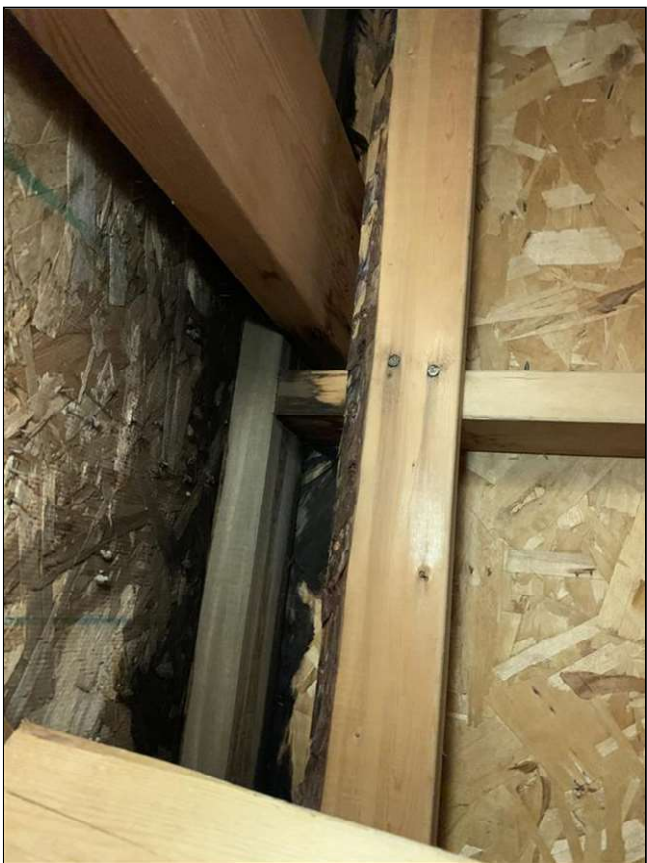
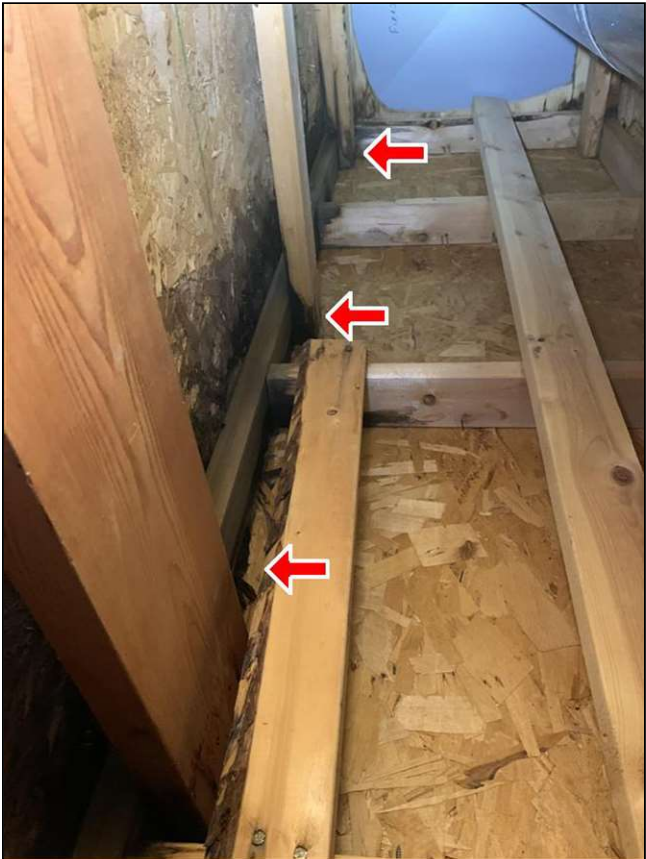
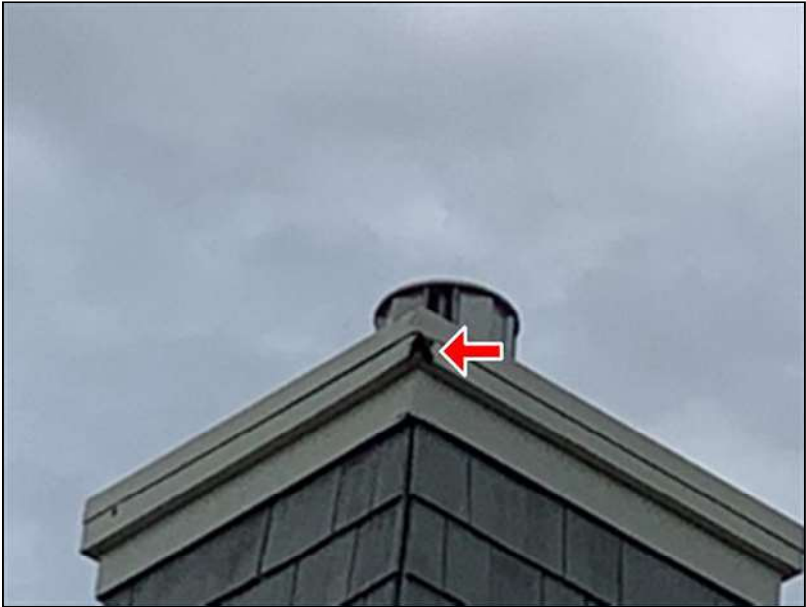
1.5 The chimney has some rotted trim resulting in leaks around the chimney chase and on the roof sheathing.

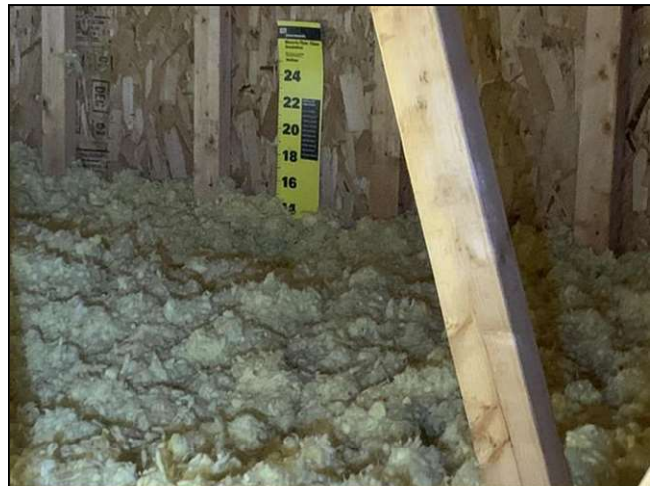
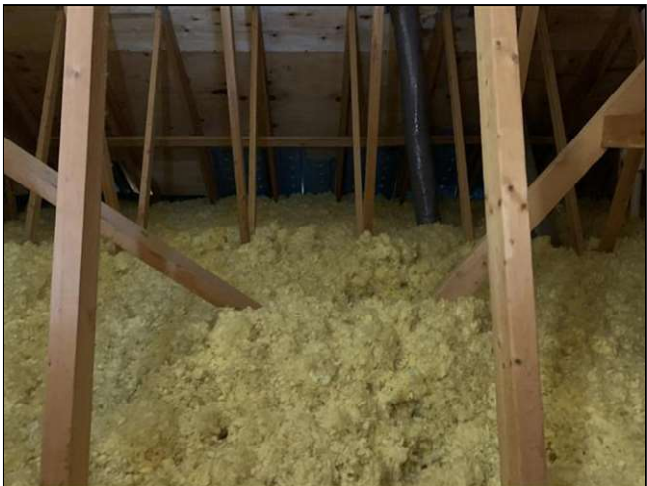
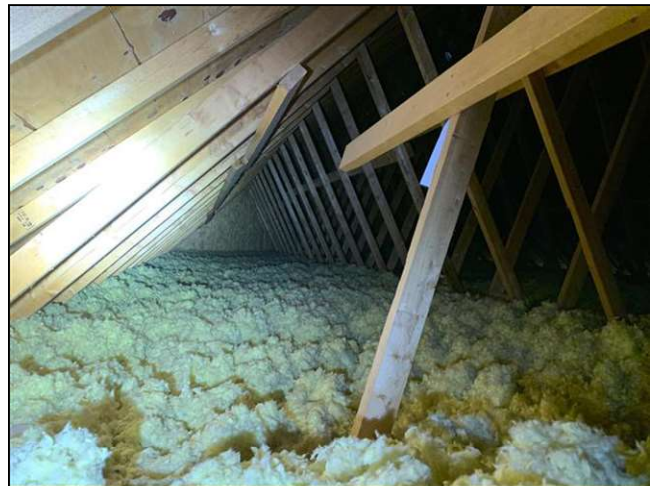
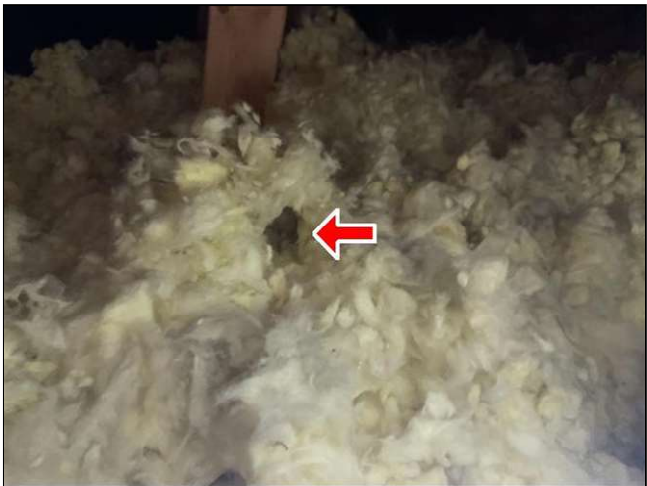
1.7 The attic insulation is adequate at about 16 inches thick and approximately R44. Evidence of rodent activity in the attic.

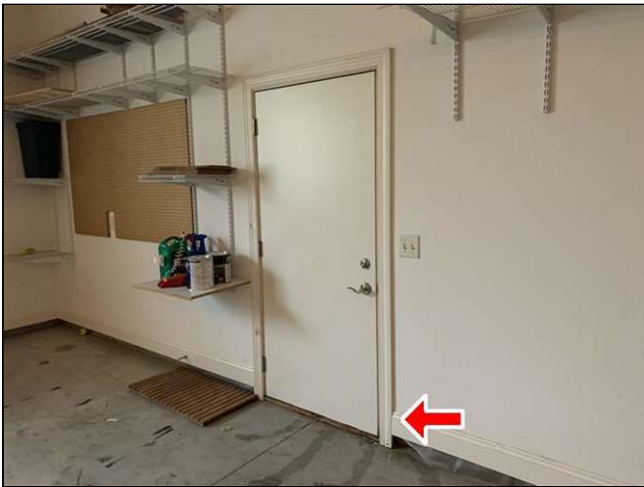
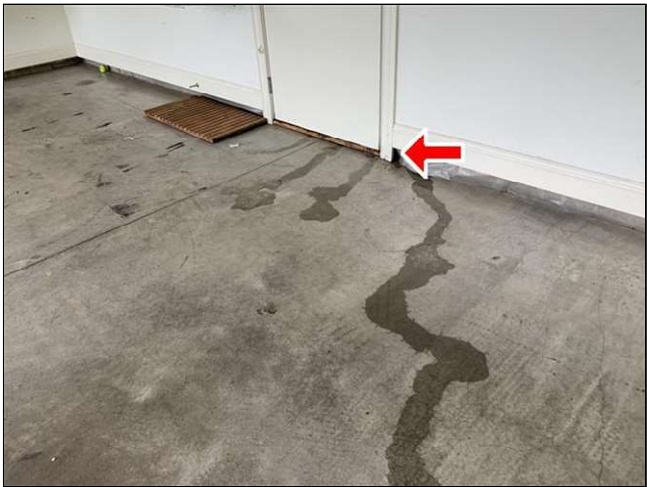
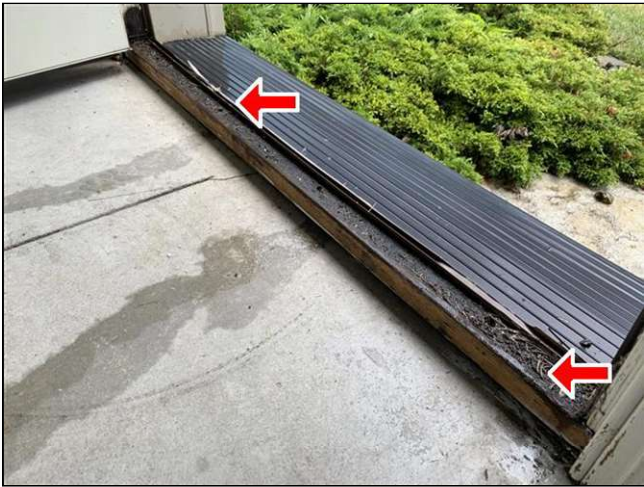
2.1 The garage service door threshold was rotted and deteriorated resulting in water intrusion.

The garage service door threshold was rotted and deteriorated resulting in water intrusion.

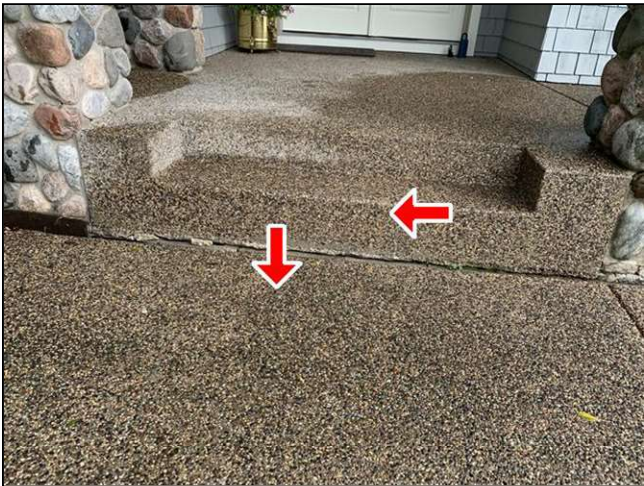
2.3 Item 1(Picture)

+ 2.3 The front entry concrete has settled resulting in uneven steps. Trip hazard.

The front entry concrete has settled resulting in uneven steps. Trip hazard.

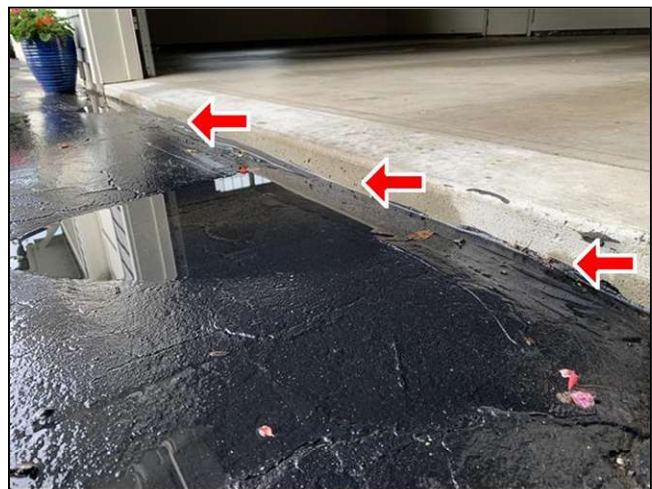
2.4 Item 1(Picture)

2.4 The driveway apron has settlement and will eventually need repair.

The driveway apron has settlement and will eventually need repair.

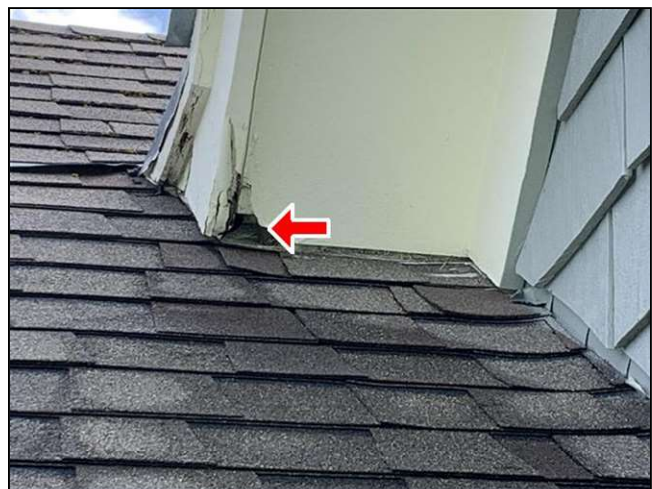
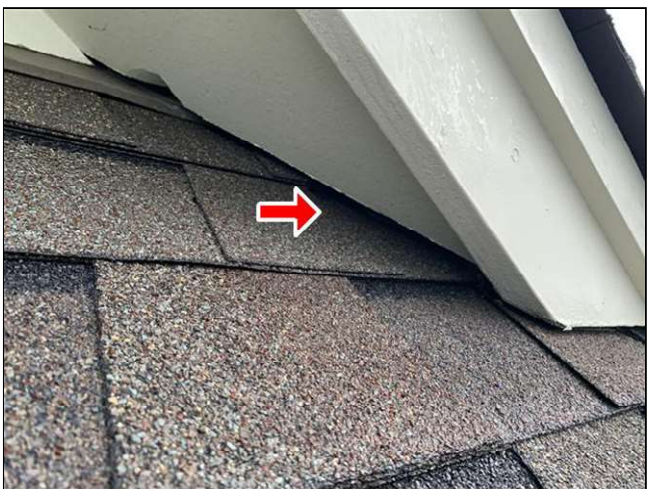
2.5 Gaps in the soffits are areas for rodent entry. Recommend sealing and gaps.

Gaps in the soffits are areas for rodent entry. Recommend sealing and gaps.

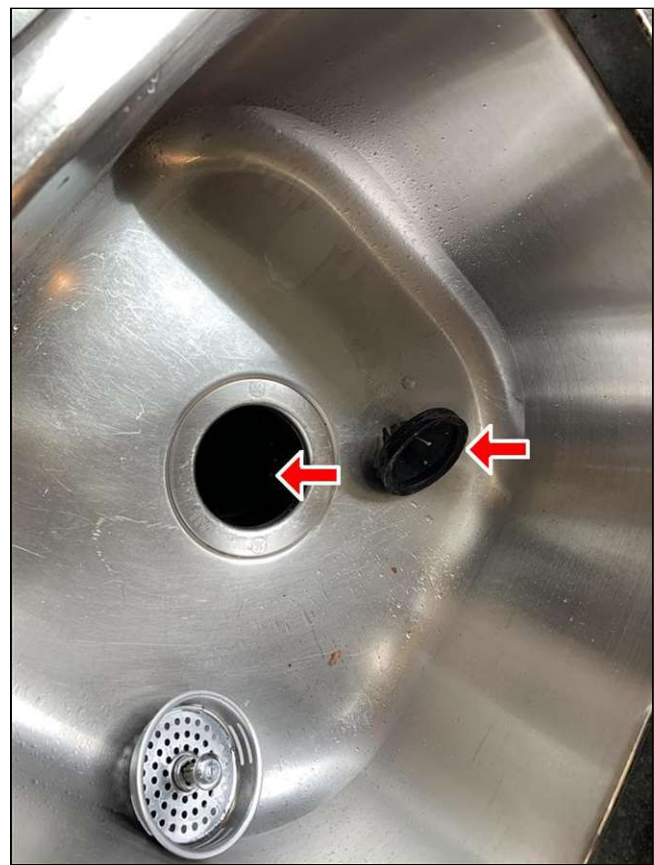
4.12 Item 1(Picture)

4.12 The disposal flange has failed and needs replacement.

The disposal flange has failed and needs replacement.

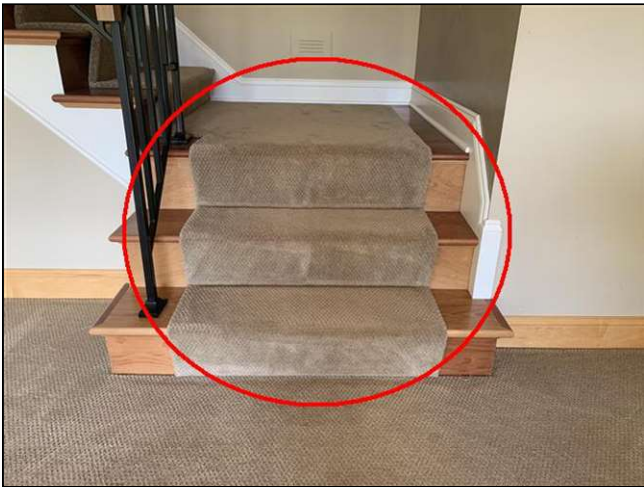
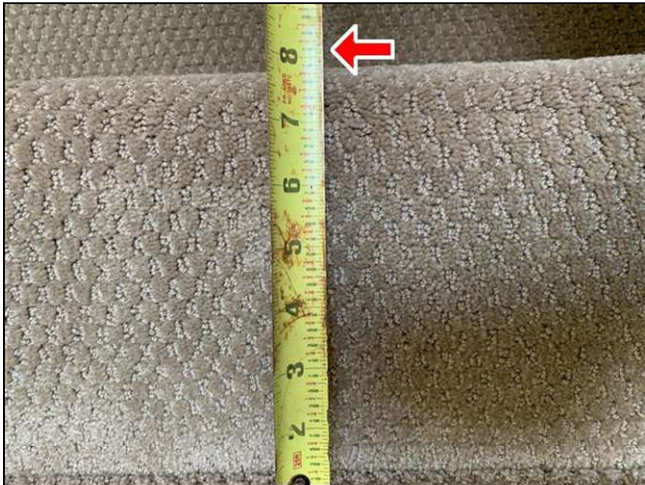
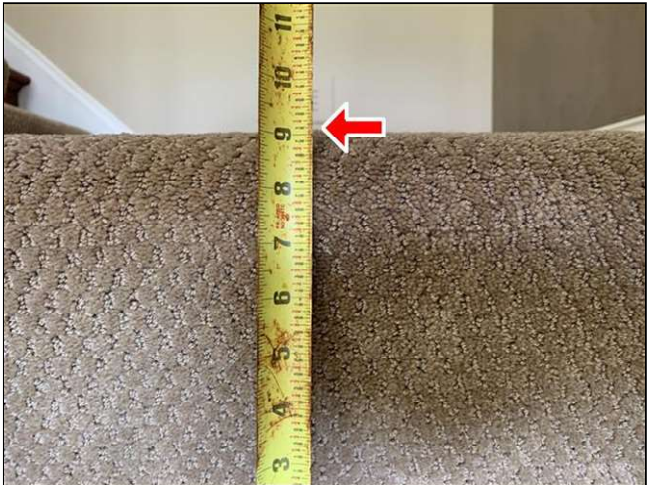
**5.3** The bottom 3 steps all have uneven heights. Trip hazard.

The bottom 3 steps all have uneven heights. Trip hazard.

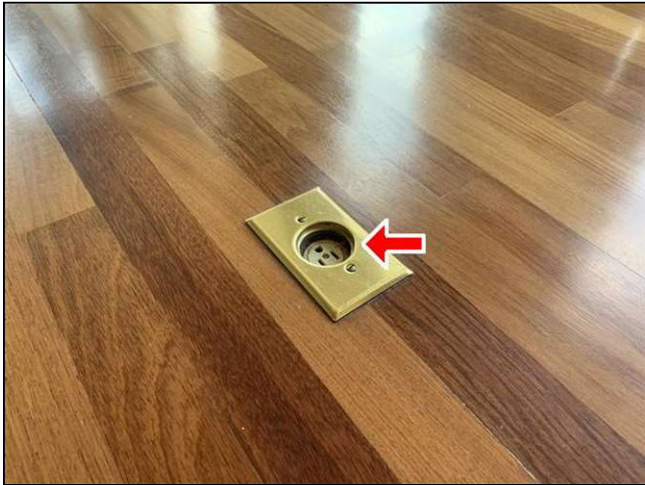
5.6 Item 1(Picture)

5.6 Floor outlet needs a cover plate

Floor outlet needs a cover plate

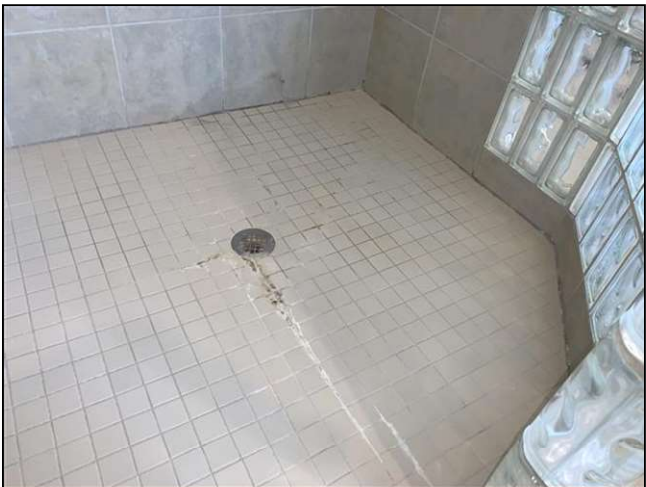
6.2 Item 1(Picture)

6.2 The master bath shower floor tiles are cracked and have been caulked. Replacement will likely be needed.

The master bath shower floor tiles are cracked and have been caulked. Replacement will likely be needed.

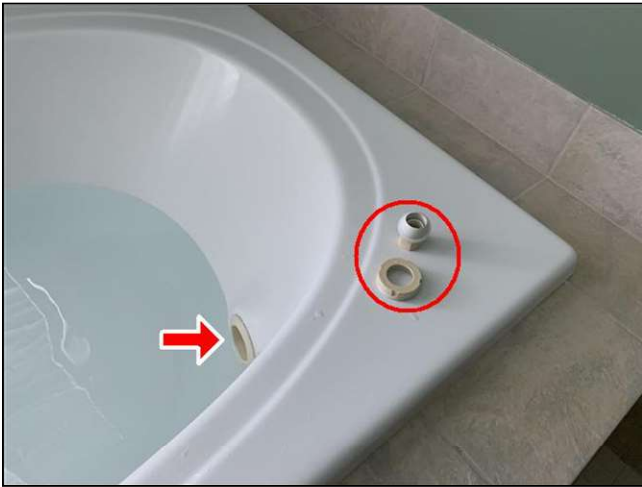
6.7 Item 1(Picture)

6.7 The master bath whirlpool tub jet port needs t be reconnected.

The master bath whirlpool tub jet port needs to be reconnected.

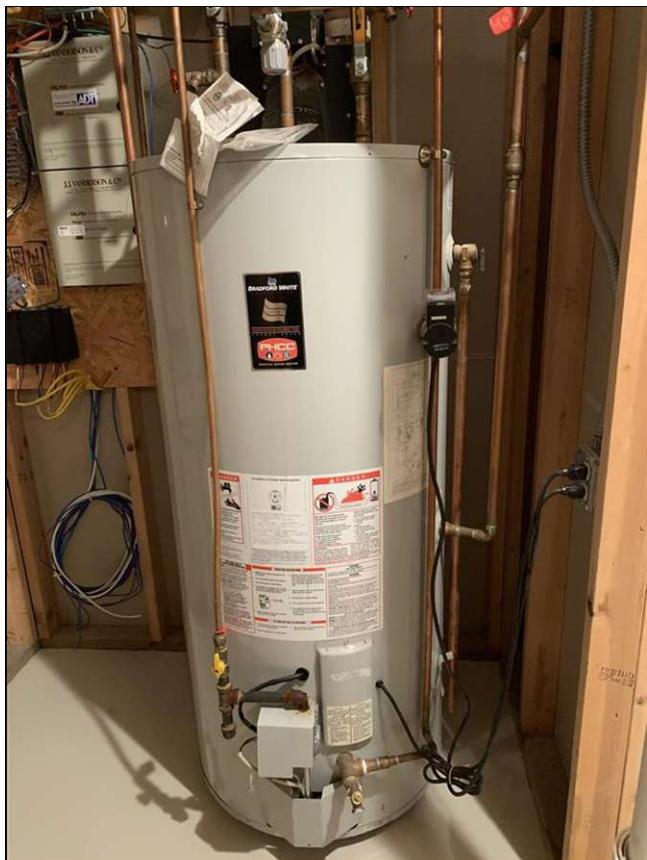
8.2 Item 1(Picture)

8.2 The water heater is 18 years old and in normal working condition but nearing the end of useful life, budget to replace within the next 5 years.

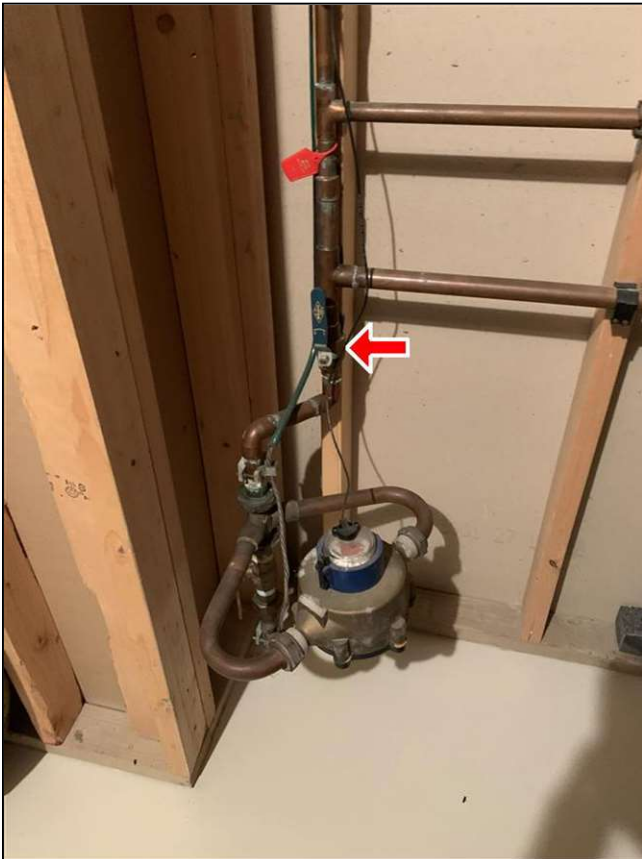
8.3 Item 1(Picture)

8.3 The main water shut off is located in the basement.

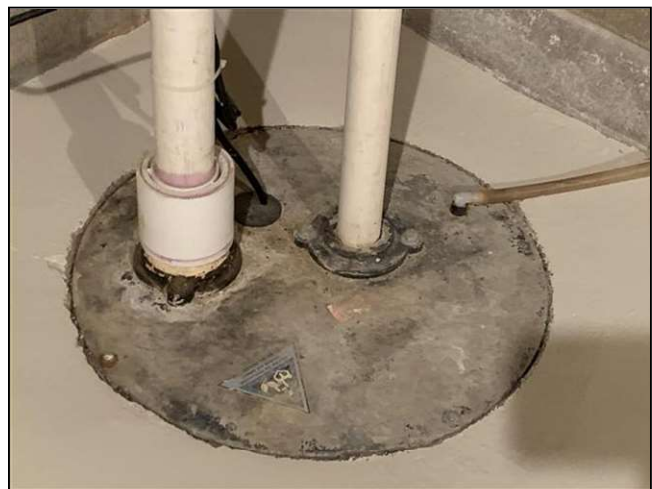
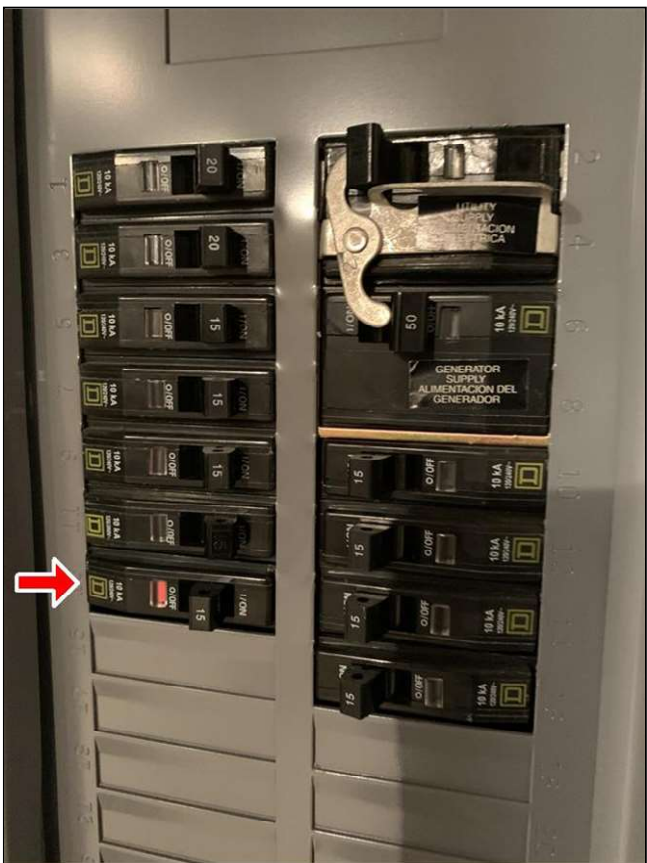
8.6 The sump pump did not operate properly, the circuit breaker trips. Sump pump replacement needed.

The sump pump did not operate properly, the circuit breaker trips. Sump pump replacement needed.

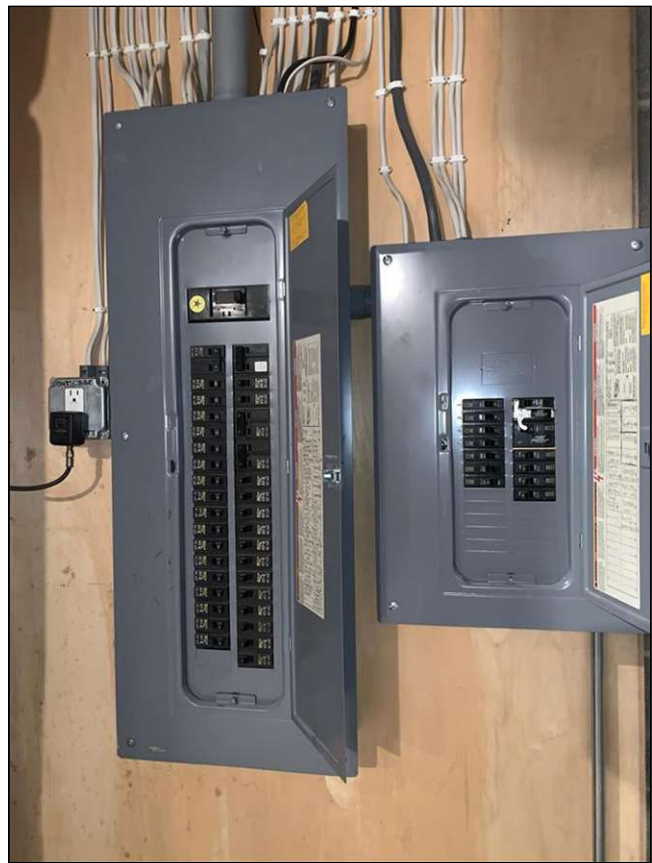
9.5 Item 1(Picture)

9.5 The main panel box is located at the basement.

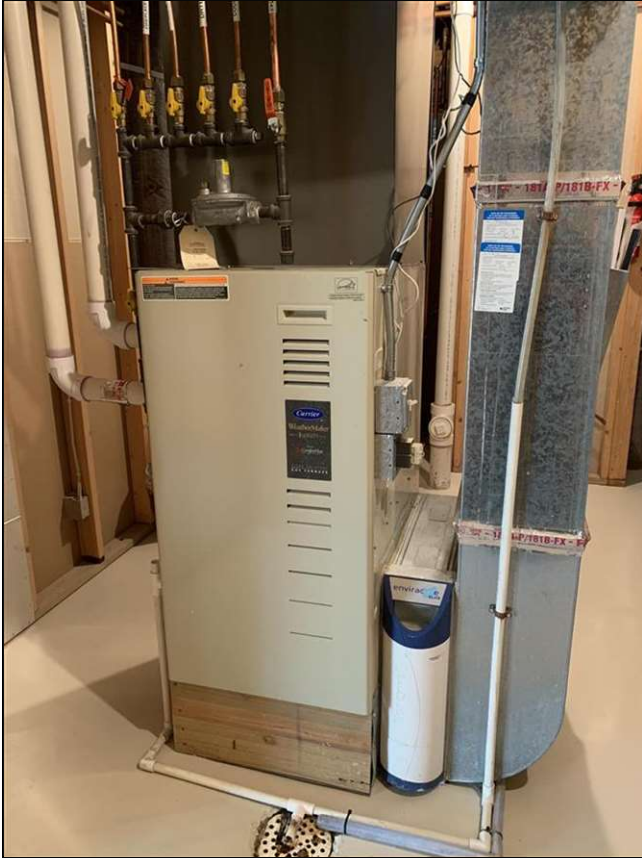
10.0 Item 1(Picture)

10.0 The furnace was in normal working condition at the time of the inspection. Furnace was 18+ years old and nearing the end of its useful life, budget to replace in the next five years.

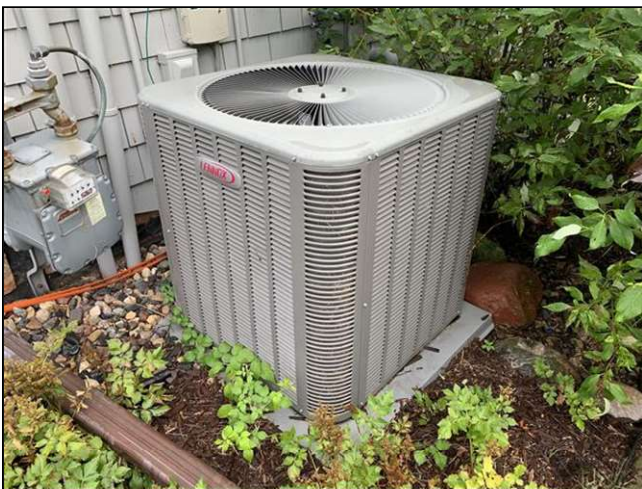
10.7 Item 1(Picture)

10.7 The AC unit was in normal working condition at the time of the inspection.
