Permeable Pavement Alleys
City of Cudahy, Wisconsin

Permeable Pavement Alley Program

Blast-furnace Slag as Storage Gallery Media

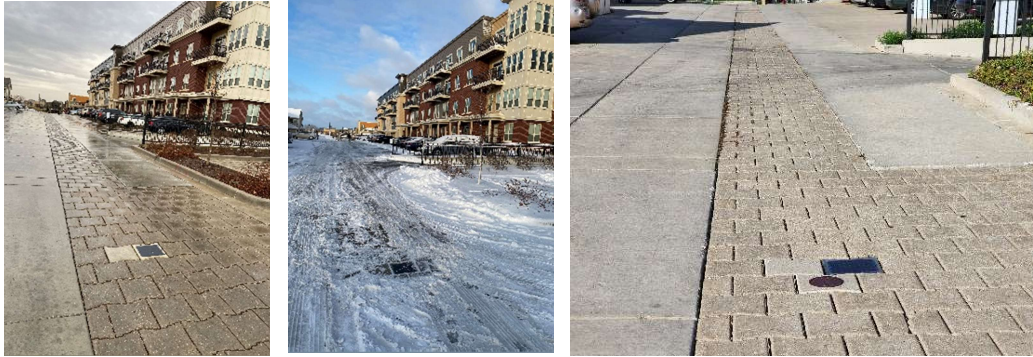
Squire Apartments

May-September 2022 - Volume Calculations - Squire		
24 Hr Rainfall Event	Rainfall	Volume Captured
No.	(in)	(gal)
1	0.8	0
2	0.77	90
3	0.25	0
4	1.8	4609
5	0.34	747
6	0.72	4962
7	1.51	10257
8	0.77	0
9	1.75	12847
10	0.34	1434
11	0.54	3916
12	1.03	7490
13	1.51	9600
14	0.43	1340
15	5.69	19568
Totals	18.25	76860

76,860 Gallons of Runoff Captured & Infiltrated
(no underdrain discharge)

TSS Removed: 75.7 lbs

TP Removed: 0.21 lbs

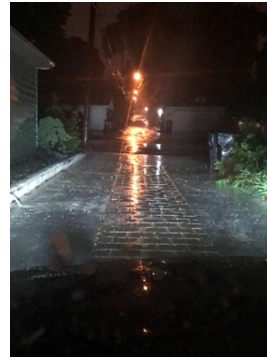
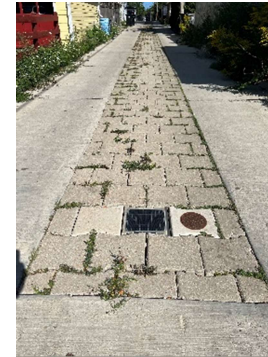
Van Norman Alley

Visual Inspections are Misleading
(NO maintenance in two years – NO degradation)

January 2020

August 2022

Visual Inspections are Misleading
(NO maintenance in two years – NO degradation)

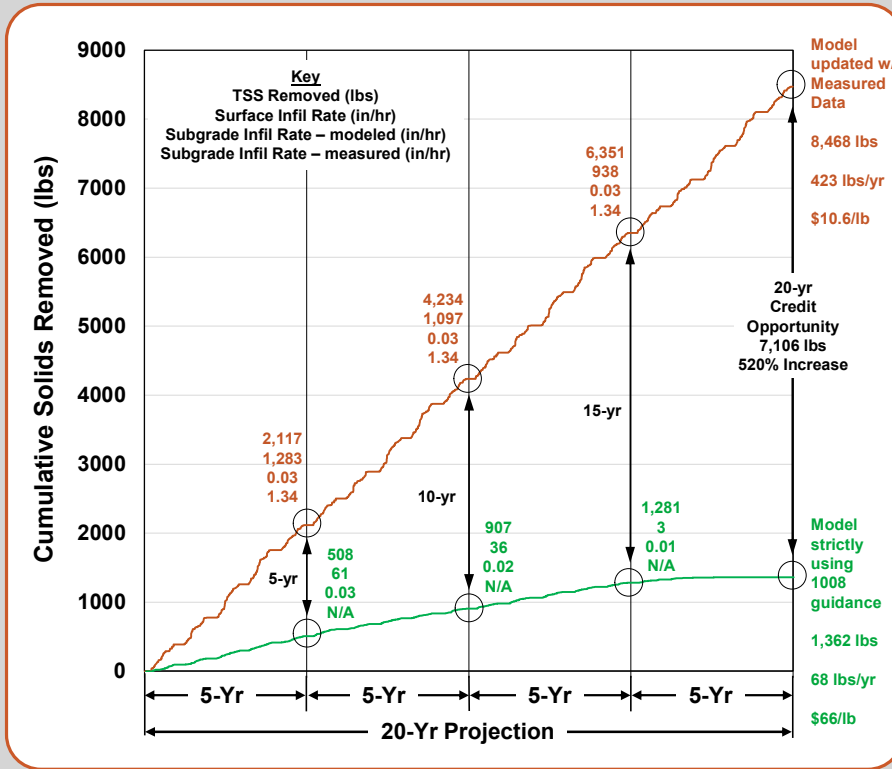
Van Norman Alley Estimated Pollutant Removal

**BMP Area for Van Norman Alley:
4200 sf (0.096 acre)**

423 lbs/year removed if modeled using data measured by P4.

4,406 lbs/BMP-acre removal efficiency

TSS Removal Cost: \$10.60/lb

68 lbs/year removed if Van Norman is modeled strictly following 1008 guidance.

708 lbs/BMP-acre removal efficiency

TSS Removal cost: \$66/lb

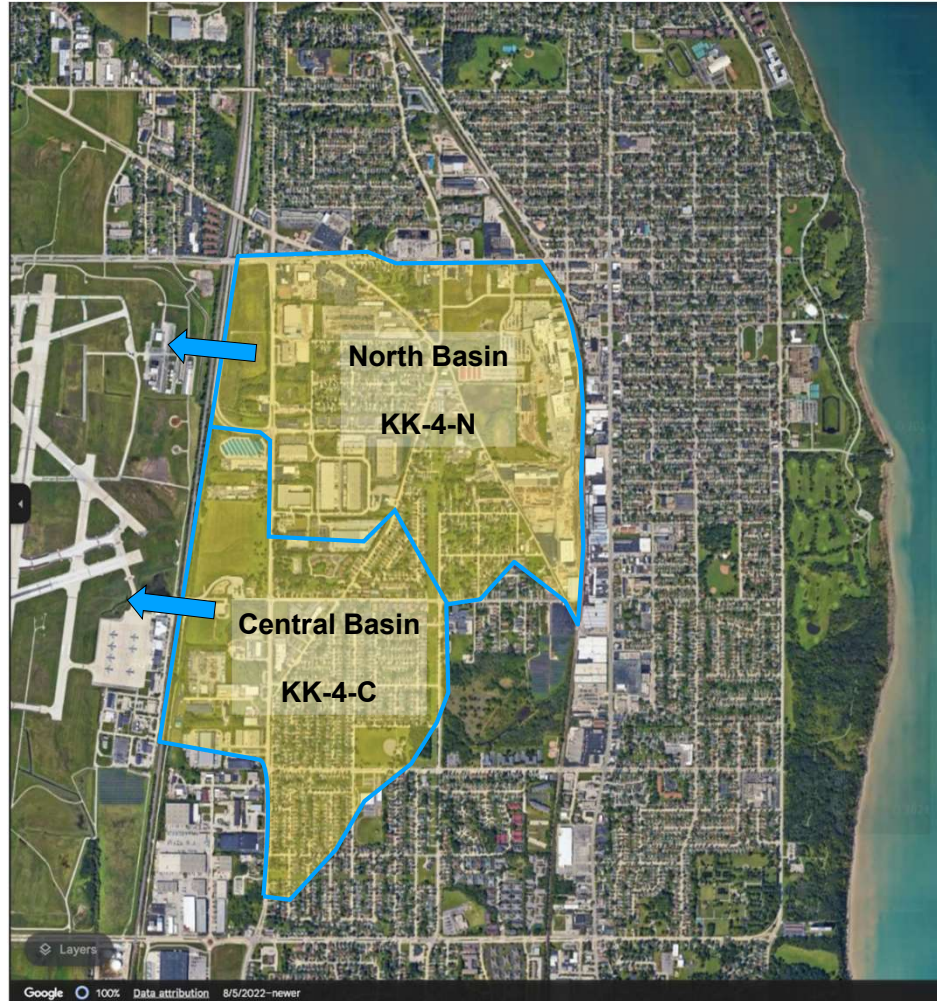
Cudahy Basins Draining to Kinnikinic River Watershed

KK River Watershed Goals:

Remove 80% TSS and 88% TP

North Basin No Controls:

233,654 lbs TSS

Central Basin No Controls:

142,873 lbs TSS

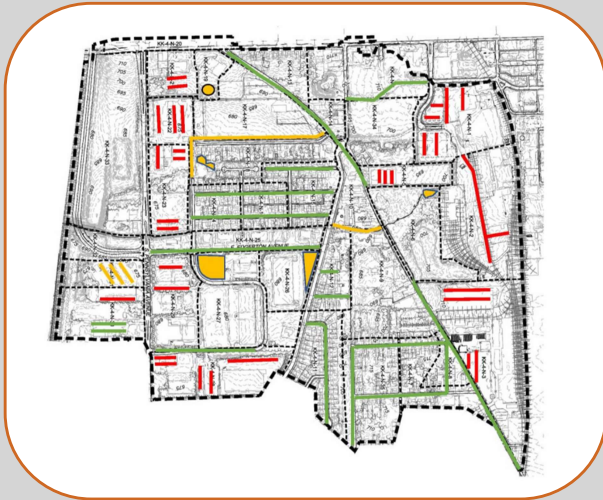
North Basin Watershed Area: 590 Acres

BMP Area Required using 5:1 Run-On: 118 Acres
Estimated Cost: \$110.1M

Area Required using Instrumentation: 13.3 Acres
Estimated Cost: \$12.4M

1. 5:1 Run-on areas required by 1008 guidance (118 acres in North Basin and 70 acres in Central Basin) are not physically available for permeable pavement construction.
2. BMP areas proposed using instrumentation (13.3 acres in North Basin and 8.1 acres in Central Basin) are shown in green on maps.
3. Ask P4 how to get DNR acceptance of run-on violations.

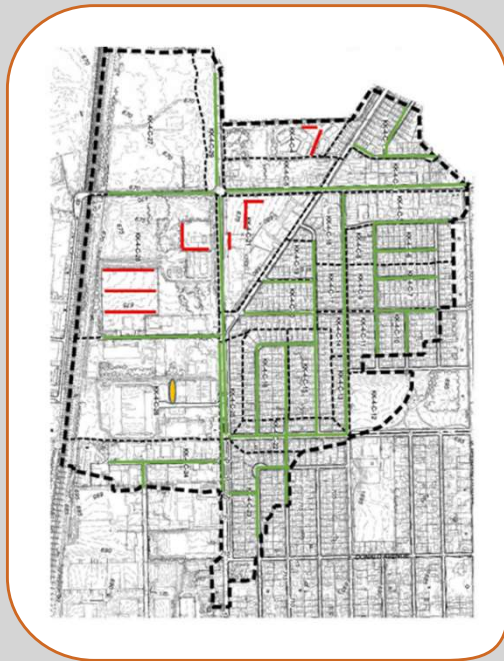
Central Basin Watershed Area: 351 Acres

BMP Area Required using 5:1 Run-On: 70 Acres
Estimated Cost: \$65.3

Area Required using Instrumentation: 8.1 Acres
Estimated Cost: \$7.6M
