Westbrook/Old Saybrook boundary

#### Shoreline and Marsh Retreat

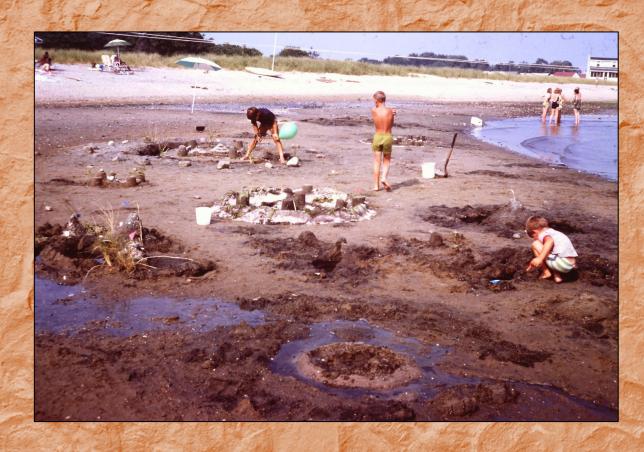
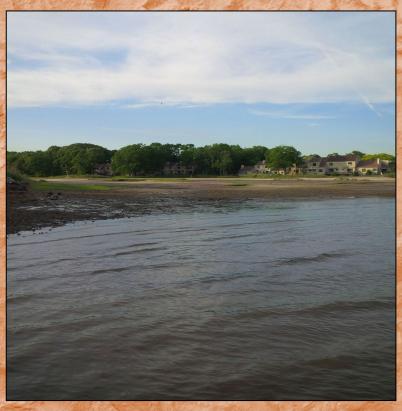
Low Tide 1972 showing 8' Beach Head

Low Tide 2021, same view

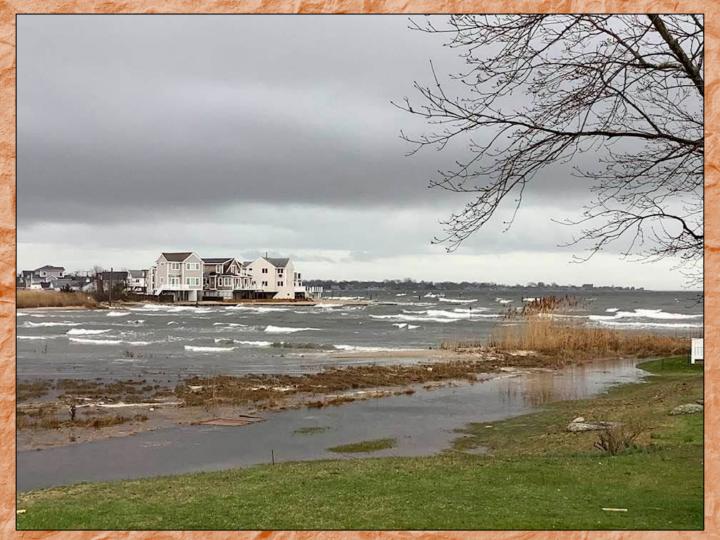
View East at Cold Spring Brook, inland incursion of tide

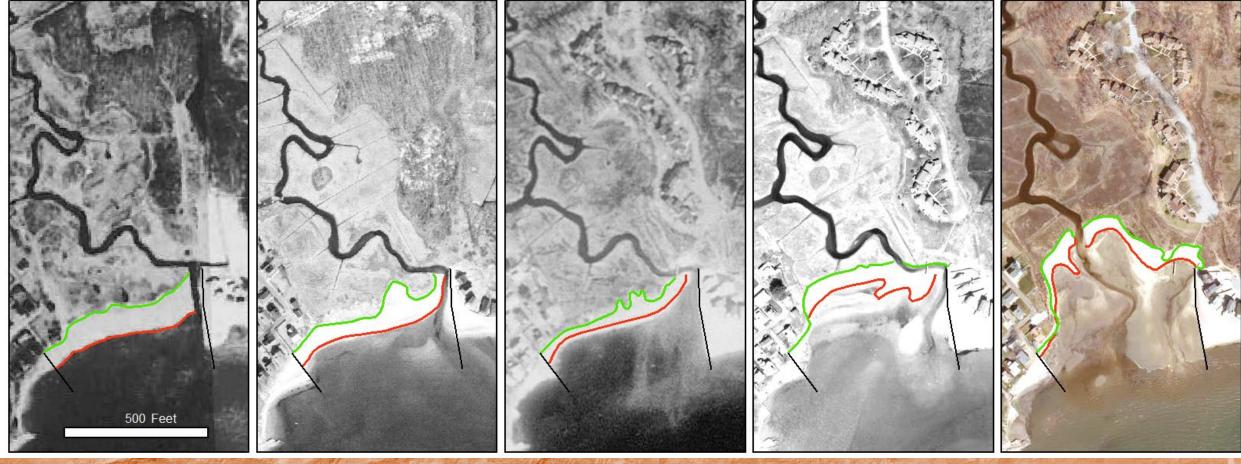
1934 1965 1990 2004 2016

- Marsh edge (green) and shoreline (red) retreat with time
- Accelerated in early 2000's after beach berm breached

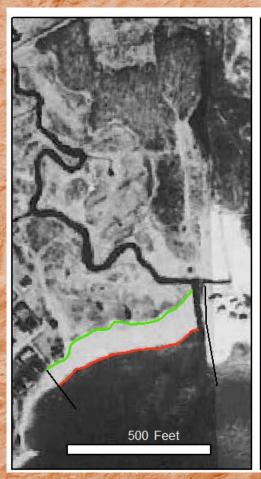
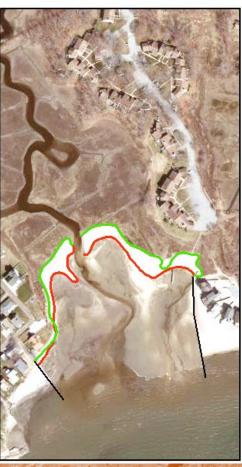
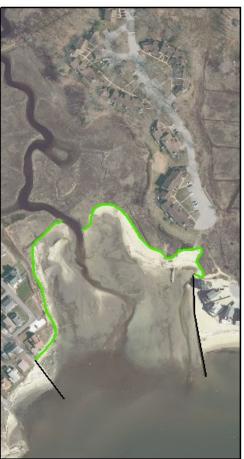
1934

2004

2016

March 21, 2022

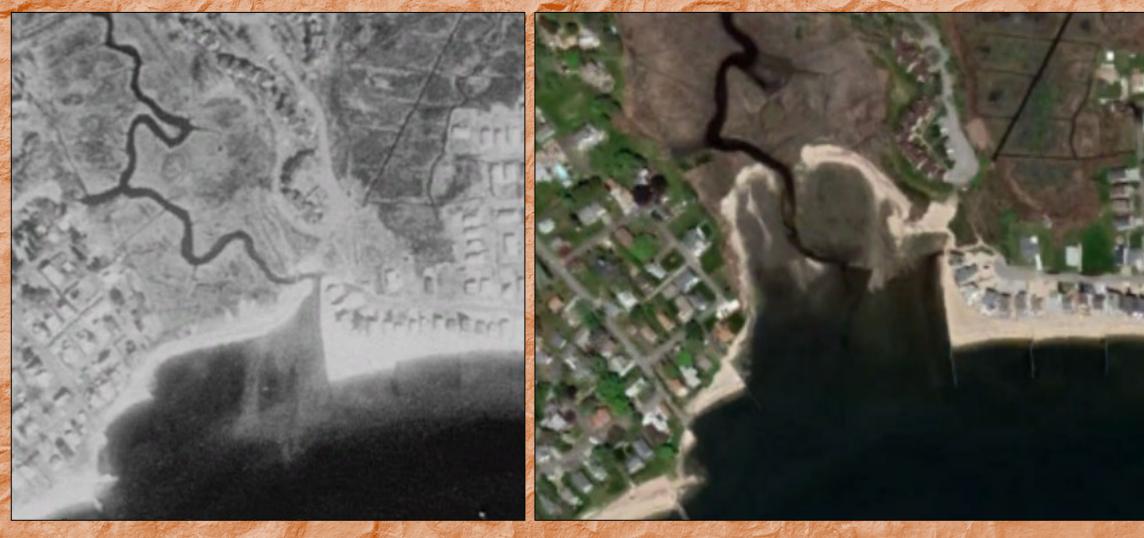
1991 2021

- With retreat, creek straightens and widens
- Tides are now swifter, waters saltier
- Both creek and marsh habitat area reduced

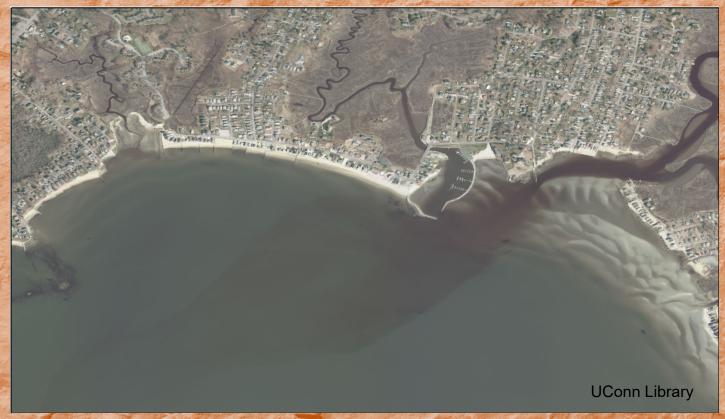
- Drowned rivers
- Sand from erosion of glacial till
- Sand trapping by groins and jetties (see Bohlen 2002)

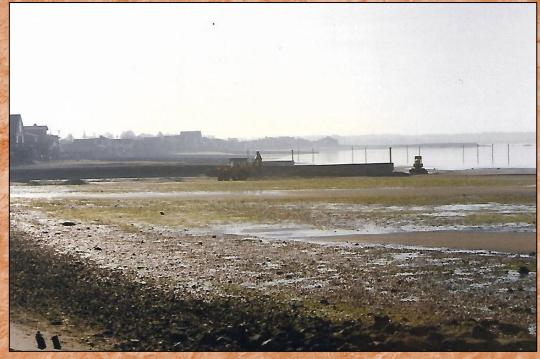
Excavation of sand for Chalker
 Beach replenishment, June 1991

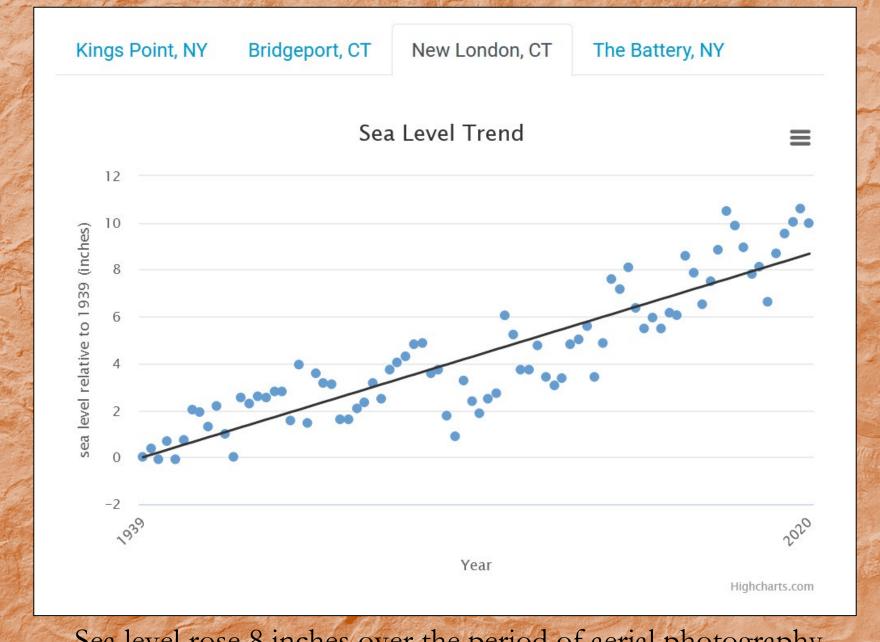
Sea level rose 8 inches over the period of aerial photography
