# Sample Education Technical Site Assurance Report

## Education Redevelopment, Gosford Hill

<b>Report reference</b>	Sample GHS-20	<b>Inspection period</b>	March 2026
<b>Project</b>	Gosford Hill	<b>Sector</b>	Education
<b>Report type</b>	Clerk of Works / Technical Site Assurance	<b>Project stage</b>	Temporary school accommodation and live site works
<b>Primary focus</b>	Temporary works, modular construction, firestopping and fit-out progress	<b>Status</b>	Anonymised sample
<b>Prepared by</b>	ITSA Ltd	<b>Public issue</b>	Names, appointment details and sensitive data redacted

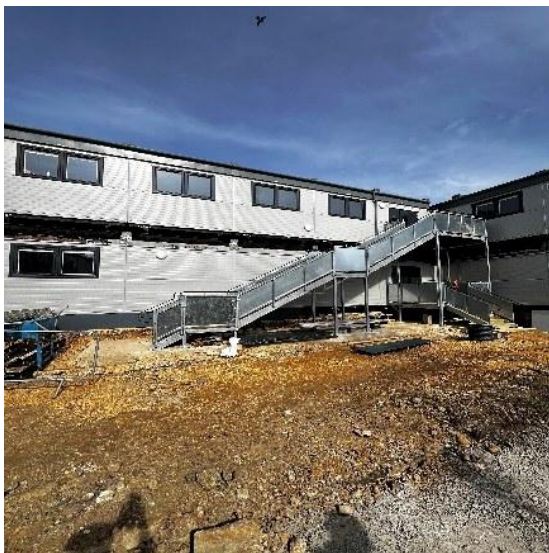
Temporary modular accommodation and external works interface

<b>Observation</b>	Works to the temporary modular school accommodation were progressing, with modular unit installation, rainwater goods, perimeter skirting and internal fit-out works advancing in sequence. Mechanical and electrical installations were taking shape internally, with decoration commencing in selected areas and further work expected as remaining modules were delivered.
<b>Risk / implication</b>	Incomplete verification can affect safeguarding, safe occupation, compartmentation integrity, compliance evidence and handover readiness.
<b>Recommended action</b>	Continue cross-checking installation against the approved layout, fire strategy, service integration requirements and handover programme.

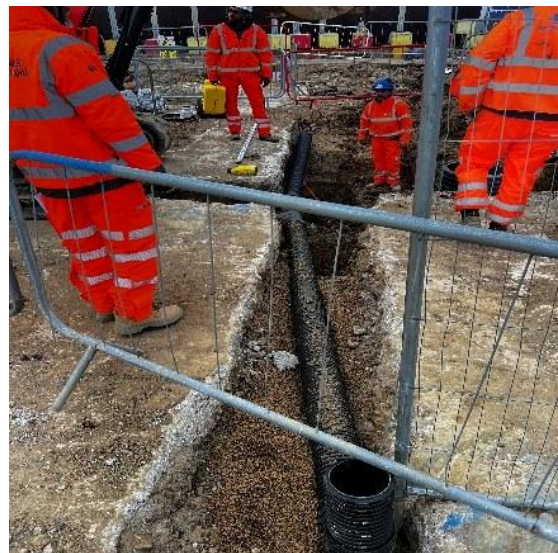
Below-ground services and segregated excavation zone

<b>Observation</b>	Groundworkers were progressing below-ground services, including ducting and drainage within open trenches. Temporary barriers and bridging arrangements were used to maintain safe access. These arrangements appeared controlled, but temporary access over excavations should be verified for stability, load capacity and inspection requirements.
<b>Risk / implication</b>	If groundworkers progress below-ground services using an uncertified temporary bridge without an approved temporary works design, incomplete verification can compromise site safety and increase risk of injury.
<b>Recommended action</b>	Ensure temporary works are captured within the temporary works register and that trench protection, barriers, bridge supports and access routes remain inspected and suitable.

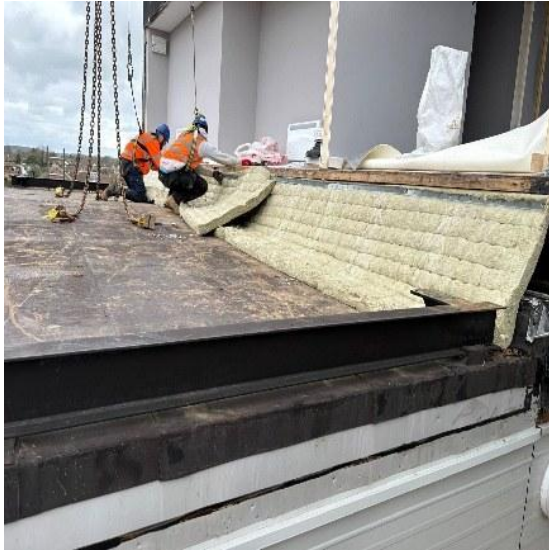
Fire barrier installation at modular roof interface

<b>Observation</b>	Firestopping to cavities and junctions between modular units was reviewed. The inspected approach included mineral wool fire barrier material, fire-rated board and intumescent sealant. The principle appeared appropriate, but final compliance depends on continuity, correct product use, installation quality and supporting manufacturer or specialist evidence.
<b>Risk / implication</b>	Incomplete verification can affect safeguarding, safe occupation, compartmentation integrity, compliance evidence and handover readiness.
<b>Recommended action</b>	Require the approved detail, photographic records and installation sign-off before closure. Monitor completed firestopping to ensure it is not disturbed by follow-on trades.

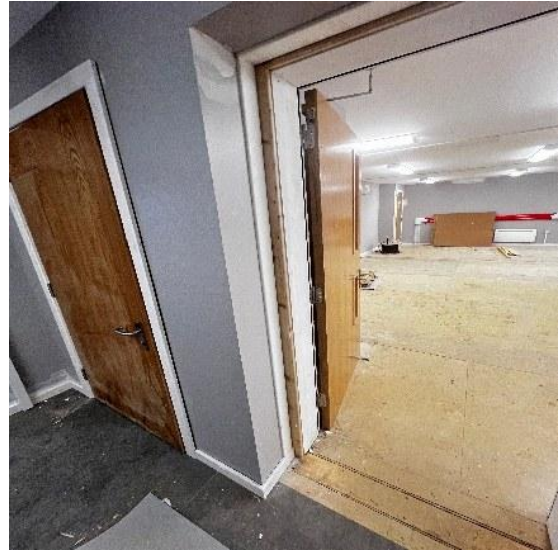
Fire door and modular junction interface under review

<b>Observation</b>	Fire door and fire curtain interface works were progressing as part of the developing compartmentation strategy. Where doors, curtains or surrounding cavity closures form part of the fire strategy, surrounding construction must be complete before the element is treated as compliant or ready for handover.
<b>Risk / implication</b>	Incomplete verification can affect safeguarding, safe occupation, compartmentation integrity, compliance evidence and handover readiness.
<b>Recommended action</b>	Confirm door set, cavity closure and fire curtain details against approved information and retain product evidence as part of the golden thread record.

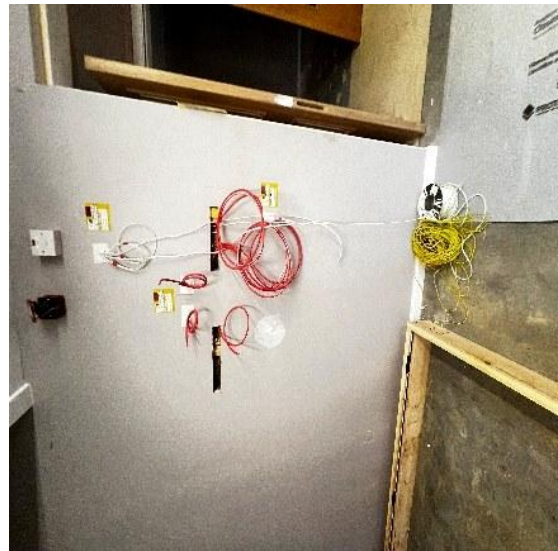
Second fix services and fire stopping coordination zone

<b>Observation</b>	Mechanical and electrical works were advancing through the modular units, with service routes, penetrations, fire alarm interfaces and finishing works progressing in tandem. As fit-out intensifies, service penetrations and follow-on work create a risk of disturbing previously completed firestopping.
<b>Risk / implication</b>	Incomplete verification can affect safeguarding, safe occupation, compartmentation integrity, compliance evidence and handover readiness.
<b>Recommended action</b>	Coordinate M&E installation with firestopping close-out. Any disturbed fire-critical work should be identified, reinstated and re-inspected before final closure.

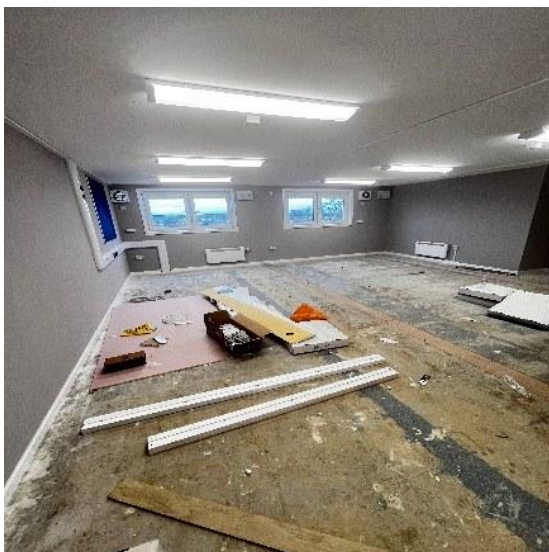
Internal fit-out progress within temporary accommodation
