# ESA Switchboard Audit

C G MSB Audit

Job Number : CGEN14

Client / Site Name : Typical Apartments

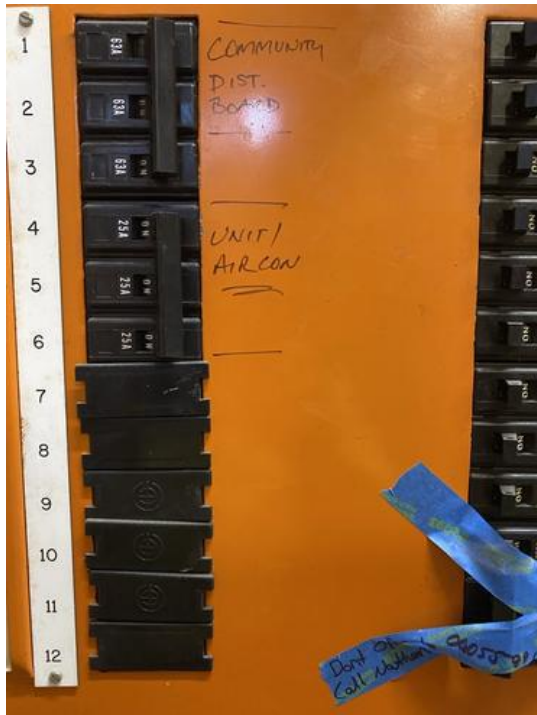
Photo 5

3.2 (i) Switchboard equipment is correctly labelled?

**Fail**

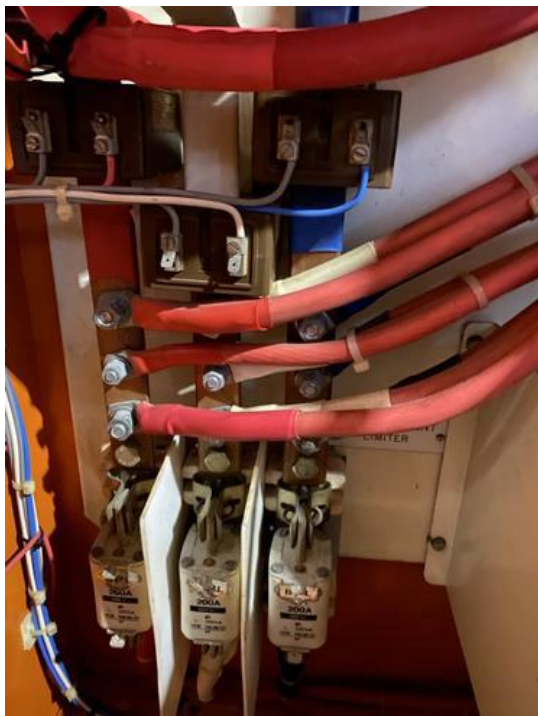
Photo 7

3.2(m) Safety distance clearances have not been compromised?

**Fail**

**Design for quotation to replace MSB, metering and Community Switchboard.**

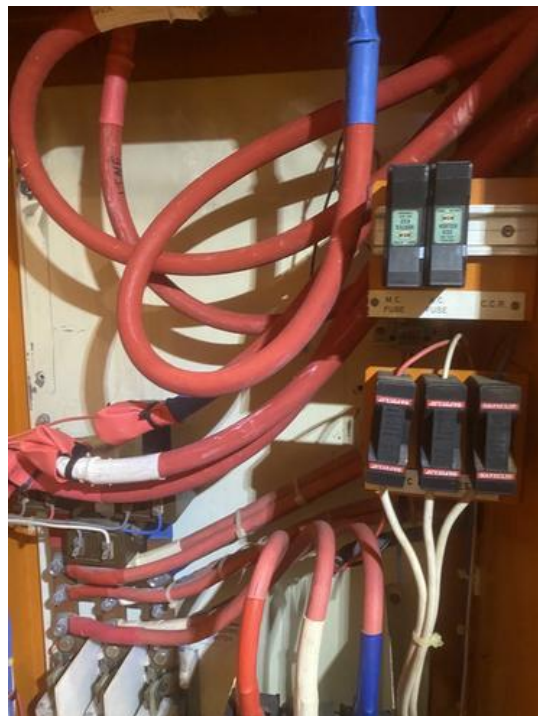
Photo 8

Evidence of alterations or additions since last inspection:

**Yes**

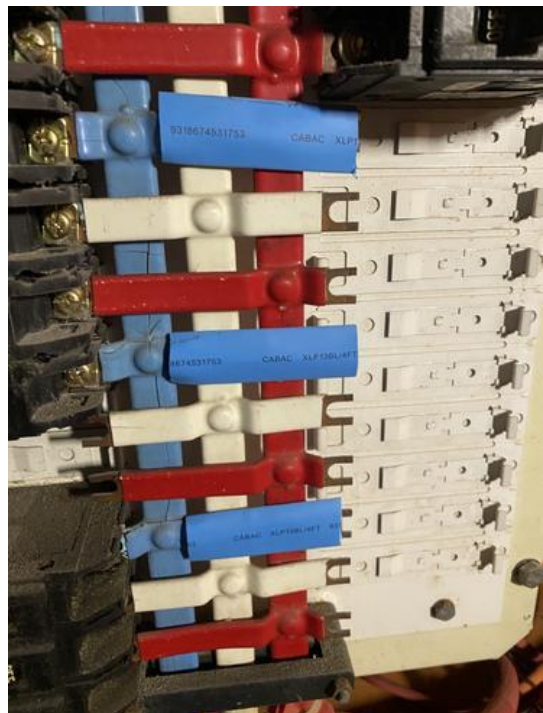
Photo 12

Prospective Short Circuit current at terminals of Essential Chassis 6.7kA. Circuit Breakers only rated to 6kA.

Chassis on Essential Section requires rectification. Some basic remedial works completed on the day.

Replace chassis

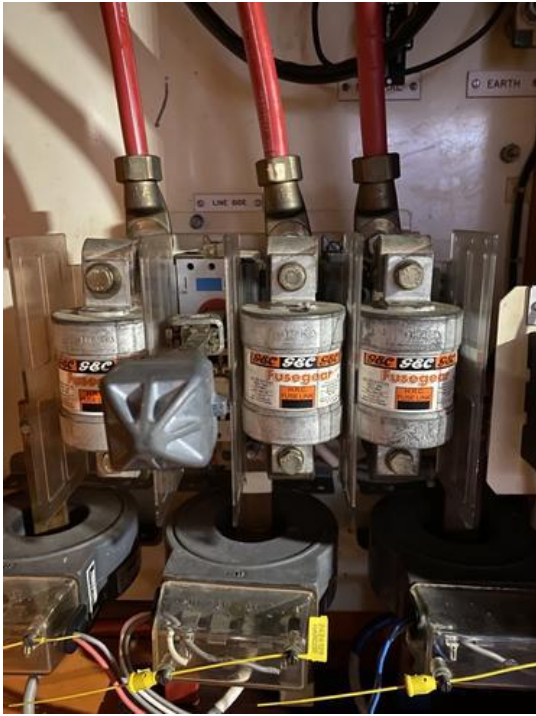
Photo 13

**Switchboard has CT metering to the Main Switch Chamber. This is not compliant with Energex Metering Standards and is required to be enclosed within its own compartment.**
