PHOENIX PLACE
 FARM LOT 6, SEC. 2 TWP. 4, R. 18
 USML
 TOWNSHIP OF BERKSHIRE
 COUNTY OF DELAWARE, OHIO

SUBMITTAL FOR: PHOENIX PLACE SOUTH THREE B'S AND K ROAD, BERKSHIRE TOWNSHIP, OHIO

Phase I Environmental Site Assessment Report

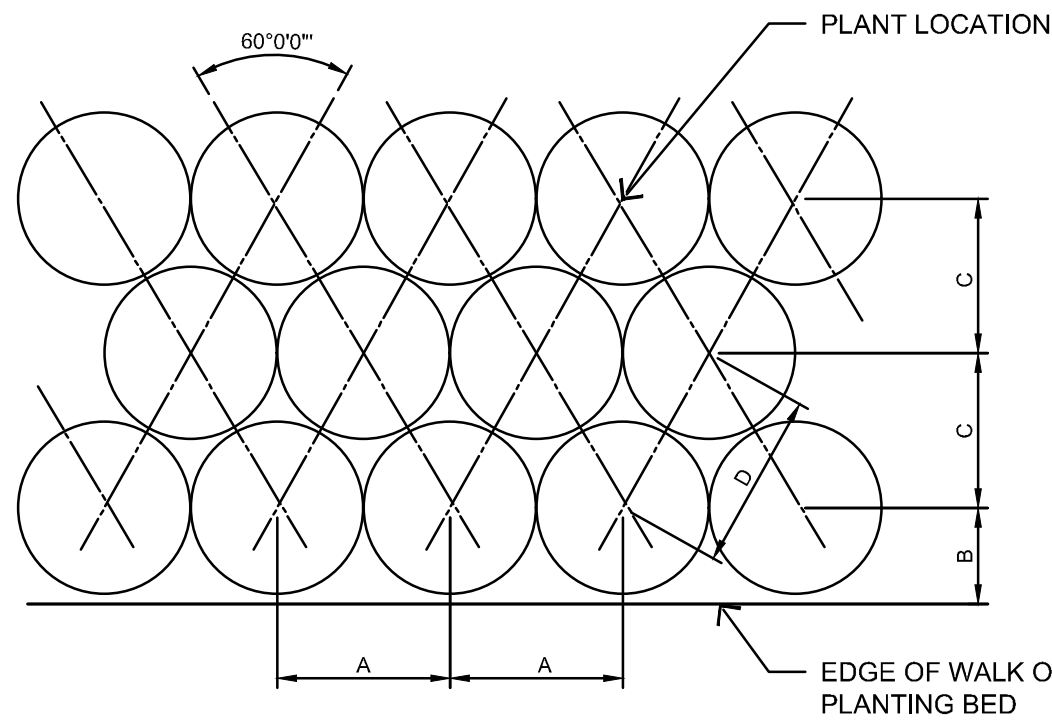
2 PERENNIAL SPACING
N.T.S.

SPACING	A	B	C	D
12"	12"	6"	10"	12"
18"	18"	8"	15"	18"
24"	24"	10"	20"	24"
30"	30"	15"	25"	30"
36"	36"	18"	31"	36"
48"	48"	21"	41"	48"

A = SPACING
B = SP/2
C = SP/1.2
D = SPACING

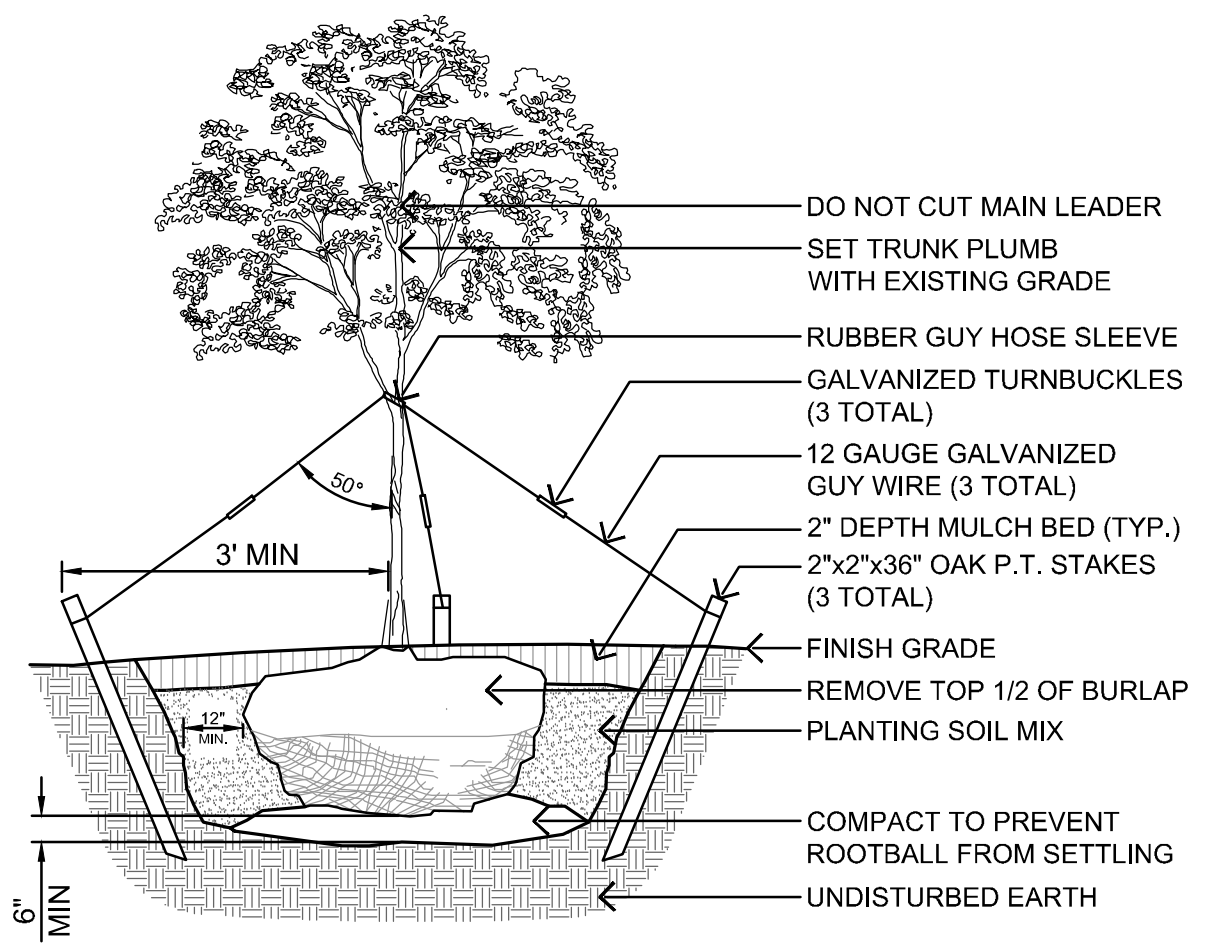
6 DECIDUOUS TREE PLANTING
N.T.S.

- NOTES:
- TOP OF ROOT BALL TO BE 2"-3" ABOVE ADJACENT FINISHED GRADE.
 - REMOVE ALL LABELS, TAGS, OR OTHER FOREIGN MATERIALS FROM LIMBS.
 - REMOVE GUY WIRES, TURNBUCKLES, HOSE AND STAKES 1 YEAR AFTER PLANTING.
 - THE AMOUNT OF PRUNING SHALL BE LIMITED TO THE MINIMUM NECESSARY TO REMOVE DEAD OR INJURED TWIGS AND BRANCHES AND TO COMPENSATE FOR THE LOSS OF ROOTS DURING TRANSPLANTING. RETAIN NORMAL SHAPE OF TREE. OWNER'S REPRESENTATIVE WILL DETERMINE AMOUNT OF PRUNING NECESSARY. PLANT TREES AT SAME GRADE AS GROWN IN THE NURSERY.
