6.0 ADDITIONAL CONSIDERATIONS REQUIRED BY OHFA

APPENDIX A – Maps and Physical Setting Information

**VACANT PROPERTY - 60± ACRES
S. THREE B'S & K ROAD
BERKSHIRE TWP., DELAWARE COUNTY, OHIO**

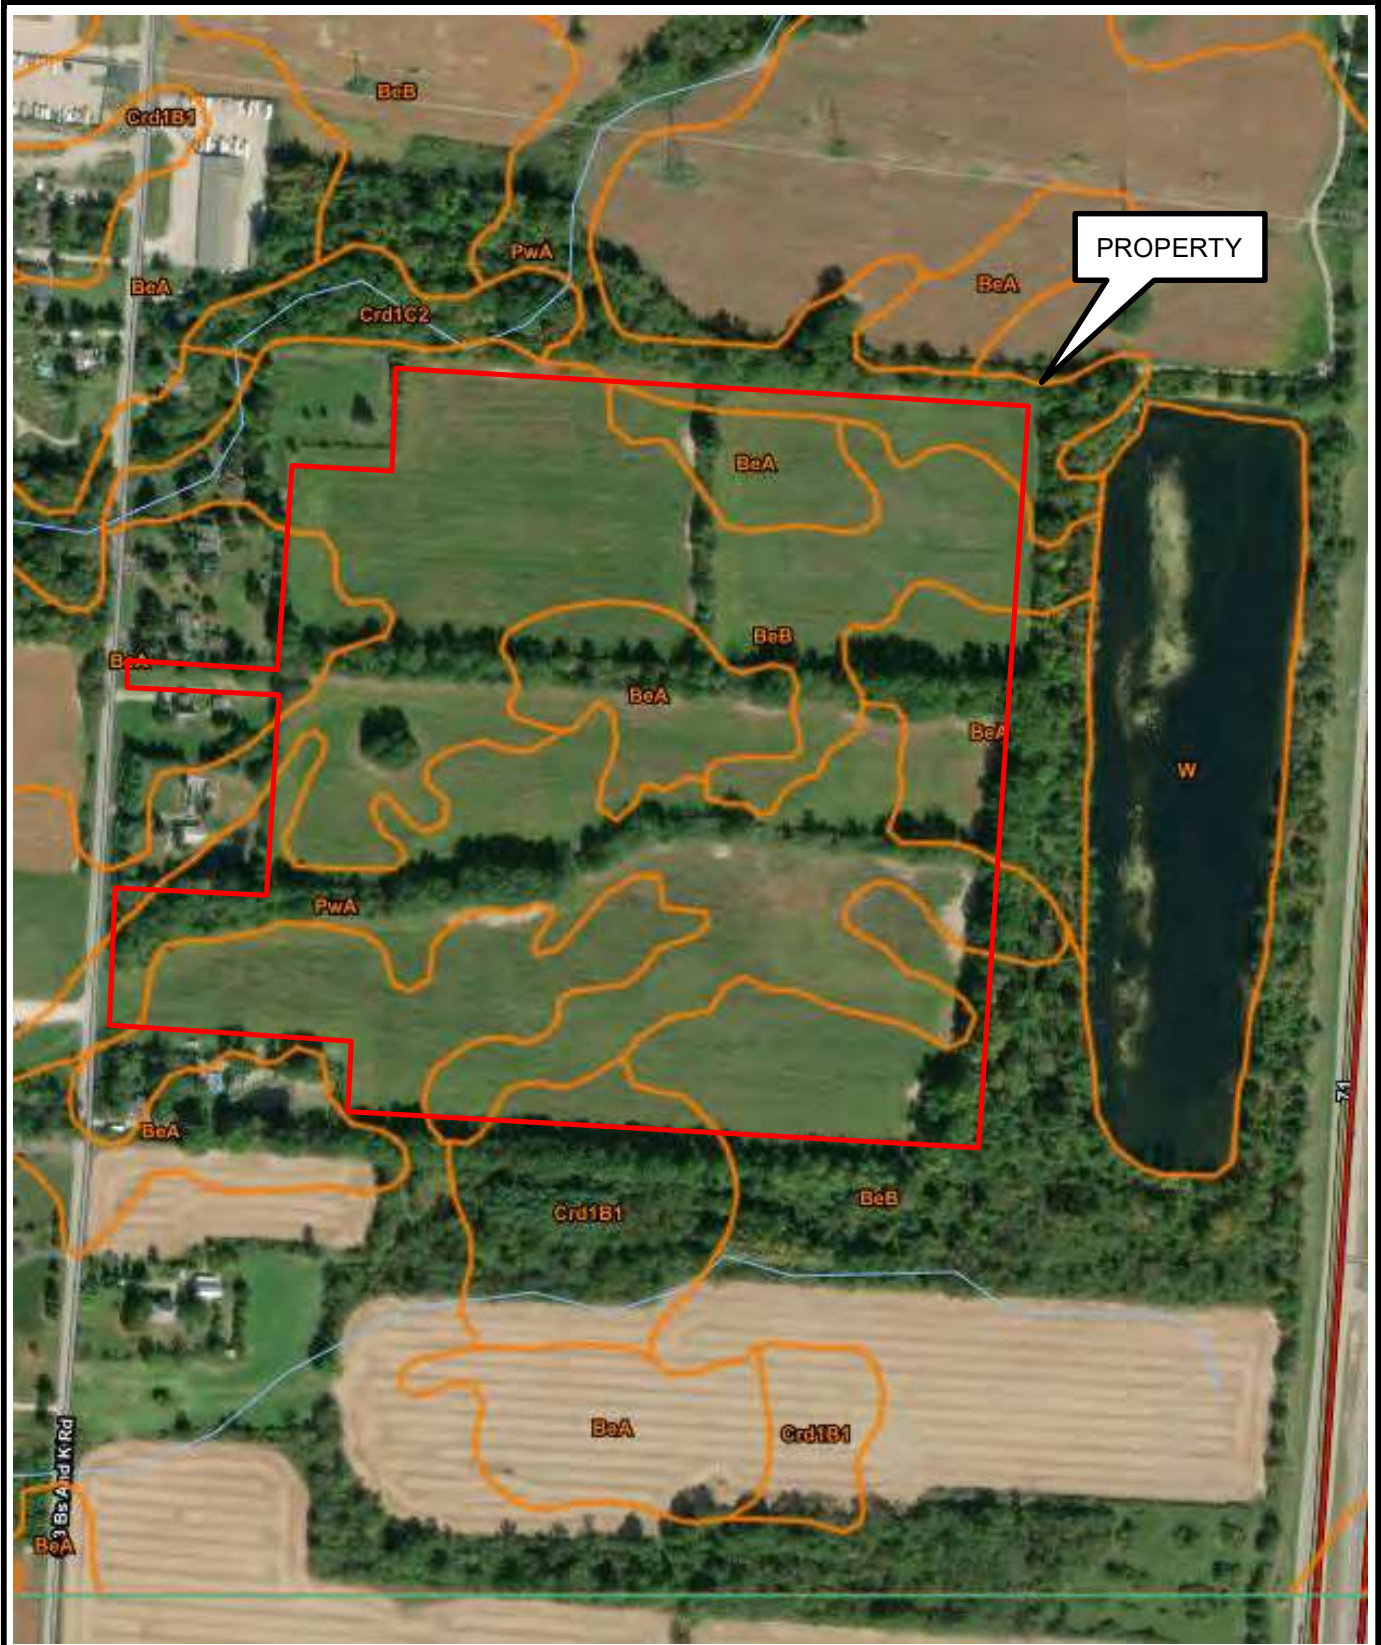
VACANT PROPERTY - 60± ACRES
S. THREE B'S & K ROAD
BERKSHIRE TWP., DELAWARE COUNTY, OHIO

GCI reviewed the Federal Emergency Management Agency (FEMA) Flood Insurance Rate Map (FIRM) for the property area. According to map number 39041C0145K for Delaware County, Ohio, the property is in Zone X, which is an area of minimal flood hazard. Provided in Appendix A is the FEMA map showing the property designation.

0.2% Annual Chance Flood Hazard, Areas of 1% annual chance flood with average depth less than one foot or with drainage areas of less than one square mile Zone X

The flood hazard information is derived directly from the authoritative NFHL web services provided by FEMA. This map was exported on 5/5/2020 at 4:03:32 PM and does not reflect changes or amendments subsequent to this date and time. The NFHL and effective information may change or become superseded by new data over time.

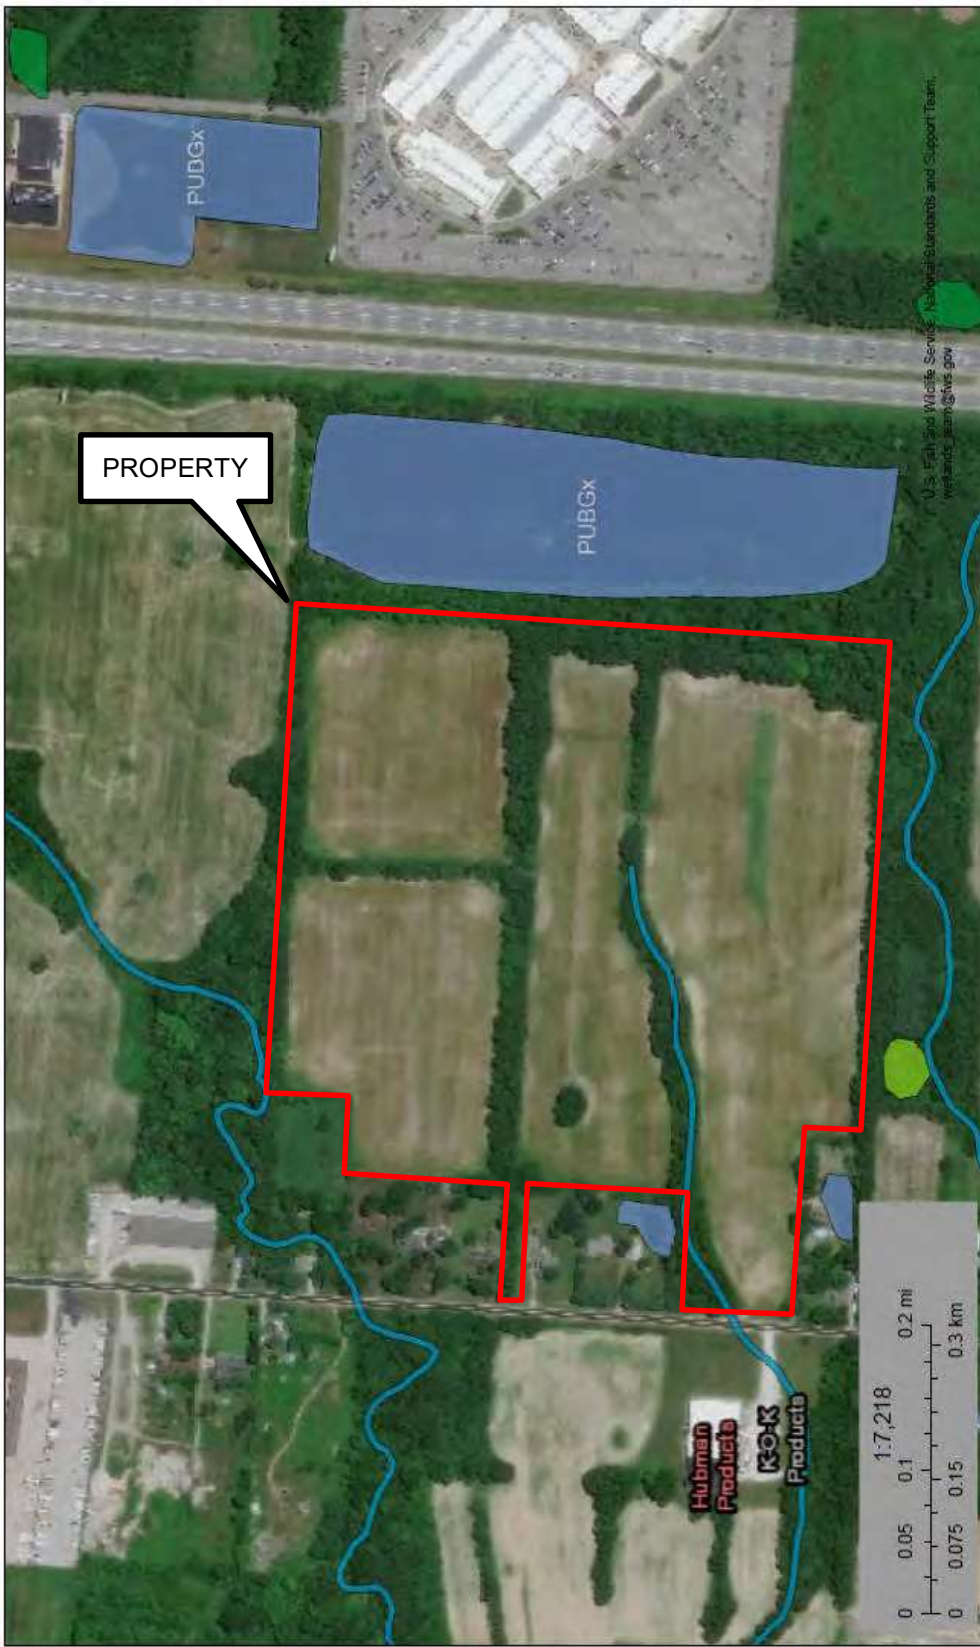
U.S. Fish and Wildlife Service
National Wetlands Inventory

GCI reviewed the US Fish and Wildlife Service, *National Wetlands Inventory (NWI) Map* for the property area. The attached National Wetlands Inventory (NWI) Map does not indicate wetland mapping symbols on the property. A stream was shown crossing the central and southwestern portions of the property. This was identified as a Riverine system, intermittent, streambed, seasonally flooded (R4SBC).
