# Inspection Report

**HomeBuyers Inspection HBI**  
Russell Buchanan OR; OCHI 1180, WA; 864  
122 Lyman Street Building 1  
Asheville, NC 28801  
828-254-2030

**INSPECTED PROPERTY ADDRESS:**  
91142  
East West Street  
Red Bud NC

<b>Date:</b> 7/29/2015	<b>Time:</b>	<b>Report ID:</b> Sample-2015
<b>Property:</b> 91142 East West Street Red Bud NC	<b>Customer:</b> Rosanna Danna	<b>Real Estate Professional:</b>

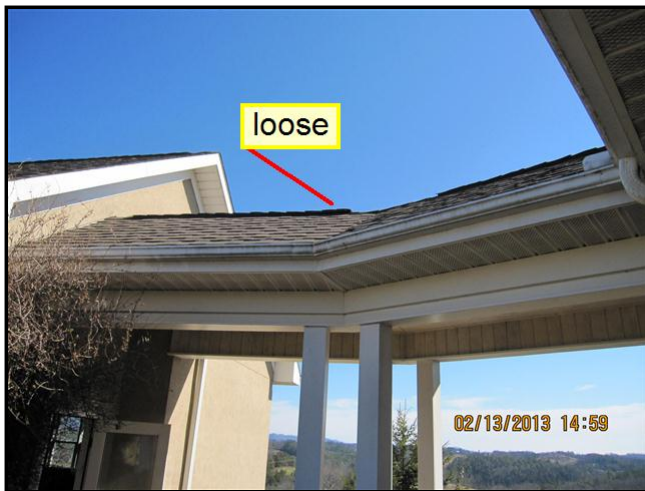
1.2 Item 1(Picture)

Ridge vent loose at end above breezeway and needs to be fastened. Nail head used to fasten should be sealed with sealant.

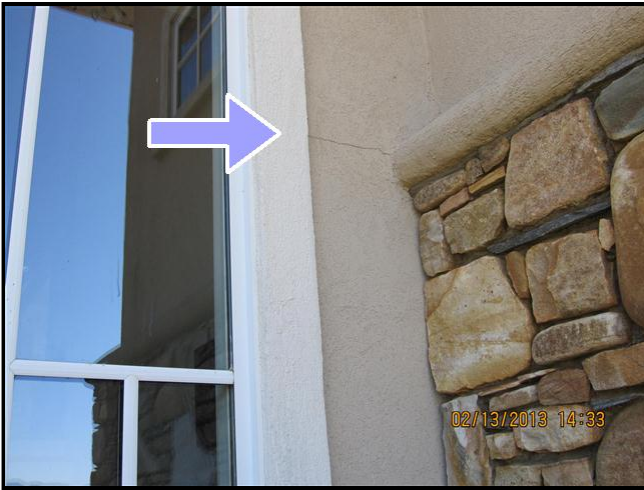
2.0 Item 2(Picture)

(1) Some hairline cracks in areas around home. These appear to be typical.

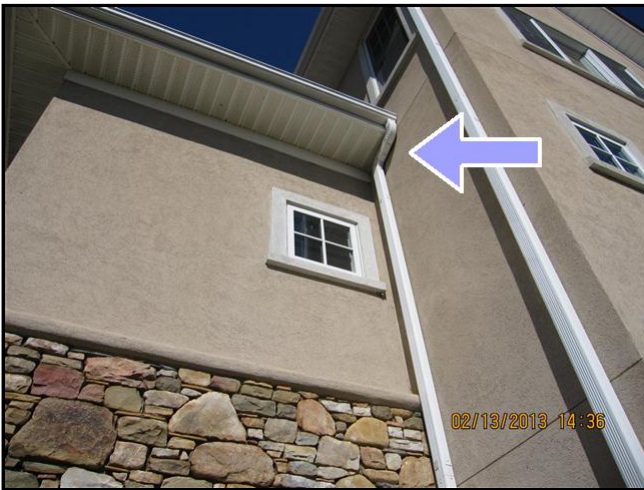
2.0 Item 3(Picture)

(2) Bird nest is wedged between downspout elbow and home should be removed and inspect further as animals can damage and allow water to get inside wall.

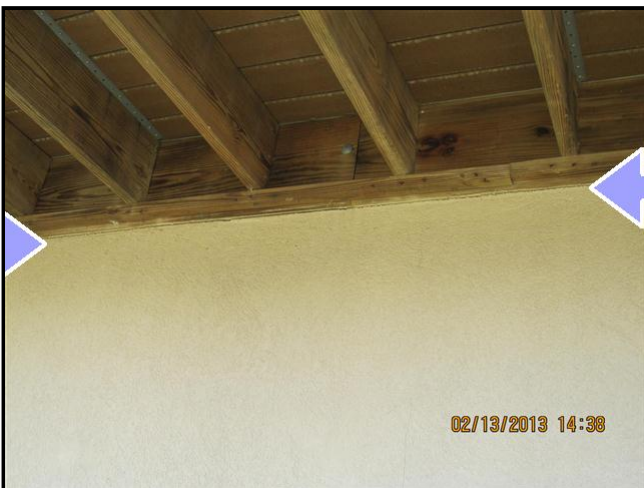
2.0 Item 4(Picture)

- (3) A common seam where stucco and ledger meet under deck. I recommend silicone caulking to seal.
- (4) The wall cladding on the home is an EIFS type some call Hard-Coated Stucco. I did not do any invasive or destructive test. There were no visual signs of deterioration.

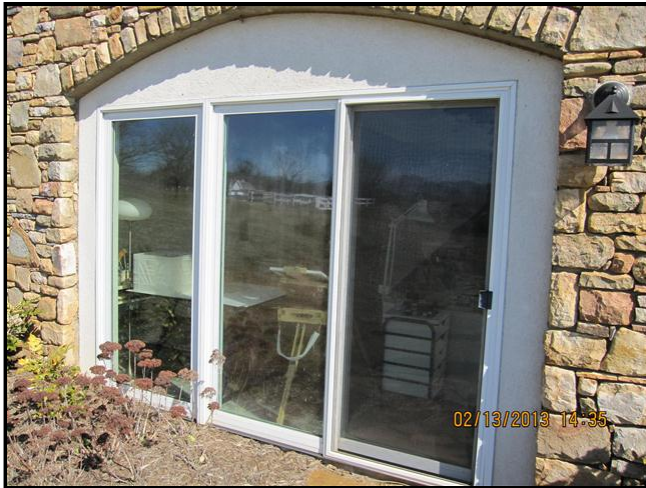
2.1 Item 1(Picture)

Glass panel doors/window at right side (facing front) cloudy or seal is broken. Glass panes that have lost their seal (cloudy) can usually be replaced without replacing the entire unit. A qualified contractor should inspect and repair as needed.

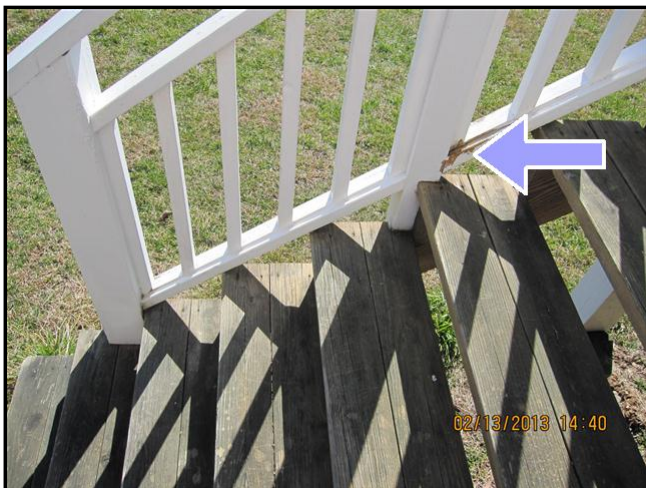
2.3 Item 2(Picture)

Bottom rail is soft or deteriorated in one area and other areas weathered. Needs prep and paint. Deck stairs need algae removed with a cleaner and seal with a non skid weather sealant.

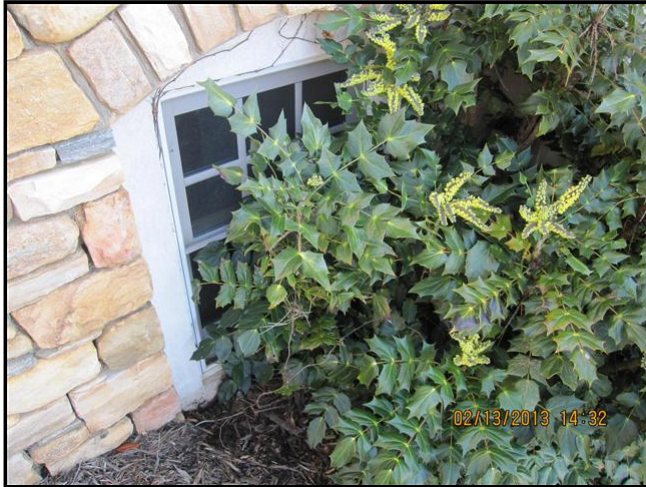
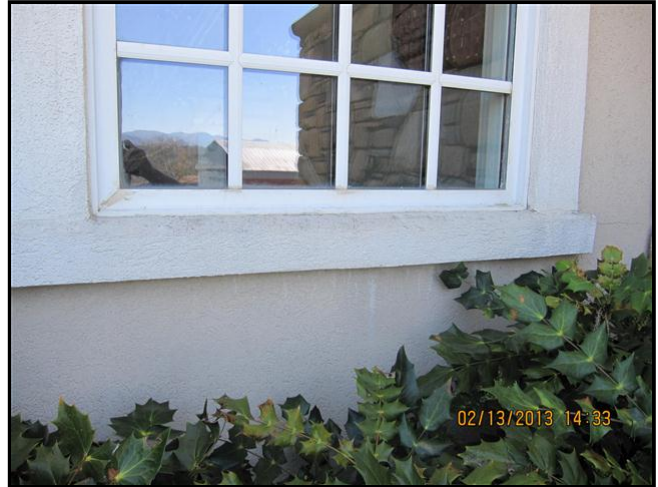
2.4 Item 2(Picture)

Thorny bushes or vegetation obstructing access and should be relocated to allow clearance from siding of home

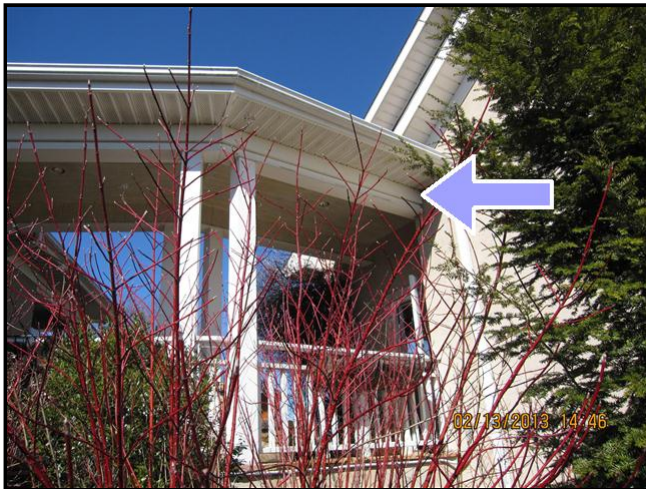
2.5 Item 1(Picture)

Some areas need prep and paint along breezeway at top fascia trim (cosmetic).

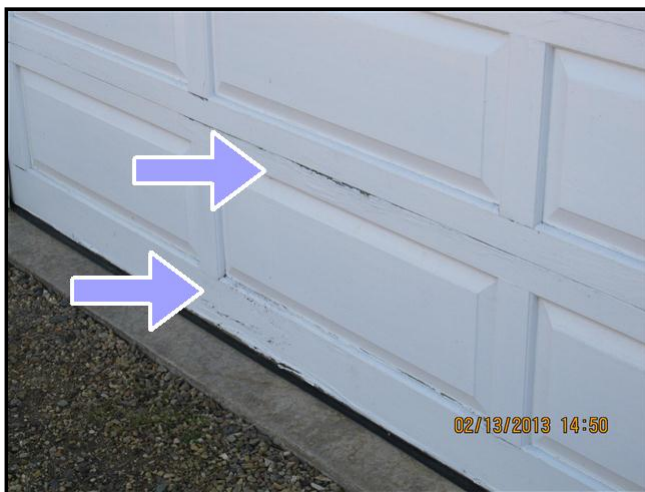
3.3 Item 1(Picture)

Weathered needs prep and paint at Garage door.

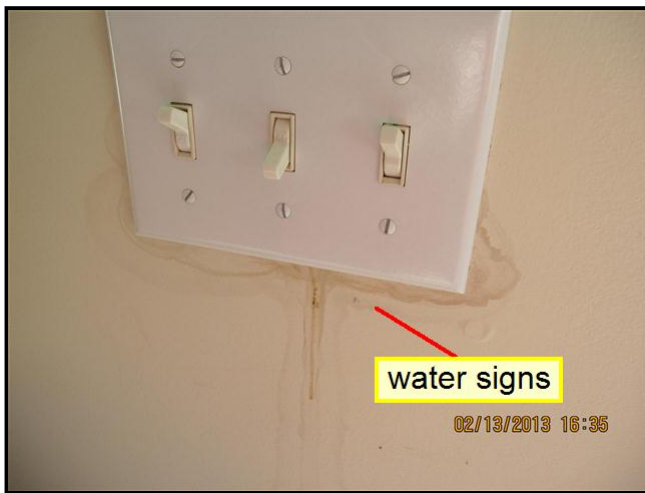
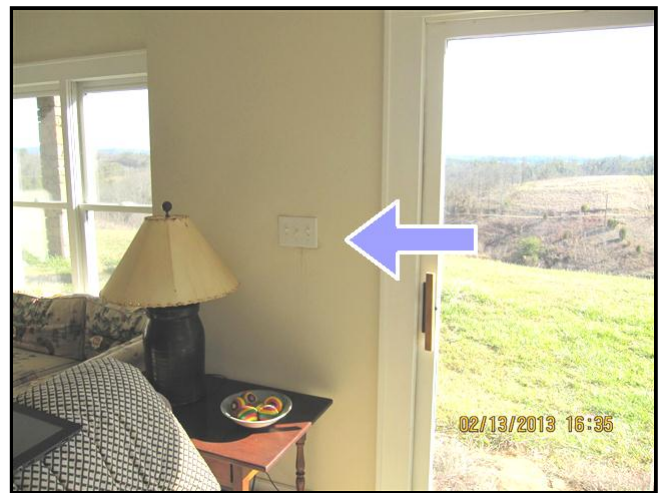
4.1 Item 2(Picture) wall switch Lower level

Wall switch at lower level shows evidence of water getting in from outside? There is a light fixture in relation to this wall switch and perhaps water is getting in there? i recommend further investigation to determine location and correct.

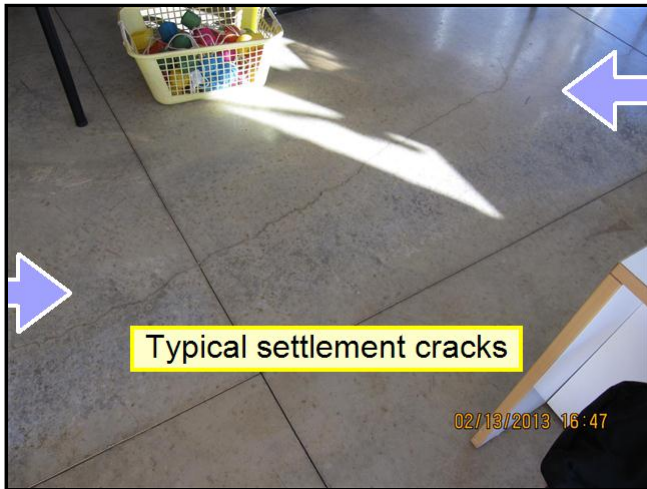
4.2 Item 1(Picture)

Lower level concrete has typical settlement cracks. We did not remove area rug or inspect underneath it.

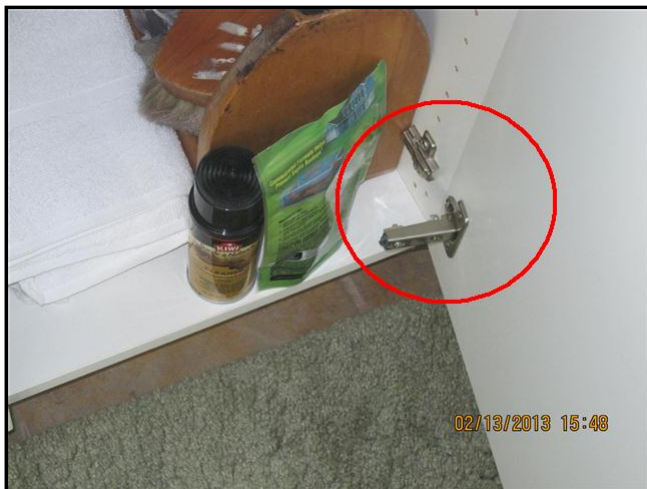
4.4 Item 1(Picture)

Hinge needs repair/replace at sink base in master bath.

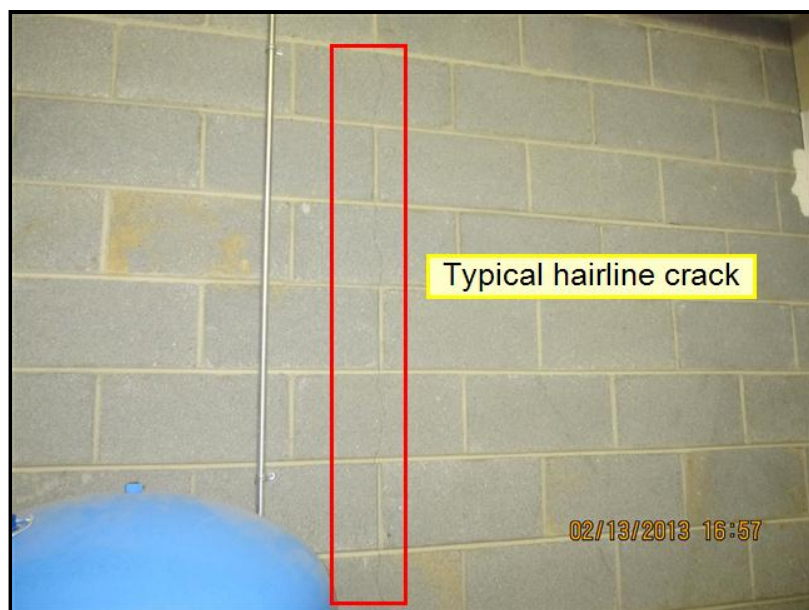
5.1 Item 1(Picture)

Hairline cracks in wall (typical).

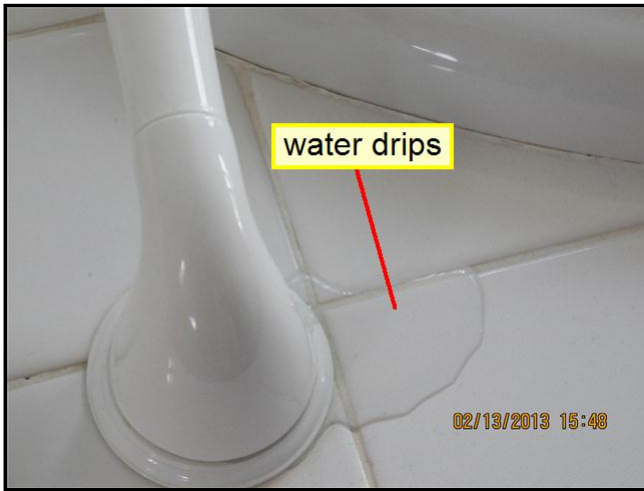
6.1 Item 1(Picture)

(1) Water drips from control knob on Jacuzzi brand tub. Also the lever to switch from spout to shower head works but feels weak when moved/turned and I am not sure if it is standard or loose? Recommend a plumber to inspect and repair as needed.

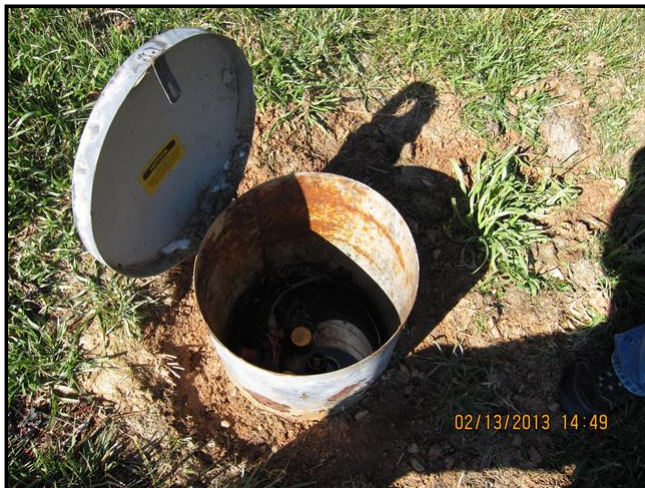
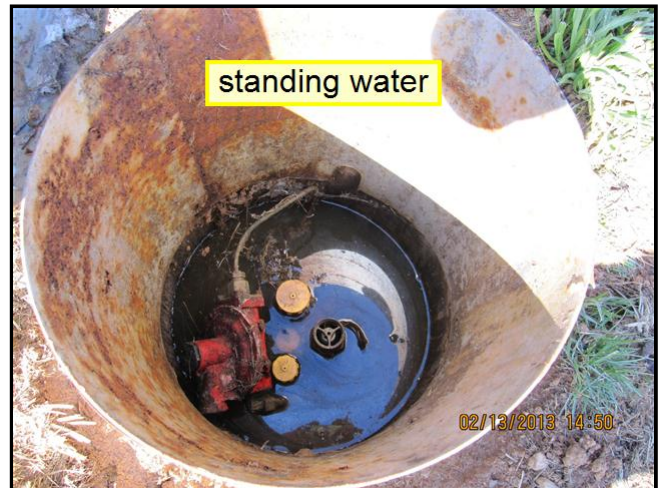
6.4 Item 2(Picture) propane tank valves

(1) Standing water should be removed and prevented from occurring at propane valves and meter access.

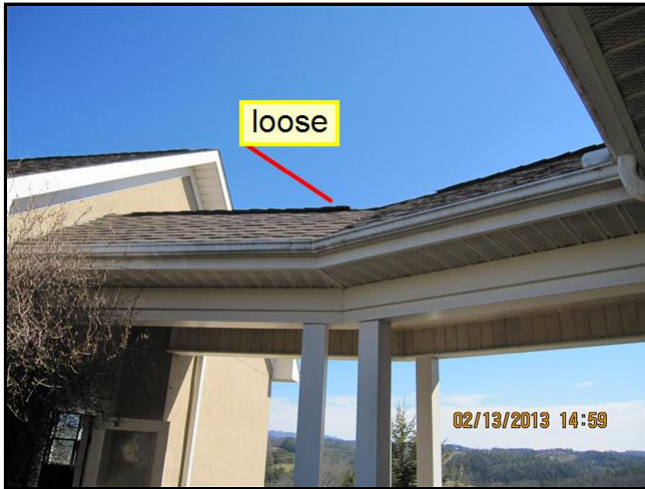
1.2 Item 1(Picture)

Ridge vent loose at end above breezeway and needs to be fastened. Nail head used to fasten should be sealed with sealant.

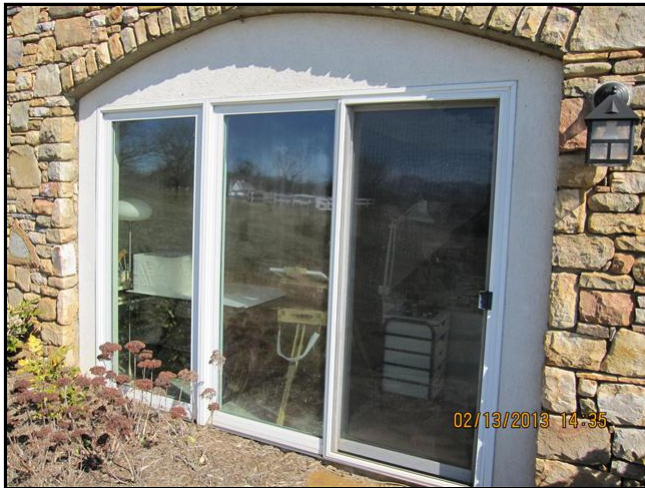
2.1 Item 1(Picture)

Glass panel doors/window at right side (facing front) cloudy or seal is broken. Glass panes that have lost their seal (cloudy) can usually be replaced without replacing the entire unit. A qualified contractor should inspect and repair as needed.

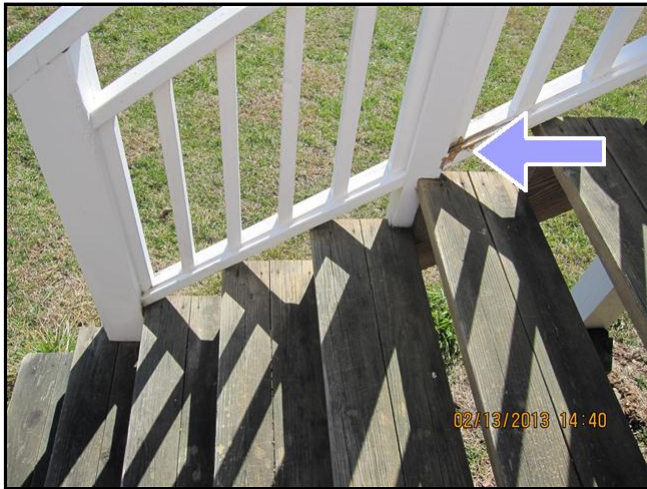
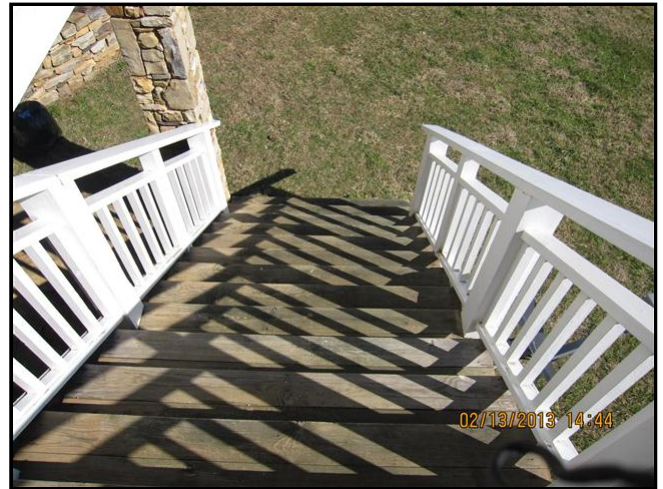
2.3 Item 2(Picture)

Bottom rail is soft or deteriorated in one area and other areas weathered. Needs prep and paint. Deck stairs need algae removed with a cleaner and seal with a non skid weather sealant.

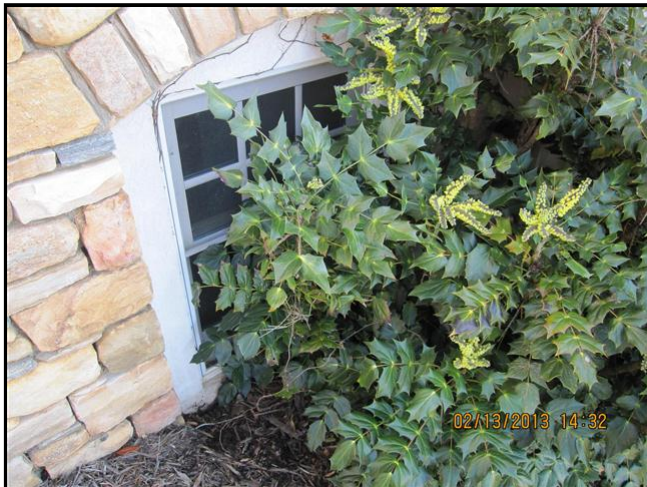
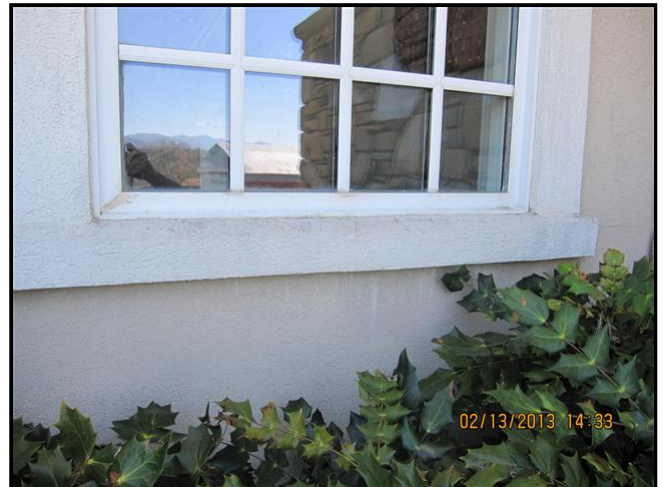
2.4 Item 2(Picture)

Thorny bushes or vegetation obstructing access and should be relocated to allow clearance from siding of home

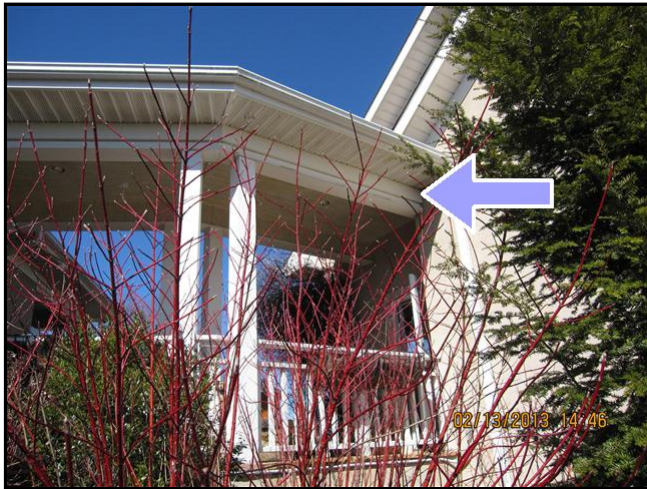
2.5 Item 1(Picture)

Some areas need prep and paint along breezeway at top fascia trim (cosmetic).

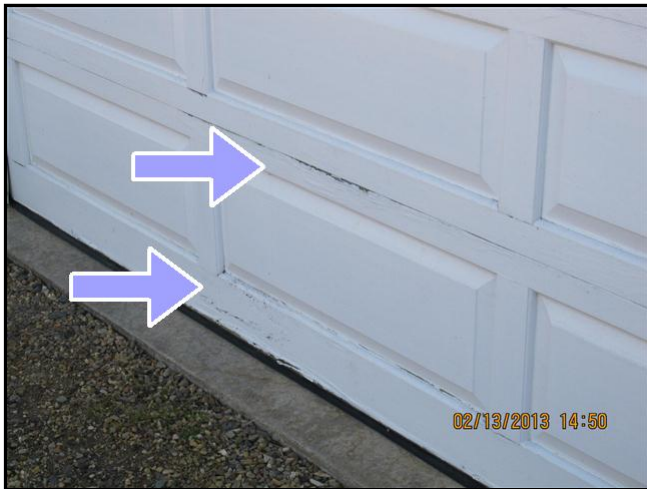
3.3 Item 1(Picture)

Weathered needs prep and paint at Garage door.

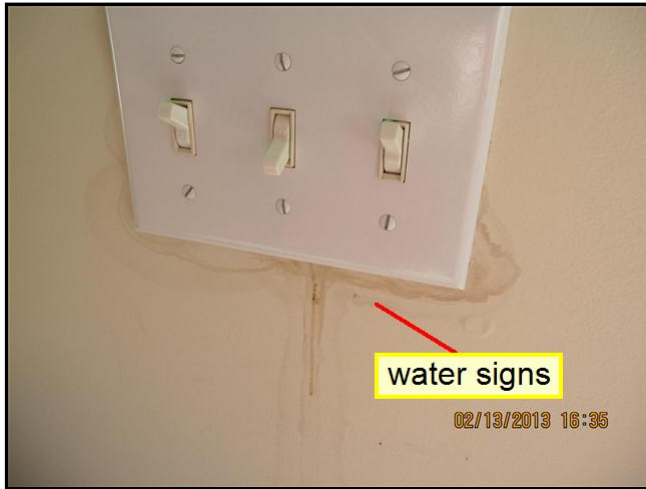
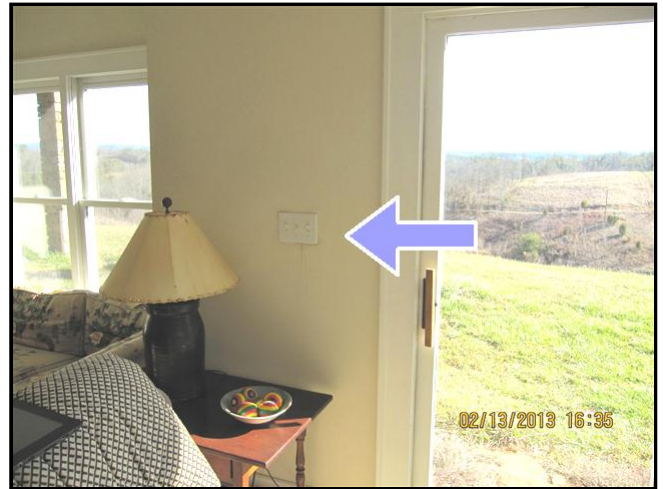
4.1 Item 2(Picture) wall switch Lower level

Wall switch at lower level shows evidence of water getting in from outside? There is a light fixture in relation to this wall switch and perhaps water is getting in there? i recommend further investigation to determine location and correct.

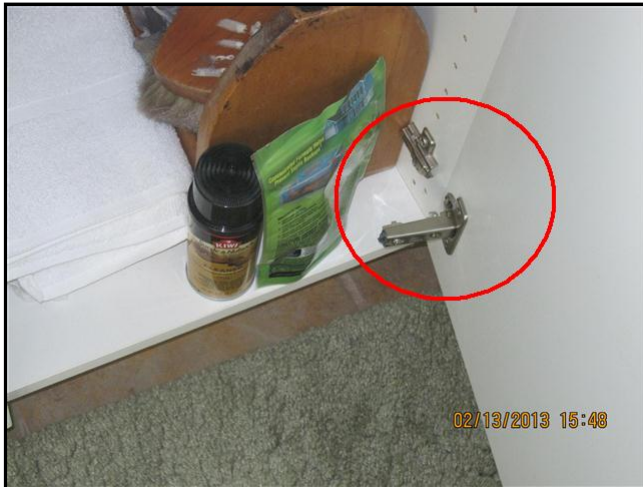
4.4 Item 1(Picture)

Hinge needs repair/replace at sink base in master bath.

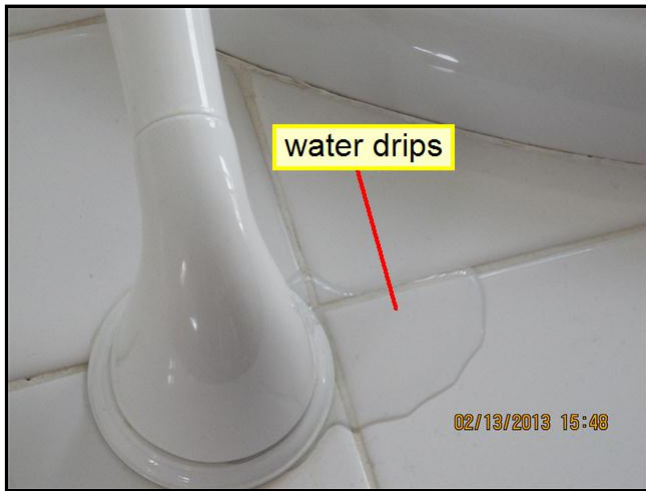
6.1 Item 1(Picture)

Water drips from control knob on Jacuzzi brand tub. Also the lever to switch from spout to shower head works but feels weak when moved/turned and I am not sure if it is standard or loose? Recommend a plumber to inspect and repair as needed.

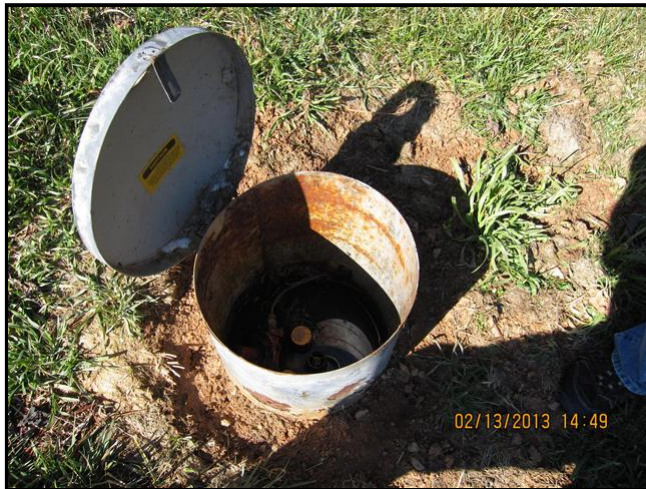
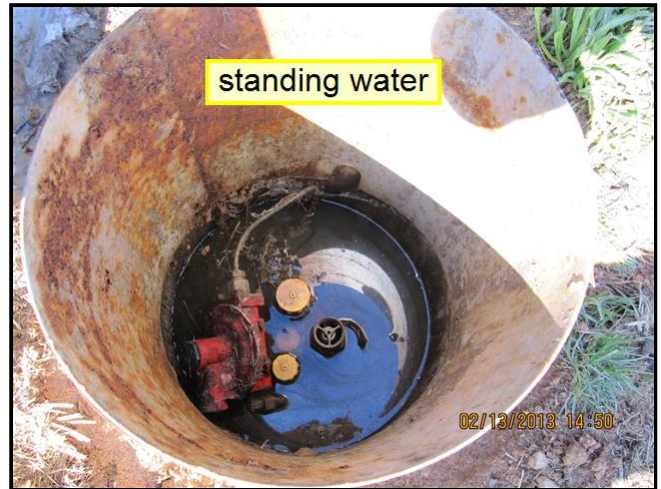
6.4 Item 2(Picture) propane tank valves

Standing water should be removed and prevented from occurring at propane valves and meter access.

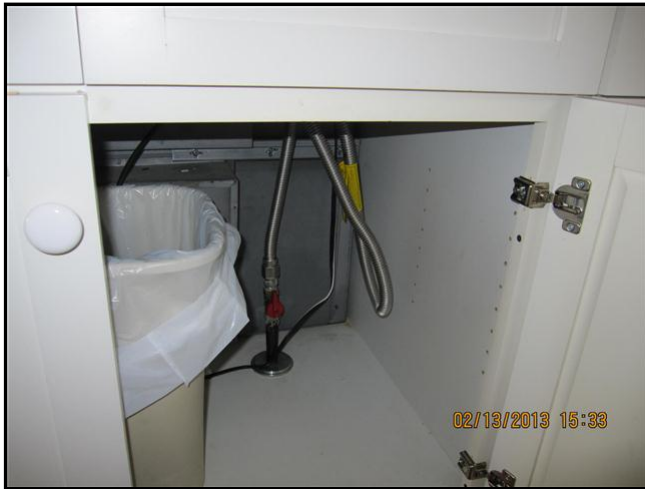
6.4 Item 3(Picture)

Gas odor detected under range in kitchen and also upon entering into Equipment room downstairs where LP gas water heater is located. Note, there is a fresh air pipe connecting the equipment room to the outside air. Some energy pros may suggest that a mechanical fan would be more energy efficient than the passive vent installed.
