PROPERTY INSPECTION REPORT

Dustin Keller
Sky Pines Home Inspections

Date of Inspection: 2/20/2024

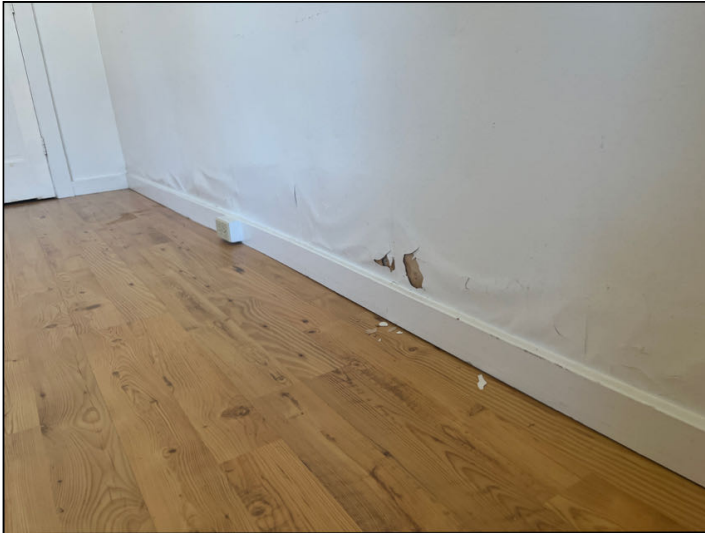
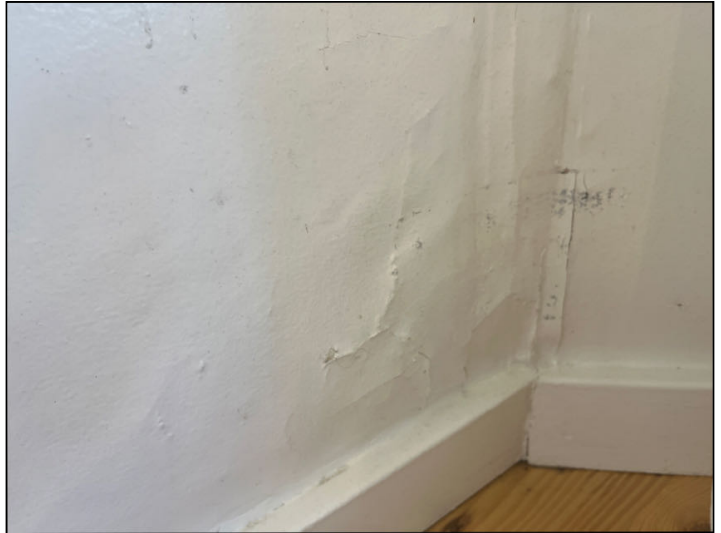
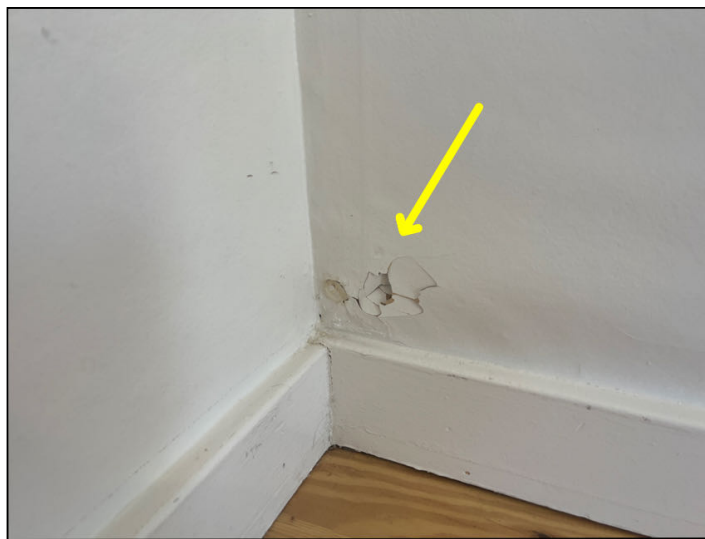
7. Wall Condition

- Possible water damage or signs of deterioration. Recommend further evaluation by a qualified contractor.

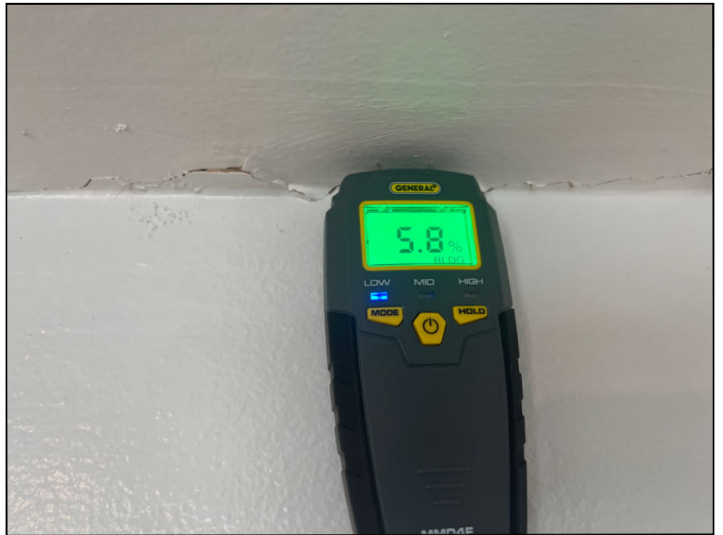
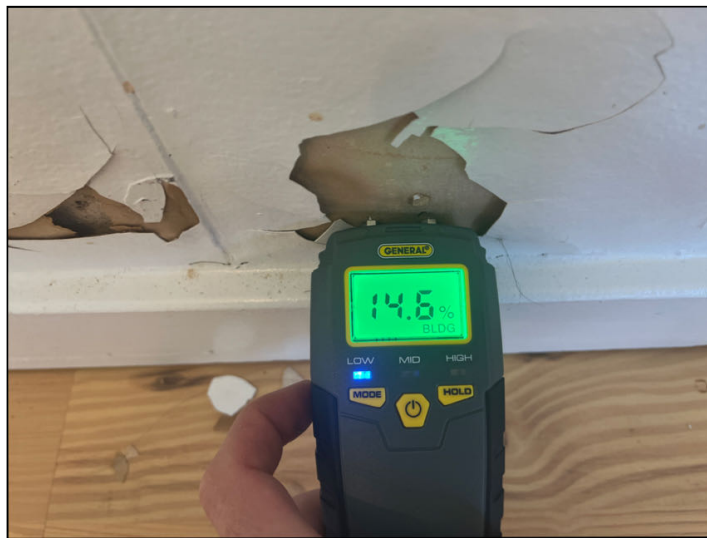
9. Ceiling Condition

- Small stains noted on the ceiling. They tested dry at the time of the inspection.

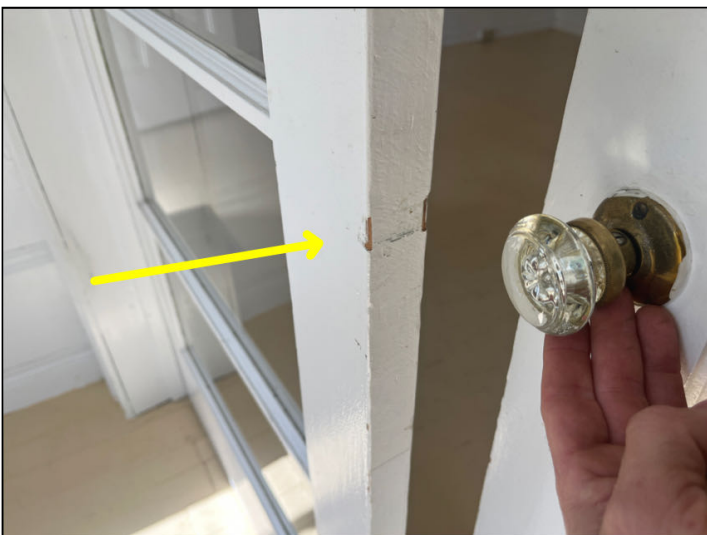
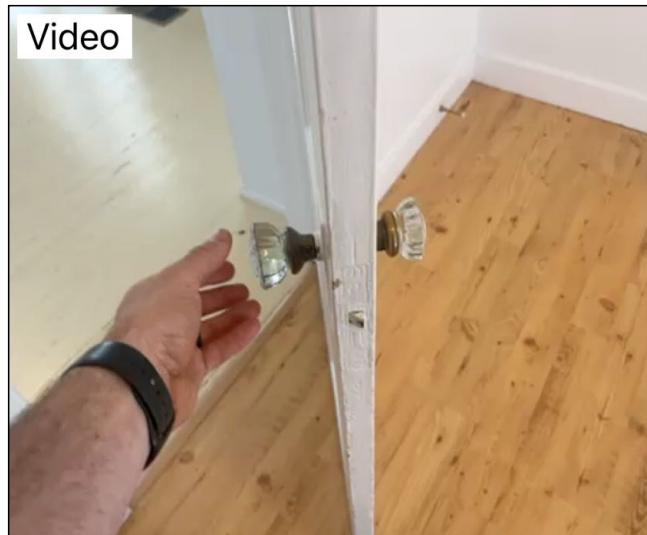
4. Doors

- Door doesn't latch properly.

Door doesn't latch

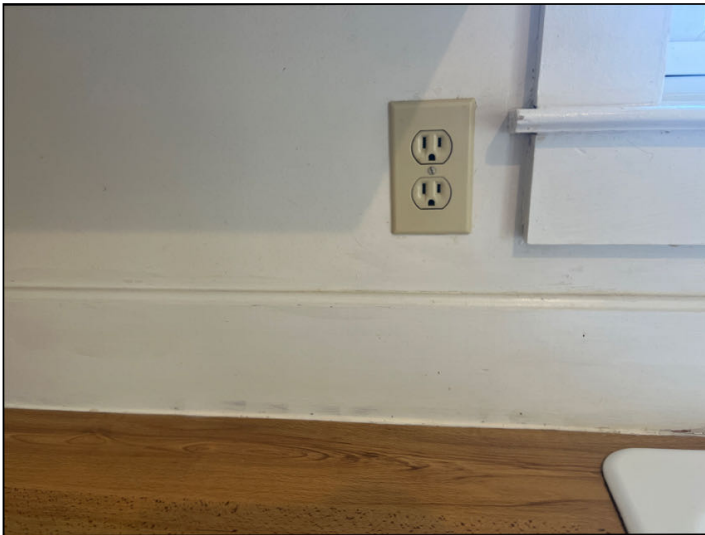
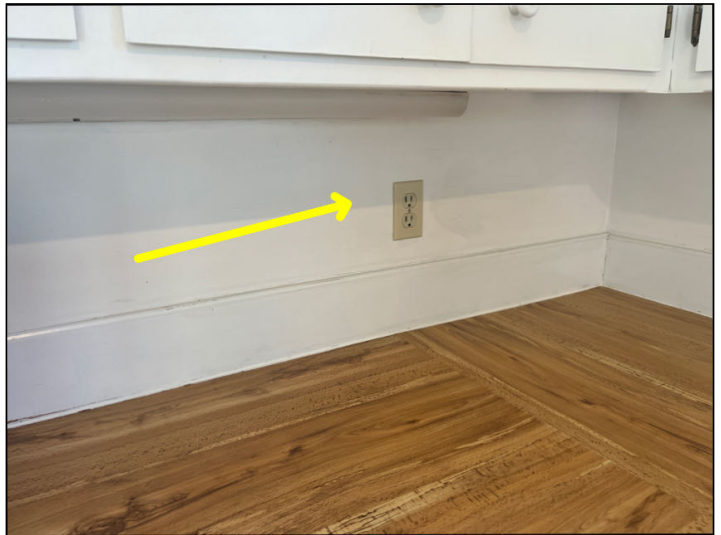
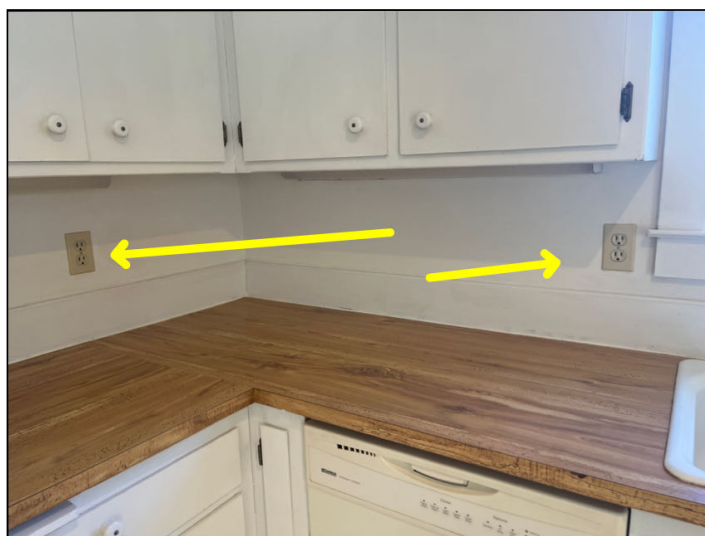
15. Electrical

- None of the outlets in the kitchen area are GFCI protected
- All outlets in the kitchen are non-GFCI.
- No smoke/ fire detectors were installed at time of inspection.

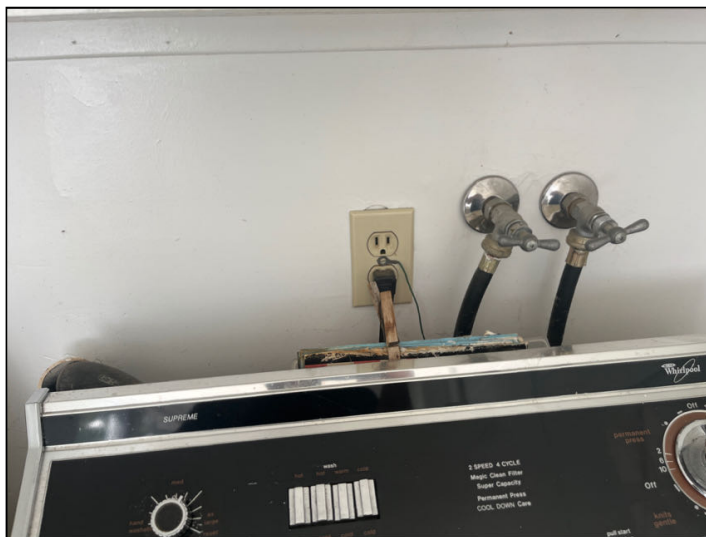
2. GFCI

- No GFCI protection present, suggest installing GFCI protected receptacles for safety.

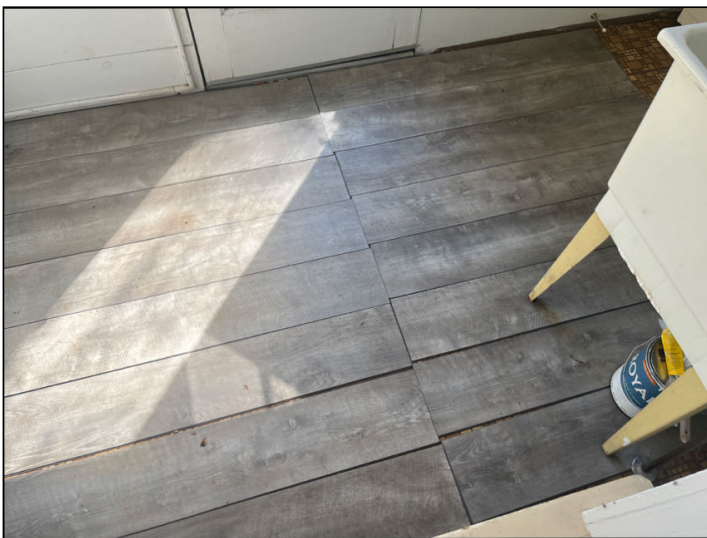
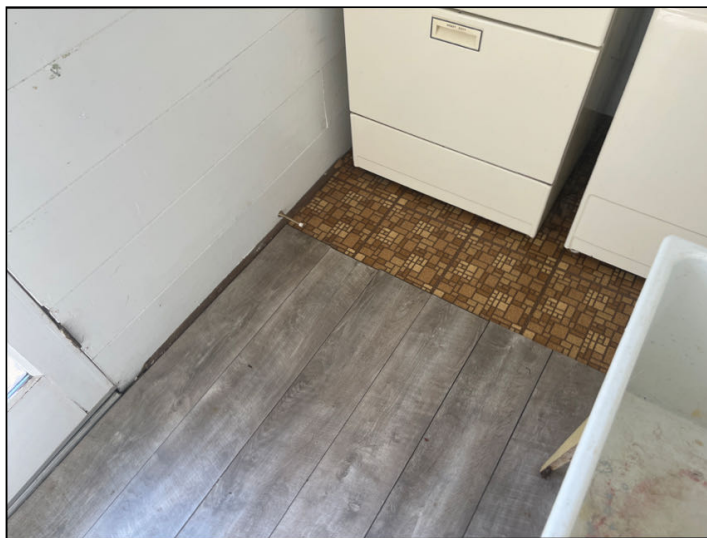
3. Floor Condition

- Laminate floating floor system was installed with poor workmanship techniques, gaps, under size cuts, and chips are visible giving a less than appealing appearance and likely lowering the serviceable life of the flooring.

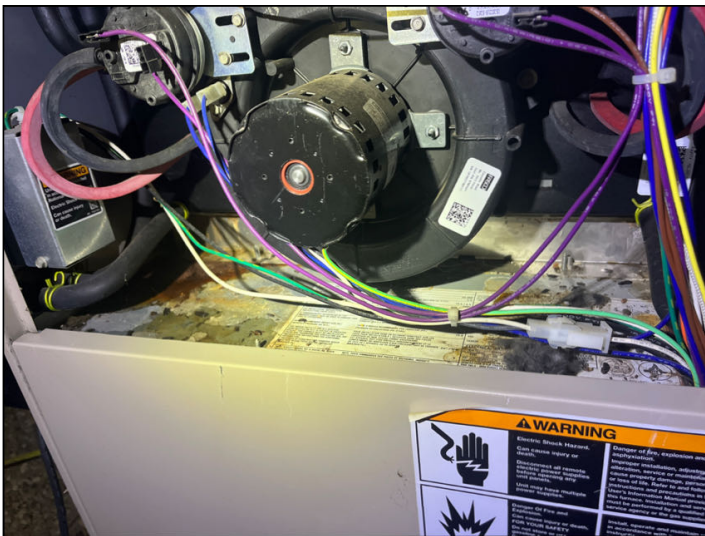
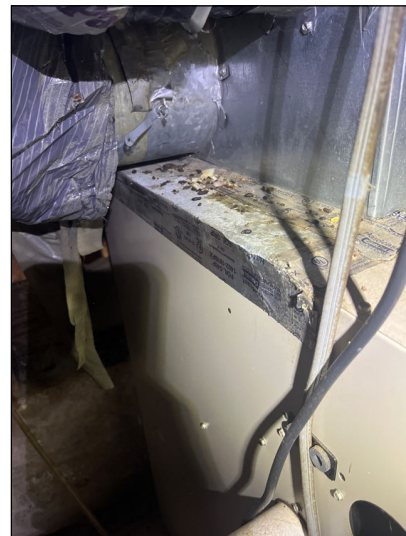
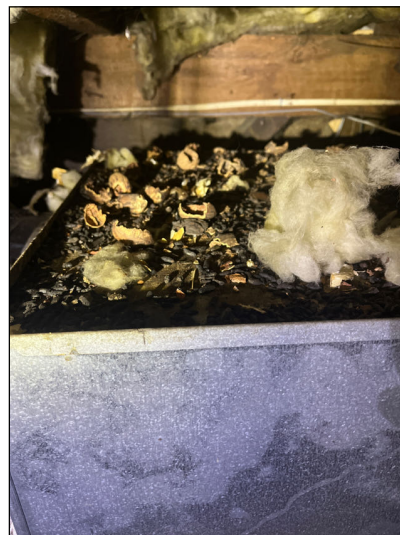
1. Heater Condition

- There is evidence of pest infiltration inside and around the heating unit itself.

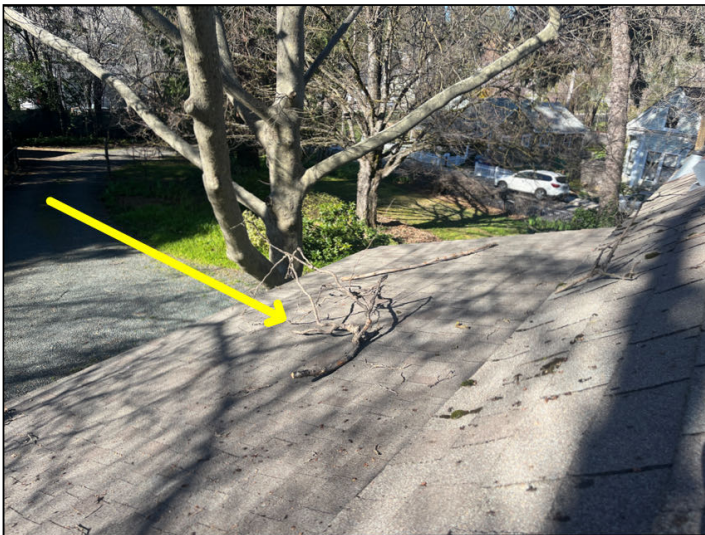
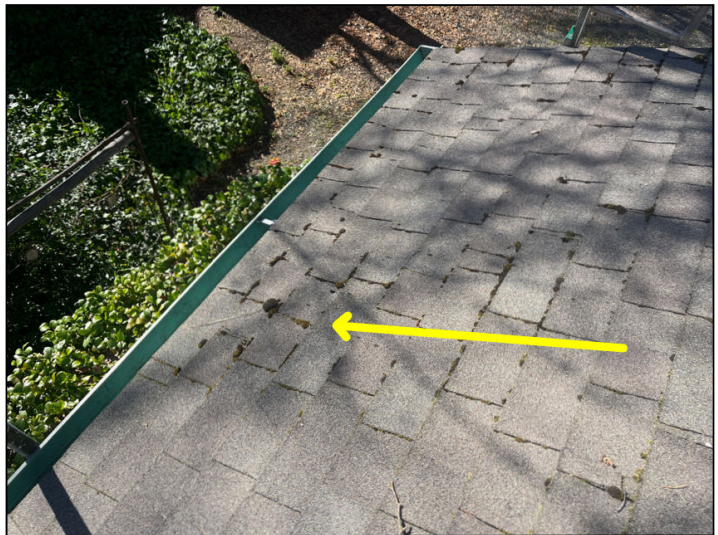
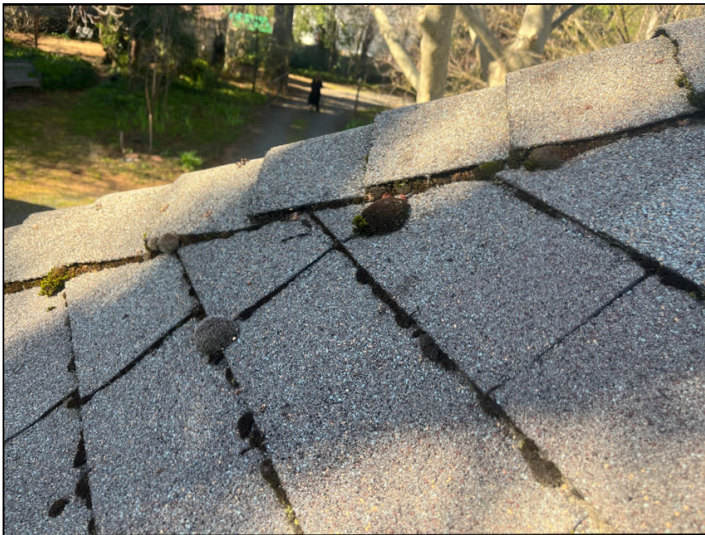
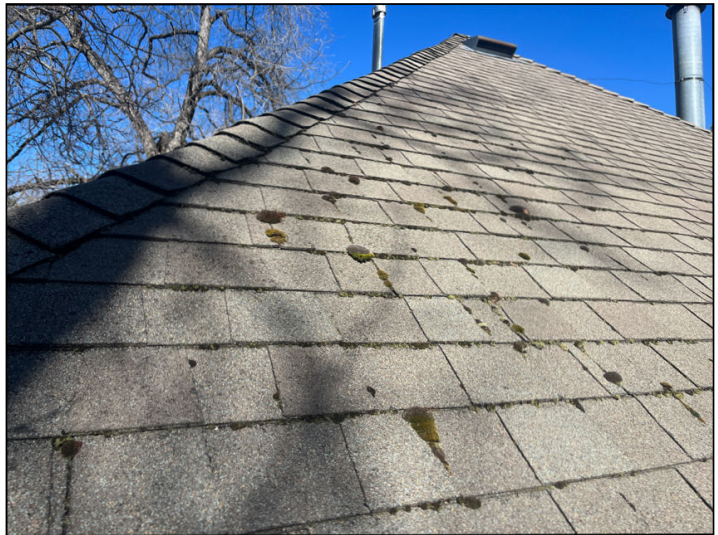
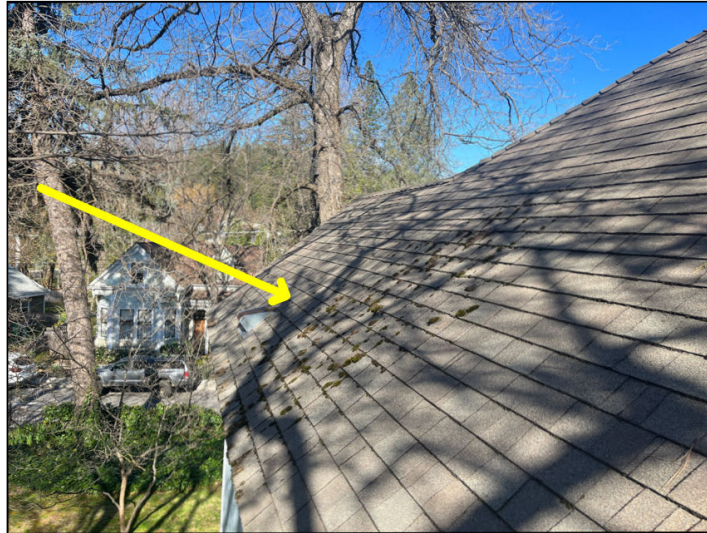
1. Roof Condition

- Clean roof areas: Significant amounts of organic debris evident.
- Moss on roof. This can lead to the premature failure of the roof and subsequent leaks. Recommend treating moss during its growing season (wet months) with a moss killer. For information on various moss treatment products and their pros and cons, visit <http://bryophytes.science.oregonstate.edu/page24.htm>.

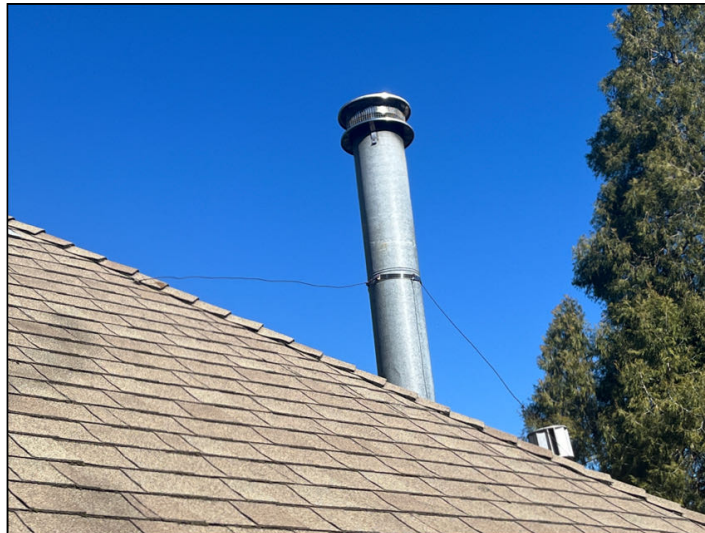
3. Chimney

- A very limited visual inspection due to access. Recommend further evaluation by a roofing contractor.

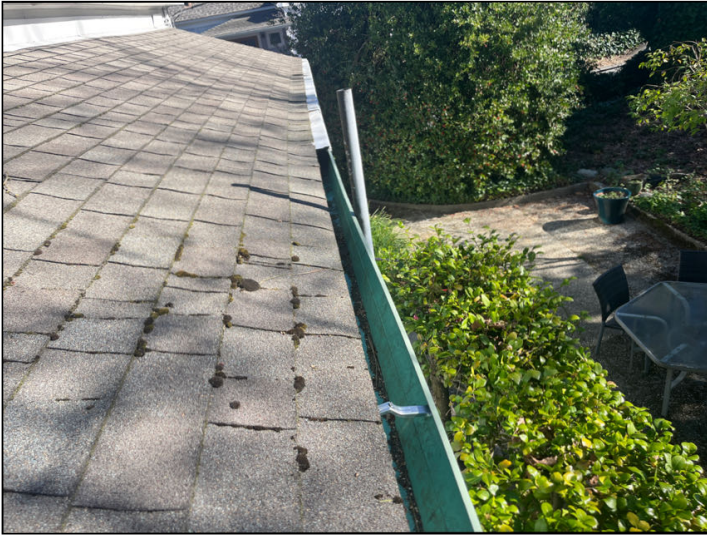
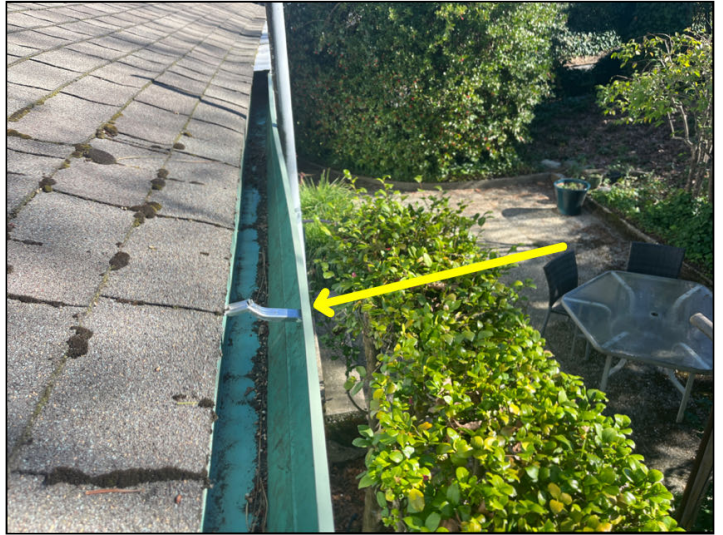
6. Gutter

- Clean gutters: Significant amounts of debris evident.
- Gutter leak(s) noted. Potential ice hazard in winter; repairs recommended.

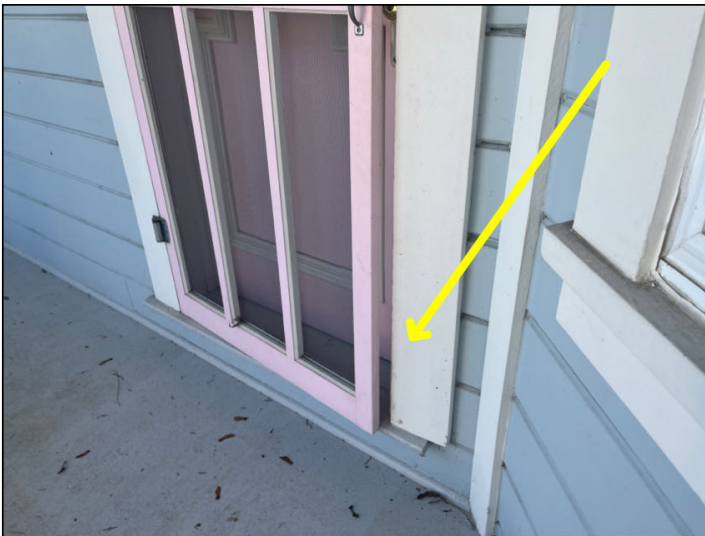
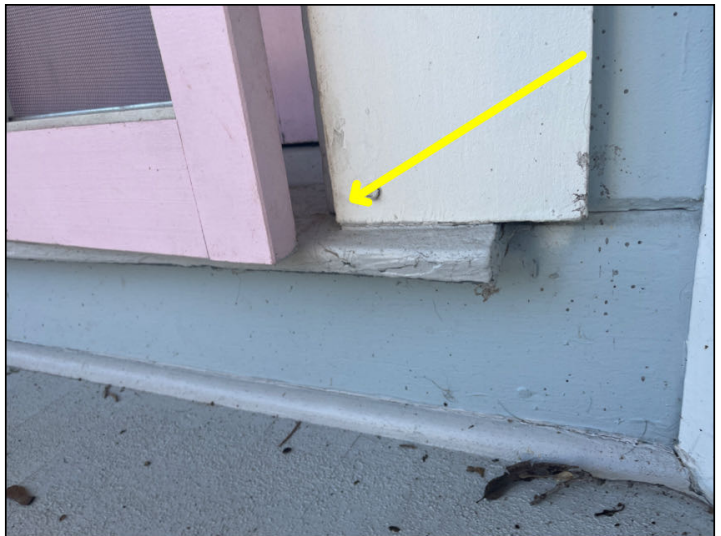
1. Doors

- The front door screen does not close all the way. Recommend repair by a qualified contractor or monitor for condition to get worse.

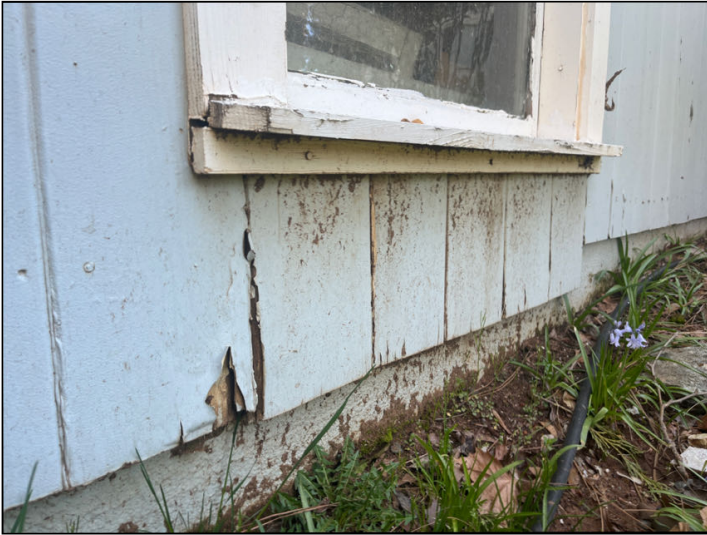
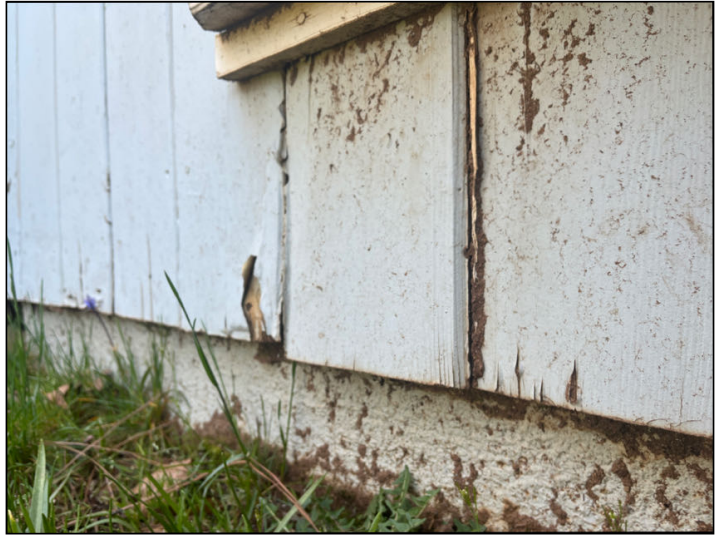
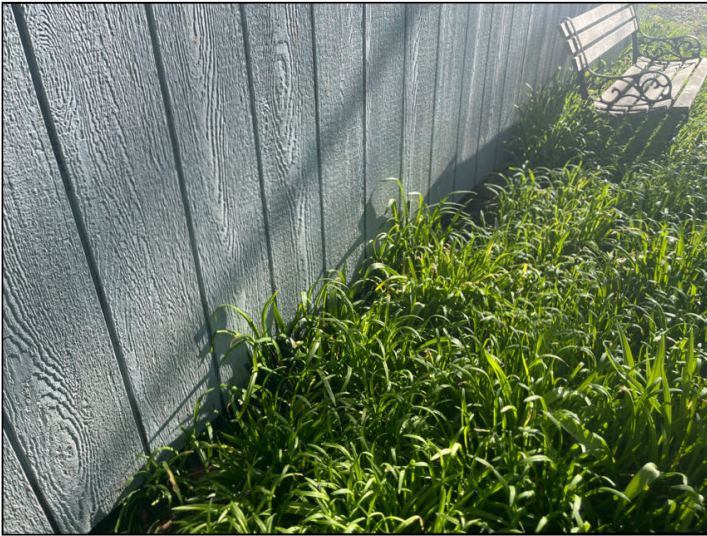
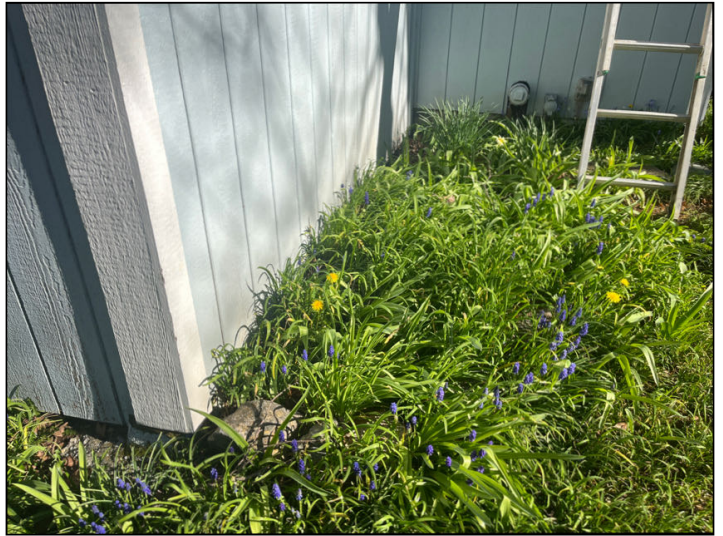
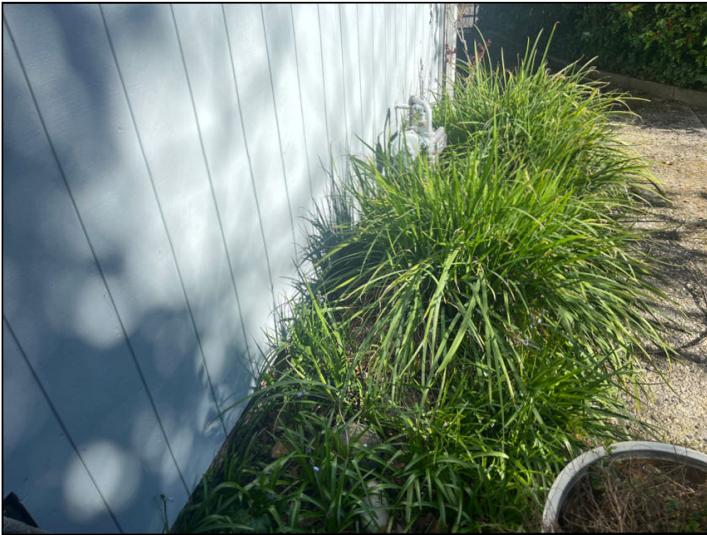
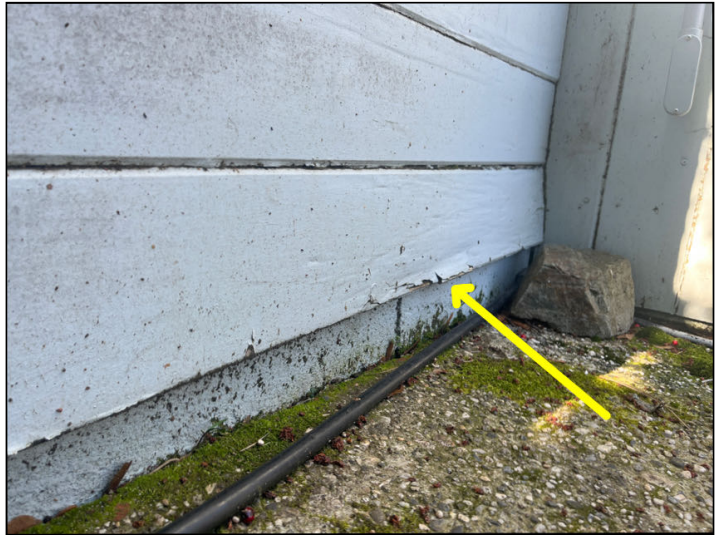
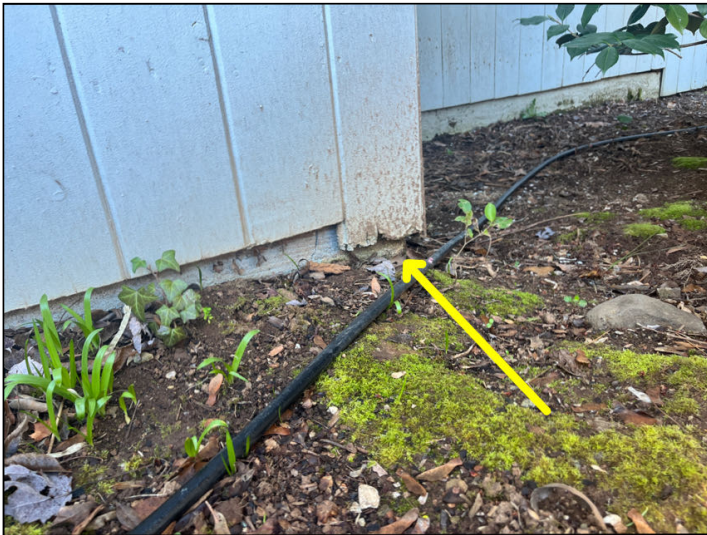
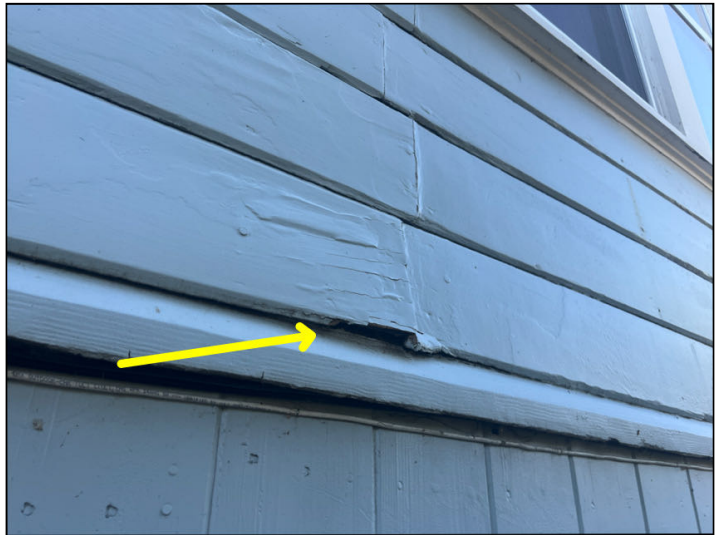
3. Siding Condition

- Vegetation, near or against the wood, siding can increase the likelihood of deterioration recommend clearing all vegetation that makes contact with the siding.
- Some areas of the siding appear to have minor water damage and or are a bit loose towards the bottom of the structure. Something to monitor for increased deterioration. Or have a qualified contractor further evaluate.

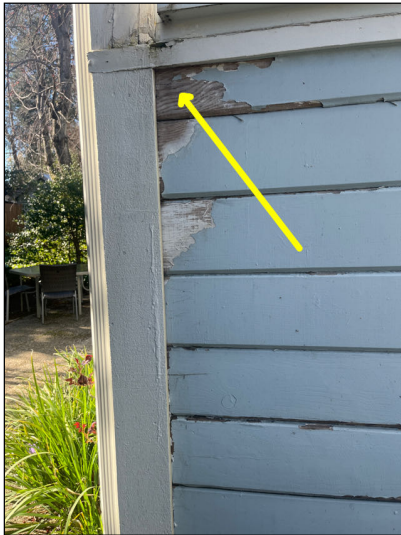
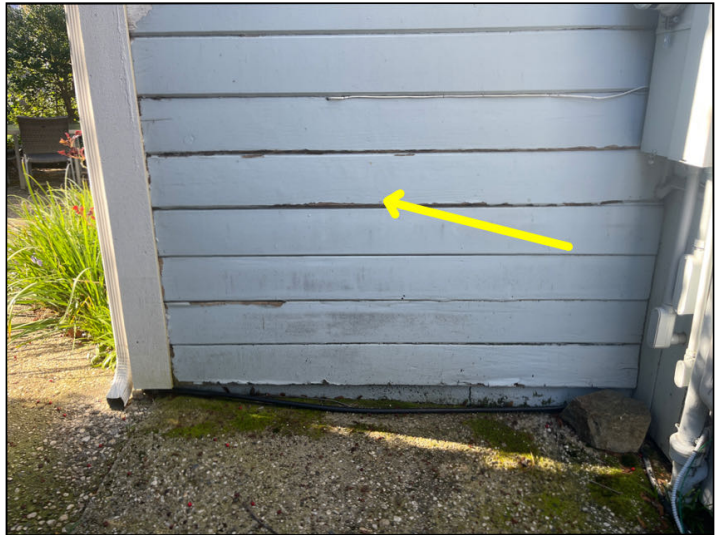
5. Exterior Paint

- Suggest caulking around doors and windows as necessary.
- Exposed wood surfaces observed. Wood rot & deterioration can occur. Prep, prime and paint wood trim surface where paint is peeling or missing.

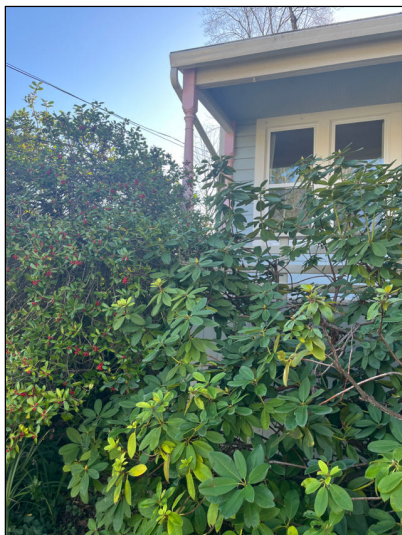
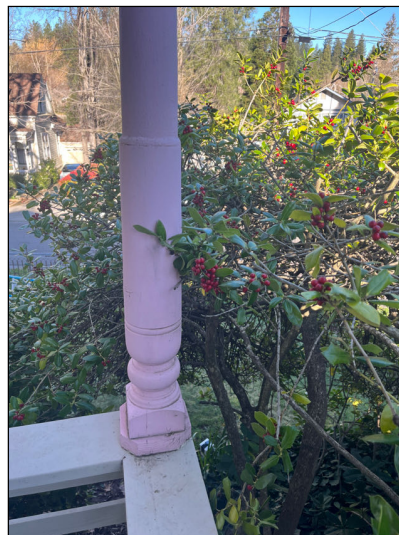
3. Vegetation Observations

- Prune or remove any plants that are in contact or proximity to home to eliminate pathways of wood destroying insects.
- Tree limbs within 10 feet of roof should be trimmed away to provide air and sunlight to roof, while minimizing debris & dampness.
- **Trim trees that are in contact or proximity to home, as branches can abrade roofing or siding.**

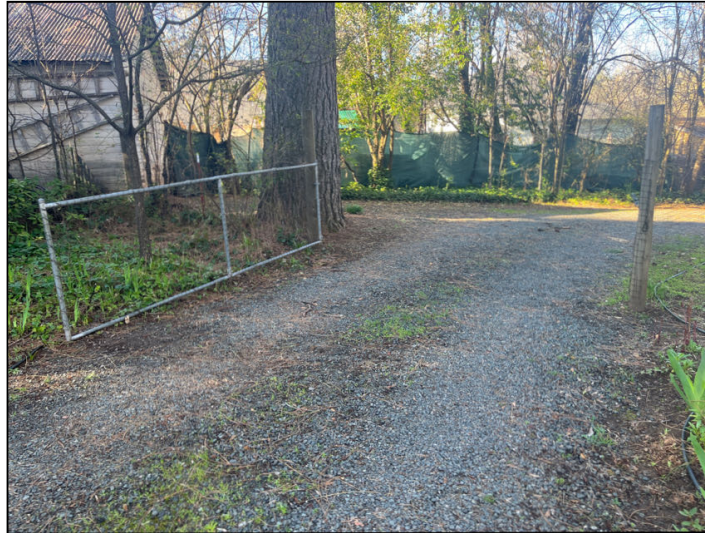
4. Gate Condition

- Gate is sagging.

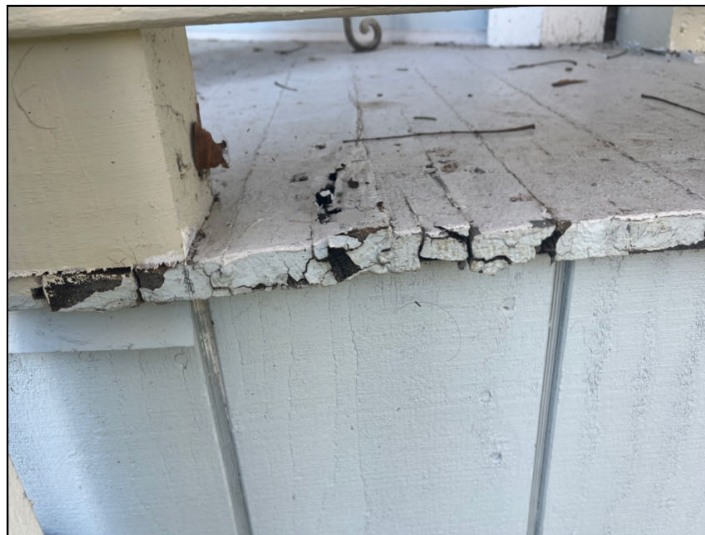
5. Patio and Porch Deck

- Rotted Wood.
- Decking board spacing less than 3/8". Recommend cleaning deck frequently to avoid accumulation of organic debris causing trapped moisture and eventual rot.
- **Some deck boards are damaged, and some others need securing.**

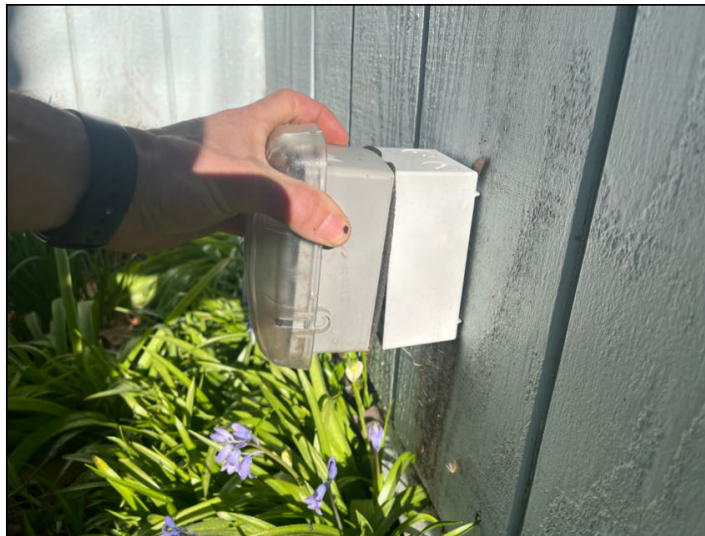
7. Grounds Electrical

- ✓ • The outdoor rated waterproof cover for the outlet is loose and just needs to be secured by either the homeowner or a qualified electrician.

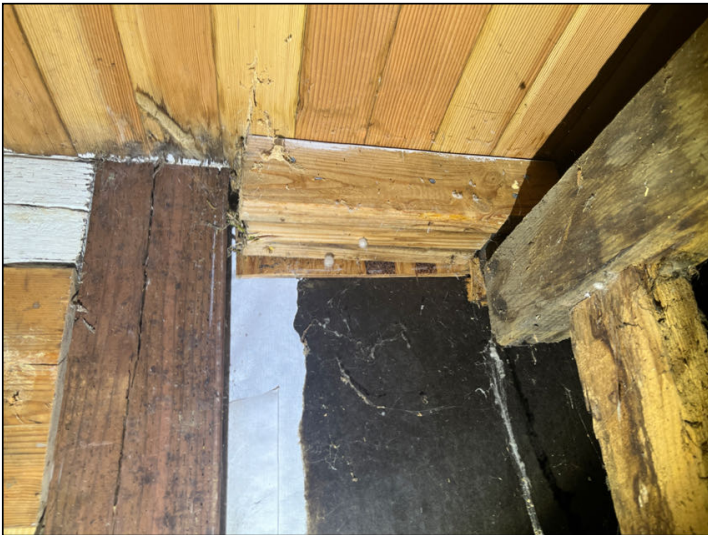
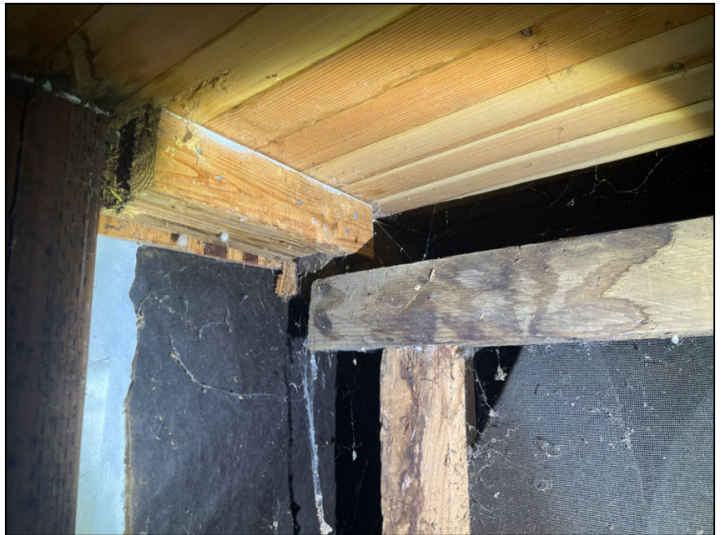
13. Balcony

- **Unstable supports. I recommend further evaluation by a qualified contractor.**

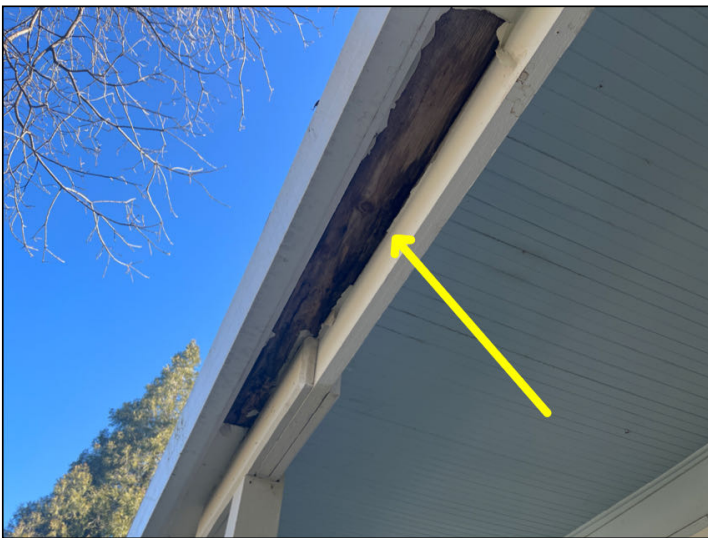
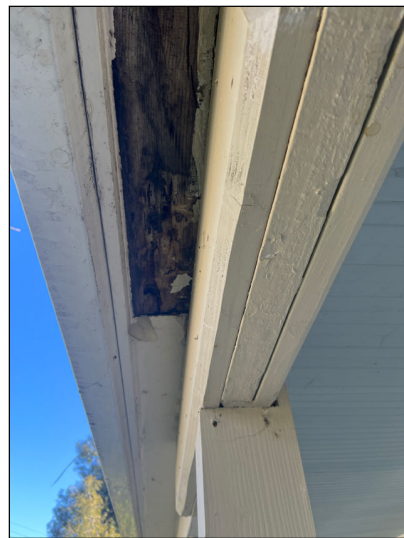
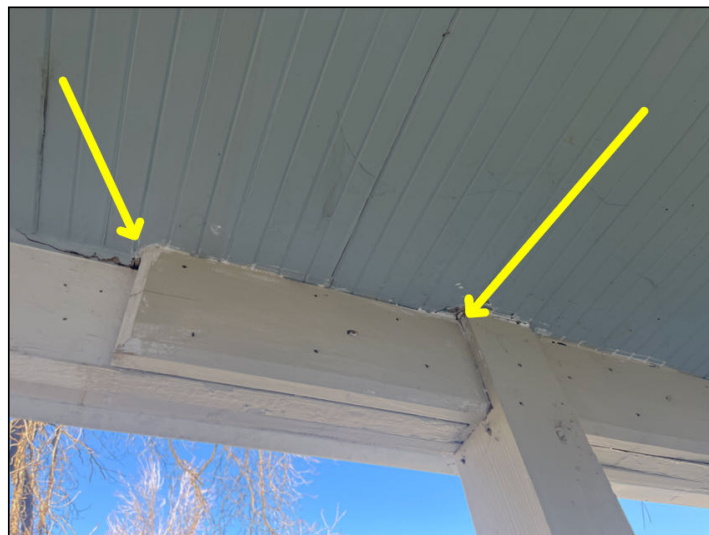
14. Patio and Porch Condition

- There are signs of water intrusion in the soffits over the deck. I recommend further evaluation by a roofing contractor.
