123 Apple Ln.

Example, WA, 12345

March 1st, 2024

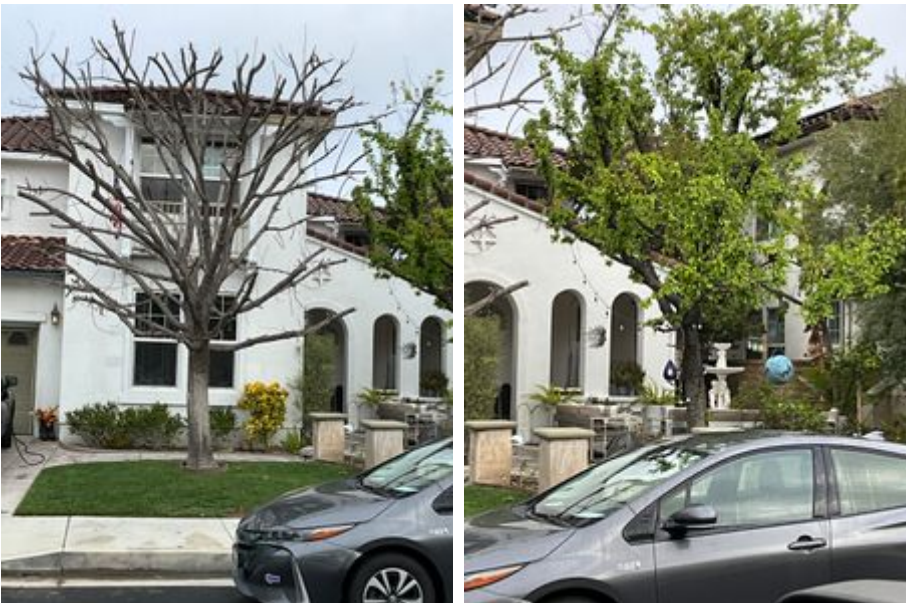
1.2 · LANDSCAPING & SITE OBSERVATIONS

The roots of mature trees could have an adverse effect on the main sewer line and any other underground piping such as area drains, water supply piping and irrigation pipes. Therefore, it would be prudent to have the trees removed. In any event, you should consult an arborist who could predict future growth potential.

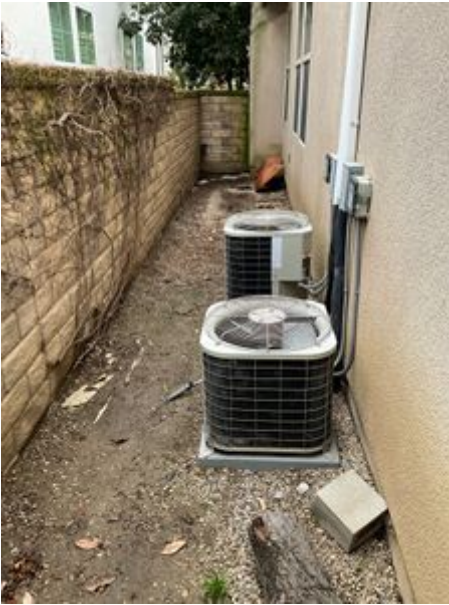
1.3 · PROPERTY LINE ENCROACHMENT

The condensing units for the AC systems have been relocated from their original location to a location that impedes the required minimum setback of 5 feet from the property line. This is a condition that may require correction if and when the Building & Safety Department becomes aware of it. You may wish to seek a second opinion on this matter, but we suggest that the units be relocated to an area that does not encroach on the property lines.

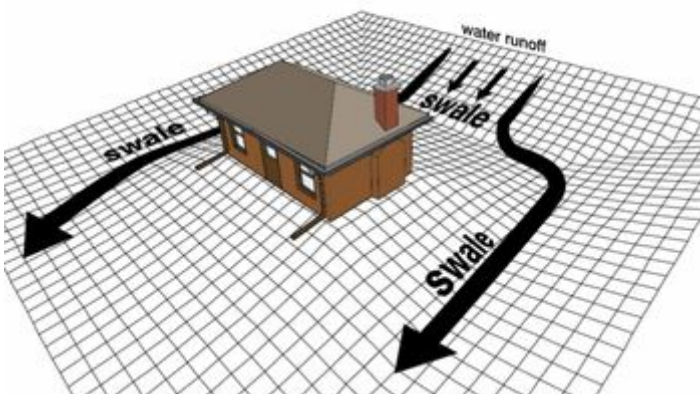
Swales

when the overall lot drainage is toward the house, swales can be used to direct surface water away from the foundation

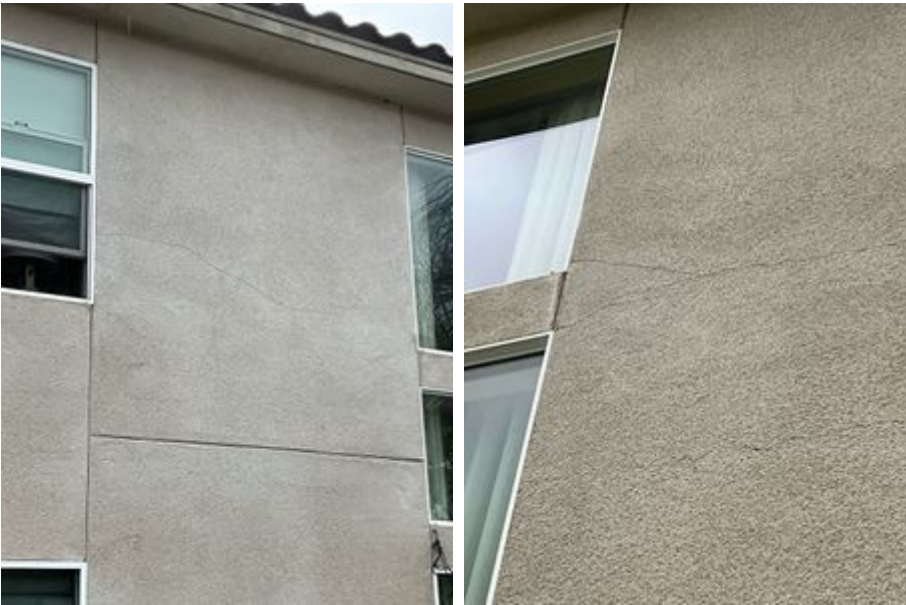
1.11 · HOUSE WALL FINISH OBSERVATIONS

There are typical cracks in the stucco, which you should view for yourself. All cracks result from movement, and are structural in that respect, but the vast majority of them have only a cosmetic significance.

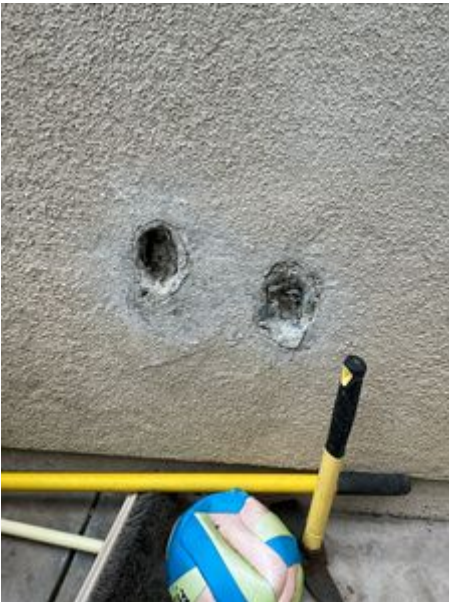
1.12 · HOUSE WALL FINISH OBSERVATIONS

Openings in the stucco siding should be sealed to prevent moisture and pest intrusion.

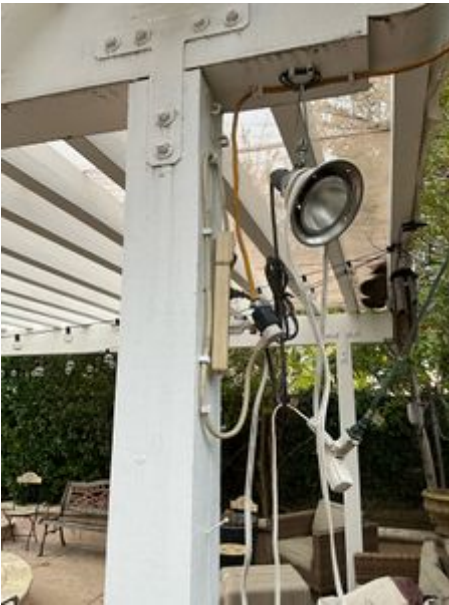
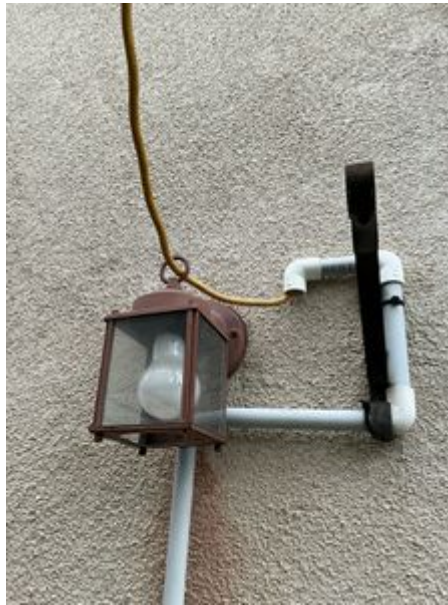
1.25 · EXTERIOR ELECTRICAL OBSERVATIONS

Extension cords are being used as permanent power sources. This is an unsafe practice. Extension cords should be removed for safety and installation of a permanent means of power should be provided by a qualified electrician.

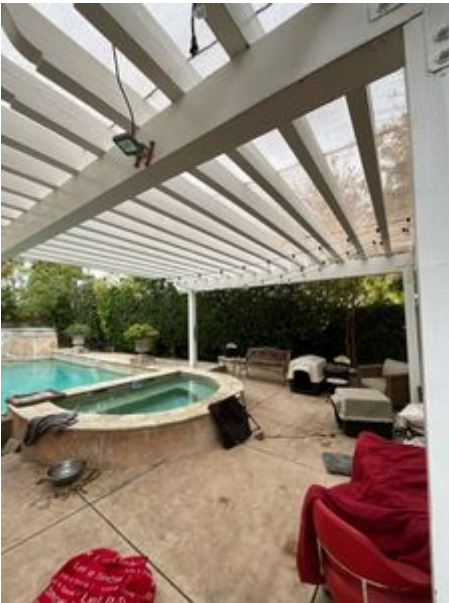
1.26 · PATIO COVERS OR GAZEBOS

The patio cover or arbor is in acceptable condition.

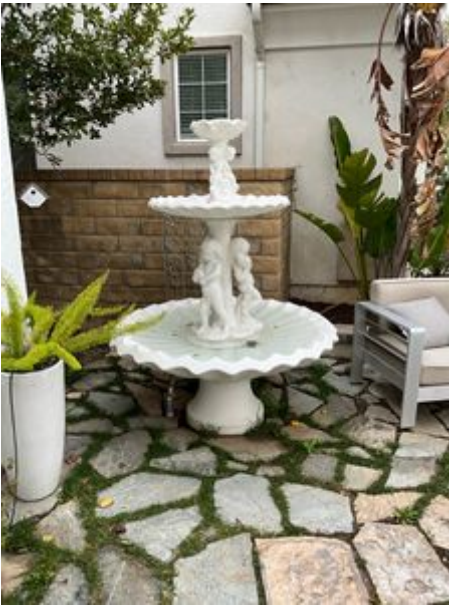
1.27 · FOUNTAINS BIRD BATHS ETC

The landscaping includes pre-cast concrete accessories, such as benches, fountains, bird-baths, large pots, or statuary. Although we disclaim an evaluation of all such items, many consist of heavy, stacked or balanced, components that can represent a safety hazard, and particularly to children. Therefore, you should verify that such components are adequately anchored or otherwise safe.

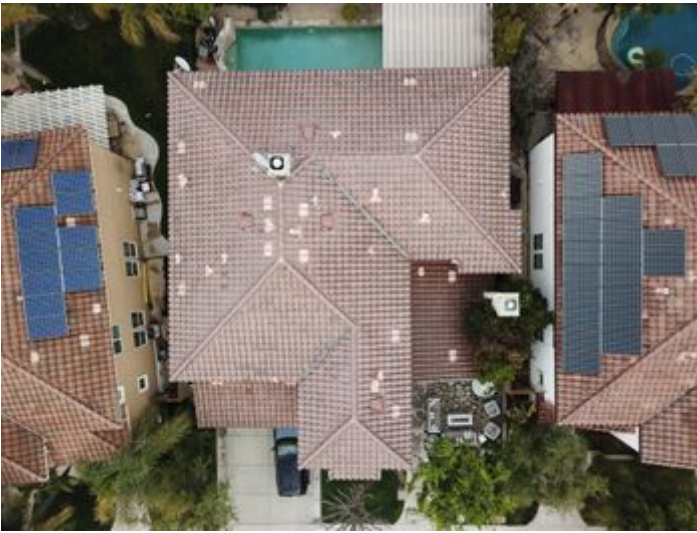
3.2 · METHOD OF EVALUATION

We evaluated the roof with the aid of a drone (unmanned aircraft), equipped with a high definition camera.

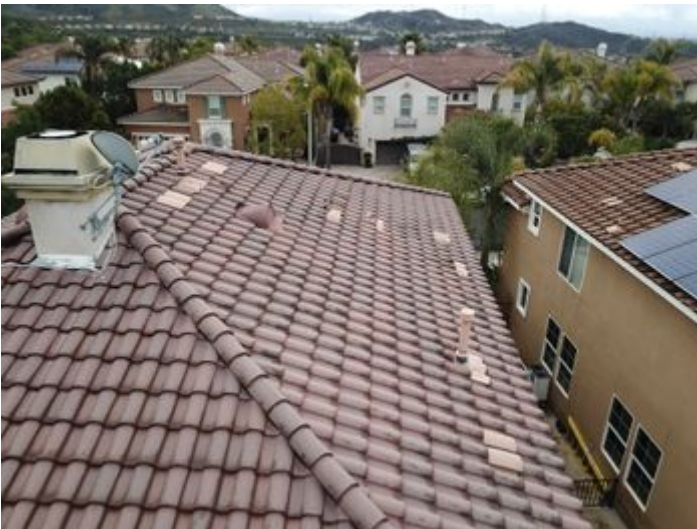
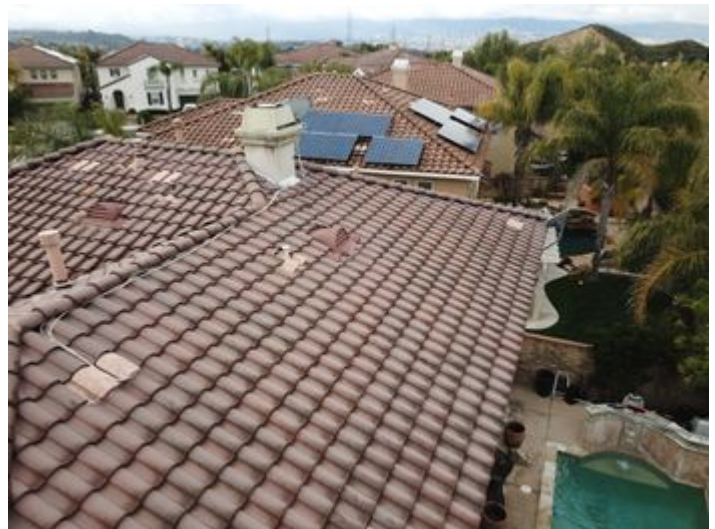
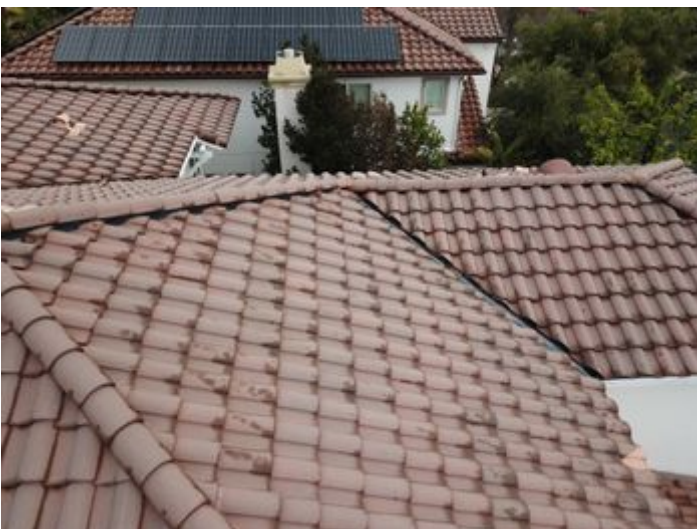
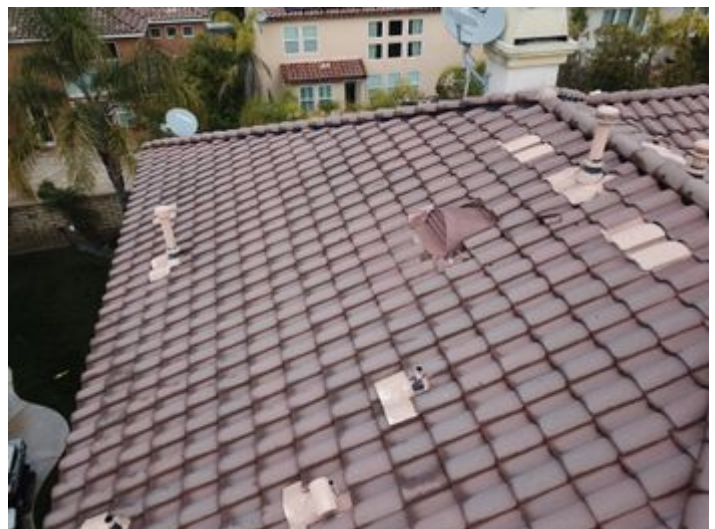
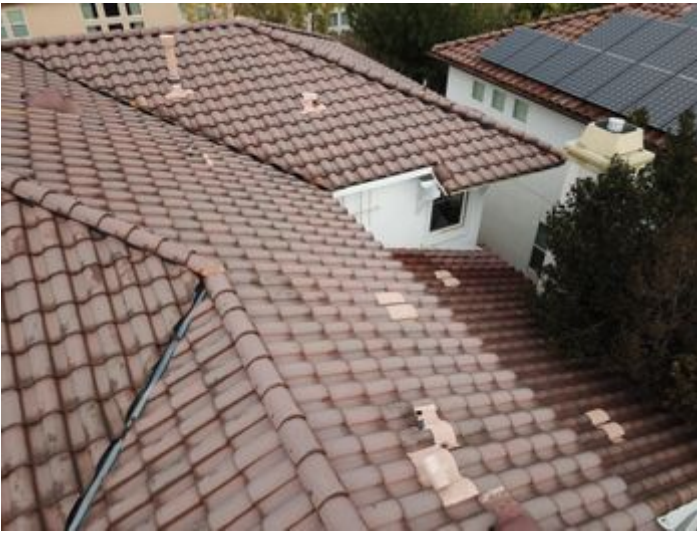
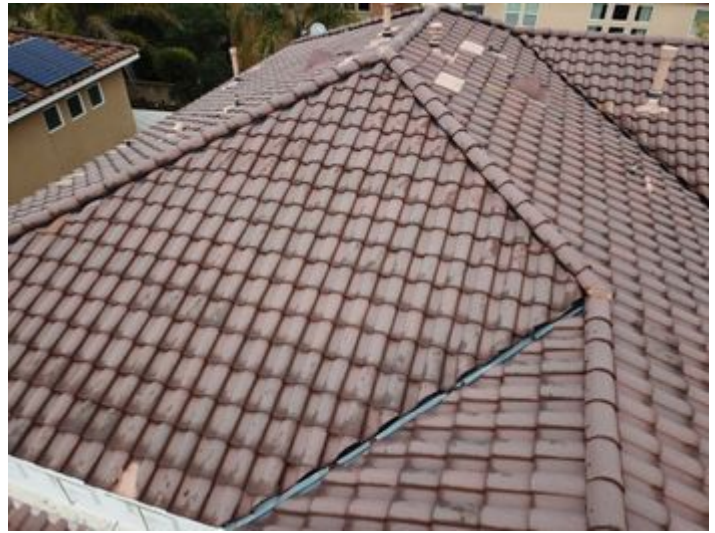
3.3 · TILE/ROOF-COVERING CONDITION

The roof is in acceptable condition, but this is not a guarantee against leaks. For a guarantee, you would need to have a roofing company perform a water-test and issue a roof certification.

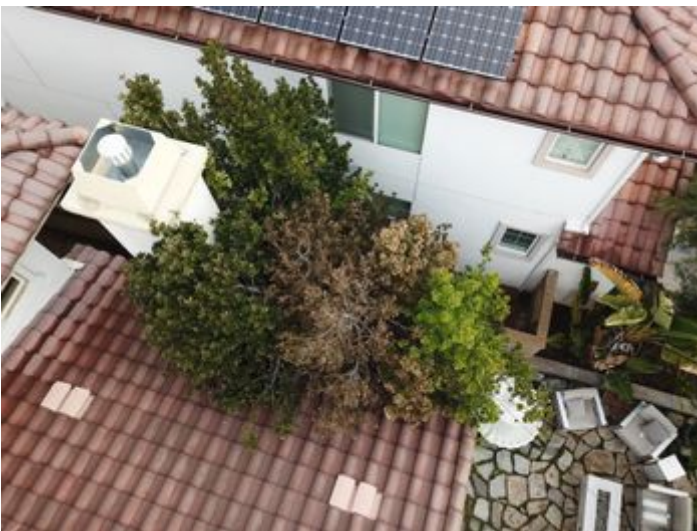
3.4 · TILE/ROOF-COVERING CONDITION

Vegetation is has overgrown onto the roof covering. This does not allow for proper drainage of the roof covering and may result in leaks, especially during heavy rainfall. The vegetation should be removed from the roof covering to reduce the potential for leaks.

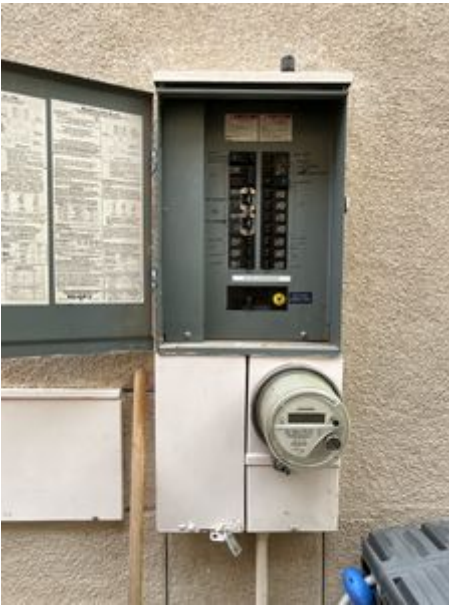
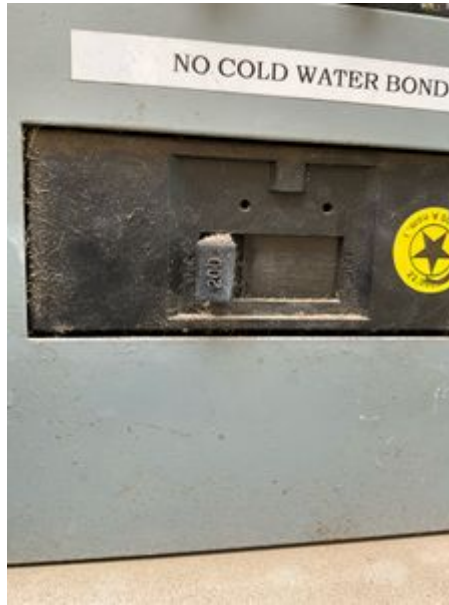
4.3 · SERVICE PANEL SIZE & LOCATION

The residence is served by a 200 amp, 240 volt panel, located in the garage side yard.

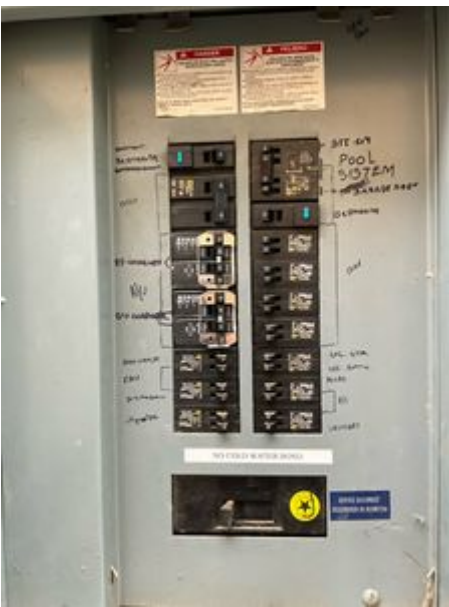
4.4 · SERVICE PANEL OBSERVATIONS

The panel and its components have no visible deficiencies.

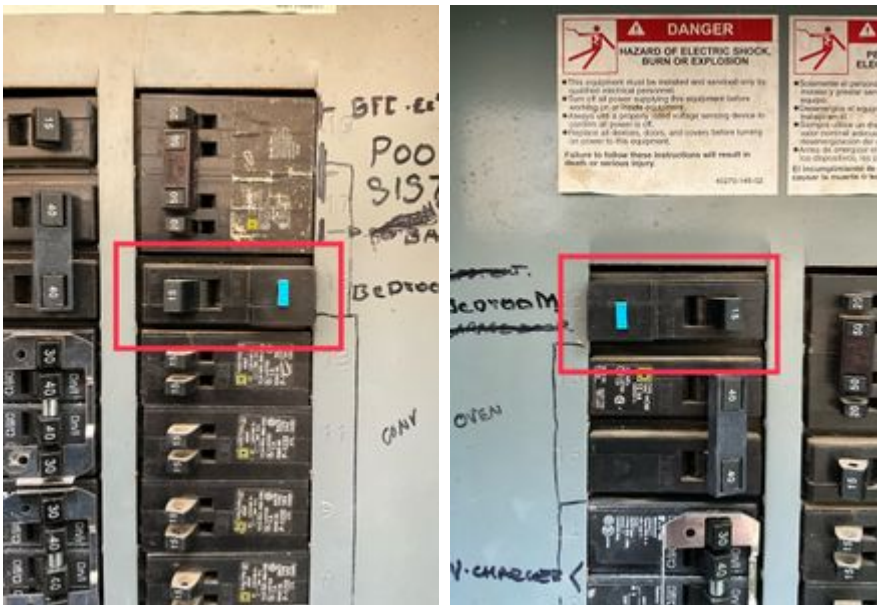
4.10 · CIRCUIT BREAKERS

The service panel includes arc-fault circuit interrupters, which are mandated by the National Electrical Code to protect 15 and 20 amp branch circuits serving bedrooms. However, these particular AFCI breakers appear to be a specific type that have been recalled by their manufacturer, which can only be confirmed by verifying their date and product code. Therefore, the breakers should be evaluated by a qualified electrician and be replaced as necessary.

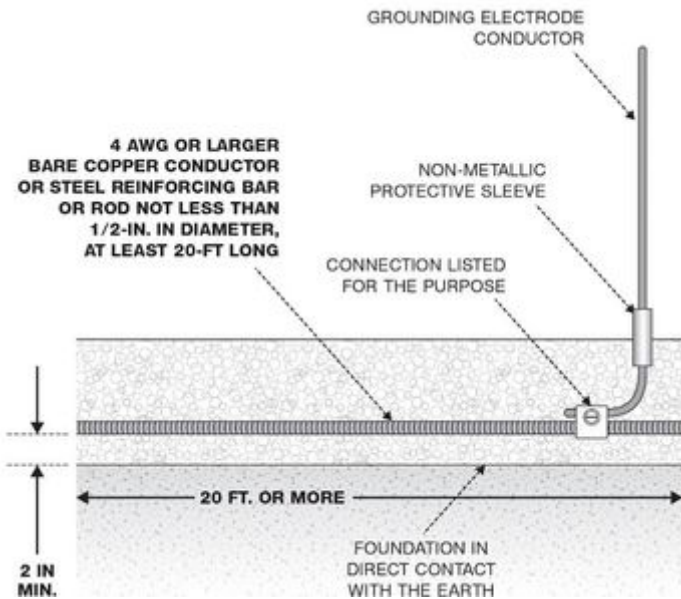
4.11 · SERVICE EQUIPMENT GROUNDING & BONDING

The system is grounded to foundation steel, known also as a UFER ground, or concrete encased electrode.

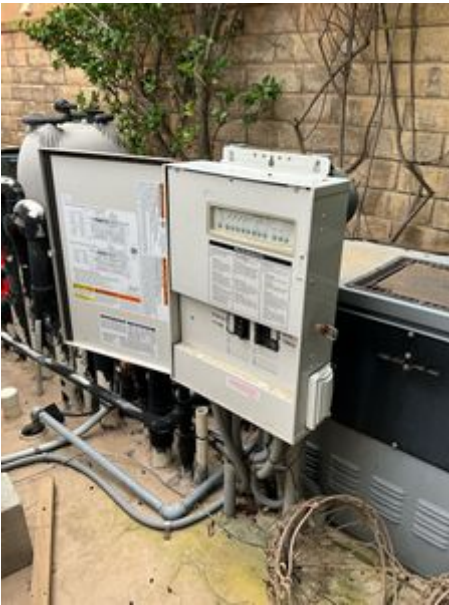
5.2 · PANEL LOCATION

The sub panel is located in the pool equipment area.

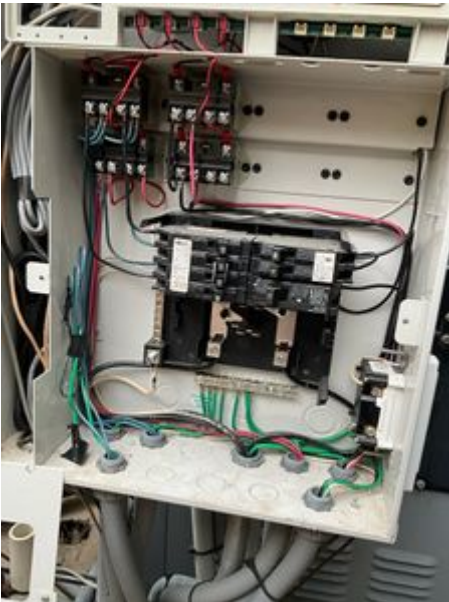
5.3 · PANEL OBSERVATIONS

The electrical sub panel has no visible deficiencies.

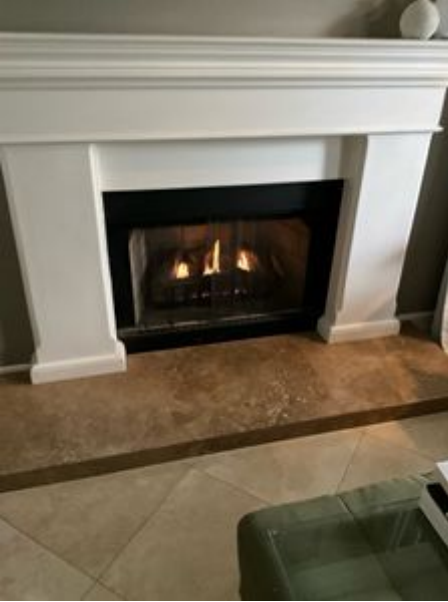
6.13 · ORNAMENTAL

The fireplace system is ornamental only and not designed to burned solid fuels. The ornamental gas log is functional and does not need service at this time.

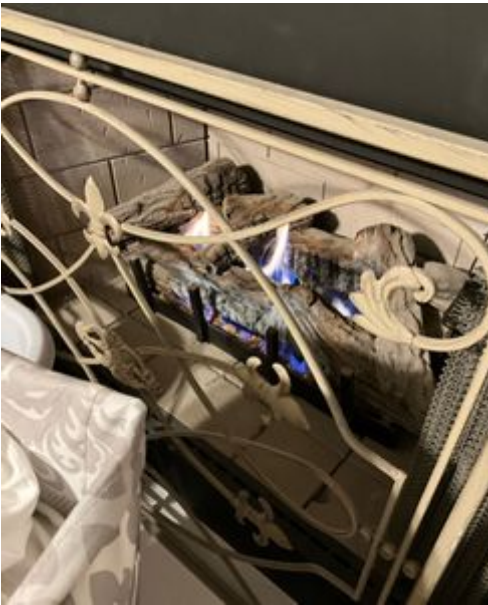
6.15 · ORNAMENTAL

The fireplace system is ornamental only and not designed to burned solid fuels. The ornamental gas log is functional and does not need service at this time.

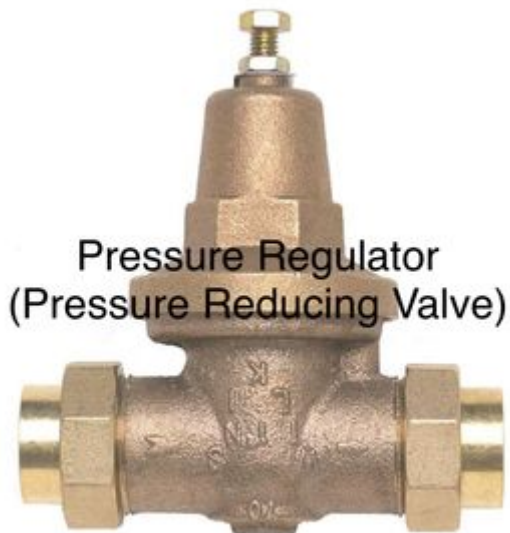
7.4 · PRESSURE REGULATORS

A functional pressure regulator is in place on the plumbing system. A water pressure regulator is a valve that automatically cuts off, or reduces the flow of water at a certain pressure. Regulators are used to allow high-pressure water supply lines or tanks to be reduced to safe and/or usable pressures for residential applications.

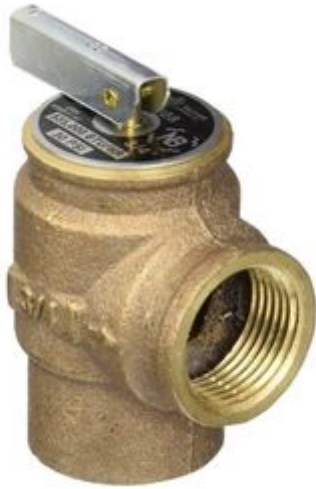
7.5 · PRESSURE RELIEF VALVES

A pressure relief valve is a safety device that relieves overpressure in the water piping. There is a pressure relief valve on the plumbing system, as required.

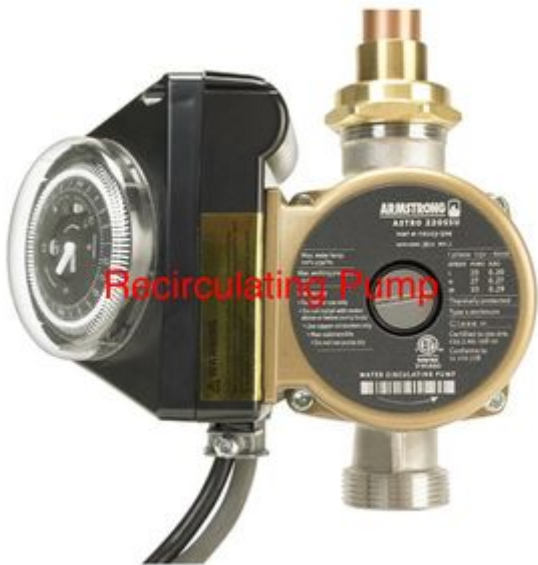
7.6 · RECIRCULATING SYSTEMS

Hot water recirculation systems deliver hot water to fixtures quickly without waiting for the water to get hot. Rather than relying on water pressure in water lines, recirculating systems use a pump to rapidly move water from a water heater to the fixtures. The plumbing system on this residence does not include a recirculating pump, which means that there will be a delay in hot water service relative to the distance of the fixture from the water heater.

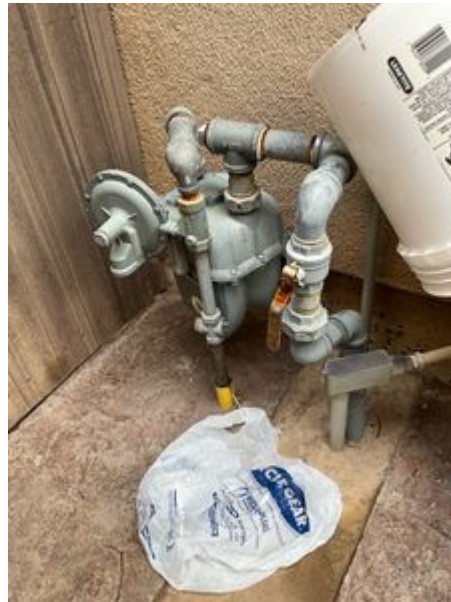
The gas main shut-off is located in the garage side yard. You should be aware that gas leaks are not uncommon, particularly underground ones, and that they can be difficult to detect without the use of sophisticated instruments, which is beyond the scope of a typical home inspection. Therefore, we recommend that you request a recent gas bill from the sellers, so that you can establish a norm and thereby be alerted to any potential leak.

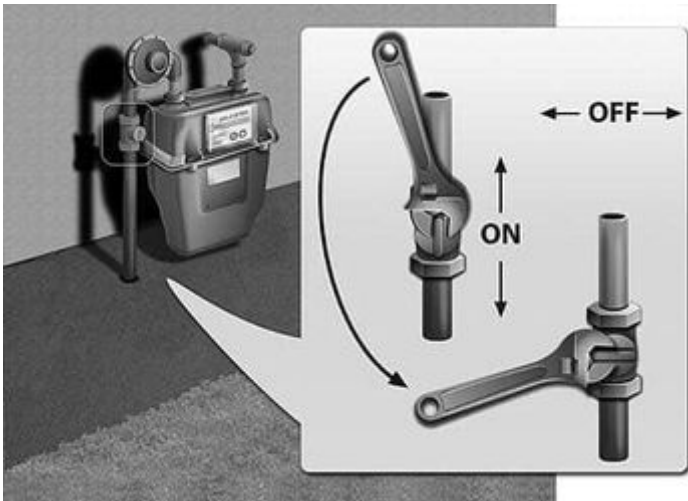
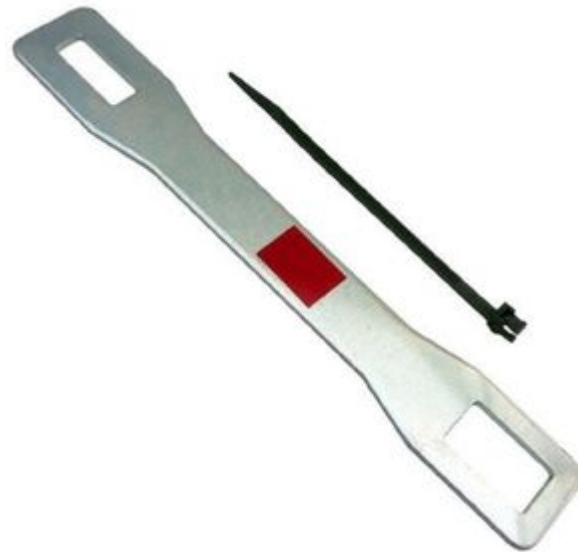
7.9 · GAS MAIN OBSERVATIONS

There is no wrench at the gas shut-off valve to facilitate an emergency shut-off, and we recommend that you buy one and leave it in-place near the valve.

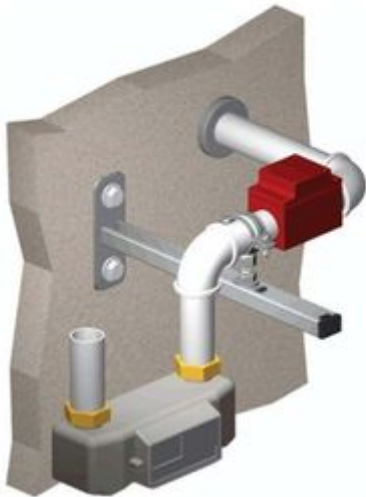
Seismic Gas Valve

The gas main is not equipped with a seismic shut-off valve. A natural gas seismic shut-off valve automatically shuts off your gas service when an earthquake of a sufficient magnitude occurs at your home's location. Although they are not mandated by this jurisdiction, many insurance companies will require that a seismic shut-off valve be installed at the gas main. Therefore, you should check with your insurance provider.

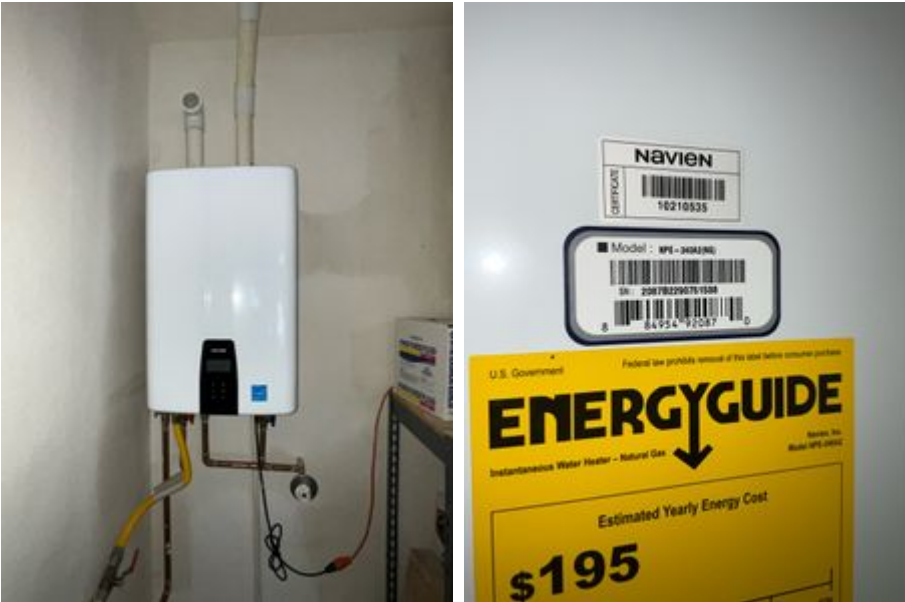
7.17 · AGE & LOCATION

Hot water is provided by a 2 year old, tankless, water heater that is wall-mounted in the garage.

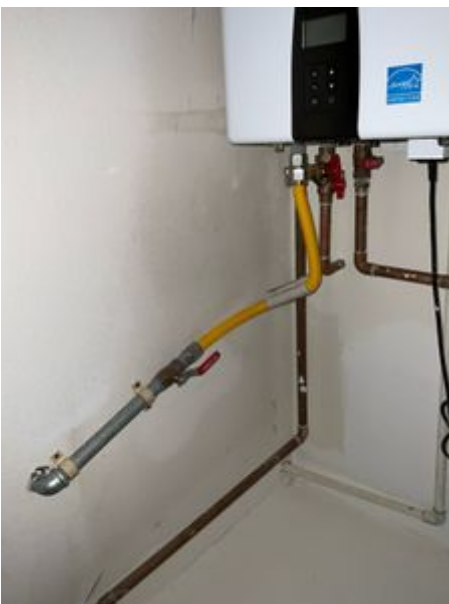
7.18 · GAS VALVE & CONNECTOR

The gas line to the water heater does not include a sediment trap, also referred to as a drip-leg. This component is required by the manufacturer and is designed to prevent contaminants from entering the gas-control valve of the heater, which could cause a malfunction of the unit. In some cases, absence of the drip leg may void the warranty of the water heater. A drip leg or sediment trap should be installed by a qualified plumber, in accordance with the manufacturers requirements.

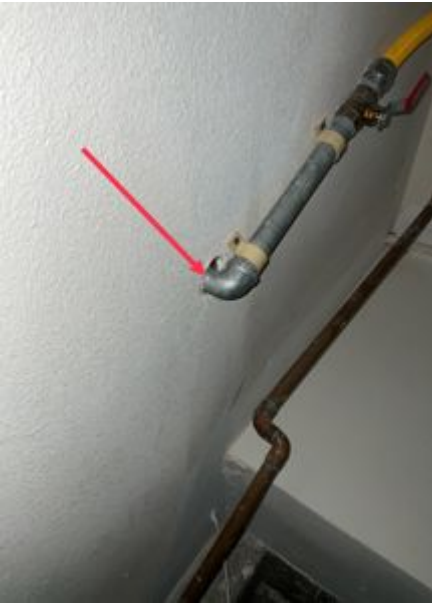
7.19 · GAS VALVE & CONNECTOR

Standard tankless water heaters require a 3/4 inch gas supply line for proper operation. The current gas piping is 5/8 inch in size. Improper sizing of the gas supply piping can cause the unit to malfunction and will void the warranty from the manufacturer. Therefore, the piping size should be verified by a qualified plumber in accordance with the manufacturers requirements and the BTU rating of this particular water heater.

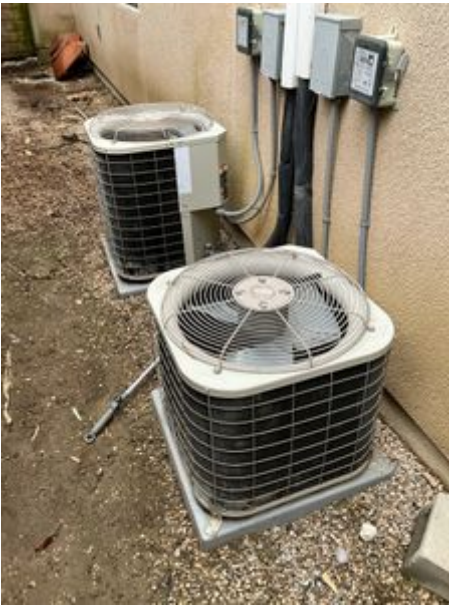
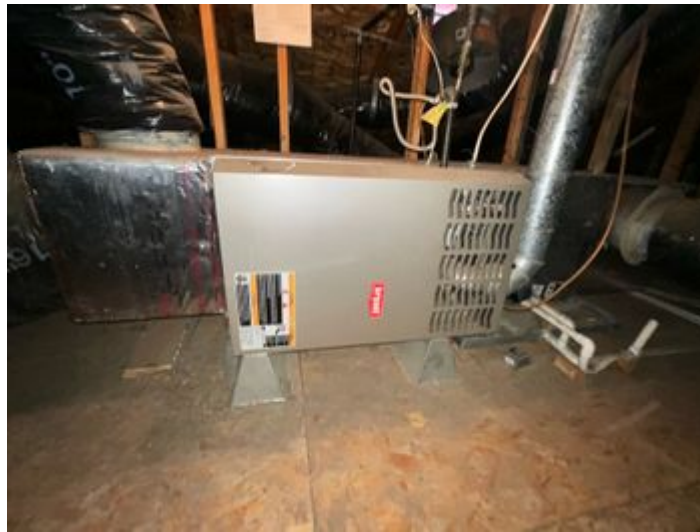
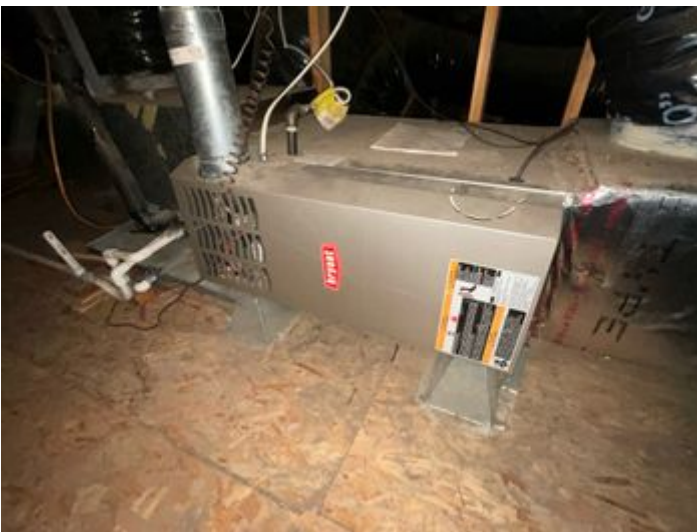
8.1 · AGE & LOCATION

Central heat and air-conditioning are provided by dual systems, consisting of two 21 year-old furnaces with evaporator coils that are located in the attic, and two 21 year-old condensing coils that are located in the back yard.

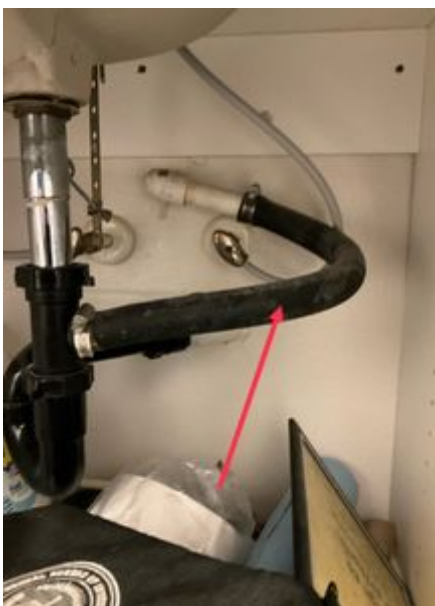
8.10 · CONDENSATE DRAINPIPE

The condensate pipe discharges at a bathroom sink drain.

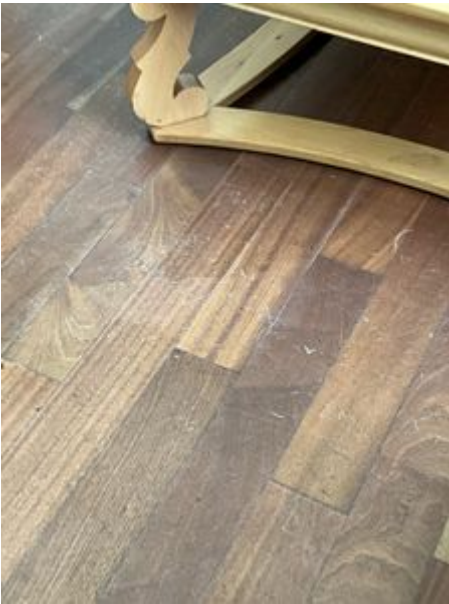
10.4 · FLOORING

The floor is worn or cosmetically damaged, which you should view for yourself.

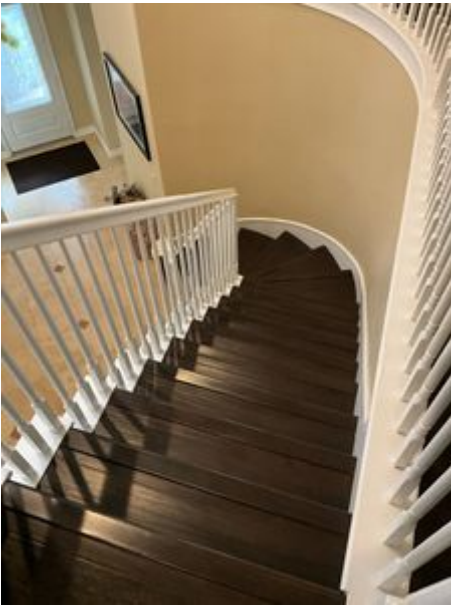
12.4 · HANDRAILS & GUARDRAILS

If small children occupy or visit this residence, suitable precautions should be taken to safeguard them.

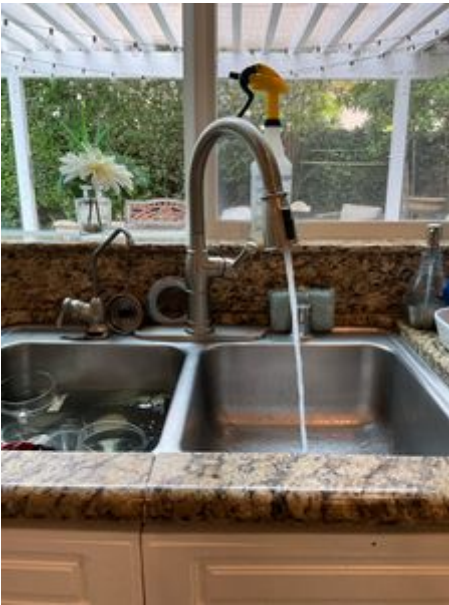
13.6 · FAUCET

The sink faucet is functional.

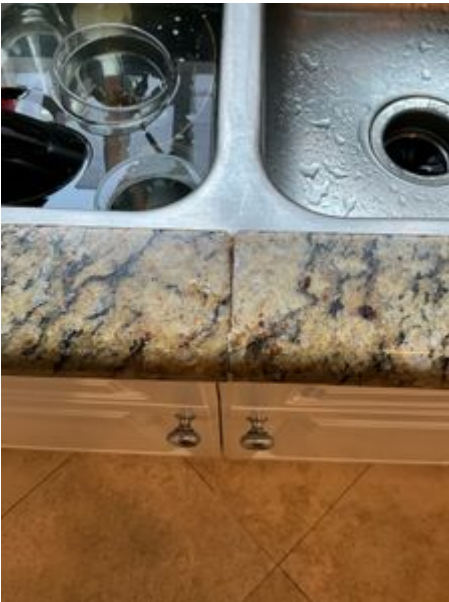
13.7 · SINK & COUNTERTOP

The countertop is separated. Food preparation surfaces should be solid and impervious to prevent bacterial contamination, and you should have the countertop repaired or replaced.

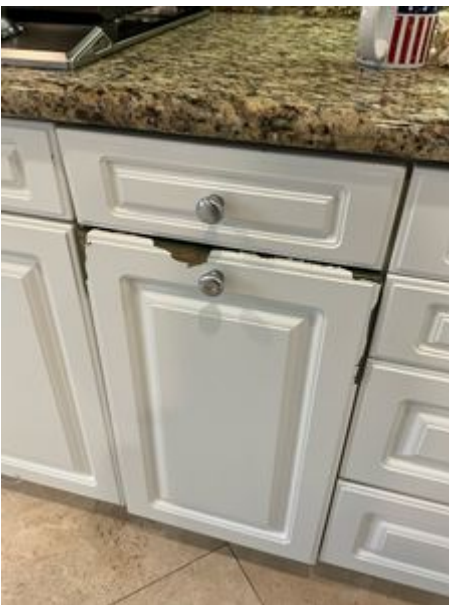
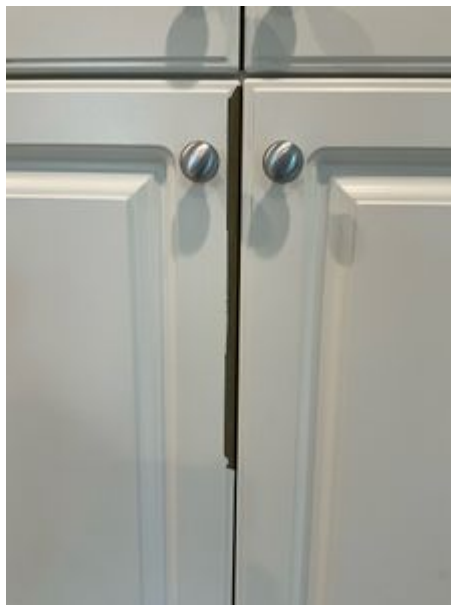
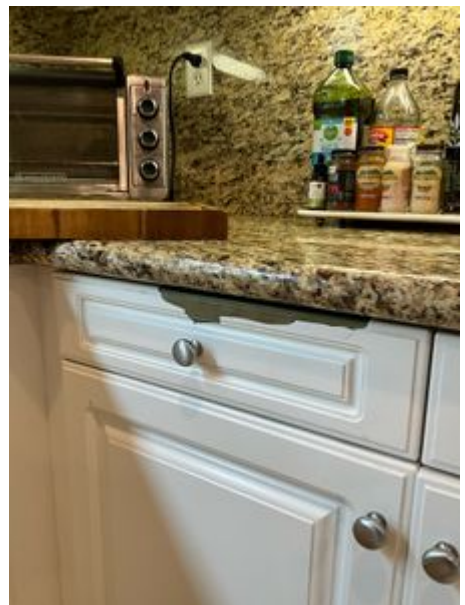
13.9 · CABINETS

The cabinets have cosmetic damage, or that which is commensurate with their age.

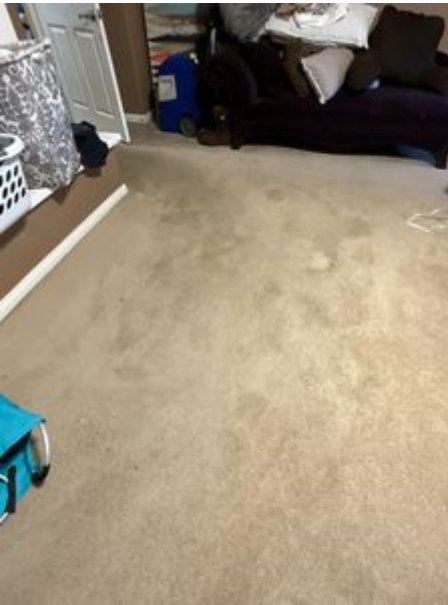
14.3 · FLOORING

The floor is worn or cosmetically damaged, which you should view for yourself.

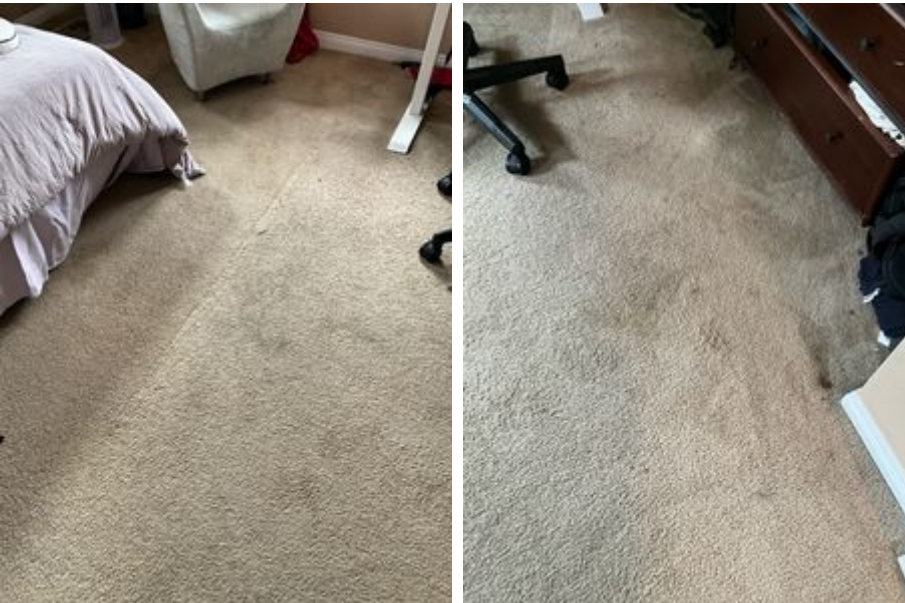
14.8 · FLOORING

The floor is worn or cosmetically damaged, which you should view for yourself.

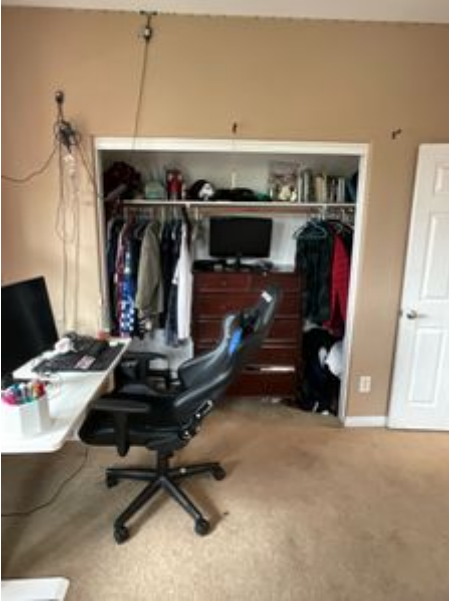
14.9 · CLOSETS

The closet doors are missing and you may wish to have them replaced.

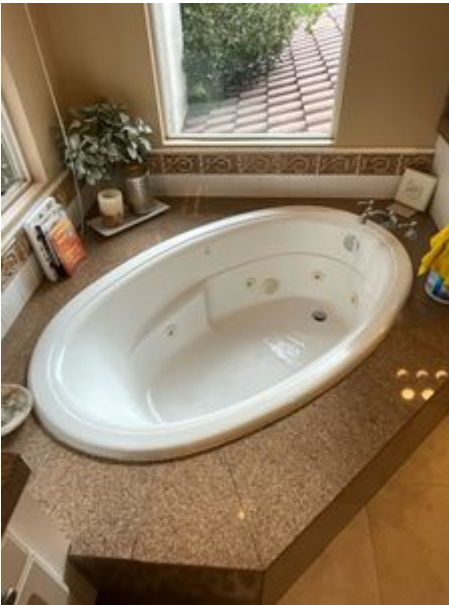
15.3 · HYDRO-SPA

The hydro-spa in the bathroom does not respond, and should be serviced and confirmed to have functional ground-fault protection.

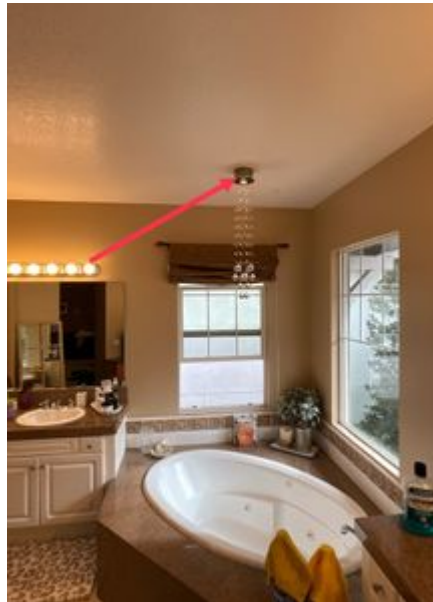
The hanging light fixture is located within a prohibited zone as identified by the California Electrical Code. No parts of cord connected fixtures, hanging fixtures, lighting track, pendants, or ceiling suspended fans are allowed to be located within the bathtub or shower zone. This zone is all encompassing and measures 3 feet horizontally and 8 feet vertically from the top rim of the bathtub, including the zone directly above the bathtub. The fixture should be removed or relocated by a qualified electrician.

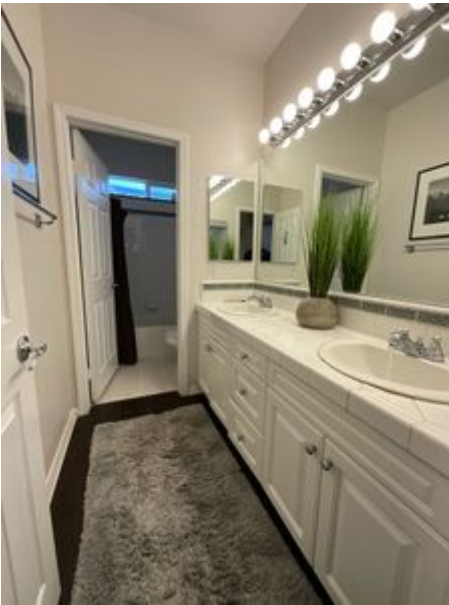
15.5 · SIZE AND LOCATION

This bathroom is a full and is located upstairs.

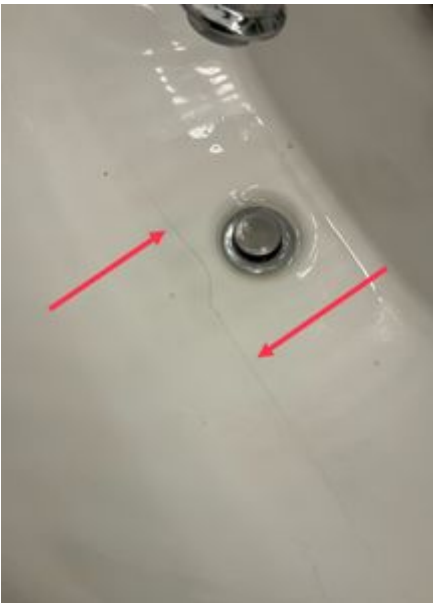
15.7 · SINK FAUCET VALVES & CONNECTORS TRAP & DRAIN

The left-side sink is cracked and will be susceptible to leaks and should be replaced by a qualified contractor.

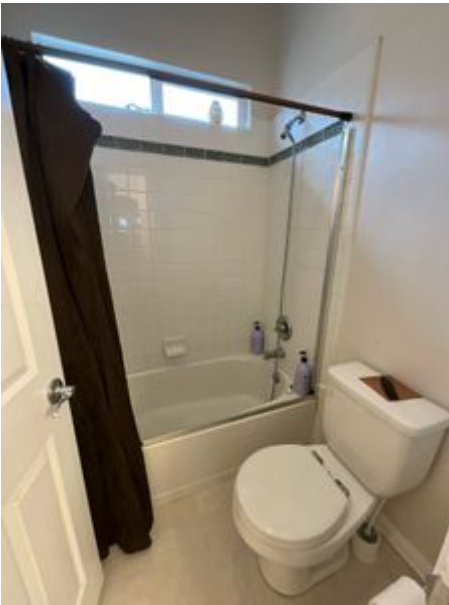
15.8 · TUB-SHOWER

The glass doors are missing from the enclosure which should be replaced by a qualified contractor.

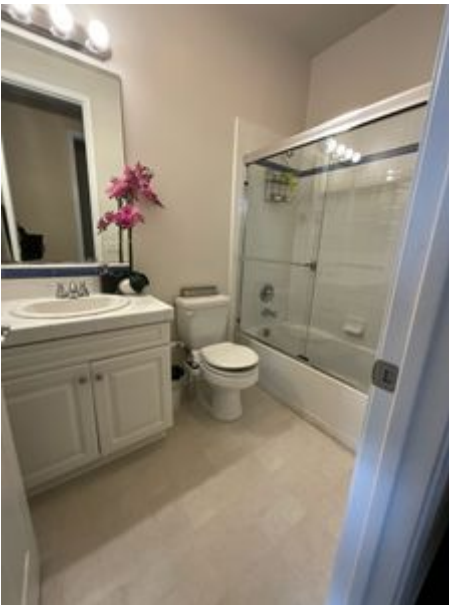
15.9 · SIZE AND LOCATION

This bathroom is a full and is located downstairs.

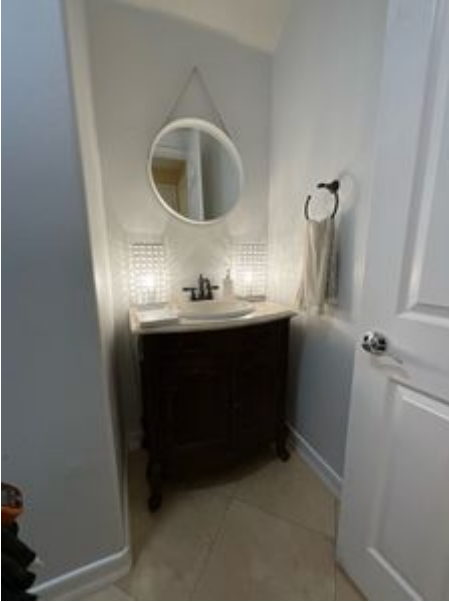
15.11 · SIZE AND LOCATION

This bathroom is a half and is located downstairs.

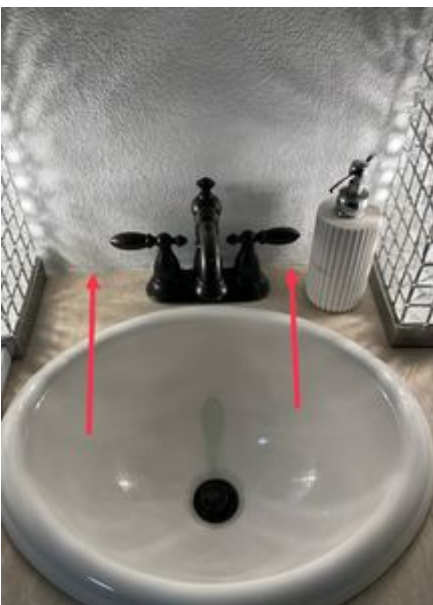
15.13 · SINK COUNTERTOP

There is no back-splash on the countertop. A backsplash or raised edge is required and intended to minimize the potential for moisture damage to the adjacent walls. You should have a back-splash installed by a qualified contractor.

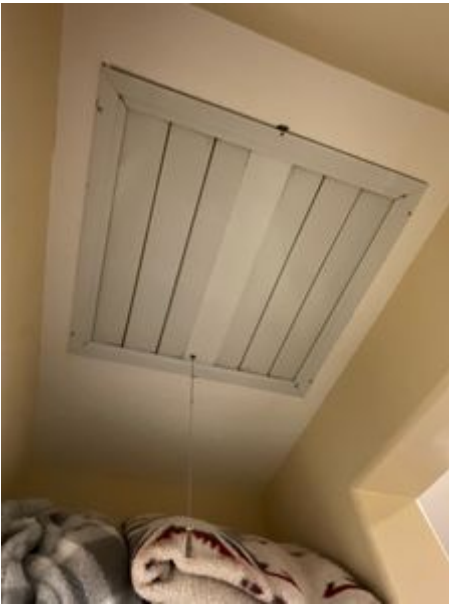
16.1 · PRIMARY ATTIC ACCESS LOCATION

The attic can be accessed through a hatch in the hallway ceiling.

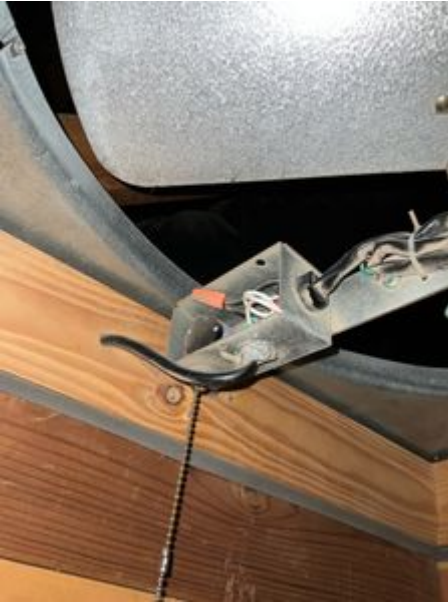
16.5 · ELECTRICAL

There is an open electrical junction box, which should be sealed so that any arcing or sparking would be contained within the box.

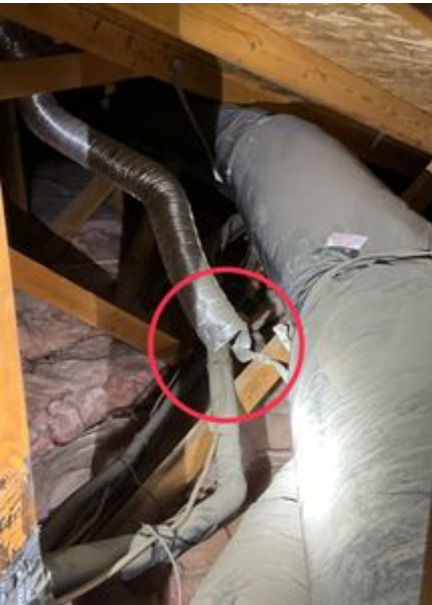
16.8 · EXHAUST DUCTS

The exhaust duct to the Primary Bathroom is separated, and should be repaired.

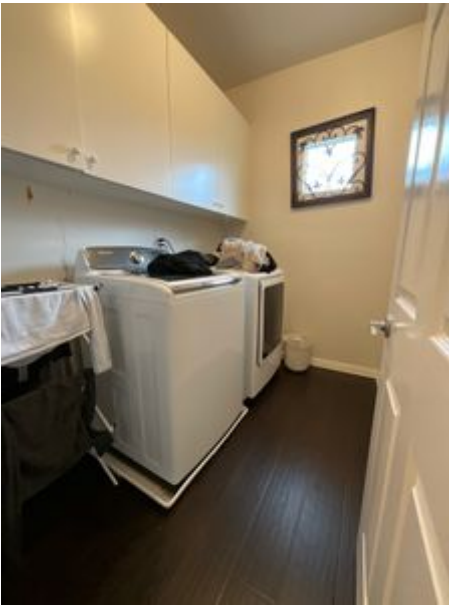
17.1 · NO RECOMMENDED SERVICE

We have evaluated the laundry room, and found it to be in acceptable condition. We do not test or inspect the laundry appliances.

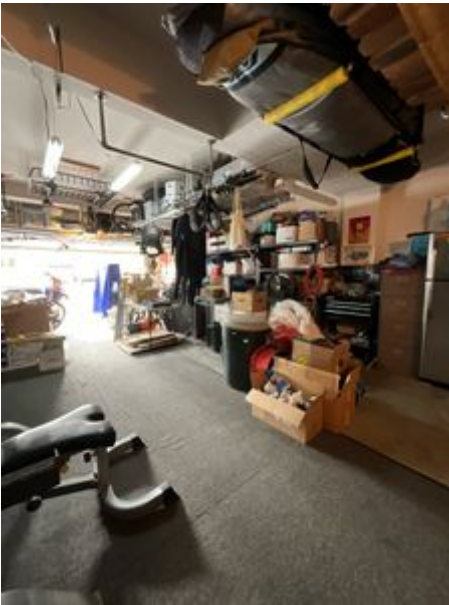
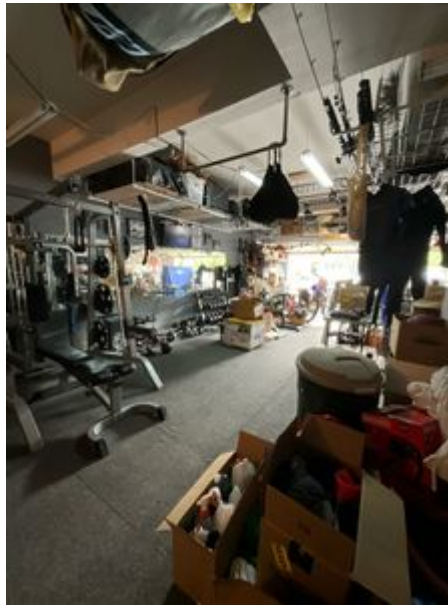
18.1 · GARAGE OBSERVATIONS

The garage is too full of personal belongings for an adequate evaluation of the systems and components within. Therefore, it is important that you do a thorough investigation at some point after the garage has been emptied to determine if any additional deficiencies exist that were not visible at the time of the inspection.
