123 Apple Ln.

Example, WA, 12345

March 1st, 2024

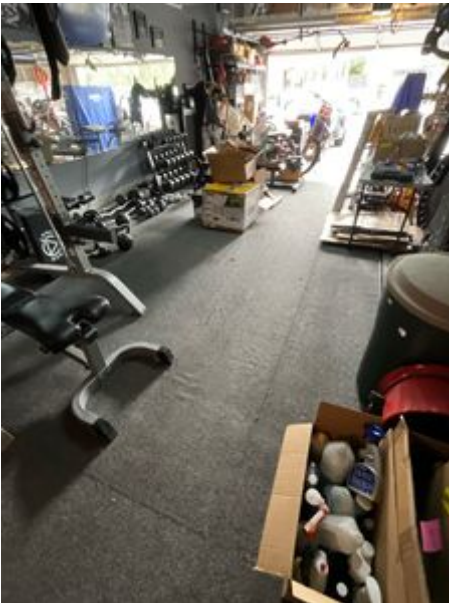
18.2 · SLAB FLOOR

The slab floor has been covered, which conceals any damage or deterioration that might be present.

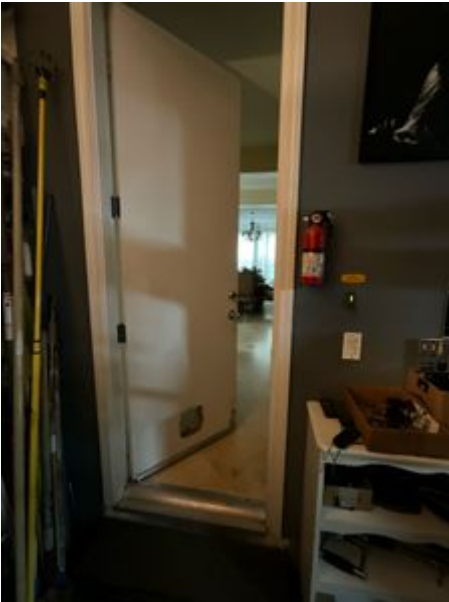
18.6 · ENTRY DOOR INTO THE HOUSE

The house entry door is not self-closing and is required to be in order to maintain the necessary firewall separation between a garage and living quarters, and will need to be serviced.

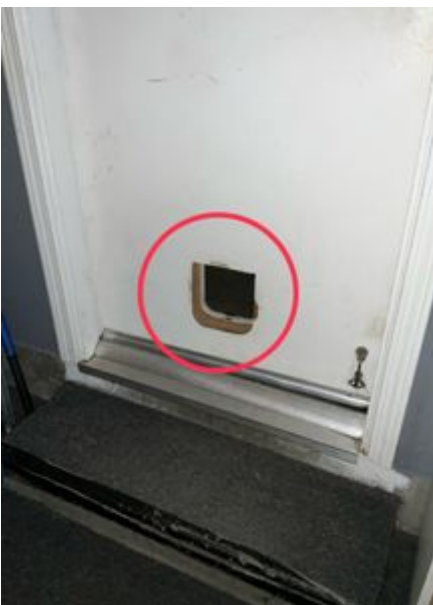
18.7 · ENTRY DOOR INTO THE HOUSE

The fire-rating of the house entry door has been nullified by the addition of an animal door, and the door should be replaced.

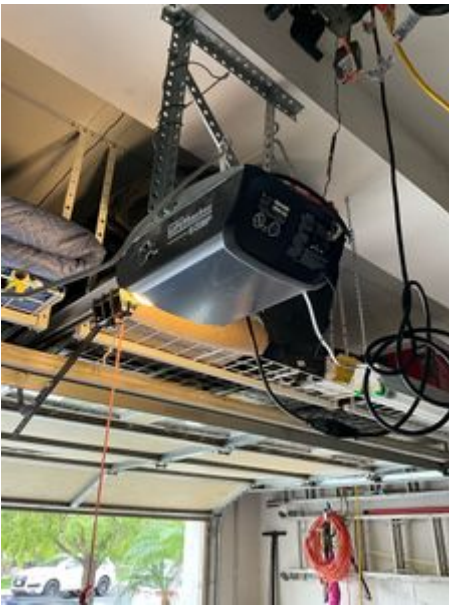
18.10 · AUTOMATIC OPENER

The automatic garage door opener is functional, but does not include a battery backup. As of July 1, 2019 California state law requires all newly installed openers and replacement openers to include battery backup power in order for the opener to function during a power outage. Although there is no requirement that existing openers be replaced, we strongly recommend replacement for reason of general safety.

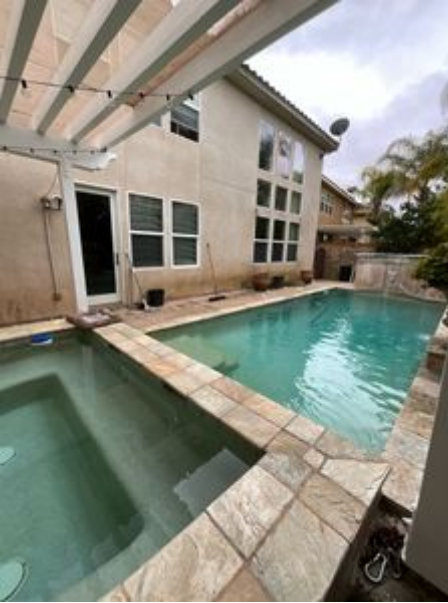
19.5 · GENERAL ENCLOSURE REQUIREMENTS AND SAFETY OBSERVATIONS

The enclosure for the pool & spa area does not comply with state law, which requires a minimum of two drowning prevention safety features. Specific components are listed in the text of the Pool Safety Act of California (PSAC), therefore, the enclosure should be evaluated and serviced by a qualified contractor to meet the requirements of the PSAC.

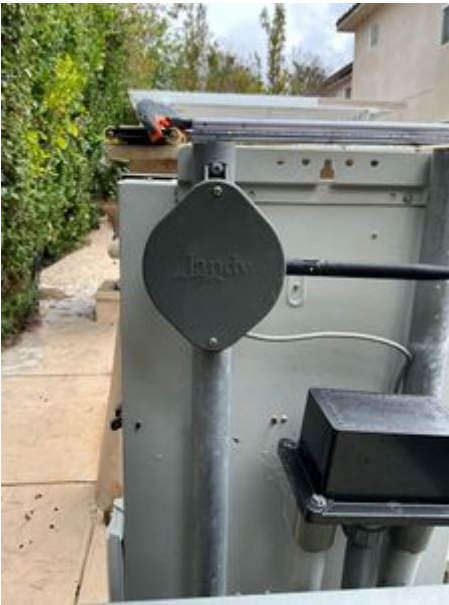
19.7 · POOL & SPA OBSERVATIONS

The pool and spa employ remote controls, which we do not evaluate, but which should be demonstrated by the sellers.

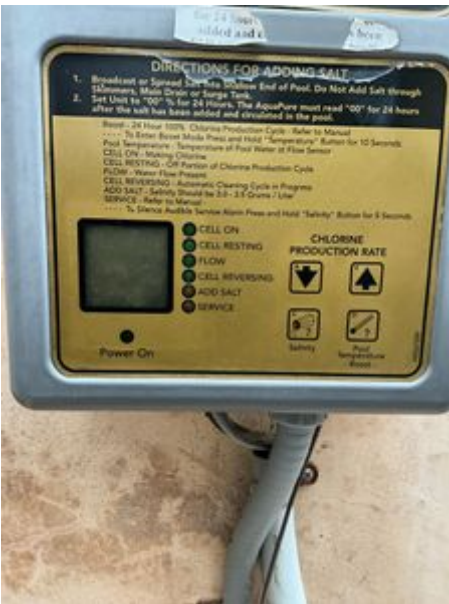
19.8 · POOL & SPA OBSERVATIONS

Although not inspected as a part of our service, the in-line chlorinator system is not powered, indicating that it may not be functional. You should have the system evaluated for service or replacement by a qualified contractor.

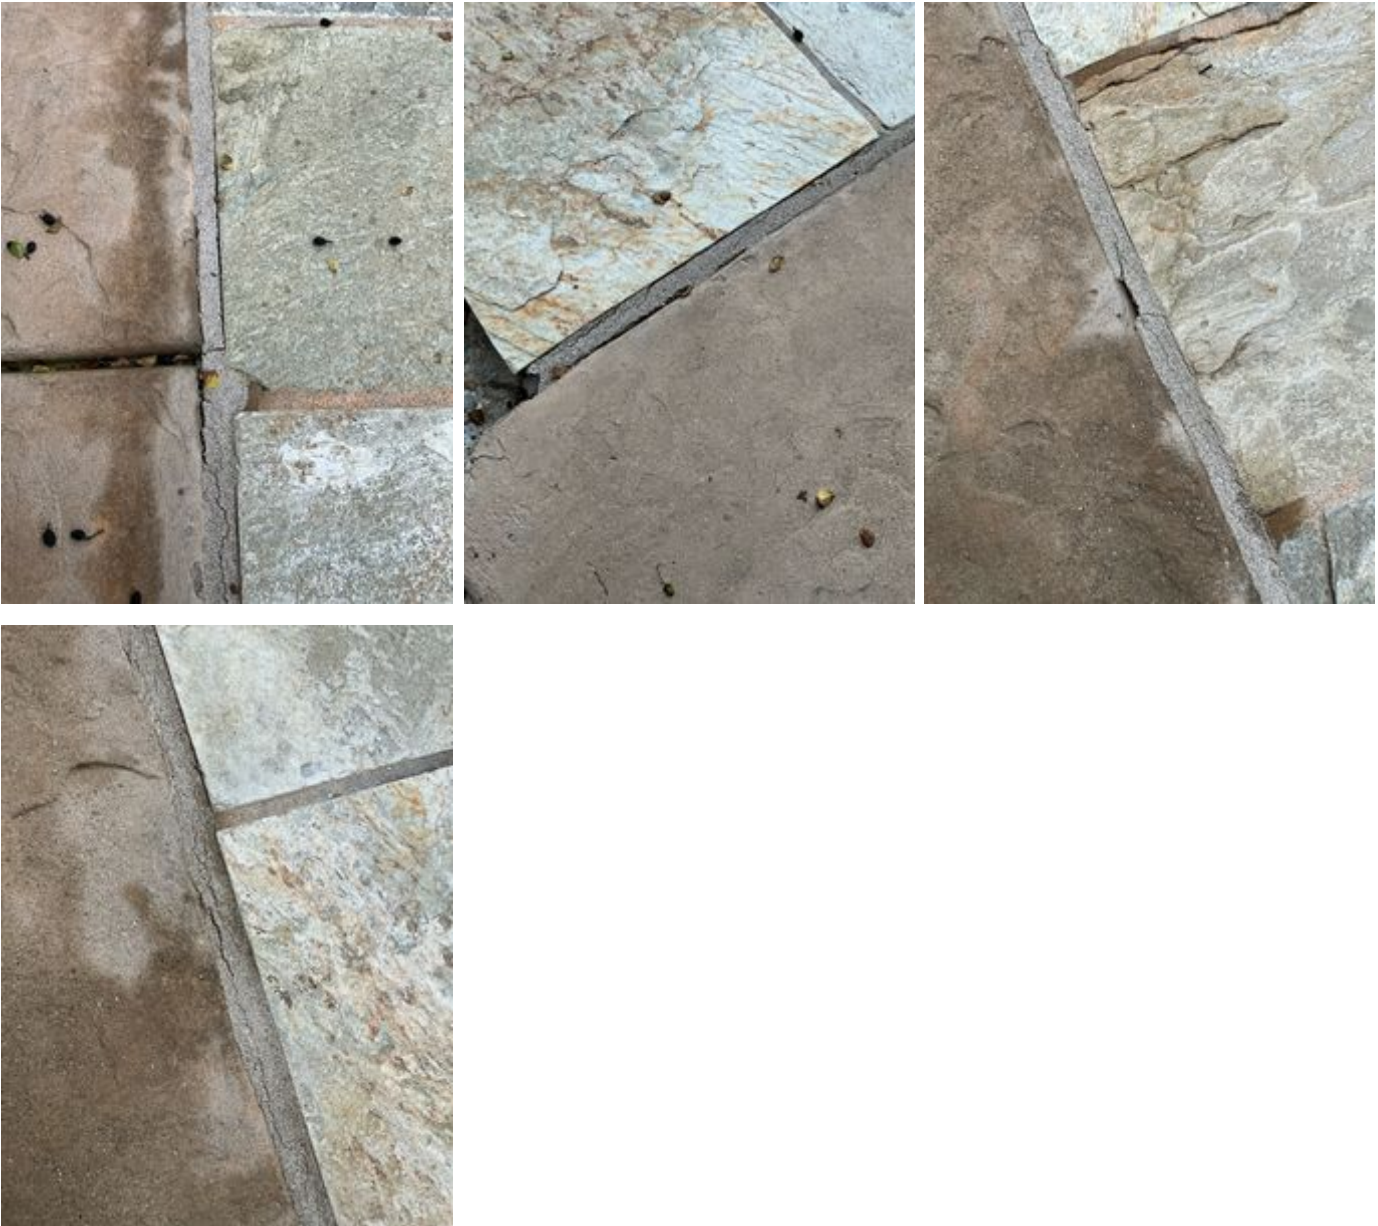
19.11 · EXPANSION JOINT

The caulking material in the expansion joint has deteriorated and cracked, and should be resealed.

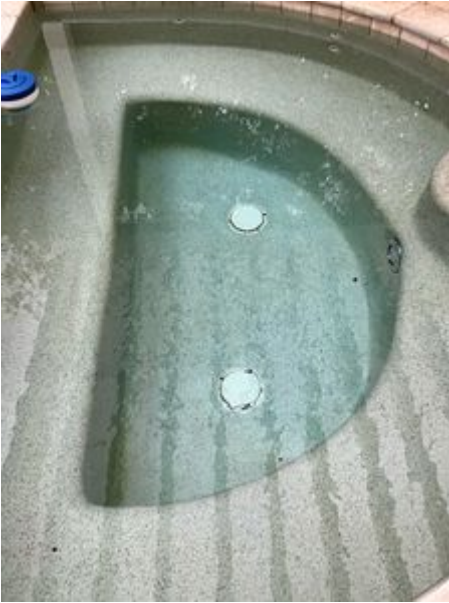
19.14 · SUCTION LINE COVERS

There are either two suction line covers in the spa, or one that is an anti vortex and child-safe type.

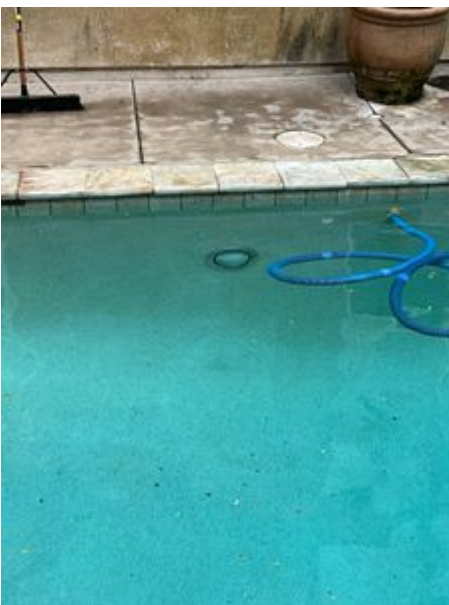
19.15 · POOL LIGHT

The pool light did not respond, and should be serviced, confirmed to have functional ground-fault protection. In addition, for reasons of safety, the circuit should be tested periodically to ensure that its ground fault protection remains functional.

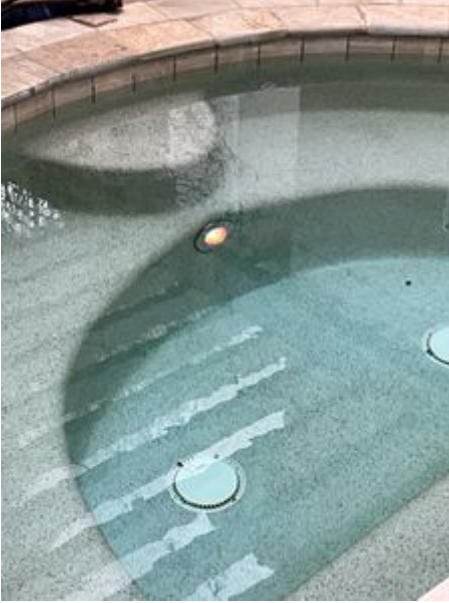
19.16 · SPA LIGHT

The spa light is functional and has been confirmed to have functional ground-fault protection. However, for reasons of safety, the circuit should be tested periodically to ensure that its ground fault protection remains functional.

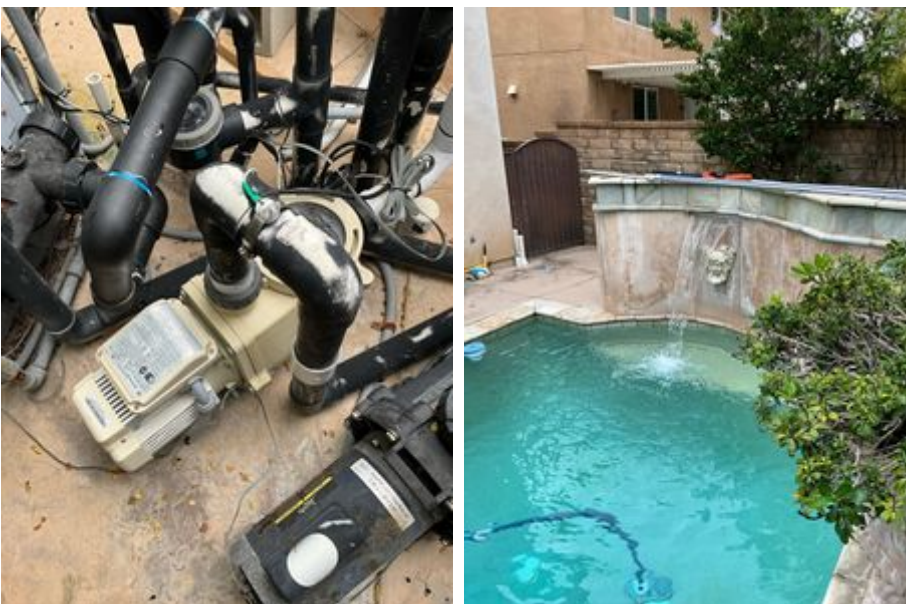
19.17 · POOL-SPA MOTORS

The pool motor is a functional, variable-speed pump, with a weather-resistant plastic casing.

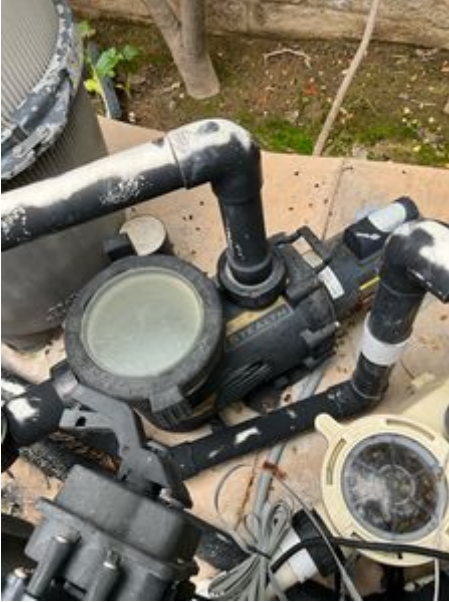
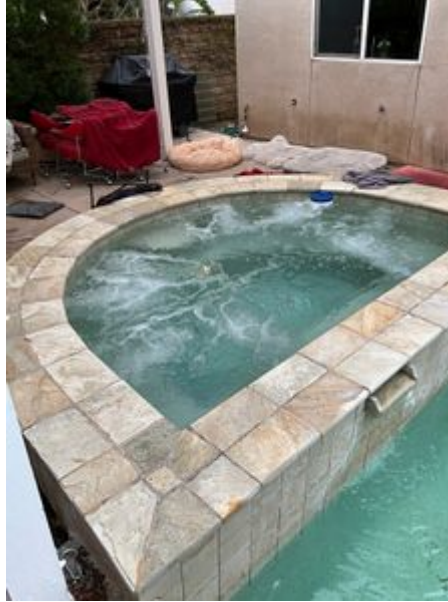
19.18 · POOL-SPA MOTORS

The spa motor is a functional newer type, with a weather-resistant plastic casing

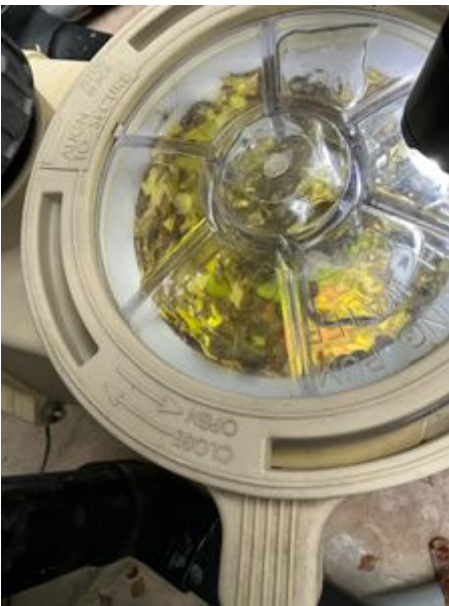
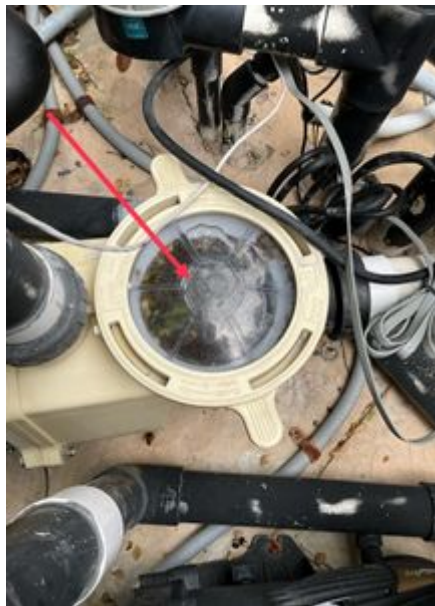
19.19 · POOL-SPA MOTORS

The filter basket in the pool motor needs to be cleaned and should be serviced.

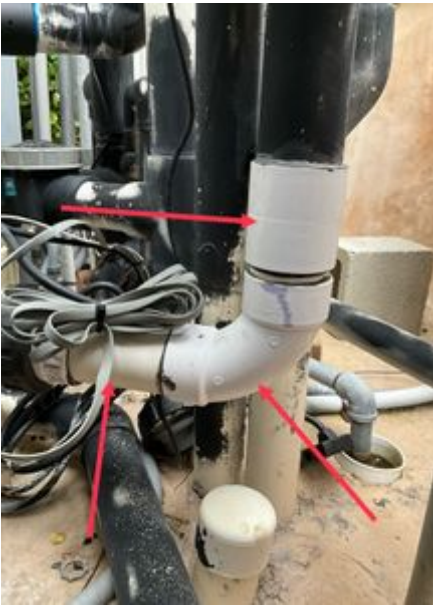
19.20 · SUPPLY & RETURN LINES ETC

PVC piping is prone to failure from direct long term exposure of UV light from the sun. The piping for the pool equipment should be protected from exposure by installing a cover, or by coating the piping with a UV resistant paint or coating

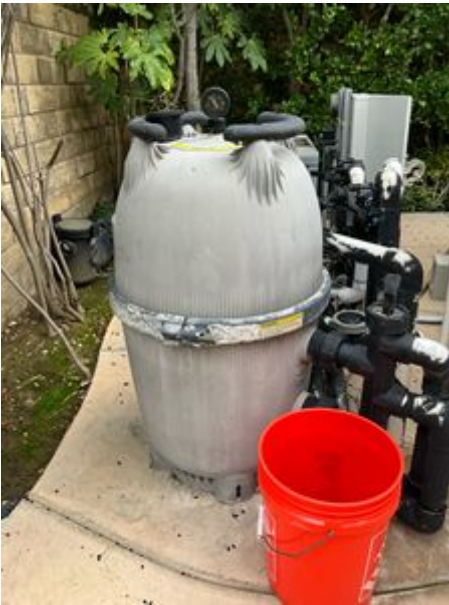
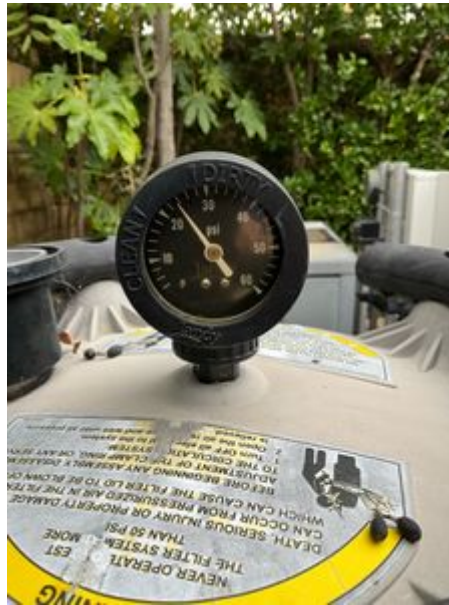
19.21 · FILTER

The filter is functional.

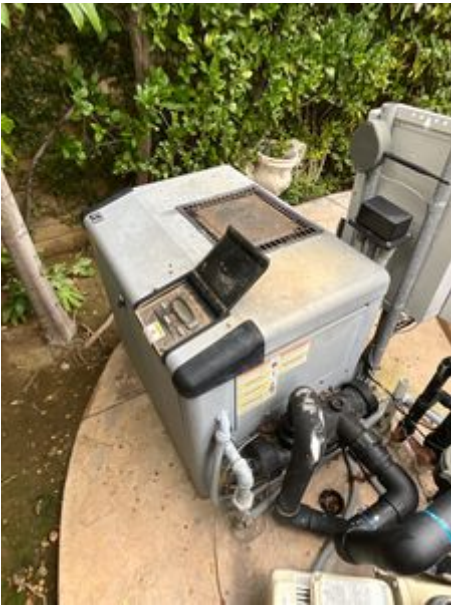
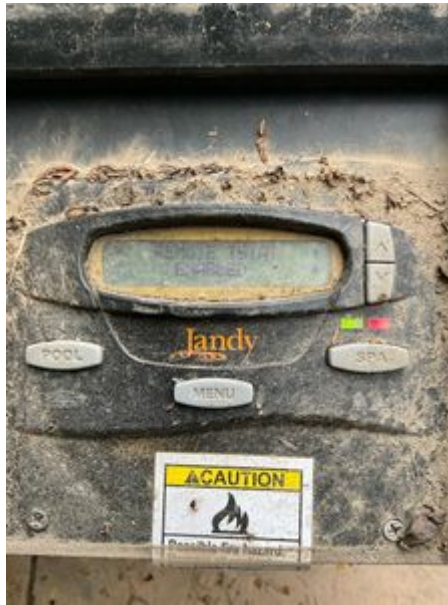
19.22 · HEATER

The pool or spa heater is functional, but should be kept clean and serviced seasonally.
