# HALFMOON LAKE

## WATERSHED-BASED MANAGEMENT PLAN

**PREPARED BY FB ENVIRONMENTAL ASSOCIATES**  
*in cooperation with the Halfmoon Lake Association*

JANUARY 2025

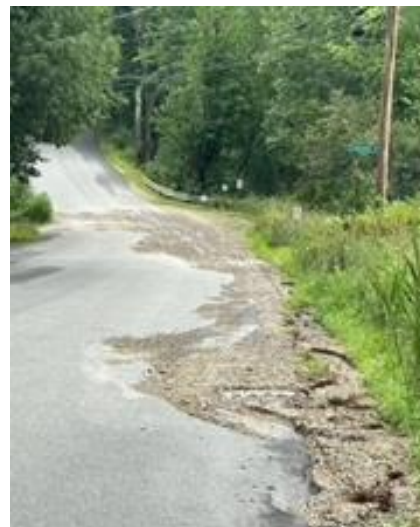
*The eroding road shoulder leading to the North Barnstead Rd boat ramp.*

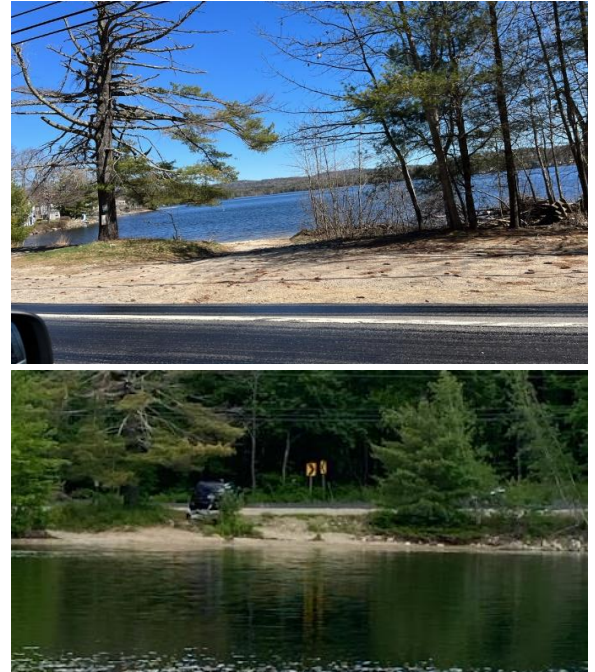
*(Top) View of unpaved lot that serves as public access to Halfmoon Lake. (Bottom) View of the access point from the water as seen during the Shoreline Survey.*

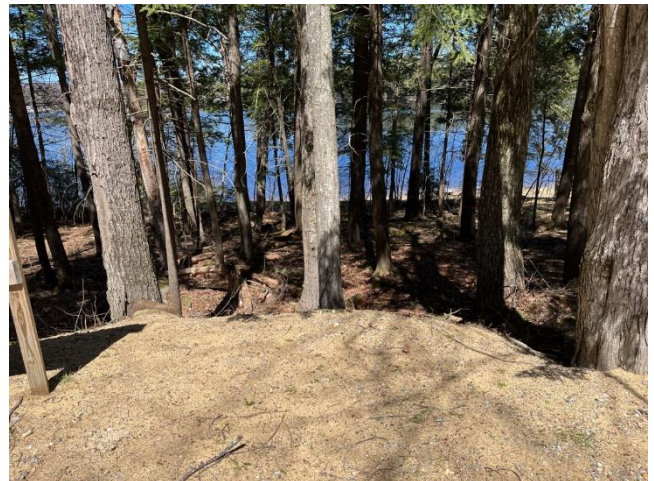
*Unpaved parking lot and steeply sloping land adjacent to Dalton Drive Beach and Halfmoon Lake. There is forest between the beach and lot.*

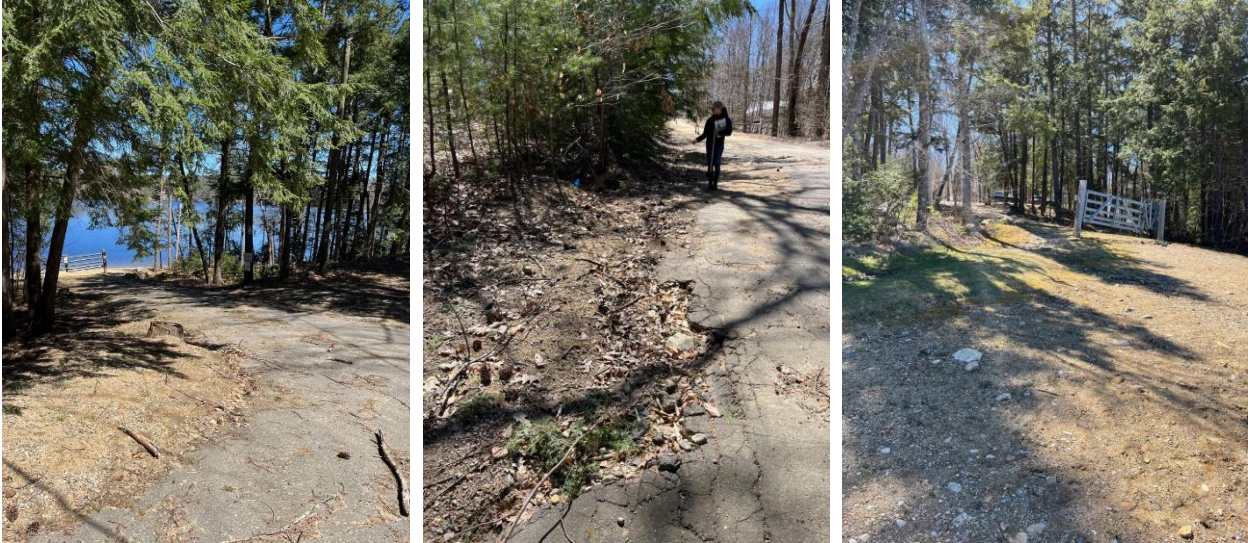
*(Left) Road shoulder erosion on the side of the parking lot to the beach area. (Middle) Road shoulder erosion leading down from the parking lot. (Right) Gullies lead down from the road onto the beach and ultimately into the lake.*

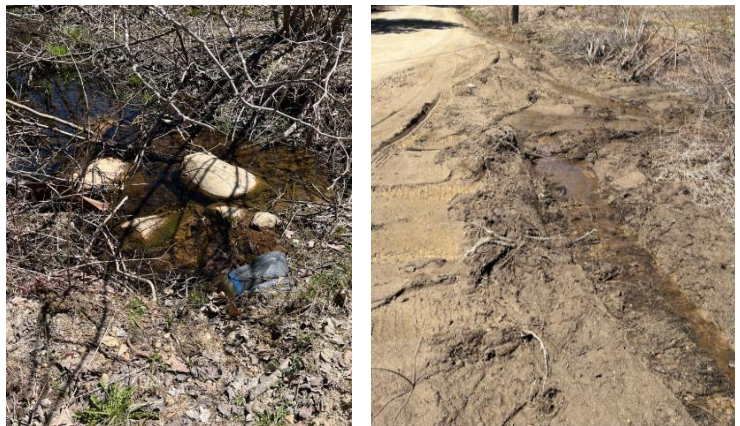
*(Left) Culvert is slightly crushed. (Right) Bare soil and eroding road shoulder has caused a channelized path*

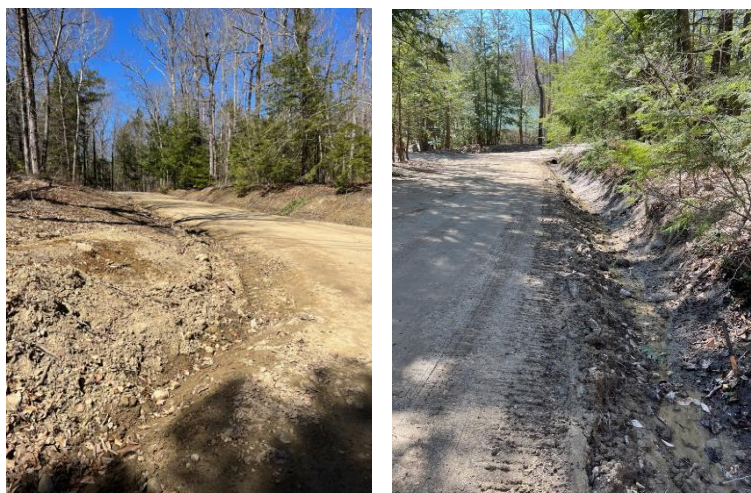
*(Left) Road shoulder erosion and bare soil on Crest Road at the intersection of O'Neill Road. Consider if the bare soil area is a suitable site for a rain garden. (Right) Eroding ditch looking west, downhill on O'Neill Road.*
