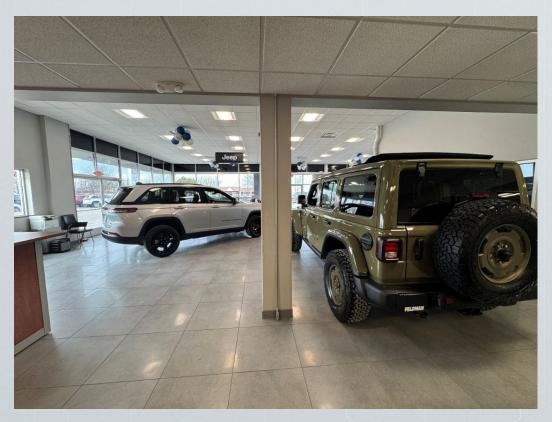
View of installed above slab pressure test port.

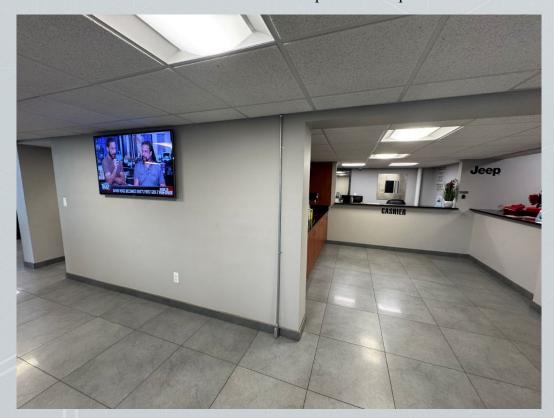
View of installed above slab pressure test port.

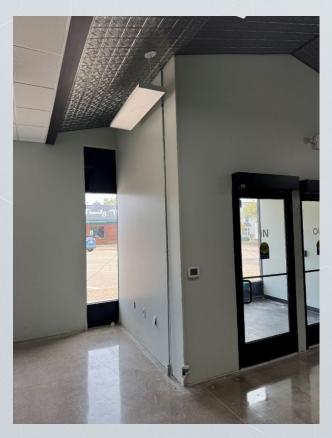
View of installed above slab pressure test port.

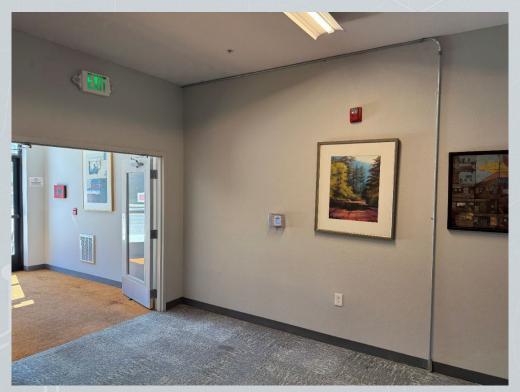
View of installed above slab pressure test port.

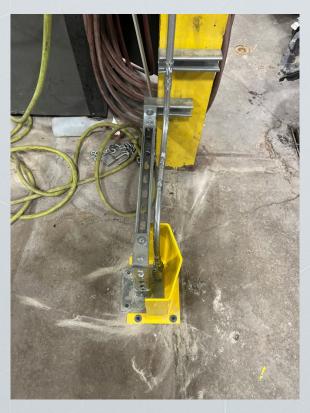
View of installed above slab pressure test port in strut base.

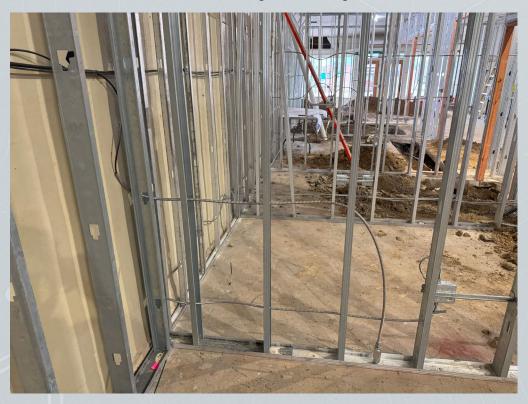
View of installed above slab pressure test port within a wall of a remodel protected with flex conduit. Also view of pressure test port tubing running back to the wall box location.

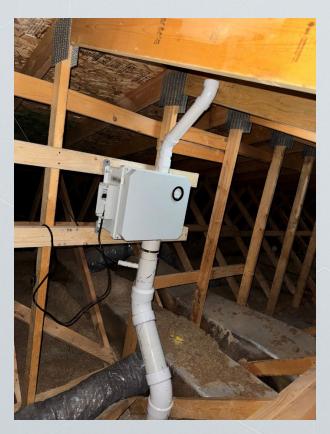
View of installed vent riser pressure test port.

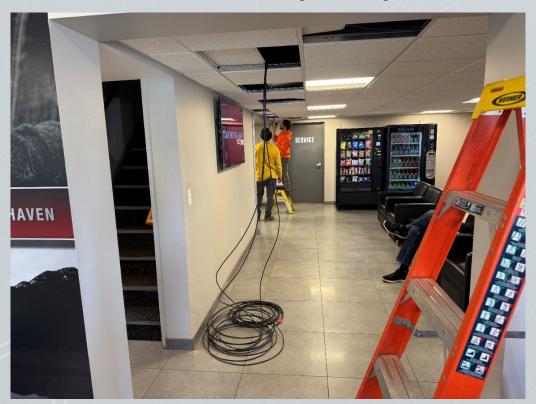
View of routing pressure test port tubing above drop ceiling.

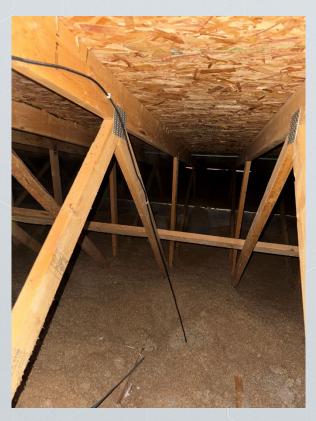
View of routing pressure test port tubing down to above slab pressure test port.

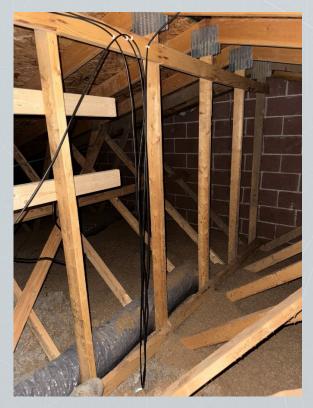
View of routing pressure test port tubing down to the wall box location.

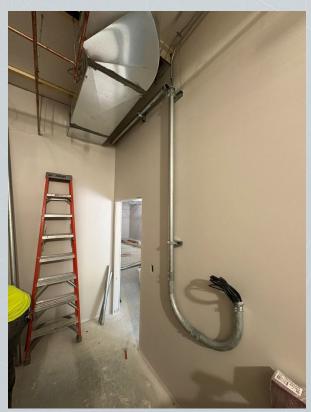
View of stubbed up pressure test port tubing for wall box.

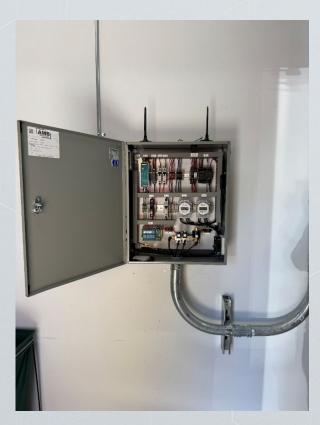
View of pressure test port tubing connected to solenoids inside of the port box.

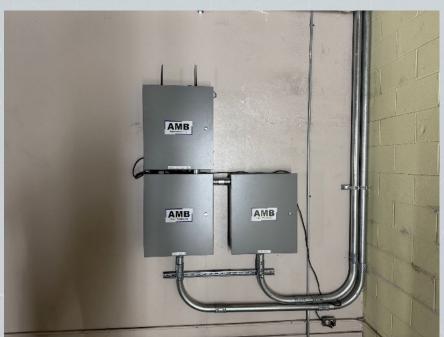
View of AMB Vapor Monitoring Telemetry System.
