RESIDENTIAL INSPECTION REPORT

1234 Main Street
Cape Coral, FL 33991

06/22/2024 9:00AM

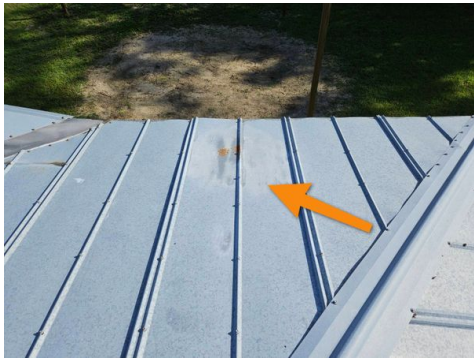
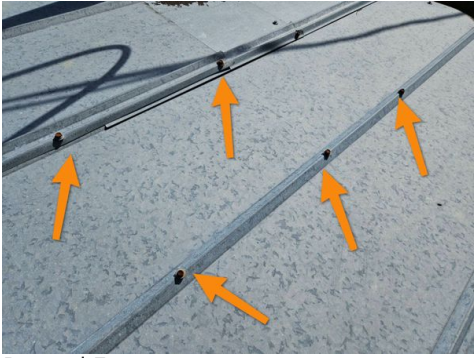
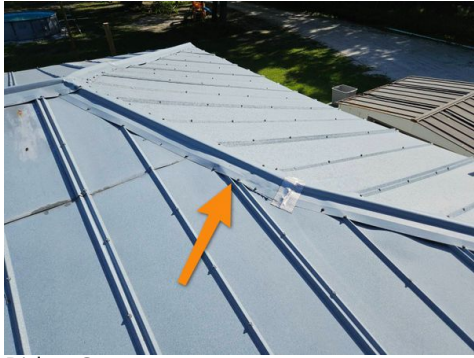
METAL ROOF COVERING-RUSTED/MINOR DAMAGE

Metal roof is rusted, loose and has minor damage throughout. The metal roof covering fastening hardware screws are rusted. Replacing the roof covering should be considered in the near future.

Contact a qualified roofing professional.

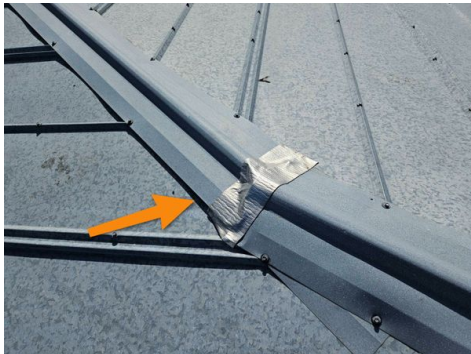
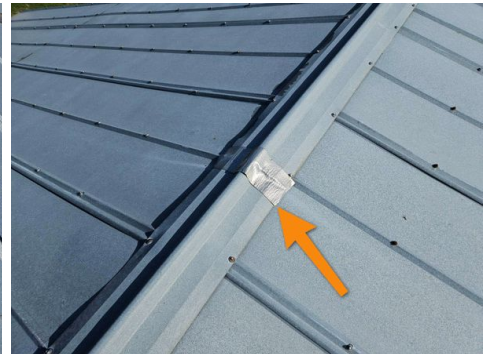
METAL ROOF PATCHED

The metal roof covering ridge caps have been patched. Ongoing monitoring of these areas is suggested.

Contact a qualified professional.

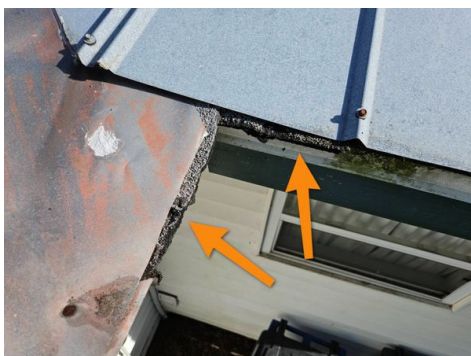
METAL OVER SHINGLES

The metal roof covering was installed over preexisting shingles. This does not allow the metal panels to lay flat as intended. Water intrusion may occur in affected areas.

Contact a qualified professional.

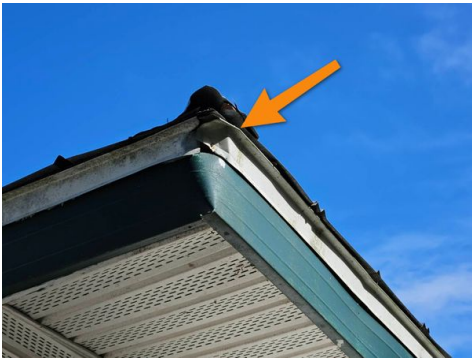
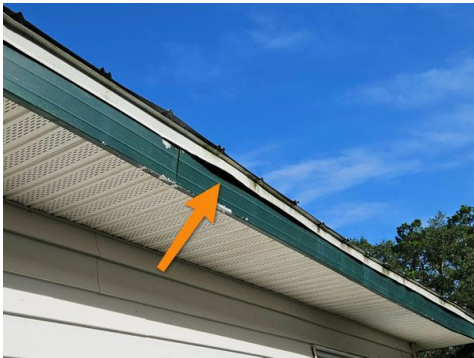
FLASHING LIFTED/DAMAGED

The roof flashing is lifted and/or has minor damage throughout. This can lead to water intrusion and is also physically distracting. Repairing/replacing the flashing is suggested.

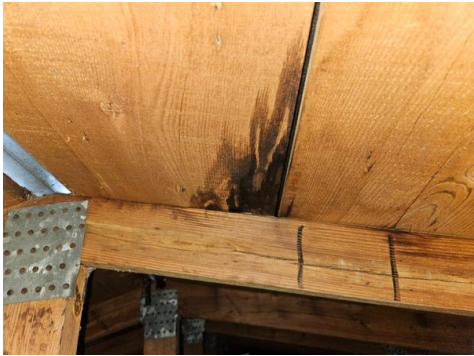
Attic Middle

WATER STAINS ON ROOF DECK

Water intrusion observed from inside the attic. Water leaks can lead to wood rot, water damage, and mold. A home inspection cannot typically determine if leaks are active or if the leak has been corrected.

Contact a qualified roofing professional.

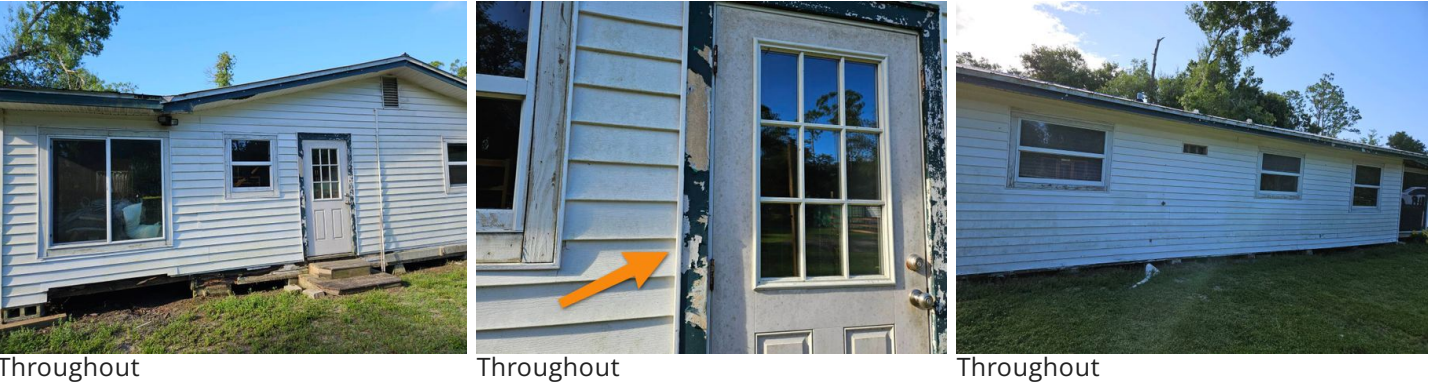
EXTERIOR PAINT

The paint on the exterior needs maintenance. Repainting the home should be considered.

Contact a qualified painting contractor.

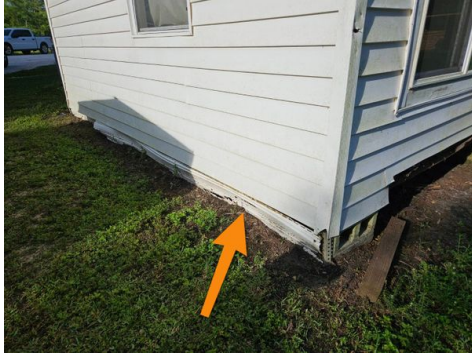
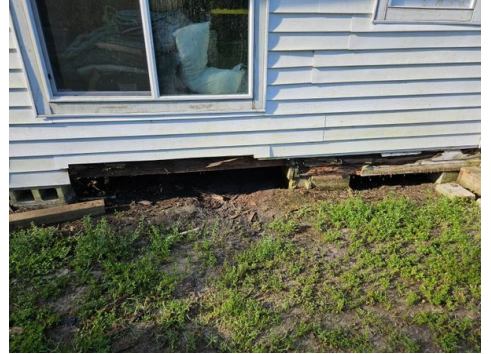
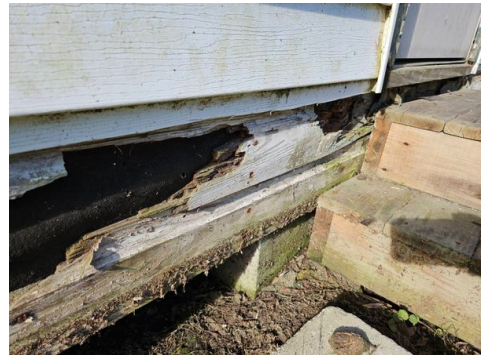
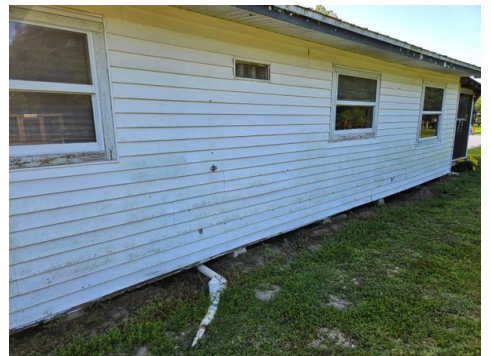
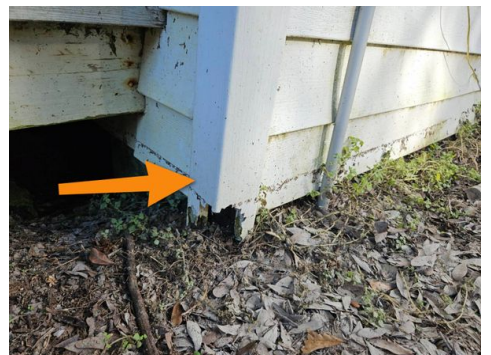
DAMAGED SIDING

Siding is loose and/or damaged in multiple areas, which can lead to pest and/or moisture intrusion. Immediate repair is recommended.

Contact a qualified professional.

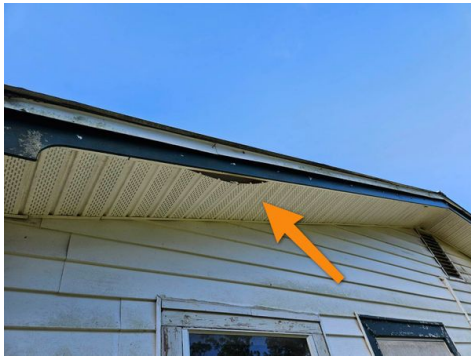
SOFFITS - MINOR DAMAGE

Metal soffit has minor damage. This may allow for pest and/or water intrusion. Repair is suggested.

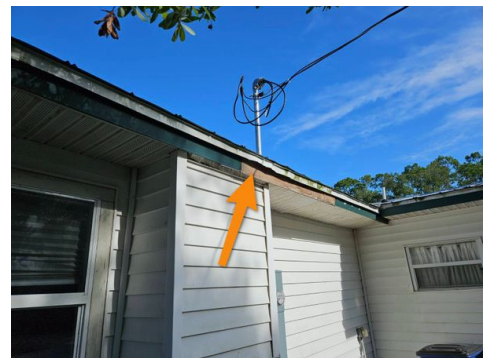
Right

FASCIA - DAMAGED

One or more sections of the fascia are damaged. Recommend qualified roofer evaluate & repair.

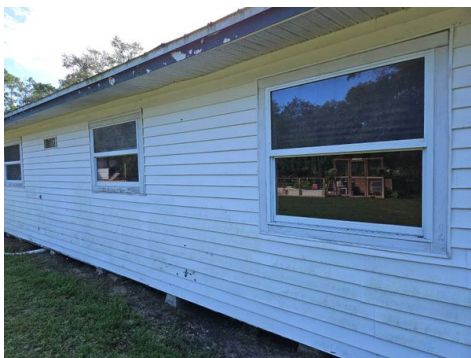
WINDOWS SCREENS MISSING

Window screens are missing. This may allow pest entry when the window is used for ventilation.

Contact a qualified professional.

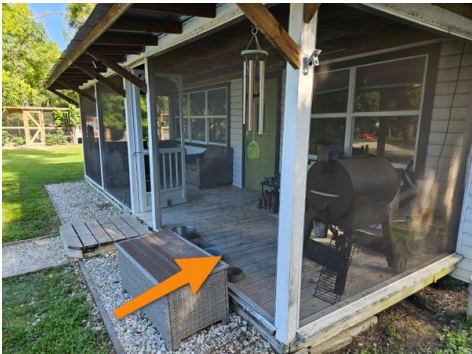
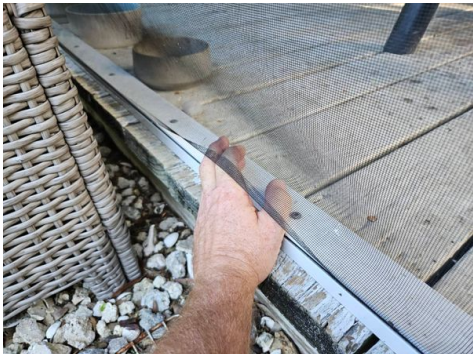
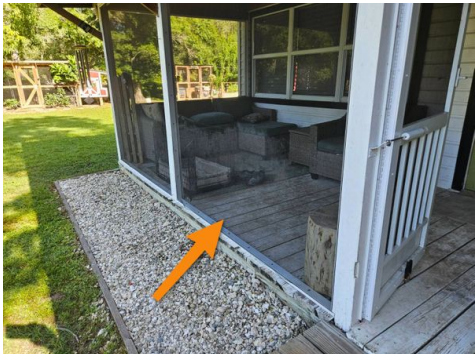
DAMAGED SCREENS

Screen enclosure has a damaged screen. This may allow pest to enter the area.

Contact a qualified professional.

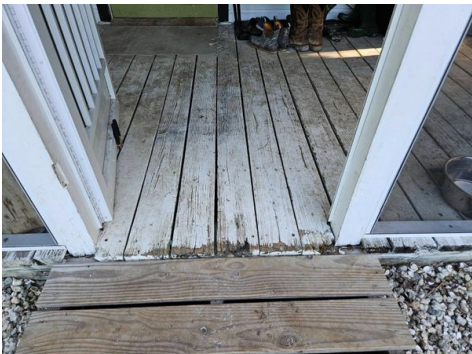
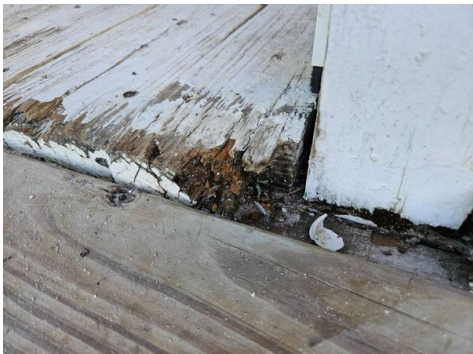
DECK - ROTTED BOARDS

Deck boards are showing signs of rot. Recommend a qualified decking contractor to repair/replace.

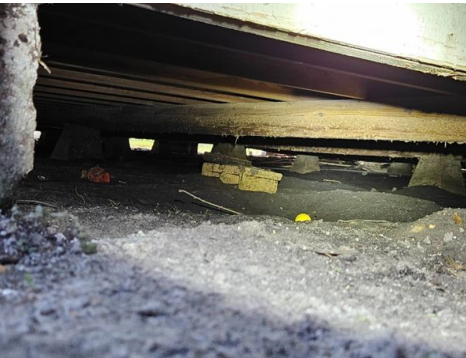
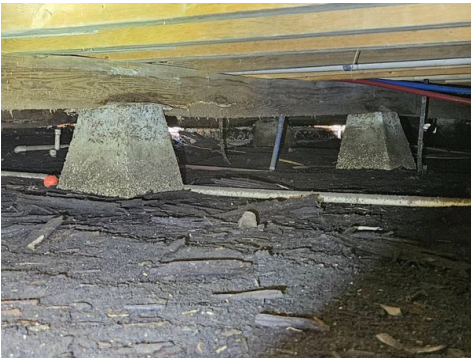
Excessive soil movement observed in crawlspace. Ground compaction integrity is suspect. Further evaluation by a specialist is recommended.

Contact a qualified professional.

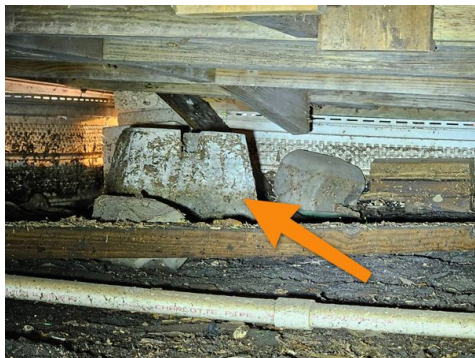
Throughout Crawlspace

FOUNDATION BLOCKS

The foundation concrete blocks show excessive movement/settling. This can compromise the structural integrity of the home. Recommend a qualified structural engineer evaluate and repair.

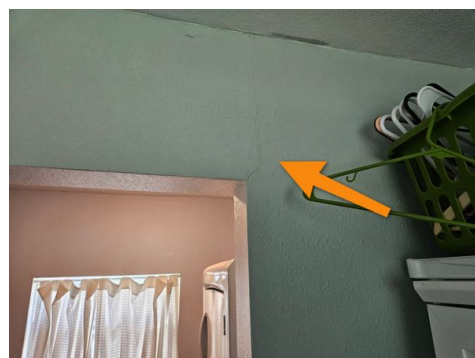
Laundry Room

CRACKS - MINOR

Minor cracking was observed in wall structure. This is common in homes this age. Recommend monitoring.

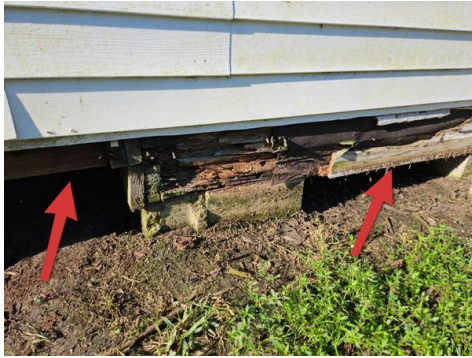
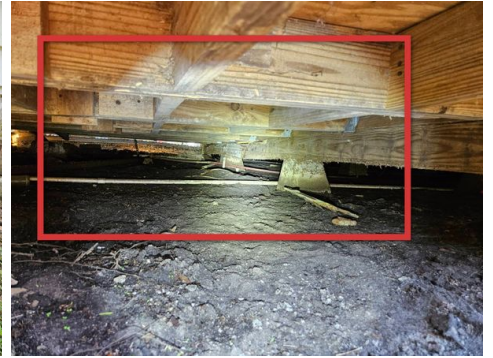
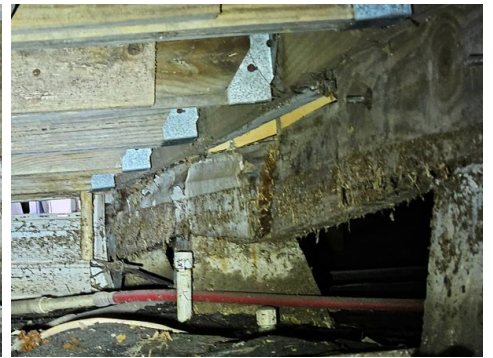
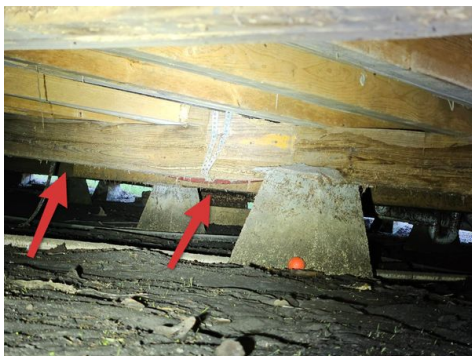
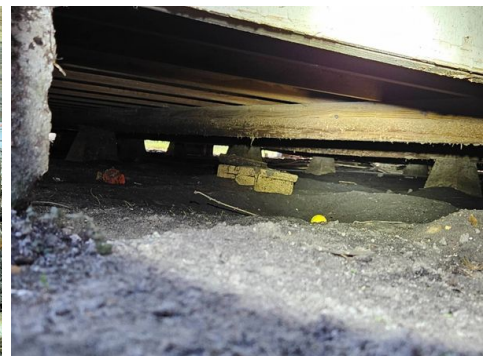
FLOOR JOISTS- STRUCTURAL DAMAGE

**Safety Hazard**

The wood floor joists show signs of structural damage. The integrity of the homes main floor joists is suspect and a safety concern. It is recommended a structural engineer evaluate and repair.

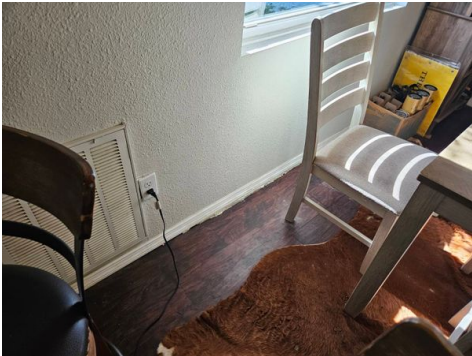
Dining Room

The interior floor covering is uneven and shows signs of significant sagging, damage and movement in the sub floor. This is a major structural concern of the home's foundation and floor joists. Review by a specialist is highly recommended.

Contact a qualified professional.

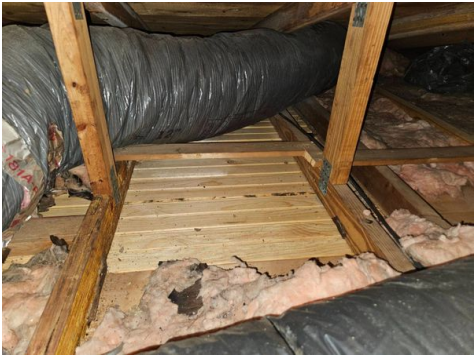
Attic Middle

INSUFFICIENT INSULATION

Insulation was inadequate at the noted location(s). Recommend installing additional insulation.

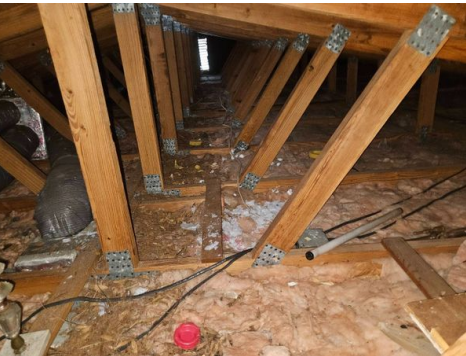
Attic

The overall condition of the attic insulation is old and insufficient. Updating the attic insulation in the near future is suggested.

Contact a qualified professional.

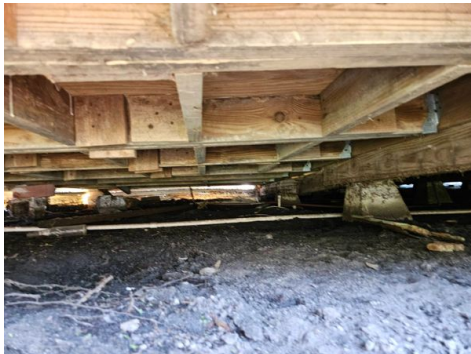
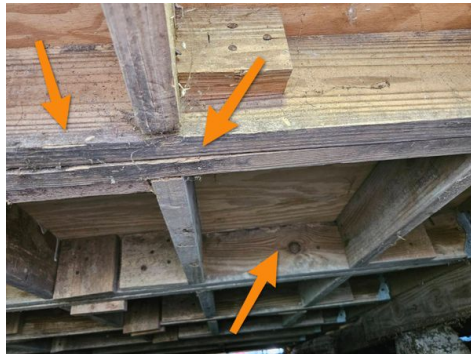
Evidence of termites observed. Evidence may include wood damage, droppings, wings, and/or mud tunnels made by termites. Termites can cause severe damage to structural components of the home. Further review and recommendation by a pest control specialist is recommended.

Contact a qualified professional.

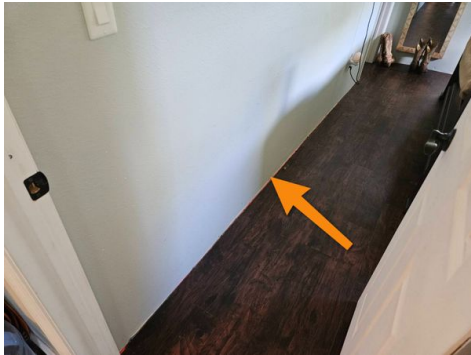
Master Bedroom

BASEBOARD MOLDING- MISSING

The baseboard molding is missing in the master bedroom areas. Install to improve the physical appearance of the walls.

Contact a qualified professional.

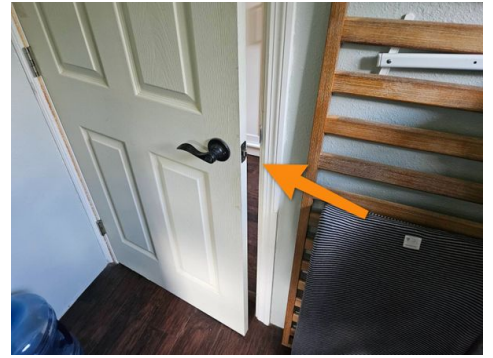
Rear Storage Room

DOOR DOESN'T LATCH

Door doesn't latch as intended. Adjust hardware so door can latch and close properly.

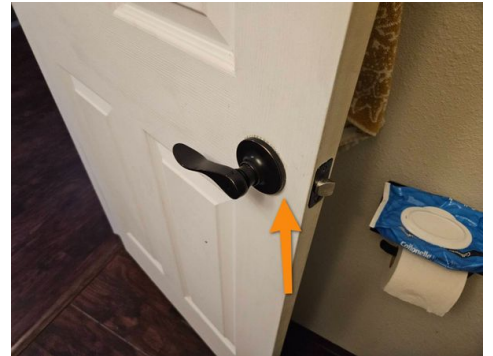
Guest Bathroom

LOOSE DOOR HARDWARE

Door has loose hardware. Loose hardware may eventually become damaged and may affect the operation of the door. Repair suggested.

Contact a qualified professional.

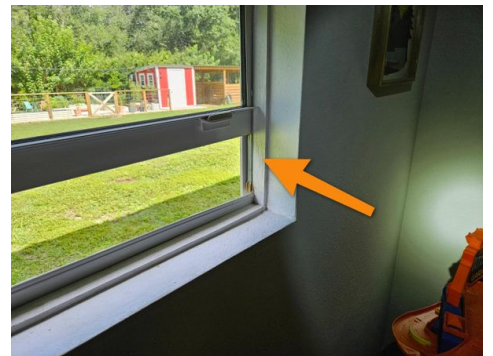
Left Bedroom

Balancing springs are damaged or loose from window. This condition may cause the window to bind or rub, but more commonly the window will not stay in the upward position. Repair suggested.

Contact a qualified professional.

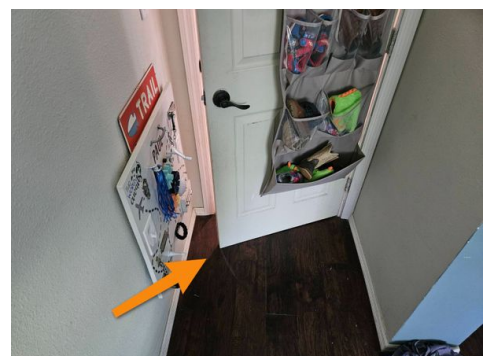
Left Bedroom

DOOR DRAGS ON FLOOR COVERING

Interior door drags/rubs on floor covering. This may eventually damage door and/or floor covering. Adjust.

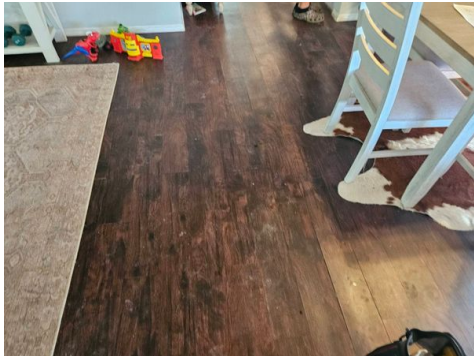
Interior

FLOOR COVERING DAMAGED

The floor covering is damaged due to wear, impact, scratches, stains, water damage, etc. that affects the cosmetic appearance of the floor.

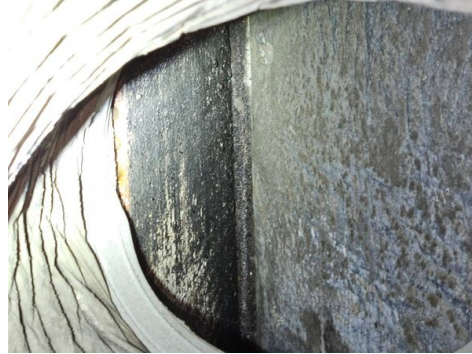
Evaporating Coils

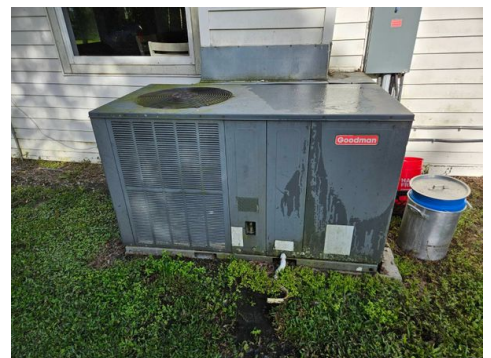
HVAC System

Air conditioning unit(s) are at or near the end of their typical life expectancy. The normal useful life of an air handler and/or condensing unit is 12 - 15 years, but with proper maintenance they can last longer. Lack of proper maintenance can greatly reduce the life span.

Contact a qualified professional.

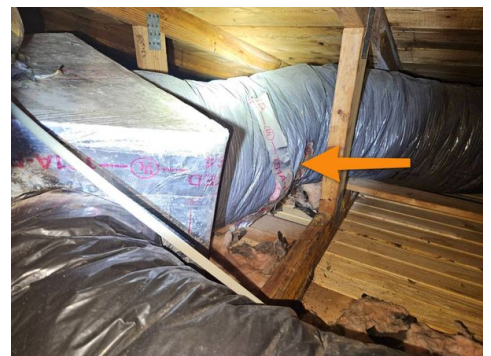
Attic Right

DUCT INSULATION DAMAGED

Air duct insulation is damaged. This can result in condensation and may reduce the efficiency of the system.

Contact a qualified professional.

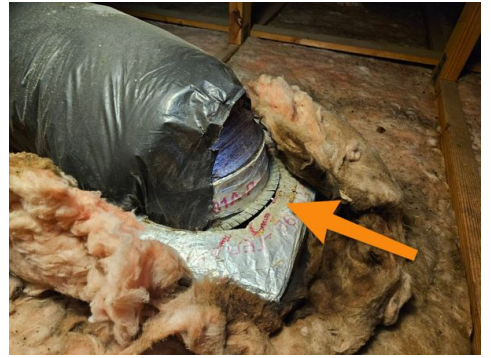
Attic Front

Air duct has come apart at its seams. This will cause a reduction in air flow to the designated area, as well as reduce the efficiency of the system. Repair.

Contact a qualified professional.

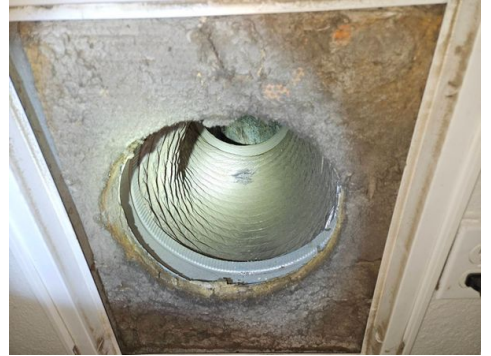
Return duct is very dirty. Cleaning is recommended in order to improve the indoor air quality.

Contact a qualified professional.

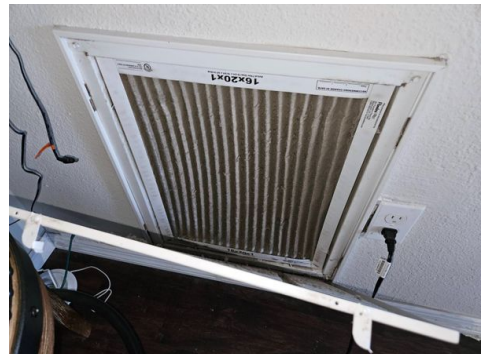
Main Air Return

DIRTY AIR FILTER

Air filter is dirty. This will reduce the efficiency of the system. Replace.

Contact a qualified professional.

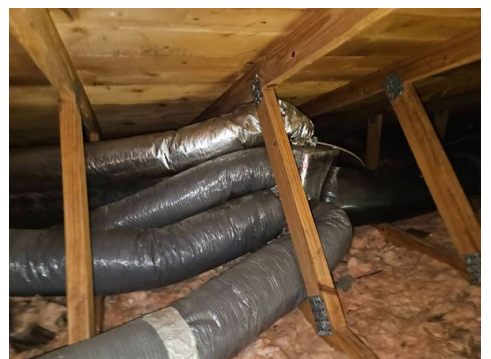
Attic

Contact a qualified professional.

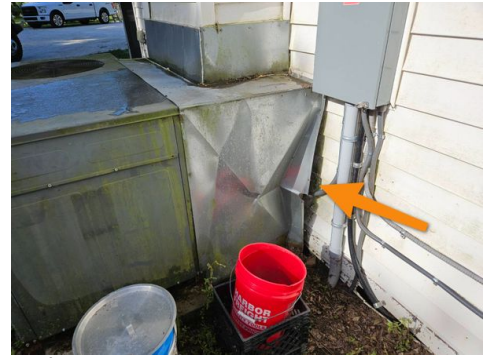
Right

The HVAC ductwork protective cover is damaged. Repair suggested.

Contact a qualified professional.

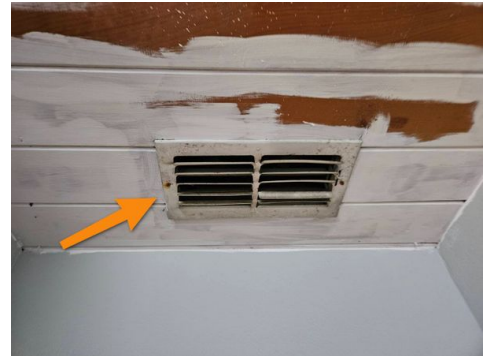
Master Bedroom

Contact a qualified professional.

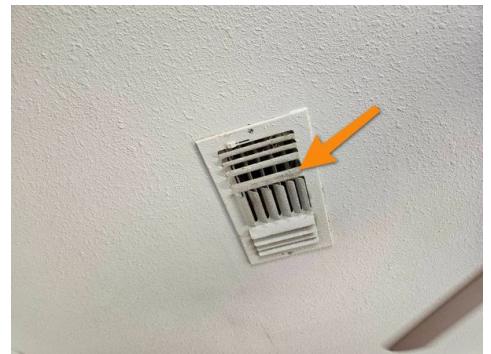
Rear Laundry Room

There is no air flow at the noted supply vent. Further review/repair by a HVAC specialist is recommended.

Contact a qualified professional.

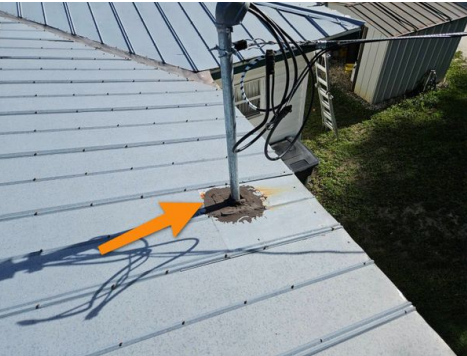
Rooftop

ELECTRICAL MAST FLASHING

Electrical mast flashing and/or rubber boot is not sealed. This may result in water leaks and should be repaired.

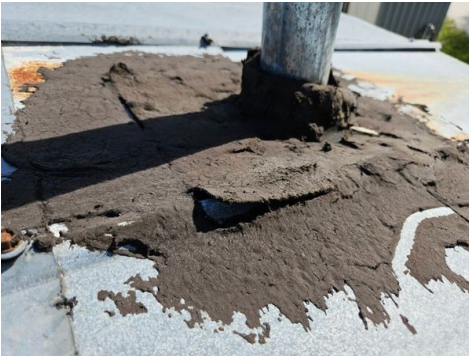
Lifed Flashing

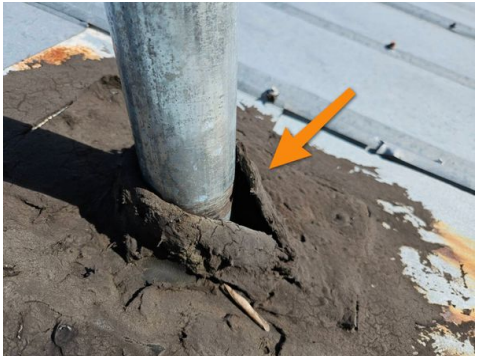
Not Sealed

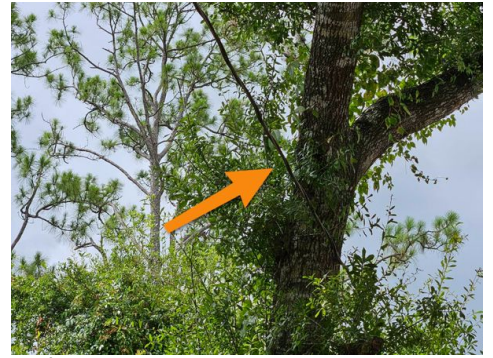
Right

Trees are in contact with electrical service wires. Cut back trees to prevent damage to the service wires.

Contact a qualified professional.

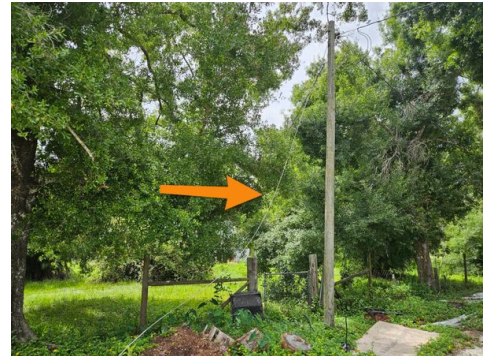
Front Right

The electricity pole support cable is loose. This presents a safety hazard during high winds. Further review by a specialist is suggested.

Contact a qualified professional.

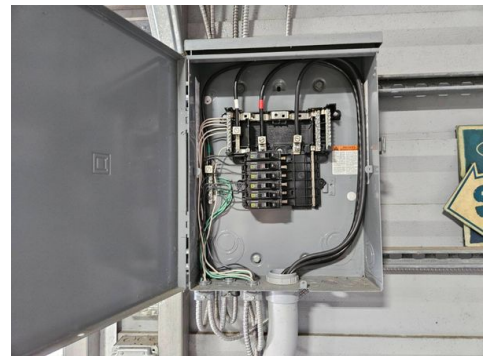
Detached Garage

PANEL PROTECTIVE COVER MISSING

The electrical panel interior protective cover is missing. Install as intended to help prevent possible electric shock.

Contact a qualified professional.

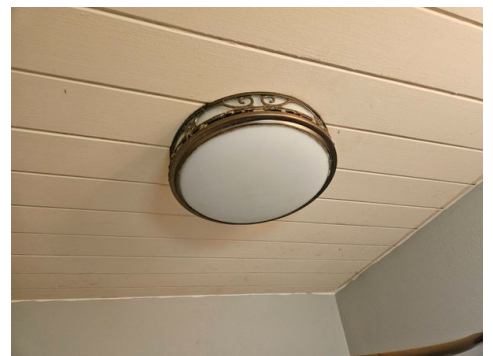
Master Bathroom

LIGHT FIXTURE INOPERABLE

Light fixture is inoperable. If changing the bulb does not correct the problem, then review by an electrician is recommended.

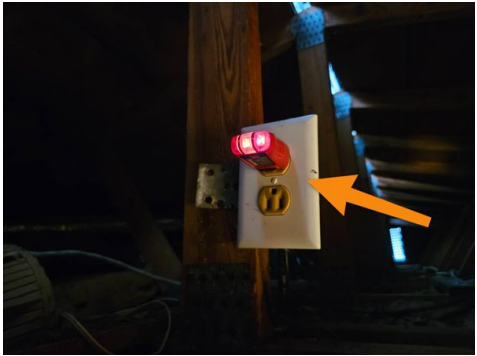
Attic

Receptacle installed reverse polarity, where the hot and neutral wires are reversed. This is a safety hazard and should be immediately corrected.

Contact a qualified professional.

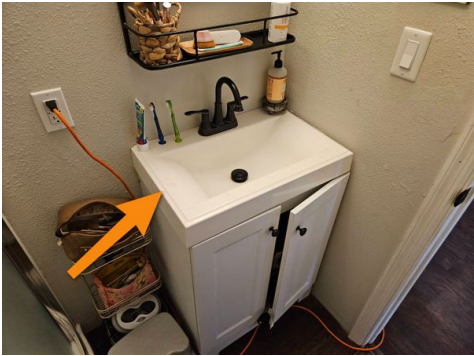
Guest Bathroom

Sink is not secured to the counter or wall. Sink may become detached and could result in water leaks.

Contact a qualified professional.

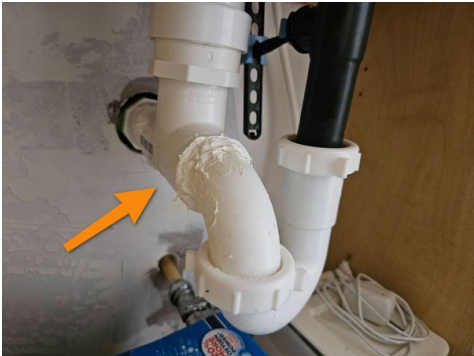
Detached Garage Bathroom

IMPROPER CONNECTION REPAIR

An improper plumbin drain repair observed. This may prevent proper drainage and/or leaks. Repair is suggested.

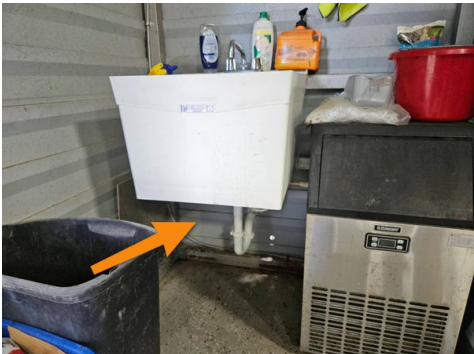
Detached Garage

LEAKING DRAINPIPE

Drainpipe leaks. Active water leakage will result in water damage and/or mold. Repair suggested.

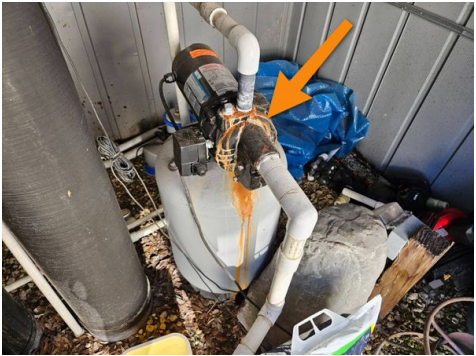
Well Equipment

EQUIPMENT LEAKING

The well equipment appears to have been leaking, causing rust/damage to the exterior of the pump. Replacement in near future may be required.

Contact a qualified professional.

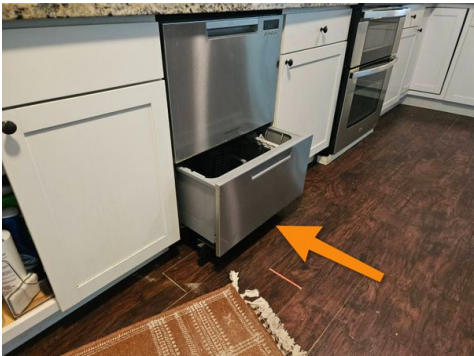
Dishwasher

Contact a qualified professional.

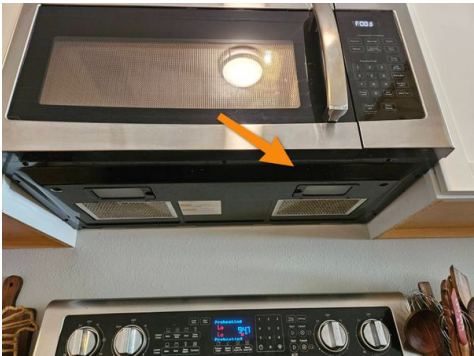
Microwave

Contact a qualified professional.
