## **Thermi Lake**

Case Study	Thermi Lake			
Location	Northern Greece			
Volume	280.000 m <sup>3</sup>			
Flowrate	< 30 m <sup>3</sup> /hr			
Treated wastewater	Surface & Treated sewage water

### Thermi Lake

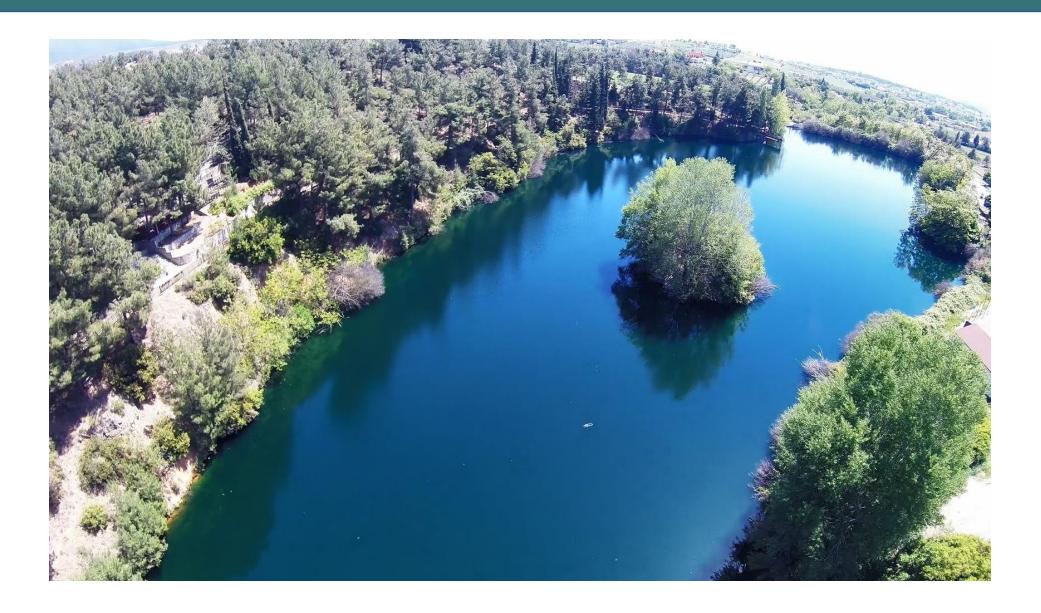
# Lake No.2 – After Application

- The overall implementation was successful for the rehabilitation of the two lakes which were polluted with stored organic load from many years.
- The odours in the surrounding areas were eliminated and the clarity was improved which was confirmed by hundreds of daily visitors.

- Two lakes in series were treated.
- Lake No1 approximate volume 30.000 m3 and Lake No2 of 250.000 m3.
- The inflow is surface water and effluent from a wastewater treatment plant.
- The target of the implementation : overall rehabilitation of both lakes.
- A combination of Facultative Microorganisms were used throughout three months.
- An increased dosage was used during the cultivation period (first month of application).
- The total microbial product quantity used was approximately 110 kg.
