Phase IA Archaeological Reconnaissance

Hawthorne Crossing Conservation Area
Campbell County, Kentucky

GAI Project No. G090805.00

December 19, 2009

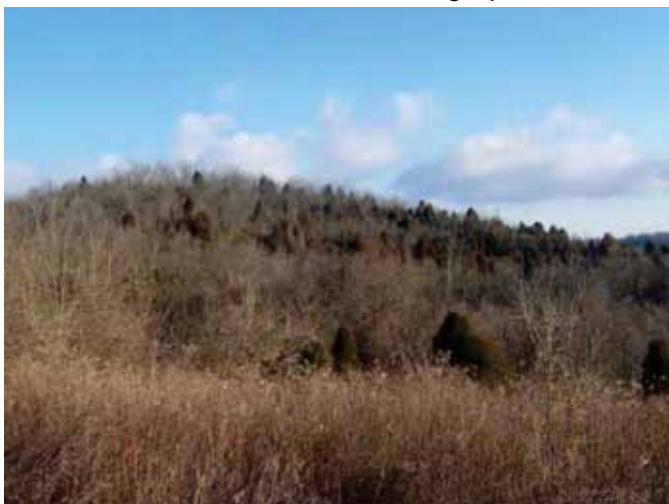
Photograph 1 Overview of uplands, view north

The Eden silty clay loam is a well-drained and well-developed soil forming in weathered limestone and shale bedrock. It occurs over the majority of the study area; on the steep side slopes which have been eroded from deforestation and the agricultural use of the area (see Figure 3). The Eden soil has 25 to 30 percent slopes and has low archaeological potential due to erosion, as shown in Photograph 1. Due to the presence of limestone and shale

bedrock, no potential exists within the study area for rock shelters and overhangs associated with the steep Eden soils.

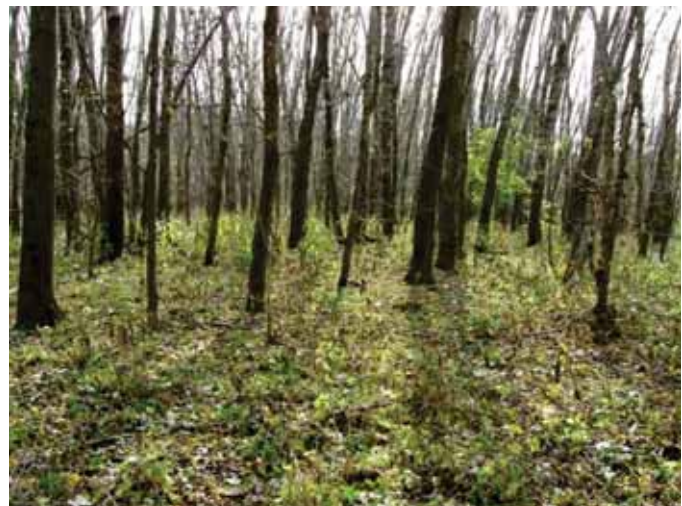
Photograph 3 Overview of floodplain, view east

The Egam soil is a well drained and moderately well developed silty clay loam forming in floodplain sediments. This soil occurs along the Riffle Creek floodplain within the northeastern corner of the study area (see Figure 3). The high-clay sediments are deposited by very slow or stagnant water during periods of high flow within the Licking River, when quiet water is backed up into the Riffle Creek valley. The relatively flat (0 to 4 percent slopes) of the Egam soil suggests it has a potential for archaeological sites. However, the geomorphological investigations indicated that the lack of soil development along Riffle Creek suggests recent origin; therefore no testing for the presence of archaeological resources was recommended. Area 10, which

flanks Riffle Creek, has been identified for judgmental shovel testing only in advance of ground disturbing activity (see Figure 2).

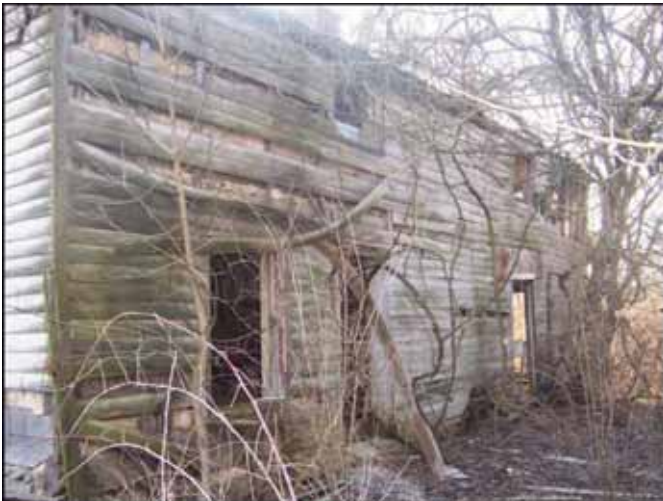
Photograph 4 Ware House, view southeast

The Ware House is an abandoned log dwelling that has been vacant for many years. Of rectangular footprint, it stands one-and-a-half-stories high under a side-gabled roof of moderate pitch that has been covered with raised-seam metal. The house apparently evolved through a three-stage process. The house's original pen is contained in the north half of the structure. Its main façade contains a window and a door. The house was expanded laterally to the south at an unknown date. The main façade of the right pen, of frame construction, contains only a door. The house features small, rectangular attic windows aligned with the door openings, and square attic windows in the gable ends.

The house is built of squared, hewn logs chinked with what appears to be clay, with small chunks of limestone added to protect the chinking. The logs are secured by V-notching. The house rests on a rubble limestone foundation. In addition, there appears to be a cellar in place beneath the dwelling. A small brick chimney is centered in the ridgeline.

During its long period of vacancy, the house suffered the loss of some original fabric. No doors survive; one 1/1 wood window sash remains on what is now an interior wall. The logs are covered with weatherboarding, much of which have falling away.

Based on currently available information, the Ware House does not appear to be associated with significant persons, events or broad patterns of history. Therefore it does not appear to meet National Register criteria A or B. The house retains hewn logs that appear to be in fairly good condition, as well as character-defining features such as the fireplace and winder stair. But its integrity of design is somewhat compromised by the rear and side additions. The stone smokehouse is also an intact example of a locally uncommon type, but does not appear to possess sufficient distinction to qualify for National Register listing in its own right. Therefore, the property does not appear to meet National Register Criterion C. Nonetheless, the Ware House may have the potential to reveal significant information about methods of log construction in rural northern Kentucky during the 19th century. Therefore it is potentially eligible under Criterion D for information potential.

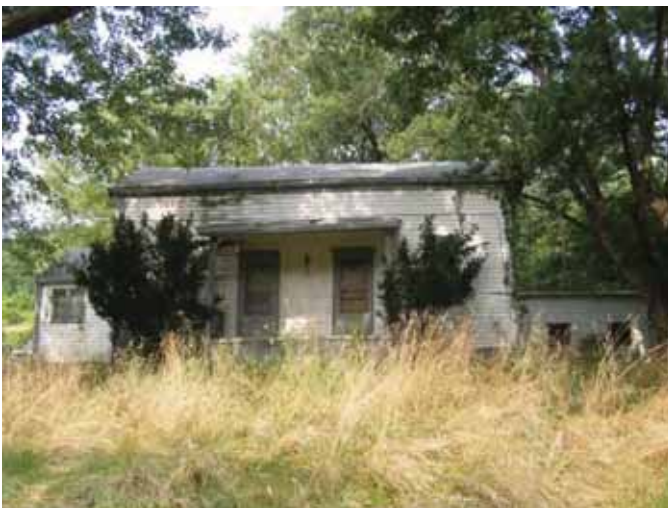
Photograph 5 Tratt House, view west

The Tratt House is a 1.5-story, single-pile, vernacular wood-frame residence of simple design, of apparent double-cell plan. It rests on a rubblestone foundation that has been parged and painted; some of the covering has fallen away. The main façade, which faces east, contains four symmetrically arranged bays. The center of the façade contains twin, half-glazed, paneled doors with wooden storm doors, flanked by single wood sashes in

the end bays. The doorways are sheltered by a minimal frame porch of simple design. The porch features a low, nearly flat roof, simple spindled balustrades, and widespread, turned wood columns posts. It rests on a stone foundation approached by four steps. It should be noted that this porch may have been added in the early 20th century. The house's gable ends contain single windows in the first and attic stories, vertically aligned. All the windows contain 1/1 sashes and have simple enframements. A narrow, straight-stack brick chimney was added to the north elevation at an unknown date, likely in the mid-20th century. The house is covered by a side-gabled, asphalt shingle roof of moderate pitch, with corner returns and hanging gutters. The roof is asymmetrically gabled, with a saltbox-like longer rear slope with corner returns. Misaligned fenestrations, and discrepancy in the trim boards, suggest this may have been a somewhat later addition, although this is by no means certain.

A one-story, single-room addition, covered by a gabled roof, was appended to the south elevation of the house, likely in the mid-20th century. It contains paired, multi-pane casement windows and is set on a concrete block foundation. This addition is set back from the plane of the main façade, somewhat reducing its prominence. It wraps around the south half of the rear of the house, as attested by a visible seam and the presence of small window openings. The house's walls are weather boarded and painted white with gray trim. The house appears to be in fair condition from the exterior, with peeling paint evident.

The Tratt farmstead is a characteristic example of a small family farm of the late 19th through mid-20th centuries, comprised of a small group of specialized mid-20th century outbuildings associated with dairy farming and poultry raising. These structures are typical of those found on many similar farms throughout northern Kentucky. They do not appear to possess significance individually or collectively for their design or construction, or for their association with local farming practices. The Tratt House appears to be a typical example of a small, rural vernacular dwelling of the late 19th century, similar to many others in northern Kentucky. Further, its integrity of design has been compromised by the mid-20th century rear addition. The property also does not appear to be associated with persons of historical importance. Therefore, the farm it does not appear to meet National Register Criteria A, B, C or D.

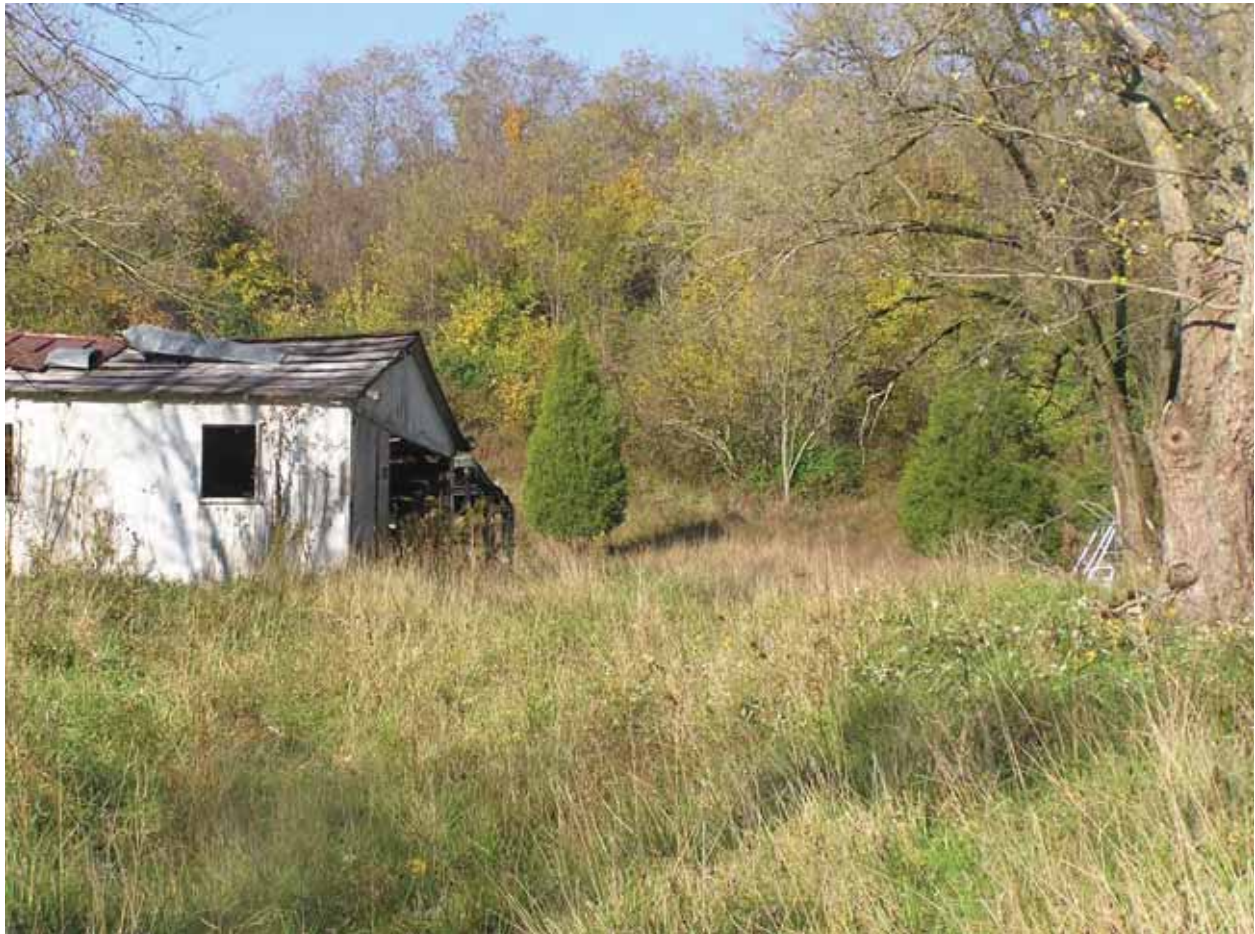
General view of the central portion of the project area, facing north. Gently-sloped Pleistocene lakebed terrace in the foreground, steeper sideslope forming in weathering bedrock in the background.

The landforms within the study area include two high and relatively narrow ridgetops, steep sideslopes, a broad Pleistocene lacustrine terrace, and floodplains of Riffle Creek and the Licking River (Photos 1 and 2). Auger Boring 1 was taken on the southern ridgetop south of an abandoned residence. The profile of this boring was of a shallow, well developed soil forming in residuum weathered from shale and limestone bedrock. The subsoil was found within 8 cm (3 in) of the surface, indicating that the majority of the original surface horizon has been lost to erosion which was accelerating after the initial deforestation and use of the area for agricultural production. Surface testing for archaeological resources is recommended within undisturbed areas of less than 15 percent slope.

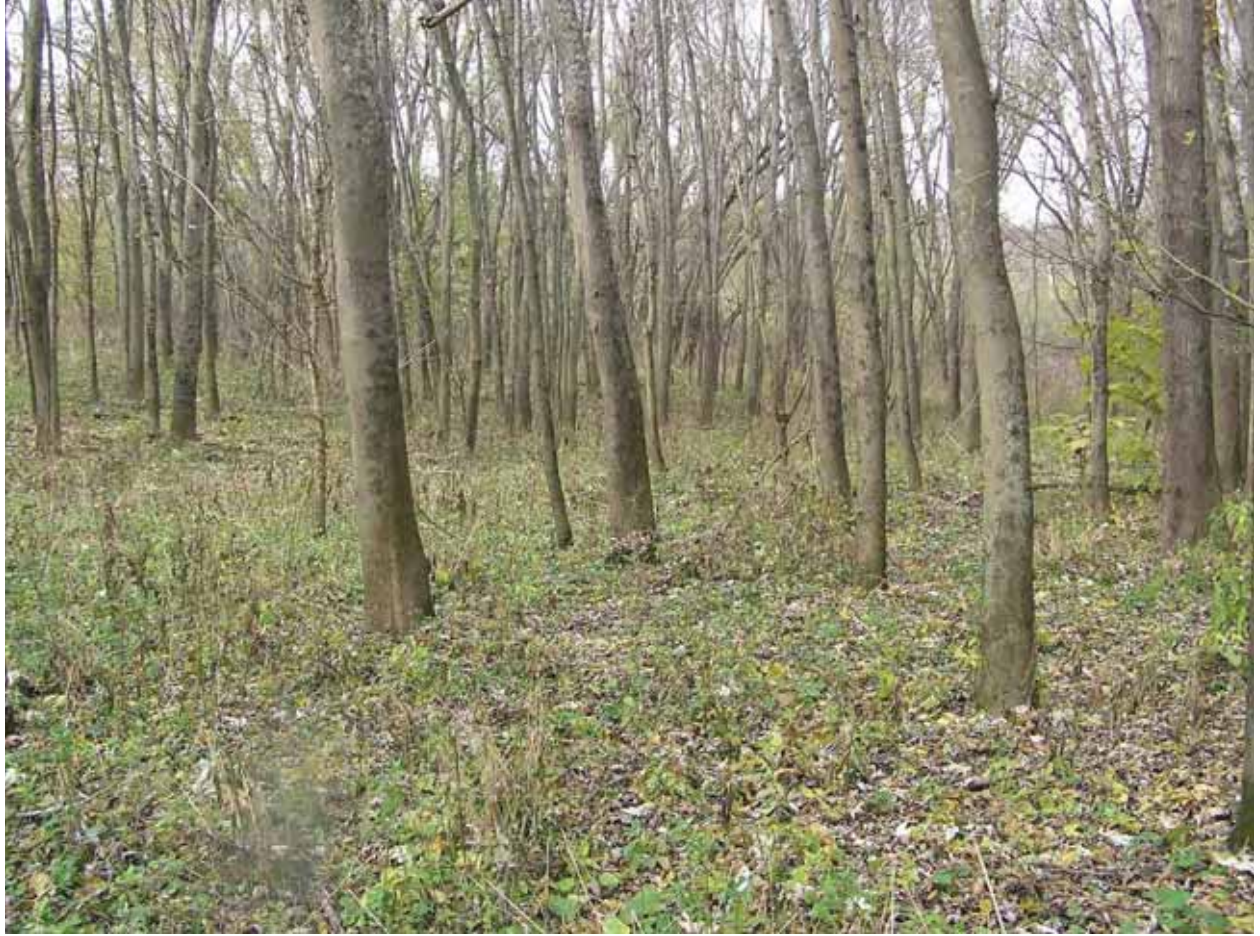
General view of the floodplain of the Licking River, facing south.

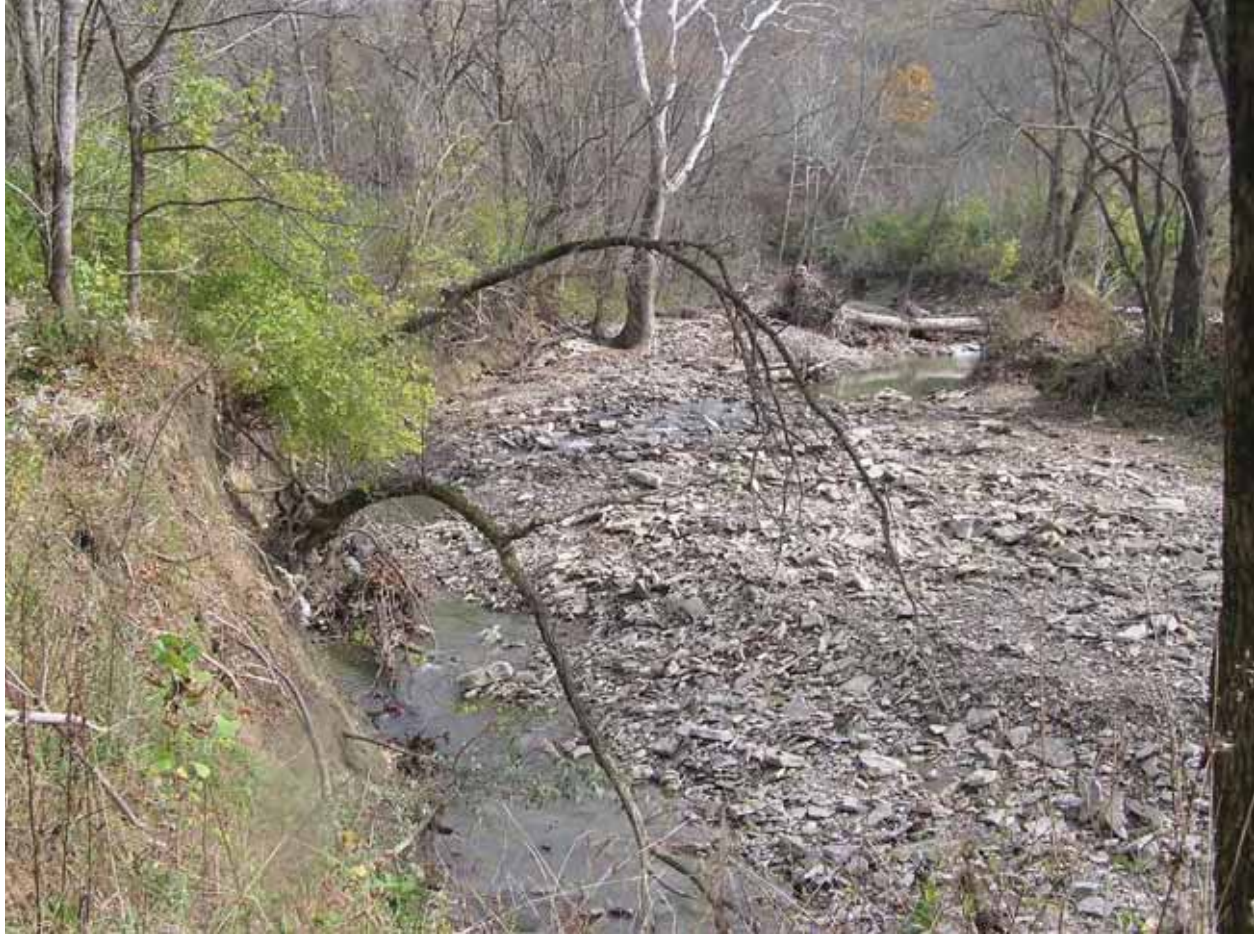
Excavations along Riffle Creek, facing northeast.

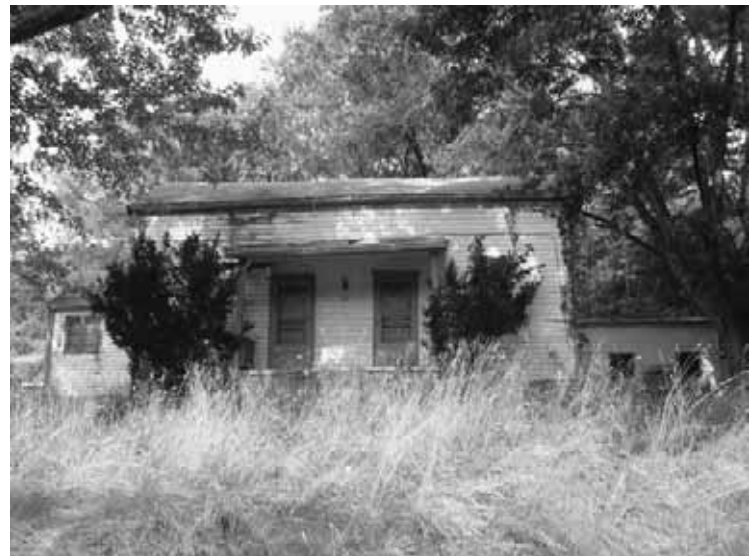
25. PHOTOGRAPHS

The Tratt House is a 1.5-story, single-pile, vernacular wood-frame residence of simple design, of possible double-cell or saddlebag plan. It rests on a rubblestone foundation that has been parged and painted; some of the covering has fallen away. (continued on Continuation Sheet below)

(continued from page 1 of Individual Survey Form CP-197) The main façade, which faces south, contains four symmetrically arranged bays. The center of the façade contains twin, half-glazed, paneled doors with wooden storm doors, flanked by single wood sashes in the end bays. The doorways are sheltered by a minimal frame porch of simple design. The porch features a low, nearly flat roof, simple spindled balustrades, and widespread, turned wood columns posts. It rests on a stone foundation approached by four steps. This porch may have been added in the early 20th century. The house's gable ends contain single windows in the first and attic stories, vertically aligned. All the windows contain 1/1 sashes and have simple enframements. A narrow, straight-stack brick chimney was added to the north elevation at an unknown date, likely in the mid-20th century. The house is covered by a side-gabled, asphalt shingle roof of moderate pitch, with corner returns and hanging gutters. The roof is asymmetrically gabled, with a saltbox-like longer rear slope with corner returns. Misaligned fenestration, and discrepancy in the trim boards, suggests this may have been a somewhat later addition, although this is by no means certain.

A one-story, single-room addition, covered by a gabled roof, was appended to the south elevation of the house, likely in the mid-20th century. It contains paired, multi-pane casement windows and is set on a concrete block foundation. This addition is set back from the plane of the main façade, somewhat reducing its prominence. It wraps around the north half of the rear of the house, as attested by a visible seam and the presence of small window openings. The house's walls are weatherboarded and painted white with gray trim. The house appears to be in fair condition from the exterior, with peeling paint evident.

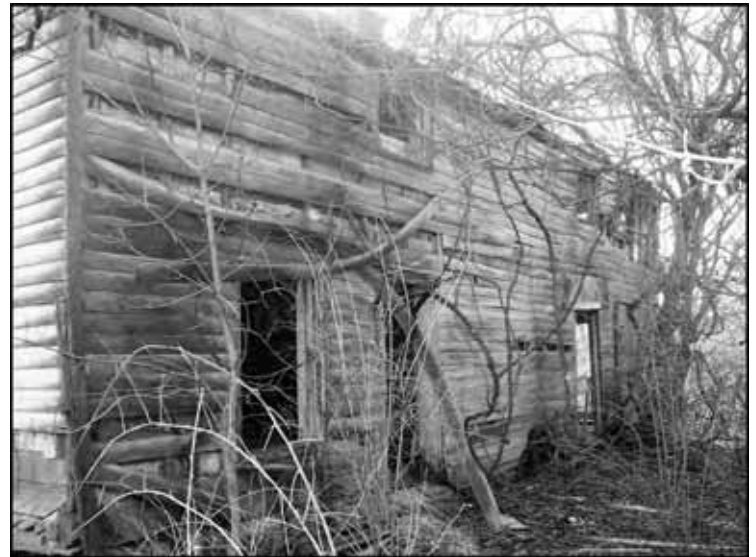
25. PHOTOGRAPHS

The house is built of squared, hewn logs chinked with what appears to be clay, with small chunks of limestone added to protect the chinking. The logs are secured by V-notching. The house rests on a rubble limestone foundation; there appears to be a cellar in place beneath the dwelling. A small brick chimney is centered in the ridgeline. The side-gabled roof is covered in raised-seam metal.

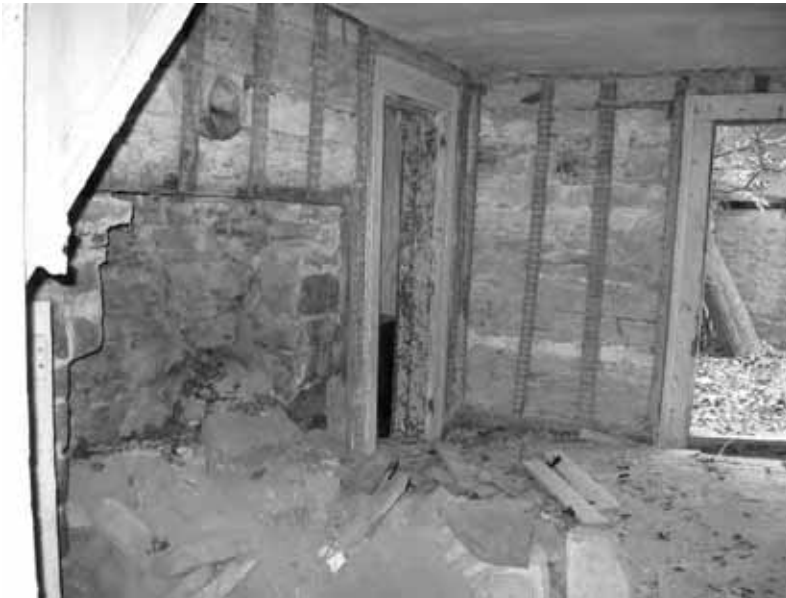
Figure 2 CP198_03. View to the west.

Foundation of former outbuilding (barn?): coursed, rubble limestone, some of which has been rather crudely mortared

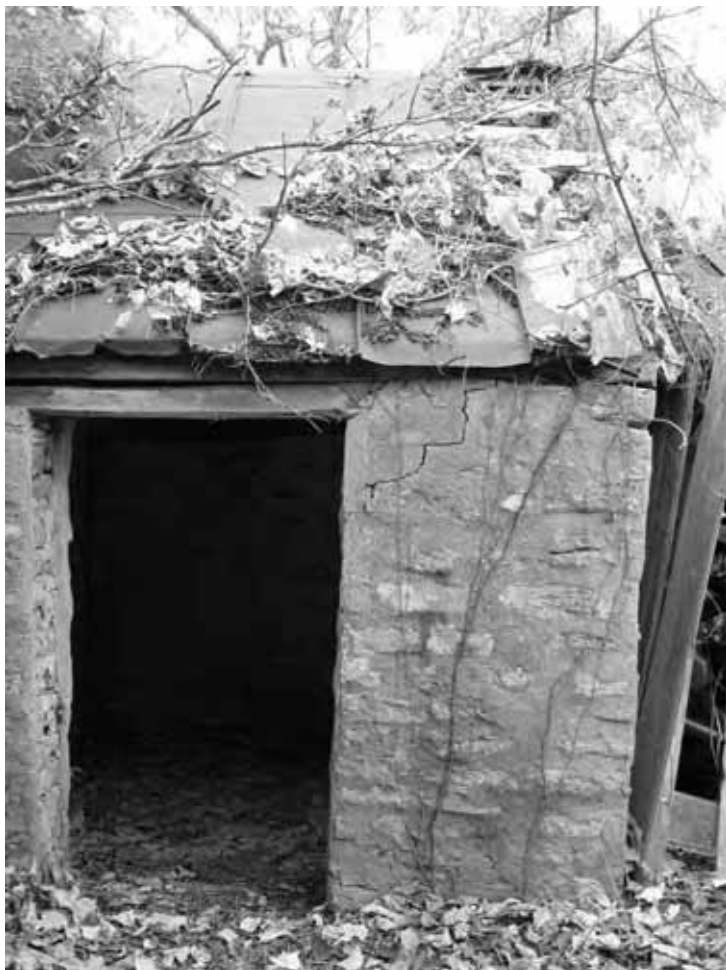
Figure 3 CP198_04. View to the west.

Smokehouse: front-gabled structure of uncoursed rubblestone, some of which has been rather crudely pointed with concrete, under a tin roof. The main façade contains only a single doorway. The interior walls also are pointed with concrete. At the rear is a rectangular frame structure, also tin-roofed, that has collapsed.
