**ANALYSIS OF BROWNFIELDS CLEANUP  
ALTERNATIVES/  
REMEDIAL ACTION PLAN**

Kleen Laundry Former Dry-Cleaning Facility  
1 Foundry Street and 25 Mechanic Street  
Lebanon, New Hampshire 03766  
NHDES Site No. 198801003 and 201704036

**Subject: Analysis of Brownfields Cleanup Alternatives/Remedial Action Plan  
Kleen Laundry Former Dry-Cleaning Facility  
1 Foundry Street and 25 Mechanic Street, Lebanon, New Hampshire 03766  
NHDES Site No. 198801003 and 201704036**

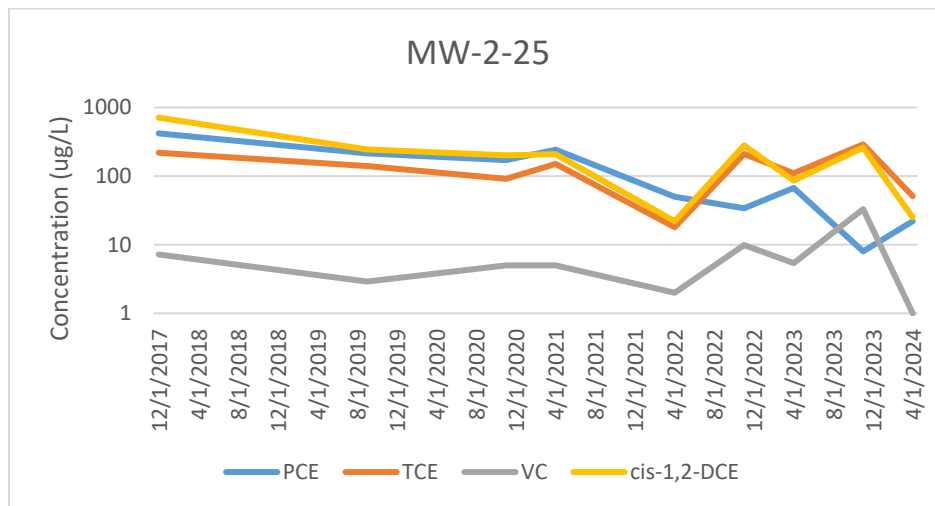
***Inset Chart A*** – Trend line for groundwater data at MW-2-25

Review of recent groundwater sampling rounds indicates an overall decrease in concentrations of PCE inverse concentrations of dechlorination products TCE, cis-1,2-DCE, and VC at MW-2-25 between 2017 and 2024. A similar pattern is observed in the downgradient CA-MW-4, with a seasonal trend of higher results of dechlorination products in November sampling rounds. This may be the result of higher concentrations of petroleum compounds migrating onto the Site during the fall allowing for oxygen depletion during petroleum degradation resulting in an anaerobic environment more favorable to increased dechlorination. Based on the apparent trend lines and presence of dechlorination products, attenuation of the plume at the source does appear to be actively occurring in recent years.

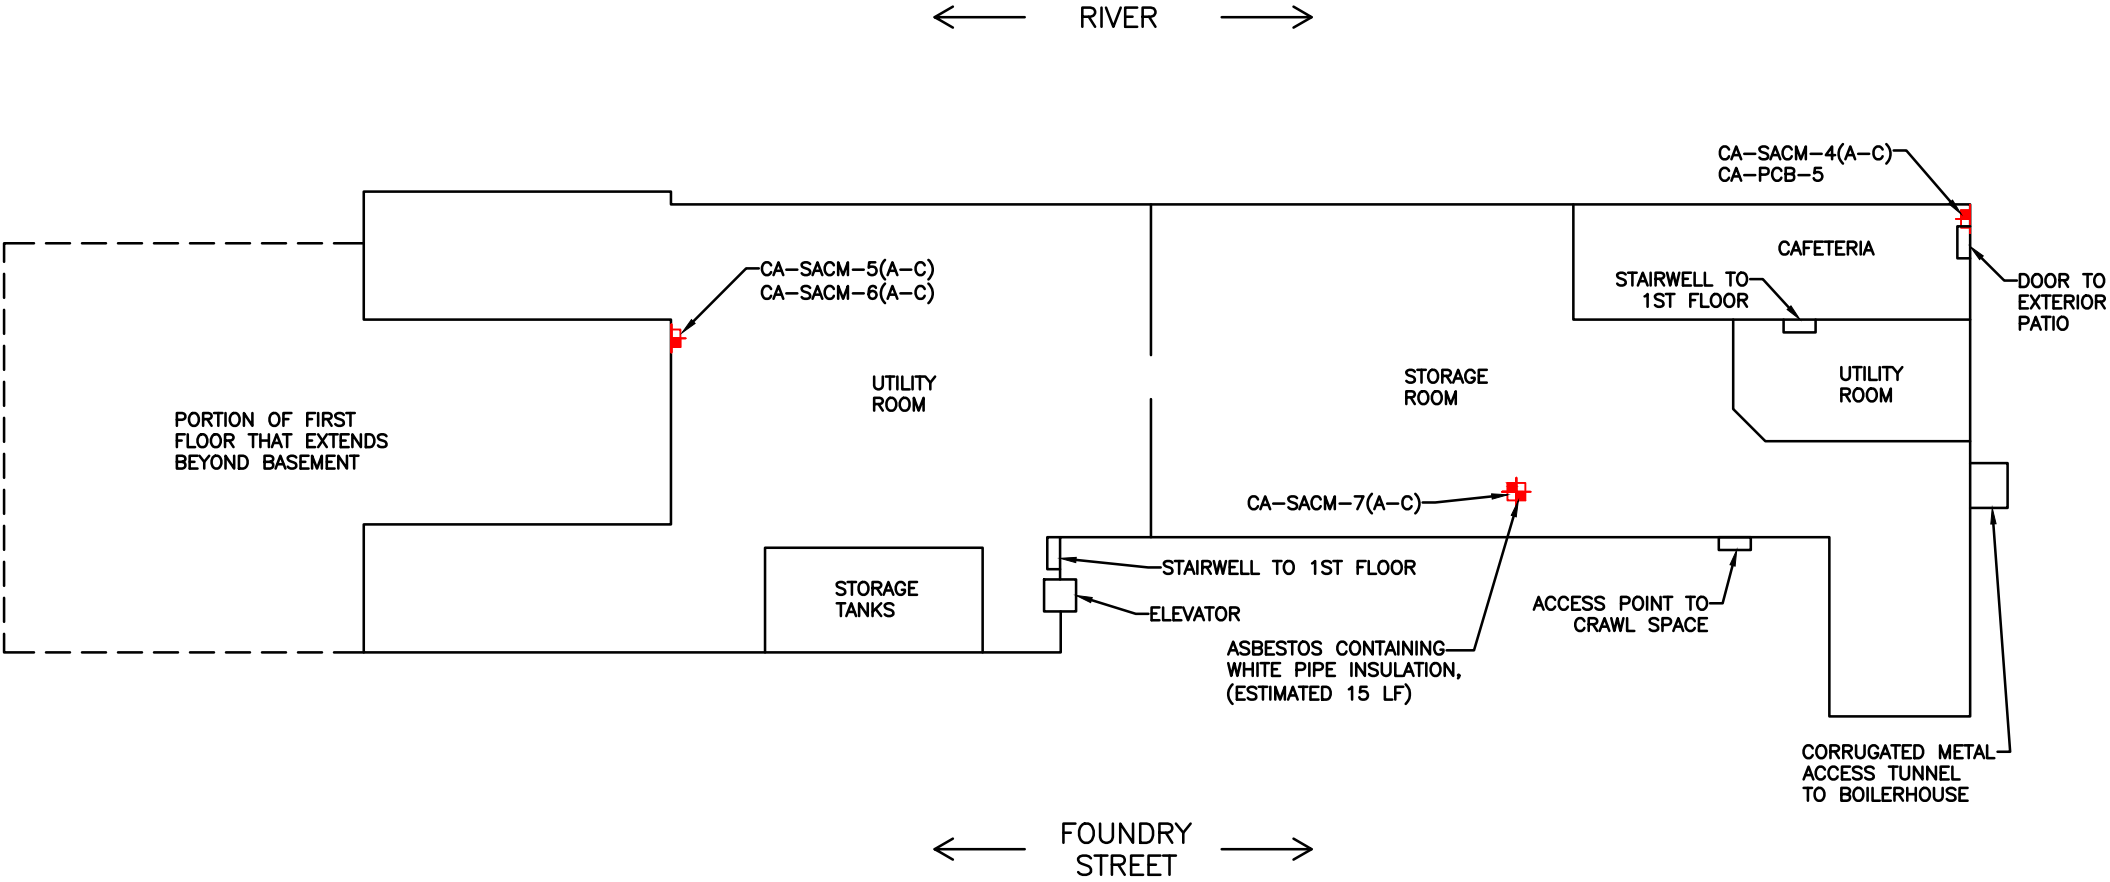
FIGURE 5A

HAZARDOUS BUILDING MATERIALS LOCATION PLAN  
MILL BUILDING - BASEMENT

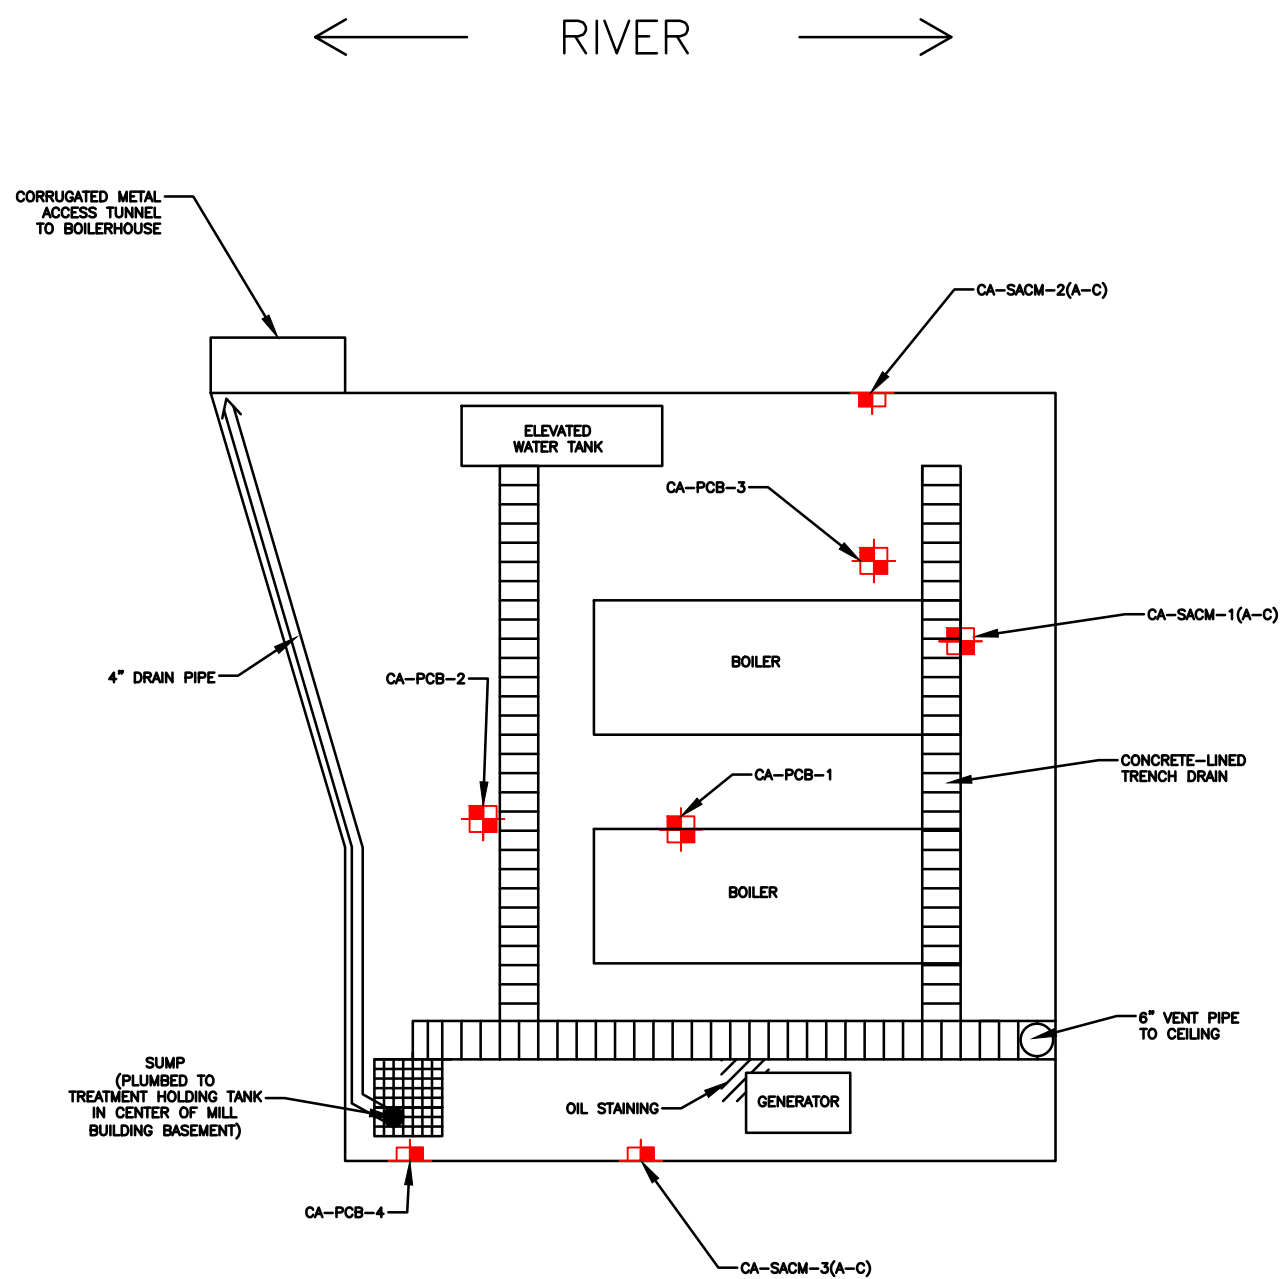
| DRAWN BY: GWK<br>CHECKED BY: ASD | DATE: 07/07/2021<br>PROJECT: 17001384 | <div>HAZARDOUS BUILDING MATERIALS LOCATION PLAN</div> <div>BOILER HOUSE</div> | <div>FIGURE 6</div> | <div>FORMER KLEEN LAUNDRY AND DRY CLEANING</div> <div>25 MECHANIC STREET AND 1 FOUNDRY STREET</div> <div>LEBANON, NEW HAMPSHIRE</div> |

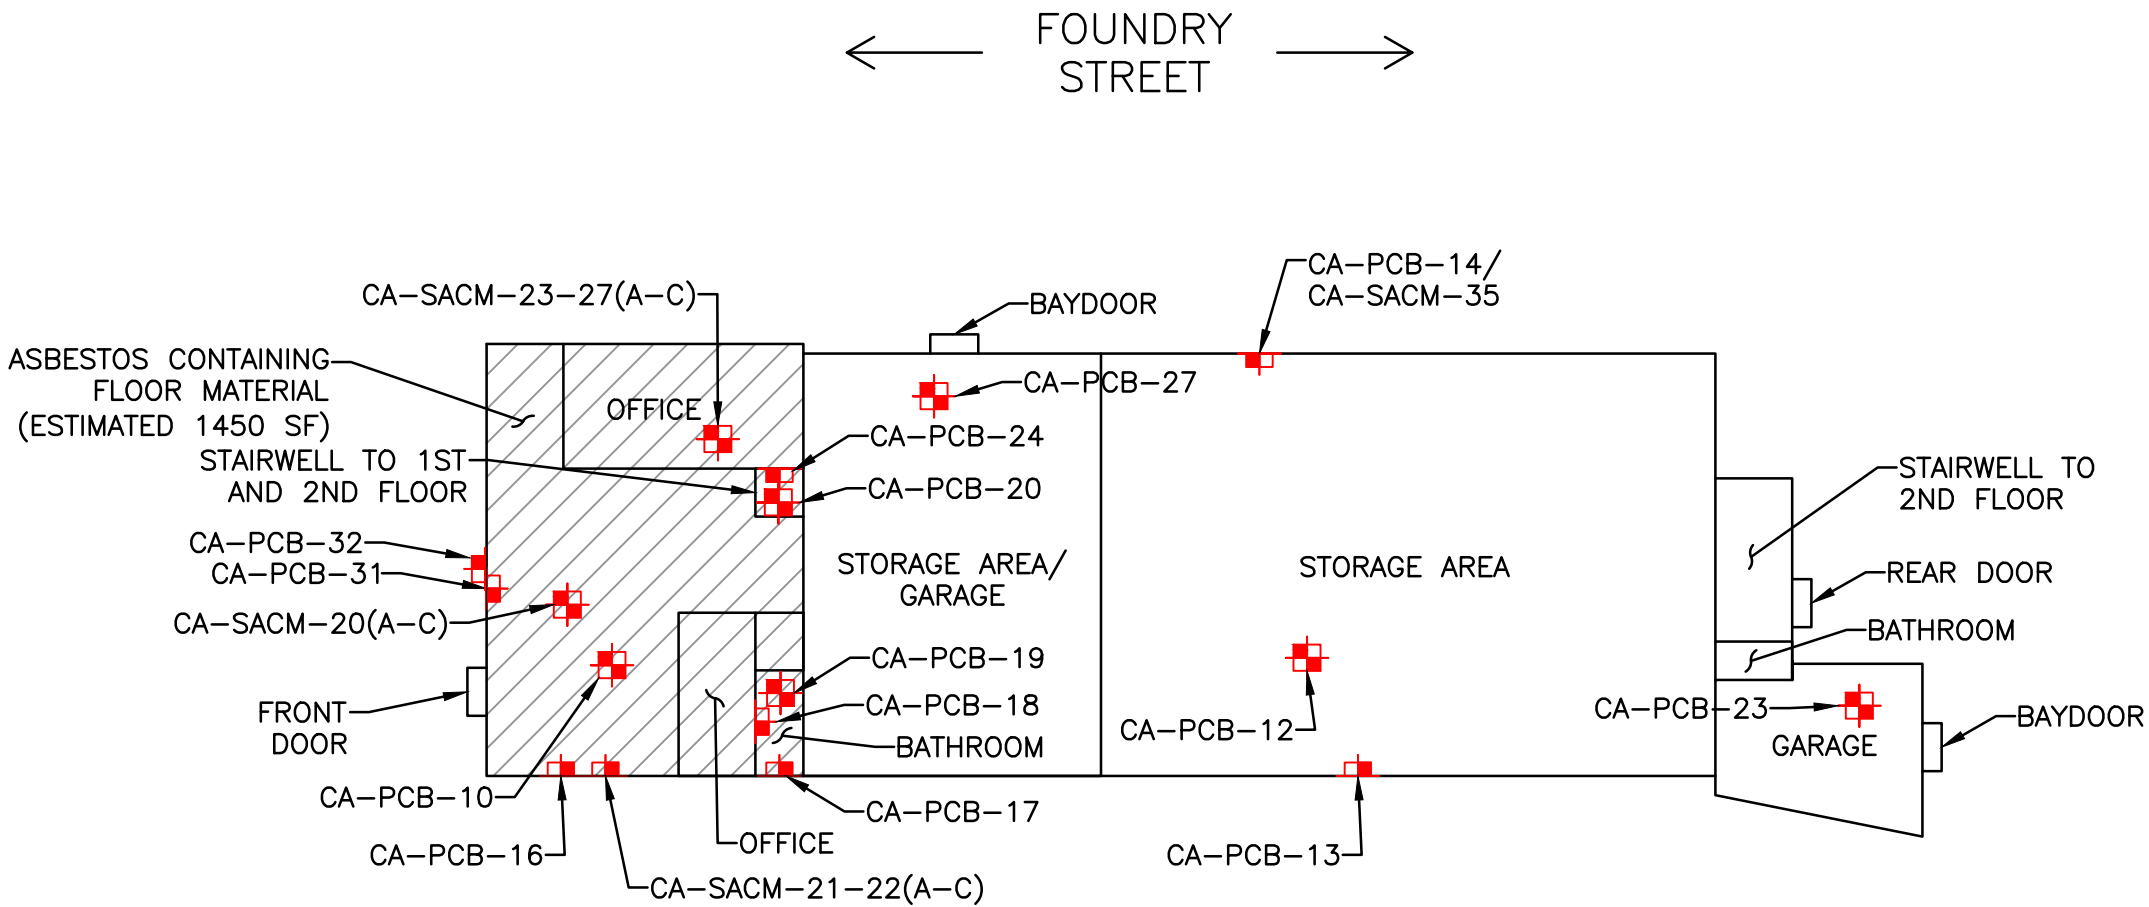
HAZARDOUS BUILDING MATERIALS LOCATION PLAN  
OFFICE/STORAGE BUILDING - FIRST FLOOR

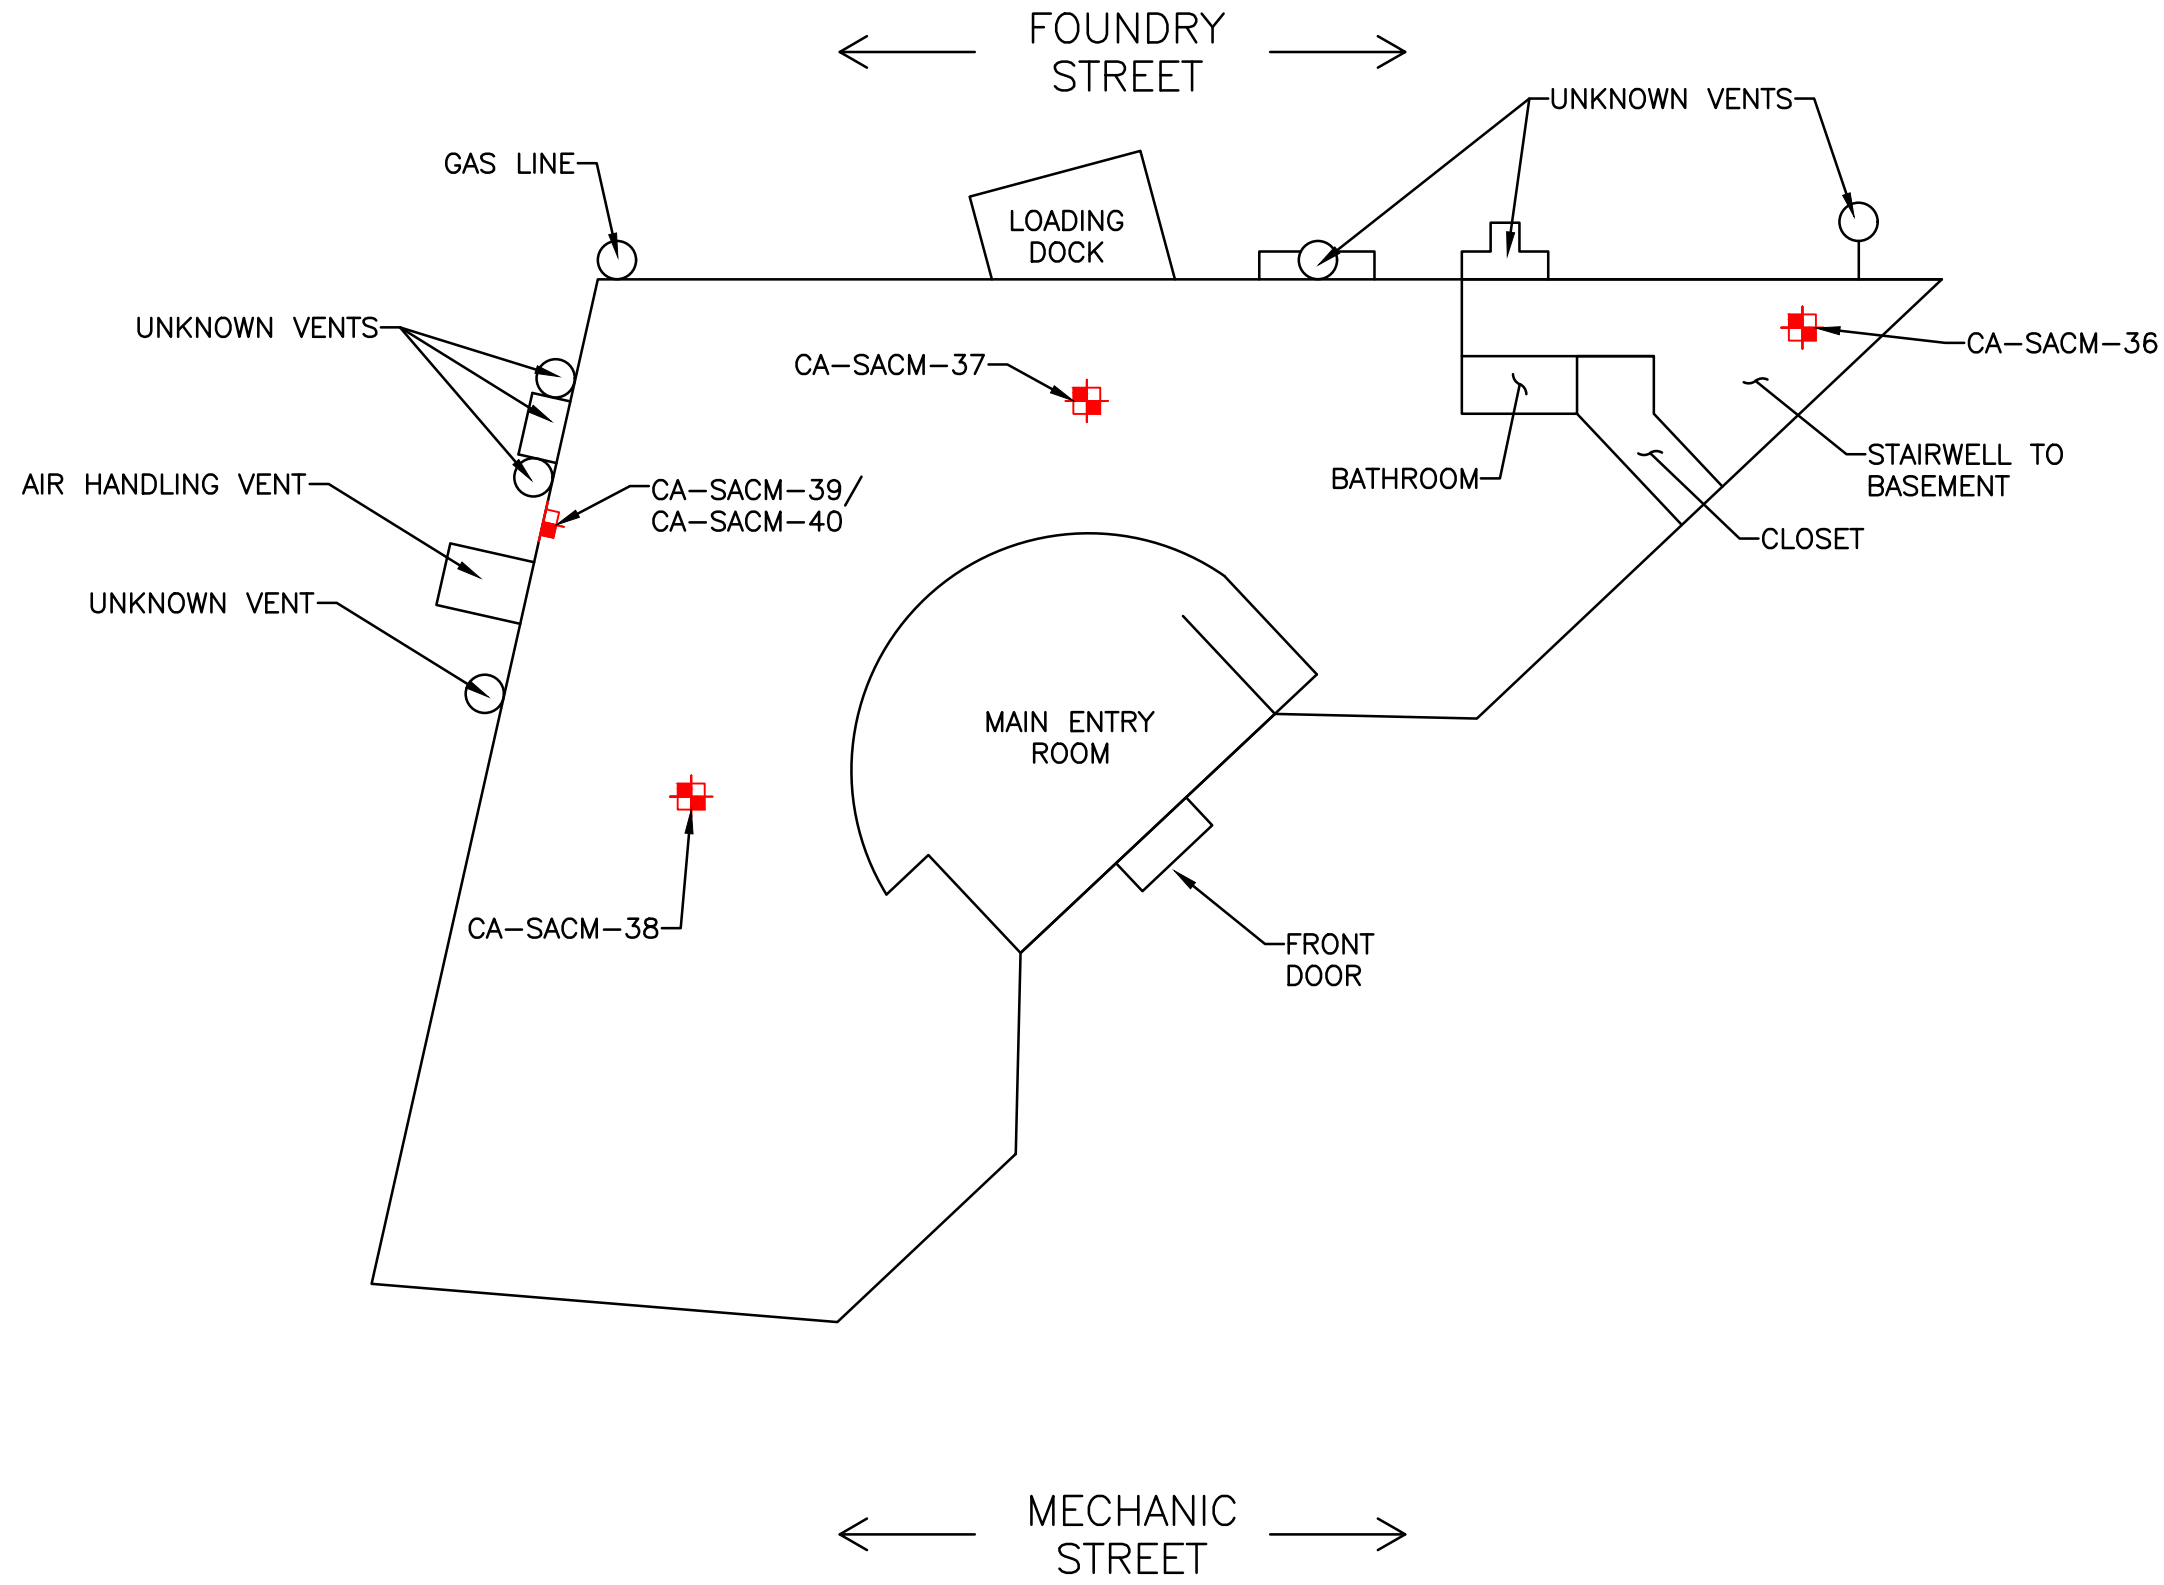
HAZARDOUS BUILDING MATERIALS LOCATION PLAN  
RETAIL BUILDING - FIRST FLOOR

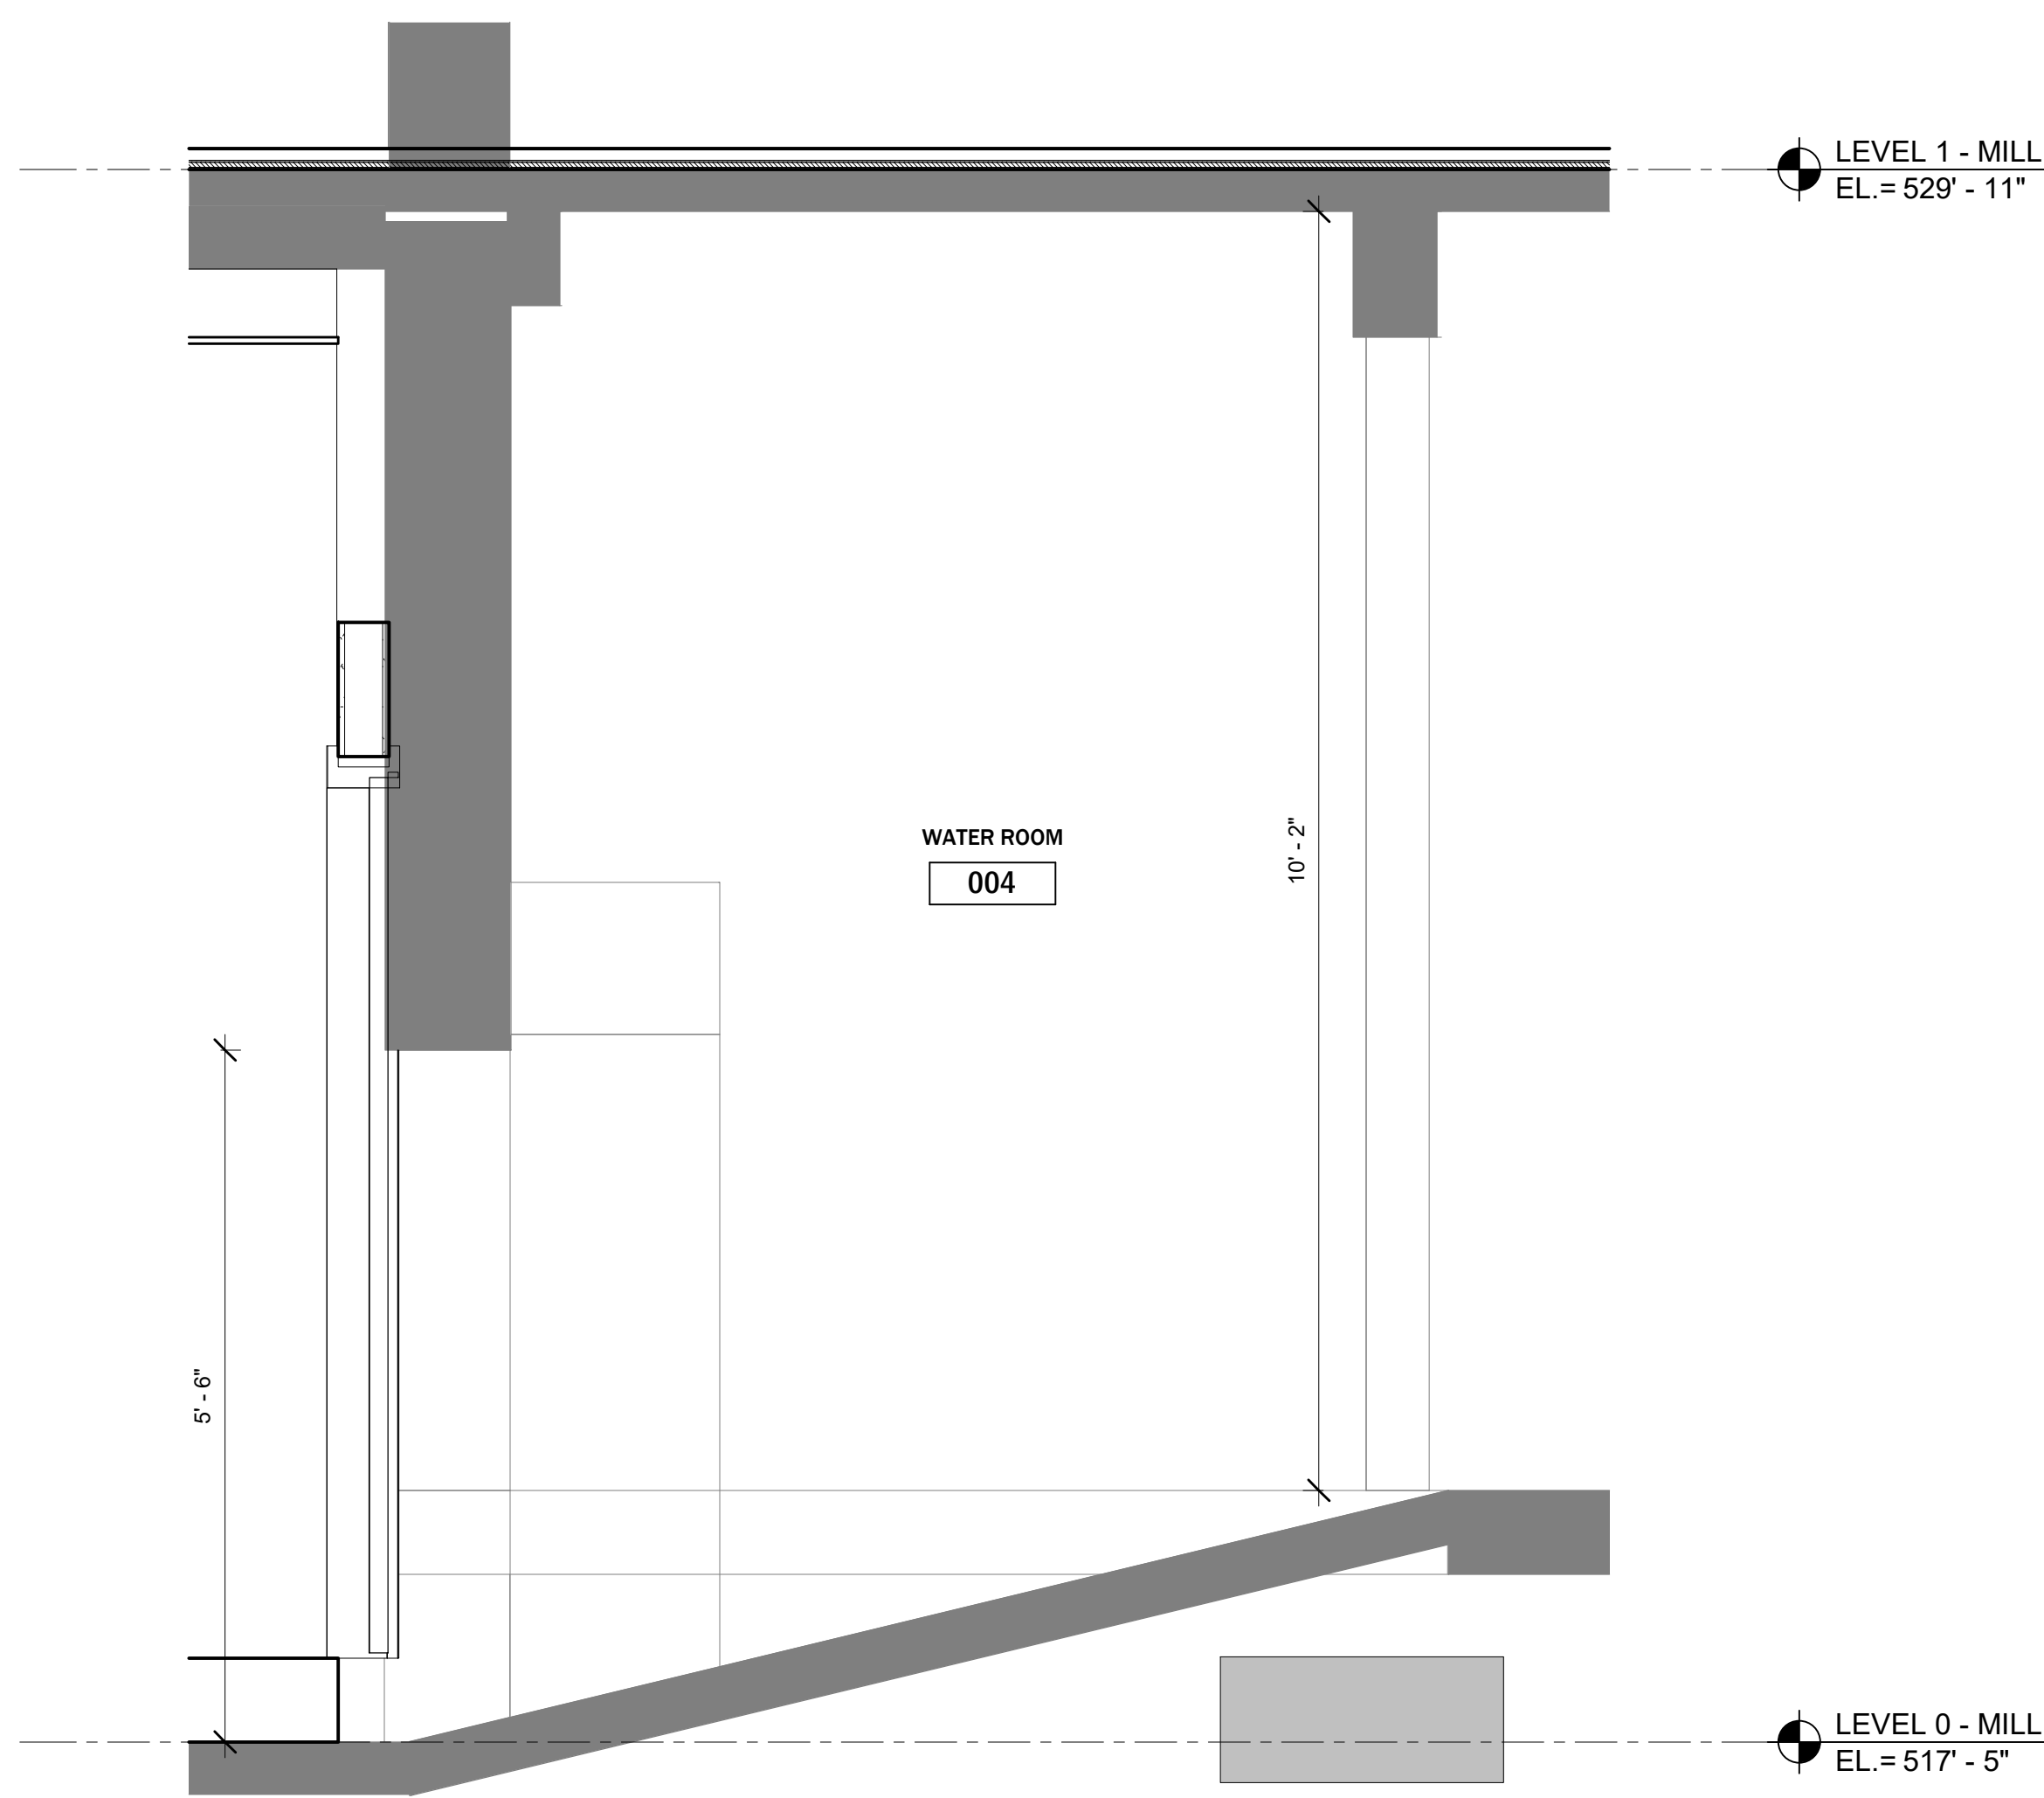
1 MILL FOUNDATION @ UNOCCUPIED WEST  
1 1/2" = 1'-0"

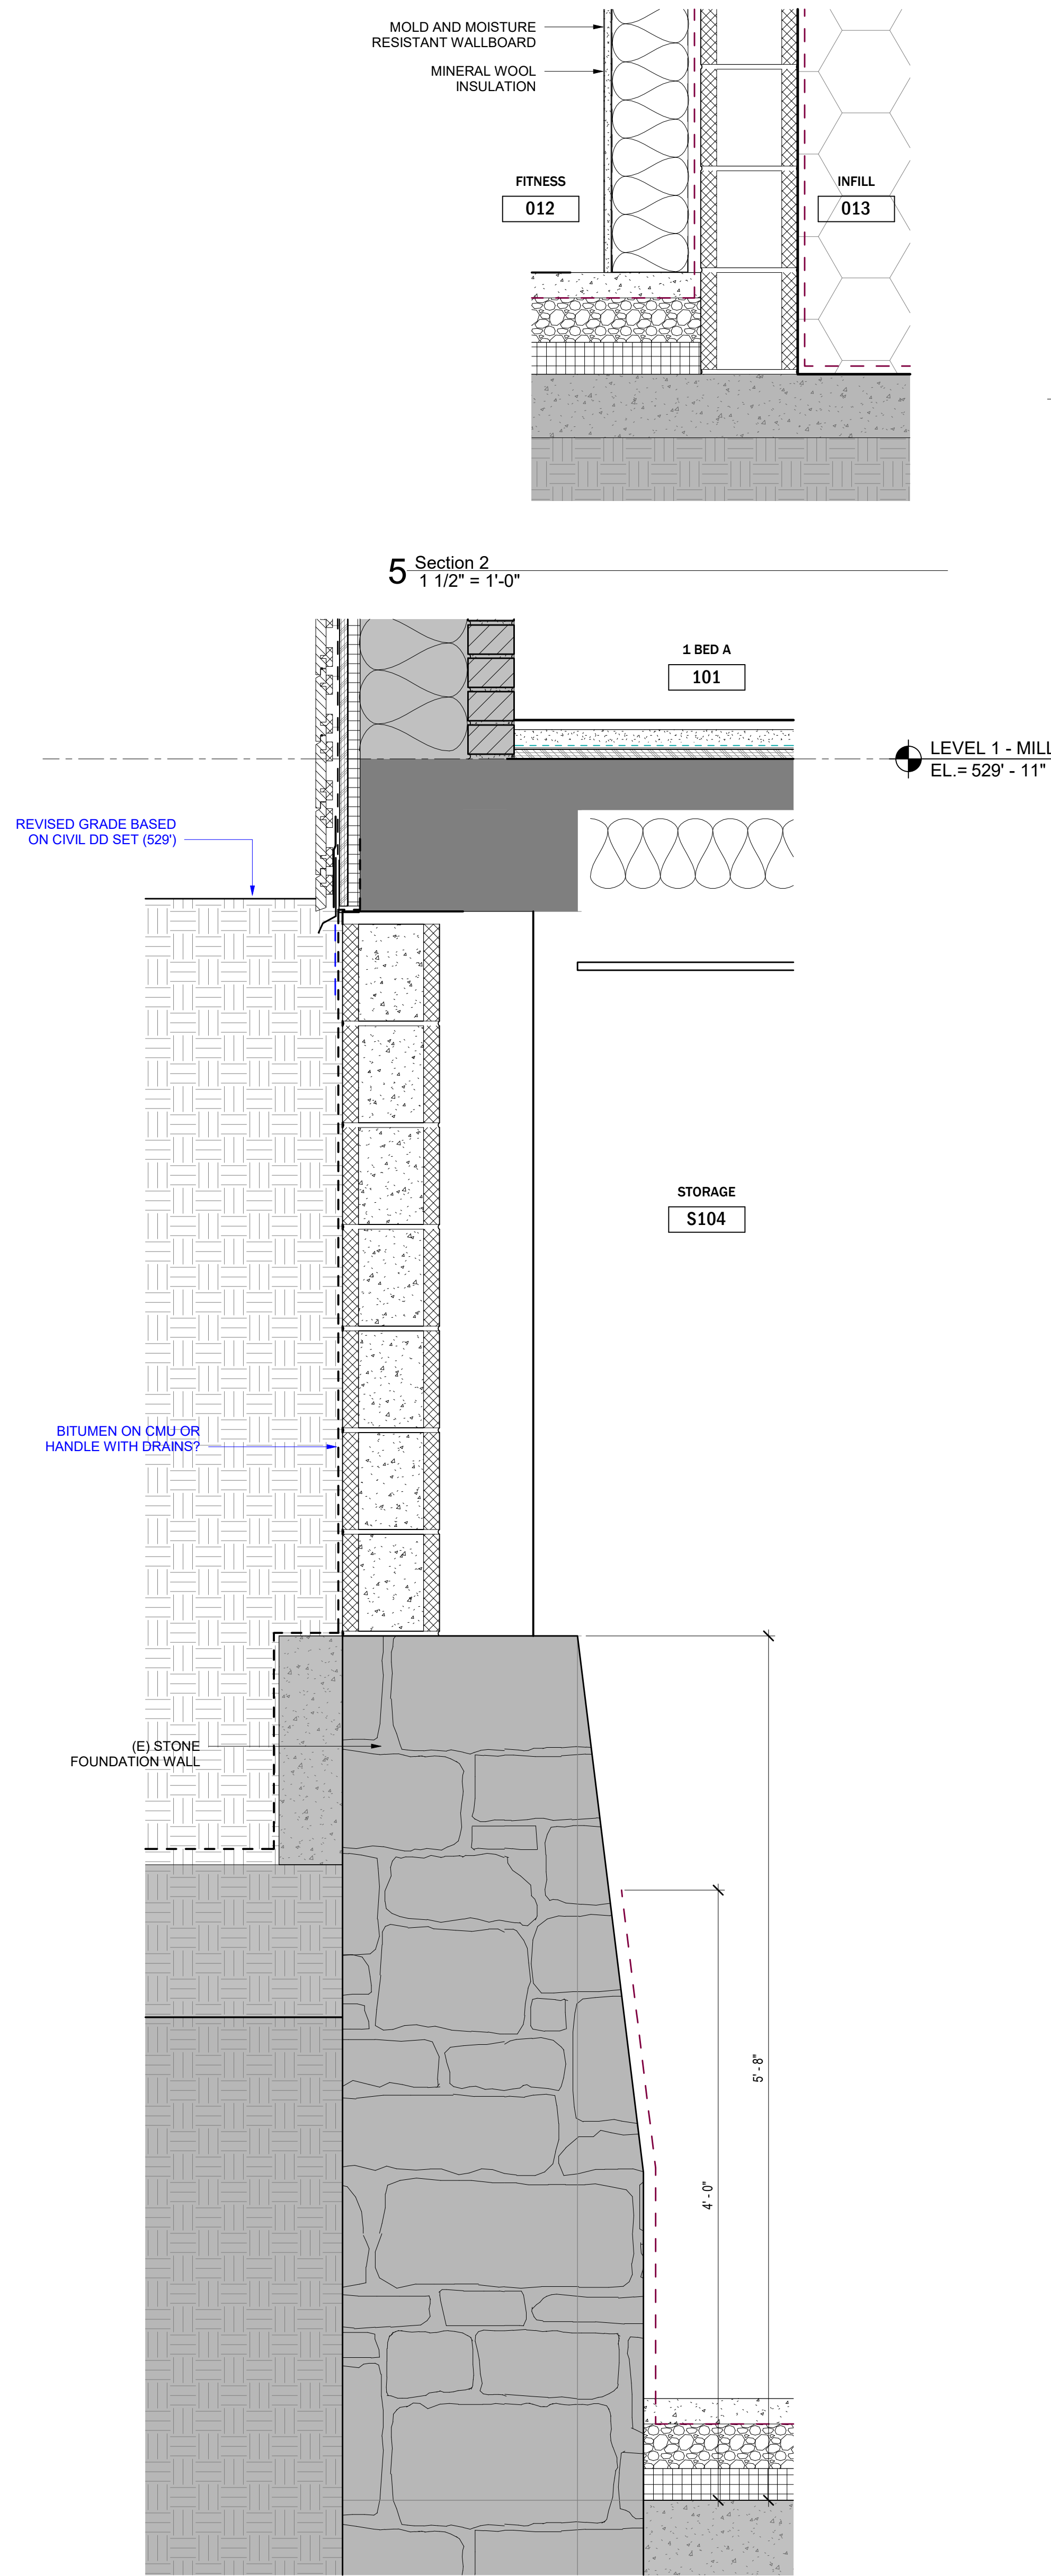
5 Section 2  
1 1/2" = 1'-0"

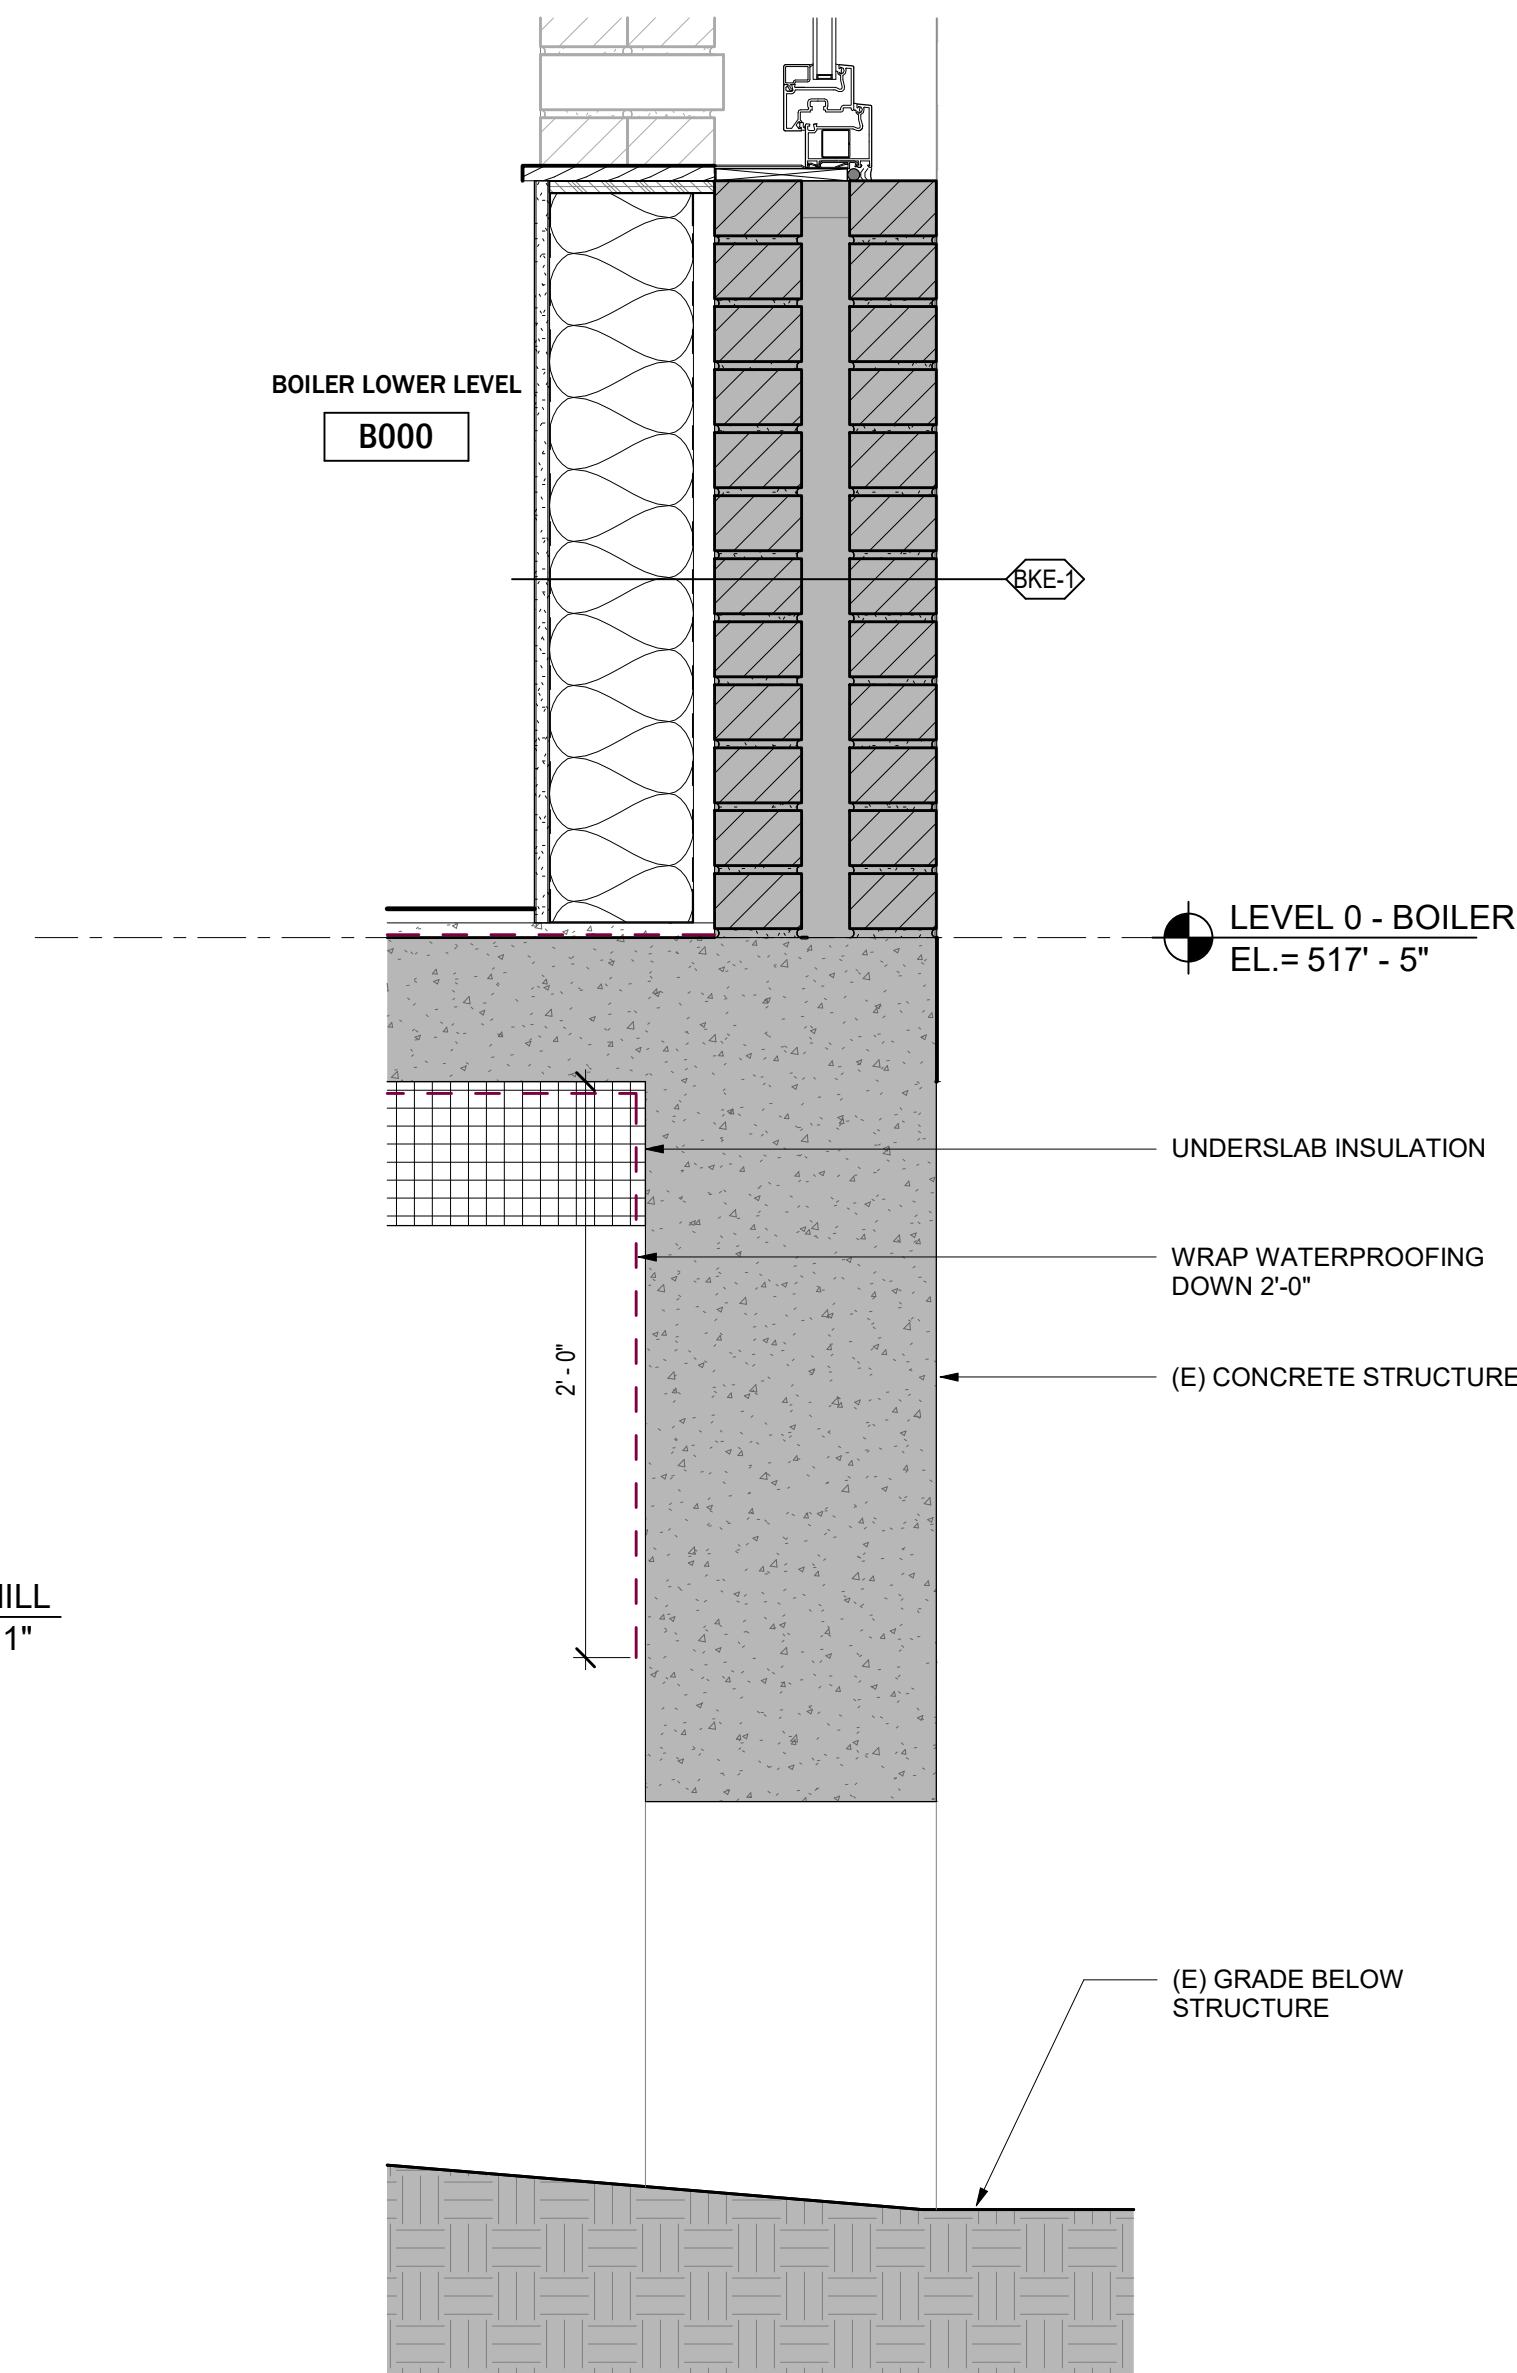
3 FOUNDATION DETAIL @ BOILER NORTH 1  
1 1/2" = 1'-0"

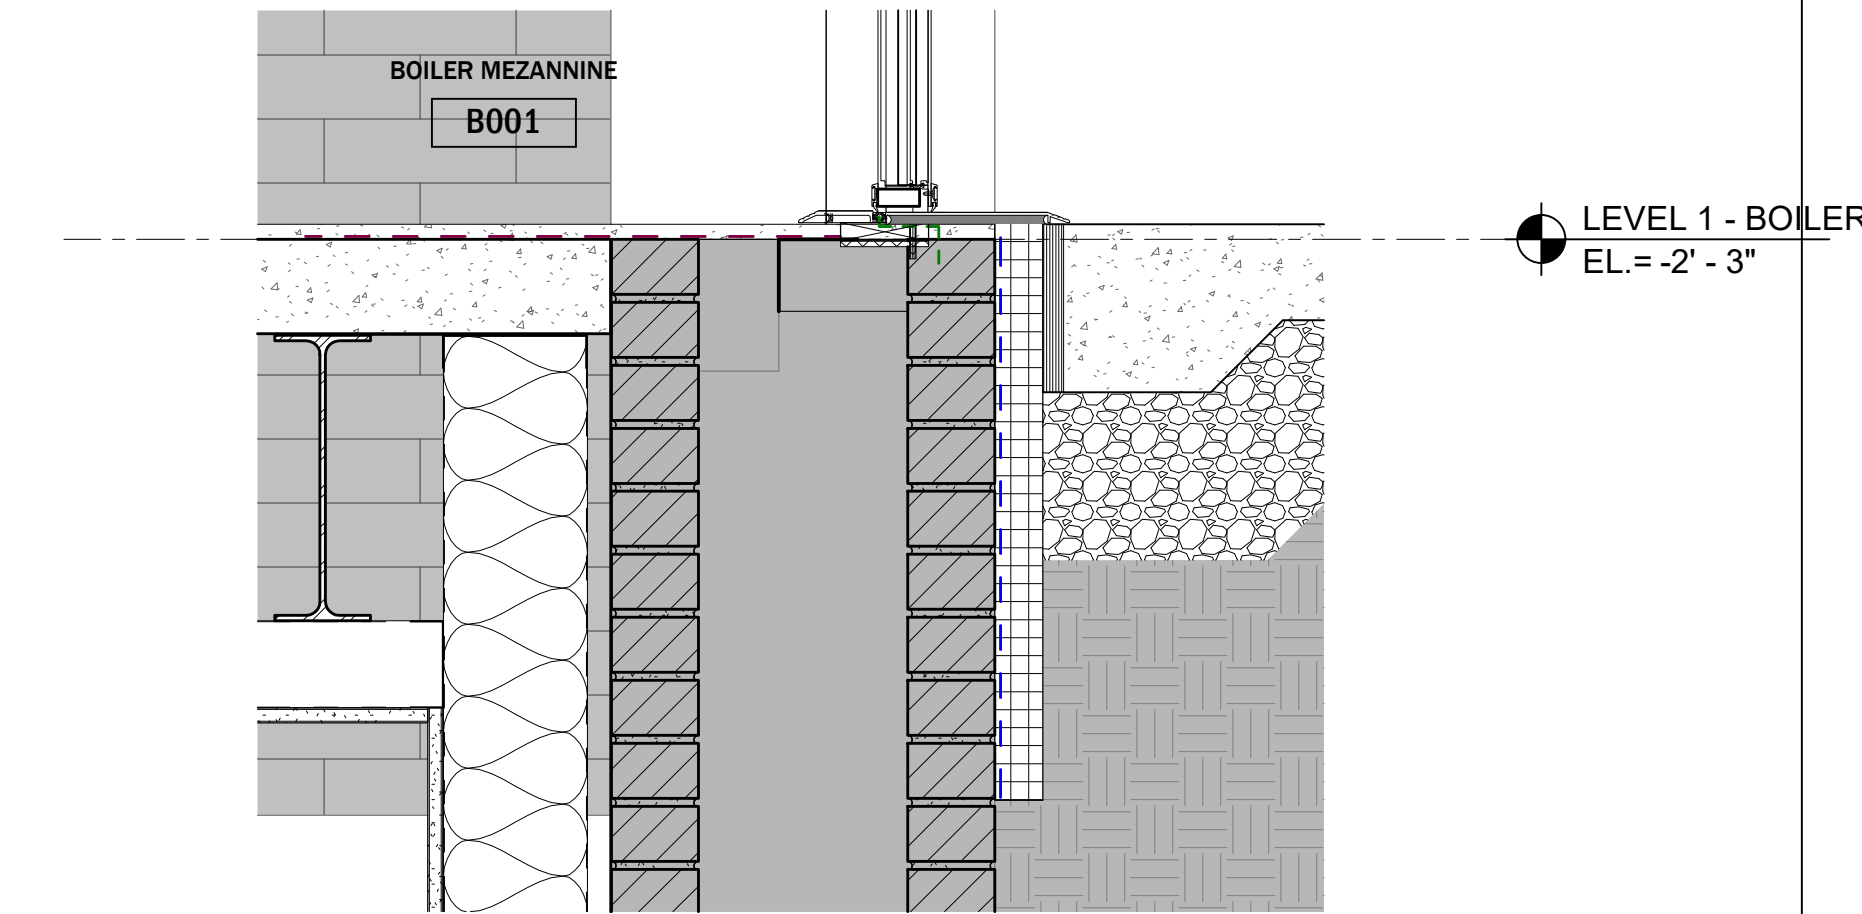
4 WALL DETAIL @ BOILER WEST  
1 1/2" = 1'-0"

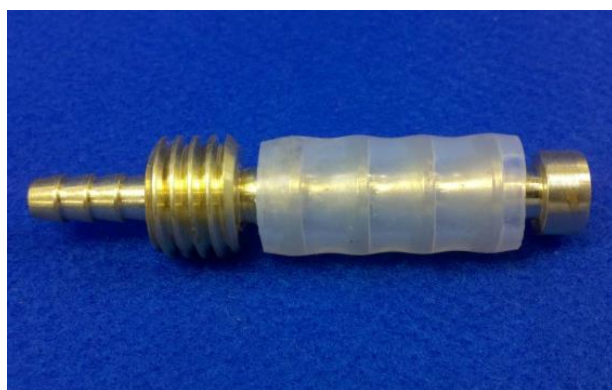
Figure 1. Assembled VAPOR PIN®

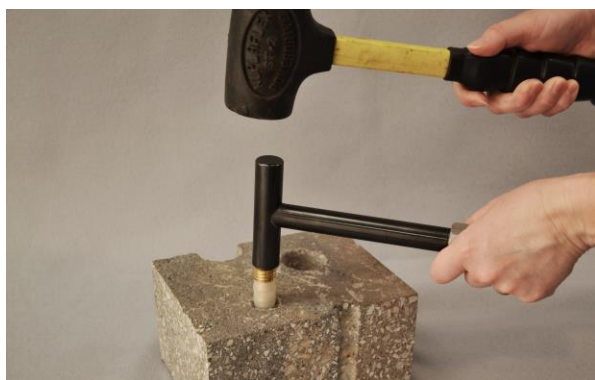
- 5) Remove the drill bit, brush the hole with the bottle brush, and remove the loose cuttings with the vacuum.
- 6) Place the lower end of VAPOR PIN® assembly into the drilled hole. Place the small hole located in the handle of the installation/extraction tool over the vapor pin to protect the barb fitting, and tap the vapor pin into place using a dead blow hammer (Figure 2). Make sure the installation/extraction tool is aligned parallel to the vapor pin to avoid damaging the barb fitting.

Figure 2. Installing the VAPOR PIN®

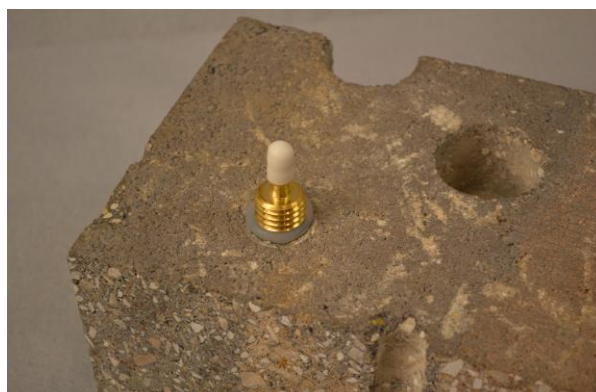
During installation, the silicone sleeve will form a slight bulge between the slab and the VAPOR PIN® shoulder. Place the protective cap on VAPOR PIN® to prevent vapor loss prior to sampling (Figure 3).

Figure 3. Installed VAPOR PIN®

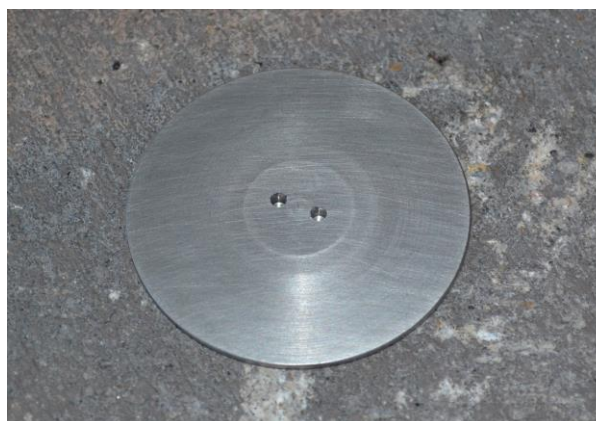
- 7) For flush mount installations, cover the vapor pin with a flush mount cover, using either the plastic cover or the optional stainless-steel Secure Cover (Figure 4).

Figure 4. Secure Cover Installed

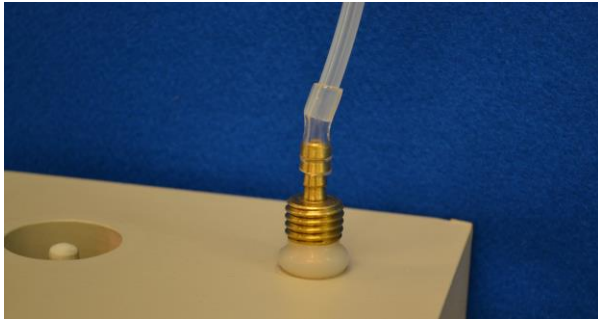
Nylaflow tubing (Figure 5). Put the Nylaflow tubing as close to the VAPOR PIN® as possible to minimize contact between soil gas and Tygon™ tubing.

Figure 5. VAPOR PIN® sample connection
