**ANALYSIS OF BROWNFIELDS CLEANUP  
ALTERNATIVES/  
REMEDIAL ACTION PLAN**

Kleen Laundry Former Dry-Cleaning Facility  
1 Foundry Street and 25 Mechanic Street  
Lebanon, New Hampshire 03766  
NHDES Site No. 198801003 and 201704036

**Subject: Analysis of Brownfields Cleanup Alternatives/Remedial Action Plan  
Kleen Laundry Former Dry-Cleaning Facility  
1 Foundry Street and 25 Mechanic Street, Lebanon, New Hampshire 03766  
NHDES Site No. 198801003 and 201704036**

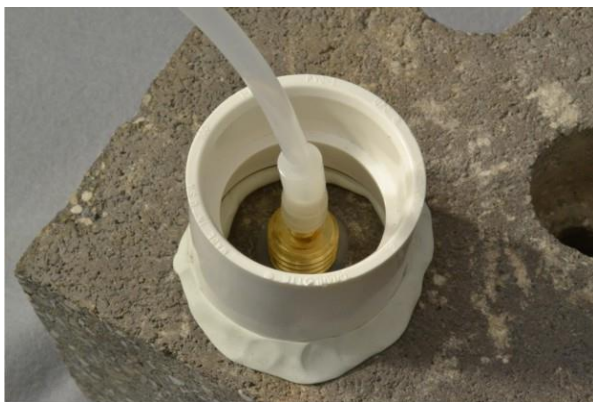
10) Conduct leak tests in accordance with applicable guidance. If the method of leak testing is not specified, an alternative can be the use of a water dam and vacuum pump, as described in SOP Leak Testing the VAPOR PIN® via Mechanical Means (Figure 6). For flush-mount installations, distilled water can be poured directly into the 1 1/2 inch (38mm) hole.

Figure 6. Water dam used for leak detection

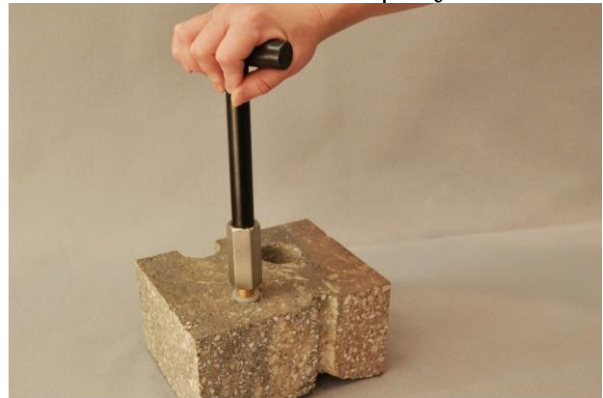
2) Fill the void with hydraulic cement and smooth with a trowel or putty knife.

Figure 7. Removing the VAPOR PIN®

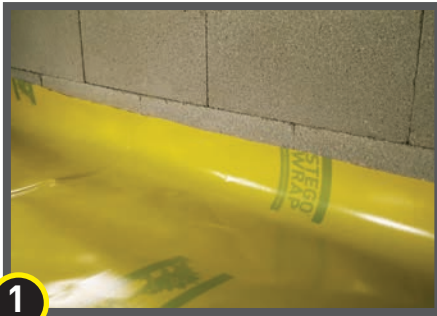
**1** Extend Stego Wrap up the vertical surface, likely to the height of the slab.  
Note: See Where to Terminate the Stego Wrap, page 5.

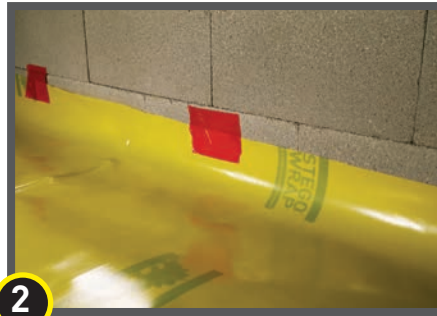
**Optional:** Temporarily secure Stego Wrap to the foundation wall with a small piece of Stego Tape.  
Note: Trim excess Stego Tape after concrete has been placed and before removal of any adjacent forms.

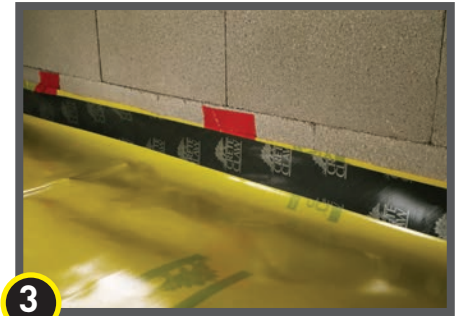
**3** Apply the entire 3" width of Stego Crete Claw Tape on the perimeter edge of Stego Wrap.  
Note: Clean surface of Stego Wrap to ensure that it is free of moisture and debris prior to the installation of Stego Crete Claw Tape.

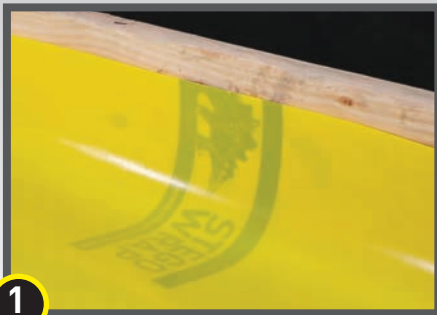
**1** Extend Stego Wrap up the vertical surface, likely to the height of the forms.  
Note: See Where to Terminate the Stego Wrap, page 5.

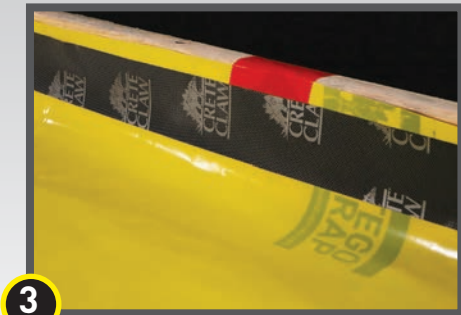
**3** Apply the entire 3" width of Stego Crete Claw Tape on the perimeter edge of Stego Wrap.  
Note: Clean surface of Stego Wrap to ensure that it is free of moisture and debris prior to the installation of Stego Crete Claw Tape.

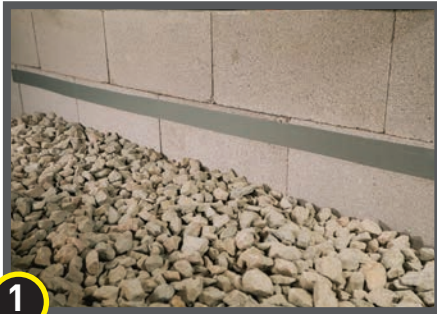
**1** Remove the release liner on one side of StegoTack Tape and stick to foundation wall at the height of the slab or at impediments.

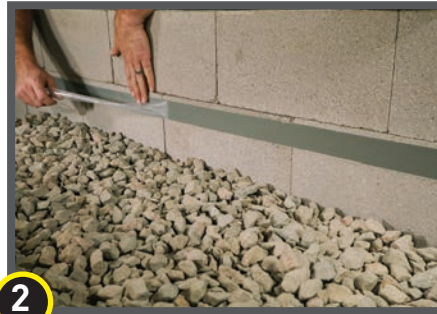
**2** When ready to apply Stego Wrap, remove the exposed release liner from StegoTack Tape.

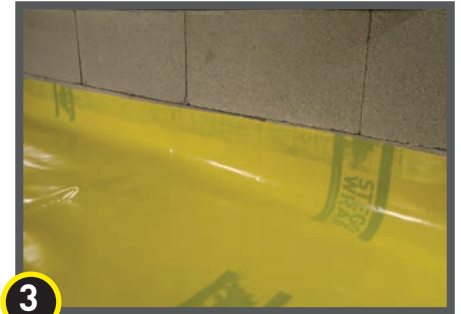
**3** Press Stego Wrap firmly against StegoTack Tape to secure.  
NOTE: If consistent, continuous pressure will not be applied (e.g. by a concrete slab), Stego Term Bar may be necessary.

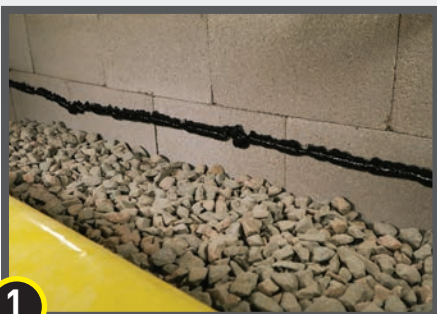
**1** Apply Stego Mastic to the foundation wall at the anticipated edge of the subsequently applied Stego Wrap at the height of the slab or impediments.

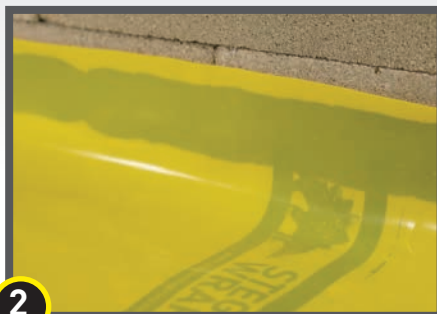
**2** Press Stego Wrap firmly against the applied Stego Mastic on the foundation wall.

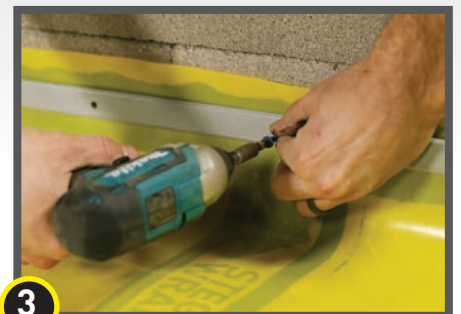
**3** If consistent, continuous pressure will not be applied (e.g. by a concrete slab), Stego Term Bar may be necessary.

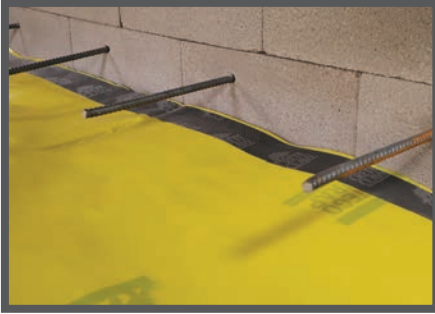
At a Foundation Wall: Install Stego Crete Claw onto the terminating edge of Stego Wrap.

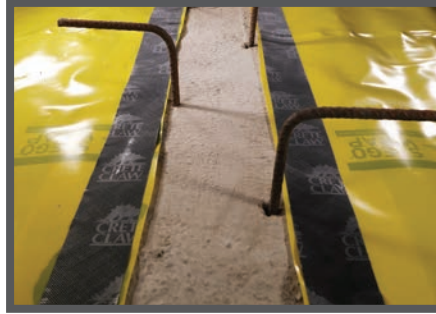
At Interior Grade Beam Impediments: Install Stego Crete Claw onto the terminating edge of Stego Wrap.

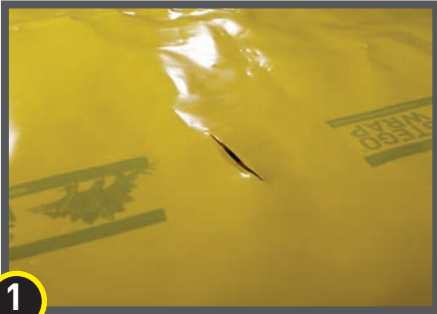
**1**  
Small hole or slice in Stego Wrap.

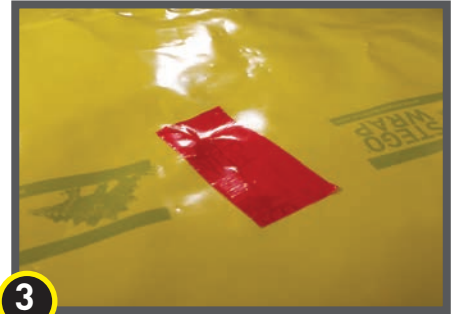
**3**  
Center Stego Tape over small hole or slice in Stego Wrap.

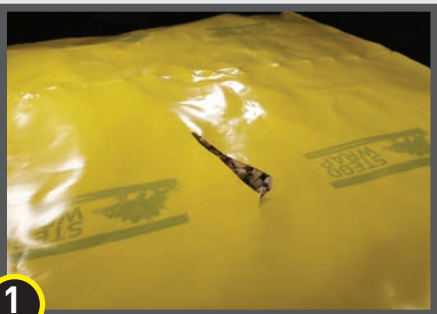
**1**  
Occasionally there are larger holes in the vapor barrier that require a patch.

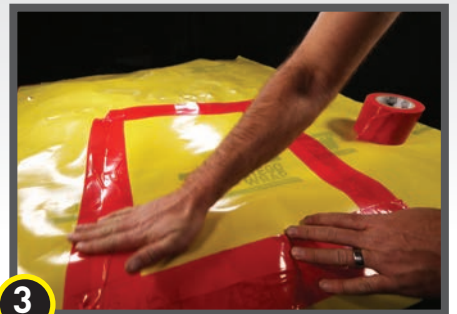
**3**  
Measure and cut a piece of Stego Wrap to cover damaged area 6" in all directions. Seal patch with Stego Tape.
