**NOXON RAPIDS & CABINET GORGE RESERVOIRS  
SANDERS COUNTY, MONTANA**

**2018 Aquatic Invasive Species  
Aquatic Pesticide Application Report (APAR)**

October 2018

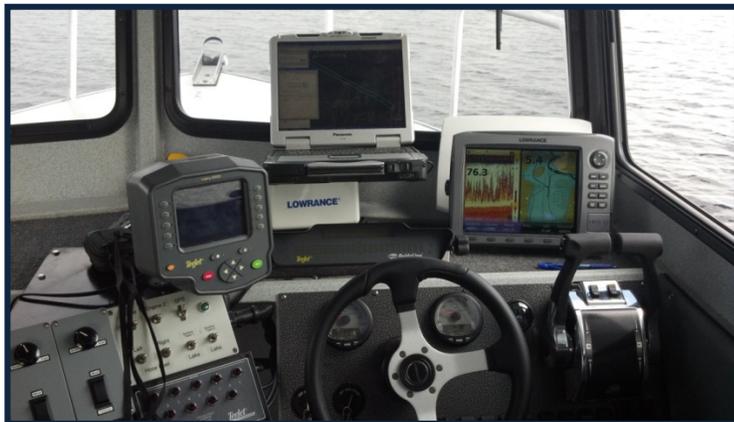
The AIS treatment area GIS shapefiles were loaded into the LittLine<sup>®</sup> computer system for vessel guidance and herbicide application data recording. The LittLine<sup>®</sup> can place herbicides at any depth within the water column (2 - 30 feet), as well as within the bottom 2 foot of the water

column. Impacts from currents, wind and wave action are reduced in deep water applications through the use of the LittLine<sup>®</sup> application system when compared to conventional subsurface applications. The herbicide application in all of the plots was within the bottom portion of the water column.

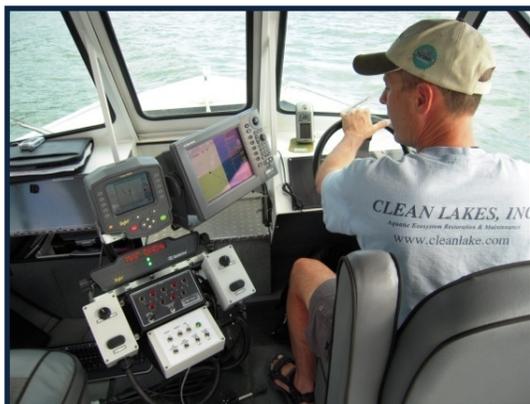
The LittLine system's computerized rate controllers regulate the aquatic herbicide applications through preset treatment rates. When the vessel speeds up and or slows down, the rate controllers adjust the herbicide application rate to match the preset rate in gallons of product per acre.

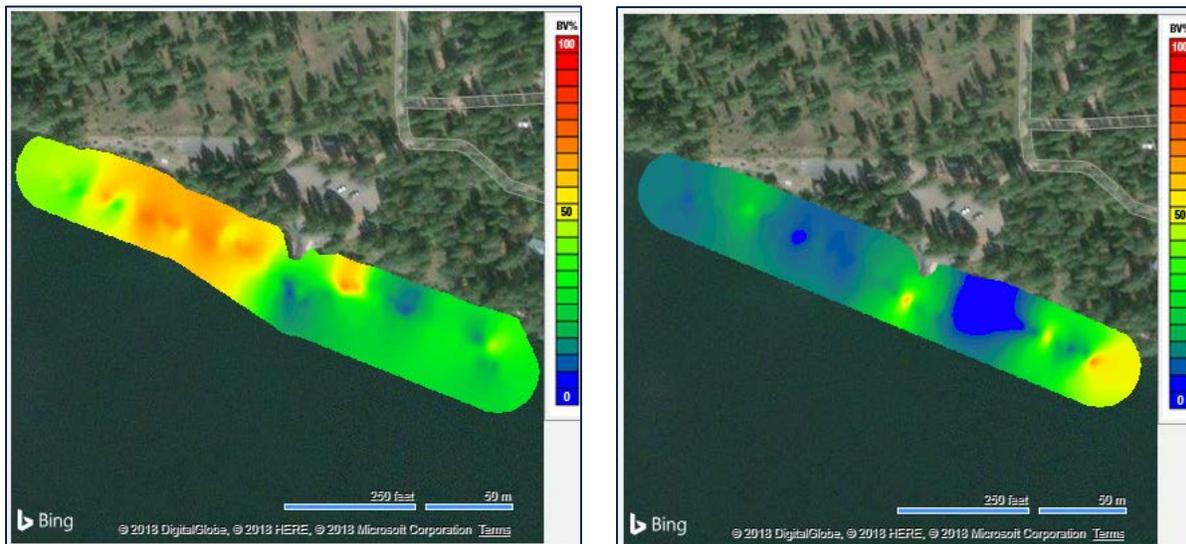
Plot Nox-03: At Time of Treatment (August 16, 2018 Left),  
~ Six (6) Weeks Post (September 27, 2018 Right)

2018 Noxon Rapids Reservoir AIS Treatment Plots: At Time of and ~ Six (6) Week Post Plot SAV % Cover and SAV BioVolume Data (Grid Data)									
Plot Number	SAV % Cover	SAV % Bio-Volume	Date Data Collected Pre Treatment	SAV % Cover	SAV % Bio-Volume	Date Data Collected- Post Treatment	SAV % BV Change	Post Treatment EWM Injury Rank	Herbicides Used (Aquathol K and or Tribune)
Nox-03	100.0	35.5	8/16/2018	94.1	19.1	9/27/2018	-46%	90% +/-	Endo/Diquat

**Observations/Notes Nox-03:** Treated with combination of endothall and diquat, control visually estimated at +/- 90%. Good control shallow and deep.

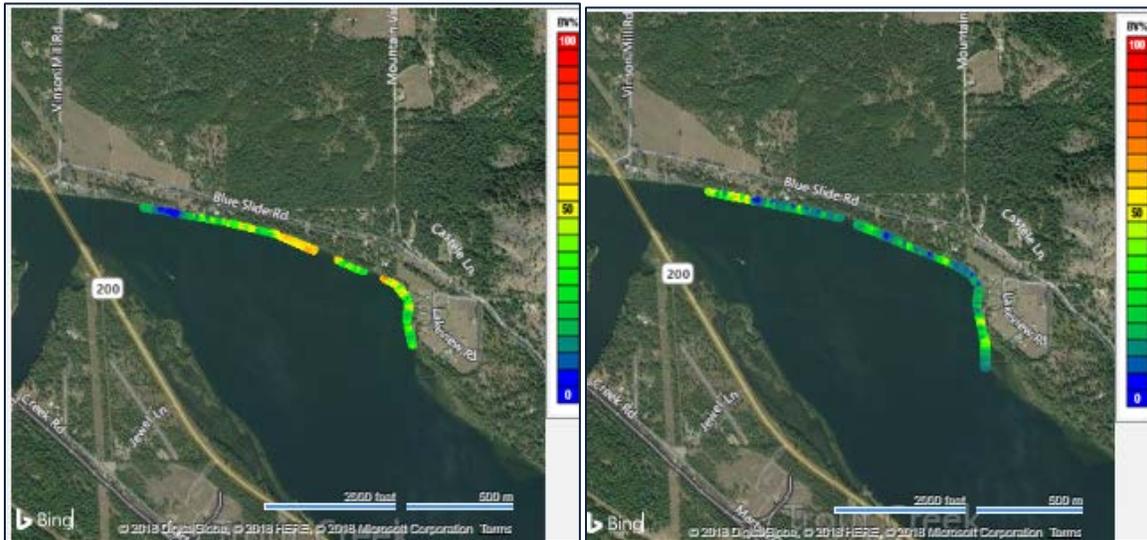
**Plot Nox-04: At Time of Treatment (August 16, 2018 Left),  
~ Six (6) Weeks Post (September 27, 2018 Right)**

2018 Noxon Rapids Reservoir AIS Treatment Plots: At Time of and ~ Six (6) Week Post Plot SAV % Cover and SAV BioVolume Data (Grid Data)									
Plot Number	SAV % Cover	SAV % Bio-Volume	Date Data Collected Pre Treatment	SAV % Cover	SAV % Bio-Volume	Date Data Collected-Post Treatment	SAV % BV Change	Post Treatment EWM Injury Rank	Herbicides Used (Aquathol K and or Tribune)
Nox-04	96.6	35.8	8/16/2018	97.6	18.5	9/27/2018	-48%	50% +/-	Endo/Diquat

**Observations/Notes Nox-04:** Treated with combination of endothall and diquat, control visually estimated at +/- 50%. Control variable, from 30% to 90%. Control appeared better in deep water. Elodea and Coontail present. 50% +/- control.

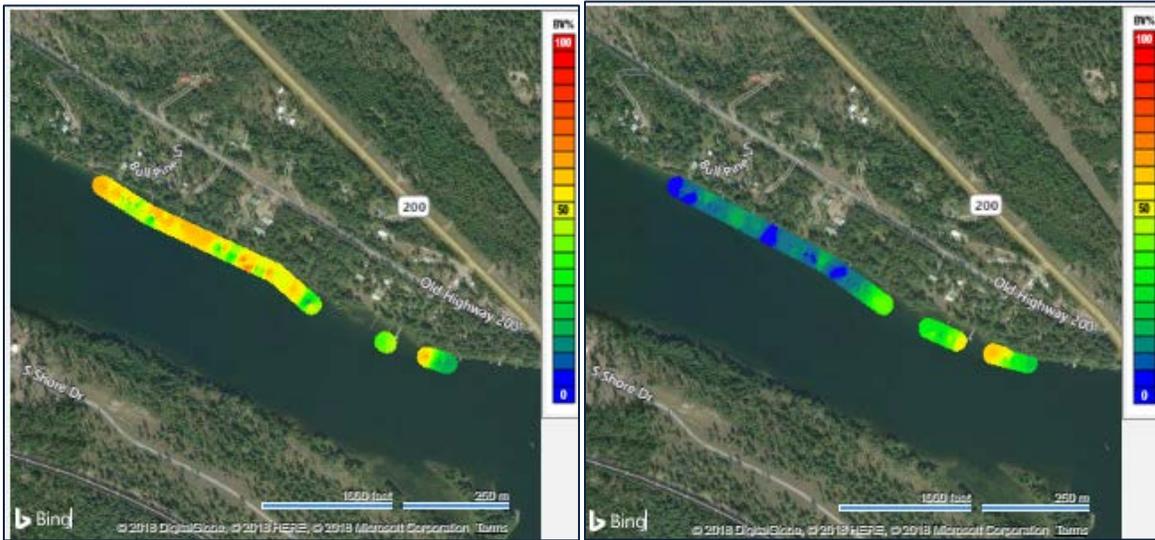
**Plot Nox-08: At Time of Treatment (August 16, 2018 Left),  
~ Six (6) Weeks Post (September 27, 2018 Right)**

2018 Noxon Rapids Reservoir AIS Treatment Plots: At Time of and ~ Six (6) Week Post Plot SAV % Cover and SAV BioVolume Data (Grid Data)									
Plot Number	SAV % Cover	SAV % Bio-Volume	Date Data Collected Pre Treatment	SAV % Cover	SAV % Bio-Volume	Date Data Collected- Post Treatment	SAV % BV Change	Post Treatment EWM Injury Rank	Herbicides Used (Aquathol K and or Tribune)
Nox-08	100.0	45.3	8/16/2018	87.2	23.1	9/27/2018	-49%	60% +/-	Endo/Diquat

**Observations/Notes Nox-08:** Treated with combination of endothall and diquat, control visually estimated at +/- 60%. Control variable, from 30% to 90%. Better control in deep water. Downstream part of plot looks better than upstream part.

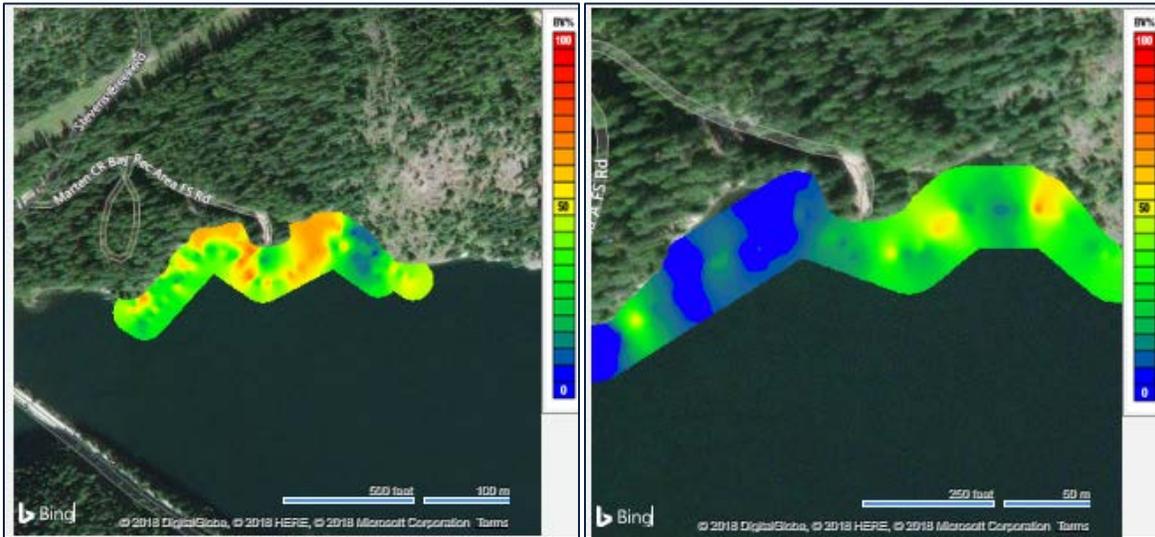
**Plot Nox-31: At Time of Treatment (August 16, 2018 Left),  
~ Six (6) Weeks Post (September 27, 2018 Right)**

2018 Noxon Rapids Reservoir AIS Treatment Plots: At Time of and ~ Six (6) Week Post Plot SAV % Cover and SAV BioVolume Data (Grid Data)									
Plot Number	SAV % Cover	SAV % Bio-Volume	Date Data Collected Pre Treatment	SAV % Cover	SAV % Bio-Volume	Date Data Collected-Post Treatment	SAV % BV Change	Post Treatment EWM Injury Rank	Herbicides Used (Aquathol K and or Tribune)
Nox-31	99.9	39.4	8/16/2018	75.1	21.7	9/27/2018	-45%	70% +/-	Endo/Diquat

**Observations/Notes Nox-31:** Treated with combination of endothall and diquat, control visually estimated at +/- 60%. Control variable, from 50% to 90%. Very good control deep, patchy control near shore. Elodea dominating the plot.

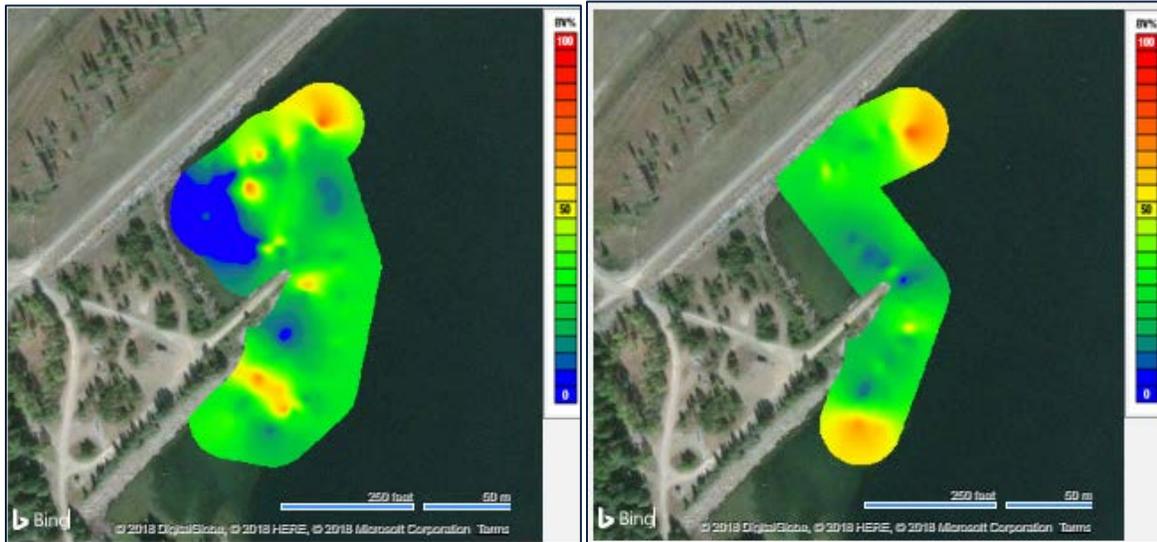
**Plot Nox-52: At Time of Treatment (August 16, 2018 Left),  
~ Six (6) Weeks Post (September 27, 2018 Right)**

2018 Noxon Rapids Reservoir AIS Treatment Plots: At Time of and ~ Six (6) Week Post Plot SAV % Cover and SAV BioVolume Data (Grid Data)									
Plot Number	SAV % Cover	SAV % Bio-Volume	Date Data Collected Pre Treatment	SAV % Cover	SAV % Bio-Volume	Date Data Collected-Post Treatment	SAV % BV Change	Post Treatment EWM Injury Rank	Herbicides Used (Aquathol K and or Tribune)
Nox-52	92.3	27.4	8/16/2018	100.0	32.8	9/27/2018	20%	90% +/-	Endo/Diquat

**Observations/Notes Nox-52:** Treated with combination of endothall and diquat, control visually estimated at +/- 90%. Control looks better deep, some bruised EWM in shallow. Looks very good.

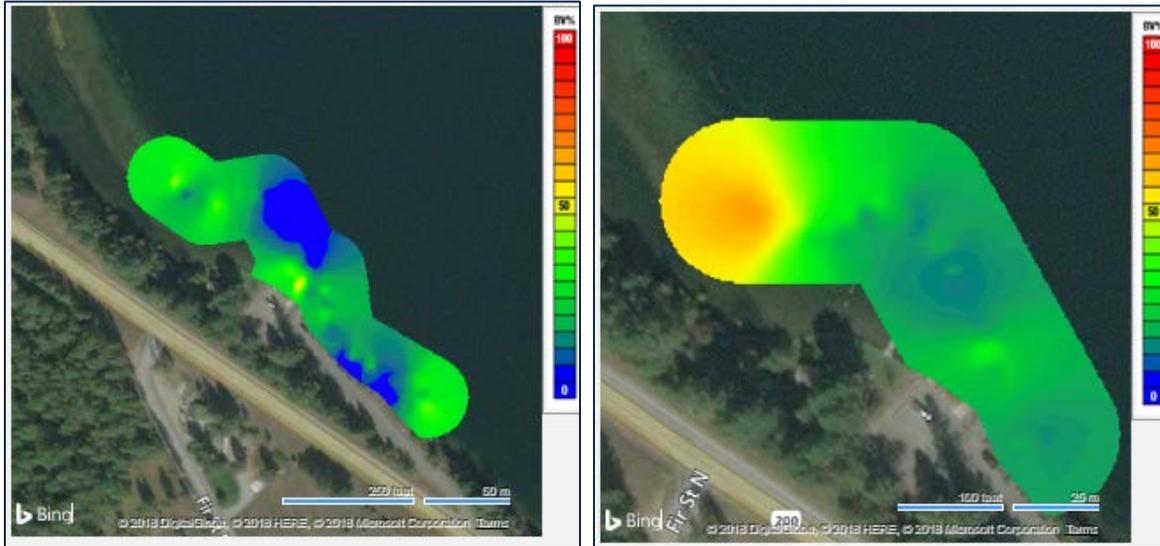
**Plot Nox-77: At Time of Treatment (August 16, 2018 Left),  
~ Six (6) Weeks Post (September 27, 2018 Right)**

2018 Noxon Rapids Reservoir AIS Treatment Plots: At Time of and ~ Six (6) Week Post Plot SAV % Cover and SAV BioVolume Data (Grid Data)									
Plot Number	SAV % Cover	SAV % Bio-Volume	Date Data Collected Pre Treatment	SAV % Cover	SAV % Bio-Volume	Date Data Collected- Post Treatment	SAV % BV Change	Post Treatment EWM Injury Rank	Herbicides Used (Aquathol K and or Tribune)
Nox-77	100.0	28.6	8/16/2018	100.0	28.6	9/27/2018	0%	95% +/-	Diquat

**Observations/Notes Nox-77:** Treated with diquat only, control visually estimated at +/- 95%. No EWM visible in plot. Some present immediately outside the plot. Elodea visible on bottom.

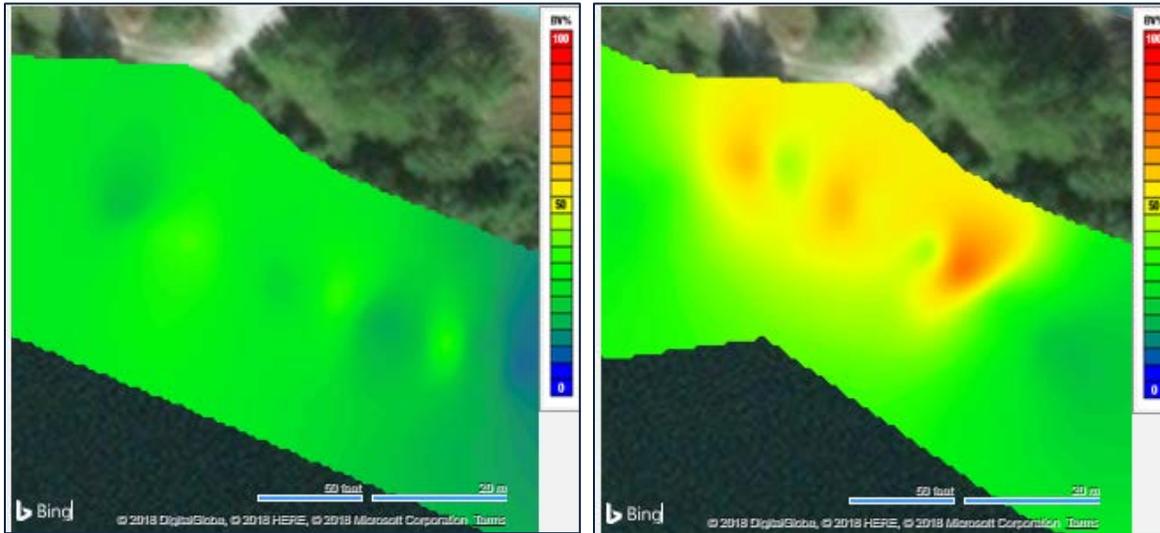
**Plot Nox-78: At Time of Treatment (August 16, 2018 Left),  
~ Six (6) Weeks Post (September 27, 2018 Right)**

2018 Noxon Rapids Reservoir AIS Treatment Plots: At Time of and ~ Six (6) Week Post Plot SAV % Cover and SAV BioVolume Data (Grid Data)									
Plot Number	SAV % Cover	SAV % Bio-Volume	Date Data Collected Pre Treatment	SAV % Cover	SAV % Bio-Volume	Date Data Collected- Post Treatment	SAV % BV Change	Post Treatment EWM Injury Rank	Herbicides Used (Aquathol K and or Tribune)
Nox-78	100.0	32.3	8/16/2018	100.0	32.3	9/27/2018	0%	50% +/-	Diquat

**Observations/Notes Nox-78:** Treated with diquat only, control visually estimated at +/- 50%. Elodea abundant, EWM present upstream as strip.

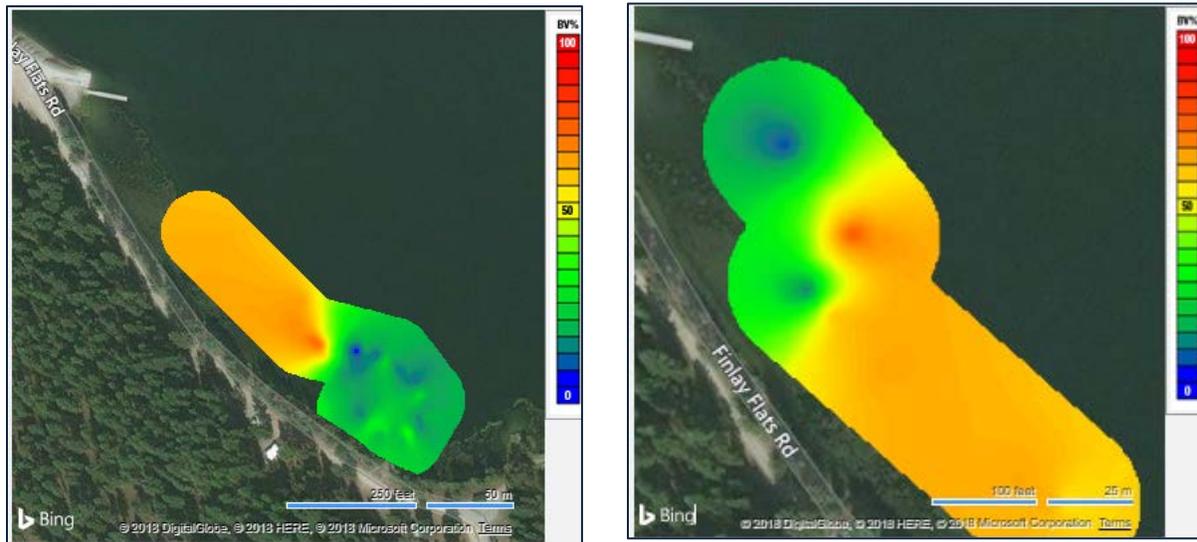
**Plot Nox-79: At Time of Treatment (August 16, 2018 Left),  
~ Six (6) Weeks Post (September 27, 2018 Right)**

2018 Noxon Rapids Reservoir AIS Treatment Plots: At Time of and ~ Six (6) Week Post Plot SAV % Cover and SAV BioVolume Data (Grid Data)									
Plot Number	SAV % Cover	SAV % Bio-Volume	Date Data Collected Pre Treatment	SAV % Cover	SAV % Bio-Volume	Date Data Collected- Post Treatment	SAV % BV Change	Post Treatment EWM Injury Rank	Herbicides Used (Aquathol K and or Tribune)
Nox-79	99.9	39.0	8/16/2018	100.0	44.9	9/27/2018	15%	85% +/-	Endo/Diquat

**Observations/Notes Nox-79:** Treated with combination of endothall and diquat, control visually estimated at +/- 85%. Control looks good, dead EWM visible as well as some live. Dominated by Elodea and Coontail.

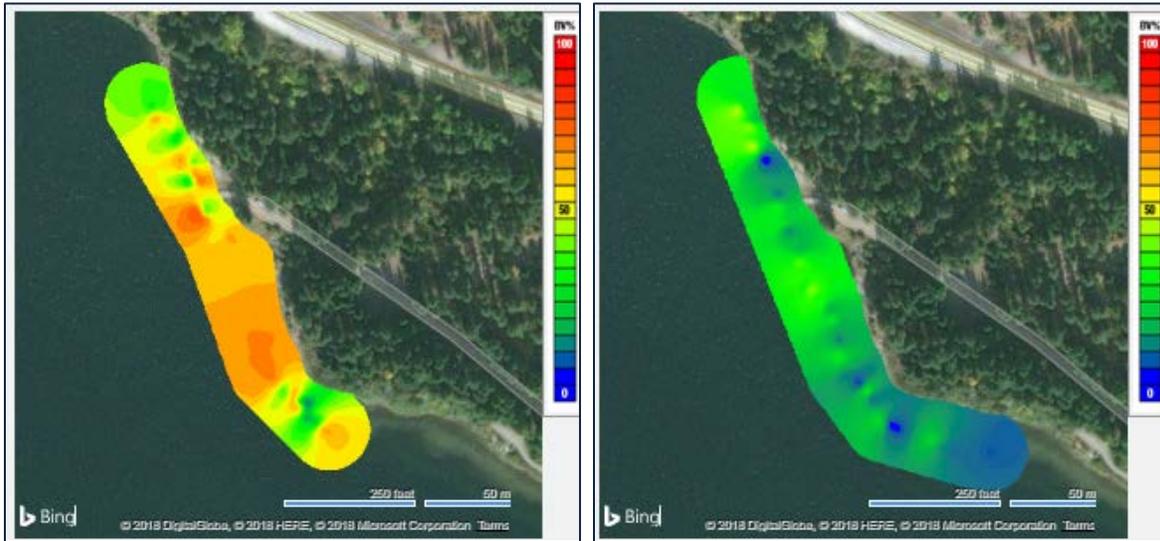
Plot Cab-12: At Time of Treatment (August 16, 2018 Left), ~ Six (6) Weeks Post (September 27, 2018 Right)

2018 Cabinet Gorge Reservoir AIS Treatment Plots: At Time of and ~ Six (6) Week Post Plot SAV % Cover and SAV BioVolume Data (Grid Data)									
Plot Number	SAV % Cover	SAV % Bio-Volume	Date Data Collected Pre Treatment	SAV % Cover	SAV % Bio-Volume	Date Data Collected-Post Treatment	SAV % BV Change	Post Treatment EWM Injury Rank	Herbicides Used (Aquathol K and or Tribune)
Cab-12	100.0	50.6	8/16/2018	99.6	19.2	9/27/2018	-62%	95% +/-	Endo/Diquat

**Observations/Notes Cab-12:** Treated with combination of endothall and diquat, control visually estimated at +/- 95%. Control looks very good.

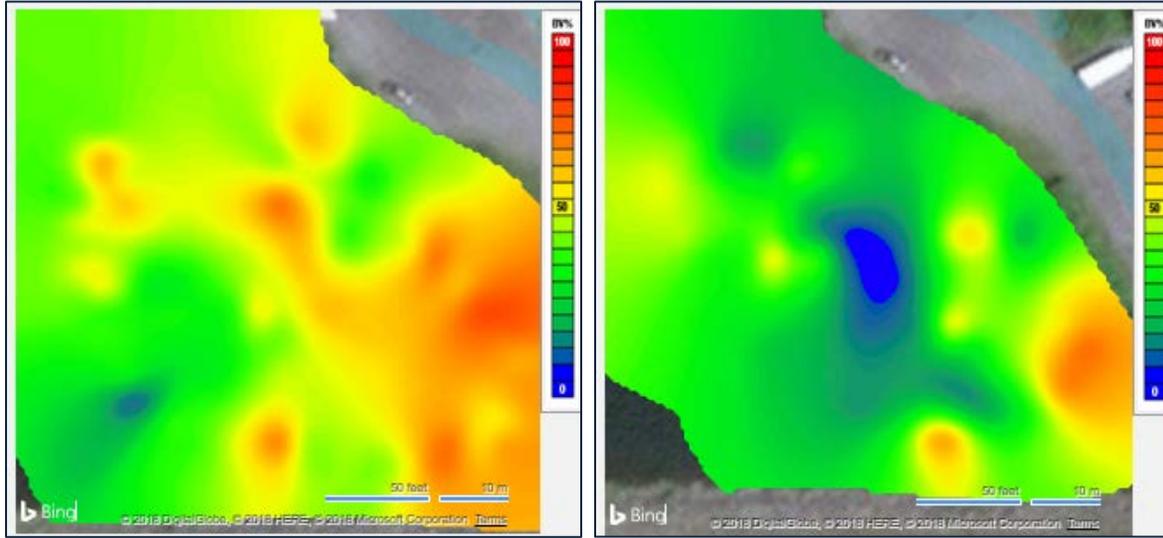
**Plot Cab-20: At Time of Treatment (August 16, 2018 Left),  
~ Six (6) Weeks Post (September 27, 2018 Right)**

2018 Cabinet Gorge Reservoir AIS Treatment Plots: At Time of and ~ Six (6) Week Post Plot SAV % Cover and SAV BioVolume Data (Grid Data)									
Plot Number	SAV % Cover	SAV % Bio-Volume	Date Data Collected Pre Treatment	SAV % Cover	SAV % Bio-Volume	Date Data Collected-Post Treatment	SAV % BV Change	Post Treatment EWM Injury Rank	Herbicides Used (Aquathol K and or Tribune)
Cab-20	100.0	43.6	8/16/2018	99.2	33.1	9/27/2018	-24%	95% +/-	Diquat

**Observations/Notes Cab-20:** Treated with diquat only, control visually estimated at +/- 95%. No EWM observed in plot.

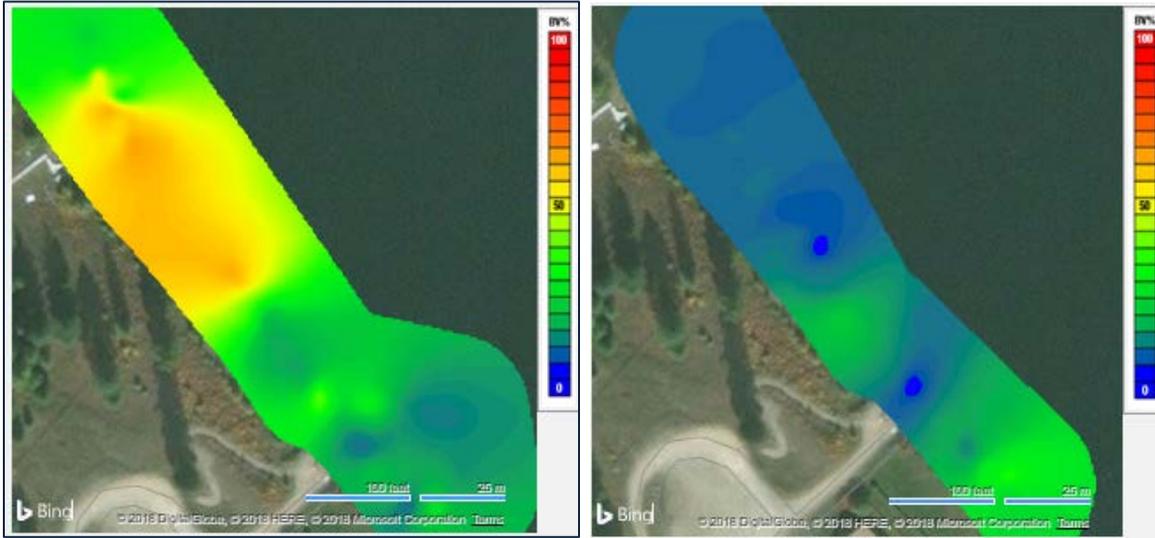
**Plot Cab-29: At Time of Treatment (August 16, 2018 Left),  
~ Six (6) Weeks Post (September 27, 2018 Right)**

2018 Cabinet Gorge Reservoir AIS Treatment Plots: At Time of and ~ Six (6) Week Post Plot SAV % Cover and SAV BioVolume Data (Grid Data)									
Plot Number	SAV % Cover	SAV % Bio-Volume	Date Data Collected Pre Treatment	SAV % Cover	SAV % Bio-Volume	Date Data Collected-Post Treatment	SAV % BV Change	Post Treatment EWM Injury Rank	Herbicides Used (Aquathol K and or Tribune)
Cab-29	100.0	27.7	8/16/2018	98.2	11.3	9/27/2018	-59%	95% +/-	Endo/Diquat

**Observations/Notes Cab-29:** Treated with combination of endothall and diquat, control visually estimated at +/- 95%. No submersed aquatic vegetation visible.

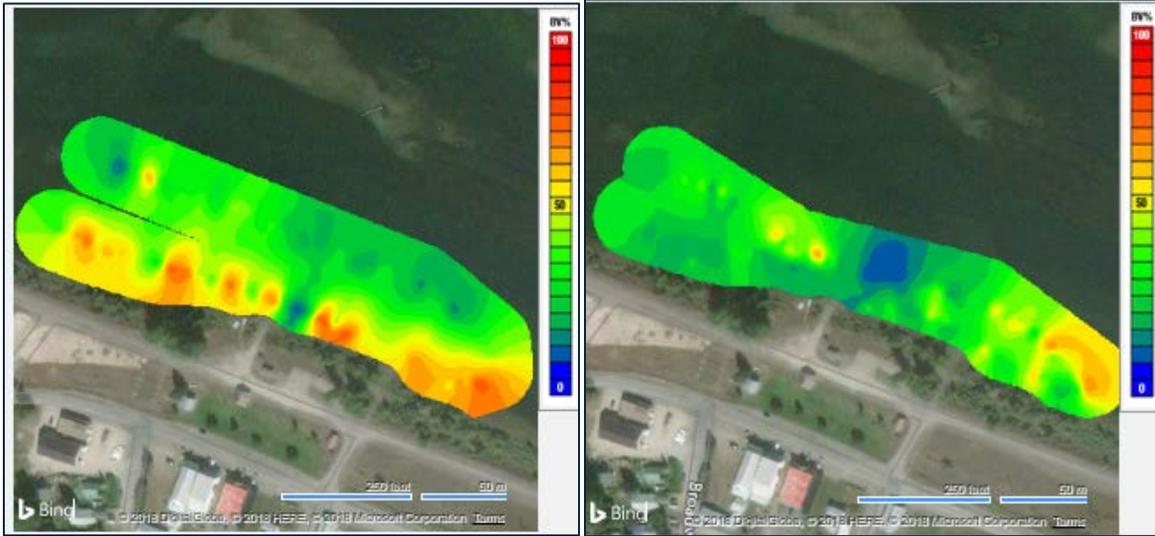
**Plot Cab-30: At Time of Treatment (August 16, 2018 Left),  
~ Six (6) Weeks Post (September 27, 2018 Right)**

2018 Cabinet Gorge Reservoir AIS Treatment Plots: At Time of and ~ Six (6) Week Post Plot SAV % Cover and SAV BioVolume Data (Grid Data)									
Plot Number	SAV % Cover	SAV % Bio-Volume	Date Data Collected Pre Treatment	SAV % Cover	SAV % Bio-Volume	Date Data Collected-Post Treatment	SAV % BV Change	Post Treatment EWM Injury Rank	Herbicides Used (Aquathol K and or Tribune)
Cab-30	100.0	33.2	8/16/2018	98.5	26.7	9/27/2018	-20%	95% +/-	Endo/Diquat

**Observations/Notes Cab-30:** Treated with combination of endothall and diquat, control visually estimated at +/- 95%. No EWM visible.
