Noxon Rapids Reservoir and Cabinet Gorge Reservoir Herbicide Treatment Survey Report

2019 Season

Prepared for: The Sanders County Aquatic Invasive Plants Task Force

Craig R McLane

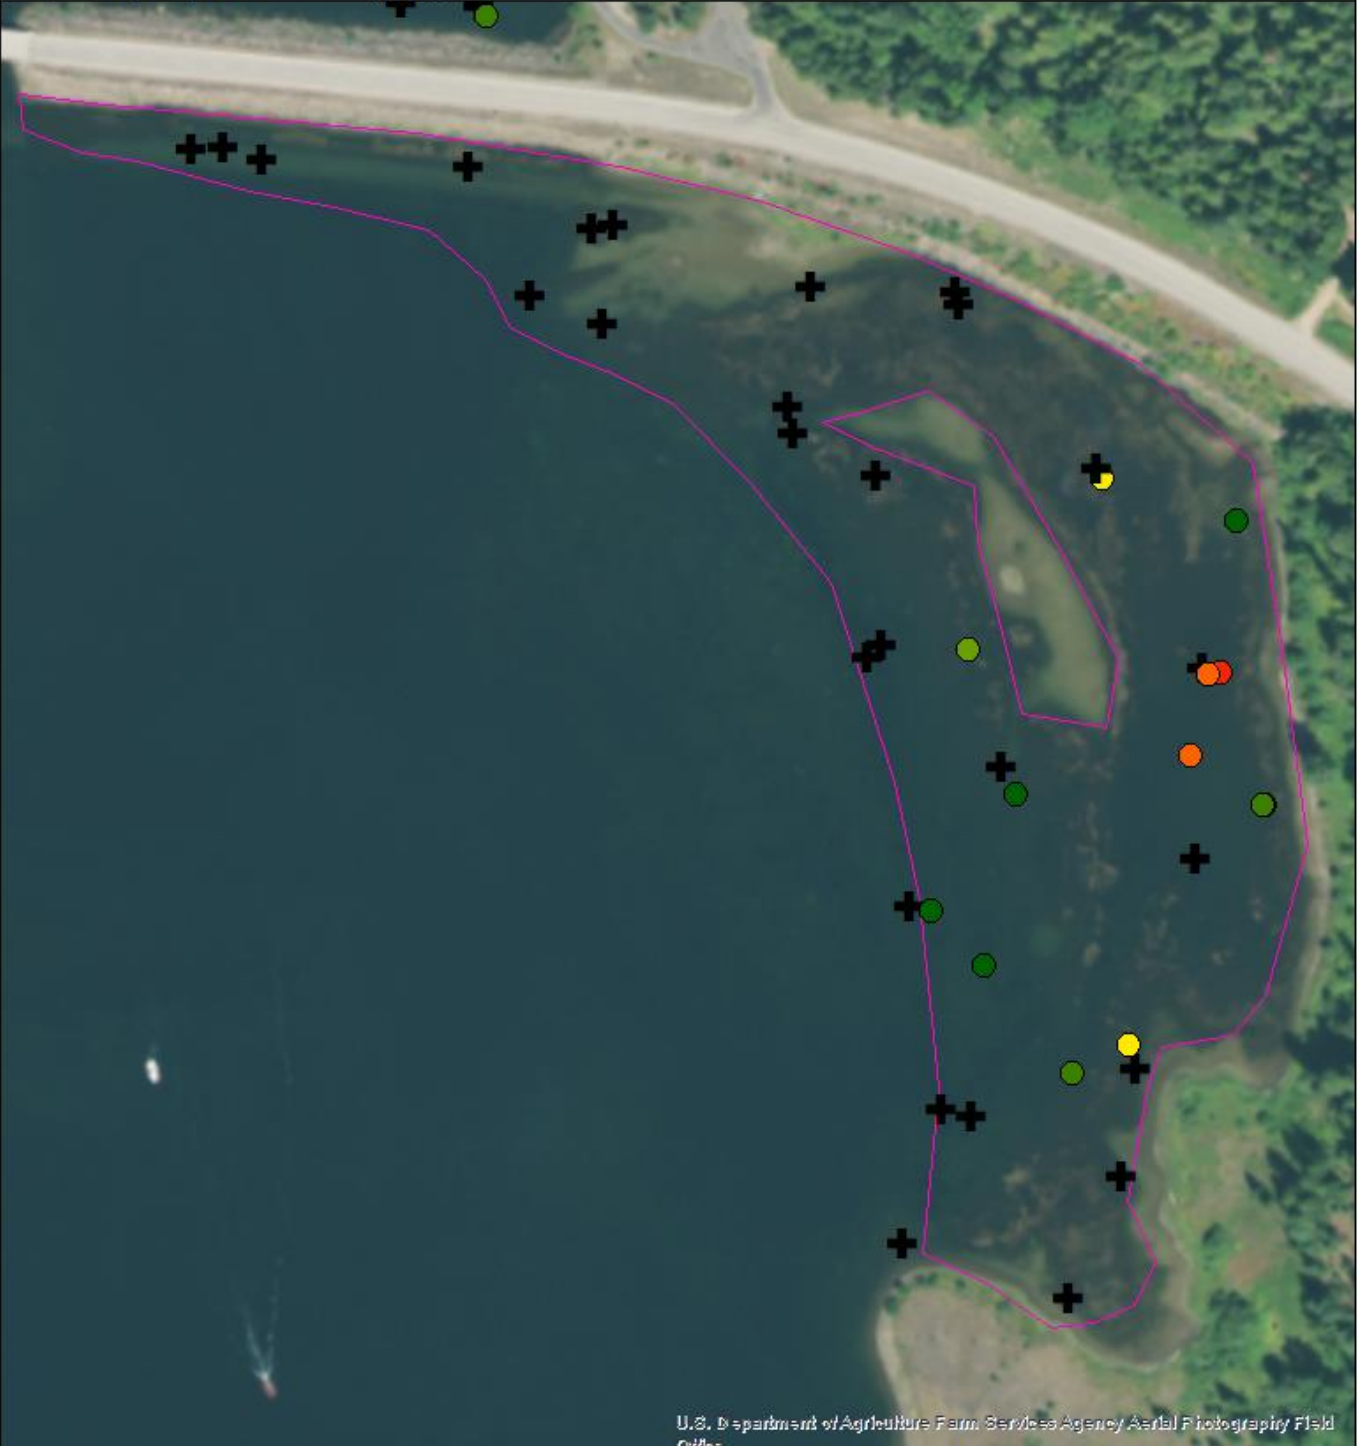
Plot: Cab-05

Cab 05 – Scattered EWM at fairly low levels; curlyleaf in dense patches east of sandbar

Sample Results for Curlyleaf Pondweed Rank - (Percent Rake Fulness Range)

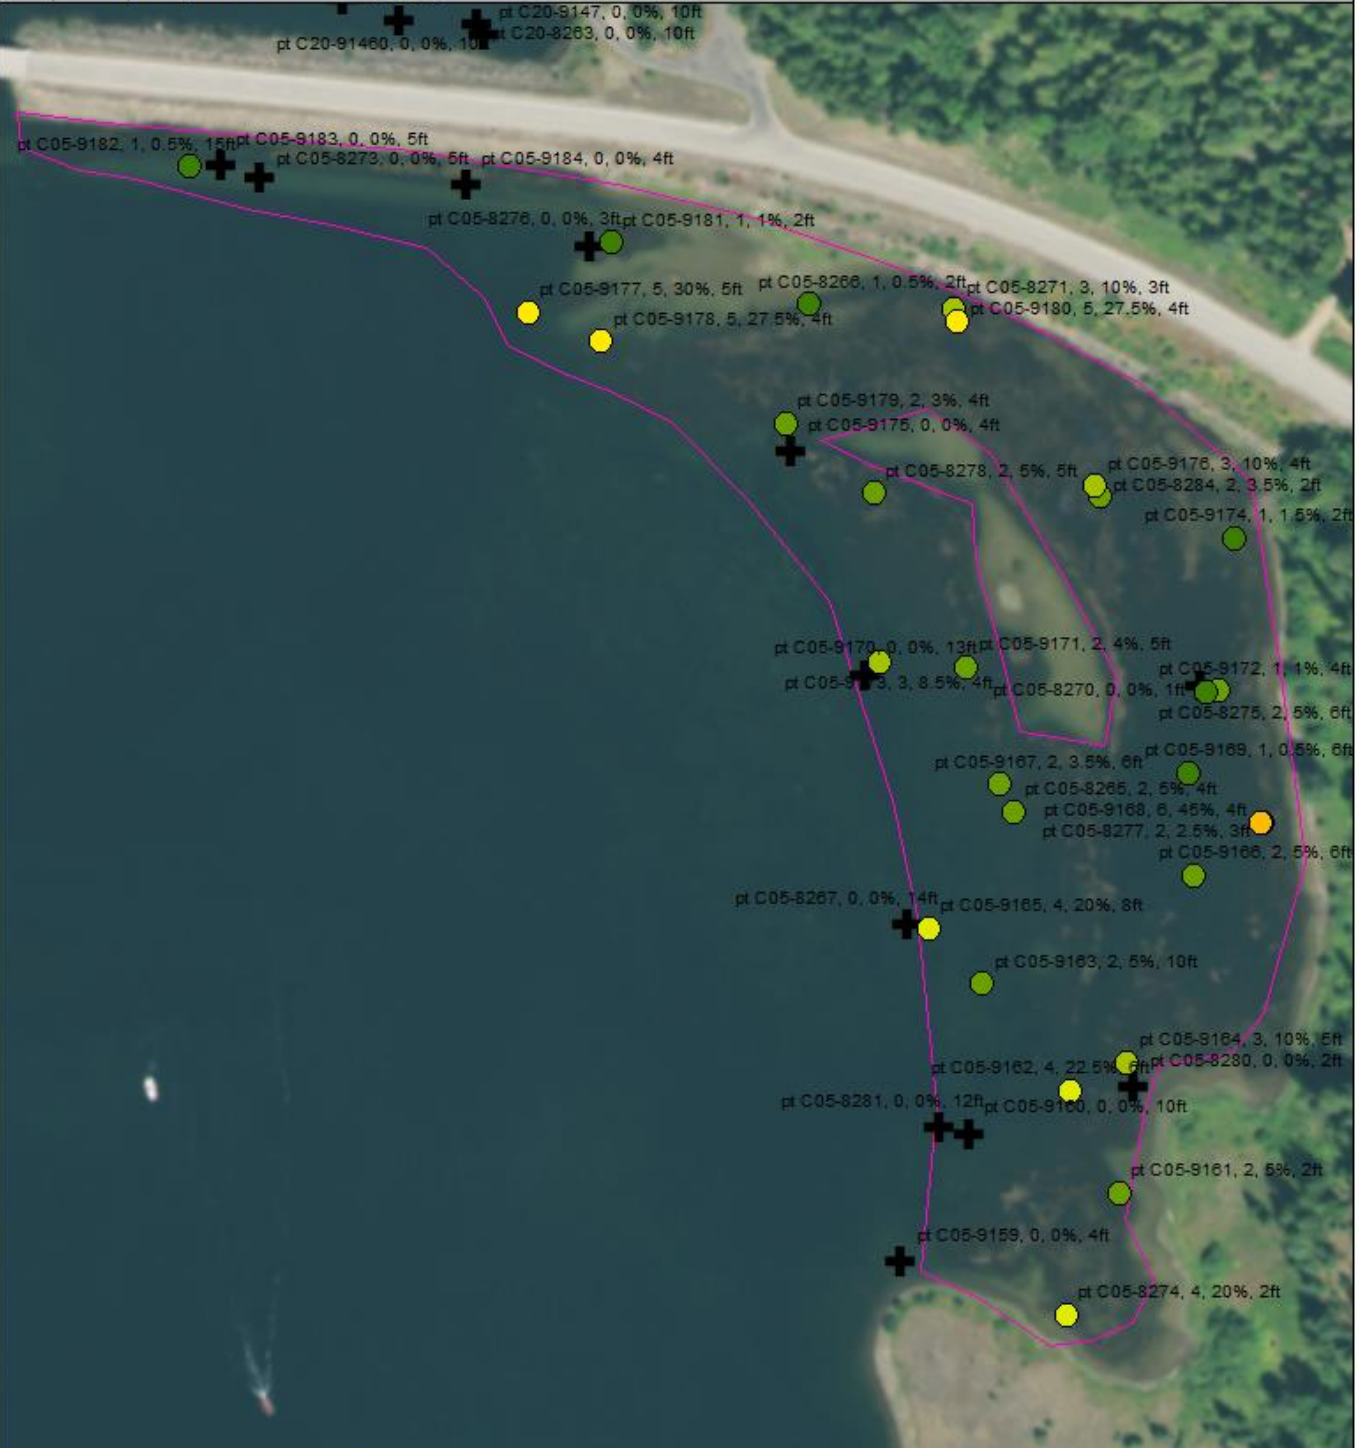
Plot: Cab-05

Sample Results for Eurasian watermilfoil Rank - (Percent Rake Fulness Range)

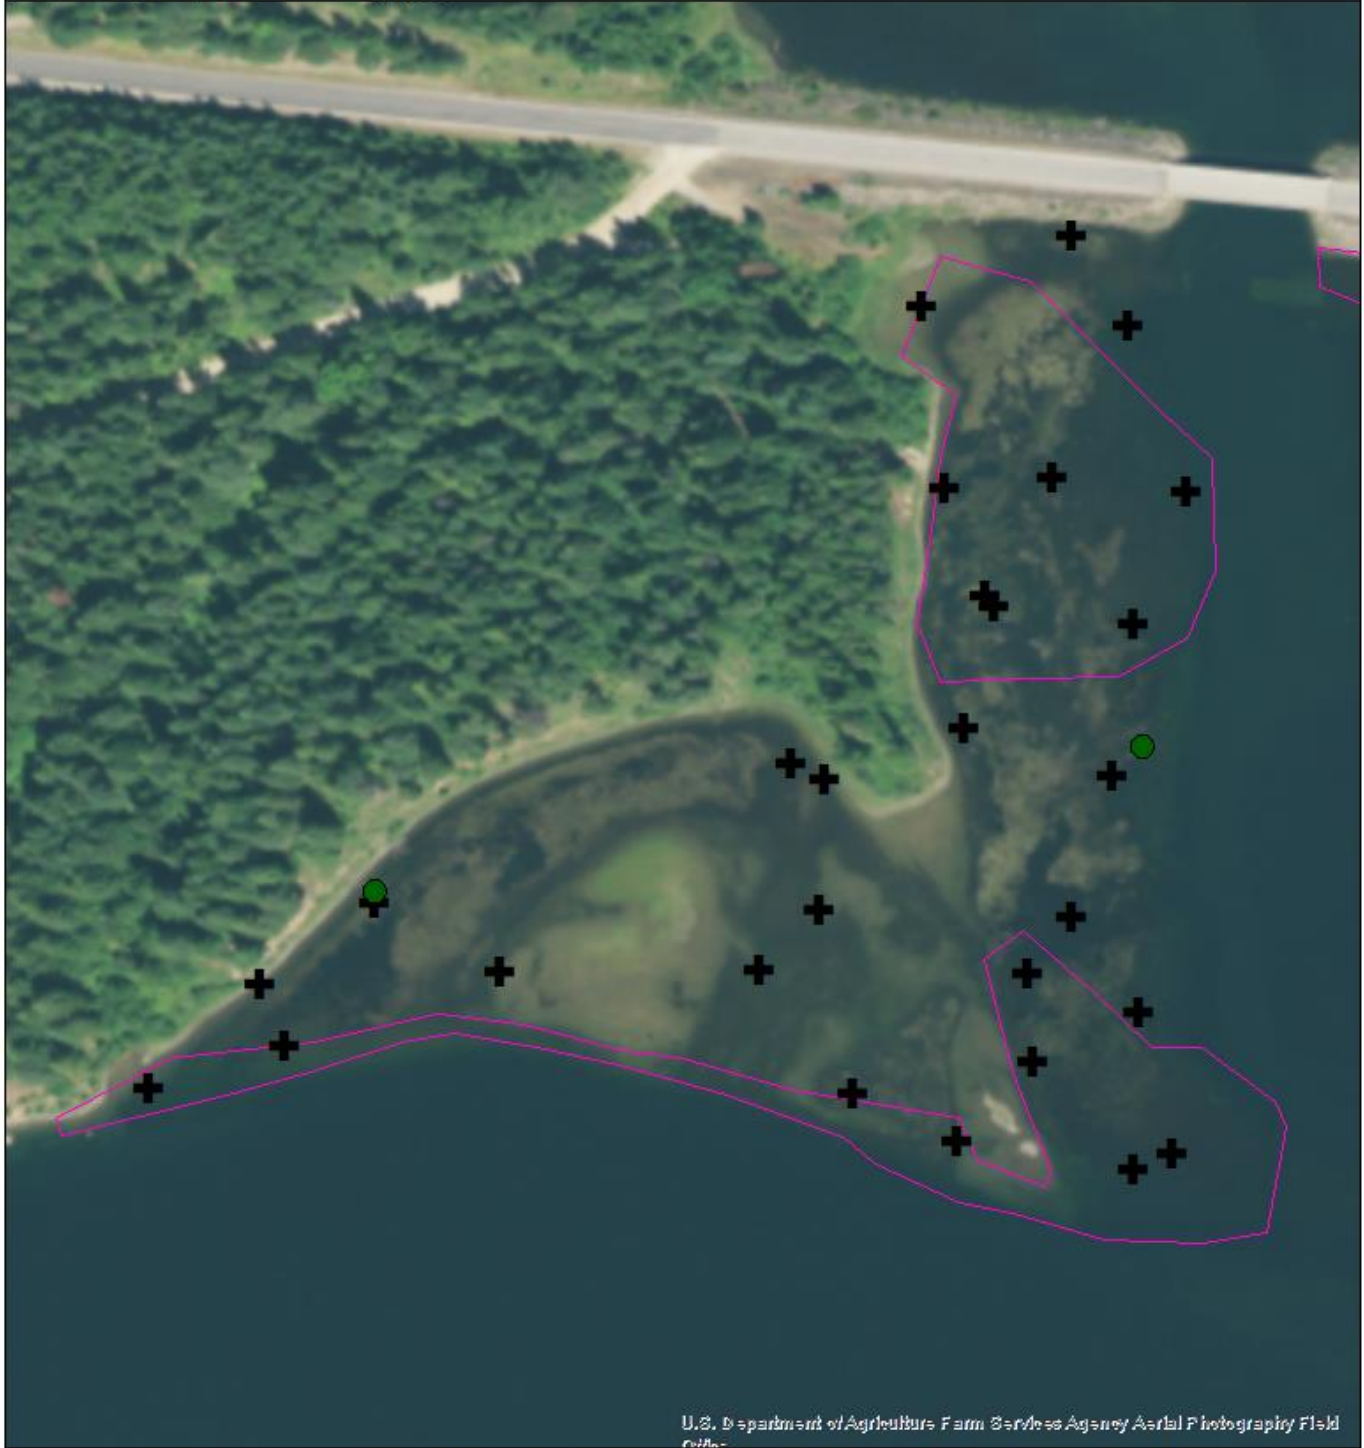
Plot: Cab-06

Cab 06 – 2 smaller patches of EWM with low- medium densities; little curlyleaf pondweed. Recommend not to treat.

Sample Results for Curlyleaf Pondweed Rank - (Percent Rake Fulness Range)

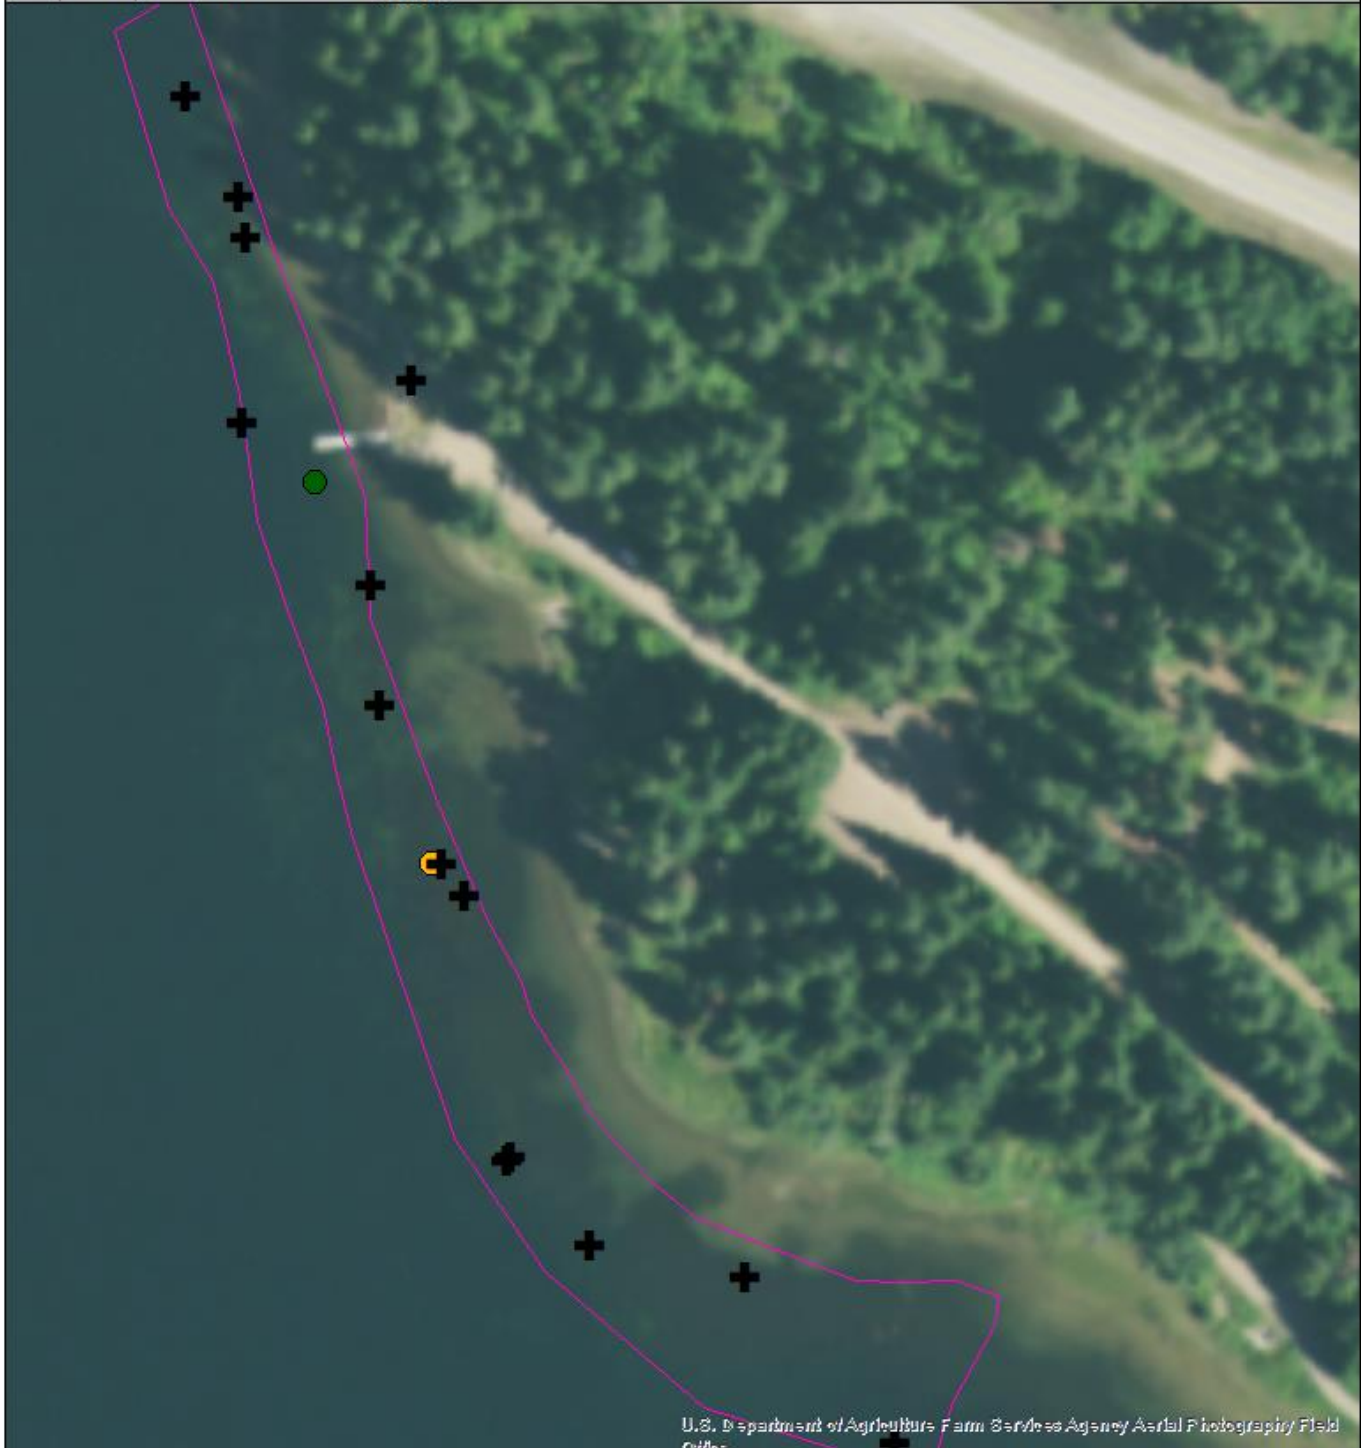
Plot: Cab-12

Cab 12 - Main patch on southern end; sporadic band of EWM in 5'-8' range along shore; very little curlyleaf pondweed

Sample Results for Curlyleaf Pondweed Rank - (Percent Rake Fulness Range)

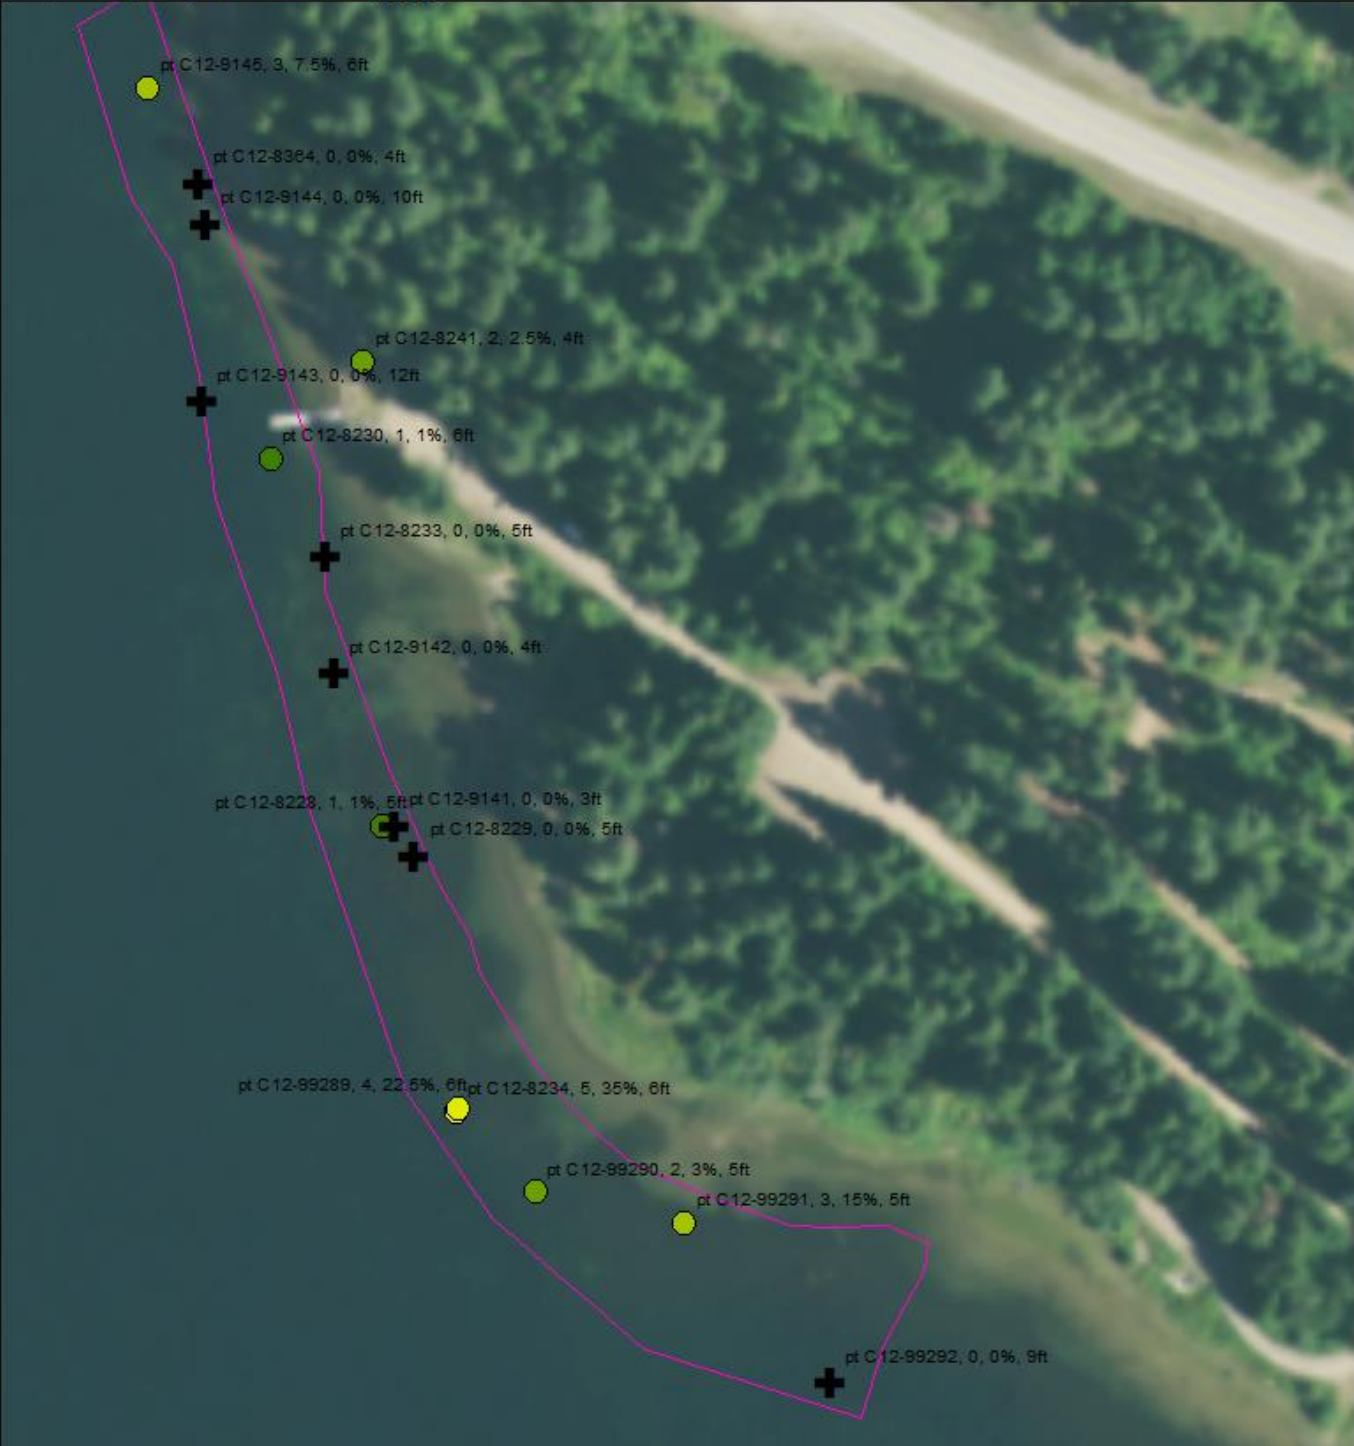
Plot: Cab-12

Sample Results for Eurasian watermilfoil Rank - (Percent Rake Fulness Range)

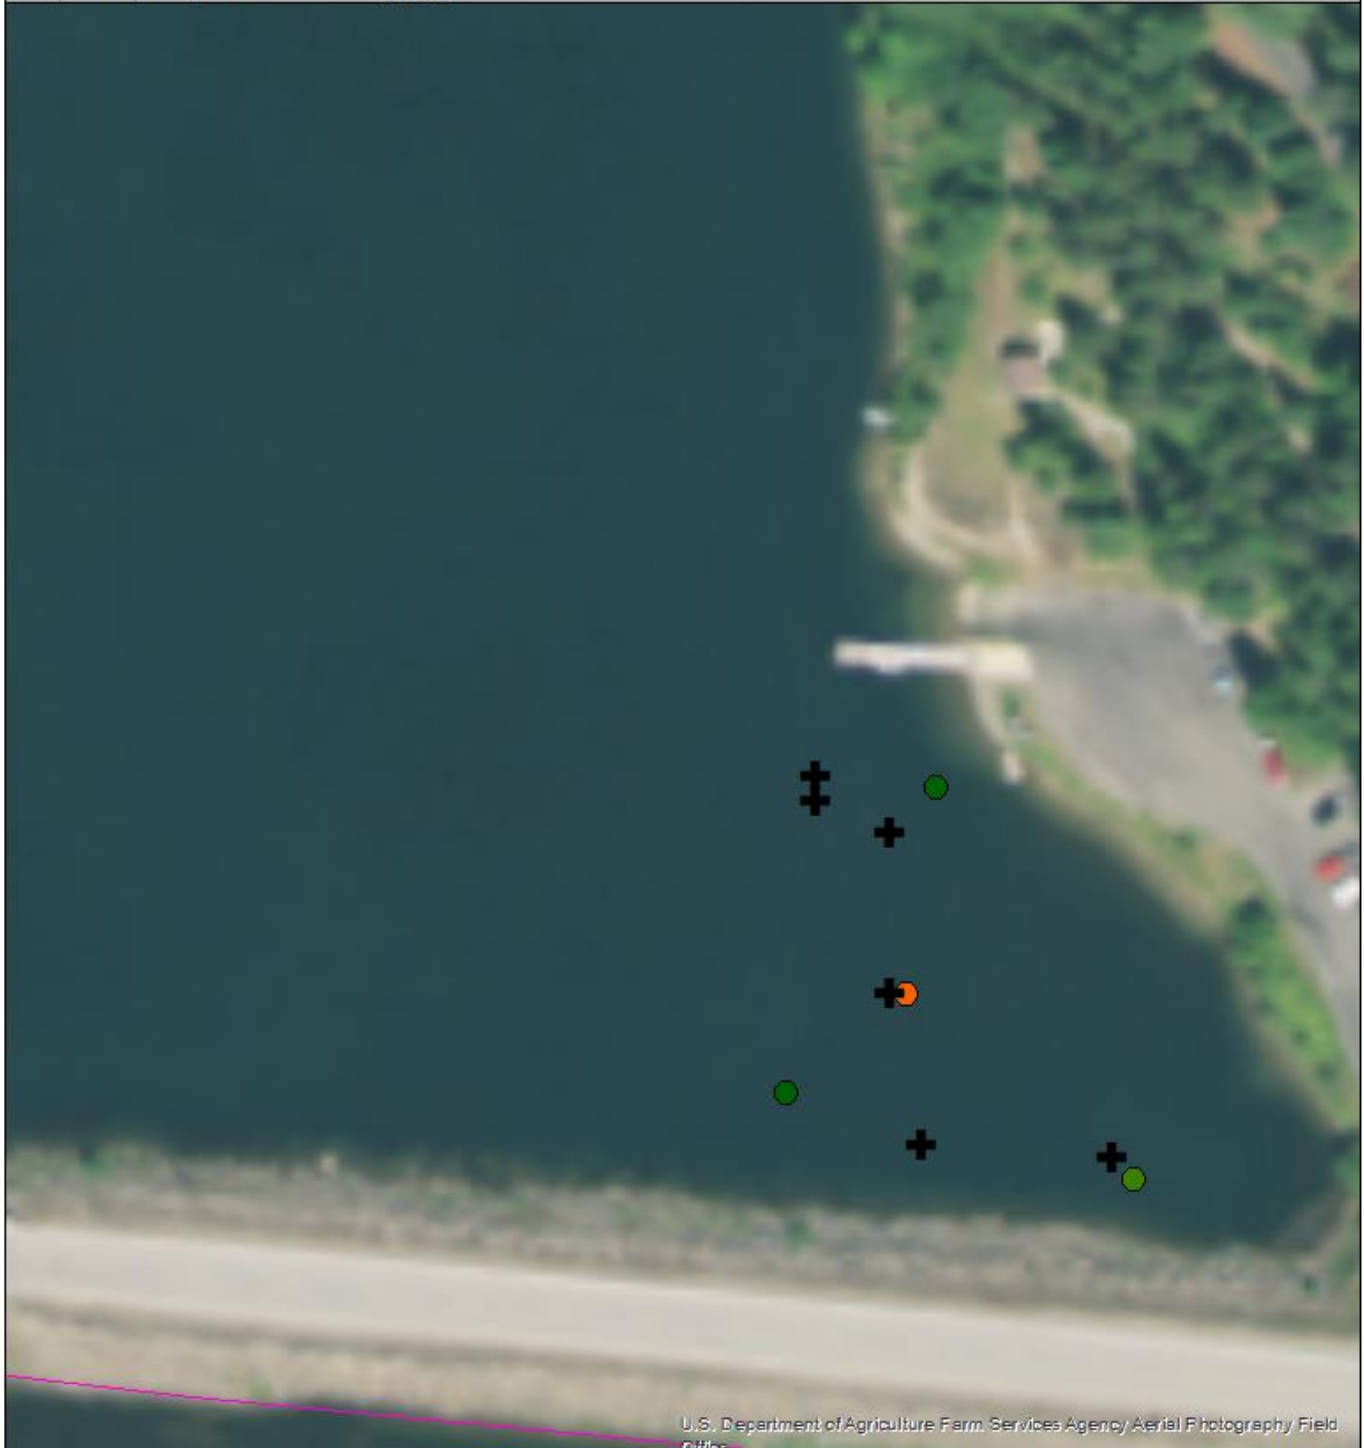
Plot: Cab-20

Cab 20 – No EWM found; one point of curlyleaf found. Recommend not to treat

Sample Results for Curlyleaf Pondweed Rank - (Percent Rake Fulness Range)

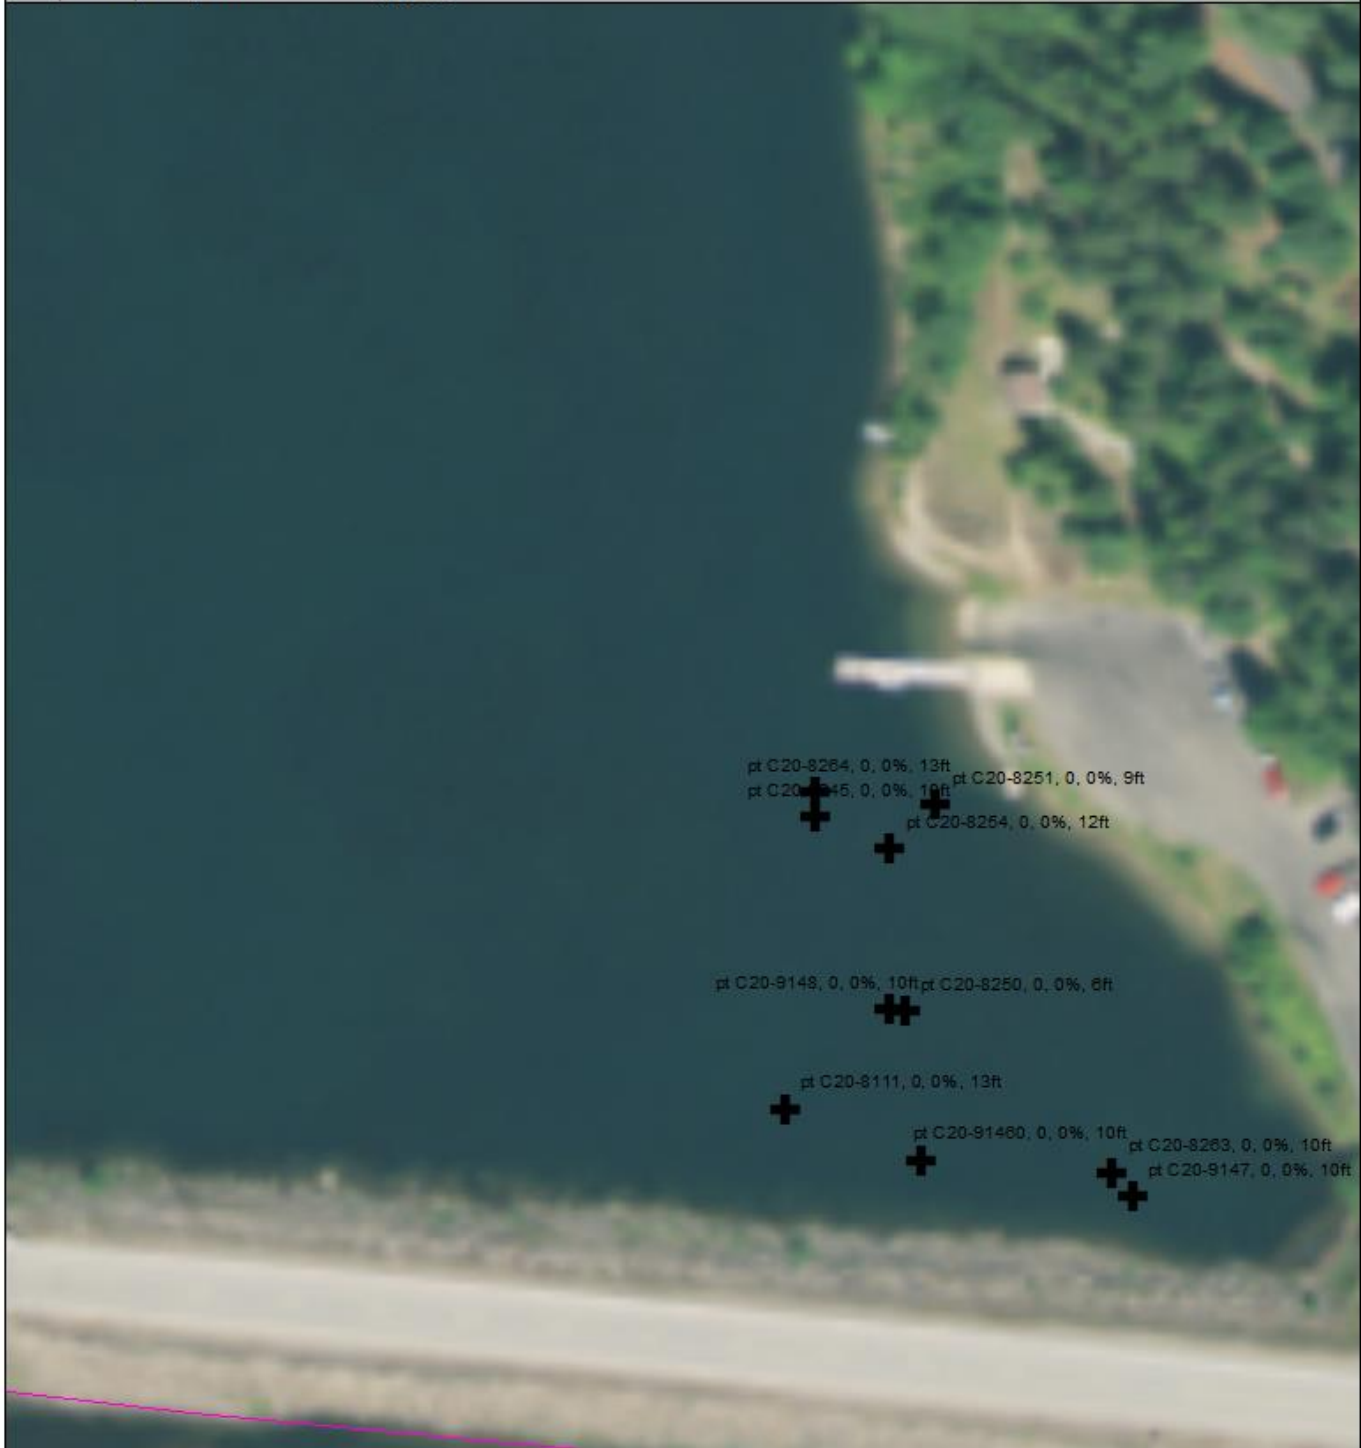
Plot: Cab-20

Sample Results for Eurasian watermilfoil Rank - (Percent Rake Fulness Range)

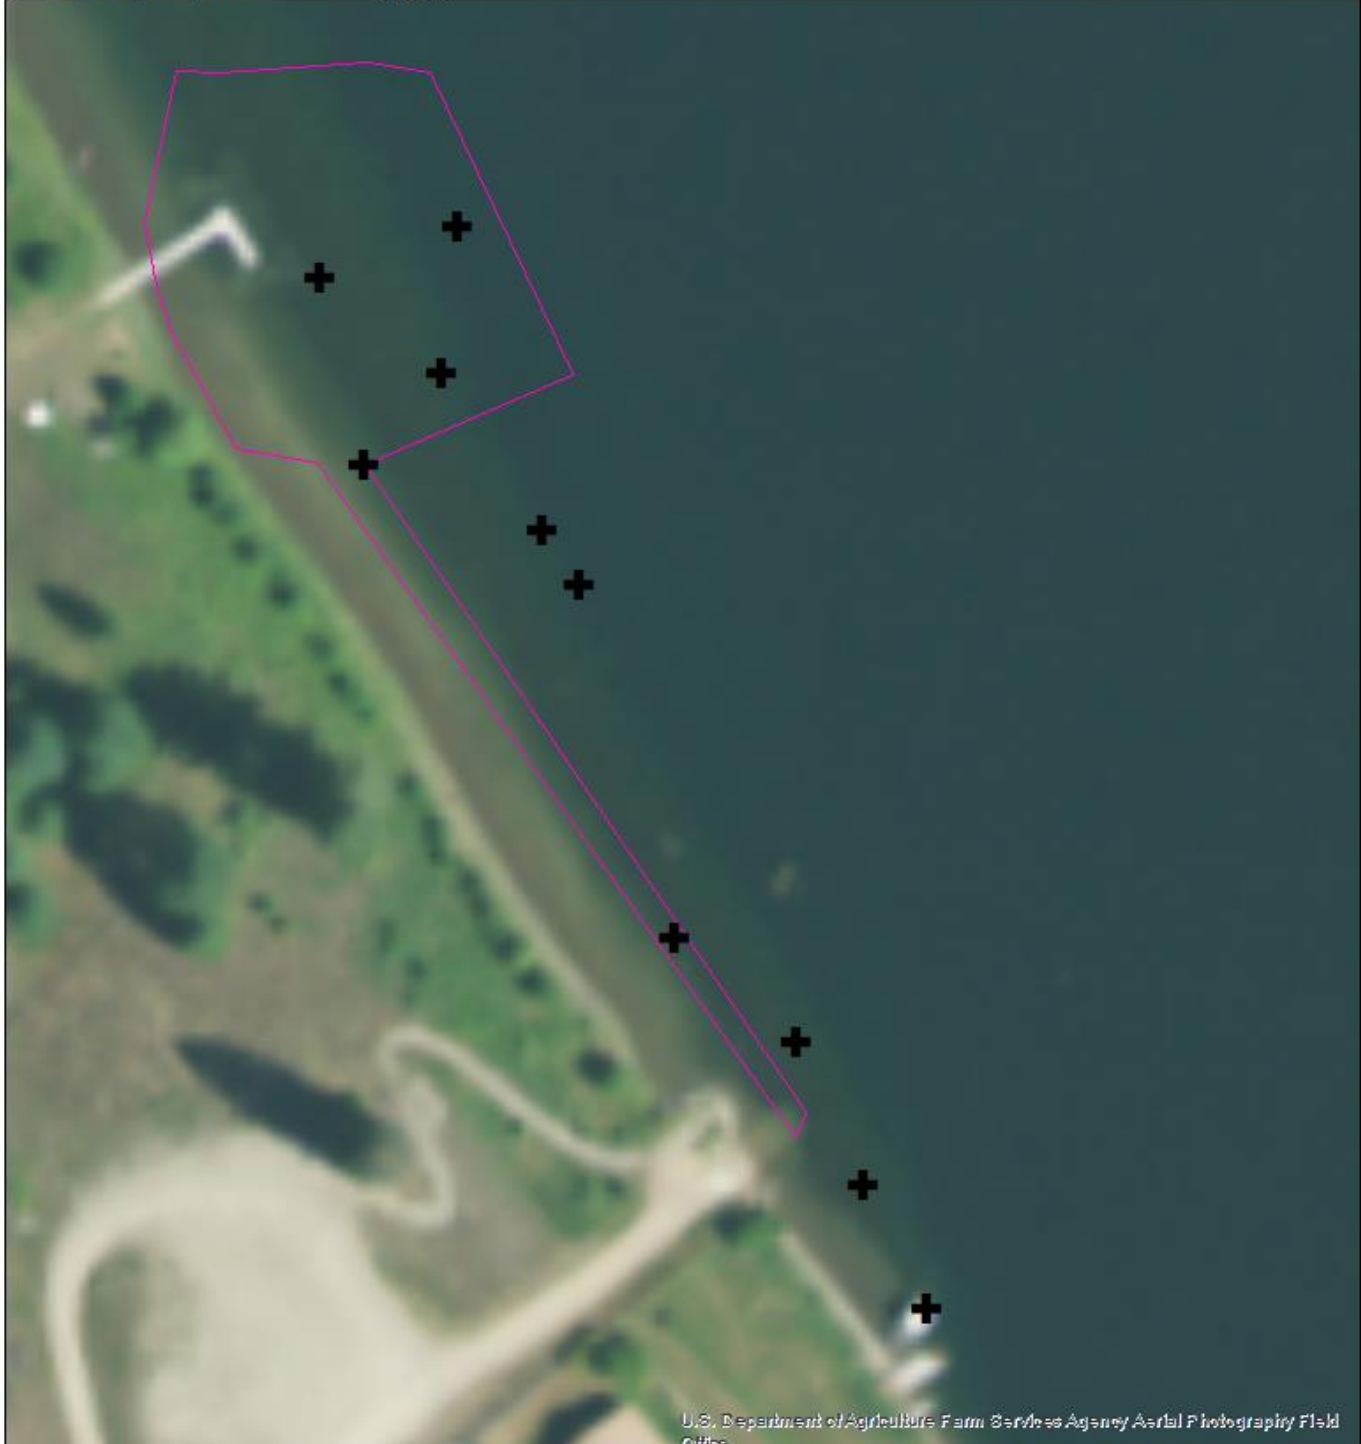
Plot: Cab-29

Cab 29 – Mainly elodea plants with scattered EWM with a narrow band along shoreline; no curlyleaf pondweed

Sample Results for Curlyleaf Pondweed Rank - (Percent Rake Fulness Range)

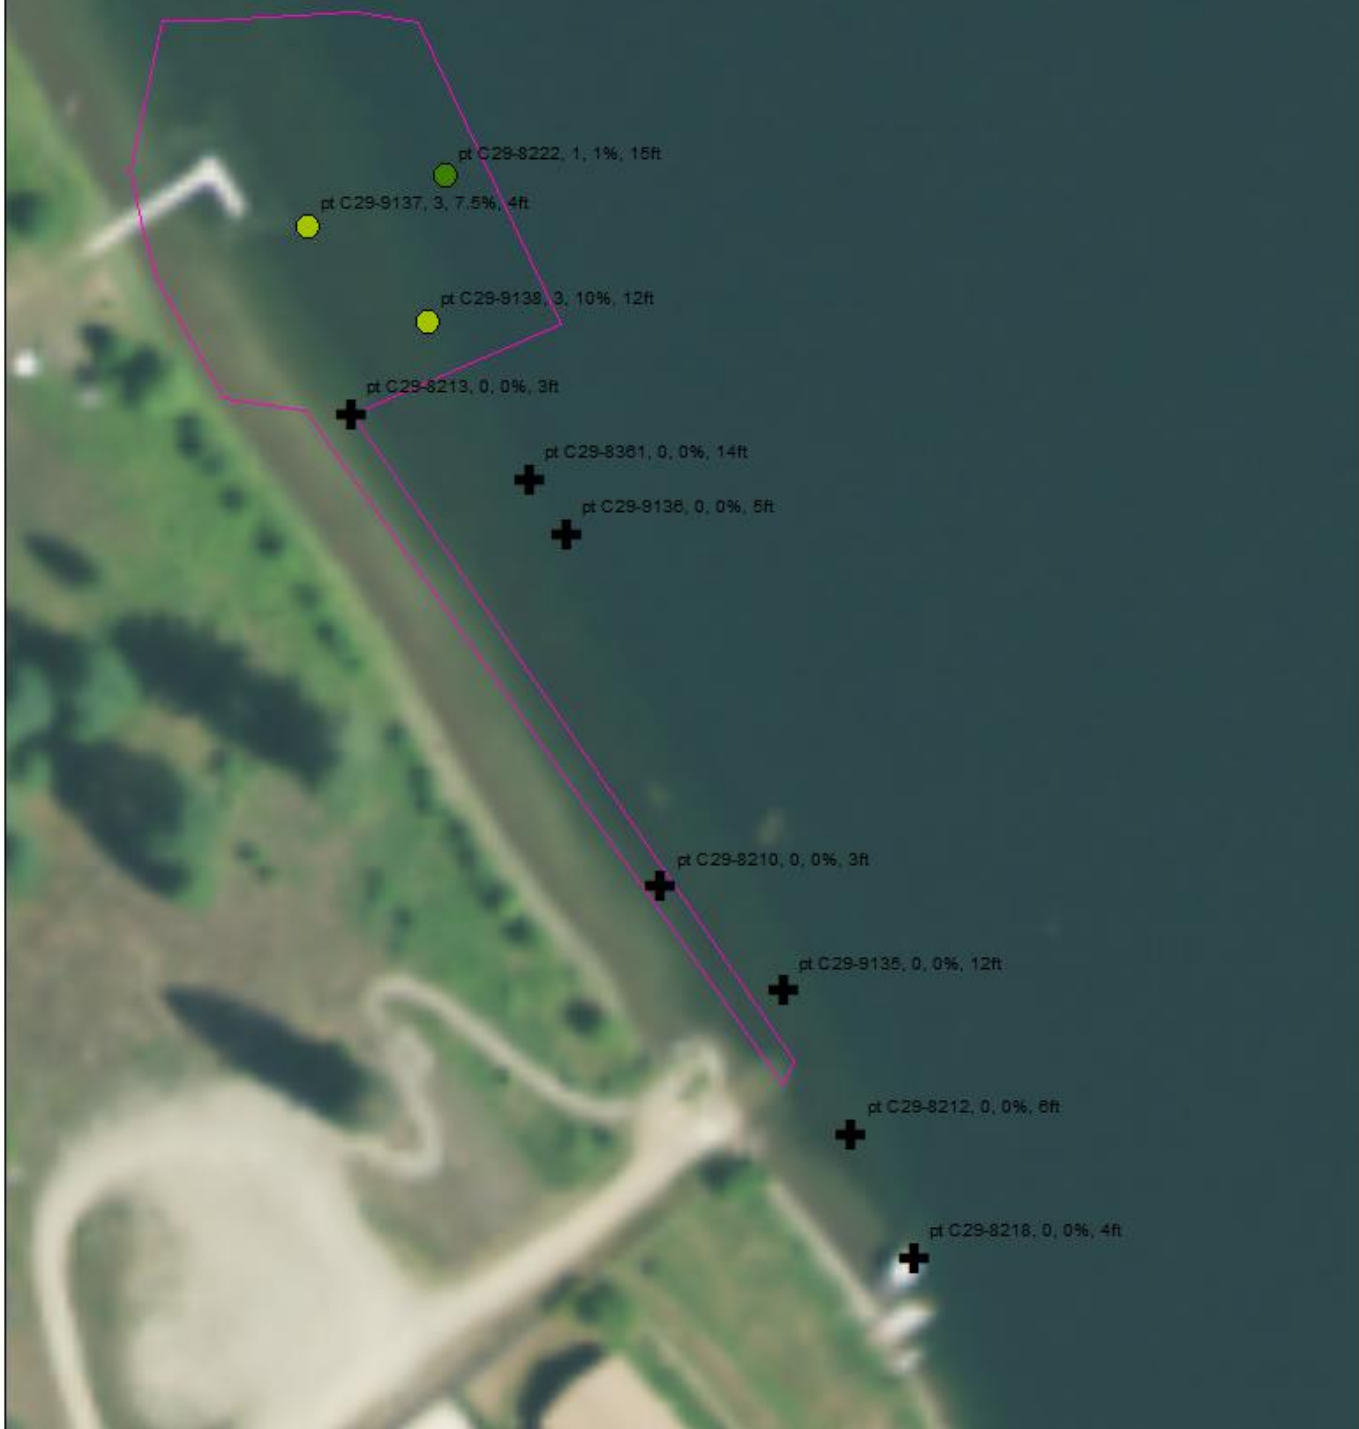
Plot: Cab-29

Sample Results for Eurasian watermilfoil Rank - (Percent Rake Fullness Range)

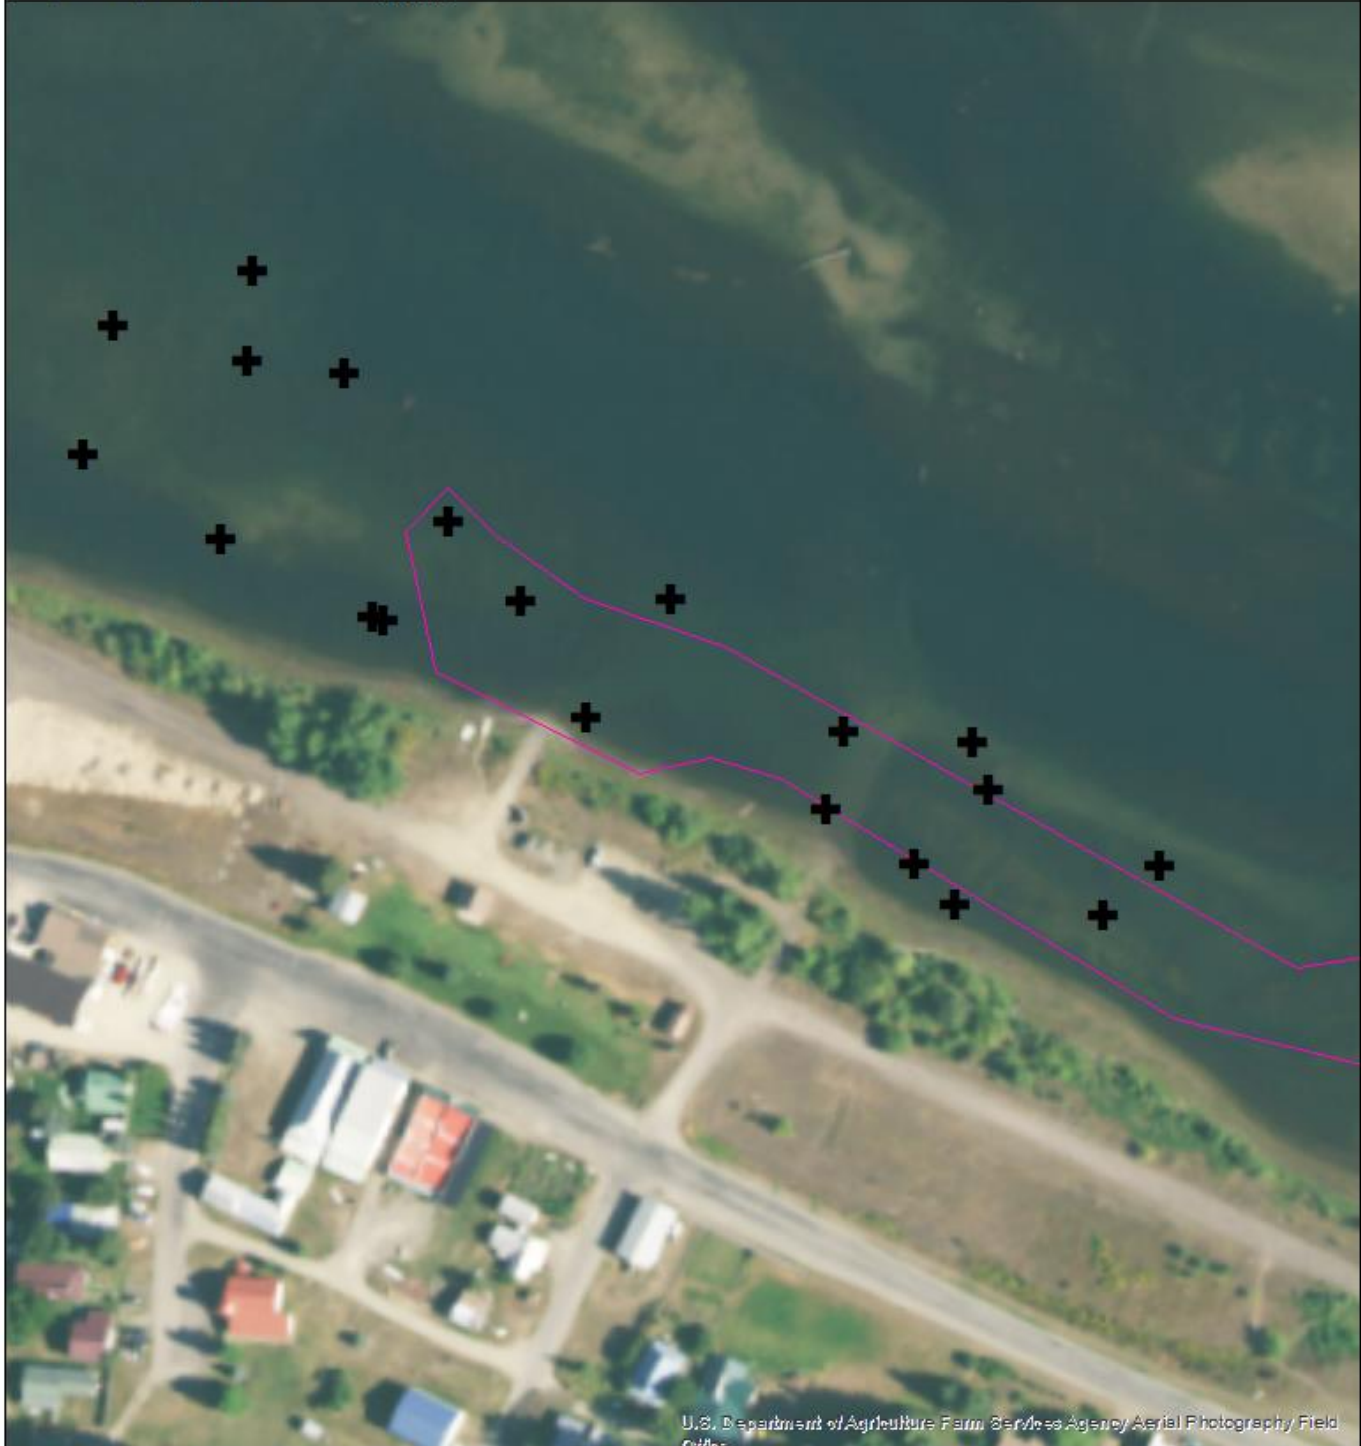
Plot: Cab-30

Cab 30 – Very little EWM on western side of plot; most of patch was located upstream and east of ramp; most of this was outside survey area but noted patch; no curlyleaf pondweed found

Sample Results for Curlyleaf Pondweed Rank - (Percent Rake Fulness Range)

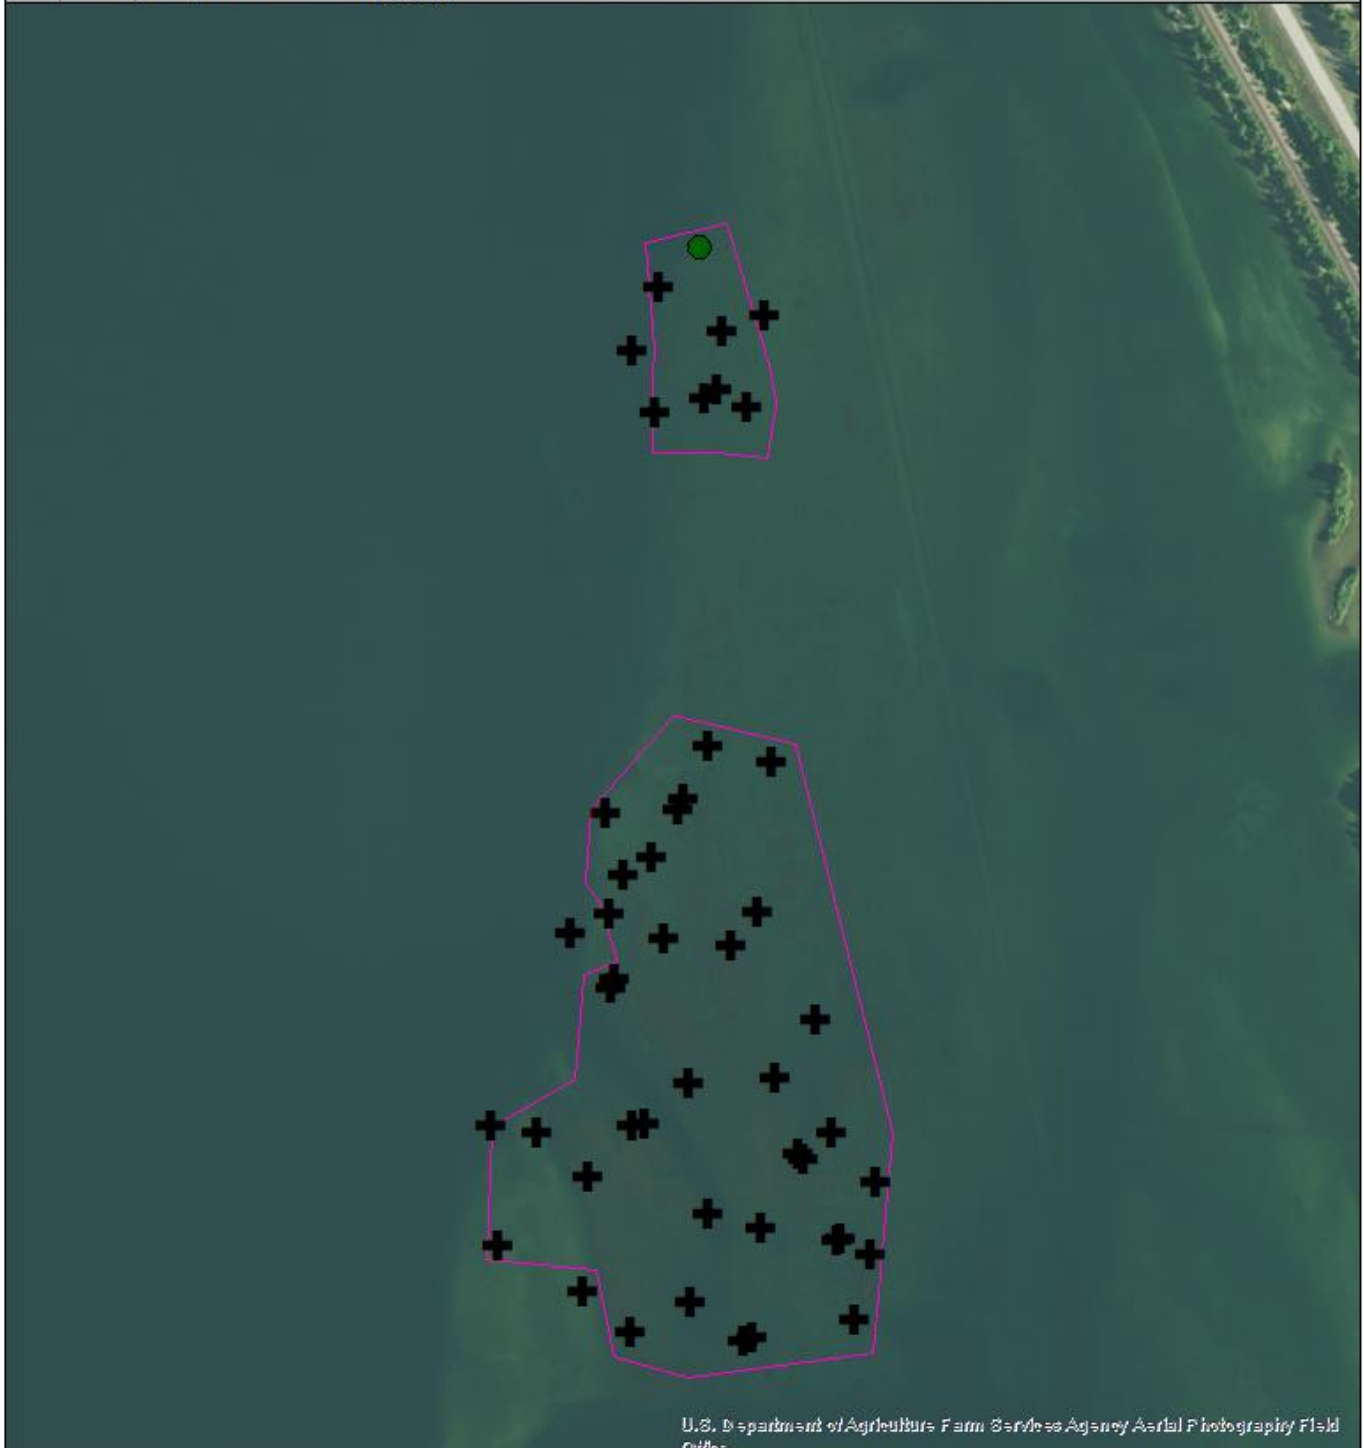
Plot: Nox-01

Nox 01 – Large patch of dense EWM; no curlyleaf pondweed found.

Sample Results for Curlyleaf Pondweed Rank - (Percent Rake Fulness Range)
