Noxon Rapids Reservoir and Cabinet Gorge Reservoir Herbicide Treatment Survey Report

2019 Season

Prepared for: The Sanders County Aquatic Invasive Plants Task Force

Craig R McLane

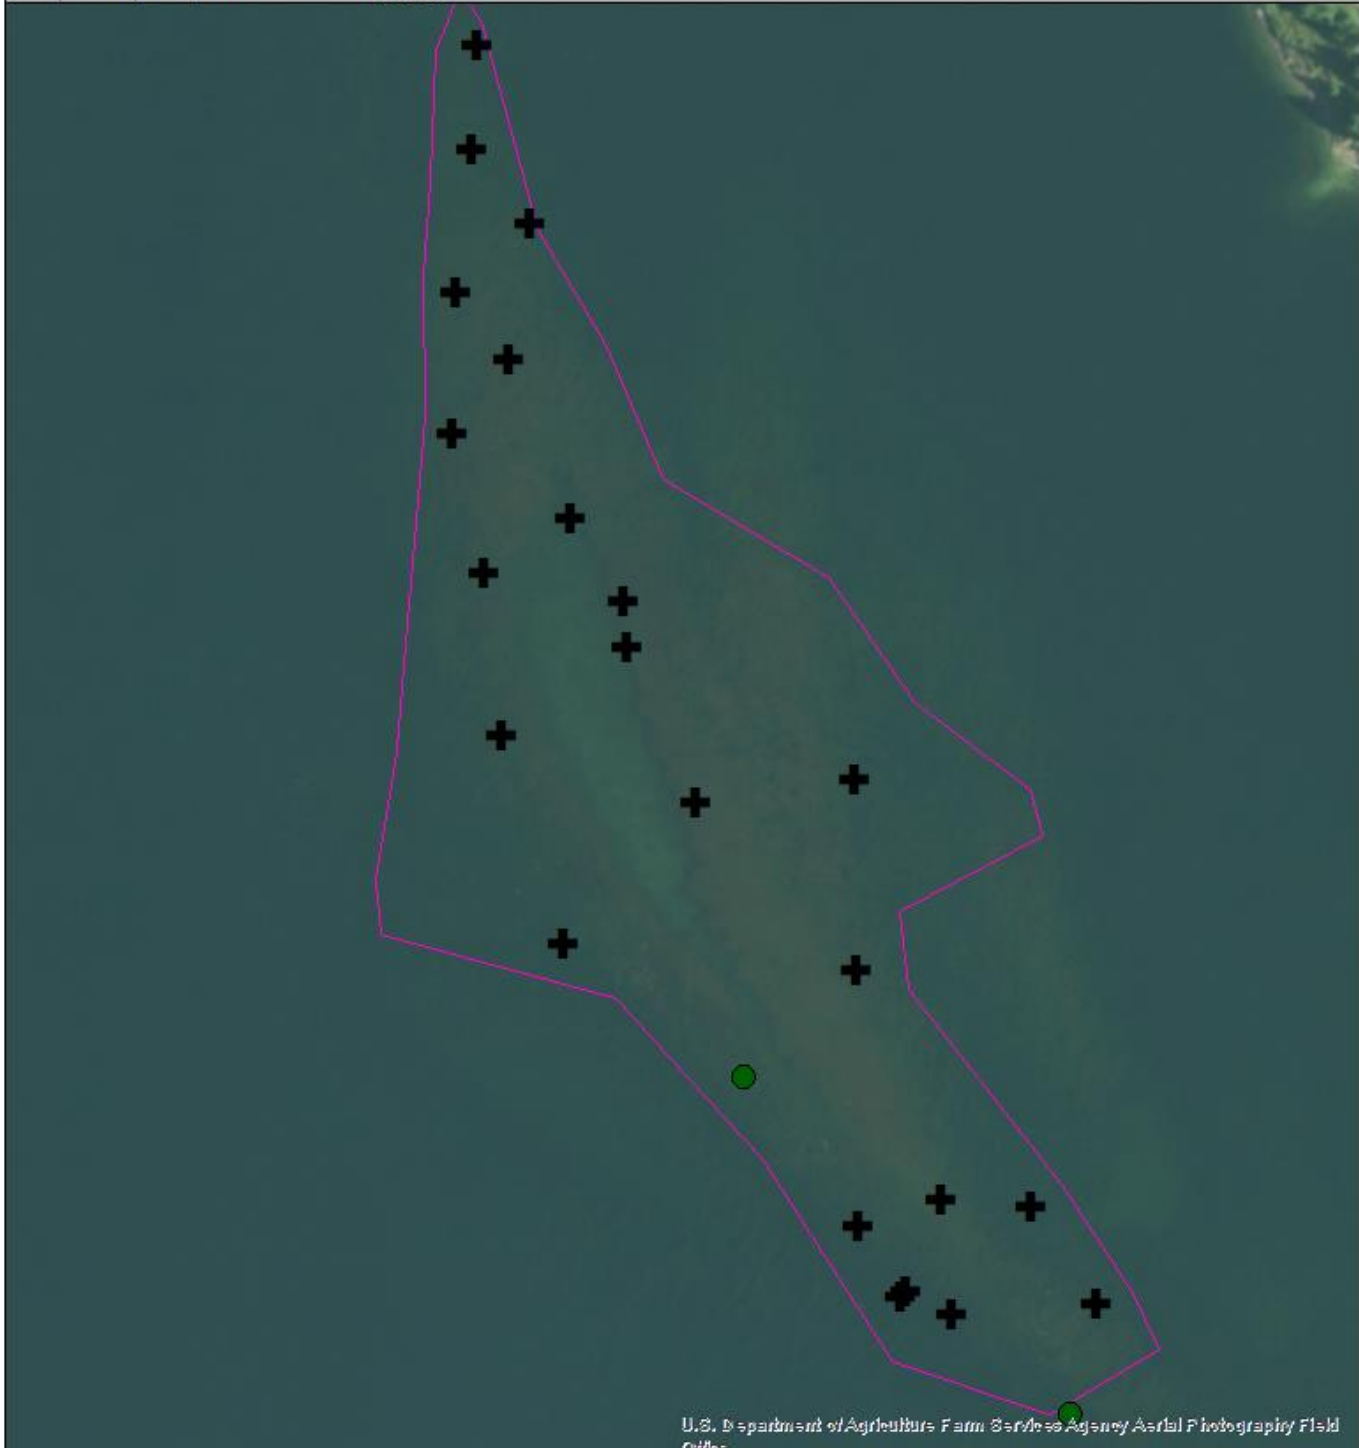
Plot: Nox-02

Nox 02 – Larger patch of EWM than put in survey area. Patches variable from scattered plants to approx. 90%. Added additional sample points to this plot; almost no curlyleaf pondweed found

Sample Results for Curlyleaf Pondweed Rank - (Percent Rake Fulness Range)

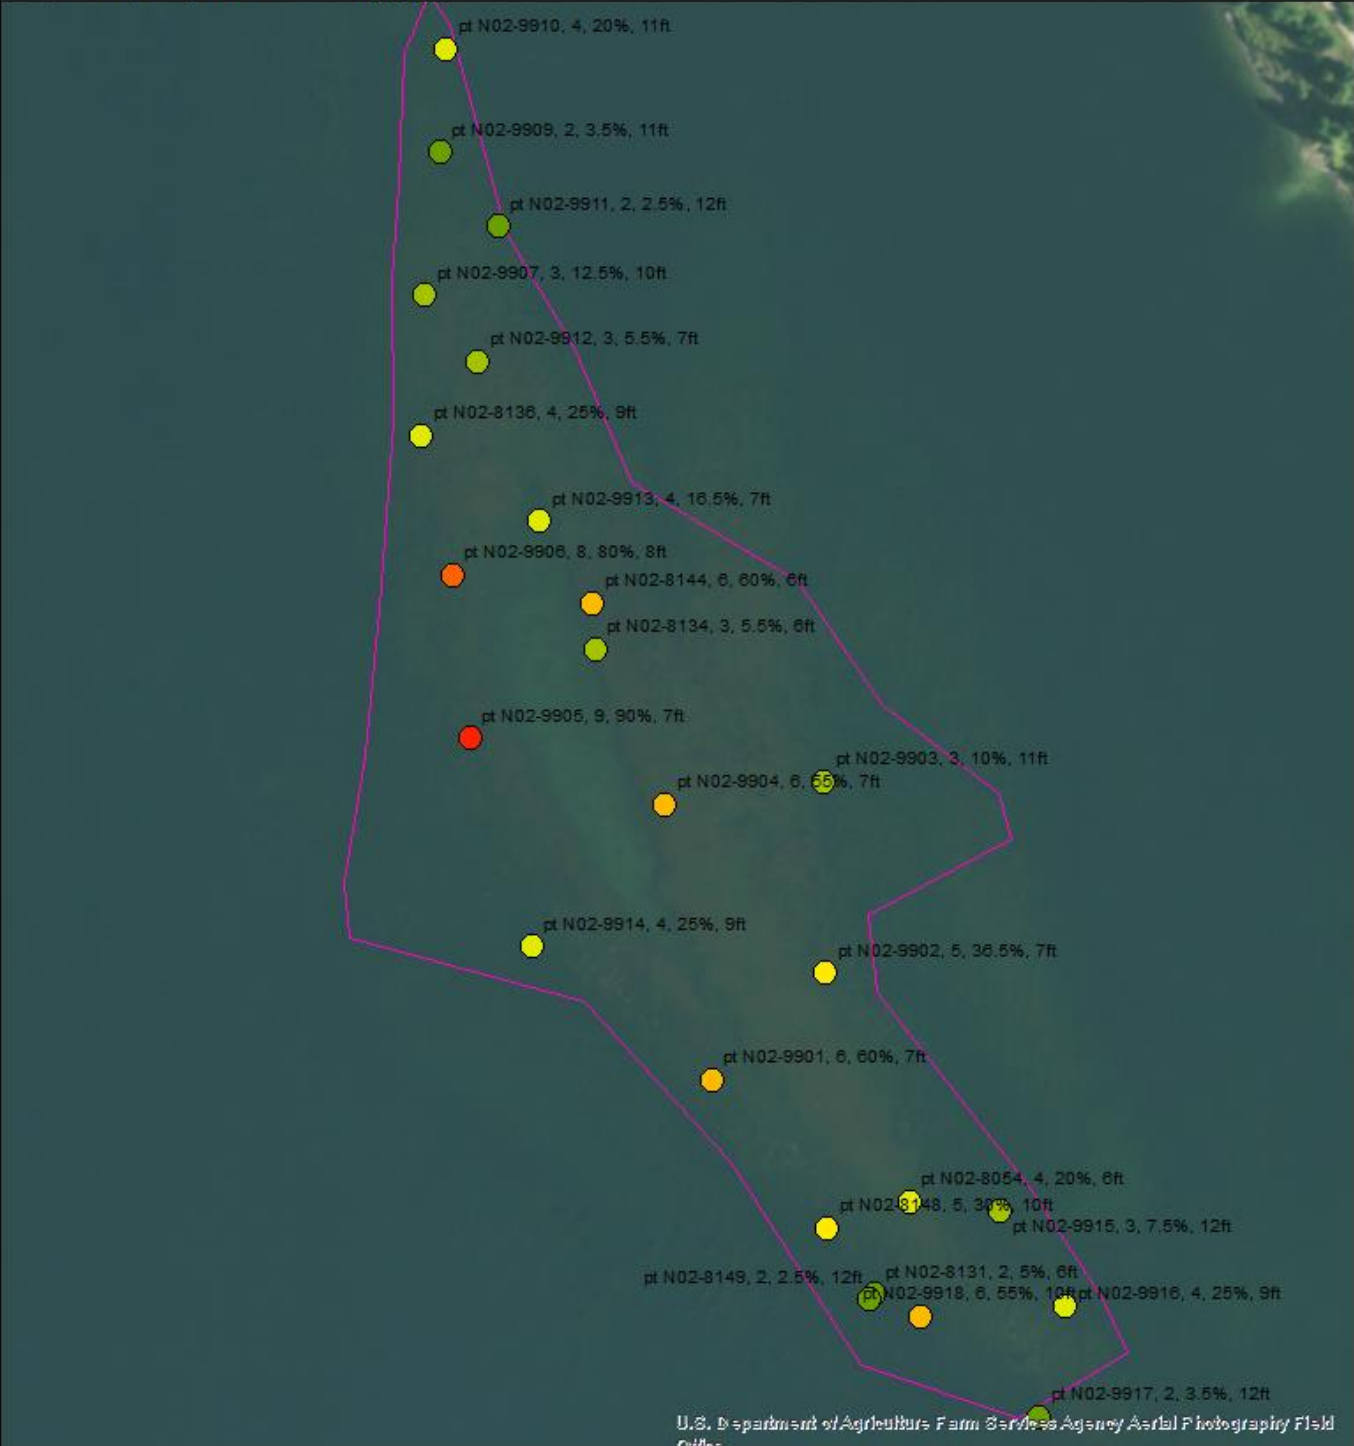
Plot: Nox-02

Sample Results for Eurasian watermilfoil Rank - (Percent Rake Fulness Range)

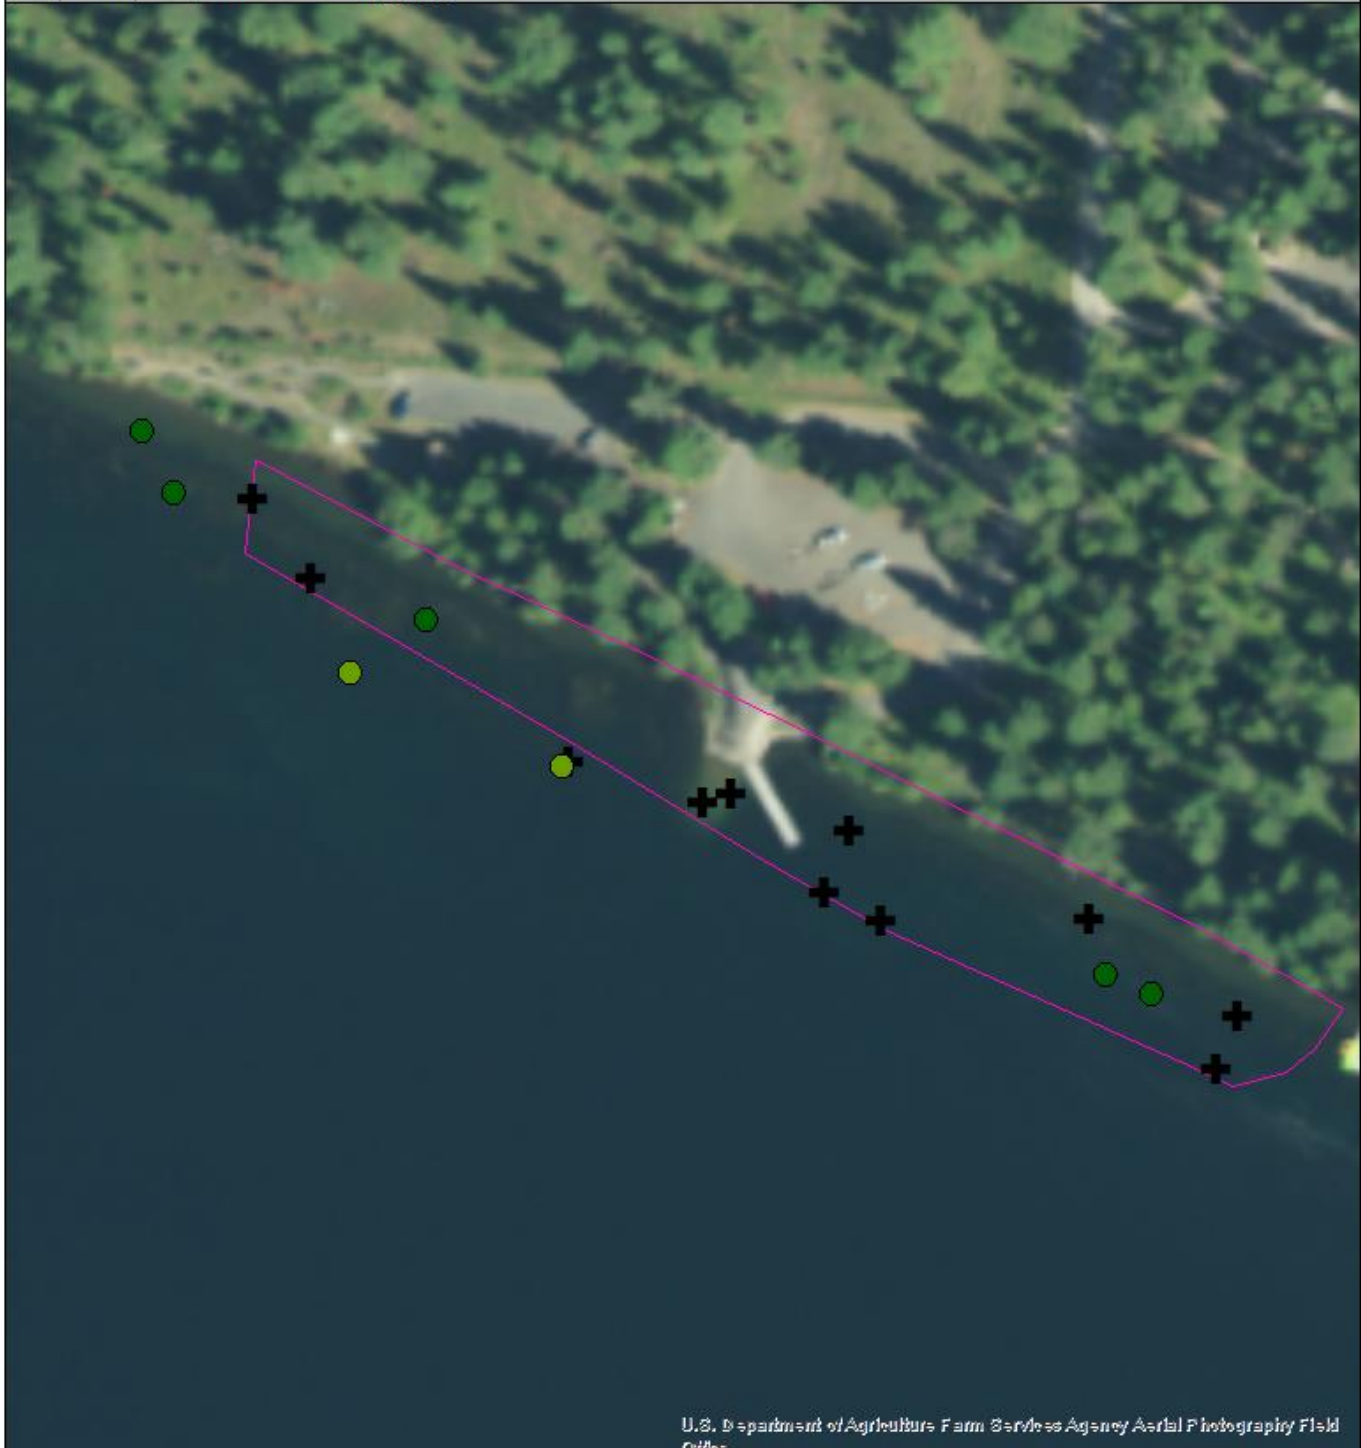
Plot: Nox-03

Nox 03 – Depths less than 5' have no vegetation. Very little EWM; Sporadic dense patches of curlyleaf pondweed west of dock in 7-8' depths.

Sample Results for Curlyleaf Pondweed Rank - (Percent Rake Fulness Range)

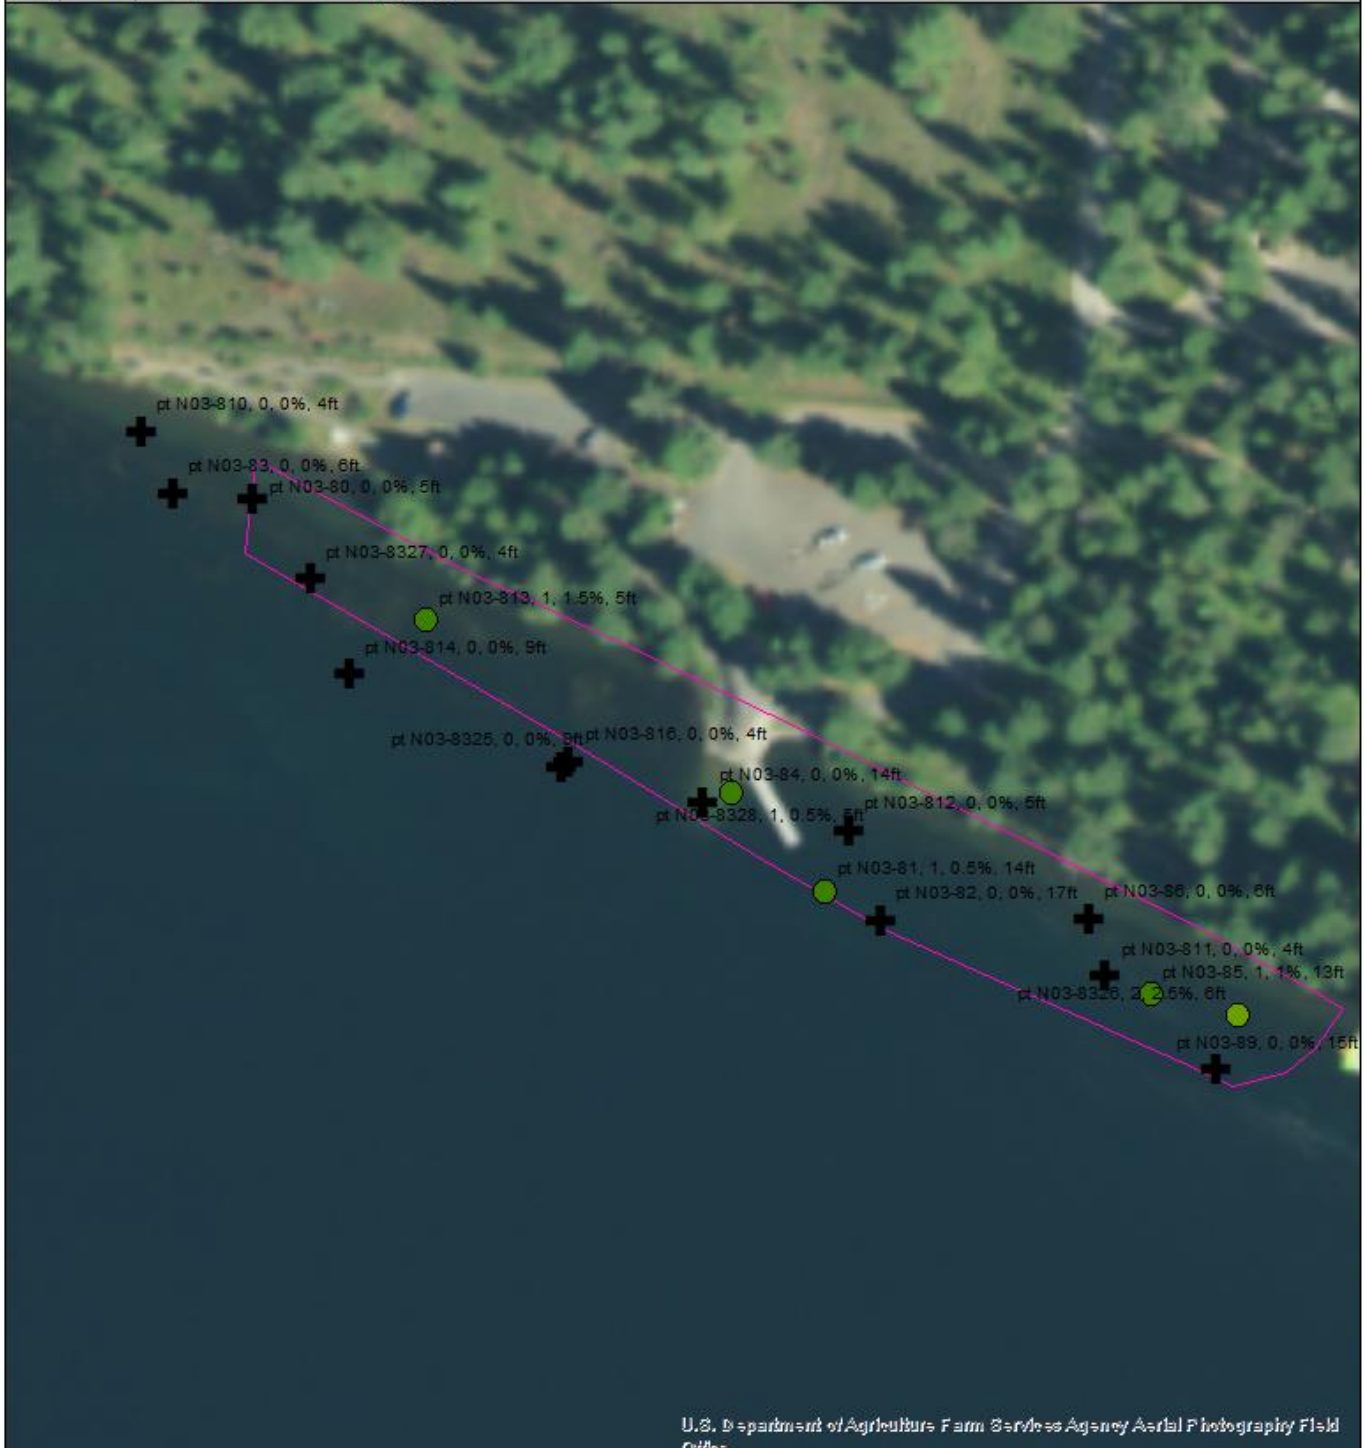
Plot: Nox-03

**Sample Results for Eurasian watermilfoil
Rank - (Percent Rake Fulness Range)**

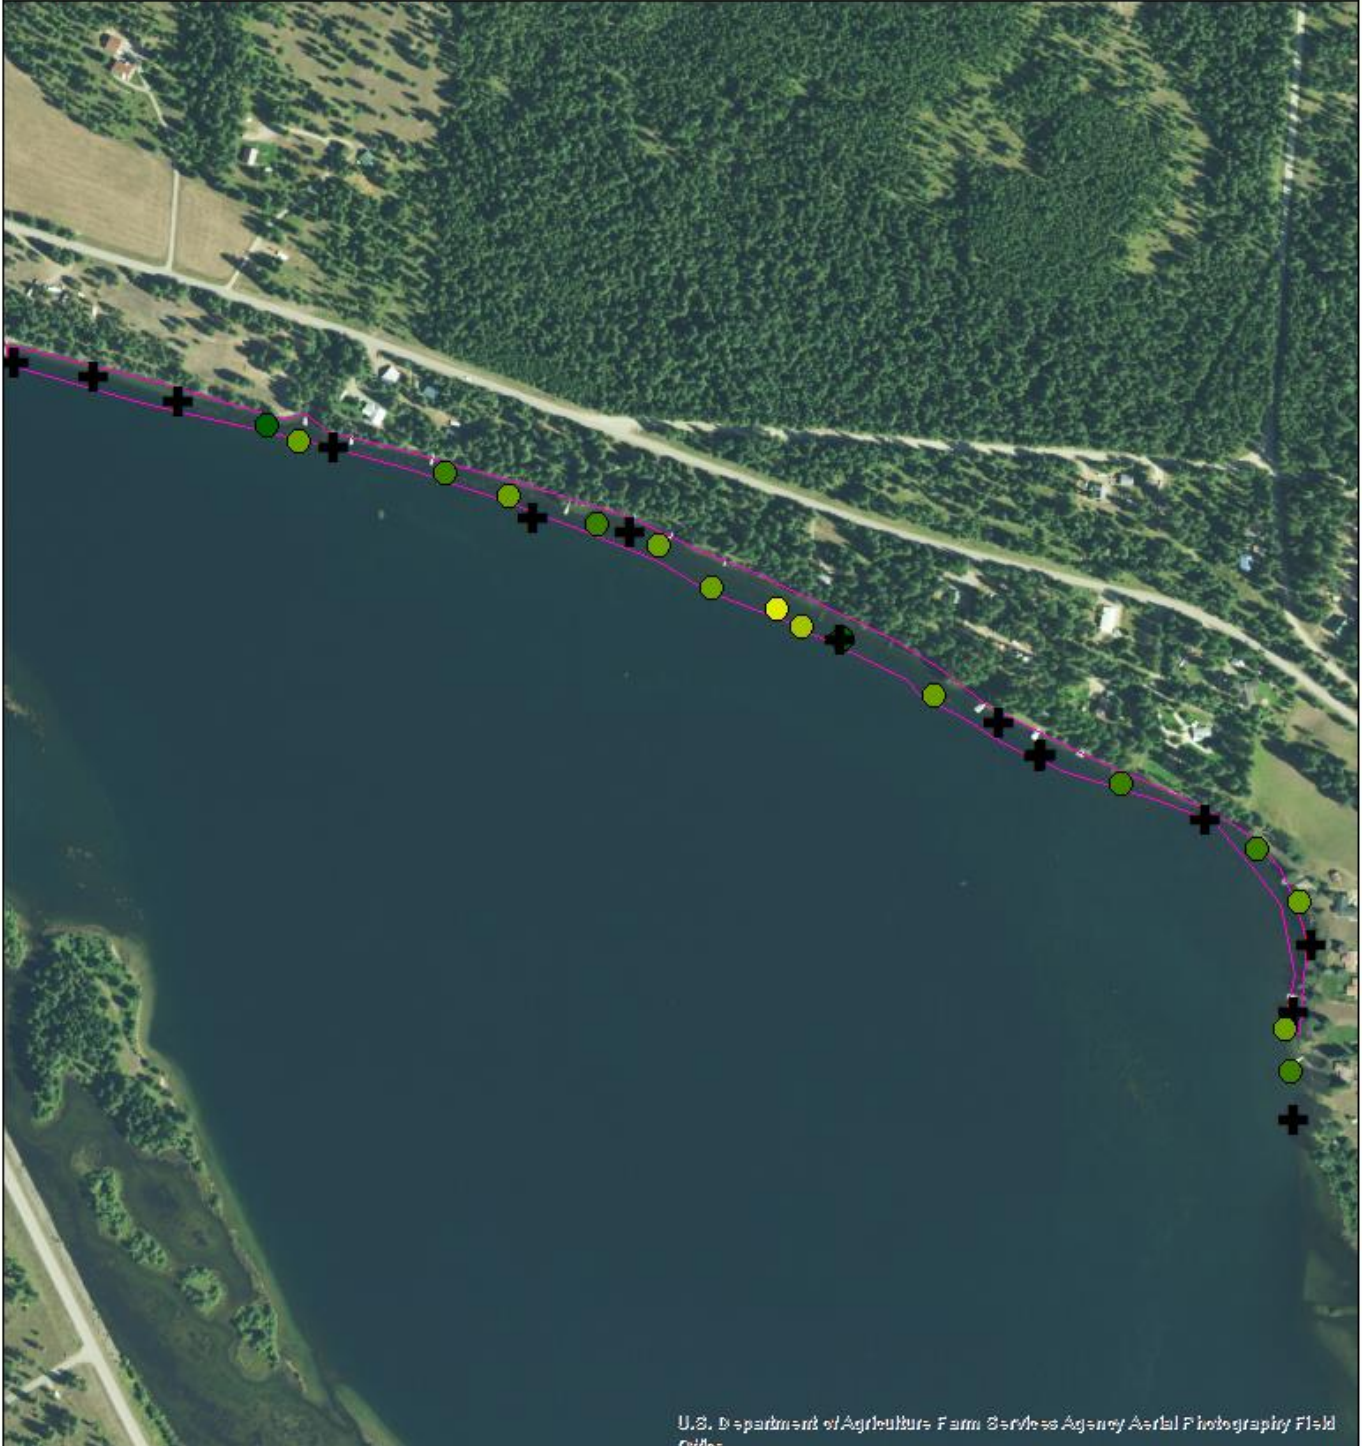
Plot: Nox-04

Nox 04 – EWM in bands along shoreline in the 5-8' depths; sporadic curlyleaf pondweed patches at lower densities.

Sample Results for Curlyleaf Pondweed Rank - (Percent Rake Fulness Range)

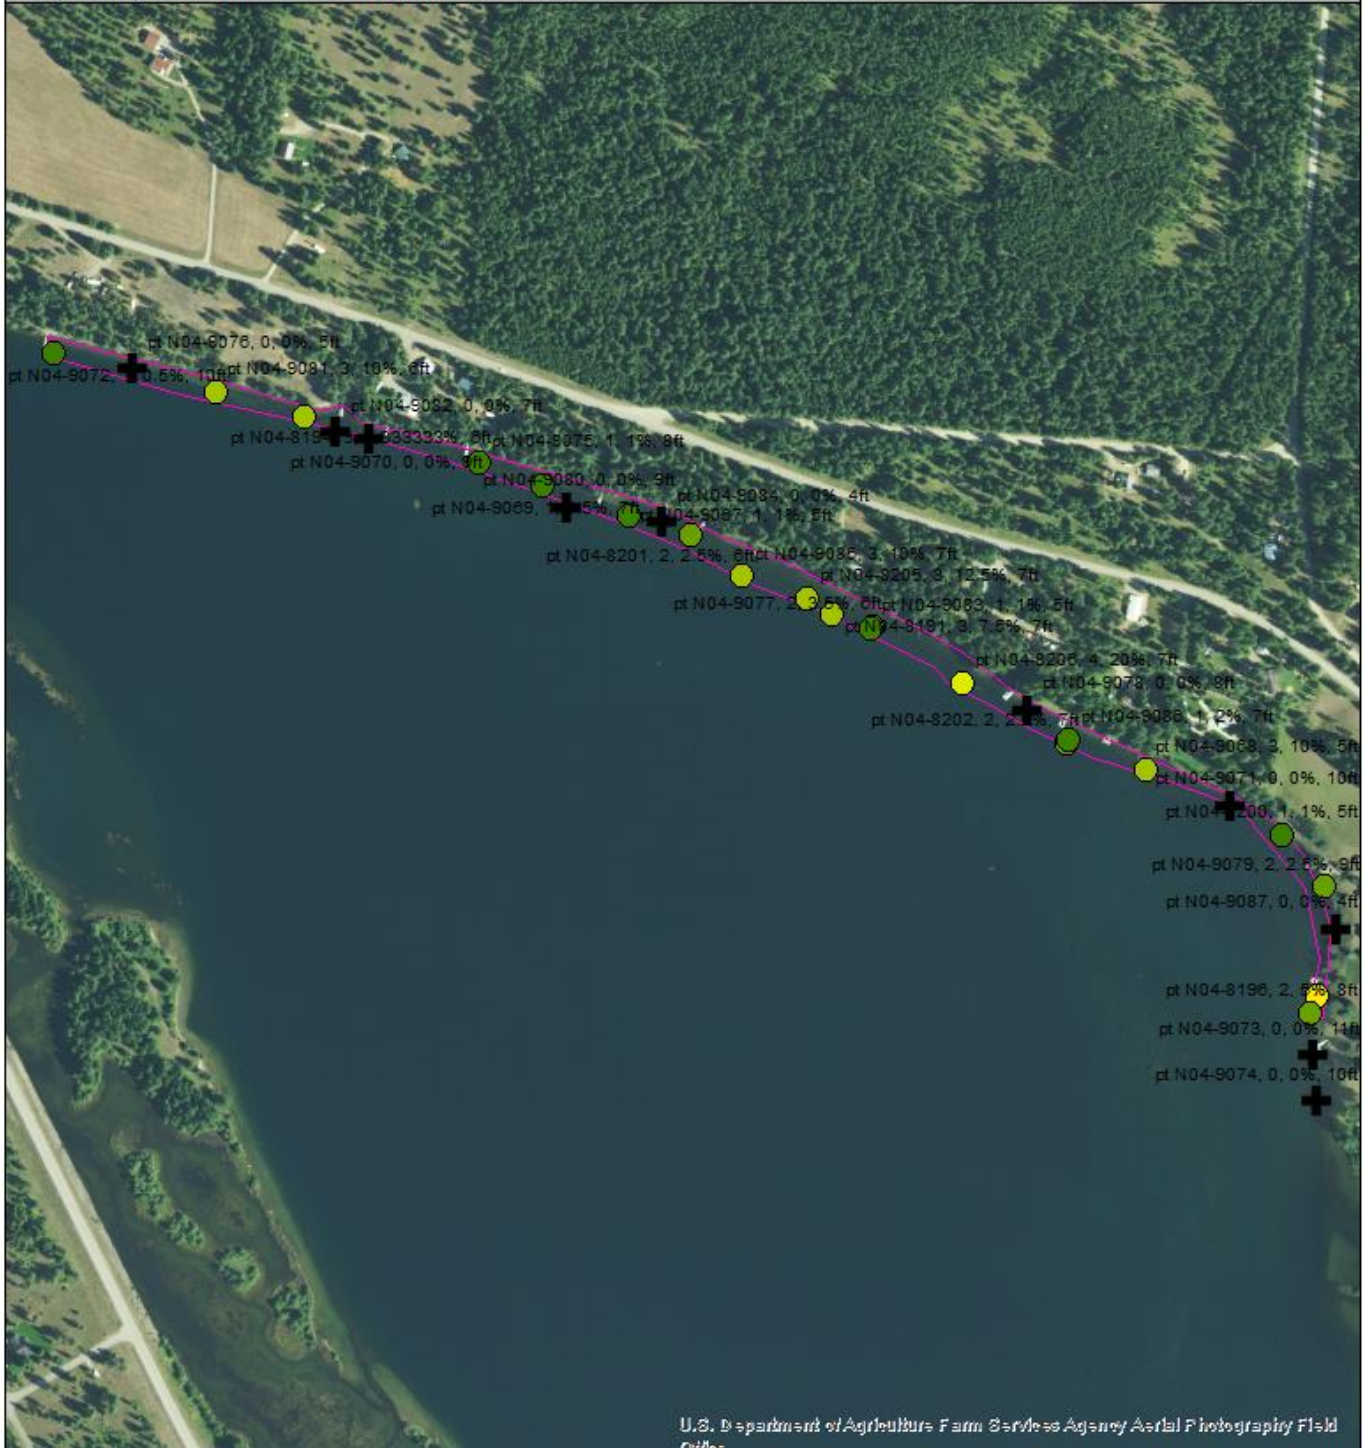
Plot: Nox-04

Sample Results for Eurasian watermilfoil Rank - (Percent Rake Fulness Range)

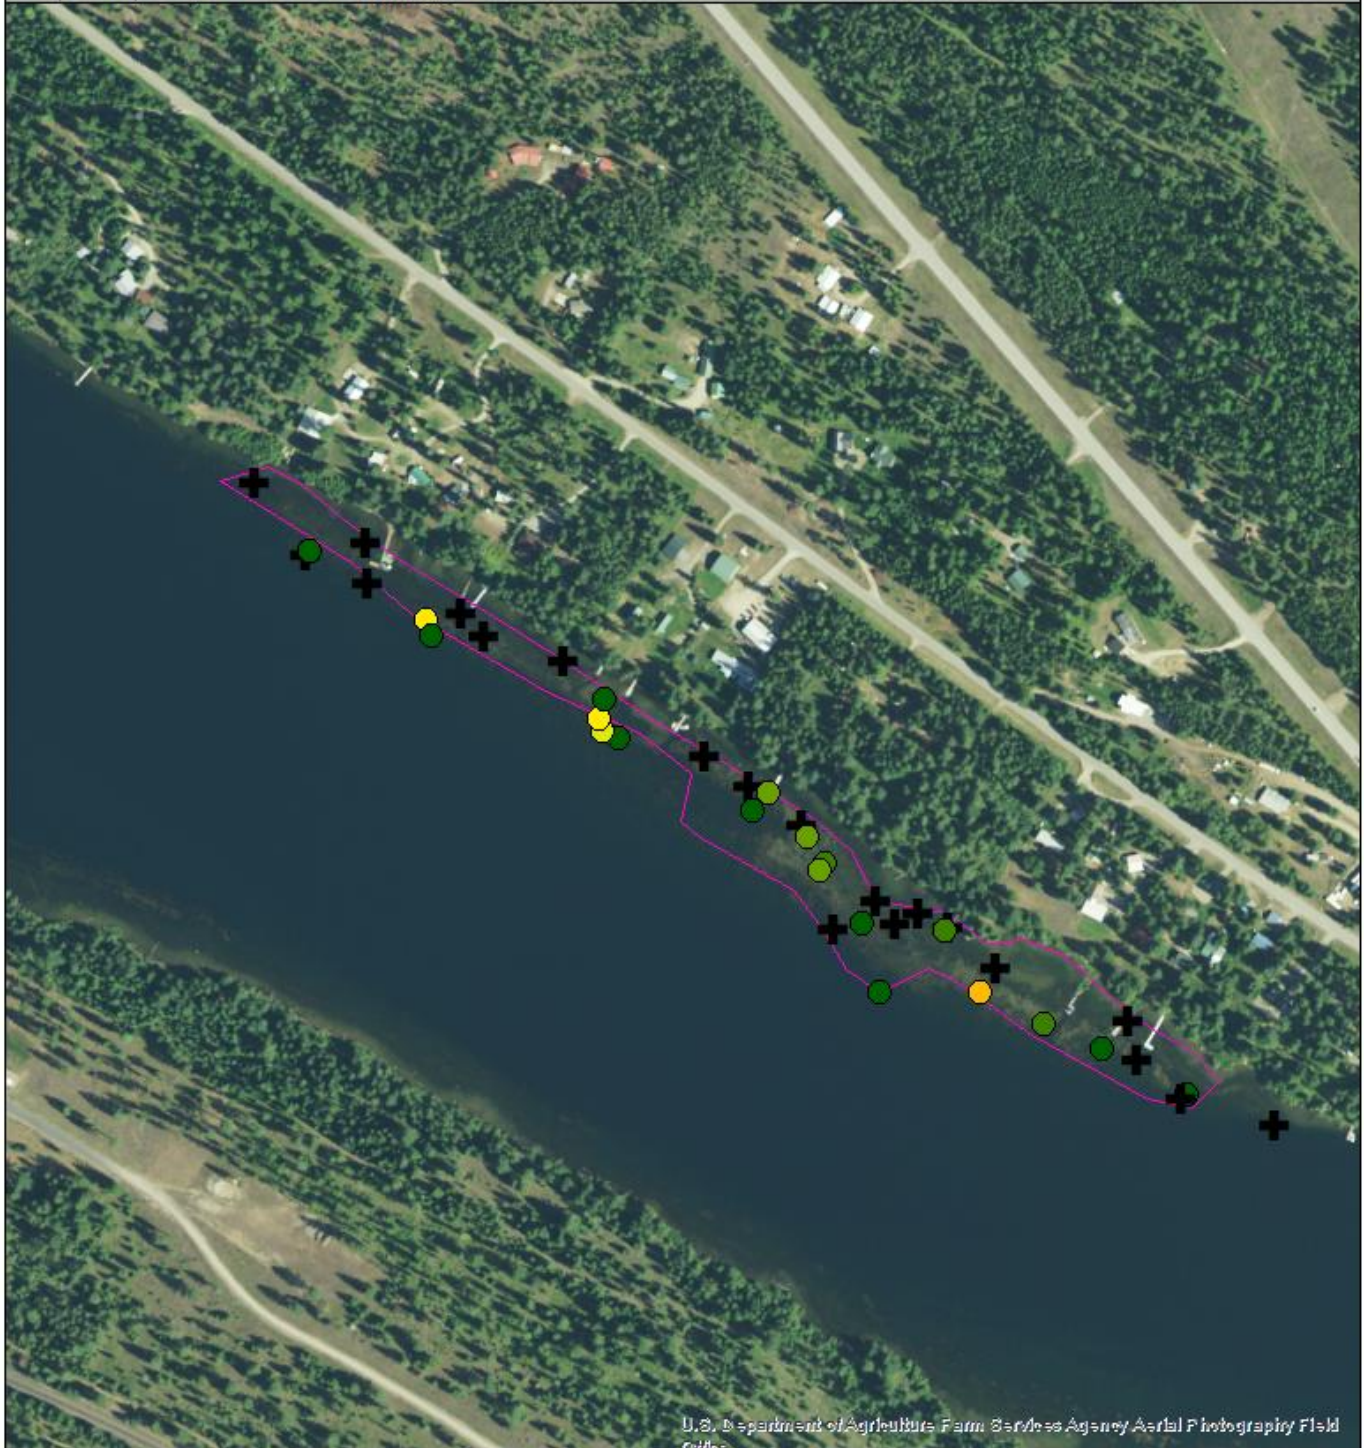
Plot: Nox-08

Nox 08 – Spotty patches of dense EWM (80% cover) mixed with lower densities (10-20% avg); curlyleaf pondweed also with spotty patches of dense areas mixed with lower densities.

Sample Results for Curlyleaf Pondweed Rank - (Percent Rake Fulness Range)

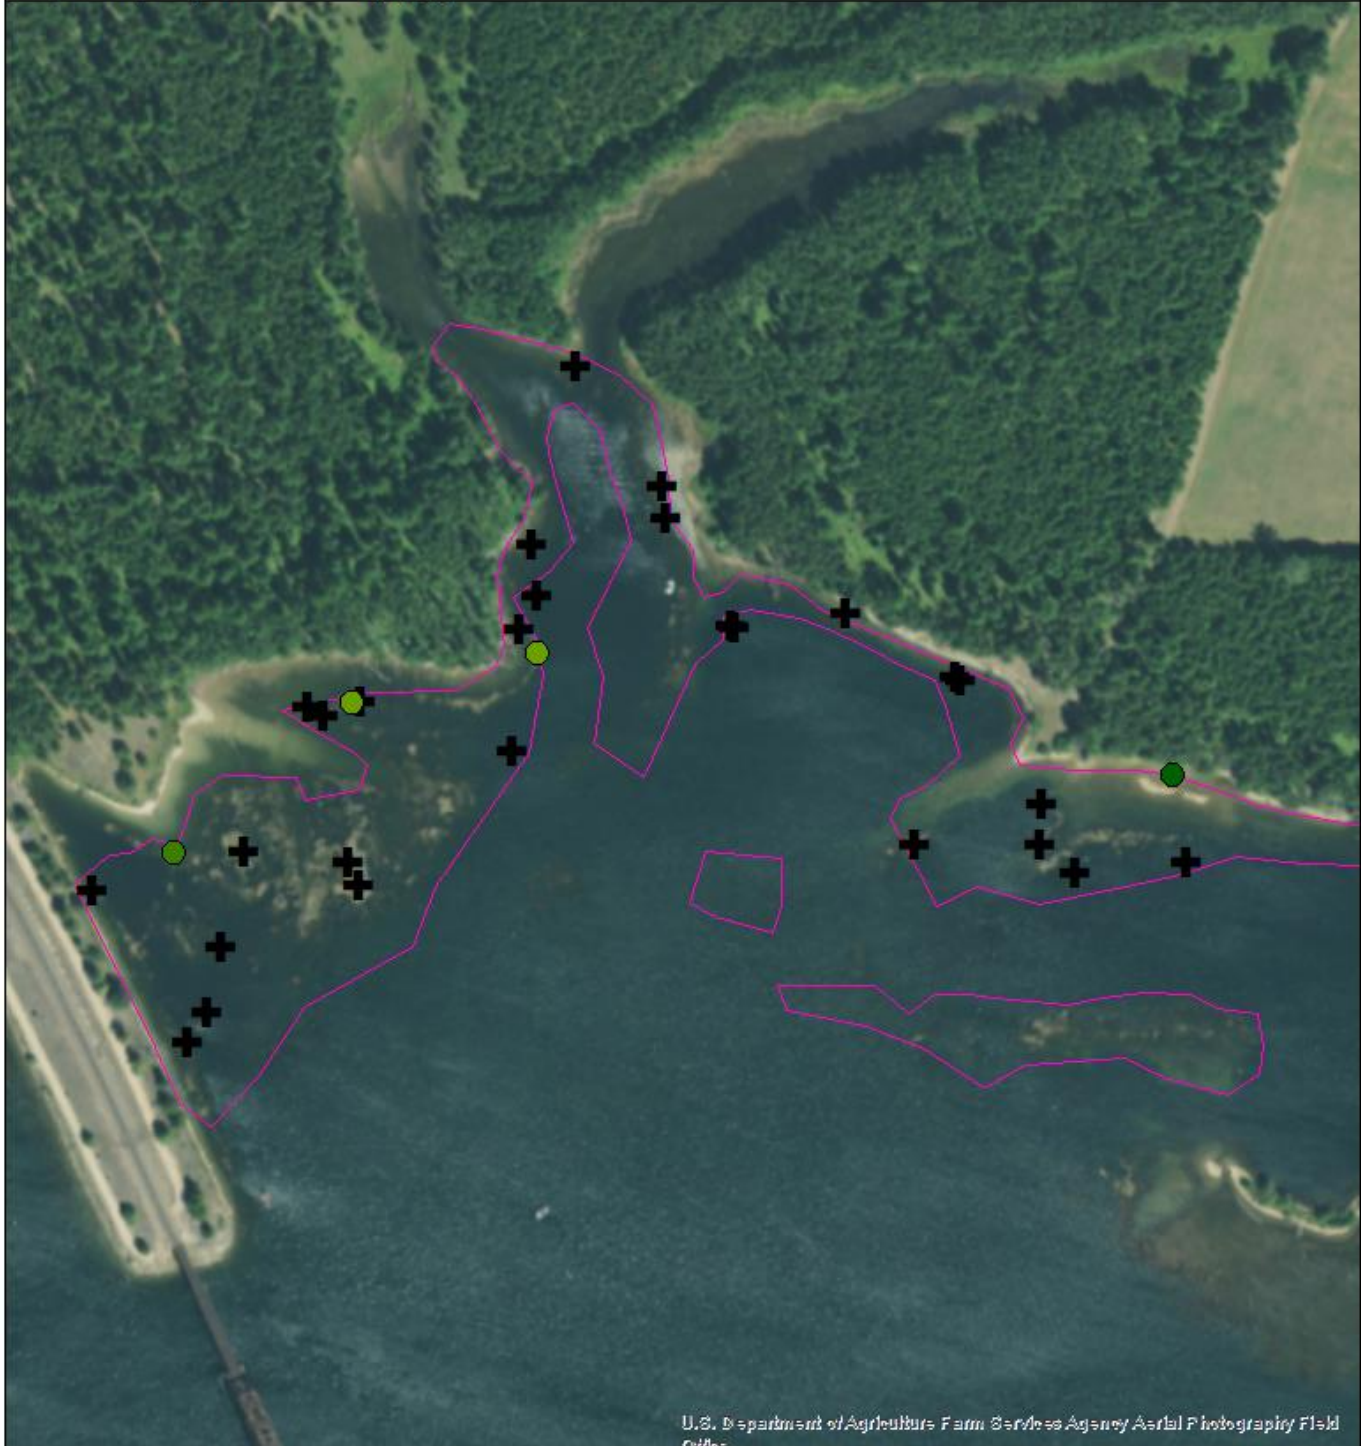
Plot: Nox-11

Nox11 – Additional dense areas of EWM outside of the sample area (60-80% cover); very little curlyleaf pondweed

Sample Results for Curlyleaf Pondweed Rank - (Percent Rake Fulness Range)

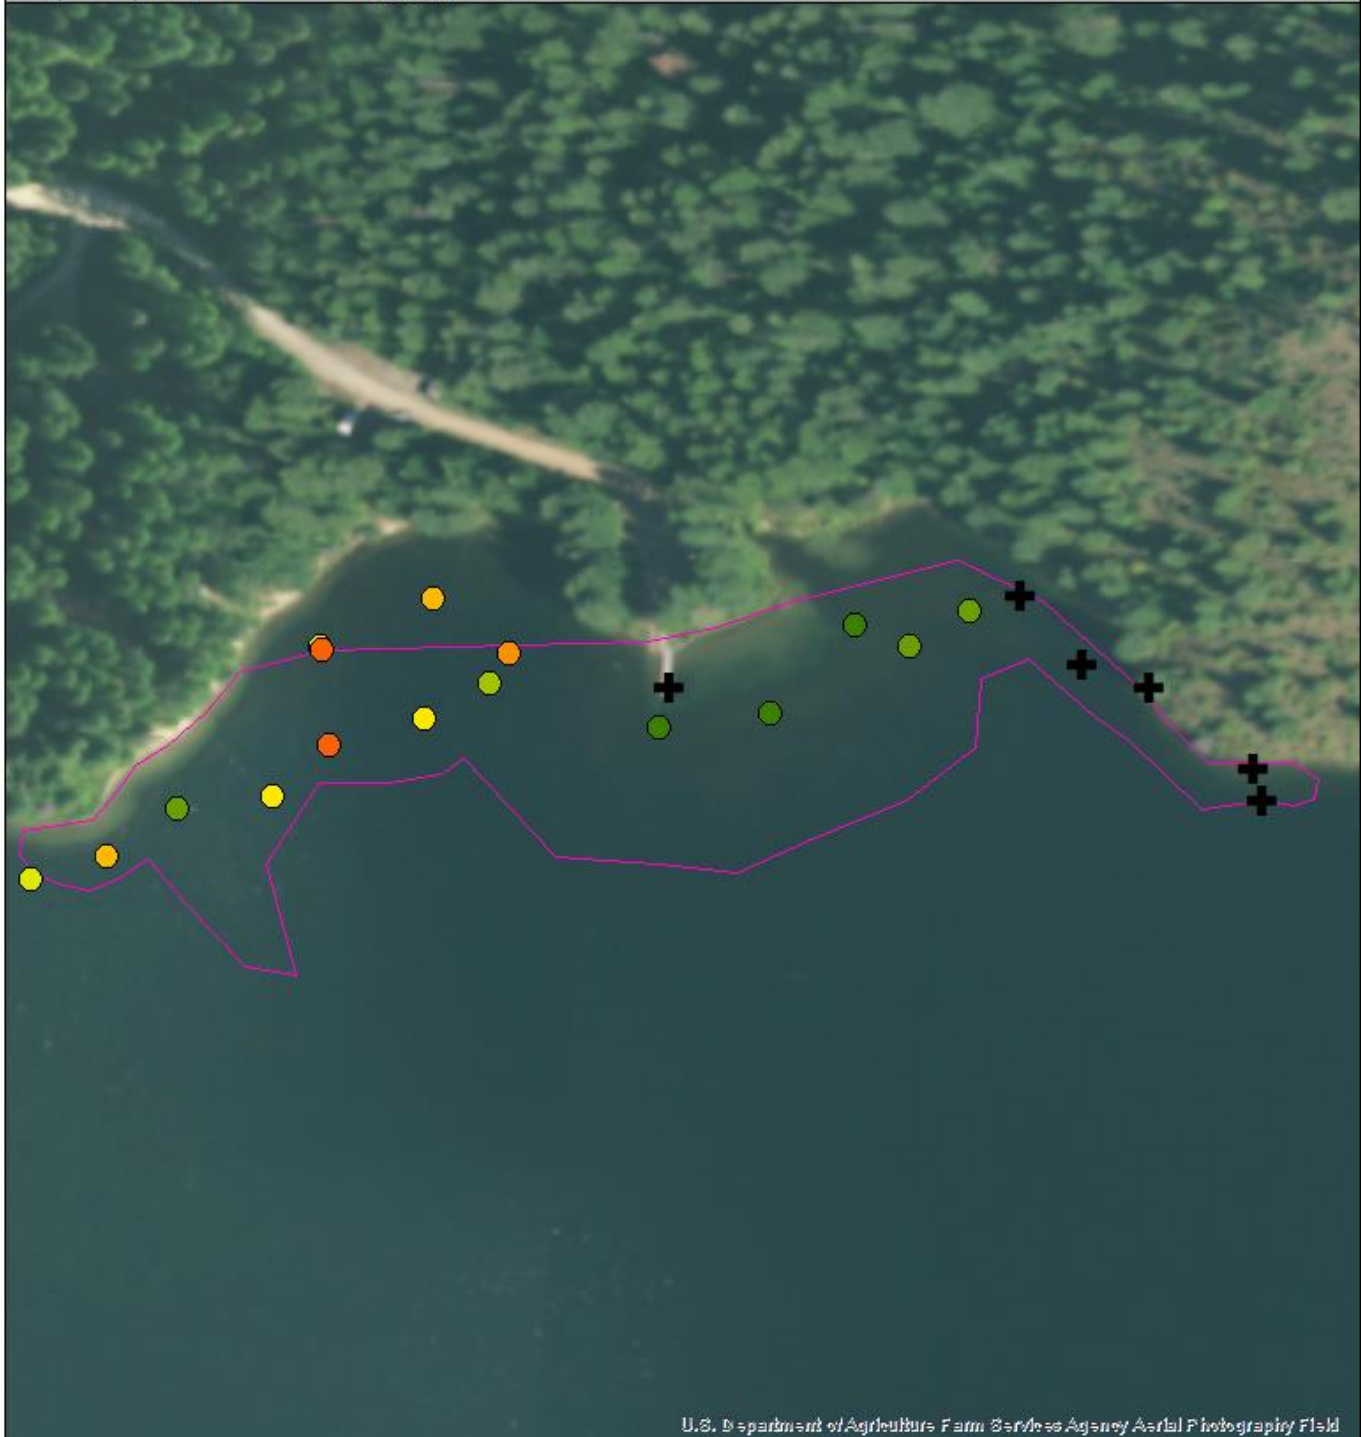
Plot: Nox-31

Nox 31 – EWM most dense (50-60% cover) from east edge of plot to dock; curlyleaf pondweed most dense (80%) from dock to west edge

Sample Results for Curlyleaf Pondweed Rank - (Percent Rake Fullness Range)

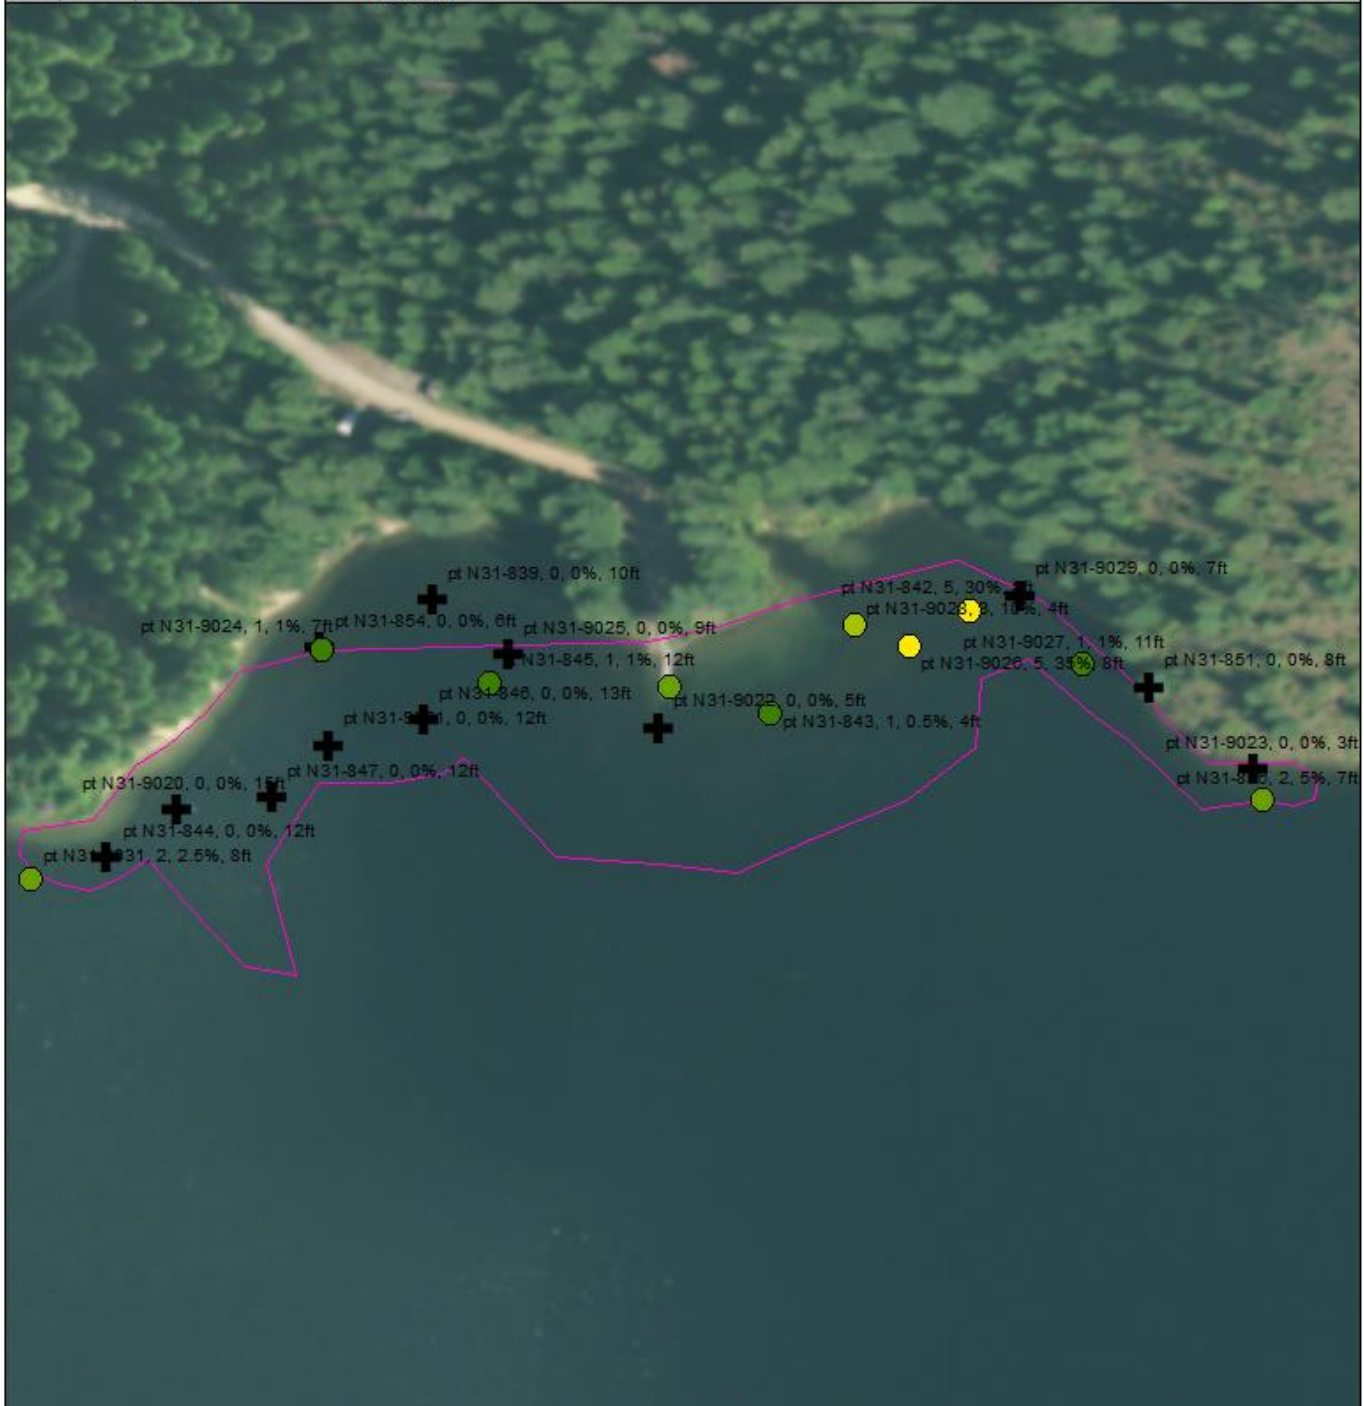
Plot: Nox-31

**Sample Results for Eurasian watermilfoil
Rank - (Percent Rake Fulness Range)**

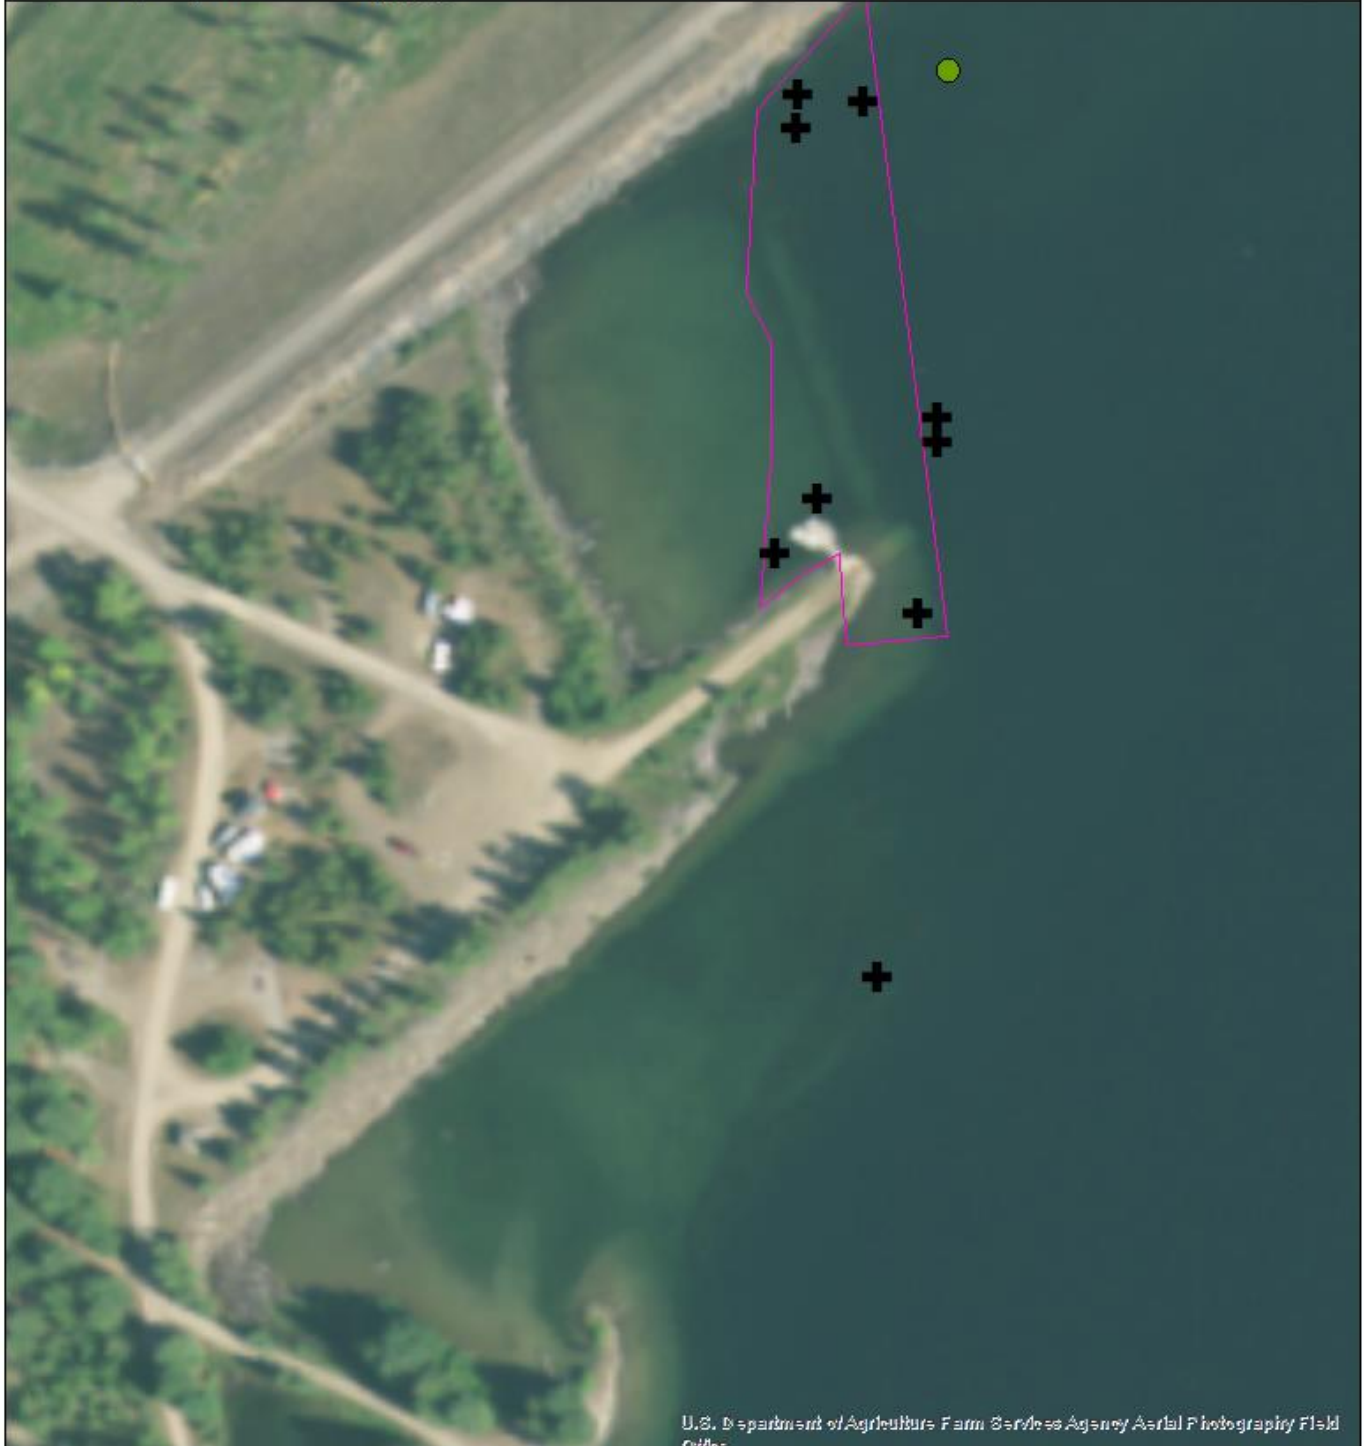
Plot: Nox-52

Nox 52 – Very little EWM found; Very little curlyleaf pondweed found. Recommend not to treat

Sample Results for Curlyleaf Pondweed Rank - (Percent Rake Fulness Range)
