Noxon Rapids Reservoir and Cabinet Gorge Reservoir Herbicide Treatment Survey Report

2019 Season

Prepared for: The Sanders County Aquatic Invasive Plants Task Force

Craig R McLane

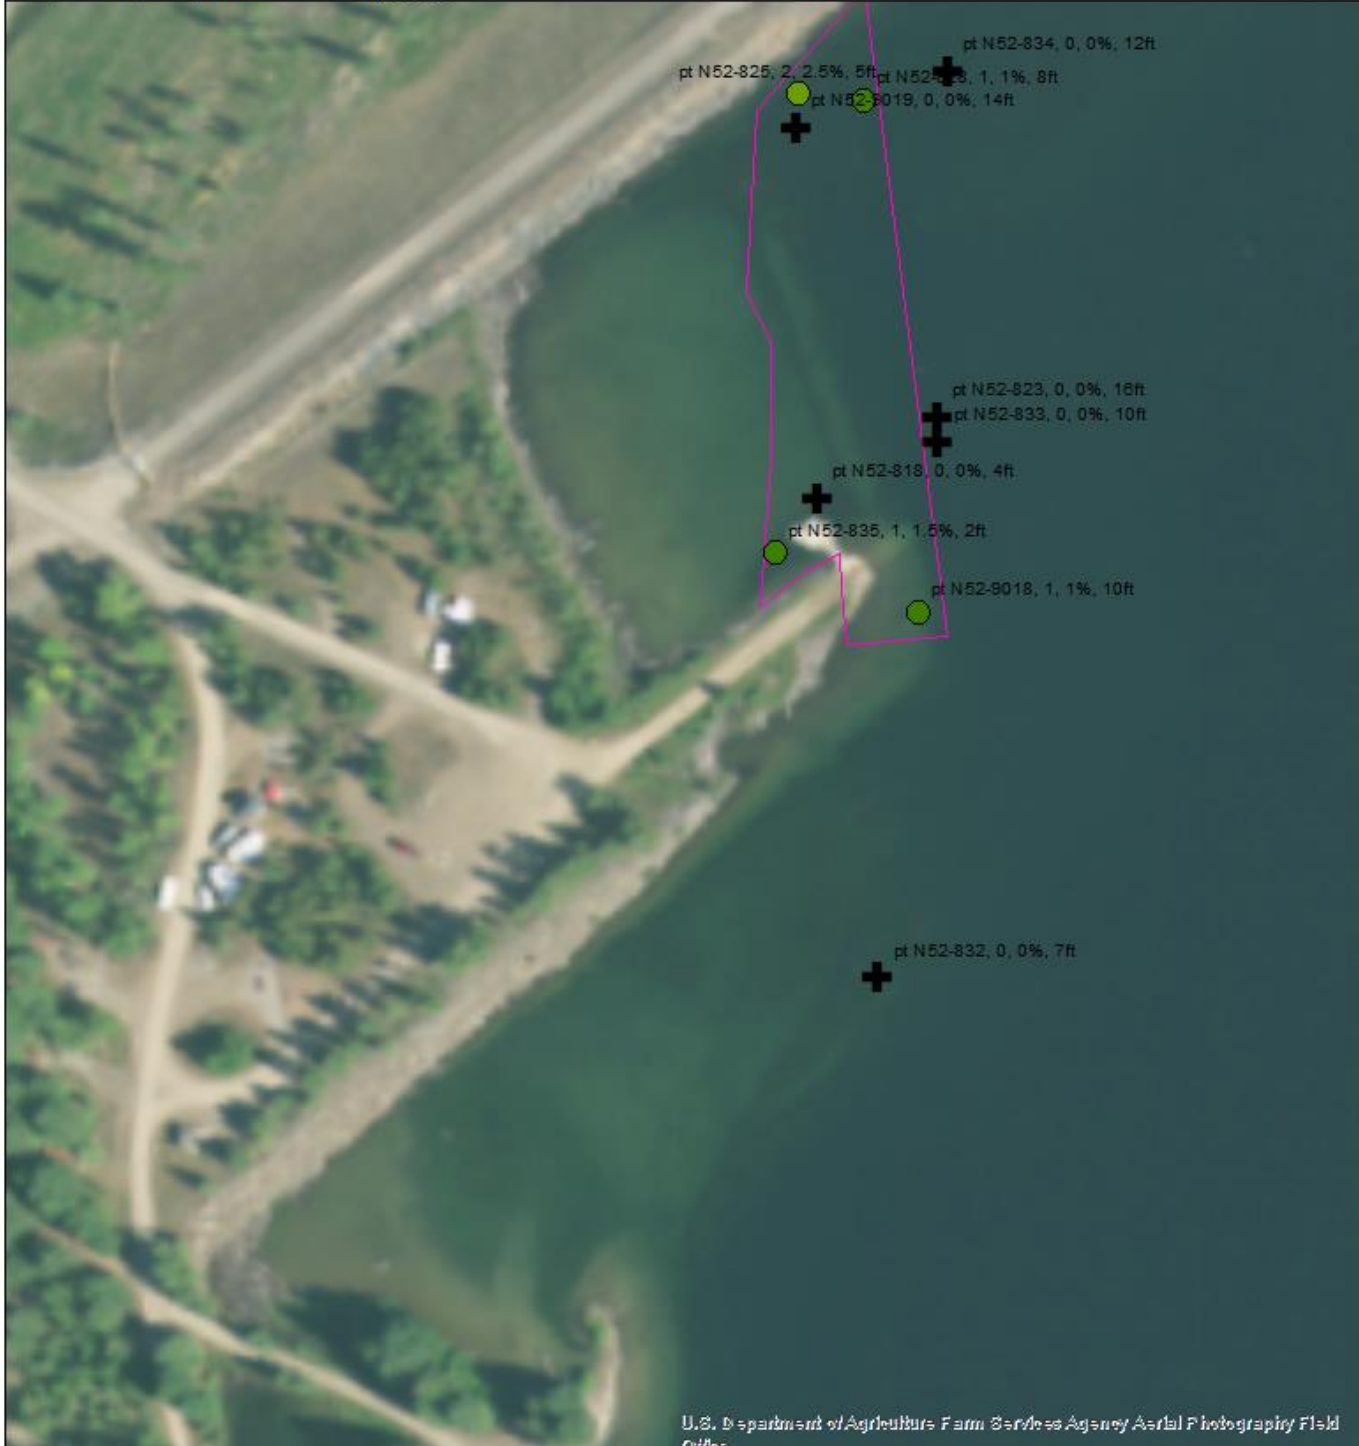
Plot: Nox-52

Nox 52 – Very little EWM found; Very little curlyleaf pondweed found. Recommend not to treat

Sample Results for Eurasian watermilfoil Rank - (Percent Rake Fulness Range)

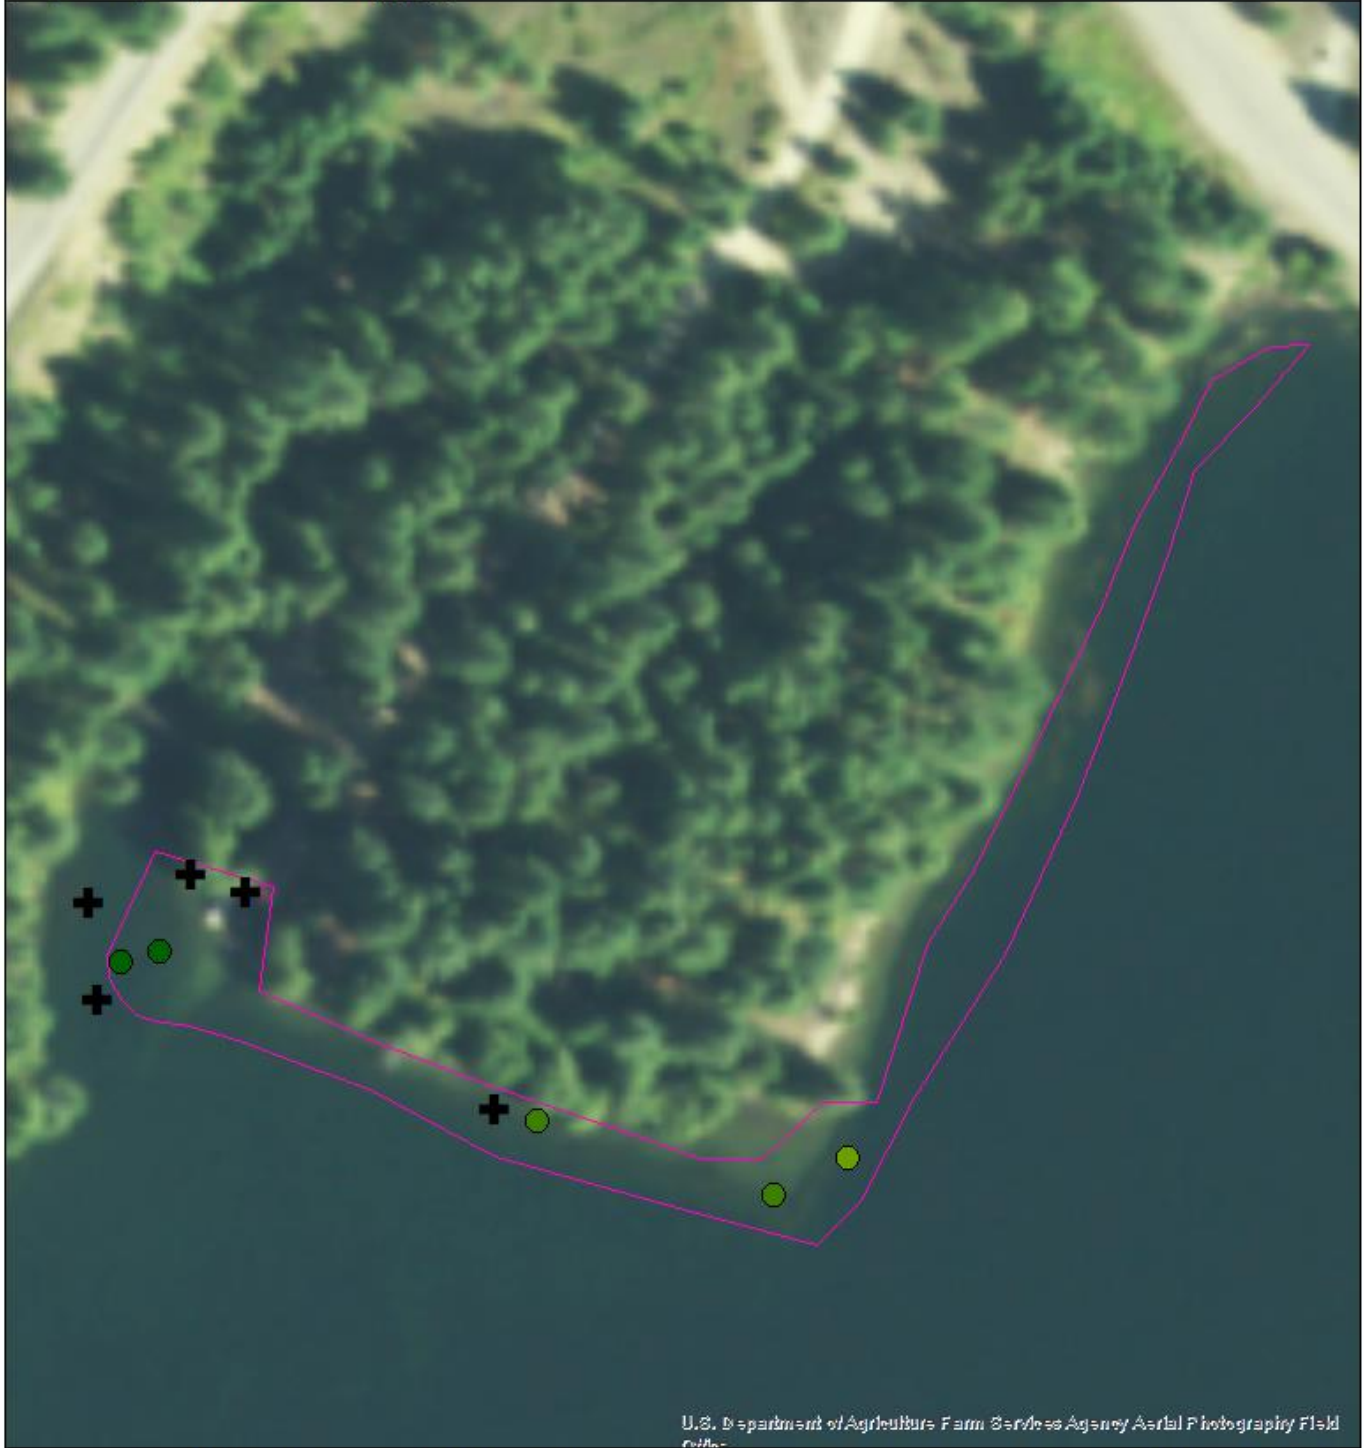
Plot: Nox-73

Nox 73 – 2-3meter wide band of dense EWM (80-100%) found from dock around corner to the north in 2-8' depths; low densities of curlyleaf pondweed.

Sample Results for Curlyleaf Pondweed Rank - (Percent Rake Fulness Range)

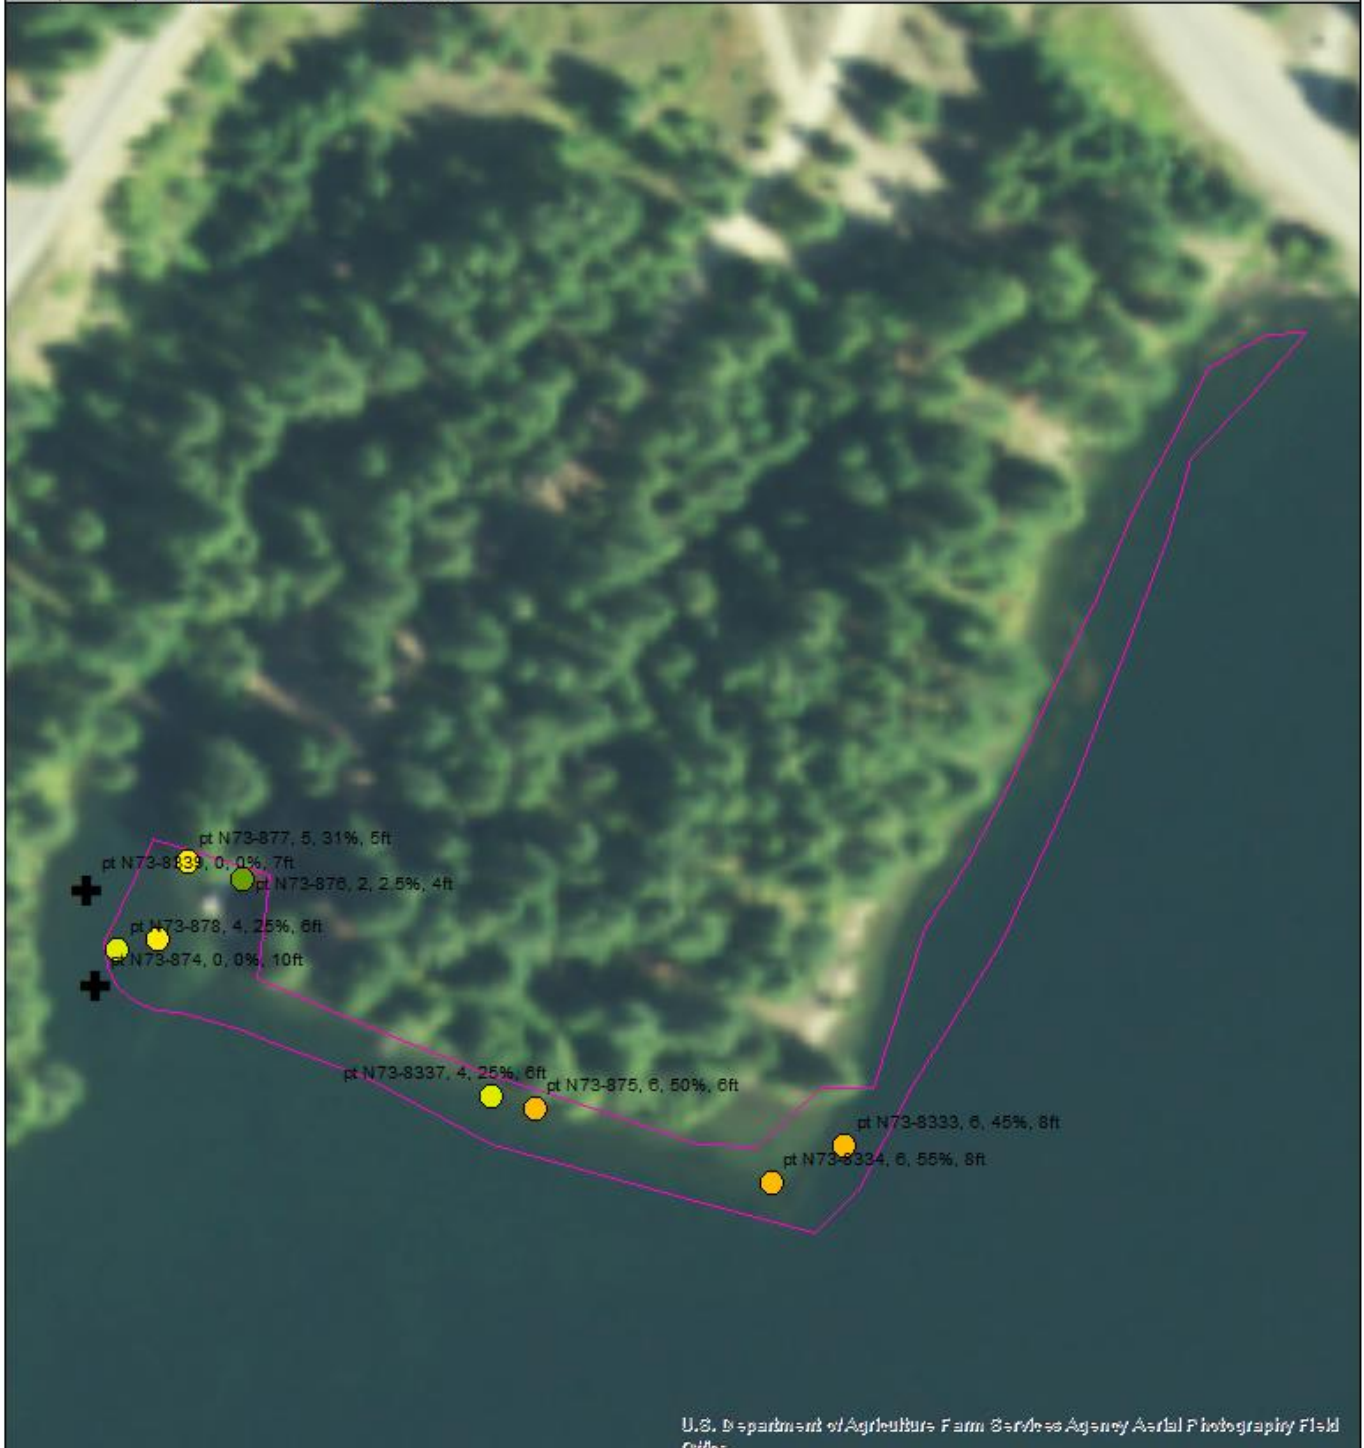
Plot: Nox-73

**Sample Results for Eurasian watermilfoil
Rank - (Percent Rake Fulness Range)**

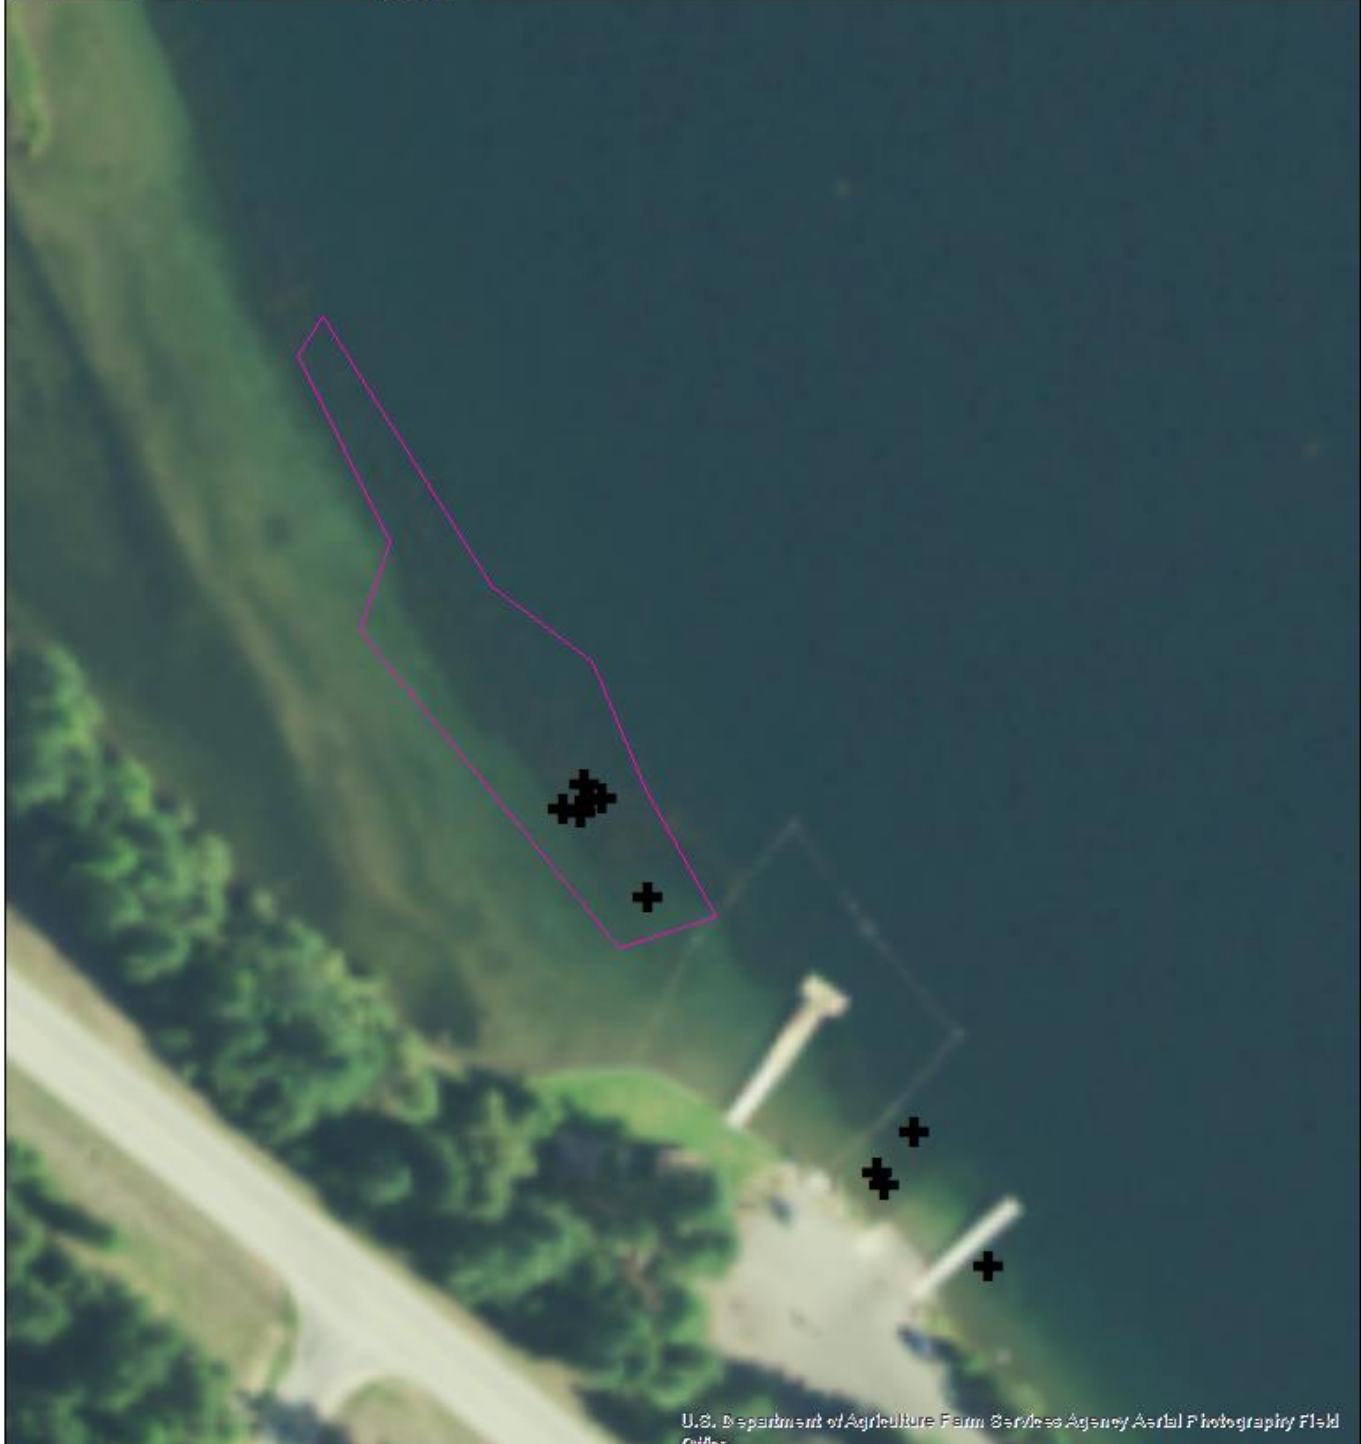
Plot: Nox-77

Nox 77 – No EWM found east of swim area; dense patch (80-90% cover) on northwestern edge of sampled area; no curlyleaf pondweed found.

Sample Results for Curlyleaf Pondweed Rank - (Percent Rake Fulness Range)

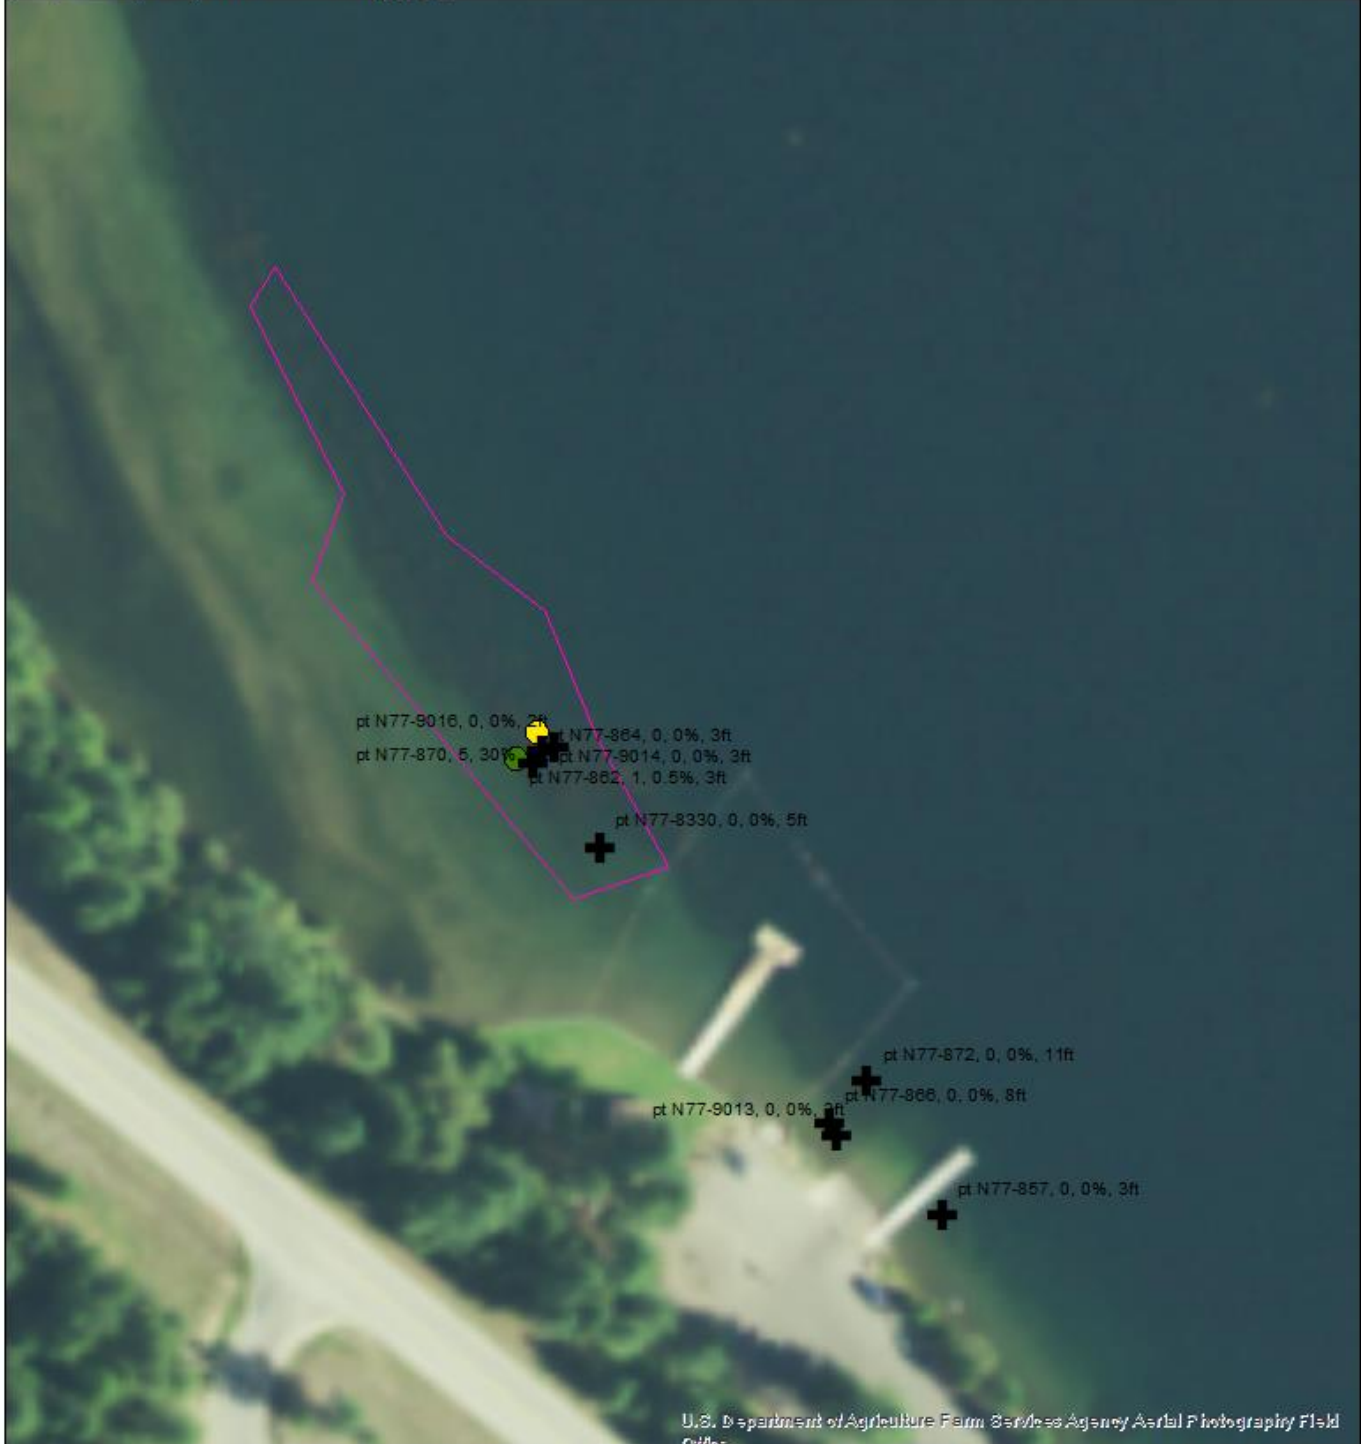
Plot: Nox-77

Sample Results for Eurasian watermilfoil Rank - (Percent Rake Fulness Range)

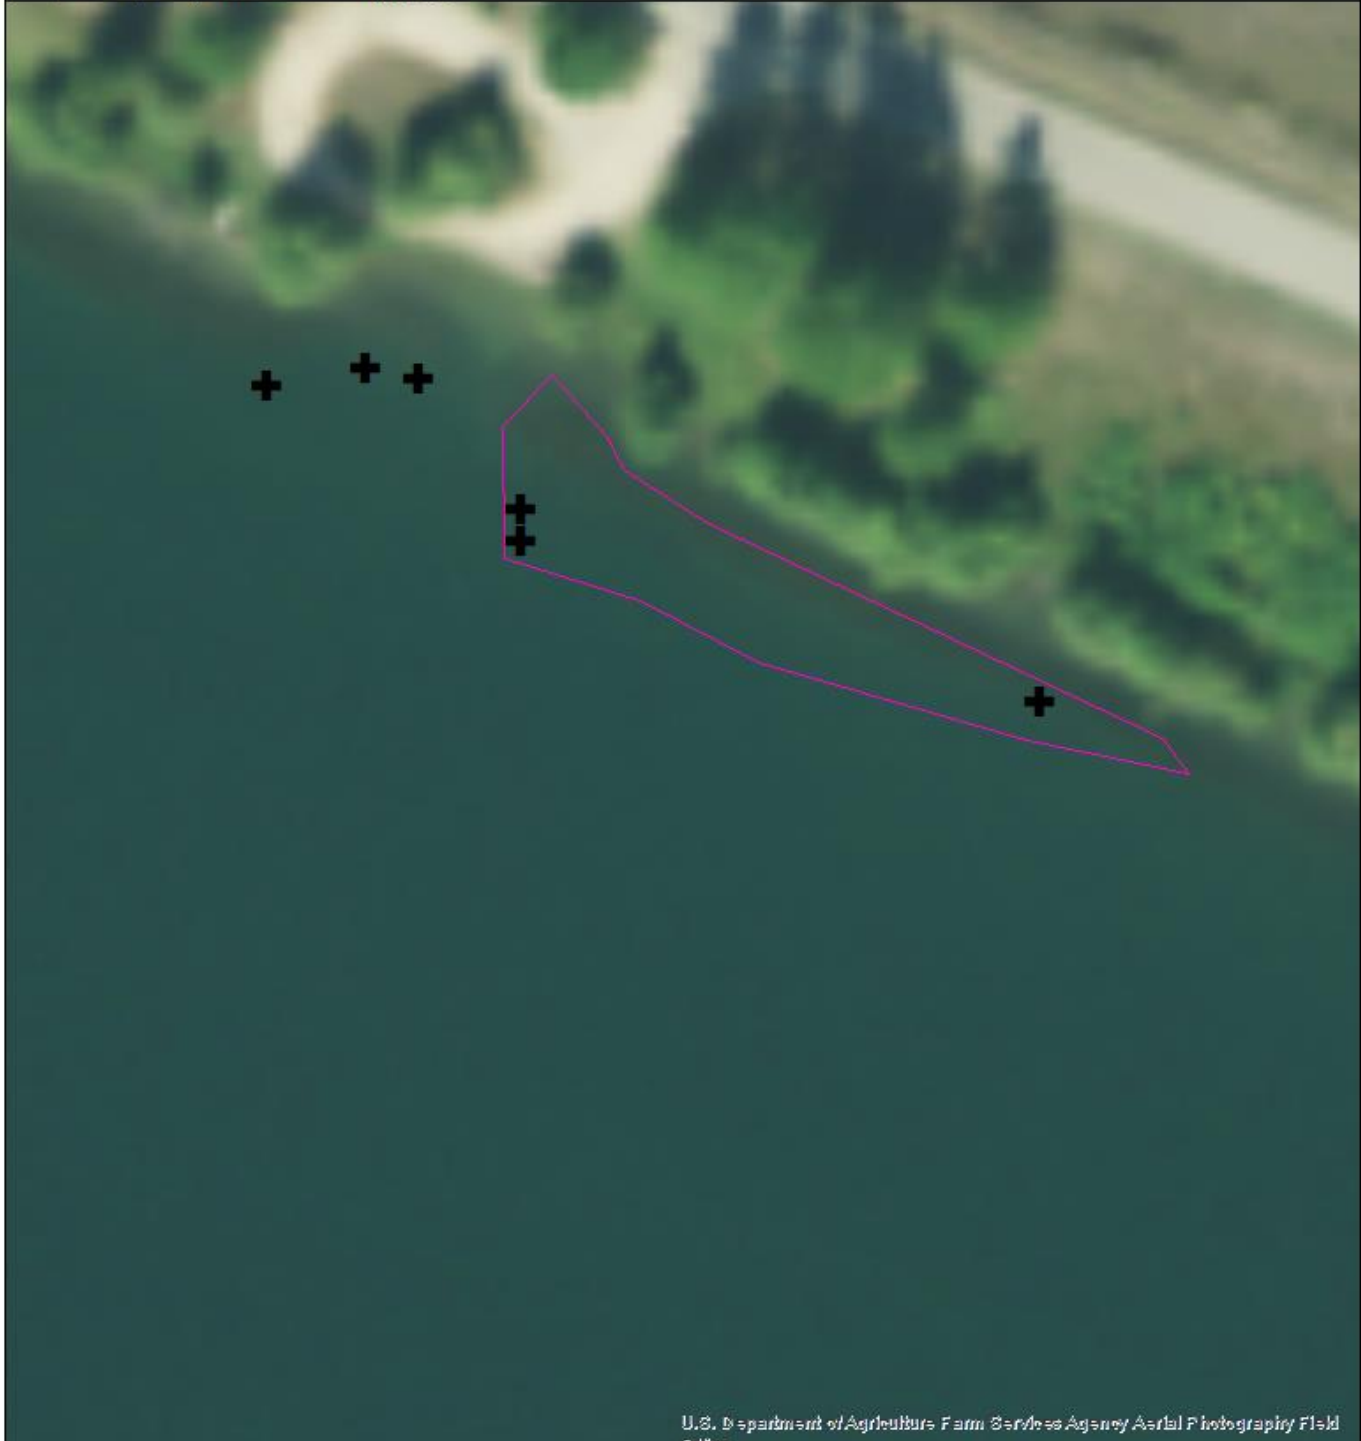
Plot: Nox-78

Nox 78 – Narrow 2m wide band with only denser patch right of ramp; no curlyleaf pondweed found

Sample Results for Curlyleaf Pondweed Rank - (Percent Rake Fulness Range)

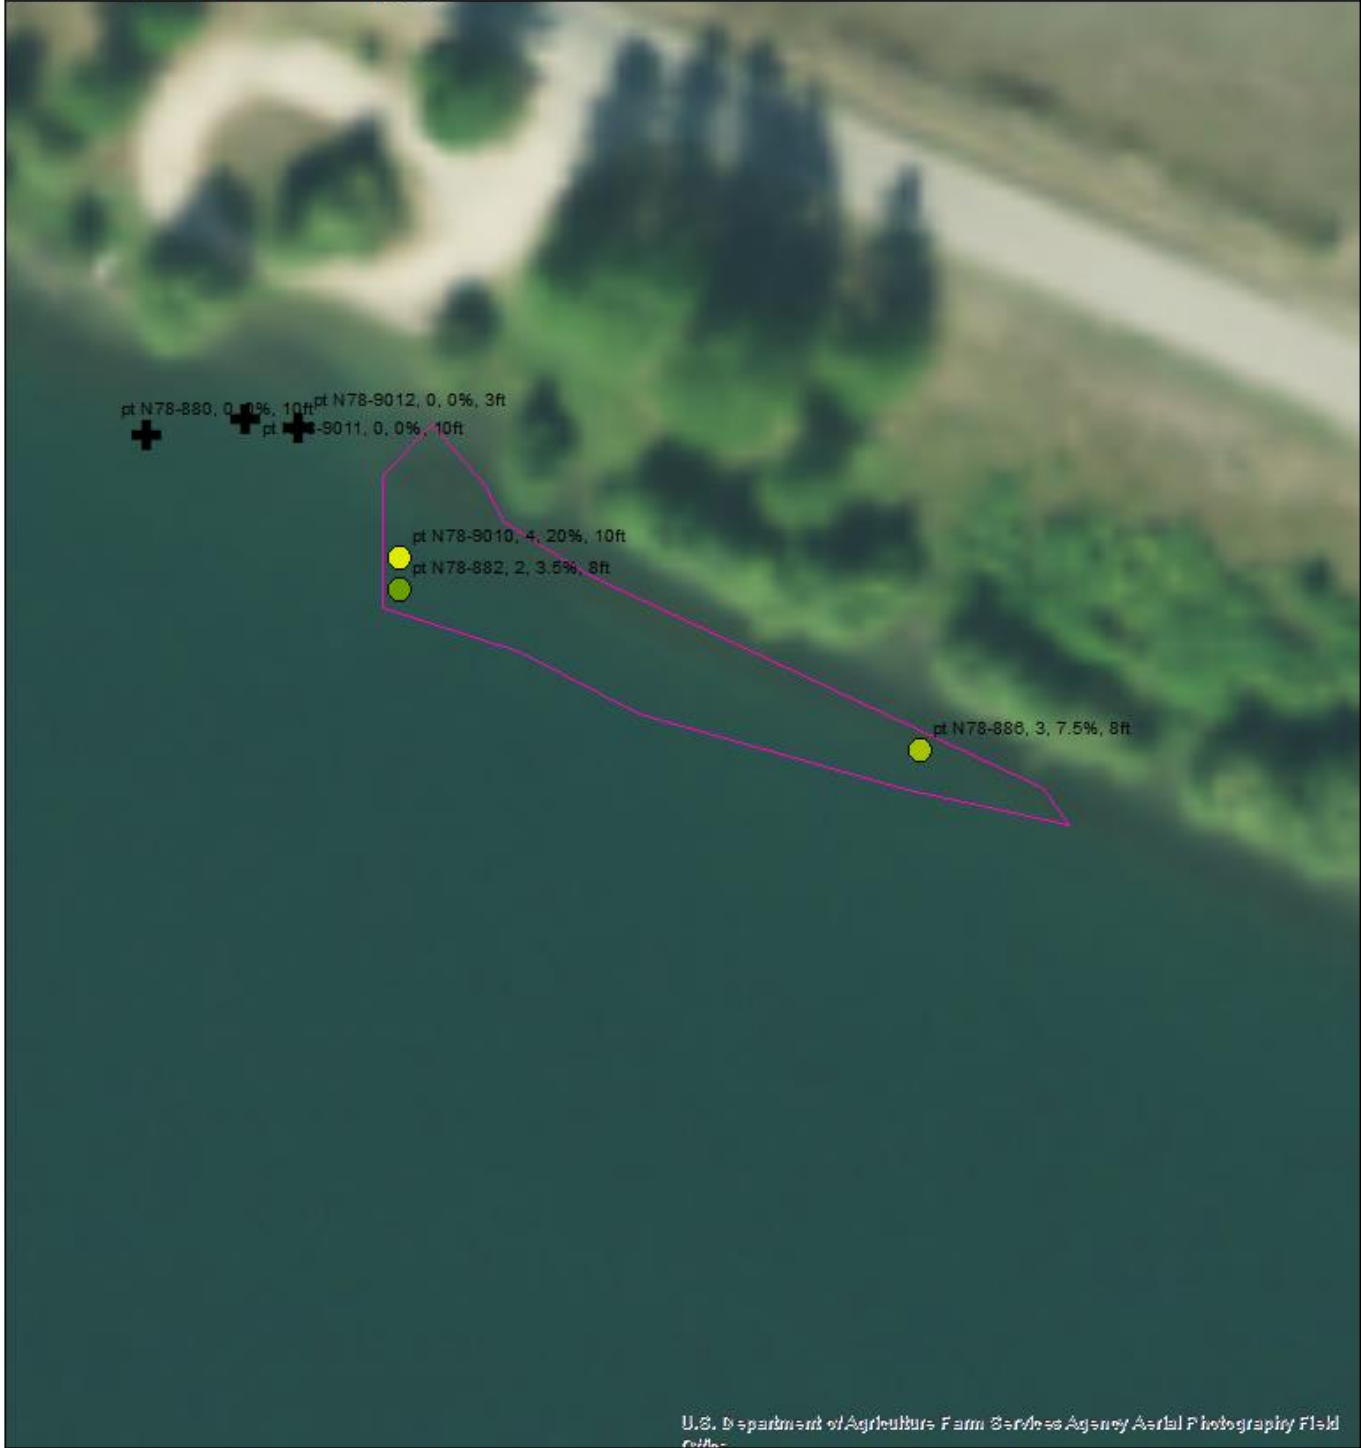
Plot: Nox-78

**Sample Results for Eurasian watermilfoil
Rank - (Percent Rake Fulness Range)**

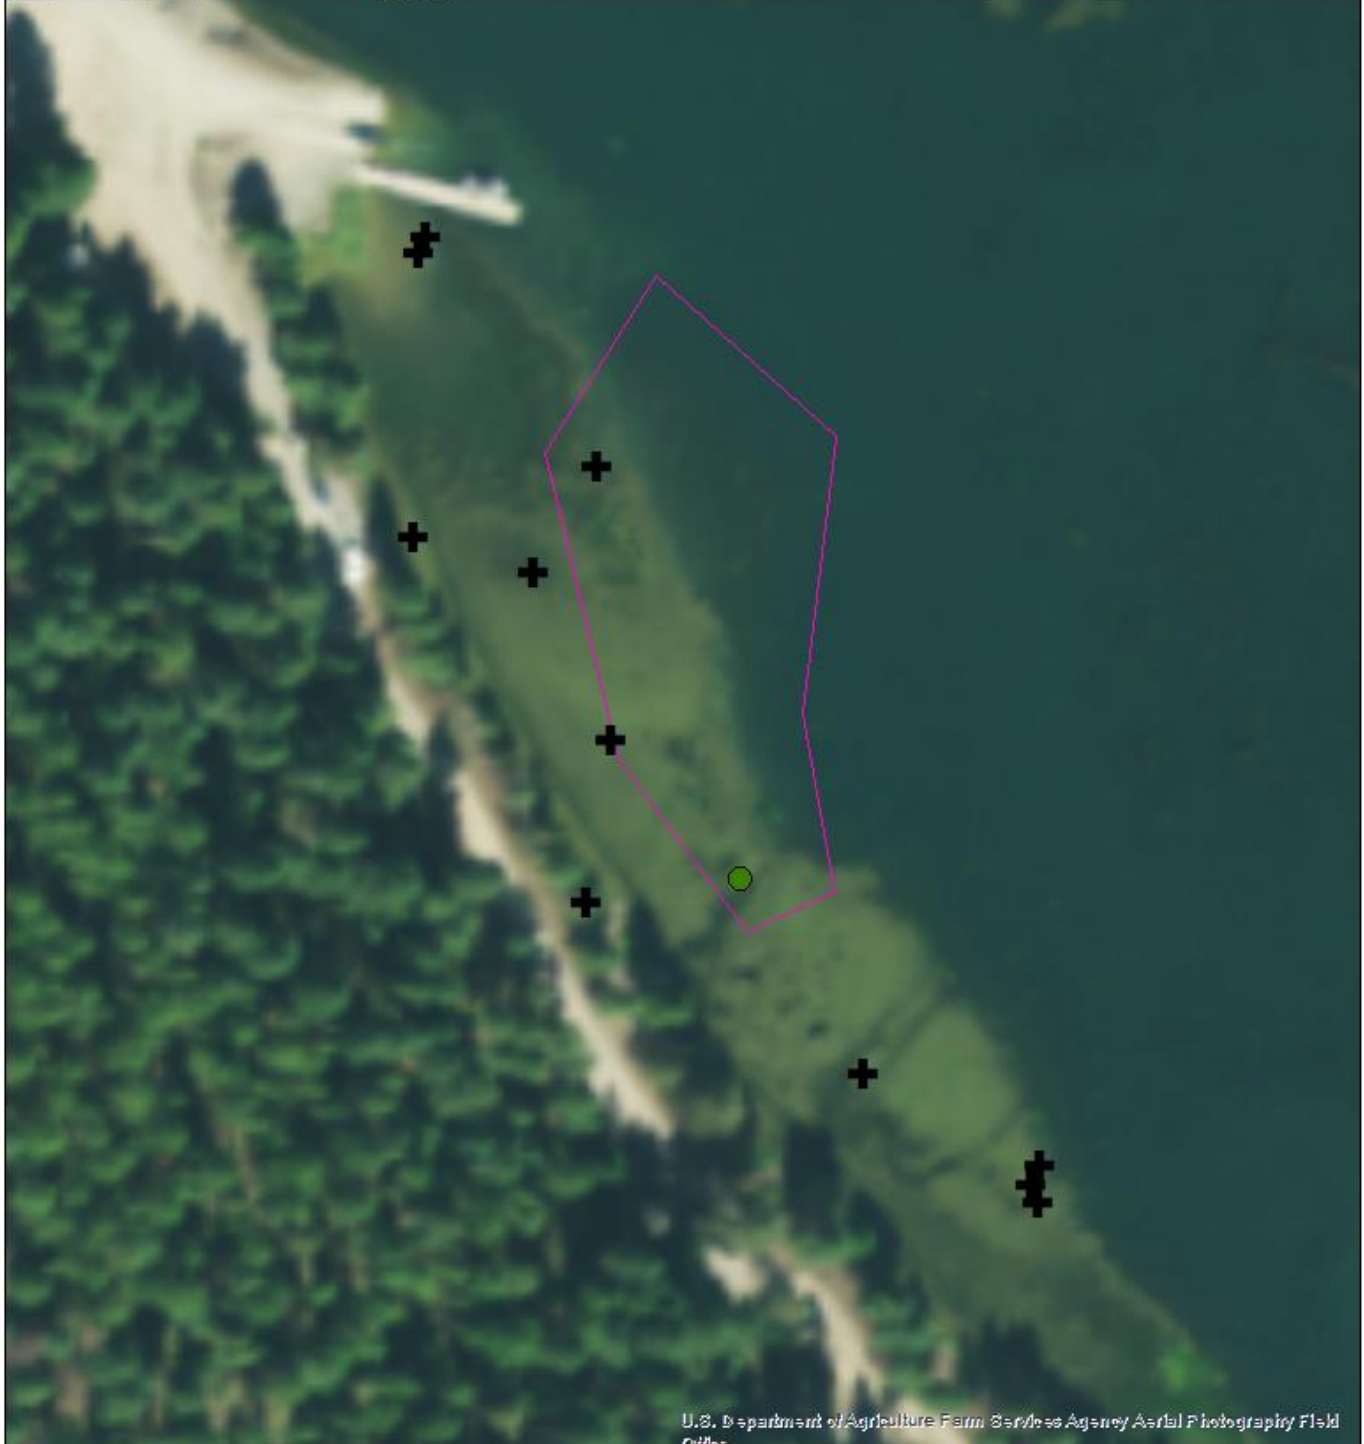
Plot: Nox-79

Nox 79 – Very little EWM found in sampled points; found a slightly denser patch out from boat ramp; almost no curlyleaf pondweed found.

Sample Results for Curlyleaf Pondweed Rank - (Percent Rake Fullness Range)

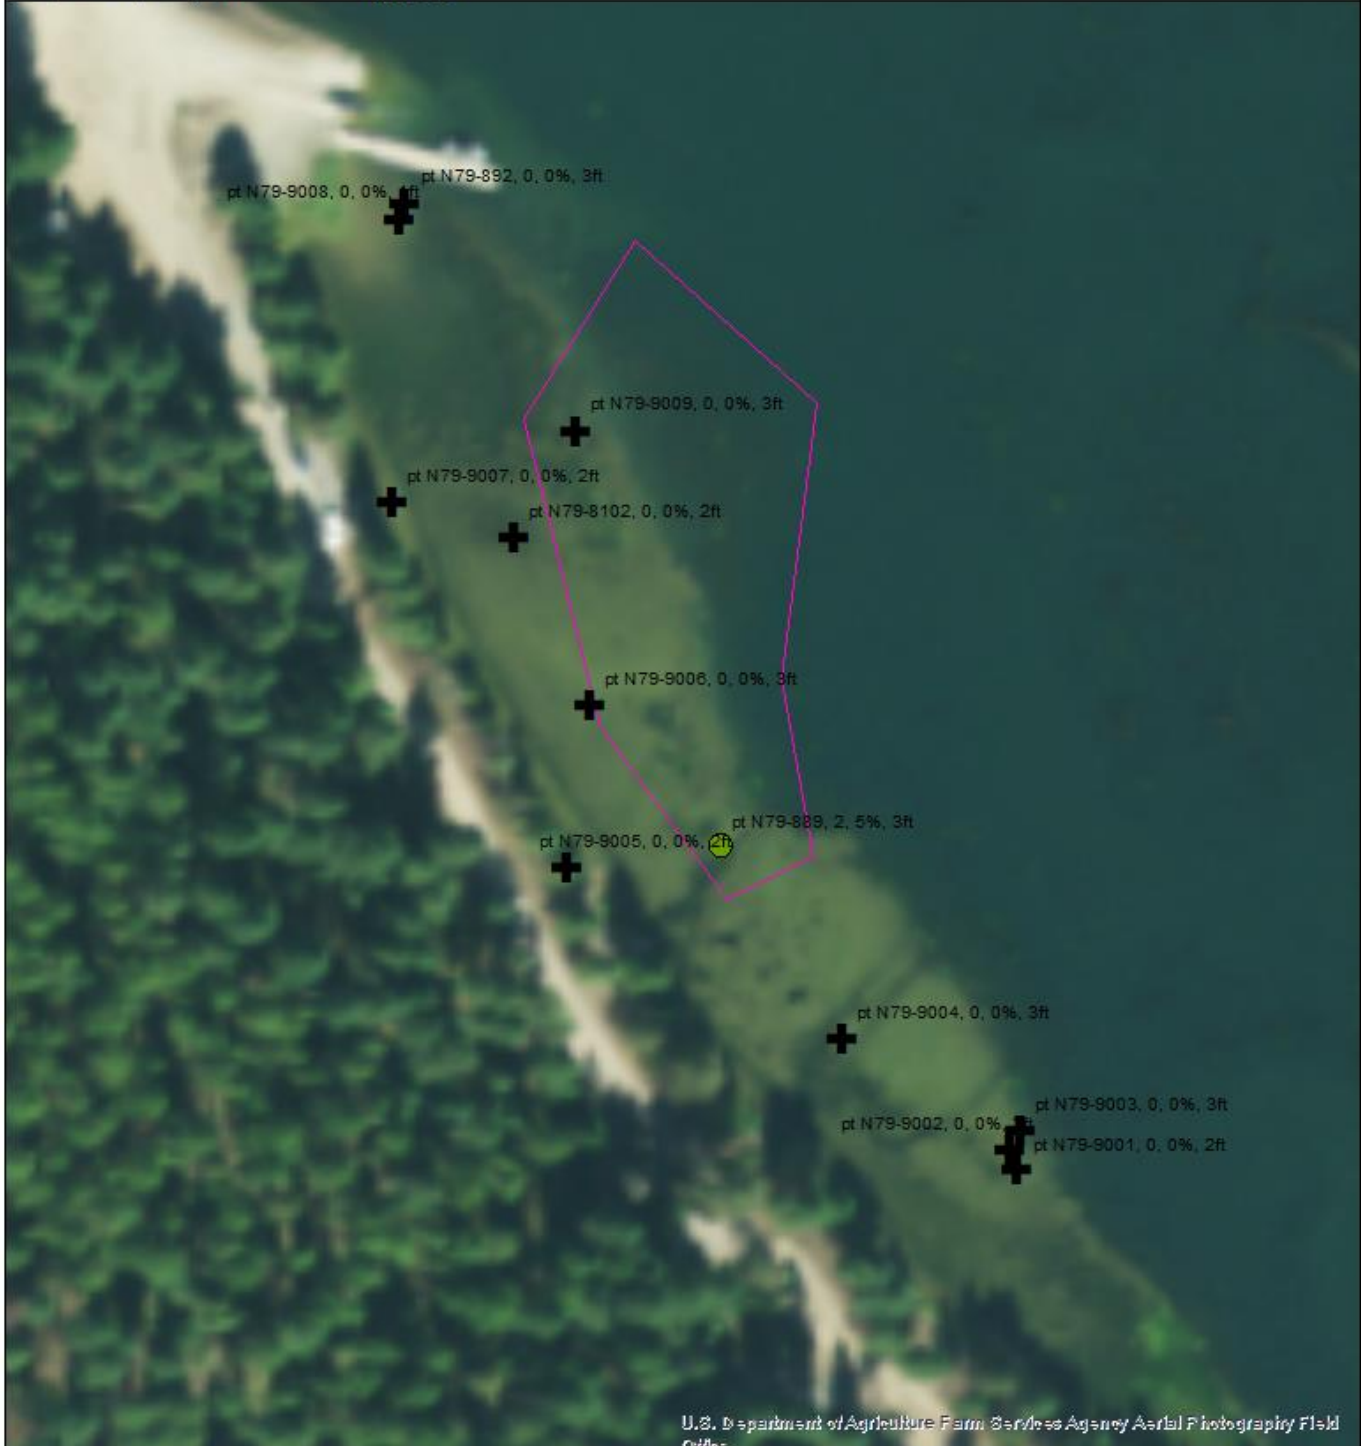
Plot: Nox-79

Sample Results for Eurasian watermilfoil Rank - (Percent Rake Fulness Range)
