**NOXON RAPIDS & CABINET GORGE RESERVOIRS
SANDERS COUNTY, MONTANA**

**2020 Aquatic Invasive Species (AIS)
Aquatic Pesticide Application Report (APAR)**

October 2020

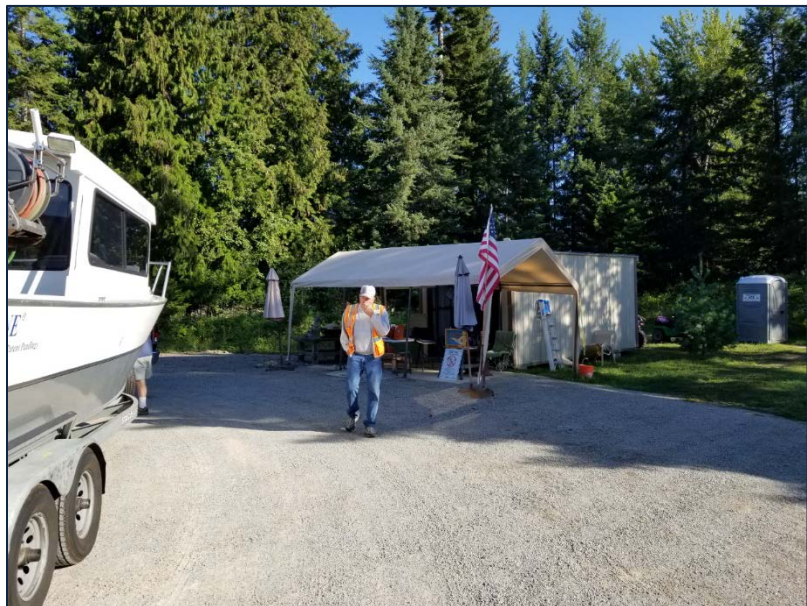
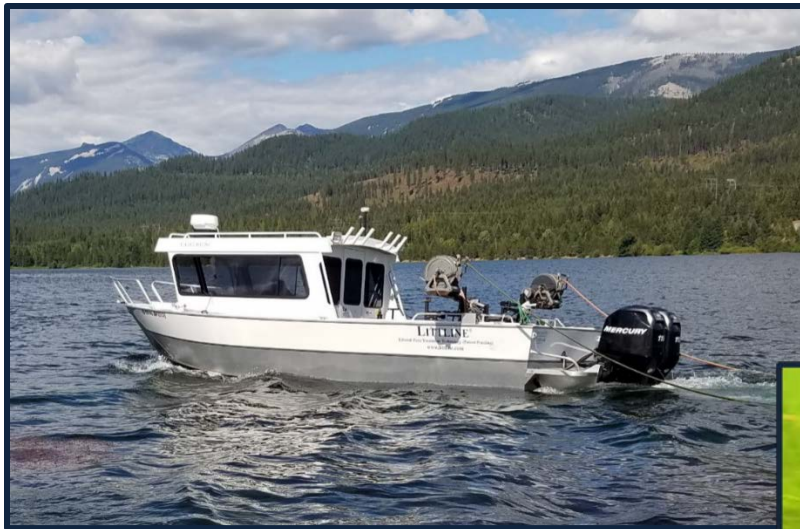
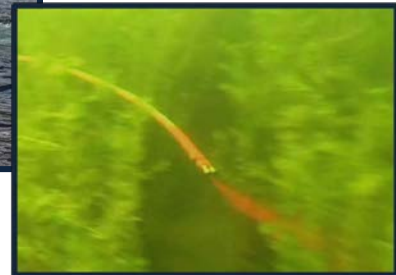
EQUIPMENT USED: A CLI Littoral Zone Treatment vessel (LittLine[®]) was used to perform the aquatic herbicide applications on August 10 and 11, 2020. The herbicide applications were made to the lower portion of the water column to increase herbicide concentration and exposure time (CET) relationships for the control of the target species. The application vessel was inspected on August 10, 2020 at the Clark Fork, Idaho Aquatic Invasive Species inspection station prior to entering Montana.

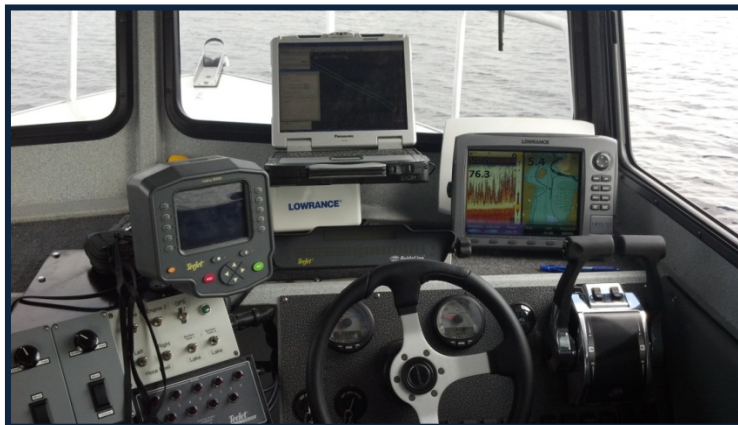
The AIS treatment area GIS shapefiles were loaded into the LittLine[®] computer system for vessel guidance and herbicide application data recording. The LittLine[®] can place herbicides at any depth within the water column (2 - 30 feet), as well as within the bottom 2 foot of the water

column. Impacts from currents, wind and wave action are reduced in deep water applications through the use of the LittLine[®] application system when compared to conventional subsurface applications. The herbicide application in all of the plots was within the bottom portion of the water column.

The LittLine system's computerized rate controllers regulate the aquatic herbicide applications through preset treatment rates. When the vessel speeds up and or slows down, the rate controllers adjust the herbicide application rate to match the preset rate in gallons of product per acre.

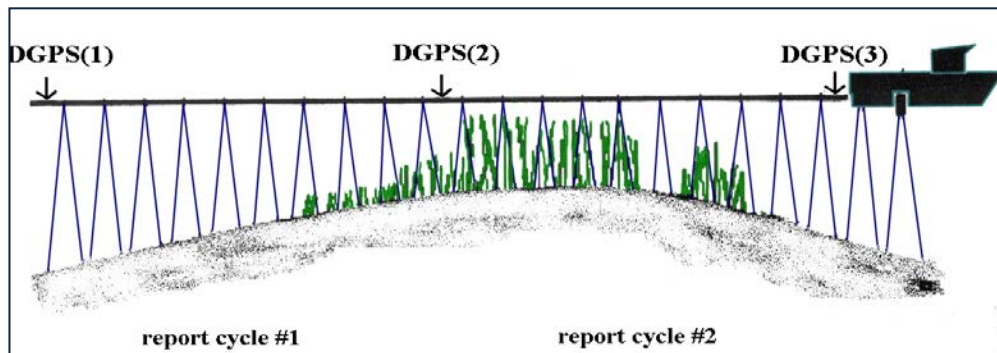
A Digital Echosounder System with a Structure Scan Module (Lowrance model) was used to record data of the submerged aquatic vegetation (SAV) profile in the control plots during treatment and during the post treatment survey. Data was collected in both the .SLG (traditional sonar on HDS line) and the .SL2 (multi-channel structure scan) formats. Due to an electronic technical difficulty, some plots in Cabinet Gorge reservoir were not captured.

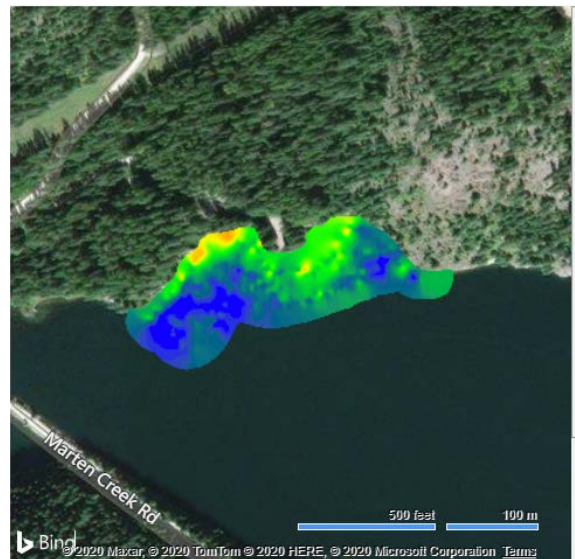
The sonar data collected was processed and analyzed for At Time of Treatment Submerged Aquatic Vegetation (SAV) in the treatment plots (August 10 and 11, 2020), and at six (6) Weeks Post Treatment (September 22, 2020). Some data could not be collected due to plant density or due to shallow water. Data was collected to compare At Time of Treatment to six (6) Week Post Treatment SAV coverage, height in the water column, and bio-volume to support post-treatment efficacy evaluations. An example of SAV conditions at time of treatment for Plot Nox-31, Noxon Reservoir, is pictured at right.

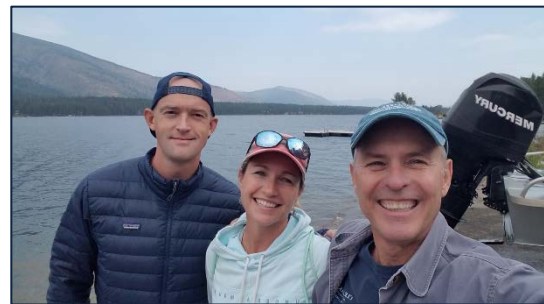
POST TREATMENT SURVEY: The Post Treatment survey was carried out by CLI (Tom Moorhouse and Drew McNabb), and a member of the Task Force (Kim Bergstrom) at Cabinet Gorge and Noxon Rapids Reservoir. Surveys were conducted through visual estimates of injury/control, through occasional rake tosses, and via the use of a Lowrance HDS-9 where depth allowed. Sonar logs were processed as described above. Water temperatures were approximately 64 F in both reservoirs on September 22, 2020. Table 3 provides information related to efficacy in each plot and compared to At-Time of Treatment and Post Treatment. Control. In Noxon Rapids Reservoir the change in SAV Biovolume (BV) shows a reduction range of 36% to 60%, while Post Treatment EWM Injury ranged from 85% to 100%. In Cabinet Gorge Reservoir the change in SAV Biovolume (BV) shows a 156% increase at CAB-12 due to large increase in native vegetation. Two plots could not be sampled due to plant density or shallow water levels. Post Treatment EWM Injury ranged from 90% to 100%.

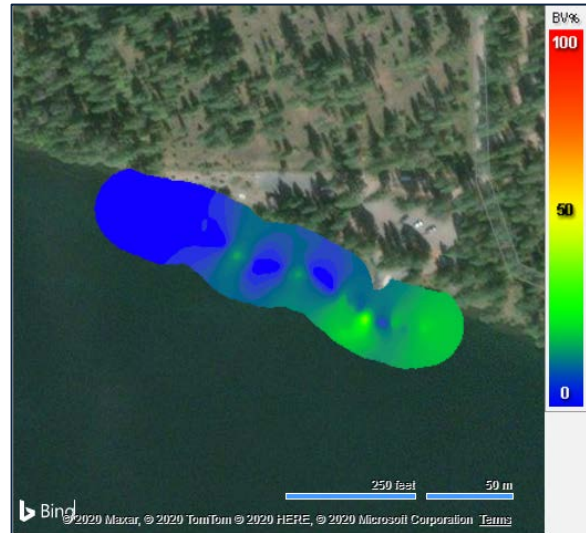
Plot NOX-03: At Time of Treatment (August 11, 2020 Left),
~ Six (6) Weeks Post (September 22, 2020 Right)

2020 Noxon Rapids Reservoir AIS Treatment Plots: At Time of and ~ Six (6) Week Post Plot SAV % Cover and SAV BioVolume Data (Grid Data)									
Plot Number	SAV % Cover	SAV % Bio-Volume	Date Data Collected Pre Treatment	SAV % Cover	SAV % Bio-Volume	Date Data Collected- Post Treatment	SAV % BV Change	Post Treatment EWM Injury Rank	Herbicides Used (Aquathol K/Tribune or Procellacor)
NOX-03	N/A	N/A	8/11/2020	42.1	12.6	9/22/2020	N/A	85-90% +/-	Endo/Diquat

Observations/Notes NOX-03: Treated with combination of endothall and diquat, control visually estimated at +/- 85 to 95%. Control excellent in downstream plot (~80% of area), poor control in upstream plot that was inside boomed swim area (~20% of area). Elodea in downstream part of plot. Consider treating further upstream in future treatments to allow application to drift/dissipate through the plot. At time of treatment August 11, 2020 image not available due to a technical issue.

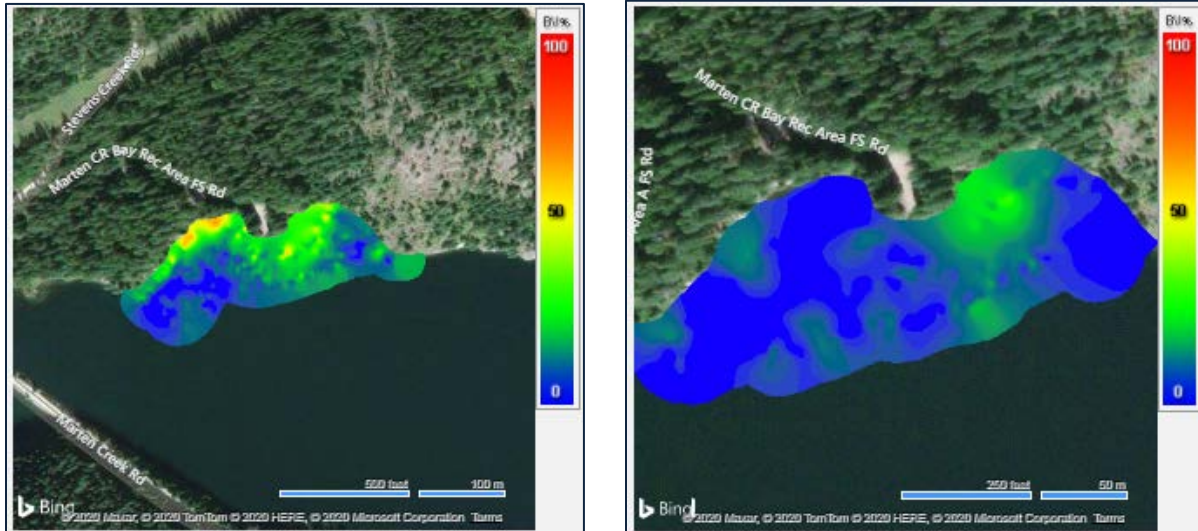
**Plot NOX-31: At Time of Treatment (August 11, 2020 Left),
~ Six (6) Weeks Post (September 22, 2020 Right)**

2020 Noxon Rapids Reservoir AIS Treatment Plots: At Time of and ~ Six (6) Week Post Plot SAV % Cover and SAV BioVolume Data (Grid Data)									
Plot Number	SAV % Cover	SAV % Bio-Volume	Date Data Collected Pre Treatment	SAV % Cover	SAV % Bio-Volume	Date Data Collected-Post Treatment	SAV % BV Change	Post Treatment EWM Injury Rank	Herbicides Used (Aquathol K/Tribune or Procellacor)
NOX-31	67.0	18.9	8/11/2020	24.2	12.1	9/22/2020	-36%	100%	Endo/Diquat

Observations/Notes NOX-31: Treated with combination of endothall and diquat, control visually estimated at 100% control. No plants visible at or near surface. Rake toss consisted of Coontail and Elodea.

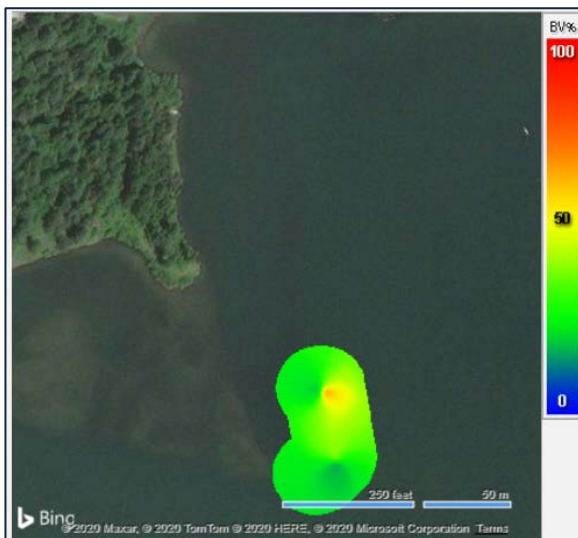
Plot CAB-06: At Time of Treatment (August 10, 2020 Left),
~ Six (6) Weeks Post (September 22, 2020 Right)

2020 Cabinet Gorge Reservoir AIS Treatment Plots: At Time of and ~ Six (6) Week Post Plot SAV % Cover and SAV BioVolume Data (Grid Data)									
Plot Number	SAV % Cover	SAV % Bio-Volume	Date Data Collected Pre Treatment	SAV % Cover	SAV % Bio-Volume	Date Data Collected-Post Treatment	SAV % BV Change	Post Treatment EWM Injury Rank	Herbicides Used (Aquathol K/Tribune or Procellacor)
CAB-06	100	32.8	8/10/2020	100.0	At Surface	9/22/2020	N/A	90 - 95% +/-	Endo/Diquat

Observations/Notes CAB-06: Treated with combination of endothall and diquat, control visually estimated at +/-90 to 95%. Coontail and Elodea present and dominate. EWM present and scattered, not abundant. Plot not surveyed by sonar on September 22, 2020 due submersed aquatic vegetation on surface throughout plot. At time of treatment sonar and associated map impacted by plant density.

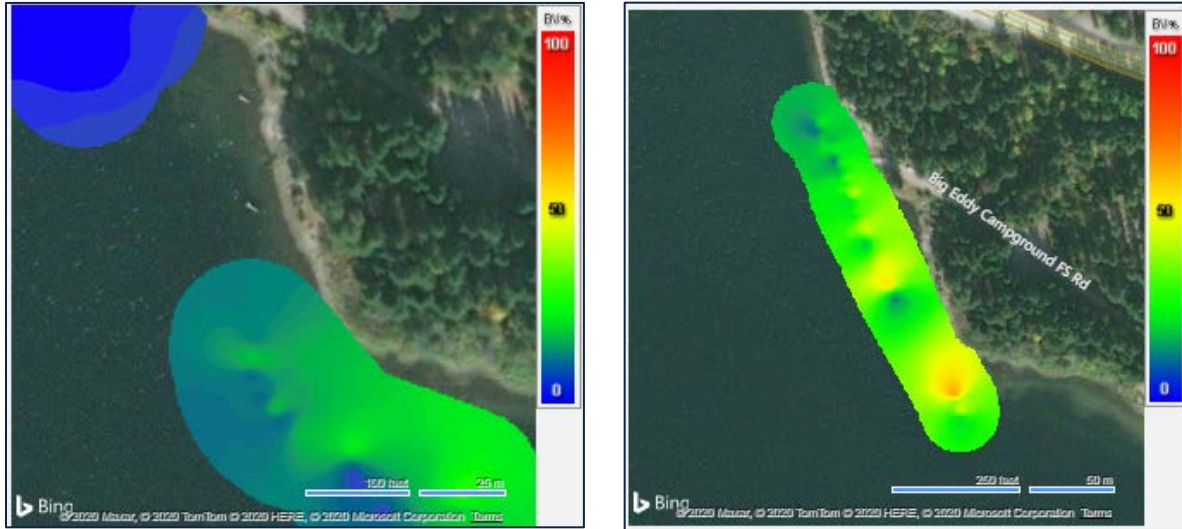
**Plot CAB-12: At Time of Treatment (August 10, 2020 Left),
~ Six (6) Weeks Post (September 22, 2020 Right)**

2020 Cabinet Gorge Reservoir AIS Treatment Plots: At Time of and ~ Six (6) Week Post Plot SAV % Cover and SAV BioVolume Data (Grid Data)									
Plot Number	SAV % Cover	SAV % Bio-Volume	Date Data Collected Pre Treatment	SAV % Cover	SAV % Bio-Volume	Date Data Collected-Post Treatment	SAV % BV Change	Post Treatment EWM Injury Rank	Herbicides Used (Aquathol K/Tribune or Procellacor)
CAB-12	66.6	13.2	8/10/2020	100.0	33.8	9/22/2020	156%	100%	Endo/Diquat

Observations/Notes CAB-12: Treated with combination of endothall and diquat, control visually estimated at 100%. Looks great. Elodea dominates and Coontail present post treatment. Some EWM fragments present in plots from river current.

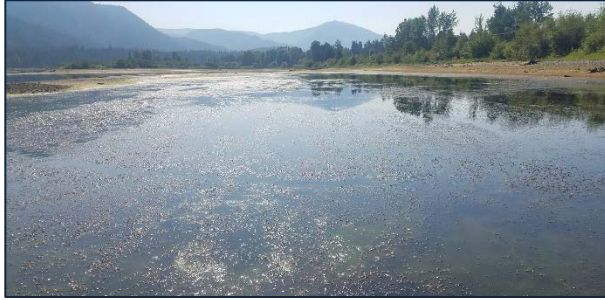
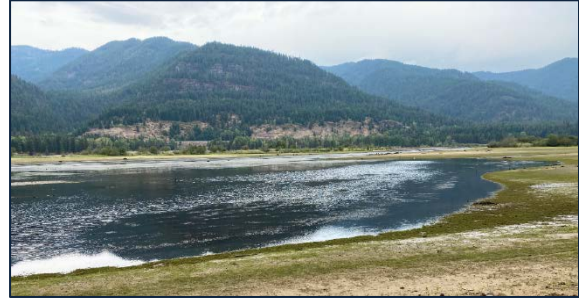
**Plot CAB-30: At Time of Treatment (August 10, 2020 Left),
~ Six (6) Weeks Post (September 22, 2020 Right)**

No Sonar data available on August 10, 2020 due shallowness at time of treatment. Picture at right was taken on August 7, 2020 by wading into plot. No data available on September 22, 2020 due inability to access the treatment site due low water. Picture at right taken from shoreline on September 22, 2020.

Observations/Notes CAB-30: Treated with combination of endothall and diquat, control visually could not be estimated due to inaccessibility into plot by boat. Submersed aquatic vegetation visible, species unknown.
