**NOXON RAPIDS RESERVOIR  
SANDERS COUNTY, MONTANA**

**2022 Aquatic Invasive Species (AIS)  
Aquatic Pesticide Application Report (APAR)**

Prepared By:  
**CLEAN LAKES INC.**

September 2022

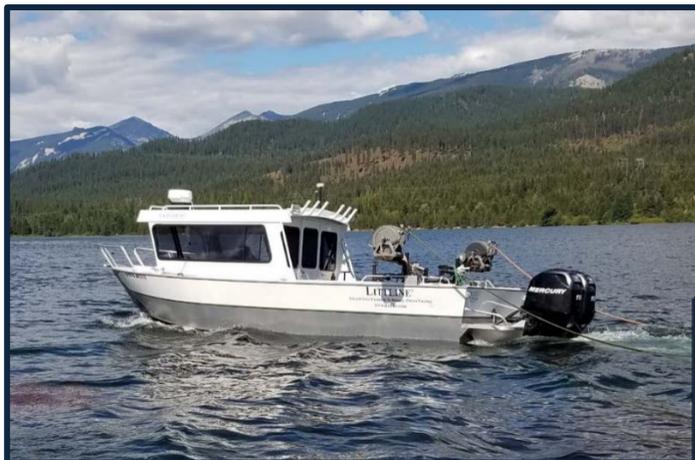
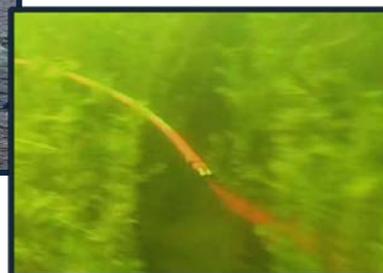
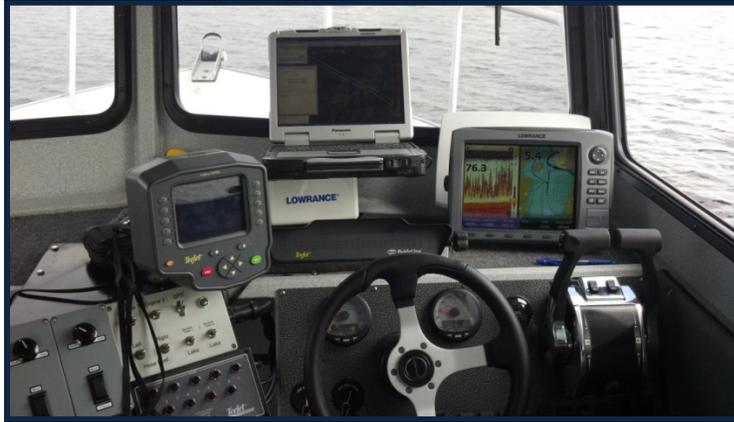
**EQUIPMENT USED:** A CLI Littoral Zone Treatment vessel (LittLine®) was used to perform the aquatic herbicide applications on August 4, 2022. The herbicide applications were made to the lower portion of the water column to increase herbicide concentration and exposure time (CET) relationships for the control of the target species. The application vessel was inspected on August 4, 2022 at the Clark Fork, Idaho Aquatic Invasive Species inspection station prior to entering Montana.

The AIS treatment area GIS shapefiles were loaded into the LittLine® GPS system for vessel guidance and herbicide application data recording. The LittLine® can place herbicides at any depth within the water column (2 - 30 feet), as well as within the bottom 2 foot of the water

column. Impacts from currents, wind and wave action are reduced in deep water applications through the use of the LittLine® application system when compared to conventional subsurface applications. The herbicide application in all of the plots was within the bottom portion of the water column.

The LittLine system's computerized rate controllers regulate the aquatic herbicide applications through preset treatment rates.

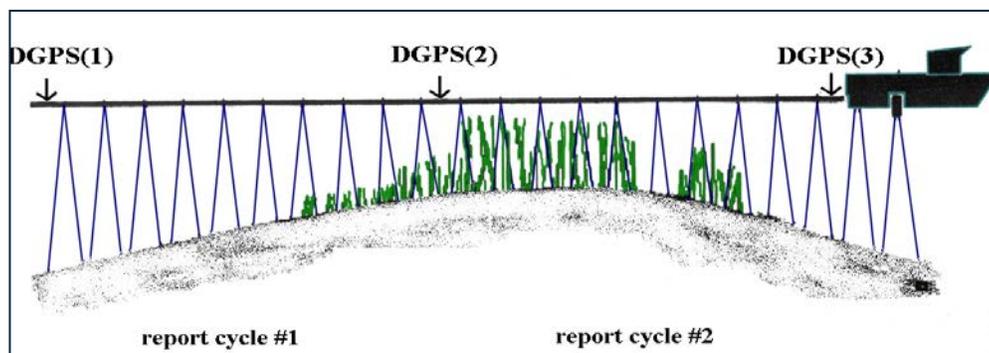
A Digital Echosounder System with a Structure Scan Module (Lowrance model) was used to record data of the submerged aquatic vegetation (SAV) profile in the control plots during treatment and during the post treatment survey. Data was collected in both the .SLG (traditional sonar on HDS line) and the .SL2 (multi-channel structure scan) formats.

The sonar data collected was processed and analyzed for At Time of Treatment Submerged Aquatic Vegetation (SAV) in the treatment plots (August 4, 2022), and at six (6) Weeks Post Treatment (September 15, 2022). Data was collected to compare At Time of Treatment to six (6)

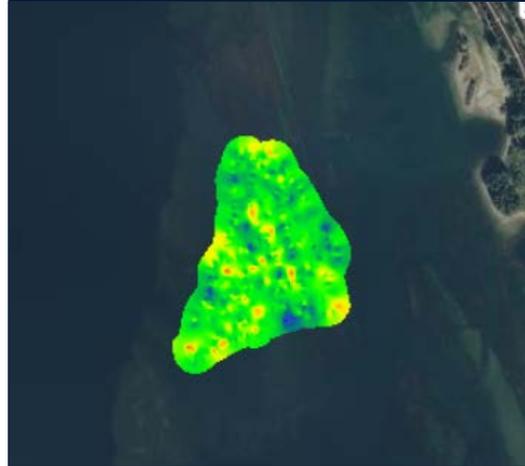
Week Post Treatment SAV coverage, height in the water column, and bio-volume to support post-treatment efficacy evaluations. An example of SAV conditions At Time of Treatment for NOX-01, Noxon Reservoir, is pictured right.

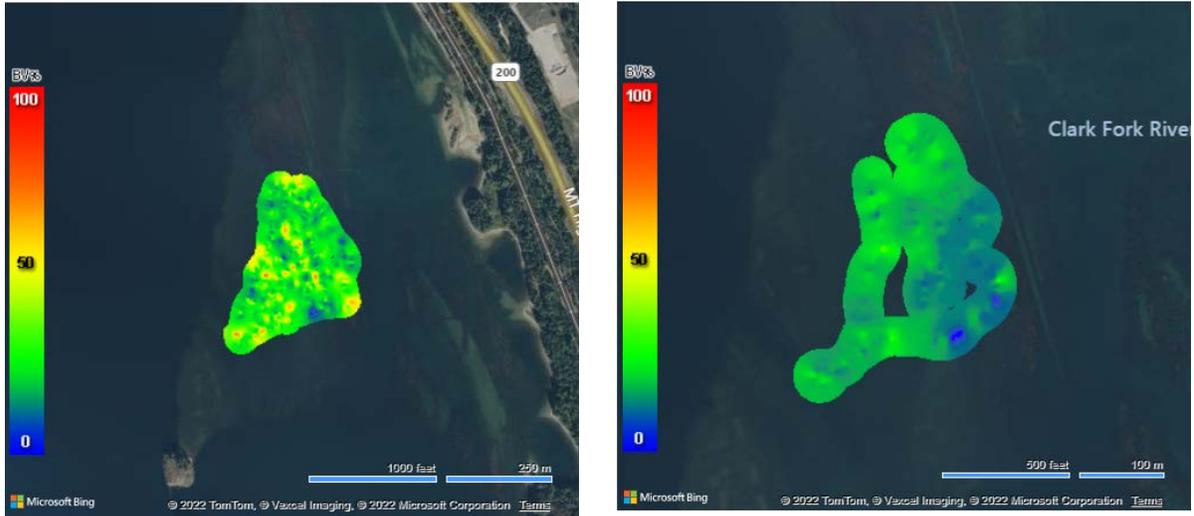
Plot NOX-1: At Time of Treatment (August 4, 2022 Left),  
~ Six (6) Weeks Post (September 15, 2022 Right)

2022 Noxon Rapids Reservoir AIS Treatment Plots: At Time of and ~ Six (6) Week Post Plot SAV % Cover and SAV BioVolume Data (Grid Data)									
Plot Number	SAV % Cover	SAV % Bio-Volume	Date Data Collected Pre Treatment	SAV % Cover	SAV % Bio-Volume	Date Data Collected-Post Treatment	SAV % BV Change	Post Treatment EWM Injury Rank	Herbicides Used (Aquathol K/Tribune)
<b>Noxon Rapids</b>									
NOX-1	99.3	28.9	8/4/2022	98.2	15.1	9/15/2022	-48%	95%	Endo/Diquat

**Observations/Notes NOX-1:** Treated with combination of endothall and diquat, control visually estimated at +/- 95%. Control excellent throughout plot. Some EWM at edges. Widespread Chara visible on bottom, and Coontail present.

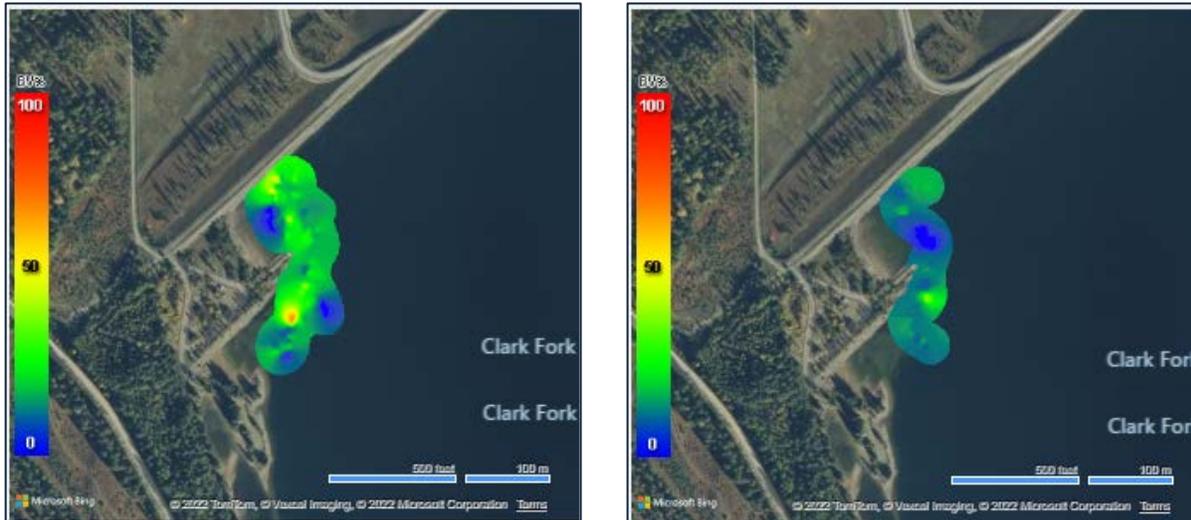
**Plot NOX-52: At Time of Treatment (August 4, 2022 Left),  
~ Six (6) Weeks Post (September 15, 2022 Right)**

2022 Noxon Rapids Reservoir AIS Treatment Plots: At Time of and ~ Six (6) Week Post Plot SAV % Cover and SAV BioVolume Data (Grid Data)									
Plot Number	SAV % Cover	SAV % Bio-Volume	Date Data Collected Pre Treatment	SAV % Cover	SAV % Bio-Volume	Date Data Collected-Post Treatment	SAV % BV Change	Post Treatment EWM Injury Rank	Herbicides Used (Aquathol K/Tribune)
<b>Noxon Rapids</b>									
NOX-52	86.9	19.8	8/4/2022	79.3	10.6	9/15/2022	-46%	100%	Endo/Diquat

**Observations/Notes NOX-52:** Treated with combination of endothall and diquat, control visually estimated at +/- 100%. Control excellent throughout plot. Native plants visible and tall.

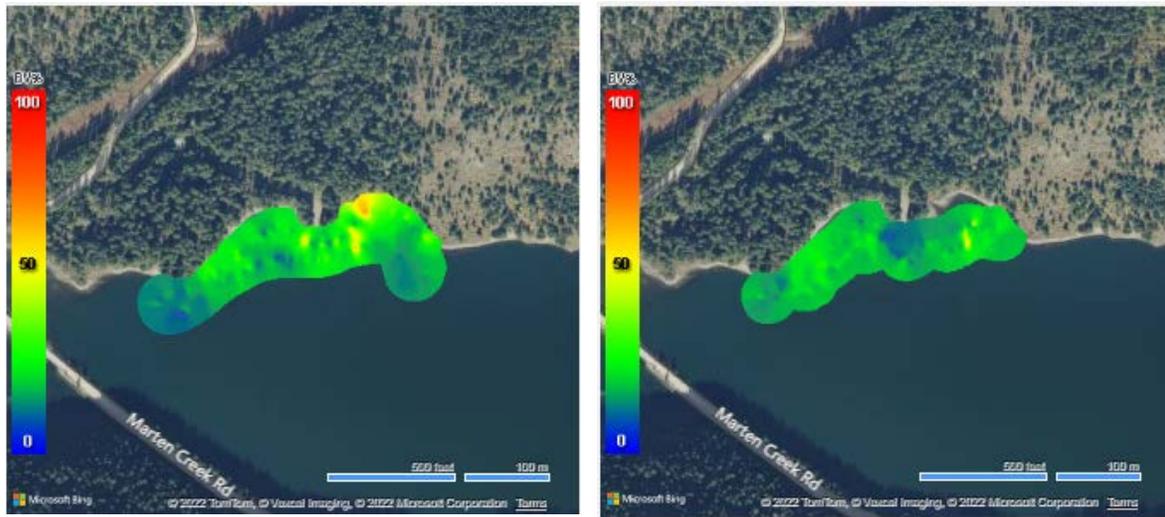
**Plot NOX-31: At Time of Treatment (August 4, 2022 Left),  
~ Six (6) Weeks Post (September 15, 2022 Right)**

2022 Noxon Rapids Reservoir AIS Treatment Plots: At Time of and ~ Six (6) Week Post Plot SAV % Cover and SAV BioVolume Data (Grid Data)									
Plot Number	SAV % Cover	SAV % Bio-Volume	Date Data Collected Pre Treatment	SAV % Cover	SAV % Bio-Volume	Date Data Collected-Post Treatment	SAV % BV Change	Post Treatment EWM Injury Rank	Herbicides Used (Aquathol K/Tribune)
<b>Noxon Rapids</b>									
NOX-31	99.1	21.2	8/4/2022	99.3	18.4	9/15/2022	-13%	98%	Endo/Diquat

**Observations/Notes NOX-31:** Treated with combination of endothall and diquat, control visually estimated at +/- 98%. Control looks very good, abundant Coontail present in plot, dead EWM stems on rake toss. Floating fragments of EWM present.

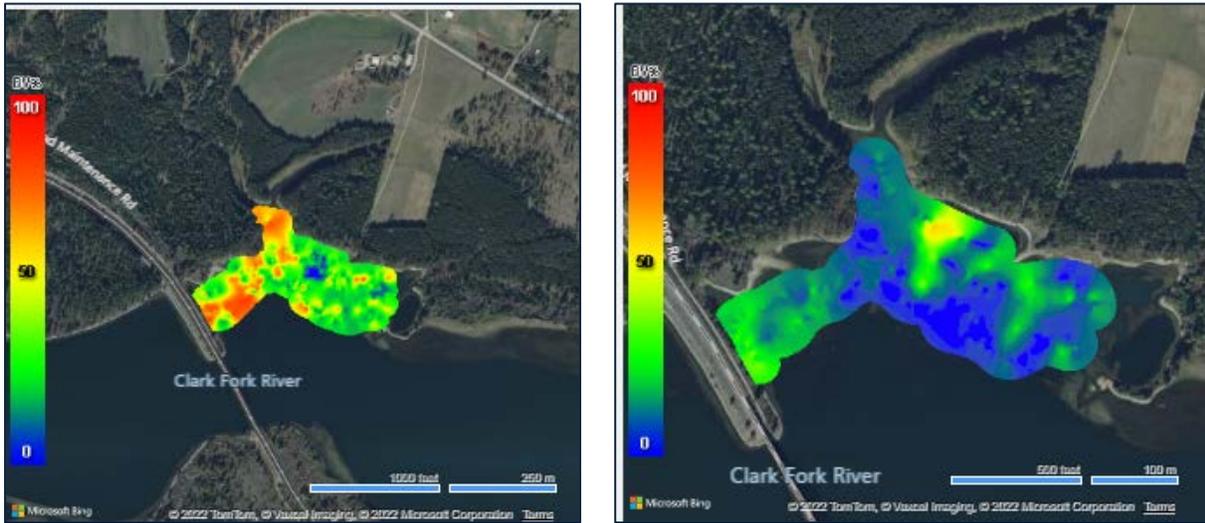
**Plot NOX-11: At Time of Treatment (August 4, 2022 Left),  
~ Six (6) Weeks Post (September 15, 2022 Right)**

2022 Noxon Rapids Reservoir AIS Treatment Plots: At Time of and ~ Six (6) Week Post Plot SAV % Cover and SAV BioVolume Data (Grid Data)									
Plot Number	SAV % Cover	SAV % Bio-Volume	Date Data Collected Pre Treatment	SAV % Cover	SAV % Bio-Volume	Date Data Collected-Post Treatment	SAV % BV Change	Post Treatment EWM Injury Rank	Herbicides Used (Aquathol K/Tribune)
<b>Noxon Rapids</b>									
NOX-11	98.1	40.4	8/4/2022	59.4	16.1	9/15/2022	-60%	95%	Endo/Diquat

**Observations/Notes NOX-11:** Treated with combination of endothall and diquat, control visually estimated at +/- 95%. Control very good, Coontail present with some Spirogyra (filamentous algae) making visual estimation difficult do to similarities in appearance to EWM. West end of plot near railroad track had EWM still present, but obviously damaged.

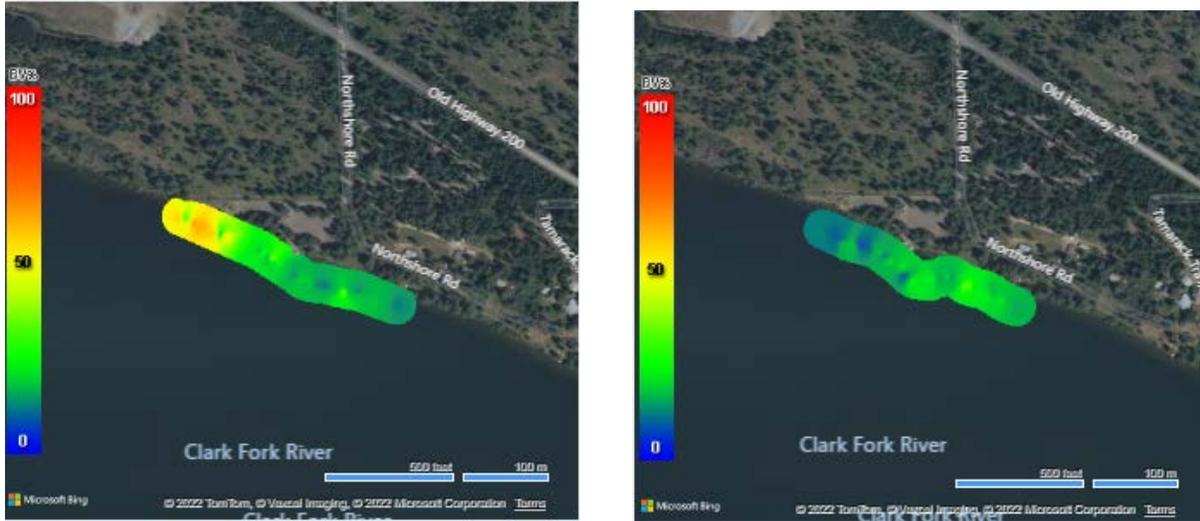
**Plot NOX-03: At Time of Treatment (August 4, 2022 Left),  
~ Six (6) Weeks Post (September 15, 2022 Right)**

2022 Noxon Rapids Reservoir AIS Treatment Plots: At Time of and ~ Six (6) Week Post Plot SAV % Cover and SAV BioVolume Data (Grid Data)									
Plot Number	SAV % Cover	SAV % Bio-Volume	Date Data Collected Pre Treatment	SAV % Cover	SAV % Bio-Volume	Date Data Collected- Post Treatment	SAV % BV Change	Post Treatment EWM Injury Rank	Herbicides Used (Aquathol K/Tribune)
<b>Noxon Rapids</b>									
NOX-3	100.0	28.3	8/4/2022	98.7	16.8	9/15/2022	-41%	98%	Endo/Diquat

**Observations/Notes NOX-03:** Treated with combination of endothall and diquat, control visually estimated at +/- 98 % control. Some EWM present at very end of plot, otherwise excellent control. Some SAV present. EWM floating fragments present.

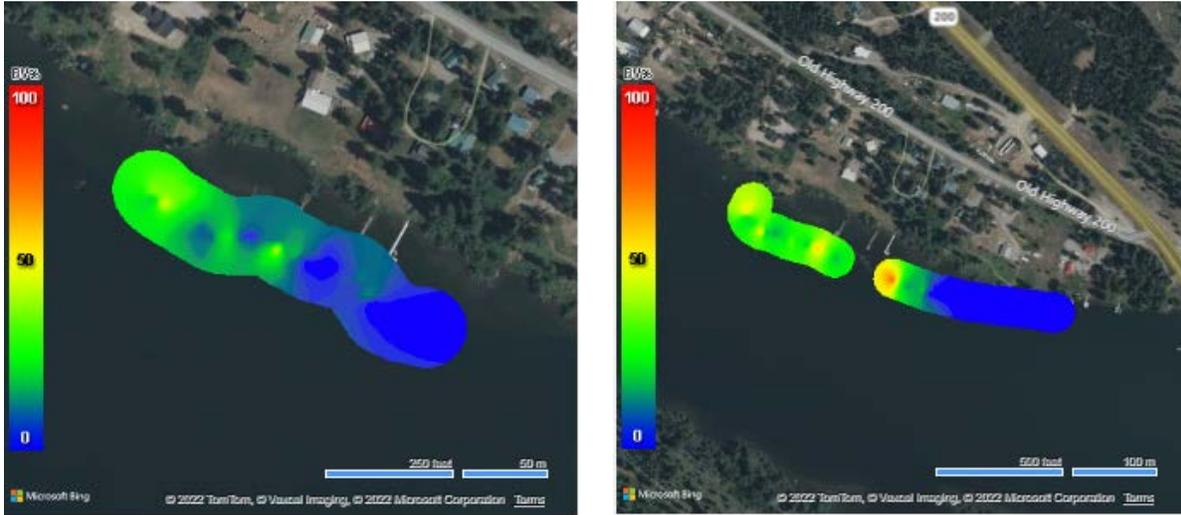
**Plot NOX-8: At Time of Treatment (August 4, 2022 Left),  
~ Six (6) Weeks Post (September 15, 2022 Right)**

2022 Noxon Rapids Reservoir AIS Treatment Plots: At Time of and ~ Six (6) Week Post Plot SAV % Cover and SAV BioVolume Data (Grid Data)									
Plot Number	SAV % Cover	SAV % Bio-Volume	Date Data Collected Pre Treatment	SAV % Cover	SAV % Bio-Volume	Date Data Collected-Post Treatment	SAV % BV Change	Post Treatment EWM Injury Rank	Herbicides Used (Aquathol K/Tribune)
<b>Noxon Rapids</b>									
NOX-8	59.0	34.5	8/4/2022	55.8	19.3	9/15/2022	-44%	60%	Endo/Diquat

**Observations/Notes NOX-8:** Treated with combination of endothall and diquat, control visually estimated at +/-60 % control. EWM present downstream end of plot, and in isolated areas within plot and near docks.

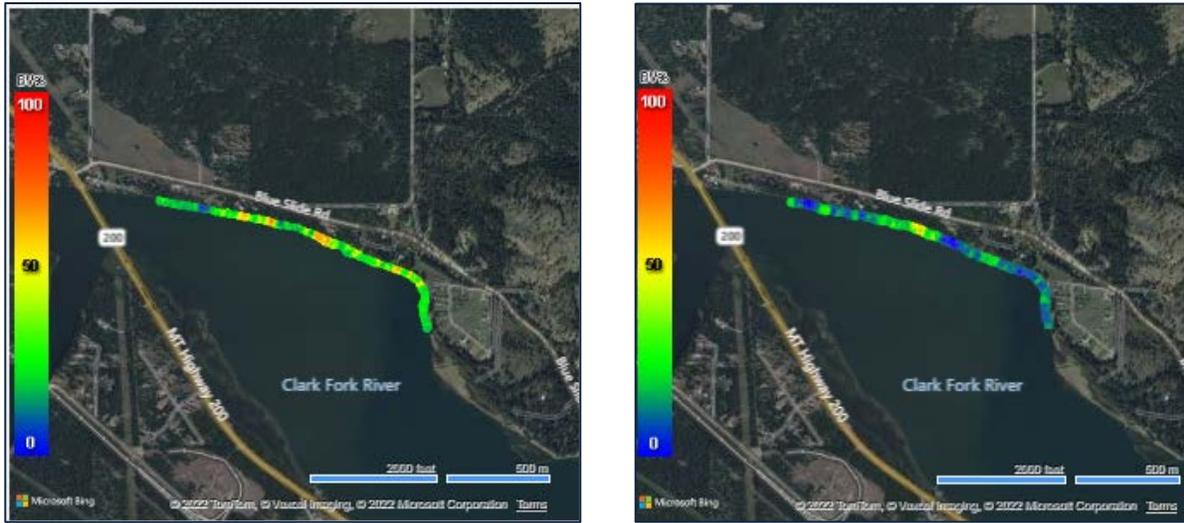
**Plot NOX-04: At Time of Treatment (August 4, 2022 Left),  
~ Six (6) Weeks Post (September 15, 2022 Right)**

2022 Noxon Rapids Reservoir AIS Treatment Plots: At Time of and ~ Six (6) Week Post Plot SAV % Cover and SAV BioVolume Data (Grid Data)									
Plot Number	SAV % Cover	SAV % Bio-Volume	Date Data Collected Pre Treatment	SAV % Cover	SAV % Bio-Volume	Date Data Collected-Post Treatment	SAV % BV Change	Post Treatment EWM Injury Rank	Herbicides Used (Aquathol K/Tribune)
<b>Noxon Rapids</b>									
NOX-4	98.4	32.2	8/4/2022	72.3	17.8	9/15/2022	-45%	90%	Endo/Diquat

**Observations/Notes NOX-04:** Treated with combination of endothall and diquat, control visually estimated at 90 % control. Upper half looked better than lower half in terms of control. EWM downstream damaged but still alive.

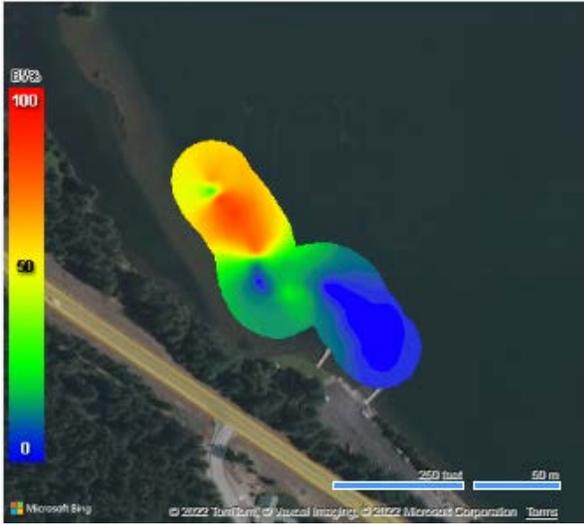
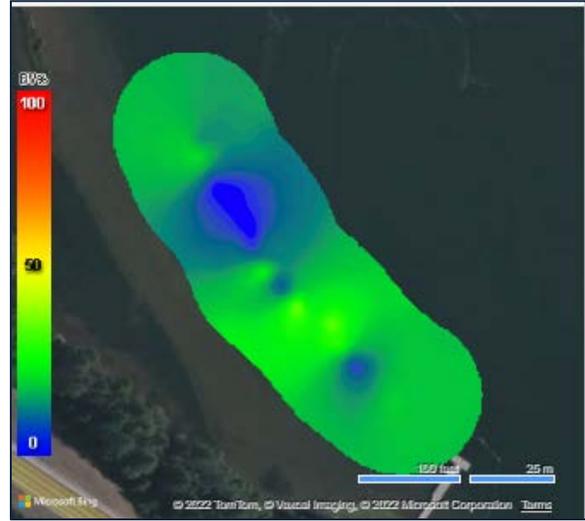
**Plot NOX-77: At Time of Treatment (August 4, 2022 Left),  
~ Six (6) Weeks Post (September 15, 2022 Right)**

2022 Noxon Rapids Reservoir AIS Treatment Plots: At Time of and ~ Six (6) Week Post Plot SAV % Cover and SAV BioVolume Data (Grid Data)									
Plot Number	SAV % Cover	SAV % Bio-Volume	Date Data Collected Pre Treatment	SAV % Cover	SAV % Bio-Volume	Date Data Collected-Post Treatment	SAV % BV Change	Post Treatment EWM Injury Rank	Herbicides Used (Aquathol K/Tribune)
<b>Noxon Rapids</b>									
NOX-77	67.5	38.4	8/4/2022	91.2	16.6	9/15/2022	-57%	90%	Endo/Diquat

**Observations/Notes NOX-77:** Treated with combination of endothall and diquat, control visually estimated at 90 % control. Treatment missed the swim beach area at boom, rest of plot looked very good.
