**CABINET GORGE & NOXON RAPIDS RESERVOIRS  
SANDERS COUNTY, MONTANA**

**2015 AIS Aquatic Pesticide Application Report (APAR)**

**CLEAN LAKES INC.**

October 2015

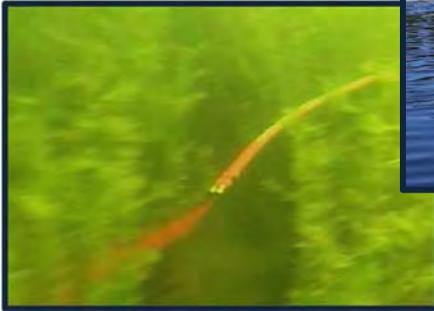
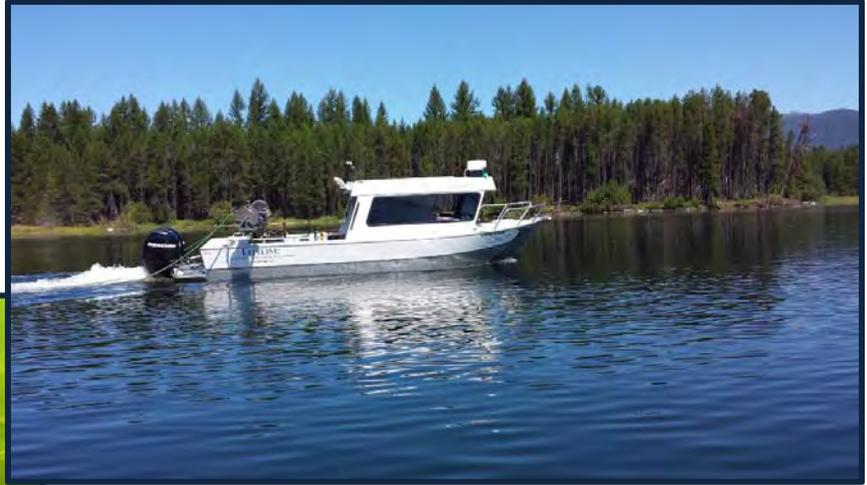
**EQUIPMENT USED:** Two of CLI's Littoral Zone Treatment vessels (LittLine®) were used to perform the aquatic herbicide applications. The herbicide applications were made to the lower portion of the water column to increase herbicide concentration and exposure time (CET) relationships for the control of the target species.

The AIS treatment area GIS shapefiles were loaded into the LittLine® computer system for vessel guidance and herbicide application data recording. The LittLine® can place herbicides at any depth within the water column (2 - 30 feet), as well as within the bottom 2 foot of the water

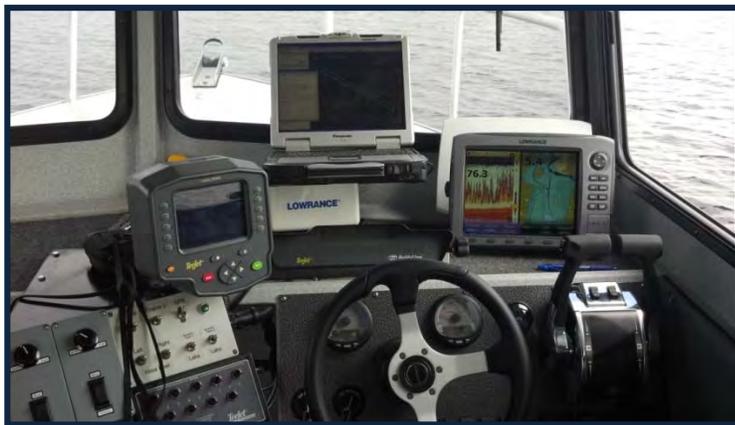
column. Impacts from currents, wind and wave action are reduced in deep water applications through the use of the LittLine® application system when compared to conventional subsurface applications. The herbicide application in all of the plots was within the bottom portion of the water

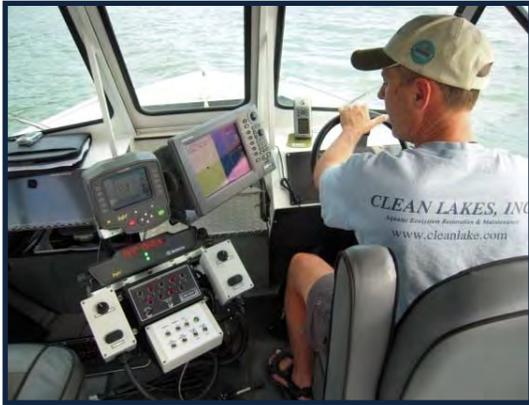
The LittLine system's computerized rate controllers regulate the aquatic herbicide applications through preset treatment rates. When the vessel speeds up and or slows down, the rate controllers adjust the herbicide application rate to match the preset rate in gallons of product per acre.

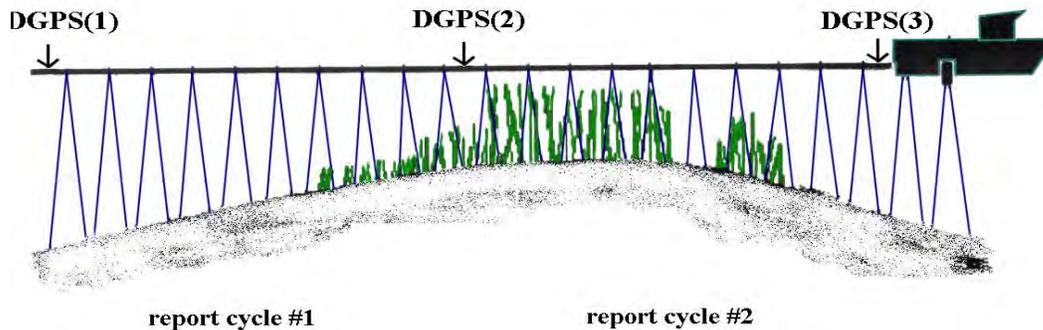
A Digital Echosounder System with a Structure Scan Module was used to record data of the submerged aquatic vegetation (SAV) profile in the control plots during treatment and during the post treatment survey. Data was collected in both the .SLG (traditional sonar on HDS line) and the .SL2 (multi-channel structure scan) formats.

The sonar data collected was processed and analyzed for At Time of Treatment Submerged Aquatic Vegetation (SAV) in the treatment plots and at six (6) Weeks Post Treatment. Data was collected to compare At Time of Treatment to six (6) Week Post Treatment SAV coverage, height in the water column, and bio-volume to support post-treatment efficacy evaluations. An example of SAV conditions at the time of treatment for Plot Nox-5, Noxon Reservoir, is pictured to the right.

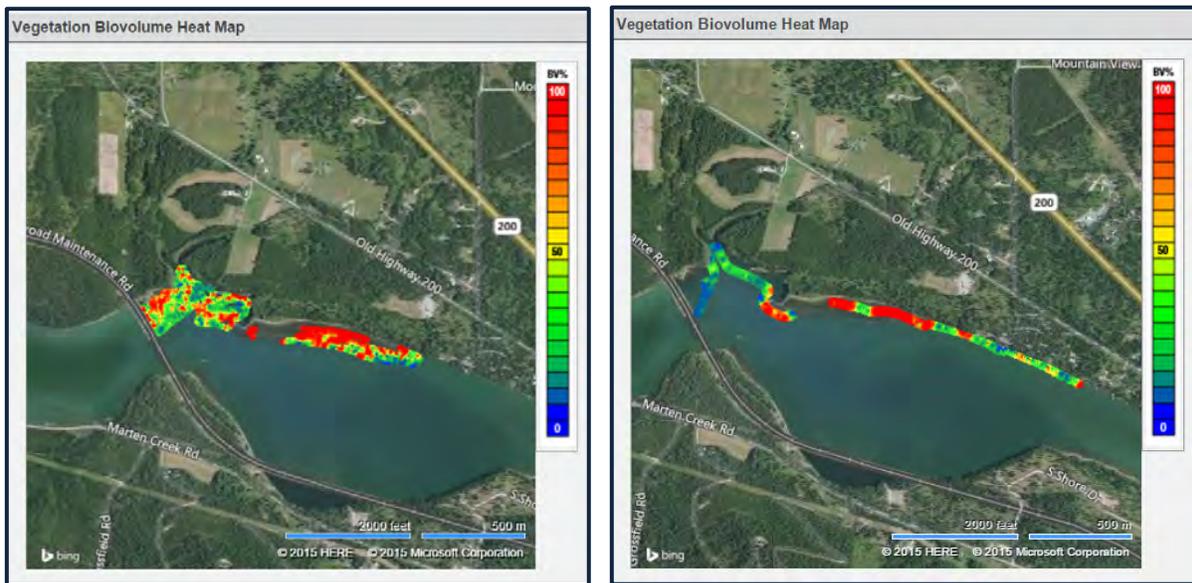
**Plot Nox-59: At Time of Treatment (July 30, 2015 Left),  
~ Six (6) Weeks Post (September 10, 2015 Right)**

2015 Cabinet Gorge and Noxon Rapids Reservoir's AIS Treatment Plots: At Time of and ~ Six (6) Week Post Plot SAV % Cover and SAV BioVolume Data (Grid Data)									
Plot Number	SAV % Cover	SAV % Bio-Volume	Date Data Collected Pre Treatment	SAV % Cover	SAV % Bio-Volume	Date Data Collected-Post Treatment	SAV % BV Change	Post Treatment EWM Injury Rank	Herbicides Used
<b>Noxon Rapids</b>									
Nox-59	98.50	55.80	7/30/2015	98.20	46.2	9/10/2015	-17%	90% +/-	End/Tri

**Observations/Notes Nox-59:** Treated with 1.0 ppm triclopyr, 2 ppm endothall, control estimated at 90%. Shoreline strip portion of plot at 80% control while bay at west end at 95% control. Native plants present, chara, elodea and northern watermilfoil (NWM).

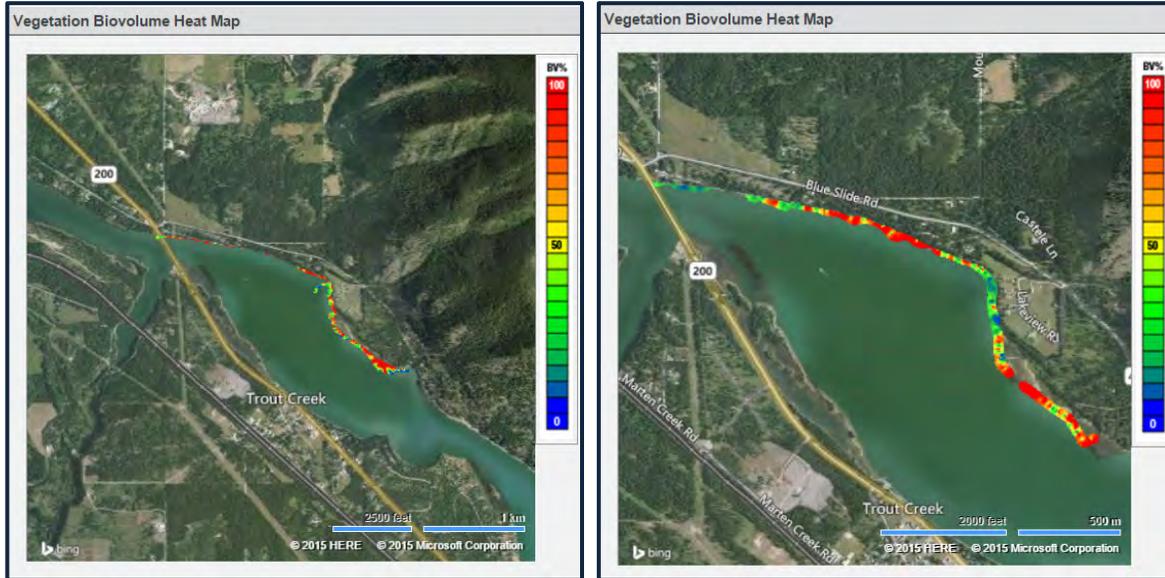
**Plot Nox-4: At Time of Treatment (July 29, 2015 Left),  
~ Six (6) Weeks Post (September 10, 2015 Right)**

2015 Cabinet Gorge and Noxon Rapids Reservoir's AIS Treatment Plots: At Time of and ~ Six (6) Week Post Plot SAV % Cover and SAV BioVolume Data (Grid Data)									
Plot Number	SAV % Cover	SAV % Bio-Volume	Date Data Collected Pre Treatment	SAV % Cover	SAV % Bio-Volume	Date Data Collected-Post Treatment	SAV % BV Change	Post Treatment EWM Injury Rank	Herbicides Used
<b>Noxon Rapids</b>									
Nox-4	92.50	61.50	7/29/2015	99.40	62.5	9/10/2015	2%	70% +/-	End/Tri

**Observations/Notes Nox-4:** Treated with 1.0 ppm triclopyr, 2.0 ppm endothall, control estimated at 70%.

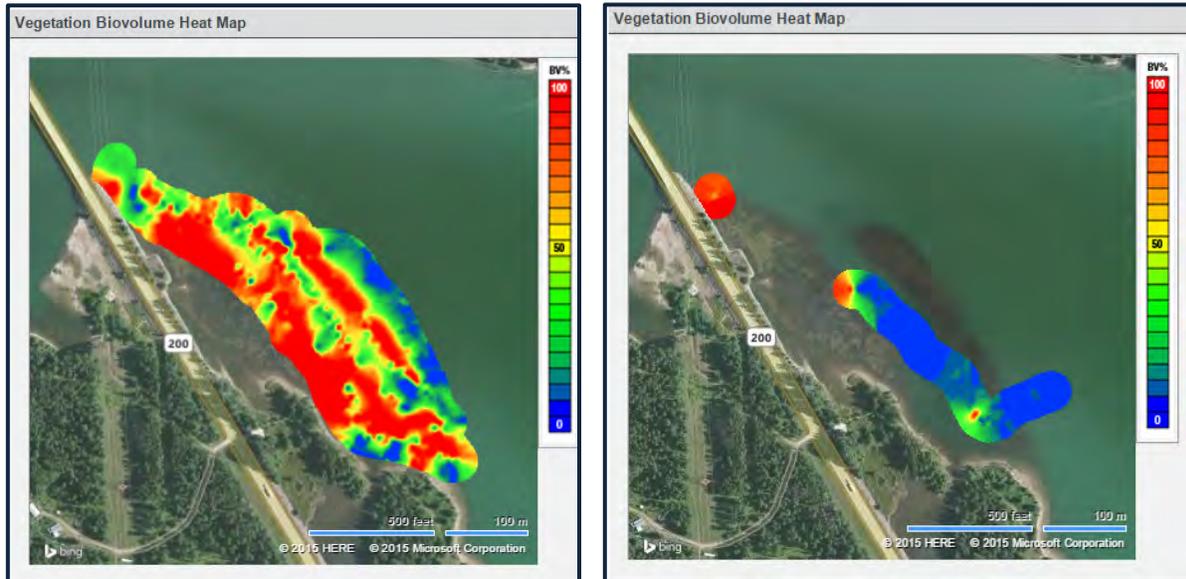
**Plot Nox-5: At Time of Treatment (July 29, 2015 Left),  
~ Six (6) Weeks Post (September 10, 2015 Right)**

2015 Cabinet Gorge and Noxon Rapids Reservoir's AIS Treatment Plots: At Time of and ~ Six (6) Week Post Plot SAV % Cover and SAV BioVolume Data (Grid Data)									
Plot Number	SAV % Cover	SAV % Bio-Volume	Date Data Collected Pre Treatment	SAV % Cover	SAV % Bio-Volume	Date Data Collected-Post Treatment	SAV % BV Change	Post Treatment EWM Injury Rank	Herbicides Used
<b>Noxon Rapids</b>									
Nox-5	96.20	62.00	7/29/2015	51.60	35.7	9/10/2015	-42%	90% +/-	End/Tri

**Observations/Notes Nox 5:** Treated with 1.0 ppm triclopyr, 2.0 ppm endothall, control estimated at 90% +/-.

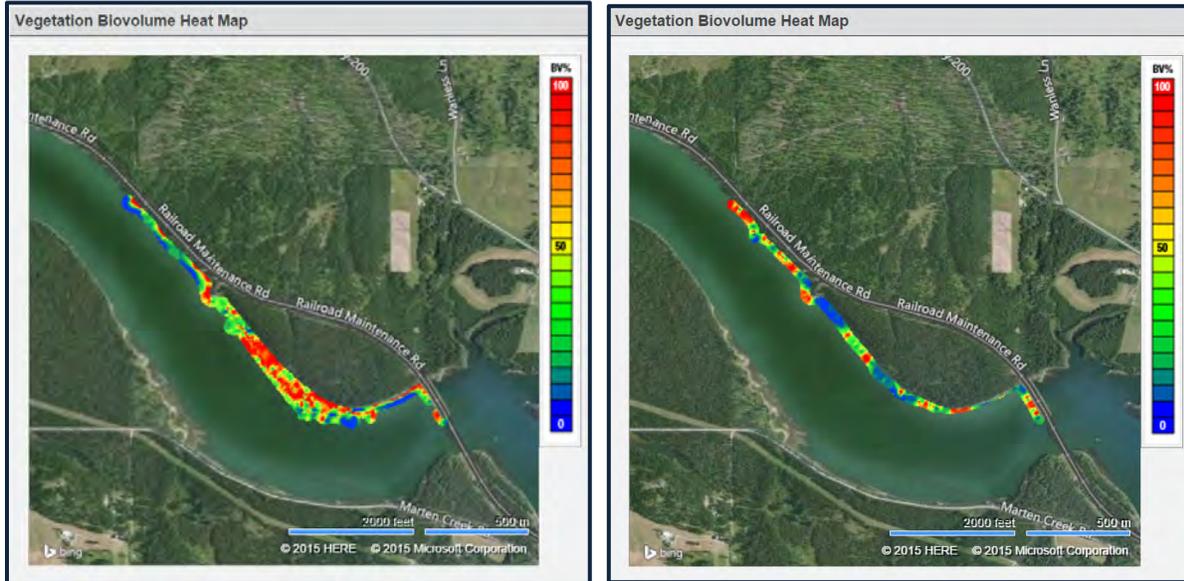
**Plot Nox-6: At Time of Treatment (July 23, 2015 Left),  
~ Six (6) Weeks Post (September 10, 2015 Right)**

2015 Cabinet Gorge and Noxon Rapids Reservoir's AIS Treatment Plots: At Time of and ~ Six (6) Week Post Plot SAV % Cover and SAV BioVolume Data (Grid Data)									
Plot Number	SAV % Cover	SAV % Bio-Volume	Date Data Collected Pre Treatment	SAV % Cover	SAV % Bio-Volume	Date Data Collected-Post Treatment	SAV % BV Change	Post Treatment EWM Injury Rank	Herbicides Used
<b>Noxon Rapids</b>									
Nox-6	90.50	52.30	7/23/2015	90.40	41.3	9/10/2015	-21%	80% +/-	End/Tri

**Observations/Notes Nox-6:** Treated with 1.0 ppm triclopyr, 2.0 ppm endothall, good widespread control estimated at 80%. Larger blocky areas estimated 85% control, narrow shoreline strips estimated at 70% control.

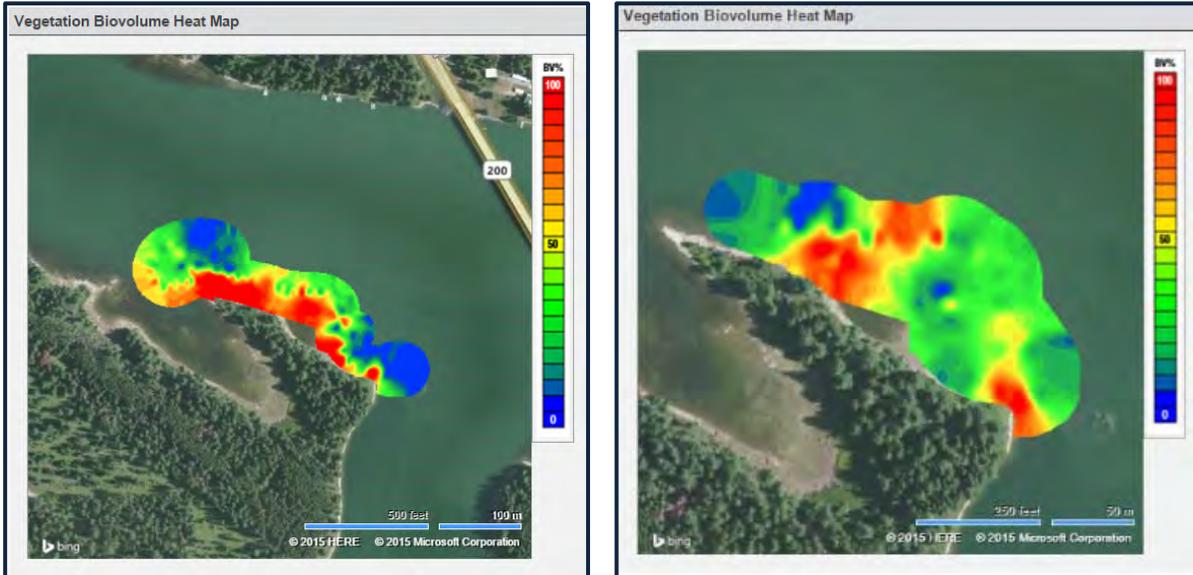
**Plot Nox-10: At Time of Treatment (July 30, 2015 Left),  
 ~ Six (6) Weeks Post (September 10, 2015 Right)**

2015 Cabinet Gorge and Noxon Rapids Reservoir's AIS Treatment Plots: At Time of and ~ Six (6) Week Post Plot SAV % Cover and SAV BioVolume Data (Grid Data)									
Plot Number	SAV % Cover	SAV % Bio-Volume	Date Data Collected Pre Treatment	SAV % Cover	SAV % Bio-Volume	Date Data Collected-Post Treatment	SAV % BV Change	Post Treatment EWM Injury Rank	Herbicides Used
<b>Noxon Rapids</b>									
Nox-10	88.40	49.30	7/30/2015	97.60	40.4	9/10/2015	-18%	98% +/-	End/Tri

**Observations/Notes Nox-10:** Treated with 1.0 ppm triclopyr, 2.0 ppm endothall, good control estimated at 98%, a few EWM plants remaining at upstream end of plot.

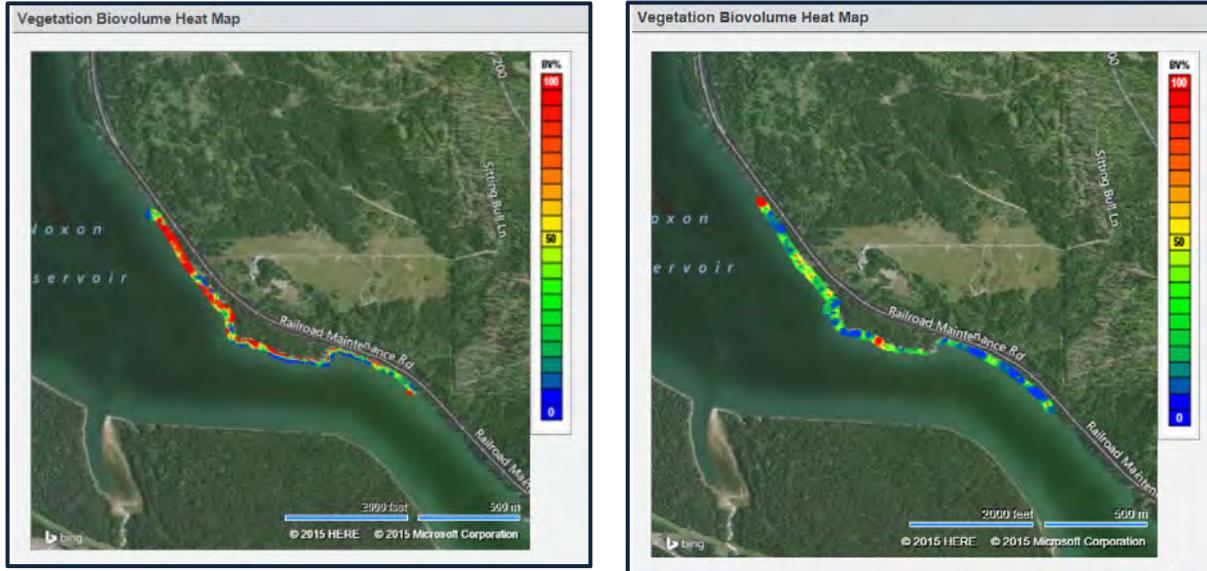
Plot Nox-25: At Time of Treatment (July 23, 2015 Left),  
 ~ Six (6) Weeks Post (September 10, 2015 Right)

2015 Cabinet Gorge and Noxon Rapids Reservoir's AIS Treatment Plots: At Time of and ~ Six (6) Week Post Plot SAV % Cover and SAV BioVolume Data (Grid Data)									
Plot Number	SAV % Cover	SAV % Bio-Volume	Date Data Collected Pre Treatment	SAV % Cover	SAV % Bio-Volume	Date Data Collected-Post Treatment	SAV % BV Change	Post Treatment EWM Injury Rank	Herbicides Used
<b>Noxon Rapids</b>									
Nox-25	85.30	59.70	7/23/2015	82.60	29.2	9/10/2015	-51%	75% +/-	End

**Observations/Notes Nox-25:** Treated with 3.0 ppm endothall, estimated at 75% control. 70% control along narrow strips, wider strip areas >80% control.

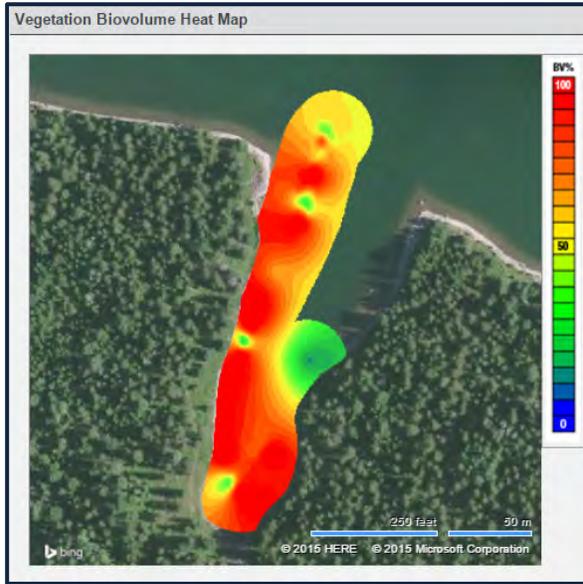
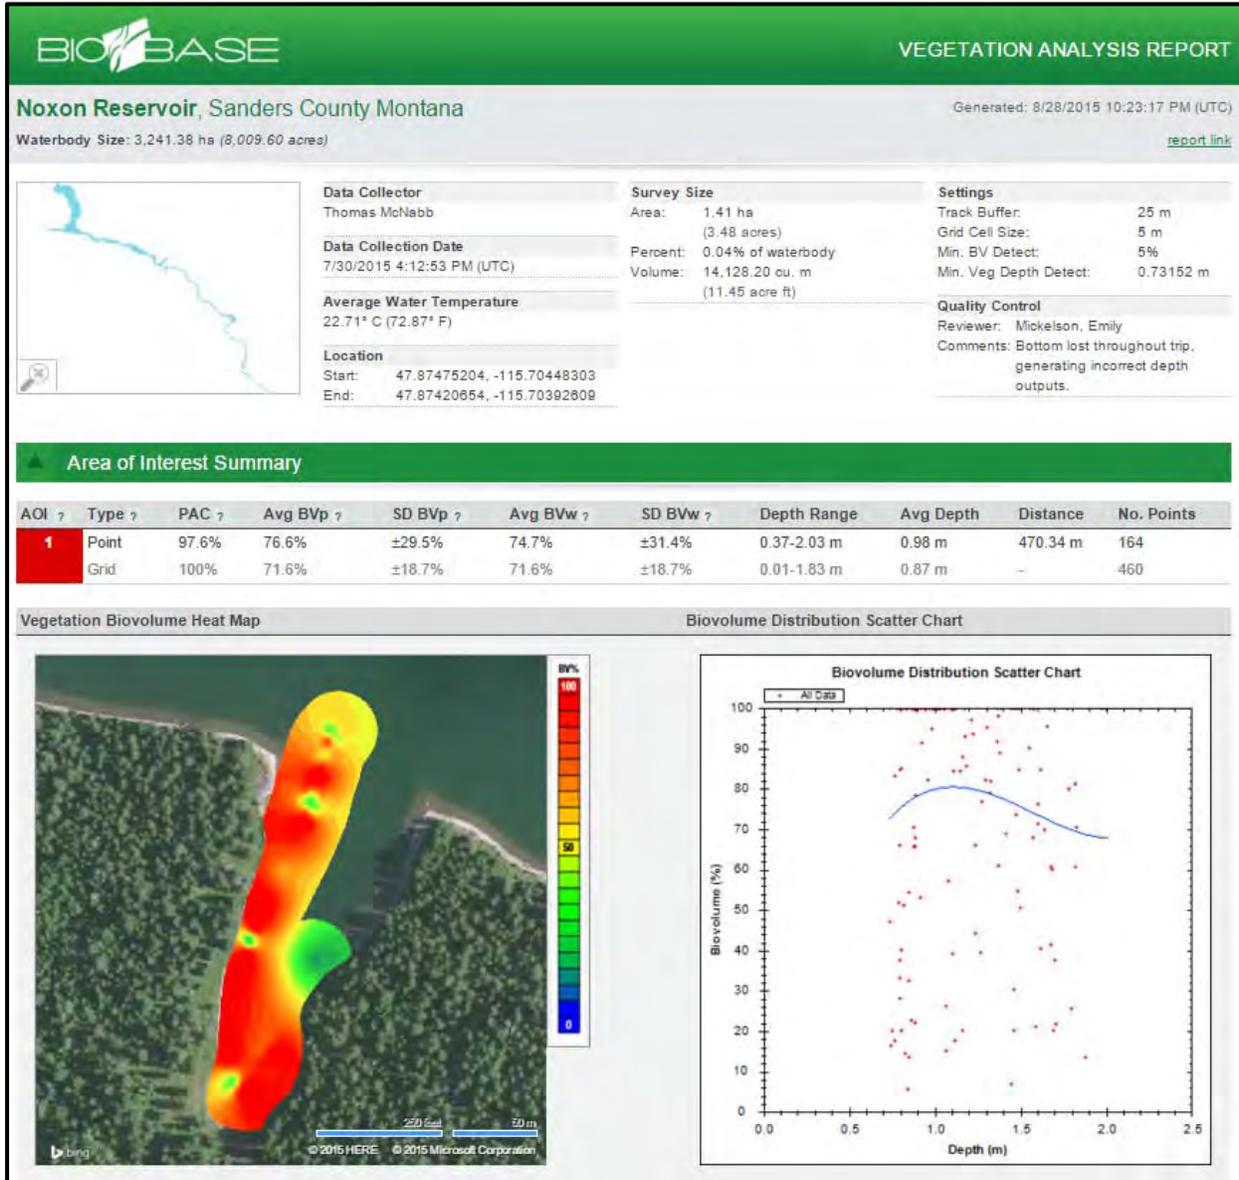
**Plot Nox-56: At Time of Treatment (July 30, 2015 Left),  
~ Six (6) Weeks Post (September 10, 2015 Right)**

2015 Cabinet Gorge and Noxon Rapids Reservoir's AIS Treatment Plots: At Time of and ~ Six (6) Week Post Plot SAV % Cover and SAV BioVolume Data (Grid Data)									
Plot Number	SAV % Cover	SAV % Bio-Volume	Date Data Collected Pre Treatment	SAV % Cover	SAV % Bio-Volume	Date Data Collected-Post Treatment	SAV % BV Change	Post Treatment EWM Injury Rank	Herbicides Used
<b>Noxon Rapids</b>									
Nox-56	100.00	71.60	7/30/2015	n/a	n/a	n/a	n/a	85% +/-	End/Tri

**Observations/Notes Nox-56:** Treated with 1.0 ppm triclopyr, 2.0 ppm endothall, estimated at 85% control.

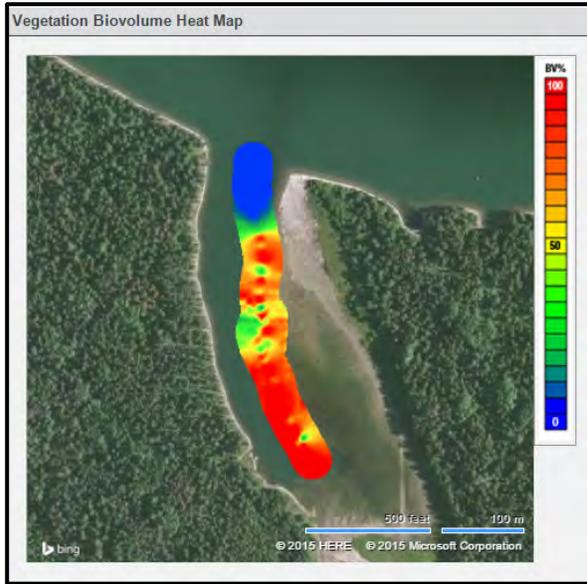
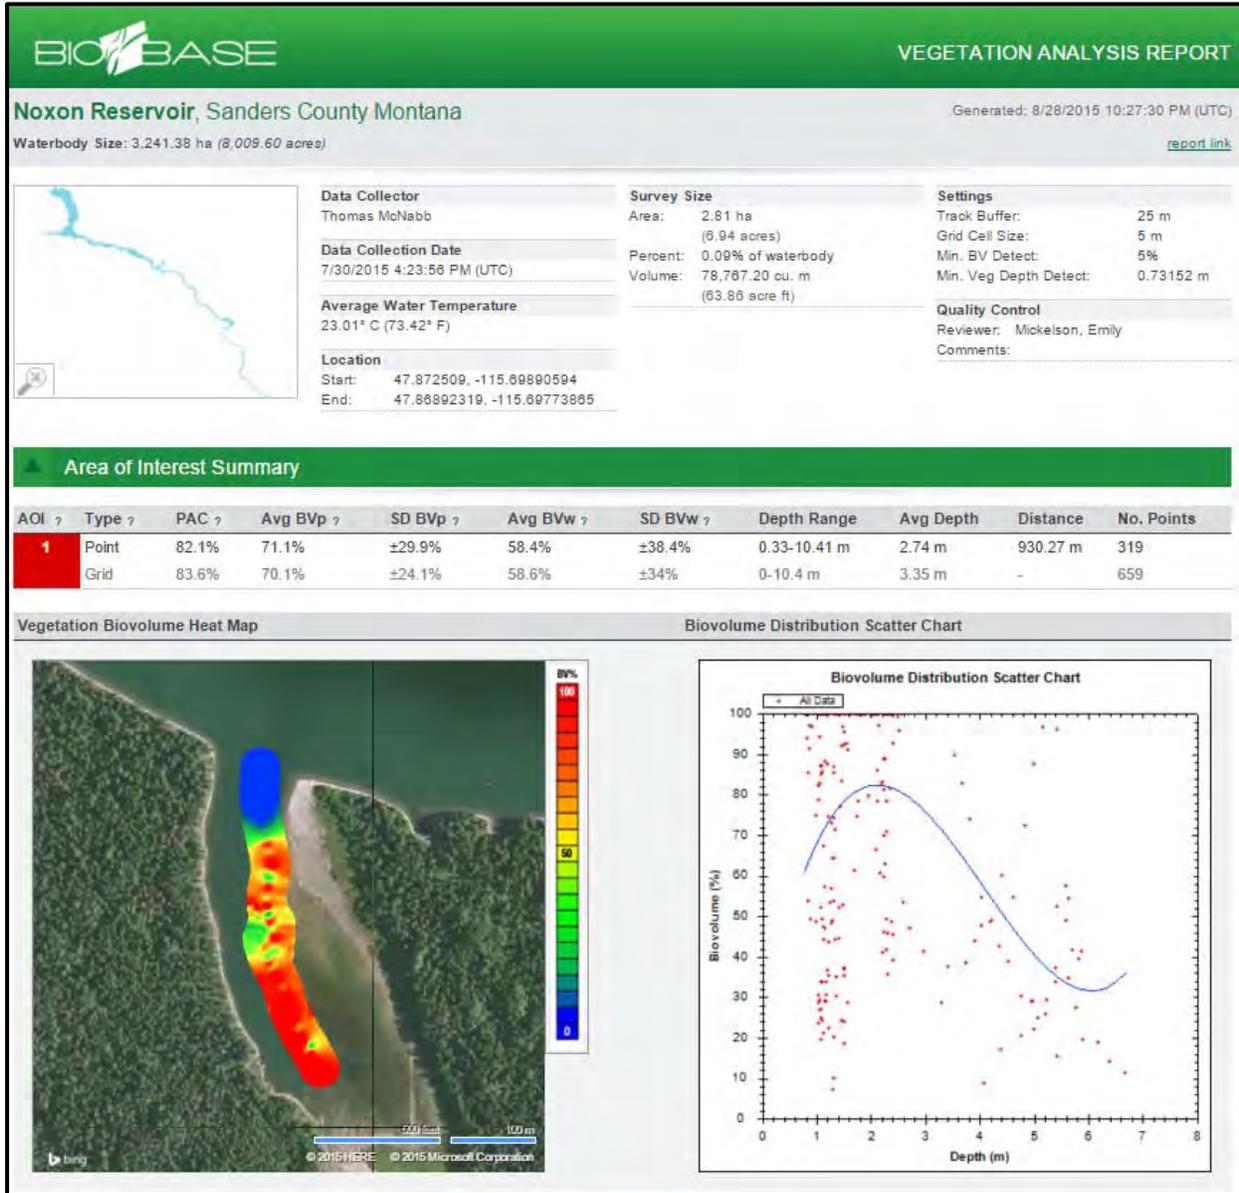
**Plot Nox-57: At Time of Treatment (July 30, 2015 Left),  
~ Six (6) weeks Post (September 10, 2015 Right)**

2015 Cabinet Gorge and Noxon Rapids Reservoir's AIS Treatment Plots: At Time of and ~ Six (6) Week Post Plot SAV % Cover and SAV BioVolume Data (Grid Data)									
Plot Number	SAV % Cover	SAV % Bio-Volume	Date Data Collected Pre Treatment	SAV % Cover	SAV % Bio-Volume	Date Data Collected-Post Treatment	SAV % BV Change	Post Treatment EWM Injury Rank	Herbicides Used
<b>Noxon Rapids</b>									
Nox-57	83.60	70.10	7/30/2015	n/a	n/a	n/a	n/a	98% +/-	End/Tri

**Observations/Notes Nox-57:** Treated with 1.0 ppm triclopyr, 2.0 ppm endothall, control estimated at 98%.

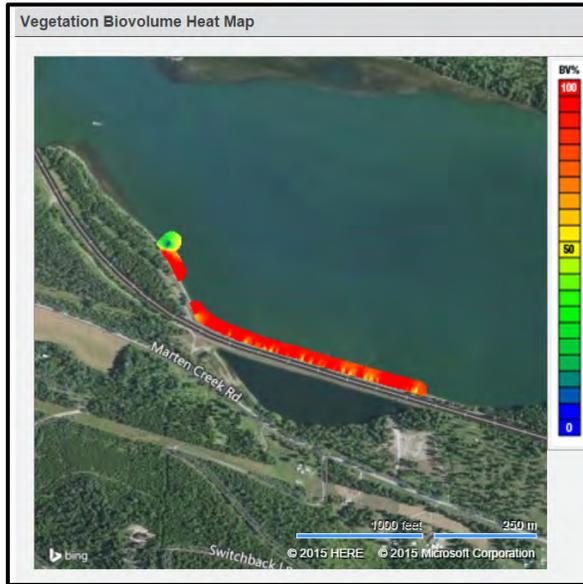
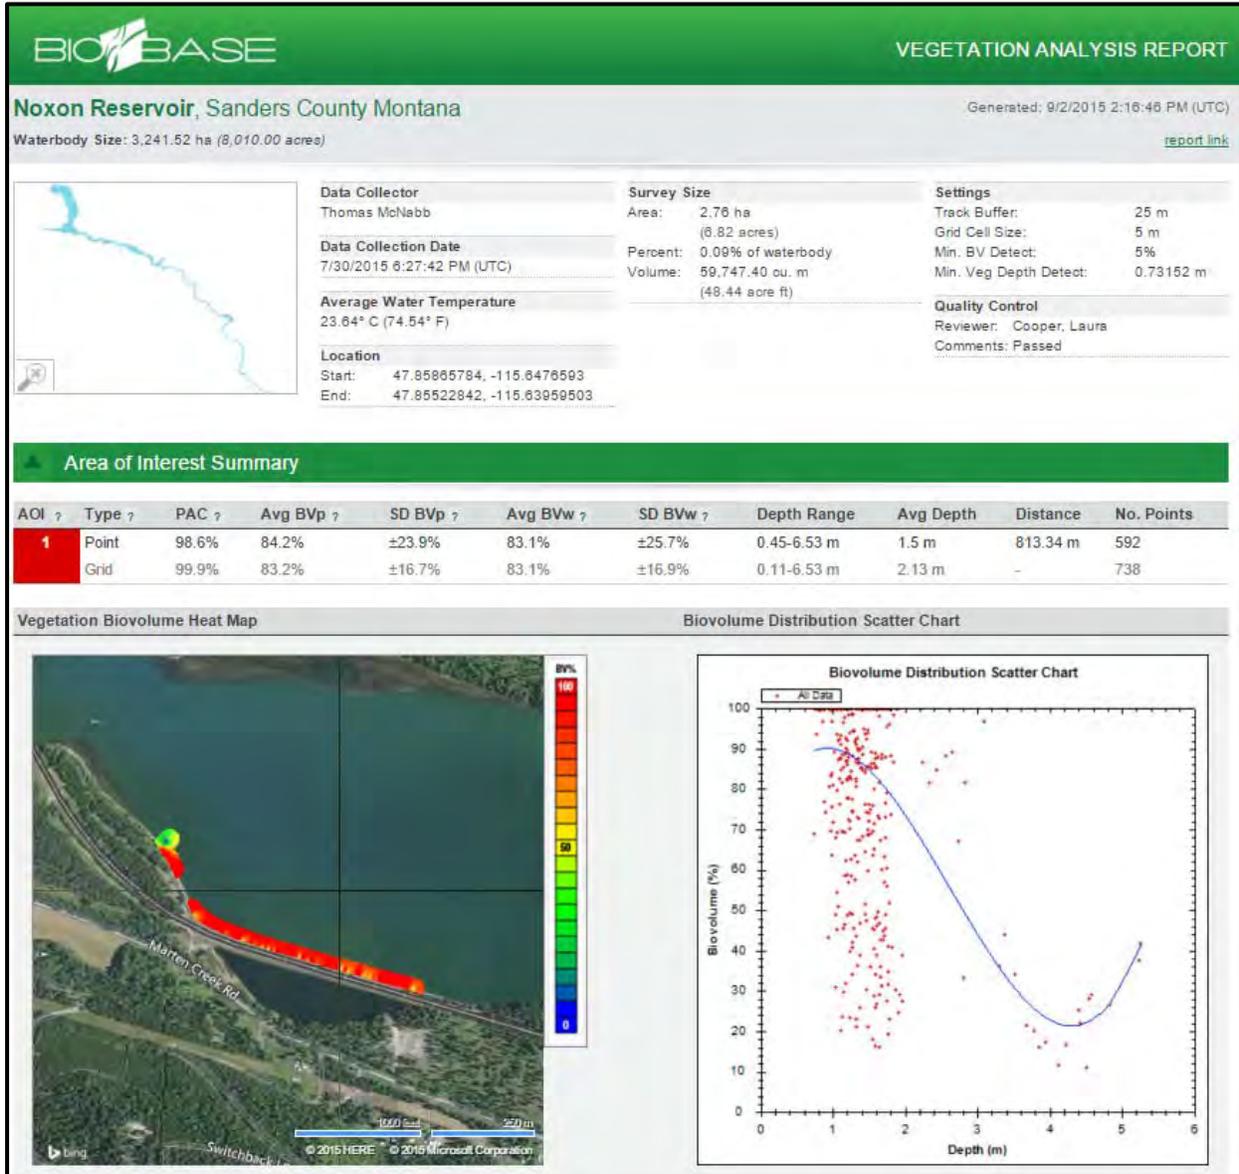
**Plot Nox-58: At Time of Treatment (July 30, 2015 Left),  
~ Six (6) Weeks Post (September 10, 2015 Right)**

2015 Cabinet Gorge and Noxon Rapids Reservoir's AIS Treatment Plots: At Time of and ~ Six (6) Week Post Plot SAV % Cover and SAV BioVolume Data (Grid Data)									
Plot Number	SAV % Cover	SAV % Bio-Volume	Date Data Collected Pre Treatment	SAV % Cover	SAV % Bio-Volume	Date Data Collected-Post Treatment	SAV % BV Change	Post Treatment EWM Injury Rank	Herbicides Used
<b>Noxon Rapids</b>									
Nox-58	99.90	83.20	7/30/2015	n/a	n/a	n/a	n/a	75% +/-	End/Tri

**Observations/Notes Nox-58:** Treated with 1.0 ppm triclopyr, 2.0 ppm endothall, control estimated at 75%. A higher level of EWM control was achieved at the downstream end of plot.

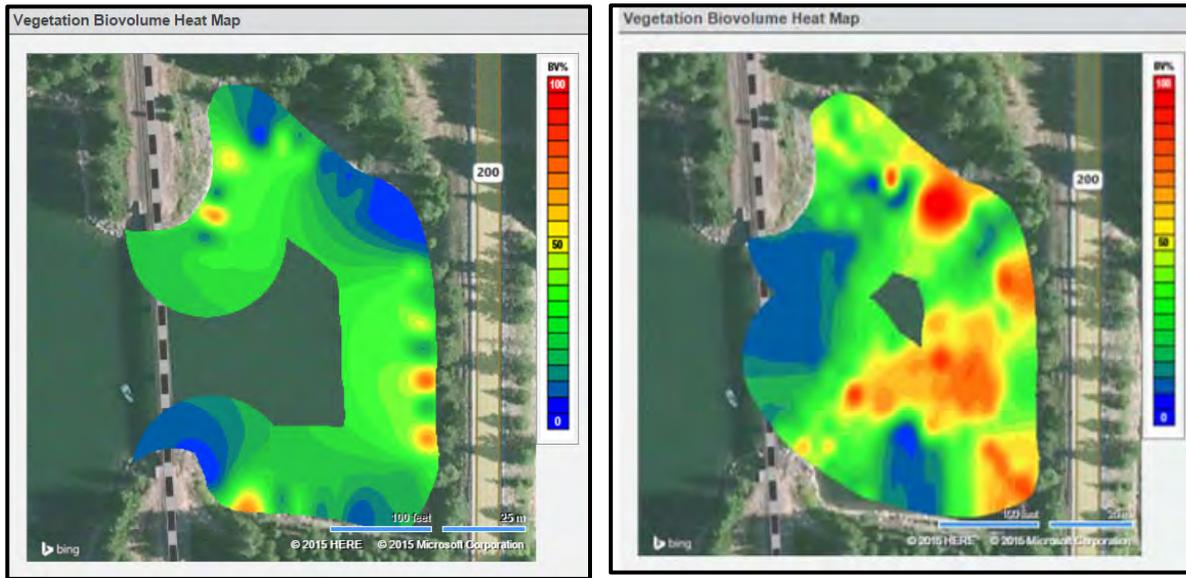
**Plot Nox-8: At Time of Treatment (July 30, 2015 Left),  
~ Six (6) Weeks Post (September 10, 2015 Right)**

2015 Cabinet Gorge and Noxon Rapids Reservoir's AIS Treatment Plots: At Time of and ~ Six (6) Week Post Plot SAV % Cover and SAV BioVolume Data (Grid Data)									
Plot Number	SAV % Cover	SAV % Bio-Volume	Date Data Collected Pre Treatment	SAV % Cover	SAV % Bio-Volume	Date Data Collected-Post Treatment	SAV % BV Change	Post Treatment EWM Injury Rank	Herbicides Used
<b>Noxon Rapids</b>									
Nox-8	97.30	26.10	7/30/2015	99.40	37.00	9/10/2015	42%	55% +/-	End/Tri

**Observations/Notes Nox-8:** Treated with 1.0 ppm triclopyr, 2.0 ppm endothall, control estimated at 55%. Narrow band of EWM, control spotty.

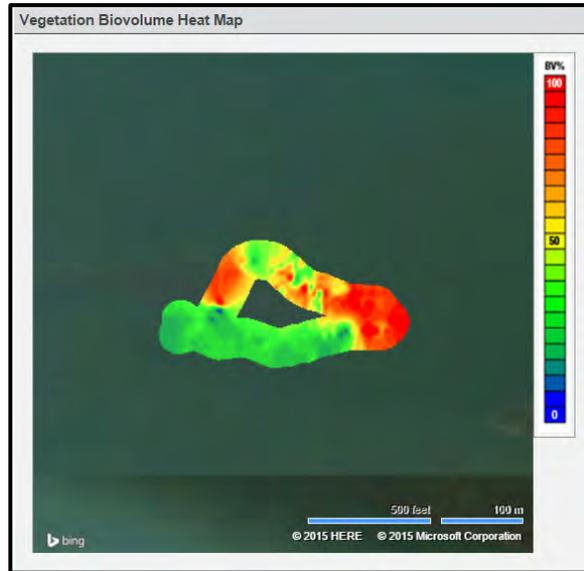
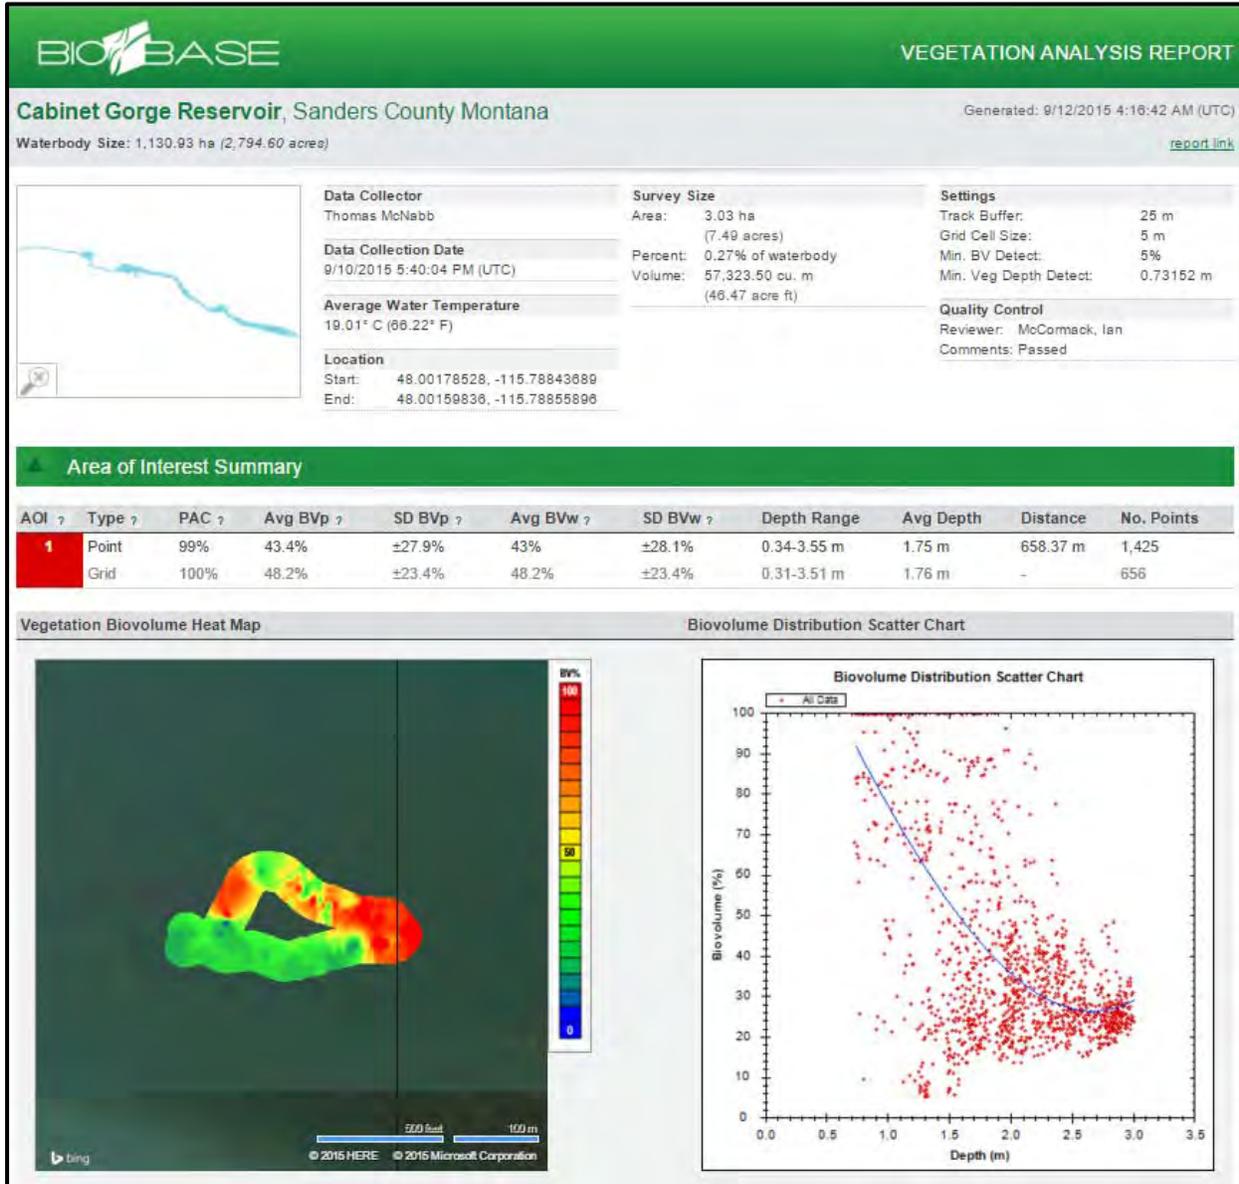
**Plot Cab-2: At Time of Treatment (July 22, 2015 Left),  
~ Six (6) Weeks Post (September 10, 2015 Right)**

2015 Cabinet Gorge and Noxon Rapids Reservoir's AIS Treatment Plots: At Time of and ~ Six (6) Week Post Plot SAV % Cover and SAV BioVolume Data (Grid Data)									
Plot Number	SAV % Cover	SAV % Bio-Volume	Date Data Collected Pre Treatment	SAV % Cover	SAV % Bio-Volume	Date Data Collected-Post Treatment	SAV % BV Change	Post Treatment EWM Injury Rank	Herbicides Used
<b>Cabinet Gorge</b>									
Cab-2	n/a	n/a	n/a	100.00	48.20	9/10/2015	n/a	88% +/-	Diquat

**Observations/Notes Cab 2:** Treated with 0.37 ppm diquat, control estimated at 88%. Plot looked good, abundant Coontail and other plants visible.

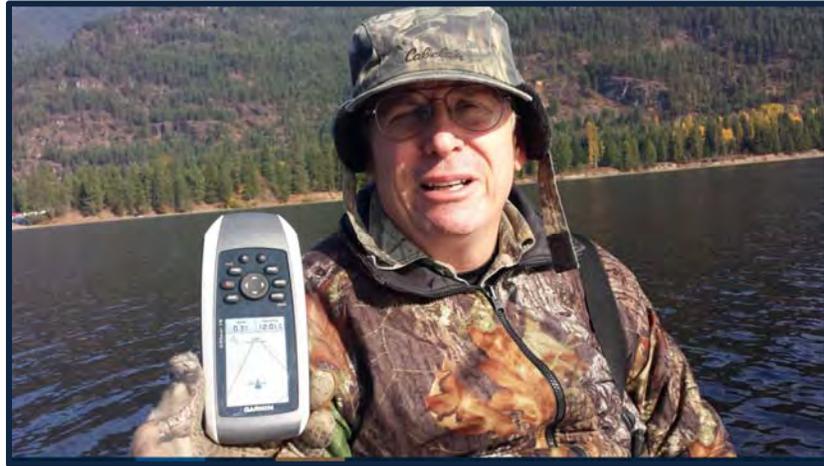
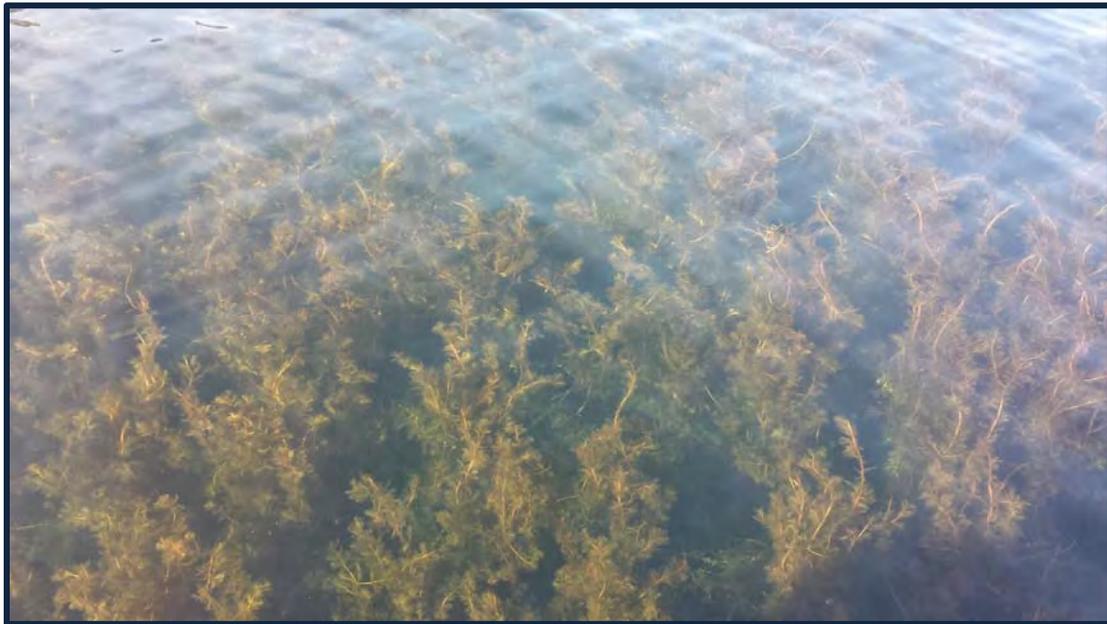
**Plot Cab 2: ~ Three (3) Month Post Treatment (October 21, 2015)**

On October 31, 2015, three month post treatment, Moorhouse, Getsinger and Mitchell revisited Cab-2 and found the plot had largely recovered from the diquat treatment per the picture above.

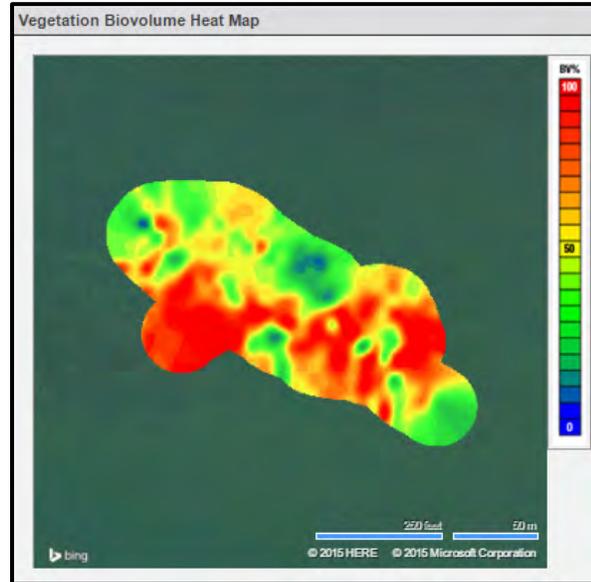
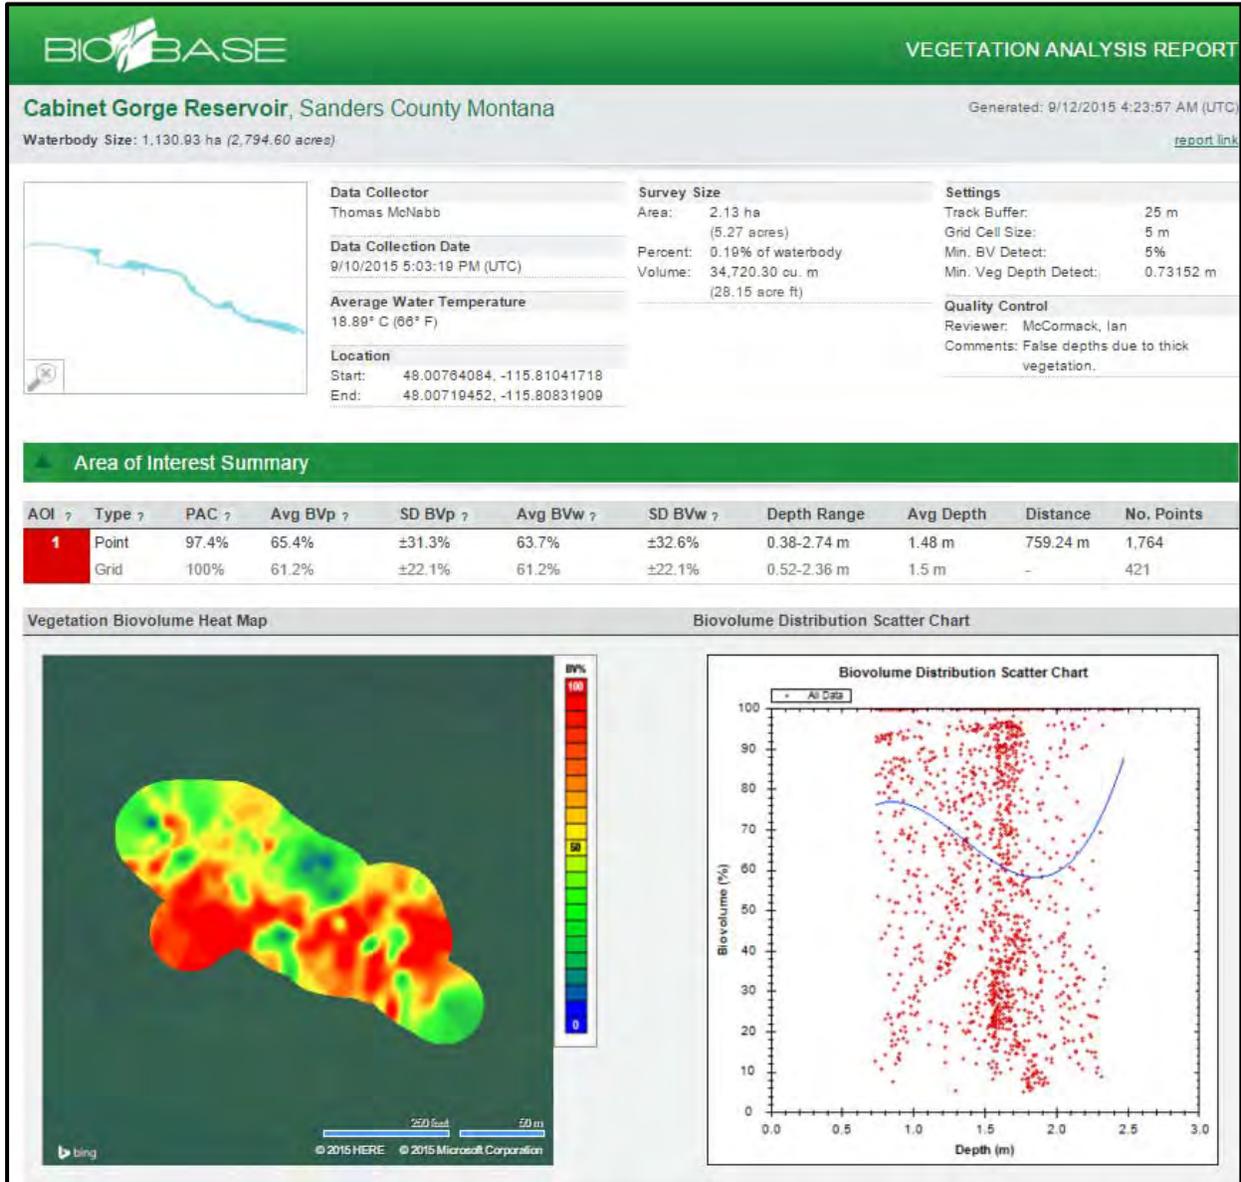
**Plot Cab 3: At Time of Treatment (July 22, 2015 Left),  
~ Six (6) Weeks Post (September 10, 2015 Right)**

2015 Cabinet Gorge and Noxon Rapids Reservoir's AIS Treatment Plots: At Time of and ~ Six (6) Week Post Plot SAV % Cover and SAV BioVolume Data (Grid Data)									
Plot Number	SAV % Cover	SAV % Bio-Volume	Date Data Collected Pre Treatment	SAV % Cover	SAV % Bio-Volume	Date Data Collected-Post Treatment	SAV % BV Change	Post Treatment EWM Injury Rank	Herbicides Used
<b>Cabinet Gorge</b>									
Cab-3	n/a	n/a	n/a	100.00	61.20	9/10/2015	n/a	85% +/-	Diquat

**Observations/Notes Cab-3:** Treated with 0.37 ppm diquat, control estimated at 88%. Plot looked good, abundant Coontail and elodea and NWM present.

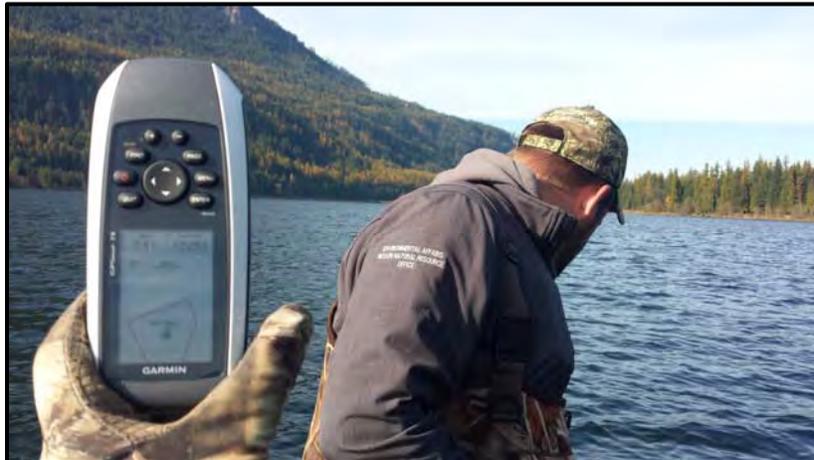
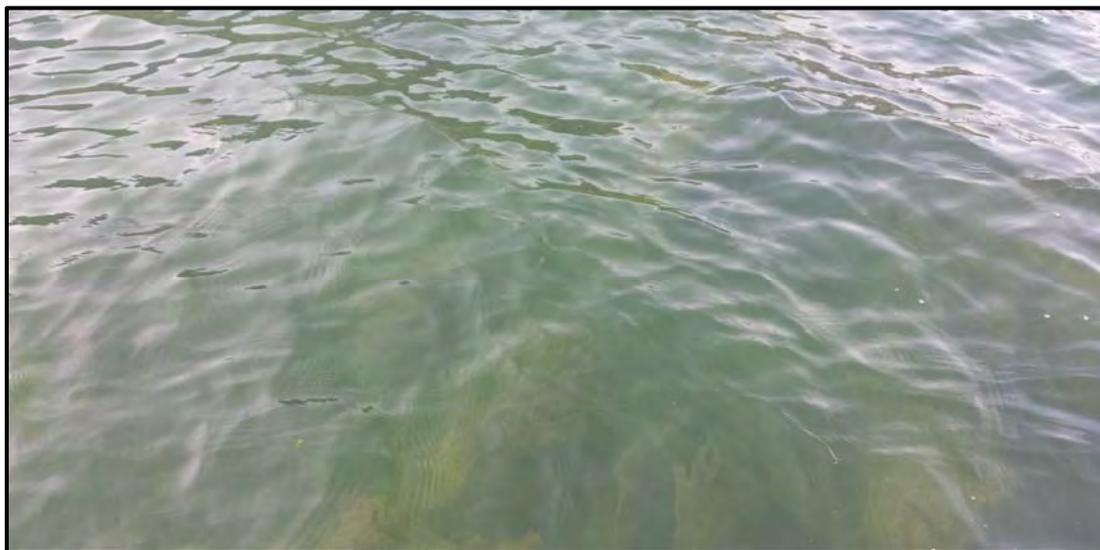
On October 31, 2015, three month post treatment, Moorhouse, Getsinger and Mitchell revisited Cab-3 and found the plot partially recovered from the diquat treatment per the picture above. EWM appeared less dense but water flows were causing the plants to lean over making observations challenging.
