**CABINET GORGE & NOXON RAPIDS RESERVOIRS
SANDERS COUNTY, MONTANA
2014 AIS Aquatic Pesticide Application Report (APAR)**

BACKGROUND INFORMATION: Clean Lakes, Inc. (CLI) was contracted by Sanders County, Montana to provide aquatic herbicide applications for the control of Aquatic Invasive Species (AIS) within specific areas of Cabinet Gorge and Noxon Rapids Reservoirs.

SCOPE OF WORK: The scope of work was for the application of aquatic herbicides, alone or in combination, for the control of Eurasian watermilfoil and Curlyleaf pondweed in up to 200 acres within pre identified areas of Cabinet Gorge & Noxon Rapids Reservoirs.

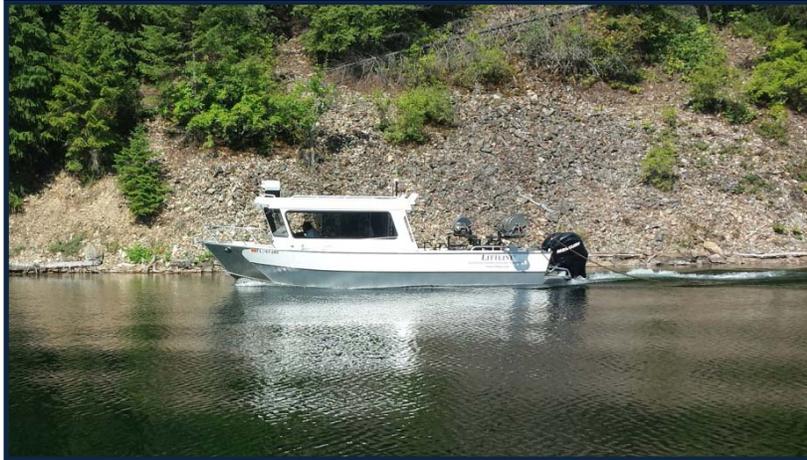
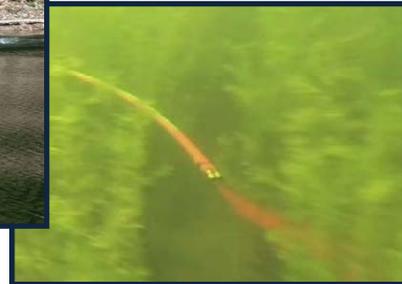
EQUIPMENT USED: Two of CLI's Littoral Zone Treatment vessels (LittLine®) were used to perform the aquatic herbicide applications. The herbicide applications were made to the lower portion of the water column to increase herbicide concentration and exposure time (CET) relationships for the control of the target species.

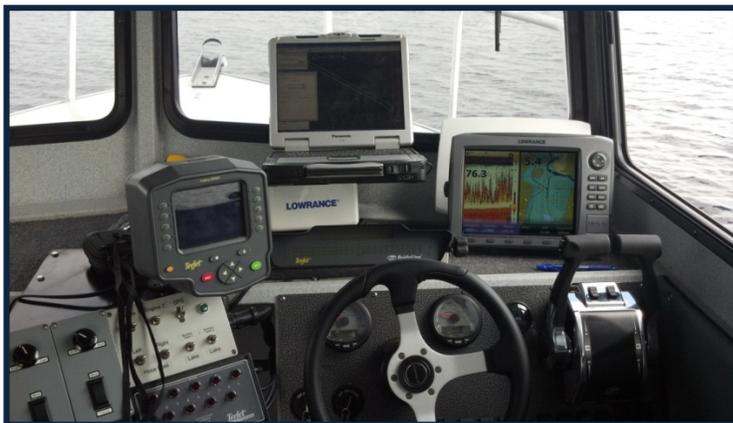
The AIS treatment area GIS shapefiles were loaded into the LittLine® computer system for vessel guidance and herbicide application data recording. The treatment tracks were automatically recorded via the LittLine vessel's GPS guidance system for the production of the

final treatment area maps to document the treatment areas.

The LittLine® can place herbicides at any depth within the water column (2 - 30 feet), as well as within the bottom 2 foot of the water column.

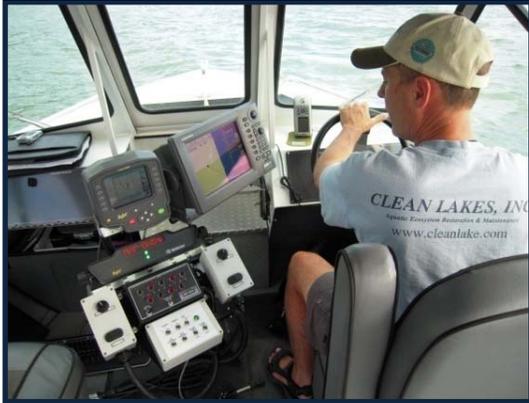
Impacts from currents, wind and wave action are reduced in deep water applications through the use of the LittLine® application system when compared to conventional subsurface applications. For the Noxon Rapids and Cabinet Gorge Reservoir applications, the application swath widths were approximately 50 foot, and the vessel speeds averaged 3 to 5 mph depending on water depths within the plots. The herbicide discharge in all of the plots was within the bottom portion of the water column. The

LittLine® hoses are electronically reeled in or reeled out based on the varying depths of the treatment Plots.

The LittLine system's computerized rate controllers regulate the aquatic herbicide applications through preset treatment rates. When the vessel speeds up and or slows down, the rate controllers adjust the herbicide application rate to match the preset rate in gallons of product per acre.

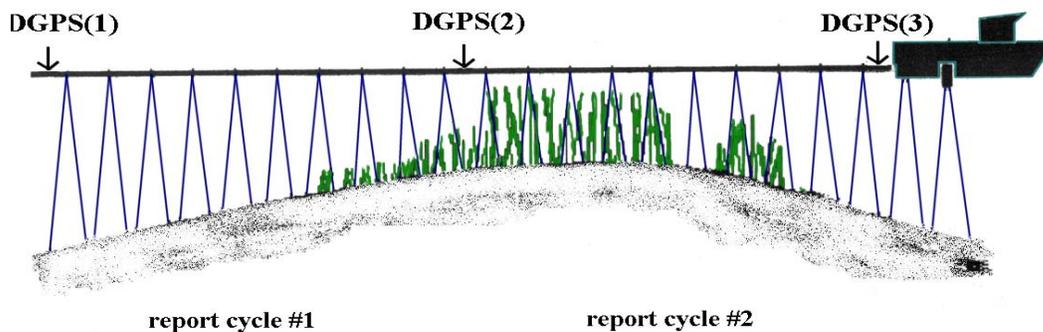
A Digital Echosounder System with a Structure Scan Module was used to record data of the submerged aquatic vegetation (SAV) profile in the control plots during treatment and during the post treatment survey. Data was collected in both the .SLG (traditional sonar on HDS line) and the .SL2 (multi-channel structure scan) formats.

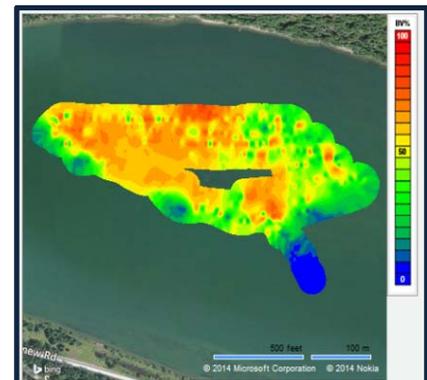
The sonar data collected was processed and analyzed for At Time of Treatment Submerged Aquatic Vegetation (SAV) in the treatment plots and at ~ 6 Weeks Post Treatment. Data was collected to compare At Time of Treatment and ~ 6 Weeks Post Treatment SAV coverage, height in the water column, and bio-volume to support post-treatment efficacy evaluations. An example of SAV conditions at time of treatment for Plot C-3-14, Cabinet Gorge Reservoir, is pictured to the right.

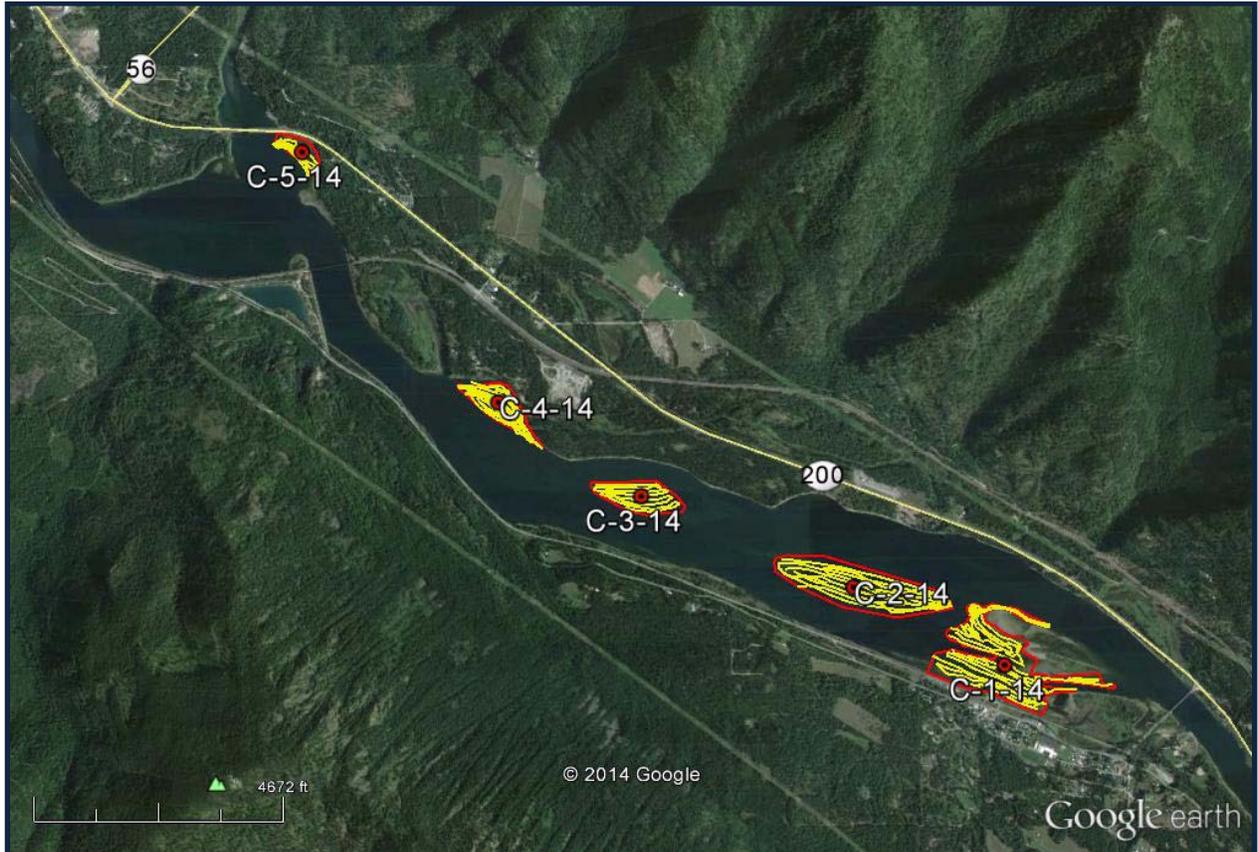
TREATMENT AREA PLOT MAPS
Cabinet Gorge Reservoir Treatment Map

SUMMARY OF ACRES TREATED: The final plan consisted of treating 181.4 acres in Cabinet Gorge Reservoir, and 18.6 acres in Noxon Rapids Reservoir, for a total of 200 acres. Based on the Pre Treatment Plot surveys, water depths were adjusted in the Plots due to water level conditions at the time of treatment. Treatment plots were named through an alphanumeric system to differentiate plots on Cabinet Gorge and Noxon Rapids Reservoirs that uses a three part naming system. A letter C or N designates the location, Cabinet Gorge or Noxon Rapids, respectively followed by numbers to designate the plot and the year the plot was identified for treatment. Therefore, a treatment area designated as C-2-14 is located in Cabinet Gorge Reservoir, is plot number 2, and was identified for treatment in 2014. A total acreage treatment cap of 200 acres encompassing both reservoirs prevented treatment of Plots C-6-14 and C-7-14

in Cabinet Gorge Reservoir. Plot C-1-14 through C-5-14 were treated. In Noxon Rapids Reservoir Plots N-1-14, N-2-14, and N-3-14 were not treated due to a lack of or low densities of EWM; Plot N-5-14 was converted from a diver dredge plot to an aquatic herbicide treatment plot; and Plot N-12-14 was created due to EWM growth along the Northshore community shoreline area.

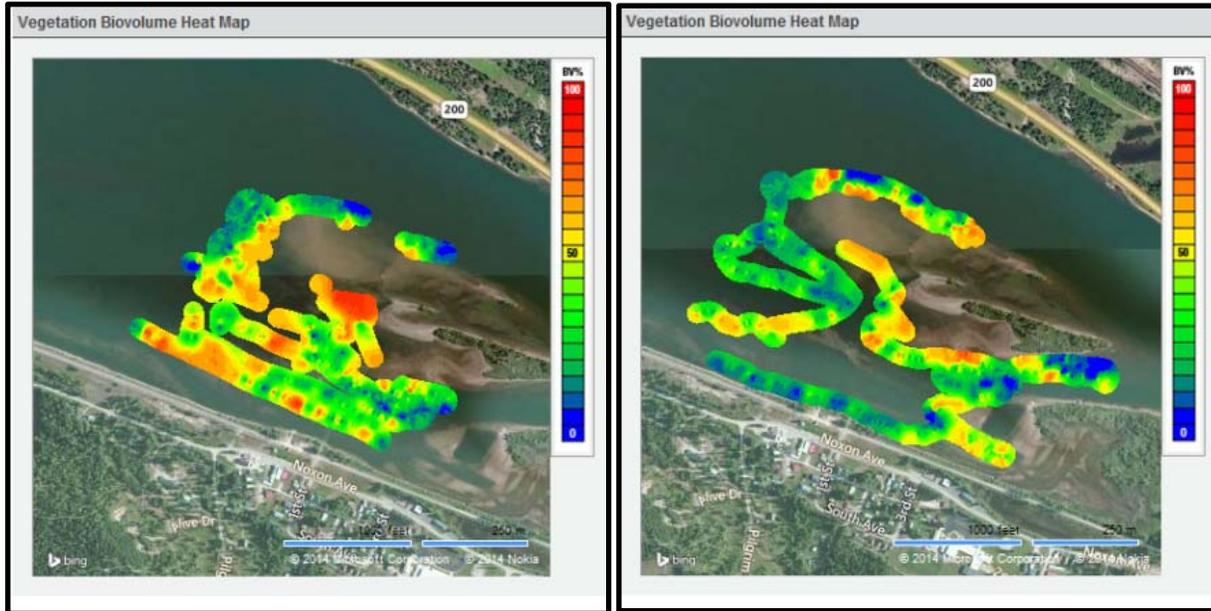
**Plot C-1-14: At Time of Treatment (August 20, 2014 Left),
~ Six (6) Weeks Post (September 26, 2014 Right)**

Observations/Notes C-1-14: Treated with 1.0 ppm triclopyr, 2 ppm endothall, control estimated at 75%. This Plot was reduced from 72.5 to 70.5 acres due to a sandbar on the upper end of the Plot with no vegetation present. East side of plot looks very good for control, Elodea and Sago abundant. Islands of EWM damaged looking amongst area of good control containing elodea and coontail. Longest finger of plot to north contains EWM with abundant filamentous algae. Some plants look healthier than other plants in that area. The level of control looks good for the challenging nature of the plot, shallow and very irregular shape. Observed black stems and leaves via visual observations and rake throws. Vast majority of plants look damaged with observed epinasty. At six (6) weeks post treatment, the herbicides could still be working through plants.

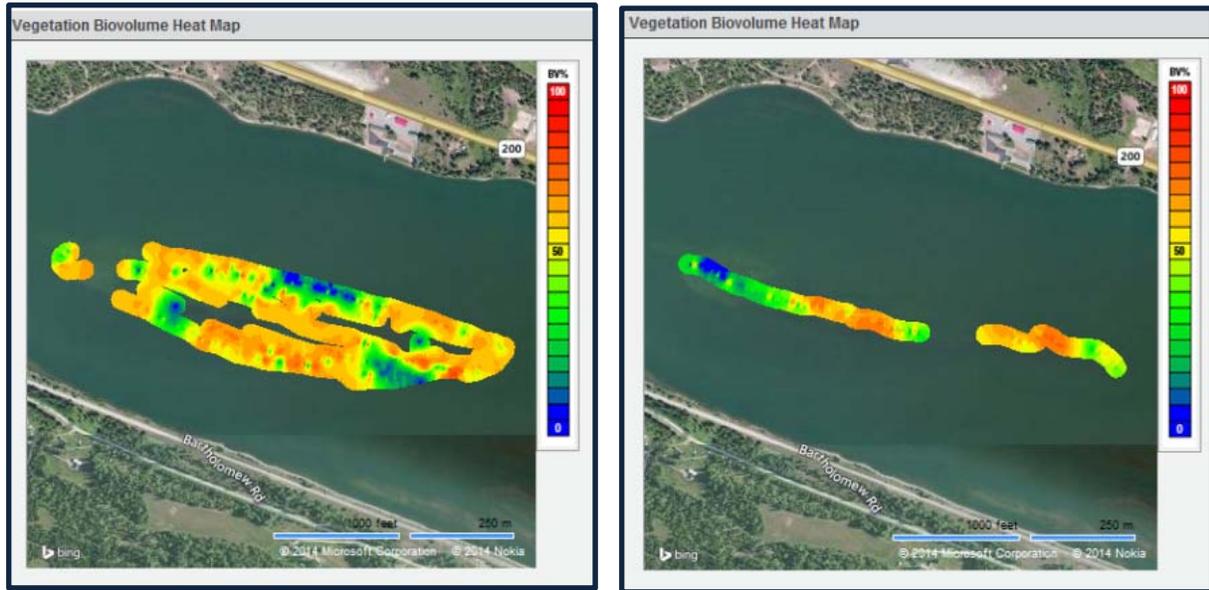
**Plot C-2-14: At Time of Treatment (August 18, 2014 Left),
~ Six (6) Weeks Post (September 26, 2014 Right)**

Observations/Notes C-2-14: Treated with 1.0 ppm triclopyr, 2.0 ppm endothall, control estimated at 50%. Upstream end of plot not showing much control, more control and damage downstream. Control at 50%, re-evaluate efficacy in 2015.

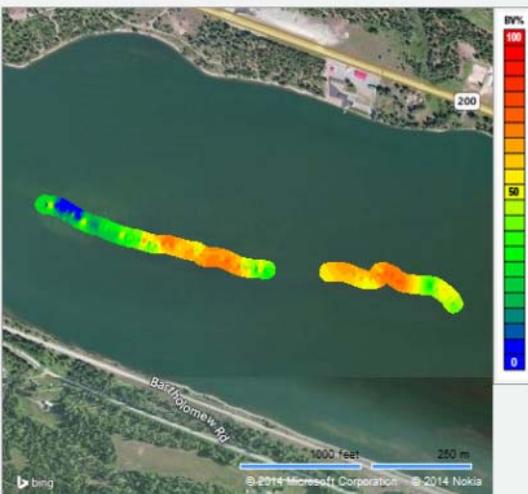
Vegetation Biovolume Heat Map

AOI ?	Type ?	PAC ?	Avg BVp ?	SD BVp ?	Avg BVw ?	SD BVw ?	Depth Range	Avg Depth	Distance	No. Points
1	Point	93.4%	57.1%	±21.5%	53.3%	±25.2%	0.77-2.32 m	1.62 m	1.17 km	1,116
	Grid	97.3%	51.6%	±17.5%	50.2%	±19.1%	0.9-2.23 m	1.58 m	-	1,412

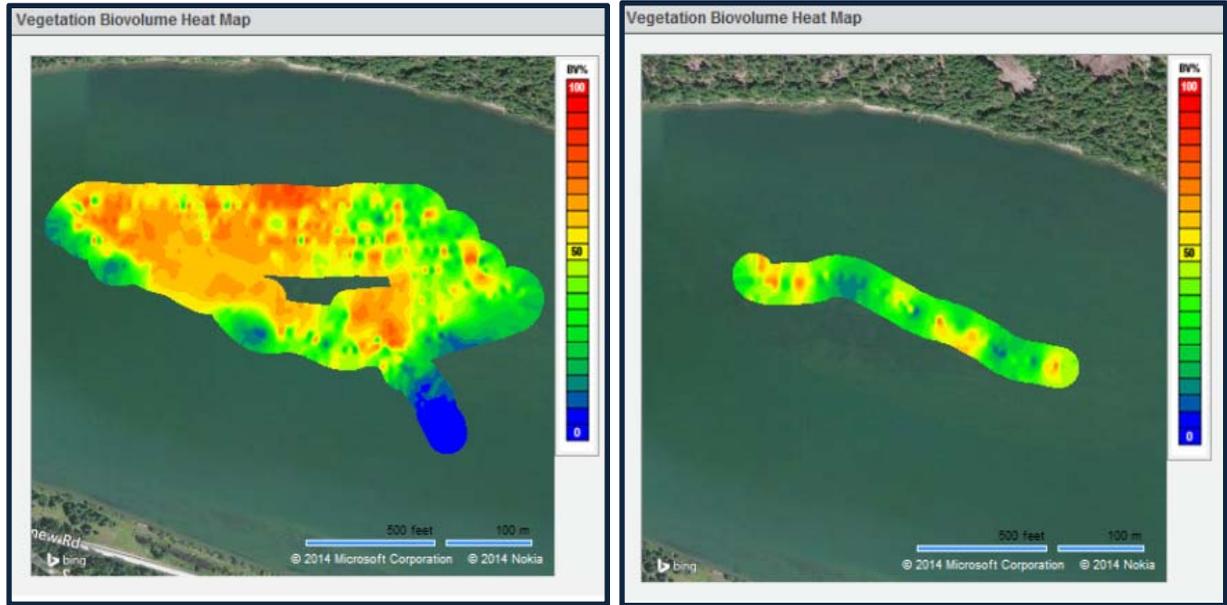
**Plot C-3-14: At Time of Treatment (August 18, 2014 Left),
~ Six (6) Weeks Post (September 26, 2014 Right)**

Observations/Notes C-3-14: Treated with 1.0 ppm triclopyr, 2.0 ppm endothall, control estimated at 70% +/- . Plot at downstream end looks more controlled than upstream.

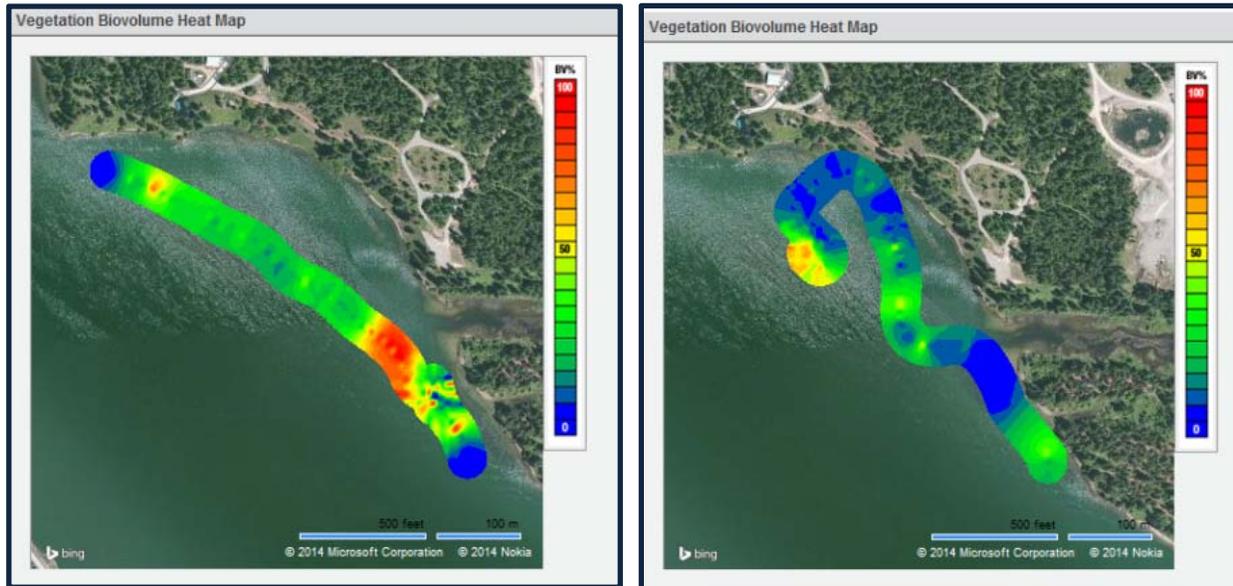
**Plot C-4-14: Pre Treatment* (July 10, 2014 Left),
~ Six (6) Weeks Post (September 26, 2014 Right)**

Observations/Notes C-4-14: Treated with 1.0 ppm triclopyr, 2.0 ppm endothall, good widespread control estimated at 95%.

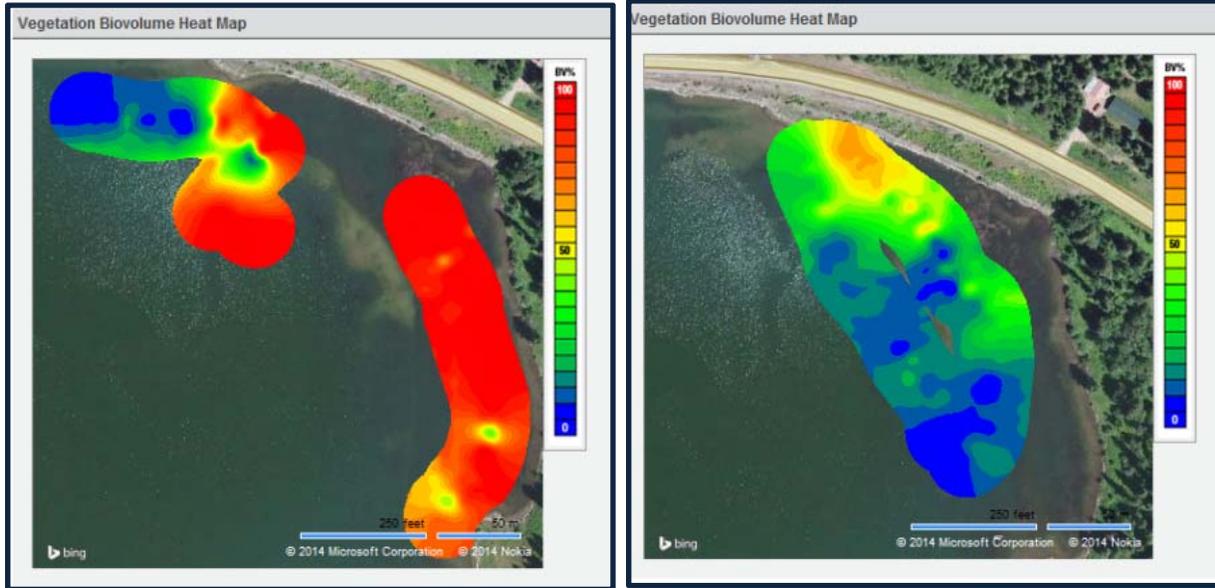
**Plot C-5-14: Pre Treatment* (July 10, 2014 Left),
~ Six (6) Weeks Post (September 26, 2014 Right)**

Observations/Notes C-5-14: Treated with 1.0 ppm triclopyr, 2.0 ppm endothall, good widespread control estimated at 95%.

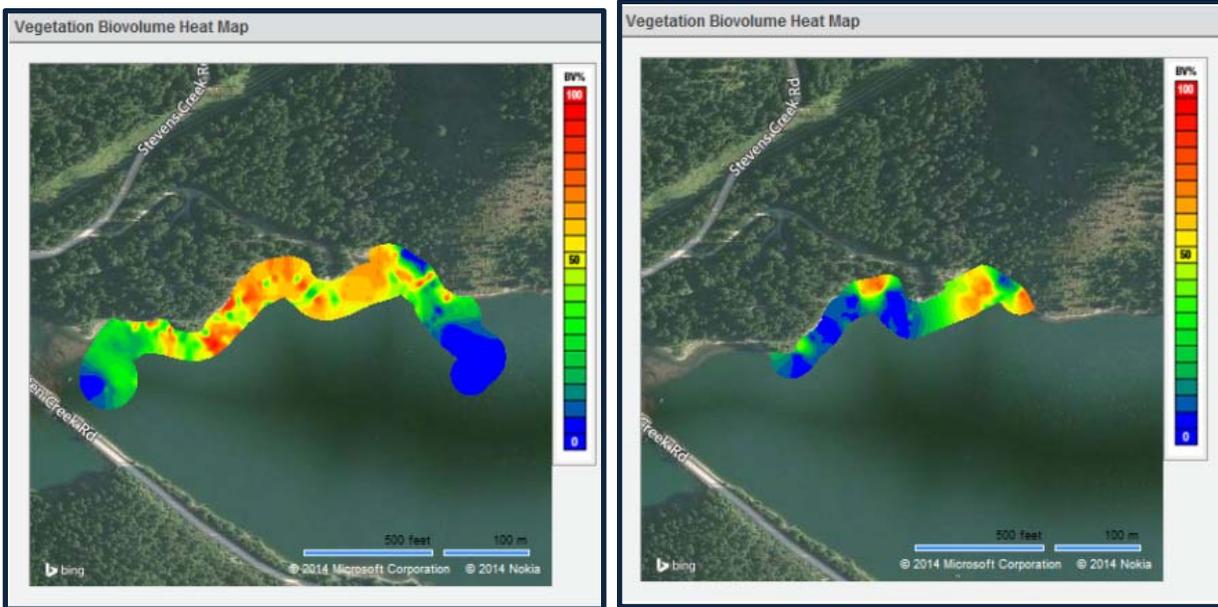
**Plot N-6-14: At Time of Treatment (August 21, 2014 Left),
~ Six (6) weeks Post (September 26, 2014 Right)**

Observations/Notes N-6-14: Treated with 1.0 ppm triclopyr, 2.0 ppm endothall, control estimated at 55%. Some topped out EWM, damaged, but roots growing from nodes, has been treated several times over the years, lots of buttercup, plants look weak, some EWM looks beat up. West end of plot looks better in terms of control, plants in the middle of plot don't seem to get impacted from the control efforts. Reevaluate efficacy in 2015.

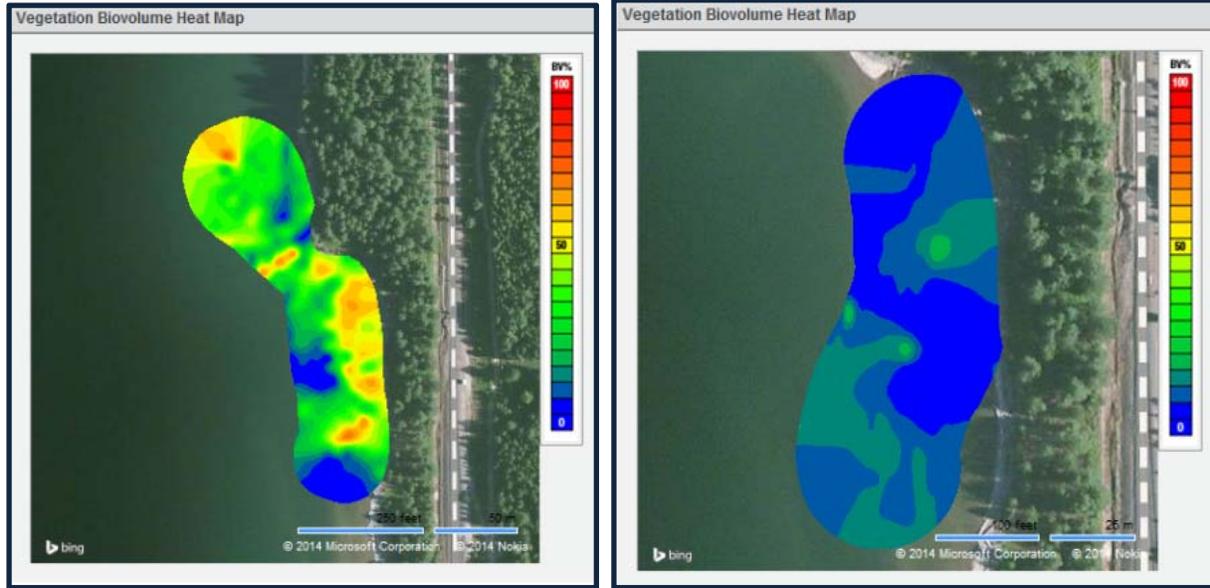
**Plot N-7-14: At Time of Treatment (August 21, 2014 Left),
~ Six (6) Weeks Post (September 26, 2014 Right)**

Observations/Notes N-7-14: Treated with 3.0 ppm endothall, control estimated at 95%. Dead Flowering Rush (FR) lying on bottom.

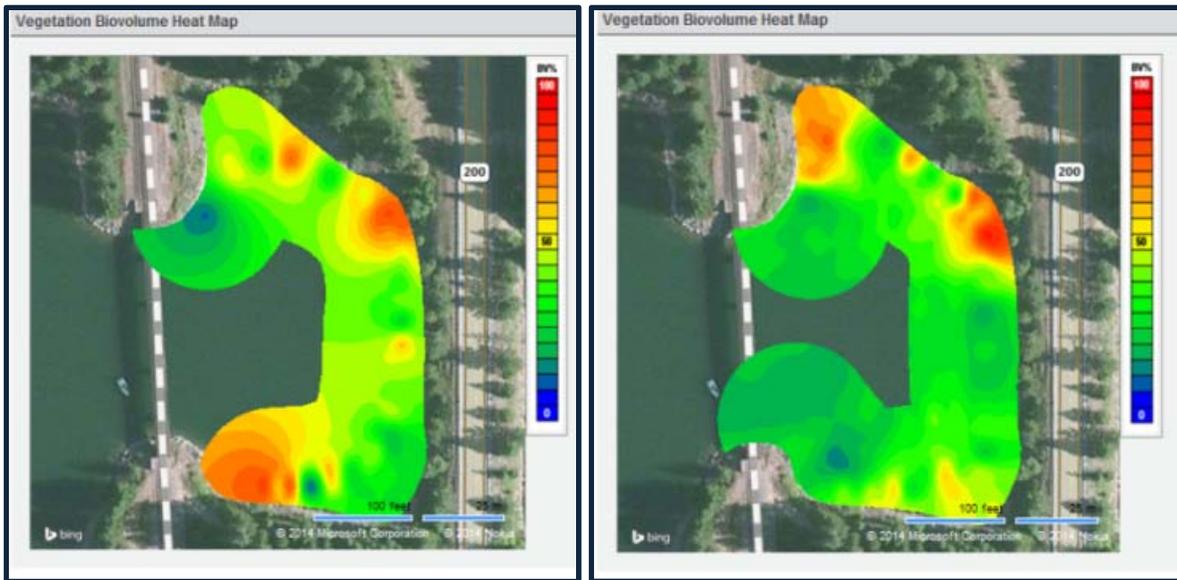
**Plot N-8-14: At Time of Treatment (August 21, 2014 Left),
~ Six (6) Weeks Post (September 26, 2014 Right)**

Observations/Notes N-8-14: Treated with 3.0 ppm endothall, control estimated at 50%. EWM mixed with native milfoil. EWM topped and flowering in corners of plot.

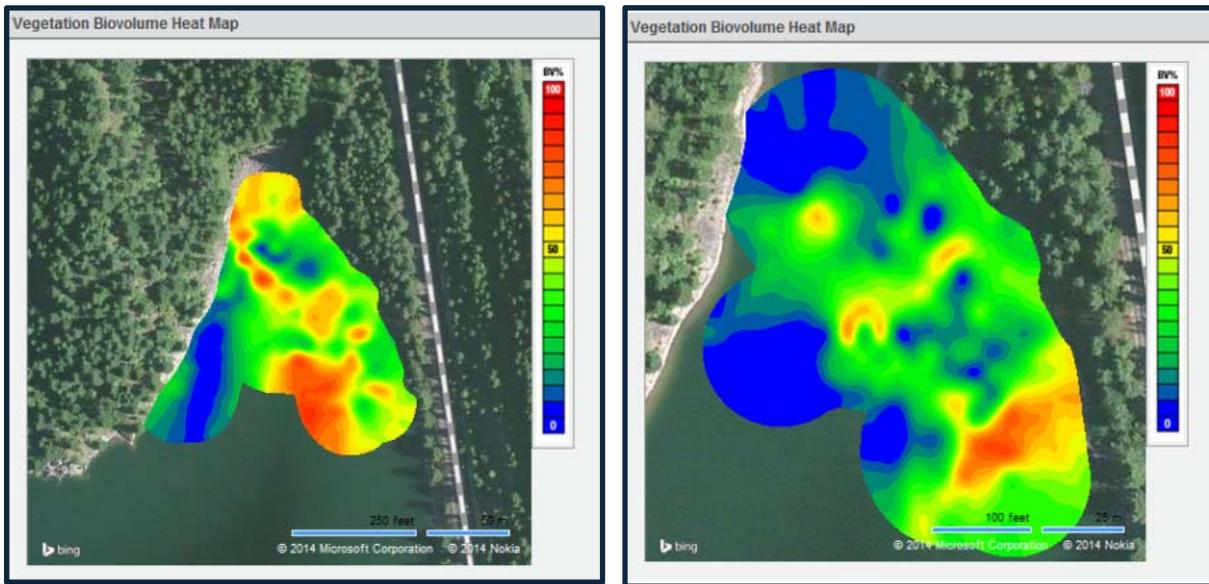
**Plot N-9-14: At Time of Treatment (August 21, 2014 Left),
~ Six (6) Weeks Post (September 26, 2014 Right)**

Observations/Notes N-9-14: Treated with 3.0 ppm endothall, control estimated at 65%. Plants in various degrees of control in some spots. Plot also has native milfoil present.
