HANSON ENVIRONMENTAL

Contract Report: Eurasian Watermilfoil removal in Noxon Reservoir.

August 2013

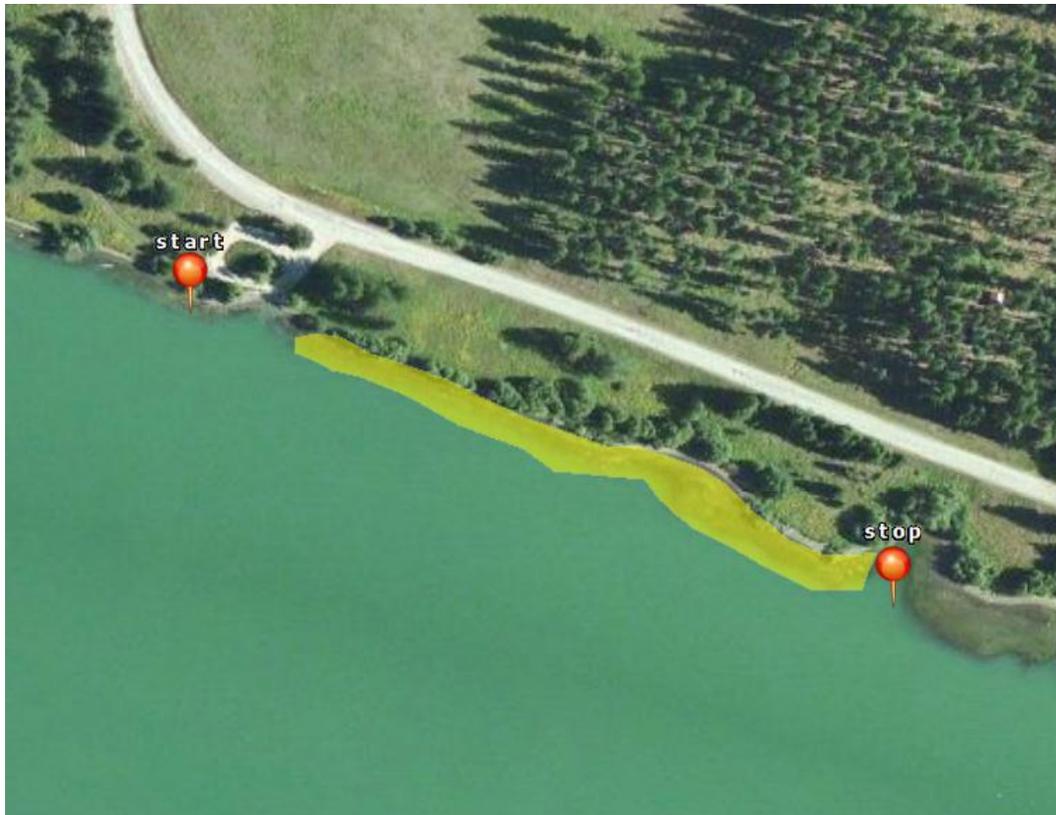
Site: t-13-19

40 lbs of Eurasian watermilfoil removed. 90% removal. The site had dense beds of Coontain with EWM growing immediately adjacent to shore and on the outside edge of the patch. Plants were scattered with a concentration at the downstream end near the boat ramp.=

Start Latitude/Longitude 47°48'49.39"N 115°31'29.30"W

Stop Latitude/Longitude 47°48'46.02"N 115°31'17.32"W

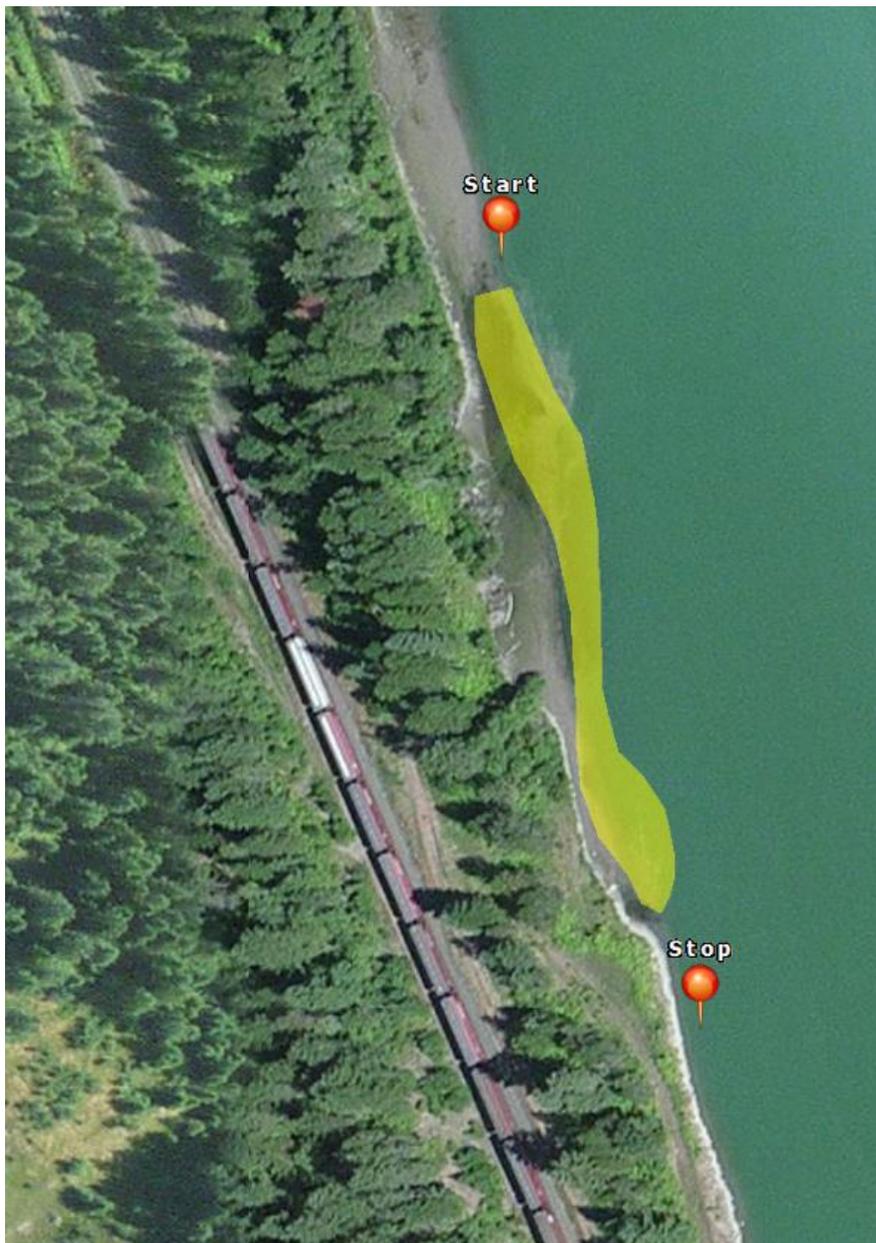
Site: T-13-16

260 lbs of EWM removed. 90% removal. Site had significant amounts of EWM mixed in with common elodea from shore to 6 ft depth. Large stands of EWM were interspersed with Coontail from 6ft deep to 12 ft. The nearshore area was too dense to dredge or swim through, so removal was conducted by hand. Approximately 50% of the EWM removed was dredged, the other hand removed by a two person crew. Scattered EWM plants continued upstream from the site but few plants were seen immediately downstream of the site.

Start Latitude/Longitude 47°47'36.55"N 115°30'14.33"W

Stop Latitude/Longitude 47°47'30.82"N 115°30'12.12"W

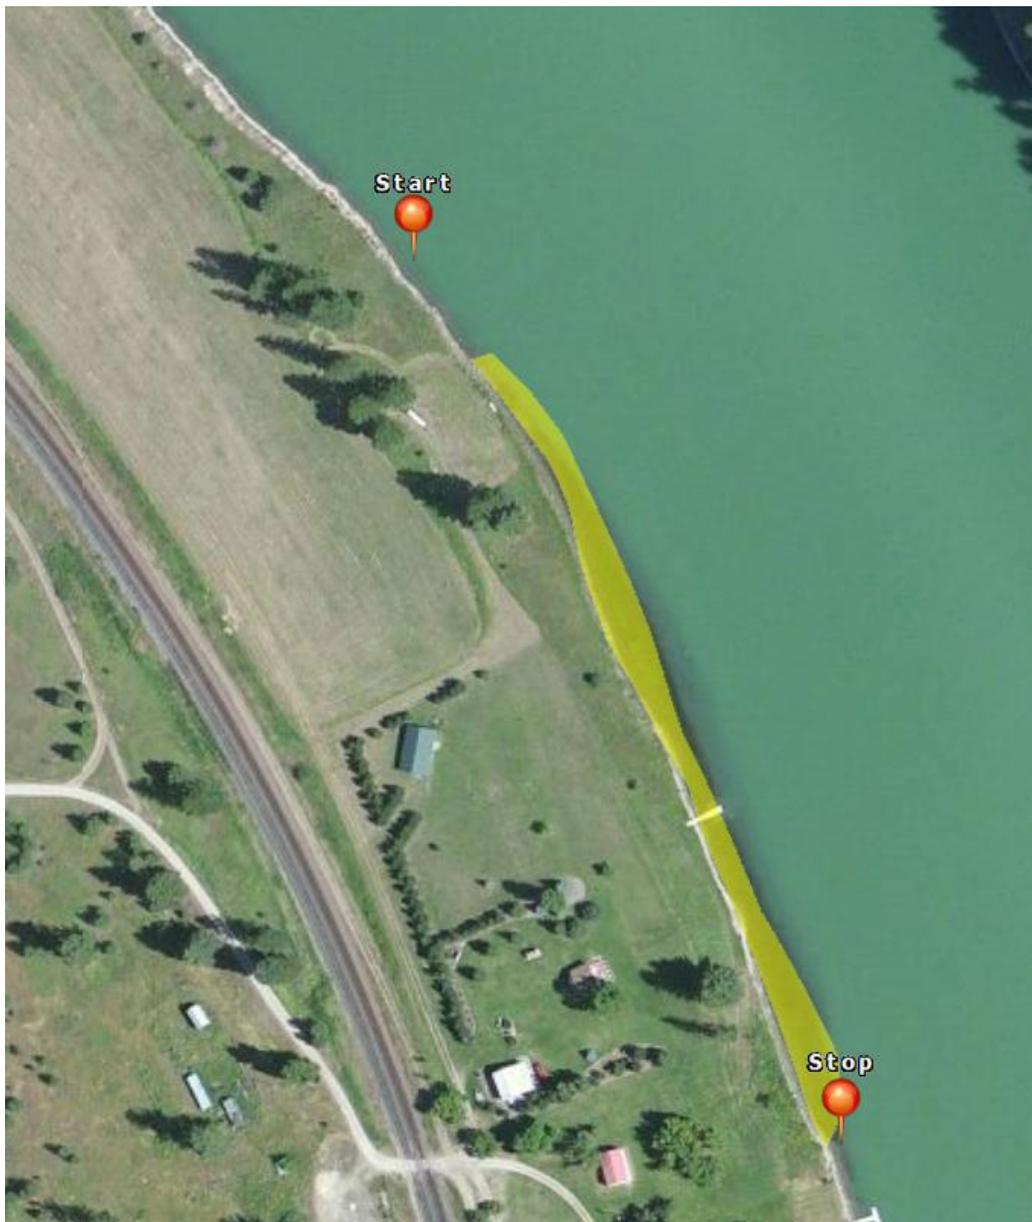
Site: T-13-12

100 lbs of EWM removed 70% removal due to EWM plants dropping out in upstream area. The upstream portion of the site appeared to be effected by the herbicide treatment of the adjacent plot. Most of the plants in that area where dead and lying on the bottom. Healthy and standing plants started occurring about halfway through the site. The majority of the EWM was on the outside of a dense band of Coontail and were scattered. Scattered EWM continued downstream of the site. As the plants were lying down in the upstream portion, few plants were removed in this area.

Start Latitude/Longitude 47°46'52.62"N 115°29'12.44"W

Stop Latitude/Longitude 47°46'42.95"N 115°29'05.49"W

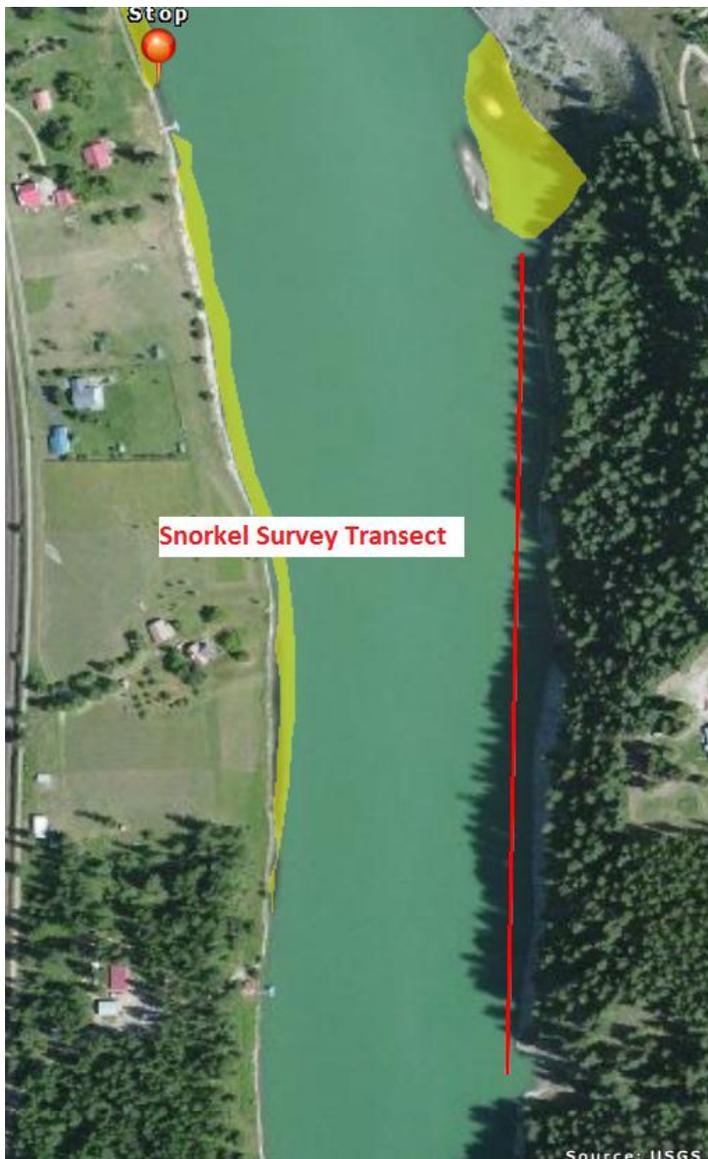
A snorkel survey transect was made upstream of site T-13-11. Scattered EWM plants were observed from the boat launch at Finley Flats down to the treatment plots. A snorkel survey was made to determine the level of infestation and potential for removal. The EWM occurs primarily in dense stands often isolated from other aquatic plants. There were significant amounts of EWM observed over the area in the transect (red line) pictured below. A video was made of a portion of the transect and can be seen online at: [Noxon EWM upstream of site 13](#)
