Inspection Report

Home Inspectors Pro
(424) 281-6940

Property Address:

767 Fairmont Ave.
Glendale, CA 91203

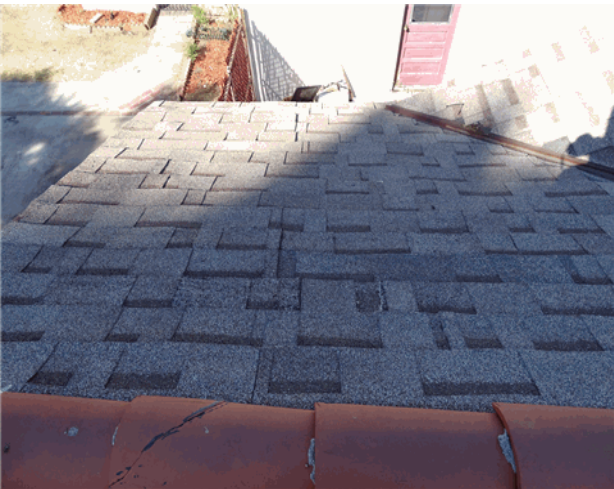
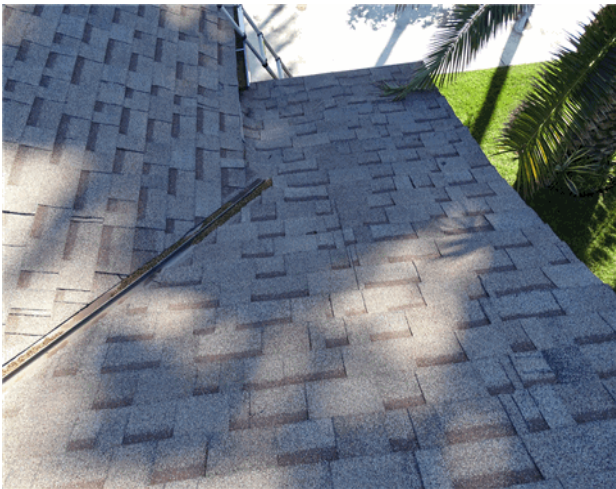
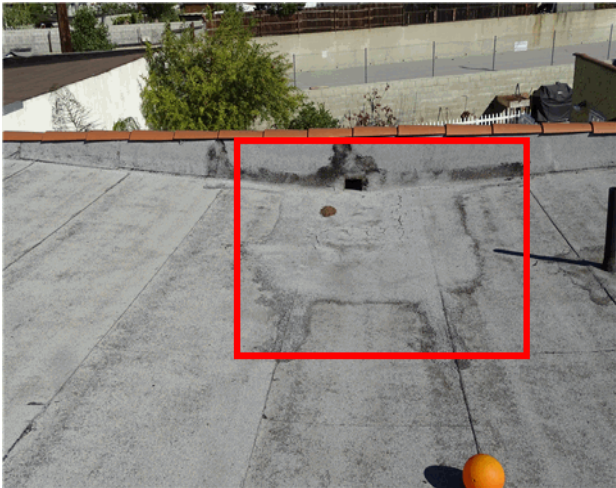
1) Roof Covering Condition

The roof covering showed signs of cracking, curling, and loss of granules. This condition generally indicates that the roofing materials are approaching or close to the end of their useful life. Although immediate replacement may not appear necessary at this time, we recommend maintenance be performed on a regular basis with annual inspection by a qualified roofing contractor. The inspector cannot offer an opinion as to whether the roof leaks today unless it is moderately raining at the time of inspection.

water stain, rolled roof has cracks.

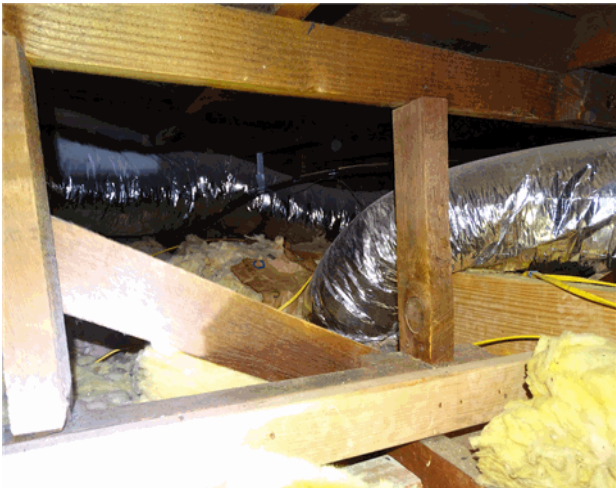
Attic Access	Master Bedroom closet
Method of Inspection	The attic was inspected by partially entering due to blocked access small attic space.
Roof Frame Type	The roof framing is constructed with truss framing.
4) Attic Conditions	<div>AS</div> The visible and accessible portions of the attic appeared to be in serviceable condition at the time of the inspection.

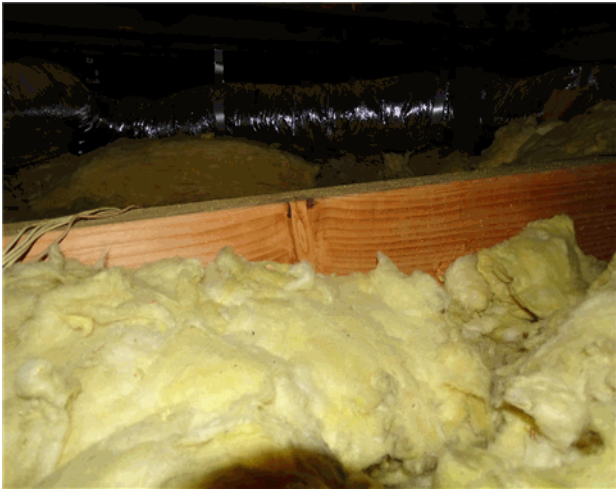
Attic Ventilation Type	Gable Vents
Attic Ventilation Conditions	The Attic Ventilation appeared to be in serviceable condition at the time of inspection.
Attic Insulation Type	Batt Insulation
5) Attic Insulation Conditions	<div>AS</div> The attic has fiberglass batt insulation. The approximate depth of the insulation is 8 to 10 inches. This appears adequate.

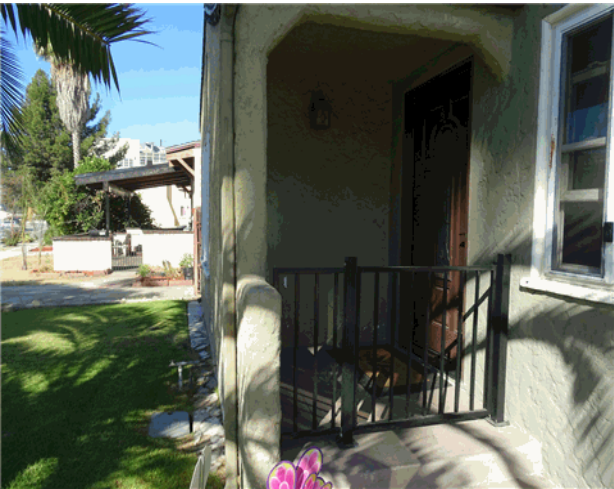
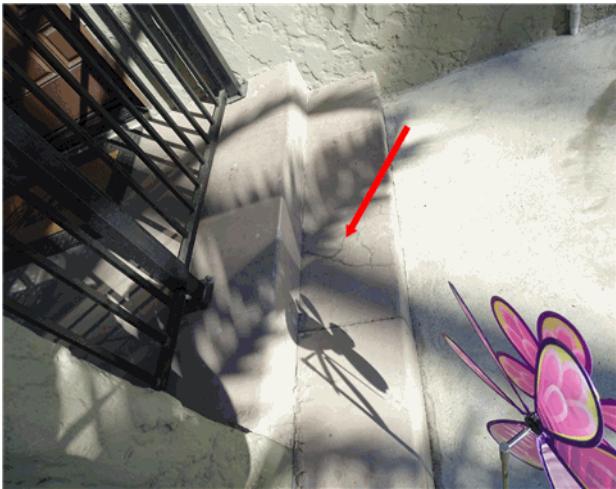
6) Front Entrance Conditions AS Common settlement type cracks were observed to the porch.

Cracks.

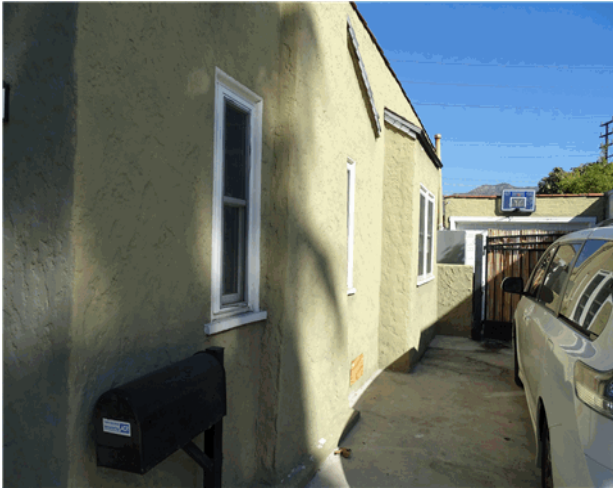
8) Exterior Wall Conditions R The paint / finish of the Stucco was deteriorated and is in need of repair, replacement and / or maintenance.

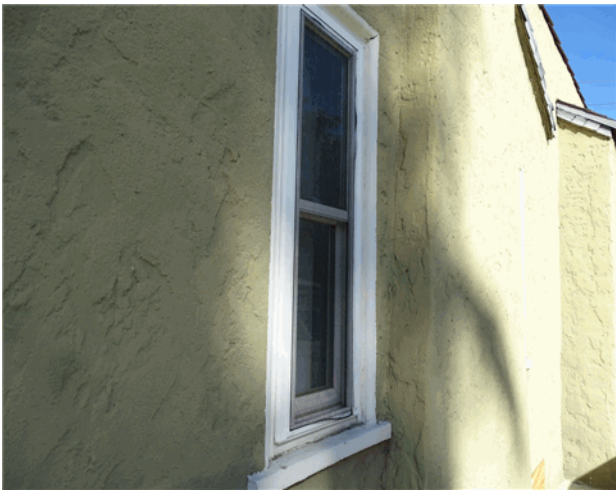
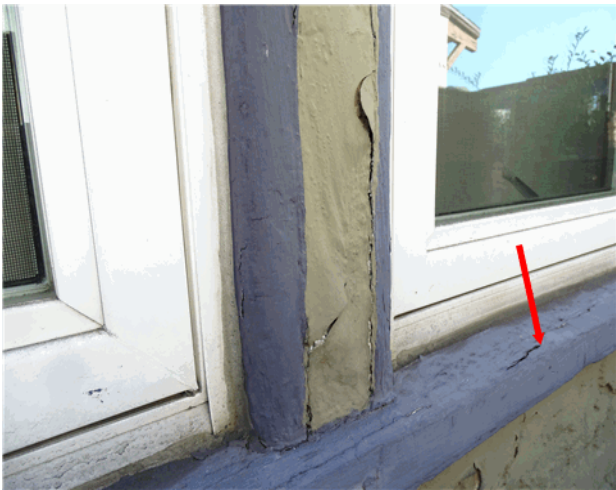
9) Window Conditions

A few of the window Stools had dry rot damage. It is suggested that a "Licensed General Contractor" be contacted for further evaluation and repair.

dry rot damage

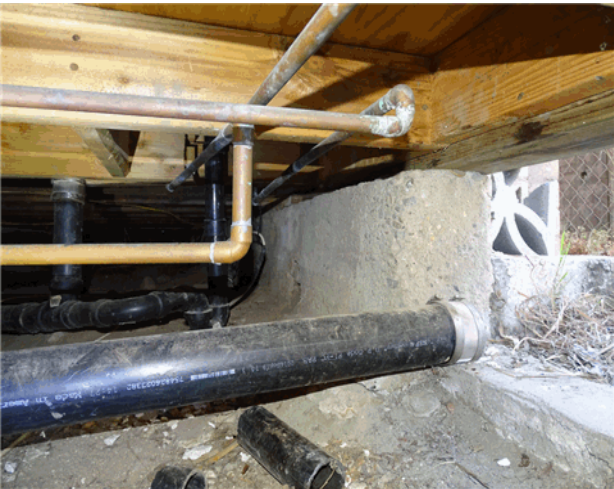
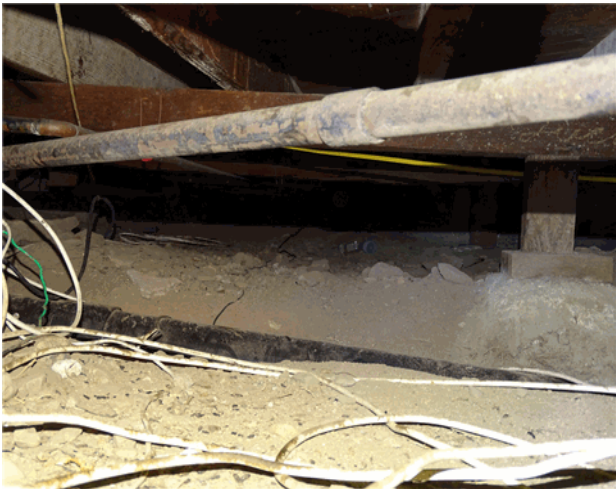
The Foundation appeared to be in serviceable condition at the time of inspection.

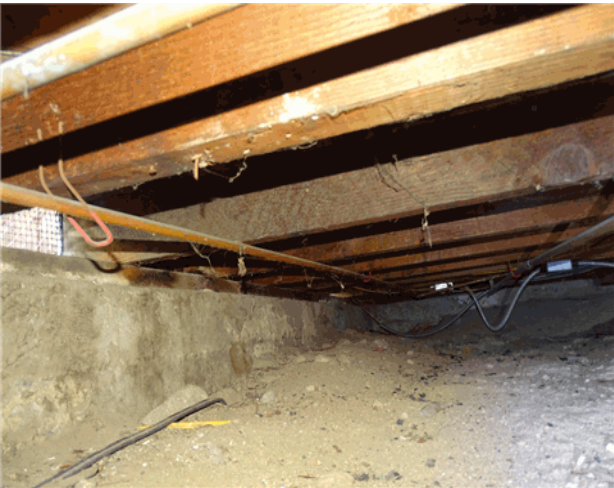
Flooring Support Type The wood framing floor system was constructed of 2 X 8 floor joists.

The visible and accessible areas of the wood framing system appeared to be in serviceable condition at the time of the inspection.

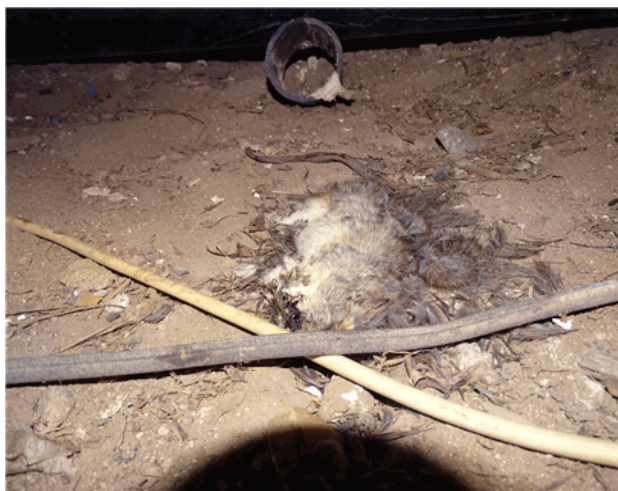
Evidence of rodents were observed. While this observation may exist now, the occurrence may have been some time ago. Client should

contact a pest control company for further evaluation.

dead rodent

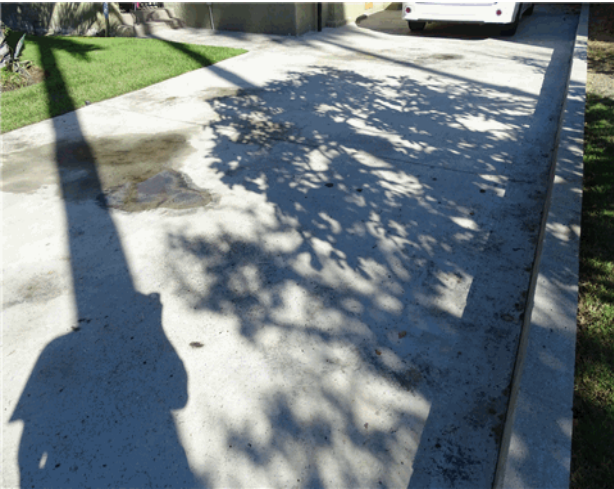
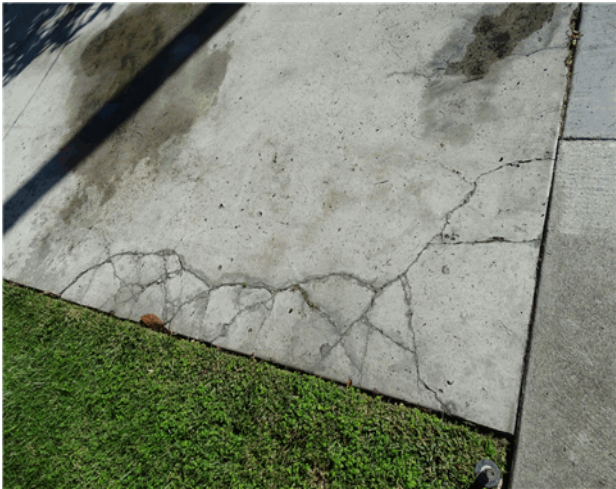
16) Driveway Conditions

Common cracks were observed in the driveway.

common cracks

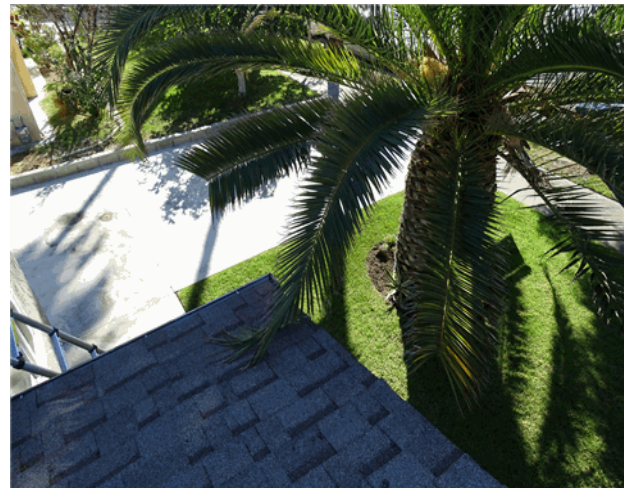
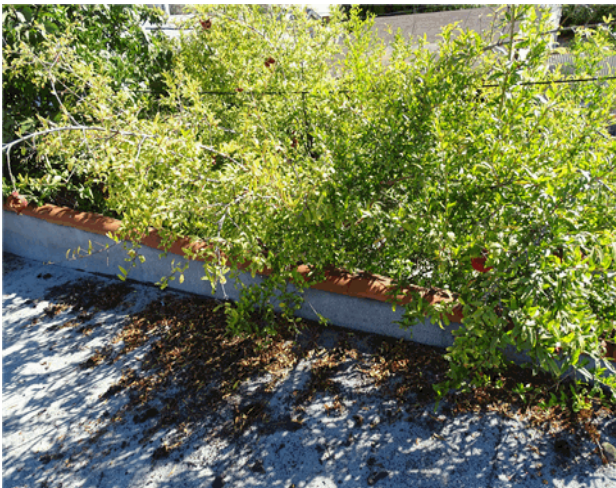
19) Description

The Vegetation on the property needs to be trimmed to prevent damage to the house. It is suggested that a "Licensed Landscaping Contractor" be contacted for further evaluation and repair.

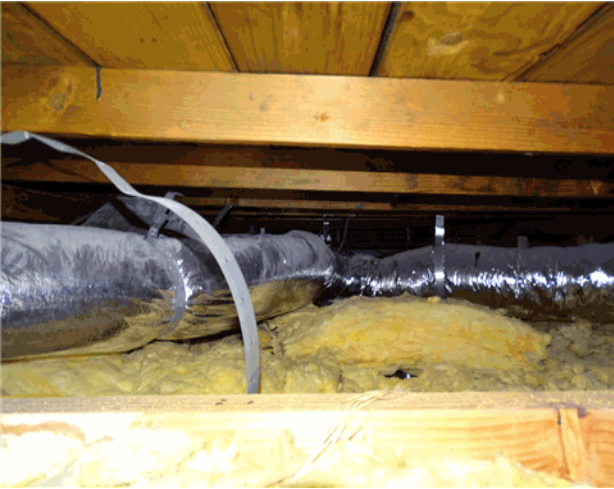
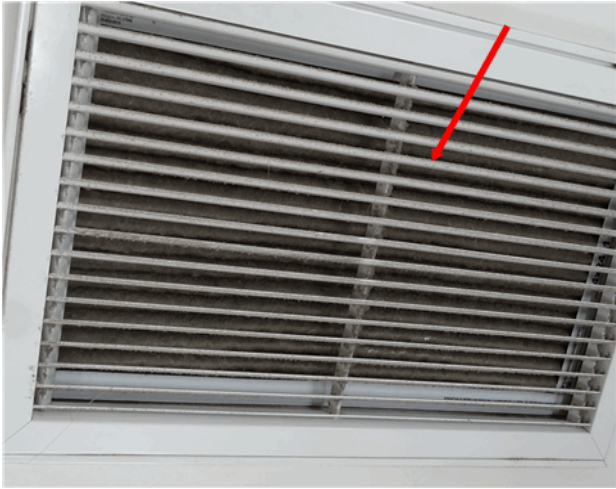
21) Unit Conditions	<div>R</div> <div>The heating system was operational at time of inspection. This is not an indication of future operation or condition. The air filter was dirty. Suggest replacing as soon as possible. To increase the efficiency of your heating system, we recommend changing your systems fir filter(s) regularly (every 2-3 months).</div>
---------------------	--

Dirty Filter

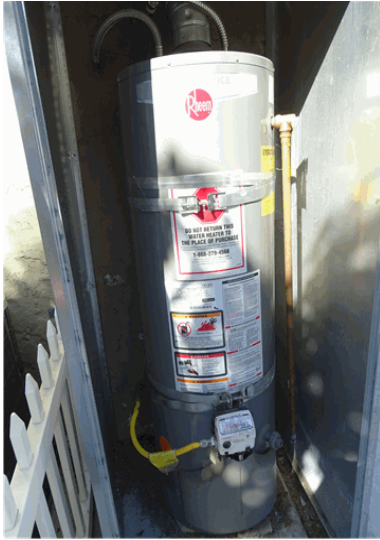
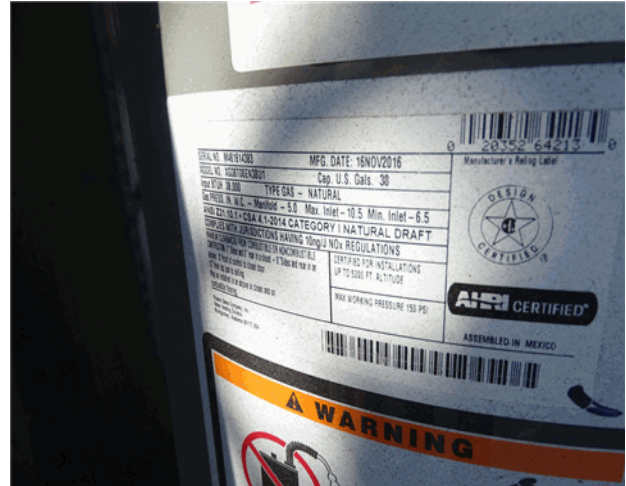
Water Heater Type	Natural Gas
Water Heater Location	exterior
Water Heater Capacity	38 Gallon

29) Water Heater Conditions	<div>AS</div> <div>The water heater was operable at the time of inspection. This does not however guarantee future performance, operation, or condition.</div>
------------------------------------	--

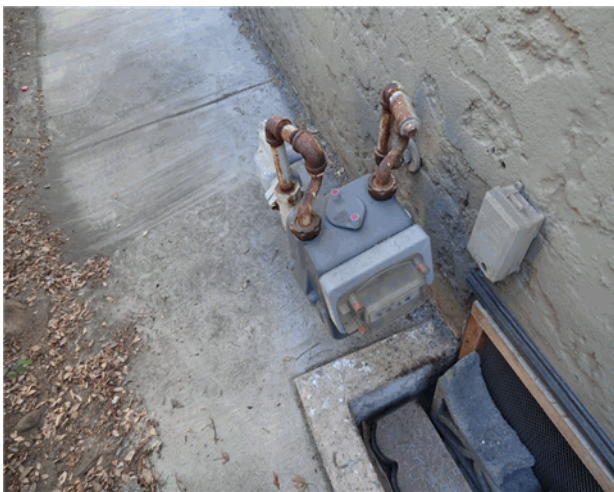
The Gas Meter appeared to be in serviceable condition at the time of inspection.

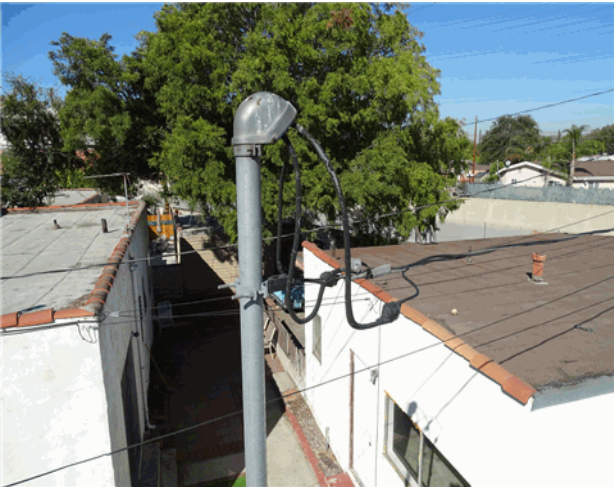
Electrical Service Type	The electrical service is overhead.
Electrical Service Material	Not Inspected
Number of Conductors	Three
31) Electrical Service Conditions	<div>AS</div> The main service entry appeared to be in serviceable condition at the time of inspection.

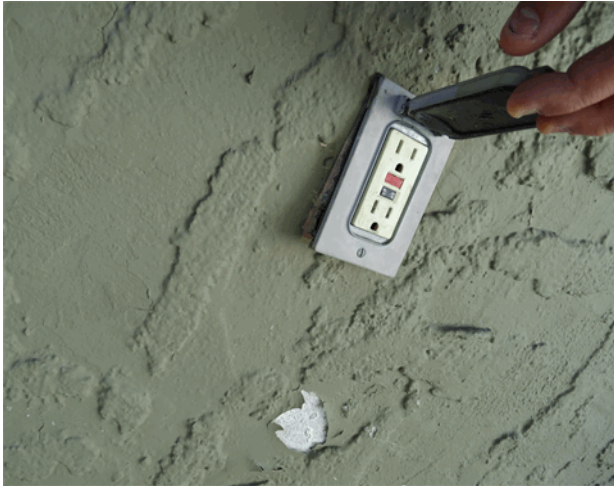
36) Exterior Electrical Condition	<div>R</div>	A few of the outlets externally were loose. Recommend have it replaced or repaired. It is suggested that a "Licensed Electrical Contractor" be contacted for further evaluation and repair.
-----------------------------------	--------------	---

Loose

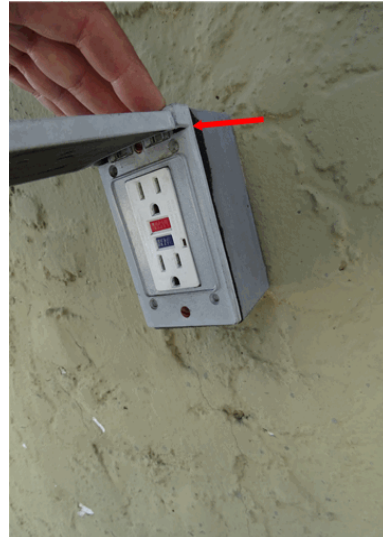
Loose

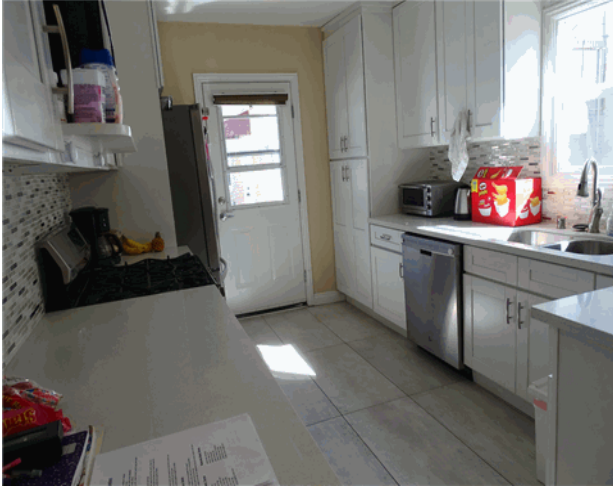
The general condition of the walls appeared to be in serviceable condition at the time of the inspection.

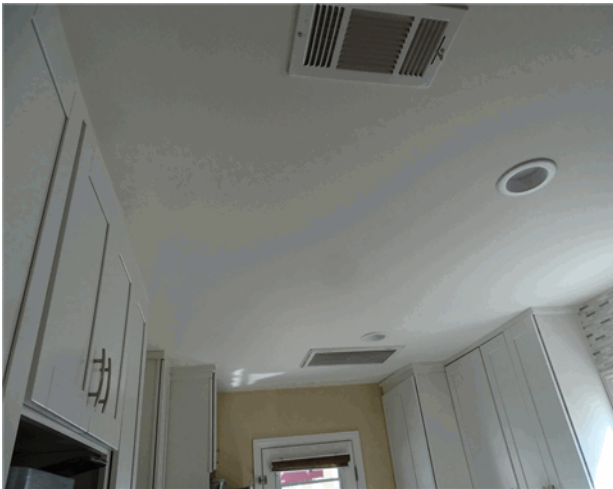
The general condition of the ceilings appeared to be in serviceable condition at the time of the inspection.

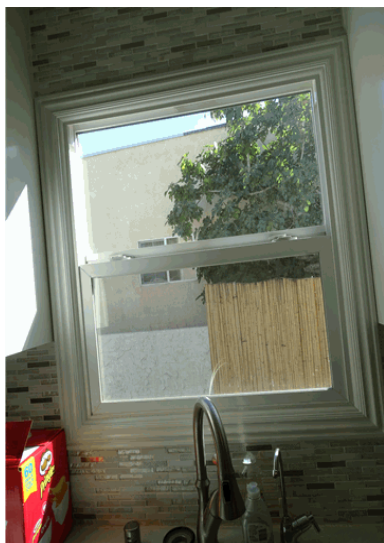
The thermal pane window(s) at appear to have lost its / their thermal seal. Moisture, fogging, and hazing are common signs of this condition. While mostly cosmetic, this condition is generally not repairable. Correction would require replacement of the window(s) or window pane(s).

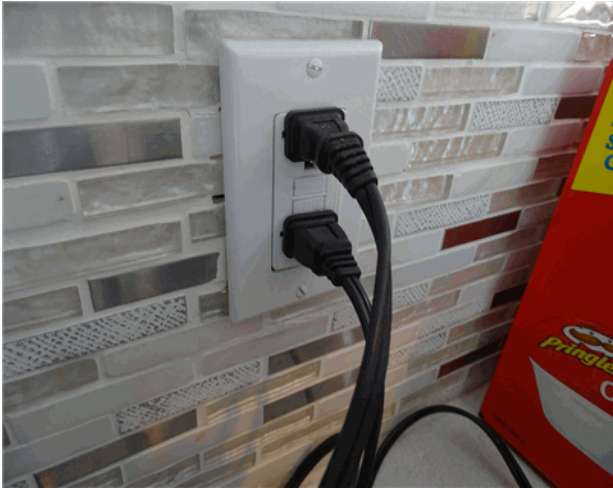
Loose / damaged outlet was observed at kitchen. It is suggested that a "Licensed Electrical Contractor" be contacted for further evaluation and repair.

Loose,

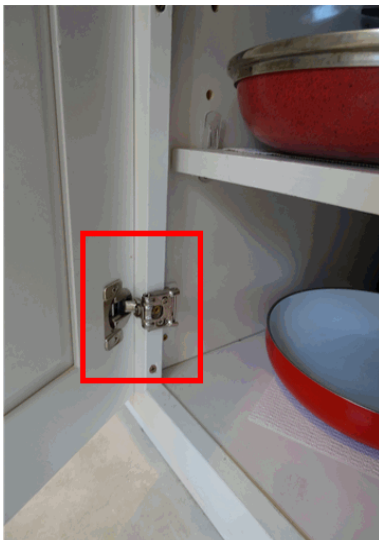
The kitchen Cabinet door hinges were loose. Recommend to have them repaired or replaced.

Cabinet drawers and or drawer guides need adjustment or repair.

Hinge was loose

It is suggested that a "Licensed General Contractor" be contacted for further evaluation and repair.

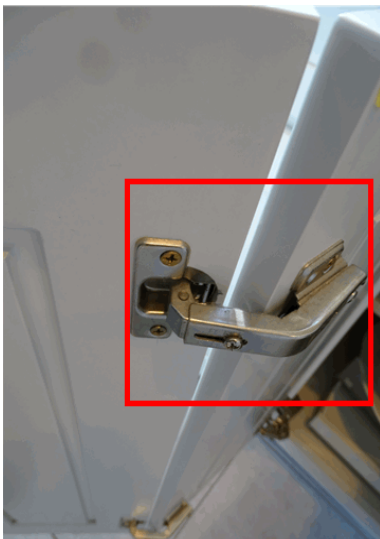
Hinge was loose.

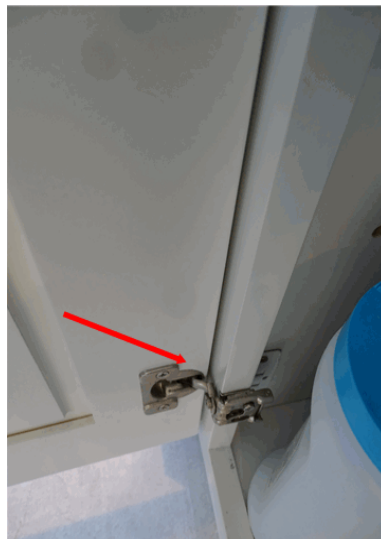
Hinge was loose.

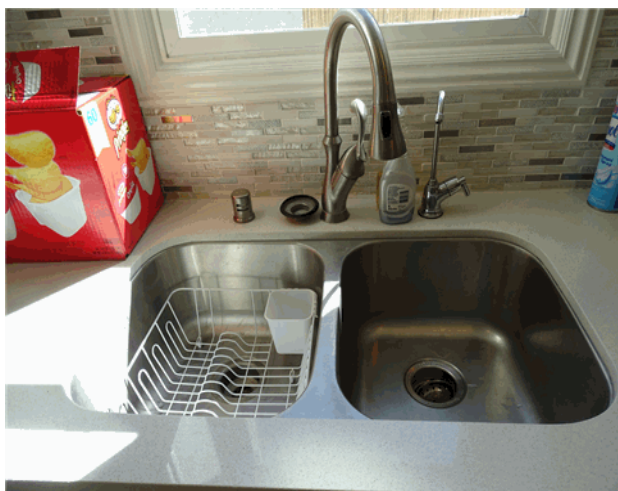
The kitchen sink appeared to be in serviceable condition at the time of the inspection. The faucet appeared to be in serviceable condition at the time of the inspection. The visible areas of the plumbing under the kitchen sink appeared to be in serviceable condition at the time of the inspection.

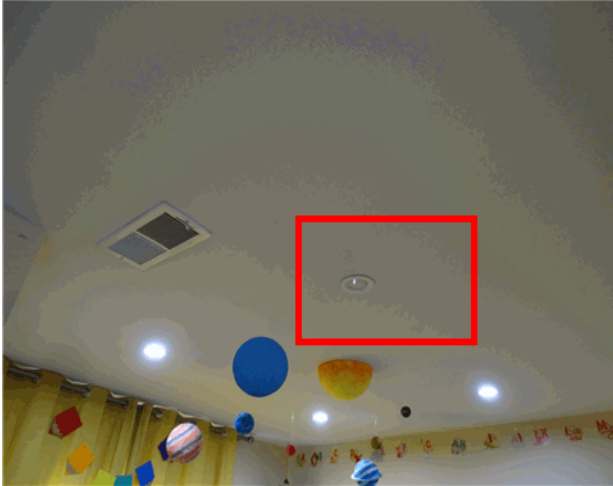
1 out of the 4 lights in the bedroom was out. Recommend having it replaced by a licensed Electrician.

light was out.

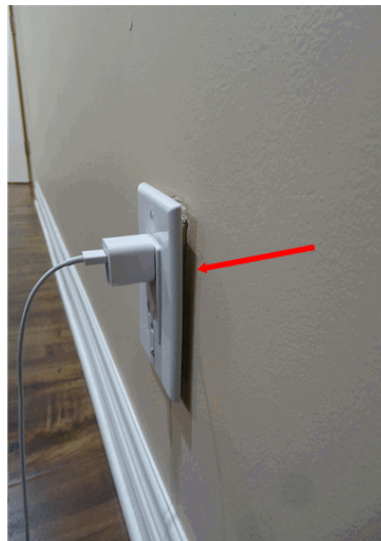
Loose / damaged outlet was observed at bedroom.
Three pronged outlets did not test for proper ground at bedroom.
It is suggested that a "Licensed Electrical Contractor" be contacted for further evaluation and repair.

Loose outlet.

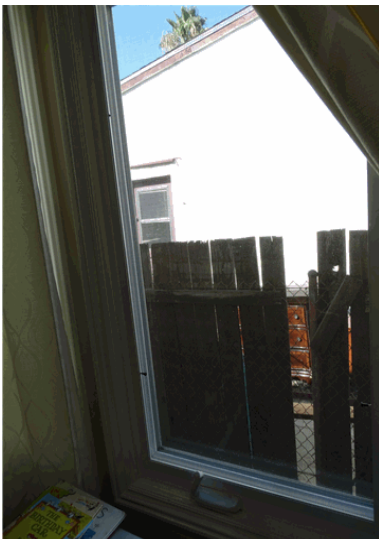
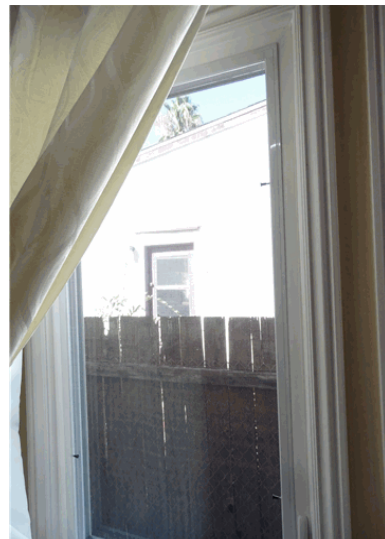
79) Interior Window Conditions

The sample of windows tested were operational at the time of the inspection.

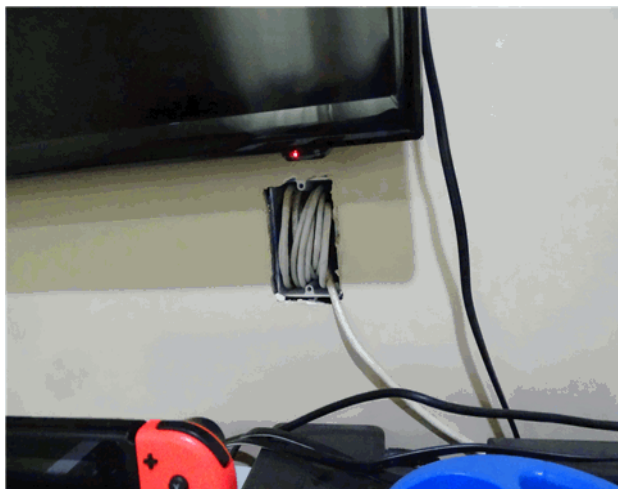
Missing receptacle or switch covers were observed at. Recommend covers be installed for safety.

Needs cover

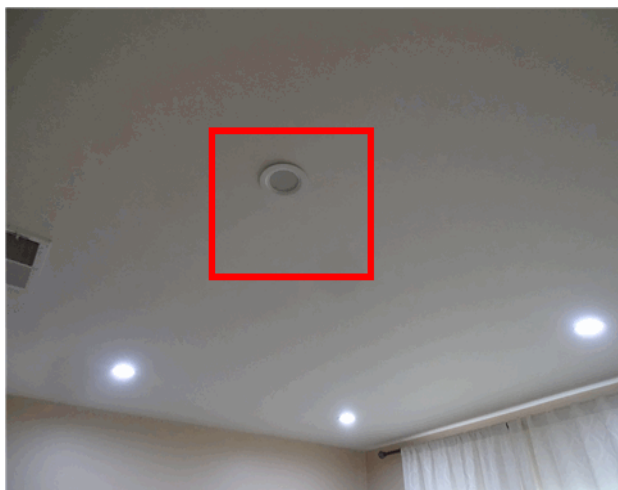
82) Lighting Conditions

1 out of the 4 lights in the bedroom was out. Recommend having it replaced by a licensed Electrician.

Light was out.

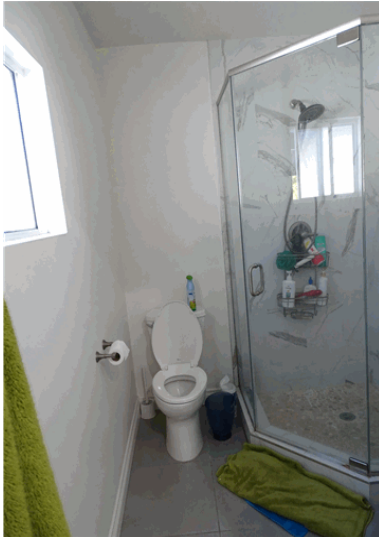
84) Wall Conditions

The general condition of the walls appeared to be in serviceable condition at the time of the inspection.

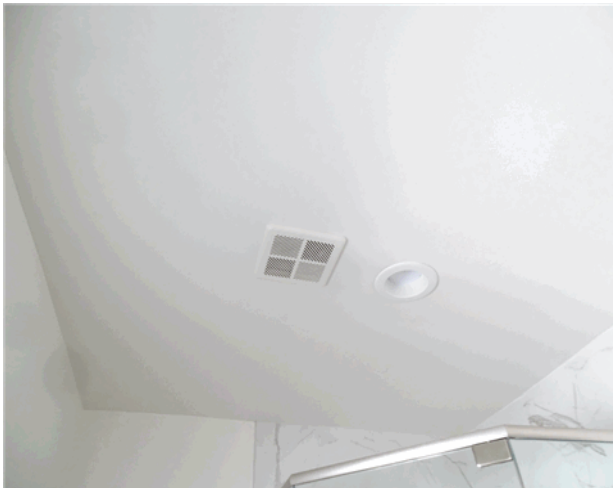
85) Ceiling Conditions

The general condition of the ceilings appeared to be in serviceable condition at the time of the inspection.

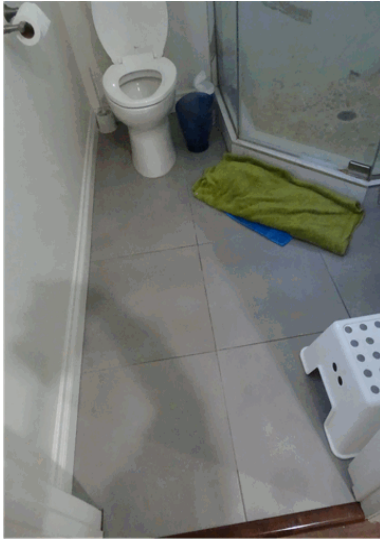
86) Floor Conditions

The general condition of the visible and accessible portions of the floors appeared to be in serviceable condition at the time of the inspection.

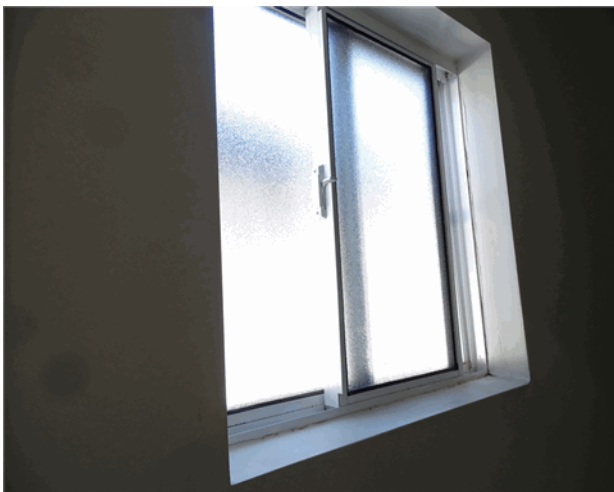
87) Bathroom Window Conditions

The sample of windows tested were operational at the time of the inspection.

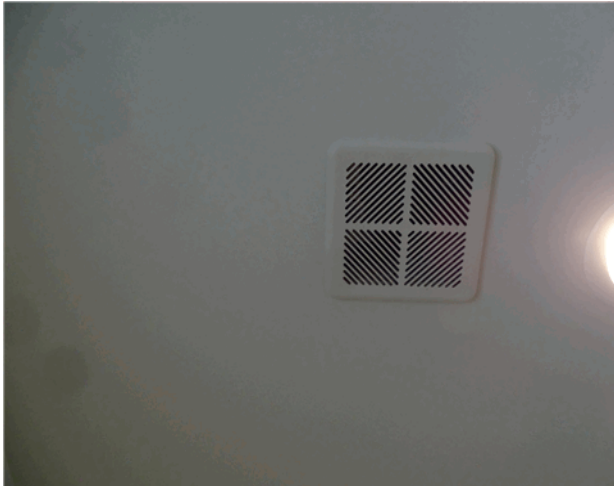
91) Vent Fan Conditions

The exhaust fan made an unusual noise / vibration in bath

Vent was loud

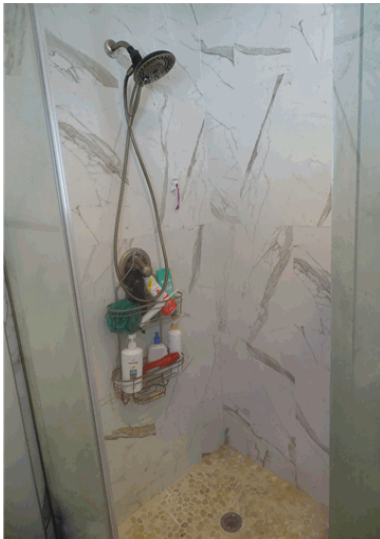
94) Shower - Tub Conditions

There were multiple tiles that were damaged on the shower wall.
Recommend having them replaced.

Tile Damaged.

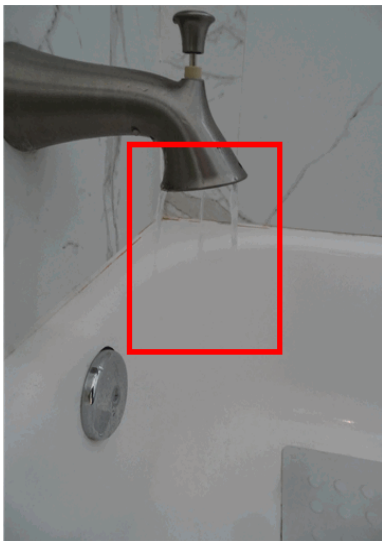
106) Shower - Tub Conditions

When the water was diverted from the tub spout to the shower head, some water was still running from the spout in bath. Adjustment or repair may be needed to the diverter faucet or tub spout. It is suggested that a "Licensed Plumbing Contractor" be contacted for further evaluation and repair.

Diverter valve leaking.

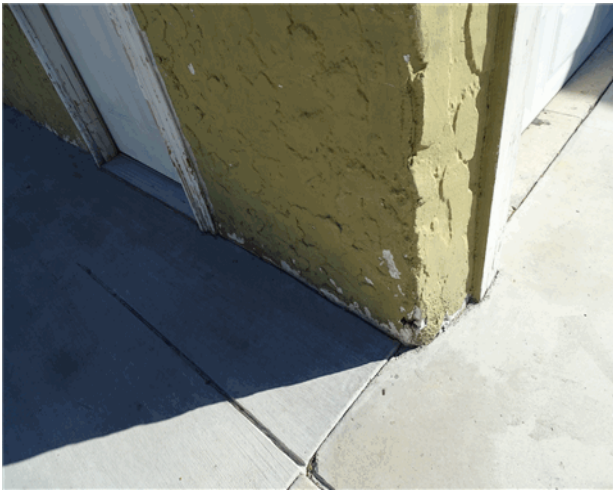
The paint / finish of the Stucco was deteriorated and is in need of repair, replacement and / or maintenance.

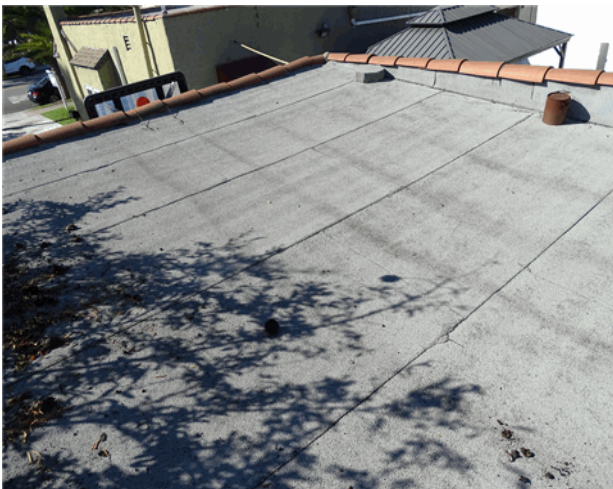
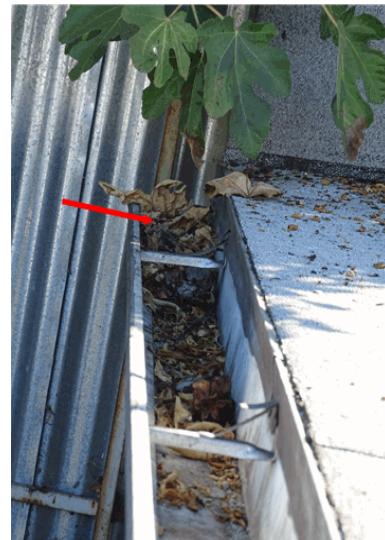
109) Roof Conditions (if detached)

The gutters were filled with leaves and debris at the time of the inspection. Suggest cleaning and removal of debris on a regular basis.

Gutter filled with debris.

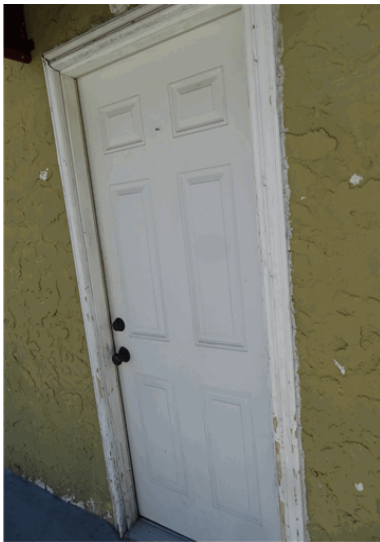
114) Door Conditions

The hinge on the door was loose. recommend having it repaired.

Hinge is loose.

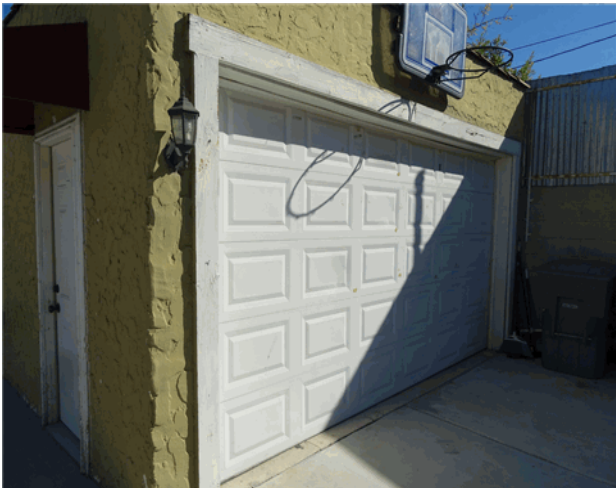
115) Vehicle Door Conditions

The vehicle door motor chain was disconnected.

Disconnected

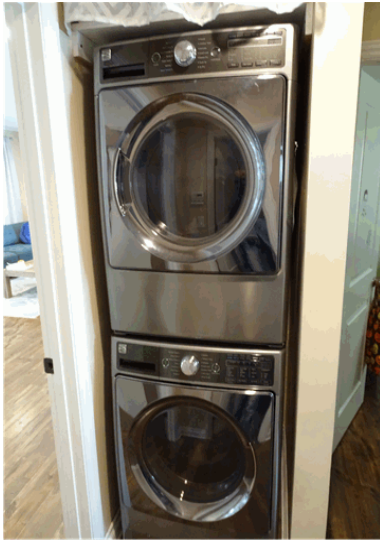
118) Laundry Room Conditions

The visible and accessible portions of the laundry plumbing components appeared to be in serviceable condition at the time of inspection.
