# *Coggeshall Home Inspections*

## **Home Inspection Report**

5459 4th St. , Long Beach, CA 90814

Date of Inspection: 10/24/2020

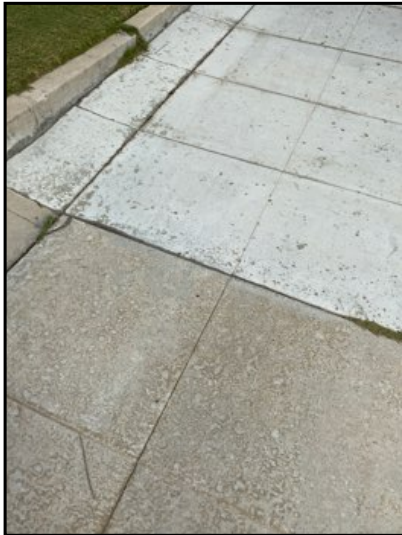
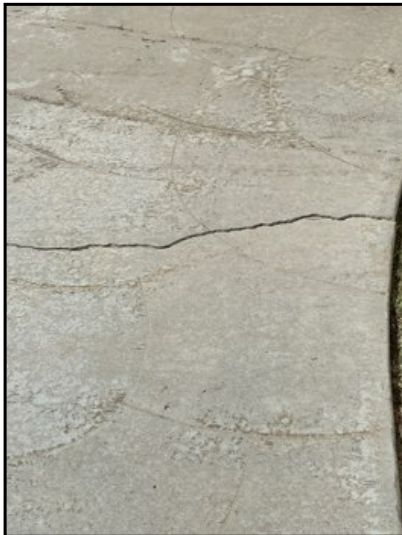
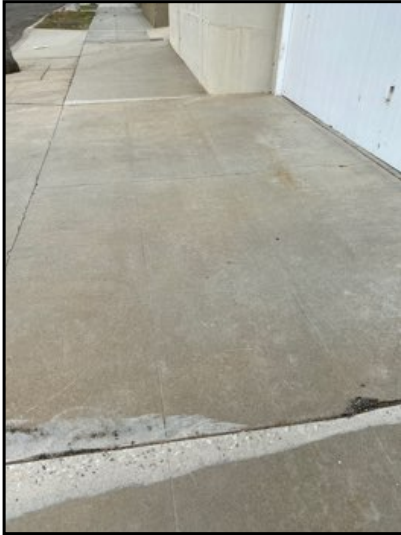
- Potential Trip Hazard(s) at sidewalk; monitor / repair as necessary.
  - Some sections of concrete driveway/walkways showed signs of crack.
- Recommend repair/seal.

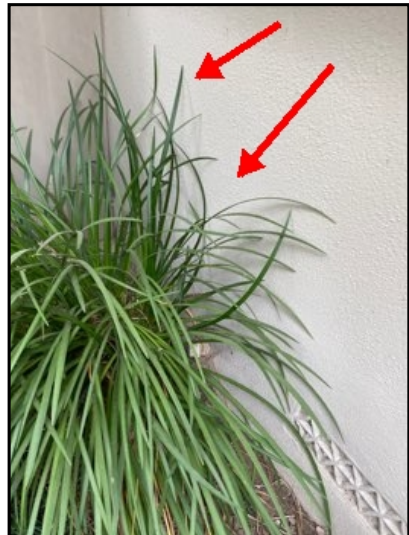
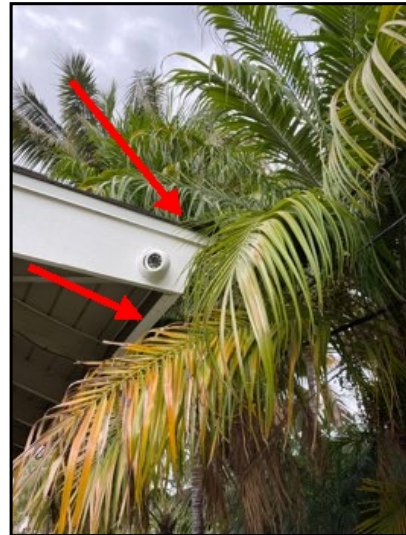
- Recommend trimming trees/vegetation so that it does not come into contact with home.

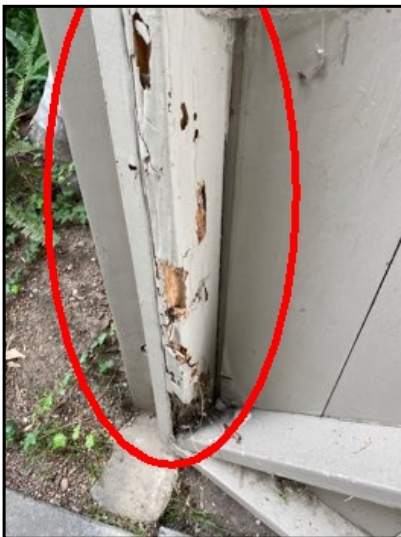
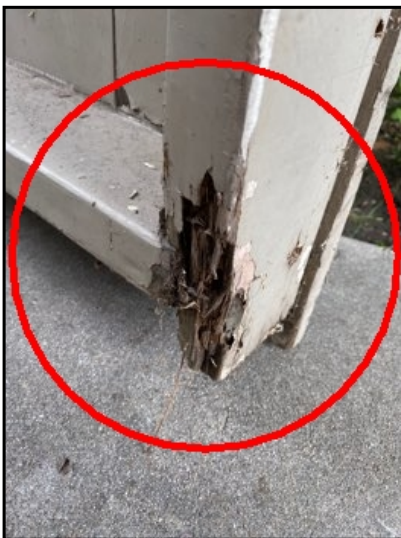
#### 4. Gate Condition

- Wooden gate showed signs of damage/deterioration at time of inspection. Recommend repair.

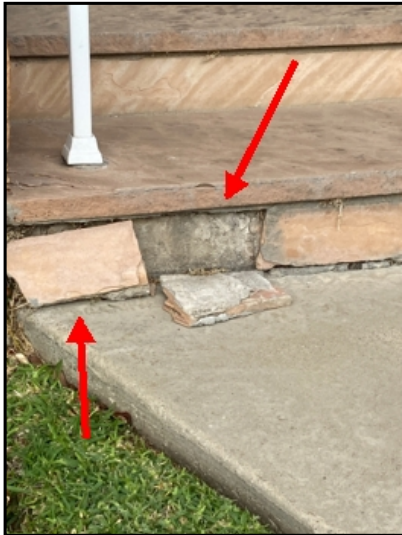
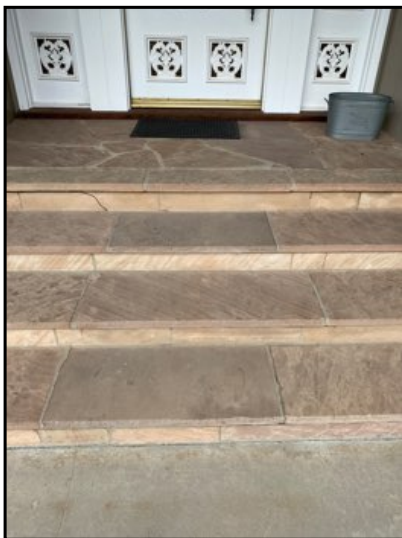
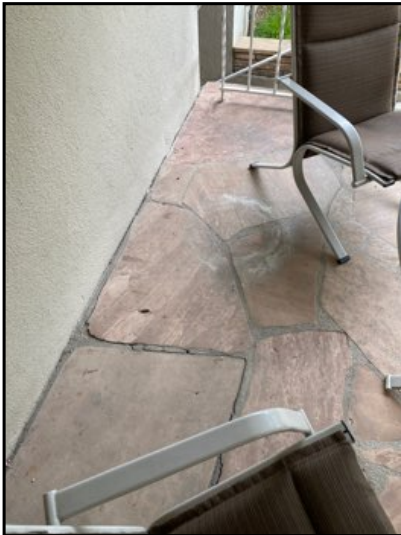
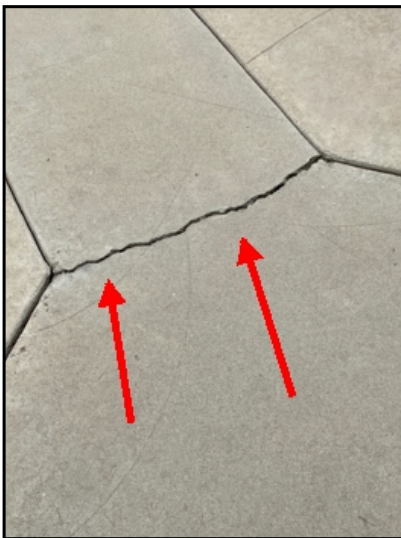
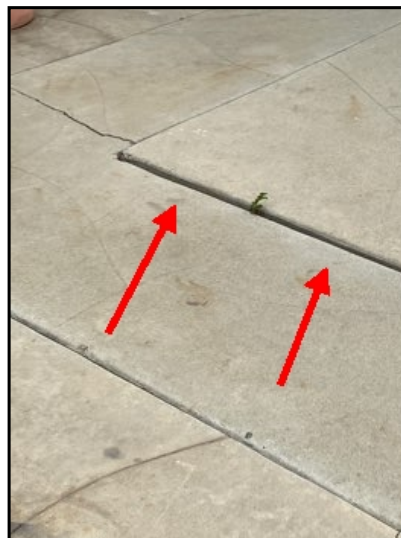
- Front porch showed signs of damaged tile/stone at time of inspection. Recommend repair.
- Common cracks/Seal as needed.
- Uneven concrete patio slabs noted in backyard. Potential trip hazard. Recommend repair.

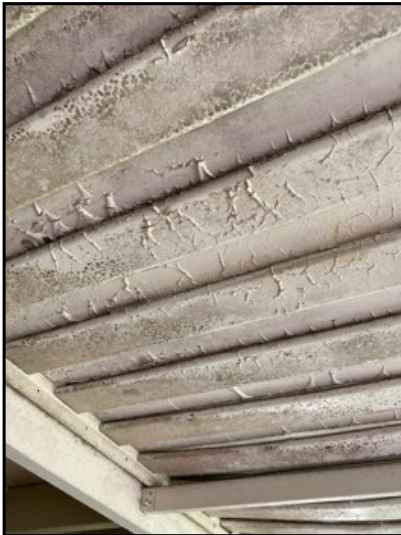
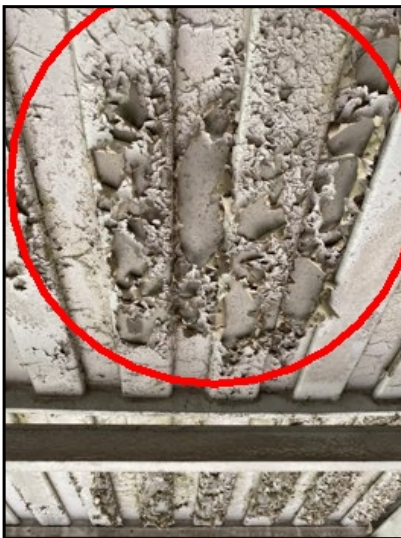
16. Patio and Porch Condition

- Backyard patio covering showed signs of damage at time of inspection. Recommend licensed contractor inspect and evaluate further for repairs.

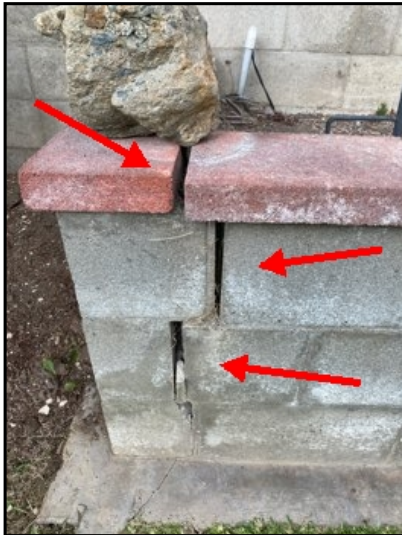
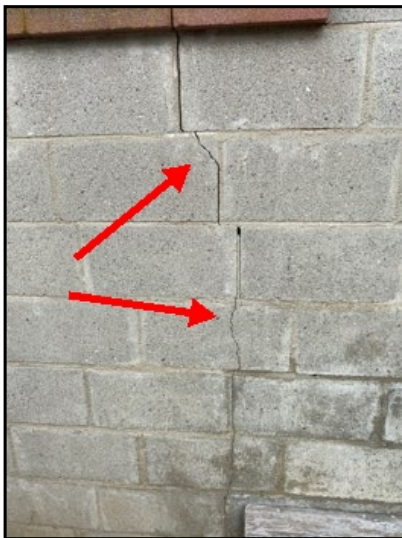
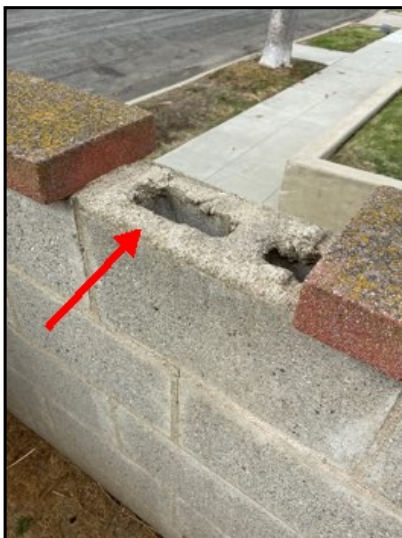
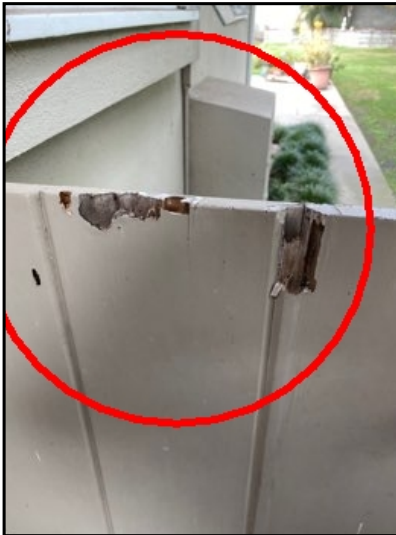
17. Fence Condition

- Wood deterioration observed. Suggest repairs/replacement as needed.
- Some sections of block wall fencing showed signs of cracks at time of inspection. Recommend repair.
- Loose/missing top blocks observed. Suggest maintenance/repairs as needed.

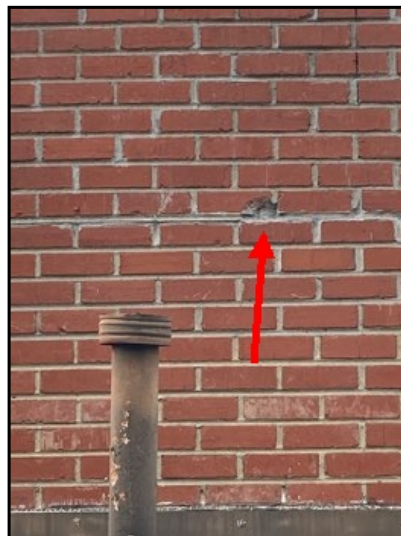
### 3. Chimney

- Evidence of damage bricks on chimney at time of inspection. Recommend licensed chimney contractor inspect and evaluate further for repairs.

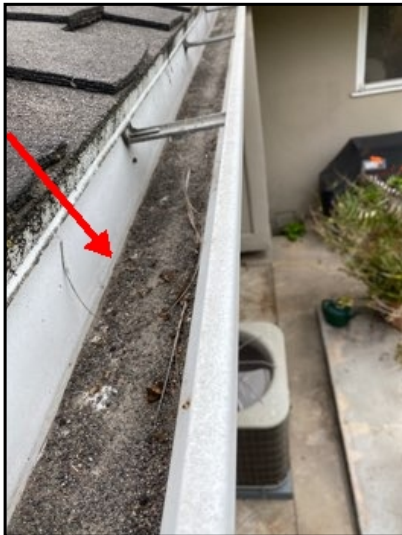
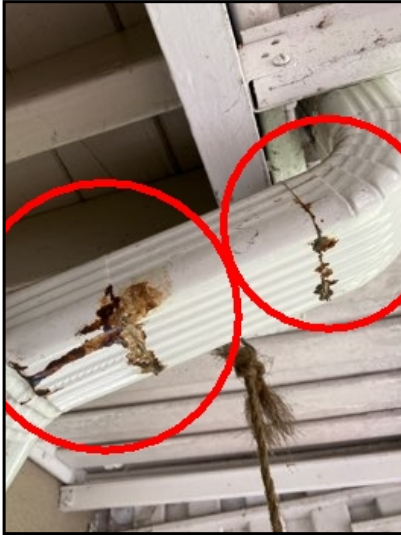
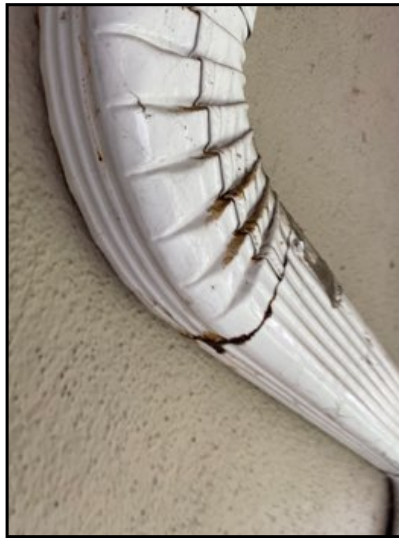
### 7. Gutter

- Clean gutters: Significant amounts of debris evident.
- Gutter leak(s) noted.
- All the gutters should be evaluated for correct pitch and condition by a qualified installer.

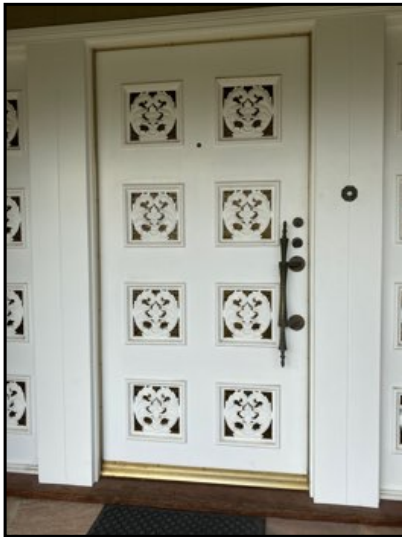
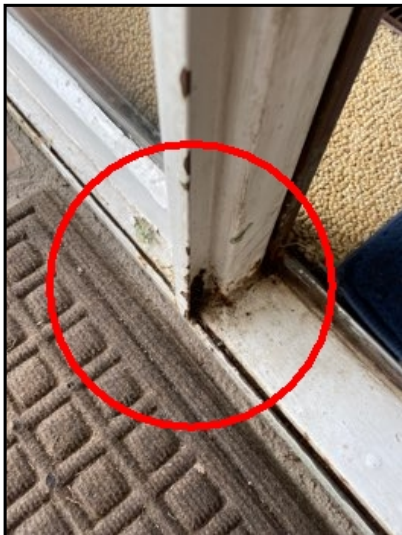
- Sliding screen door for backyard was off its tracks at time of inspection. Recommend repair.
- Backyard patio door showed signs of damage around sill plate/framing at time of inspection. Recommend repair.

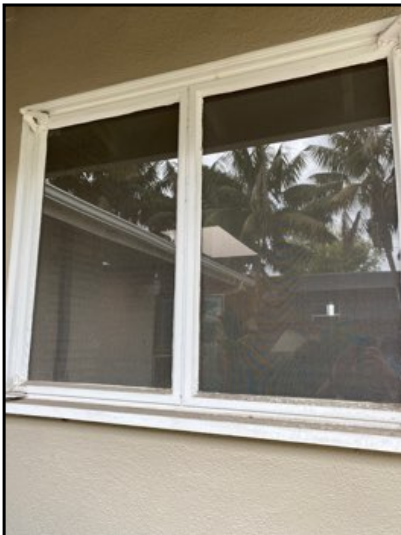
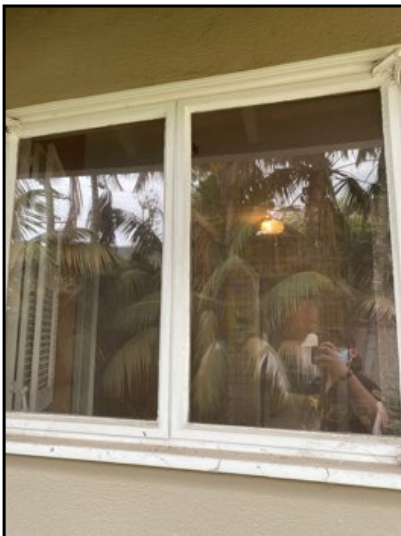
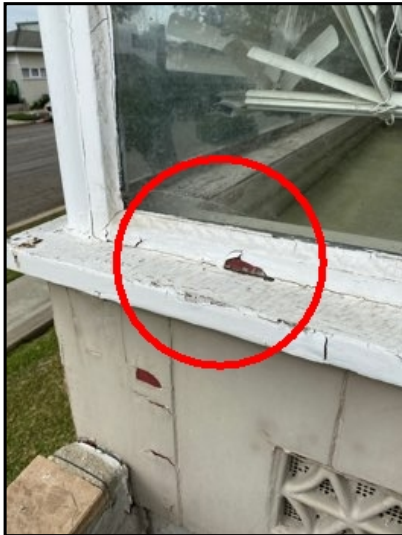
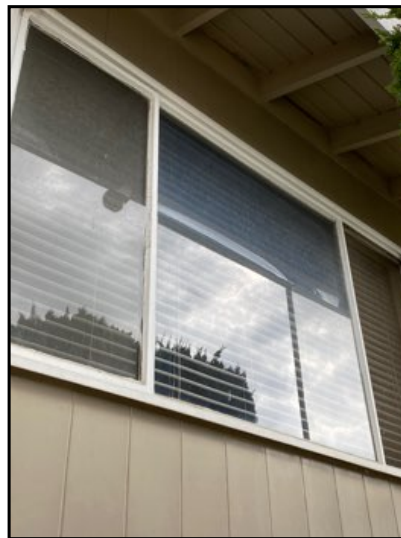
## 2. Window Condition

- Deteriorated frame(s) at window(s)

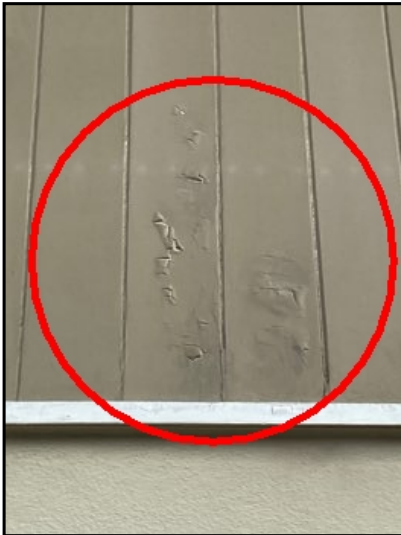
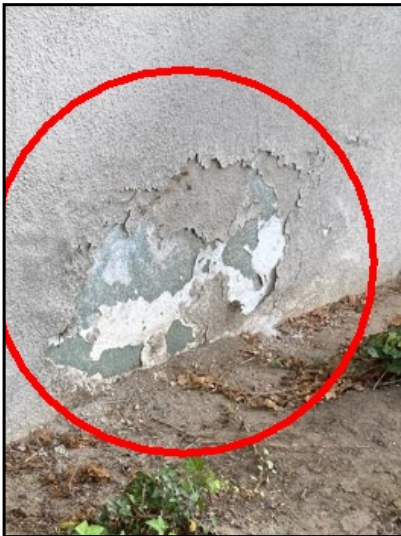
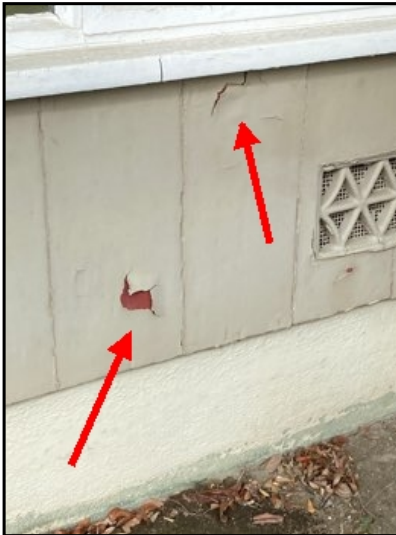
### 3. Siding Condition

- Some wood deterioration noted. Have repaired as necessary.
- Some siding deterioration noted. Have repaired as necessary.
- Some sections of siding showed signs of damage at time of inspection. Recommend repair.

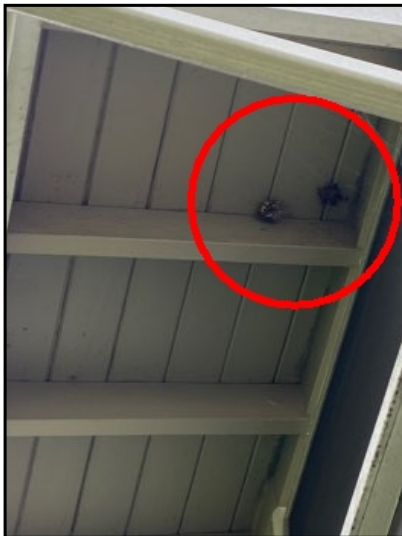
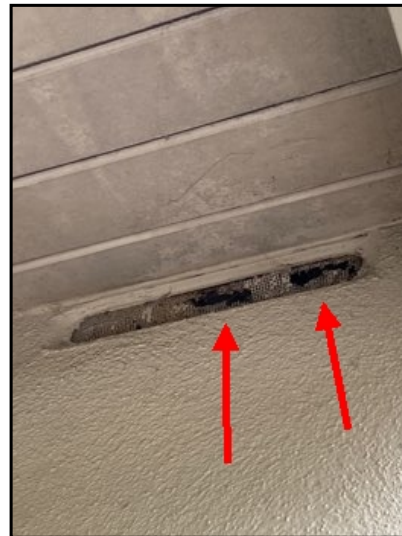
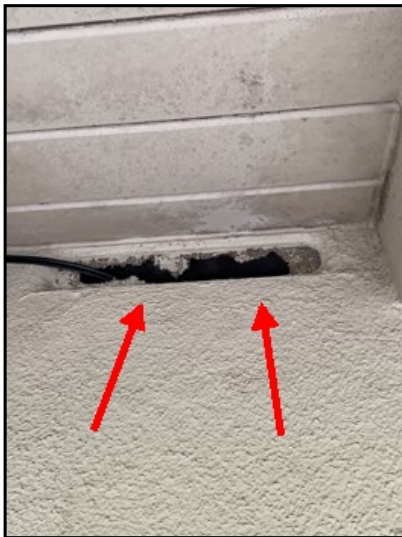
4. Eaves & Facia

- Soffit vents showed signs of damage at time of inspection. Recommend repair or replace as needed.
- Moderate amount of hornet/wasp nests under eaves edge/soffits at time of inspection. Recommend licensed pest control specialist inspect and evaluate further.

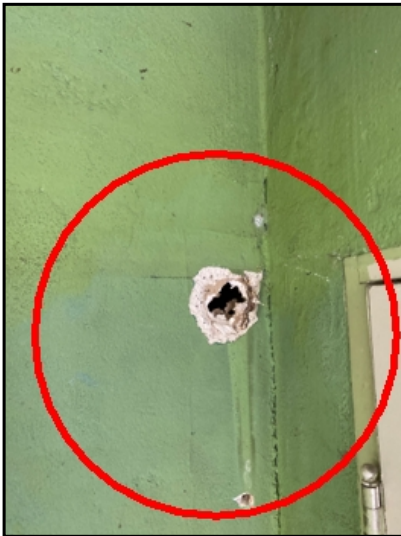
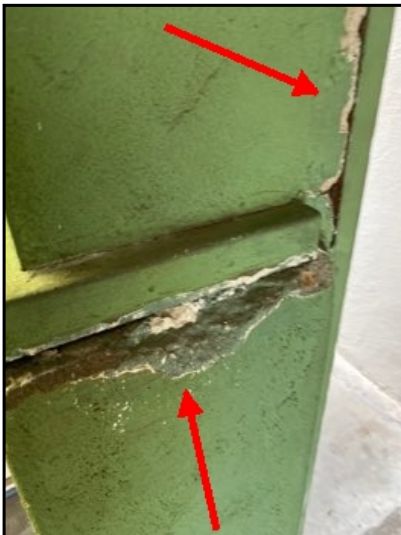
- Damaged walls noted in garage at time of inspection. Recommend licensed contractor inspect and evaluate further for repairs.

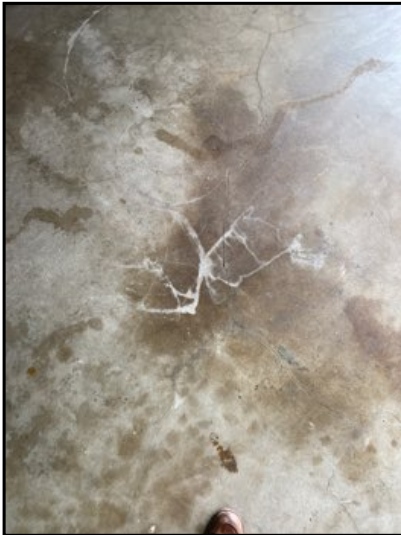
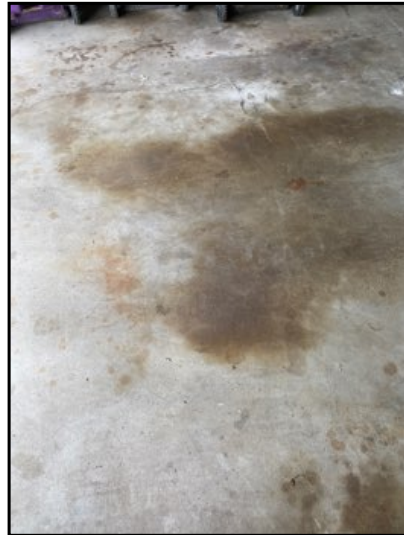
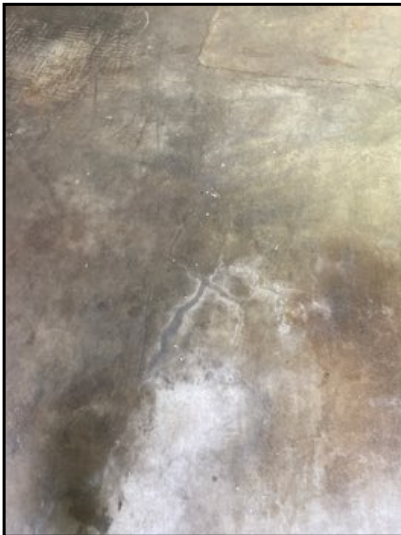
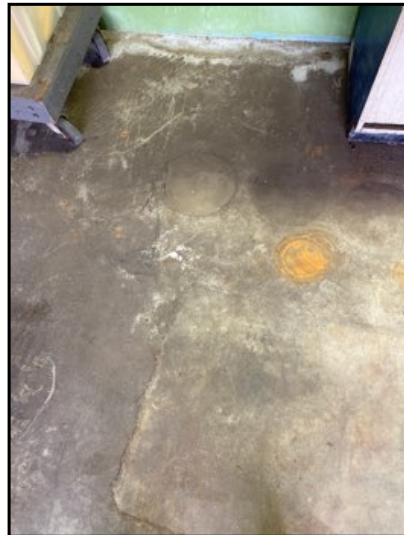
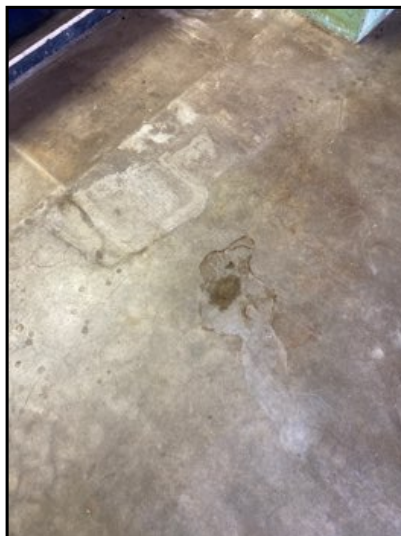
### 4. Floor Condition

- Common cracks noted.

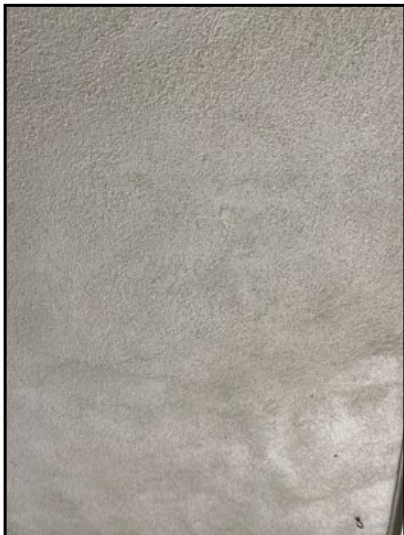
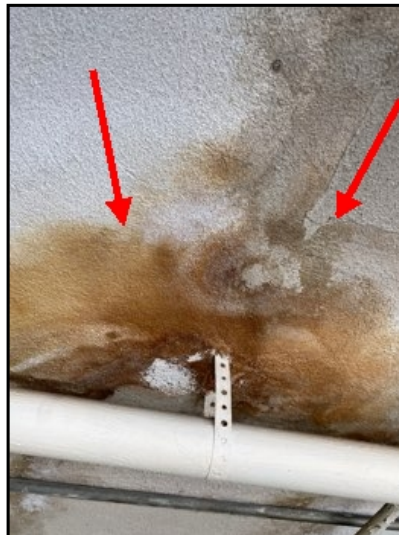
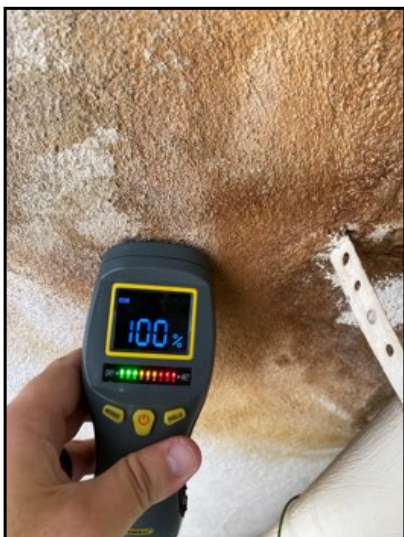
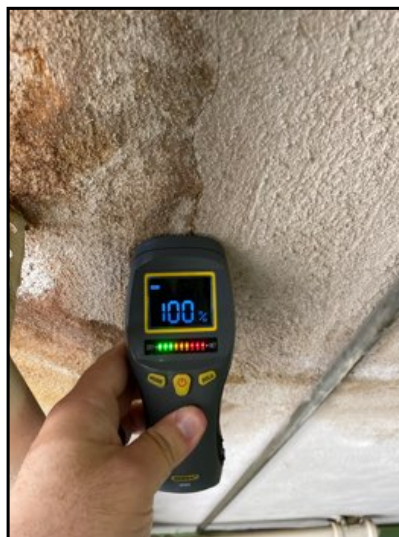
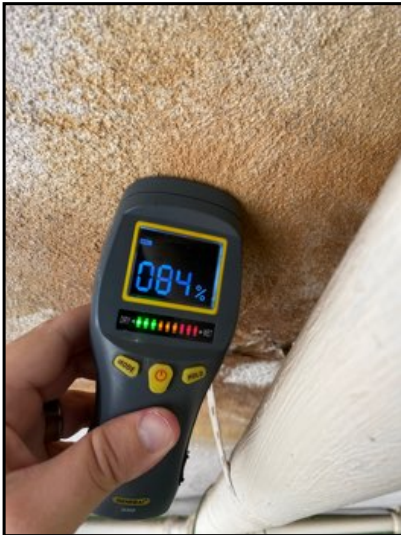
### 5. Rafters & Ceiling

• Large moisture stains found on garage ceiling at time of inspection. Moisture was detected when tested. Possible active leak present. Moisture percentage was between 80-100%. Recommend licensed contractor inspect and evaluate further for repairs.

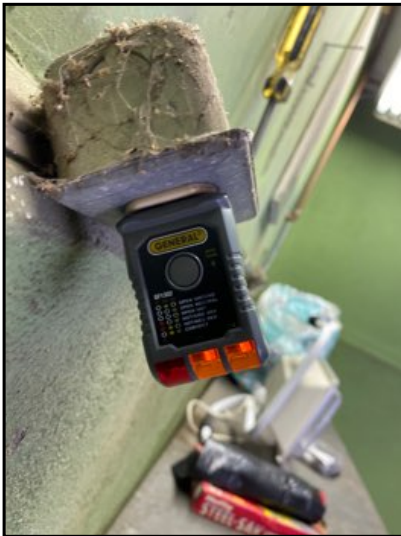
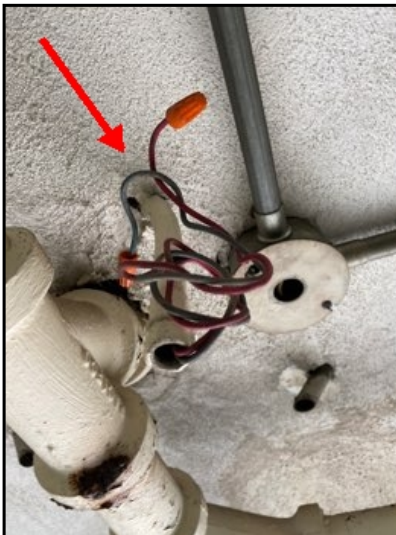
6. Electrical

• Possible evidence of handyman wiring found in garage at time of inspection. Recommend licensed electrician inspect and evaluate further for repairs.

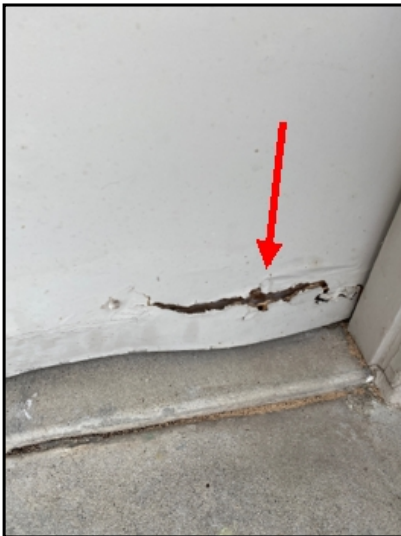
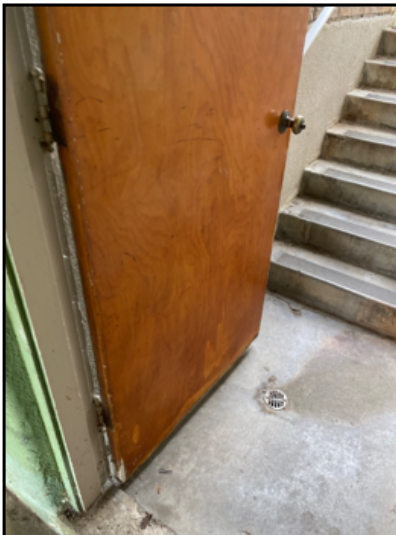
- In the inspectors opinion the door is near the end of its useful life due to .
- Exterior garage door showed signs of moisture damage at time of inspection. Recommend replace.

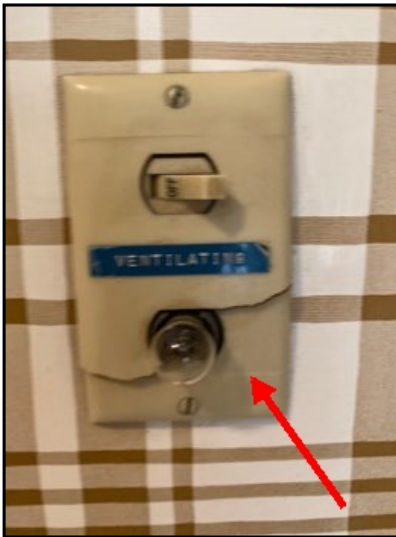
- Switch cover plate damaged. Recommend replace.

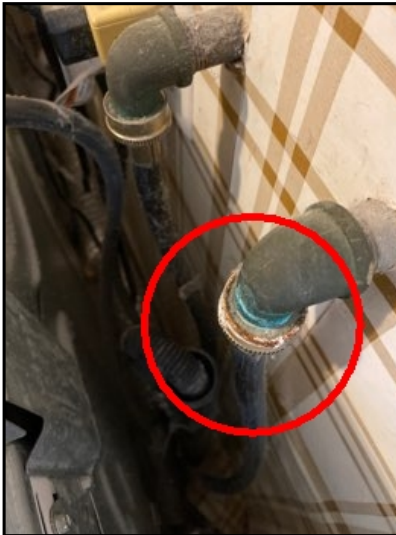
- Rusting/corrosion noted on plumbing valves at time of inspection. Recommend licensed plumber inspect and evaluate further for repairs.

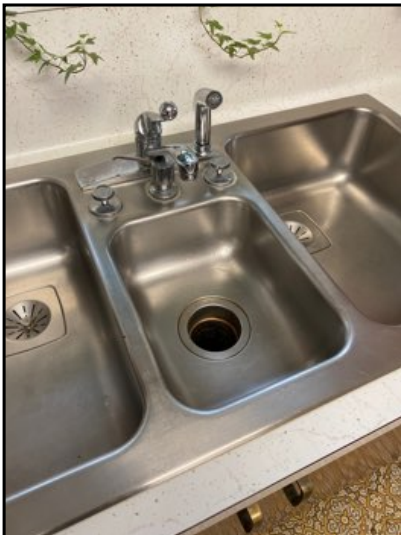
9. Sinks

• Sink rusted. Monitor for developing leaks (none found during inspection).

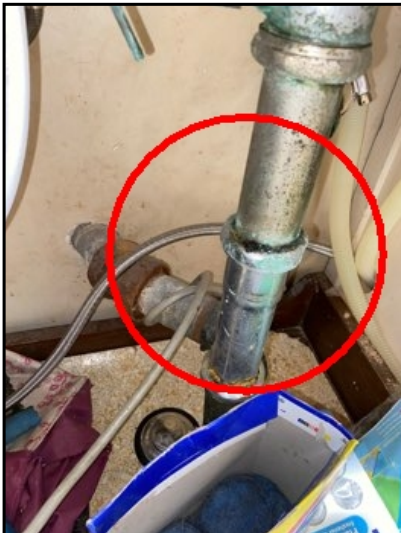
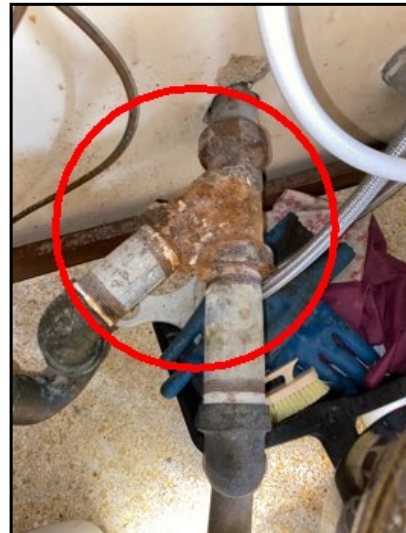
### 18. Plumbing

- Rusting and corrosion noted on plumbing piping at time of inspection. Recommend licensed plumber inspect and evaluate further for repairs.

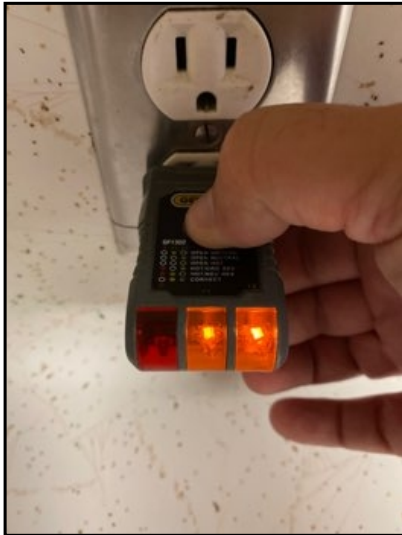
- Ungrounded receptacles observed at water sources or exterior locations ideally should be grounded, suggest installing GFCI's for safety.

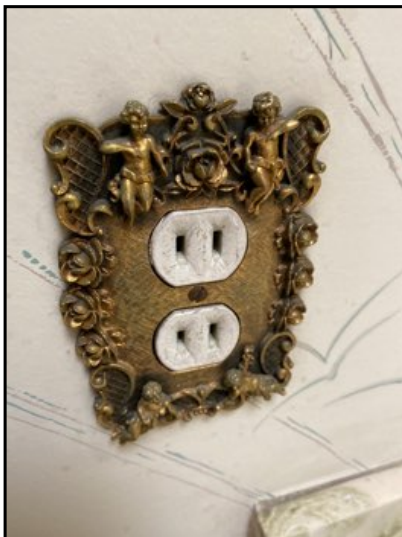
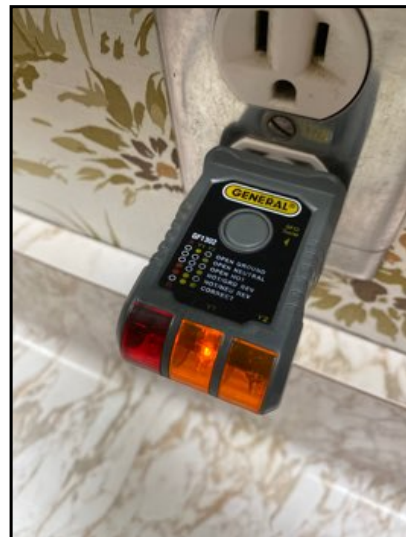
- Open ground (or 2-wire) outlets present. This means that the 3rd (round) part of an appliance plug is not getting ground protection. This may be a concern with items such as computers and electronic devices.

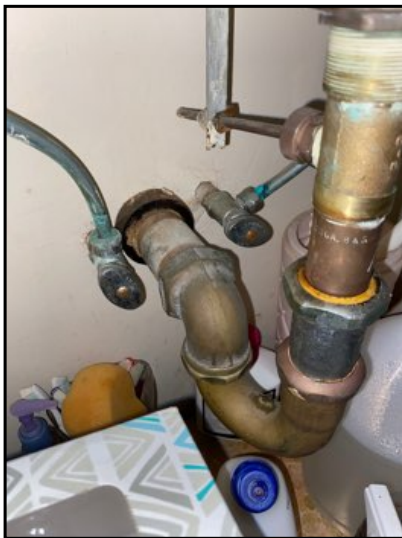
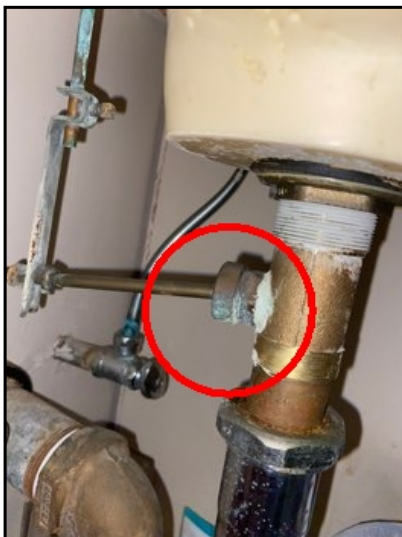
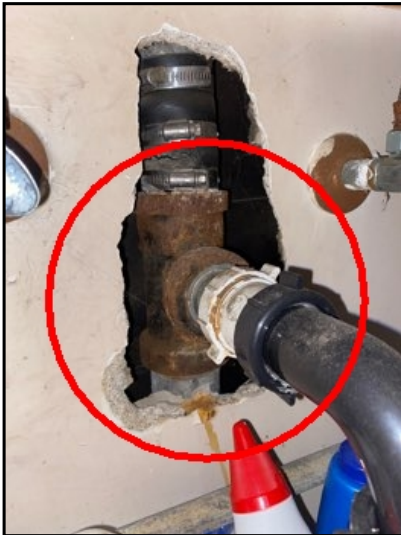
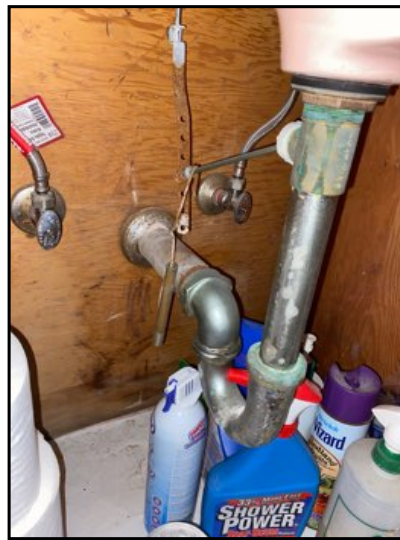
12. Plumbing

• Evidence of rusting and corrosion found in bathroom plumbing pipes at time of inspection. Recommend licensed plumber inspect and evaluate further for repairs.

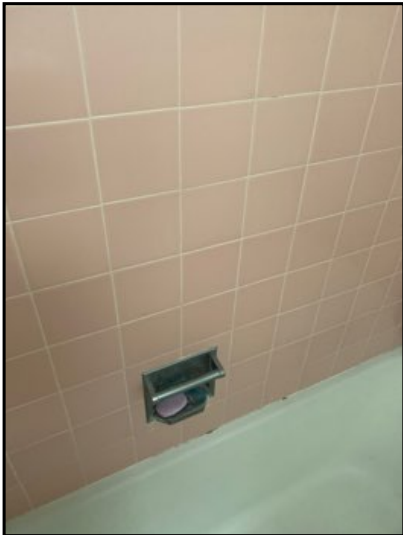
15. Shower Walls

• Some areas of drywall near shower showed signs of damage. Recommend repair.

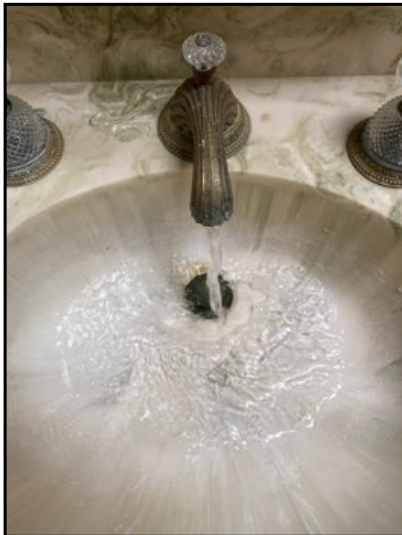
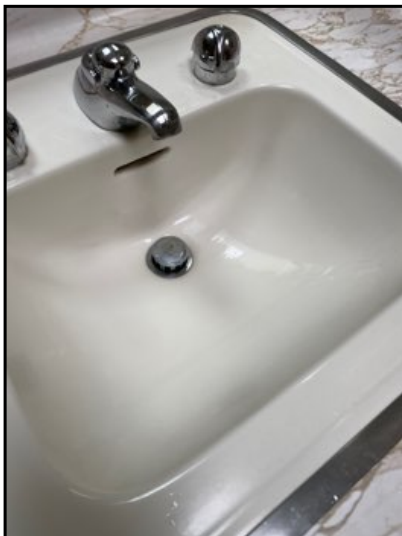
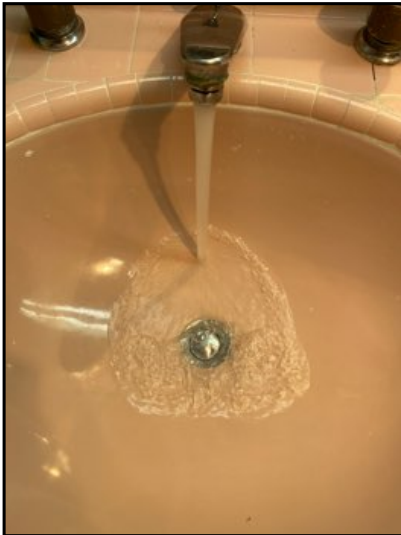
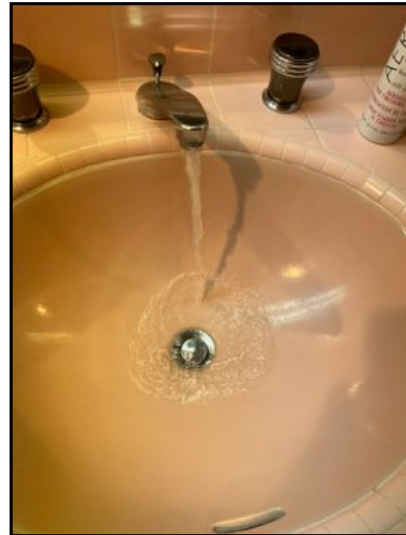
- Some sink faucets showed signs of corrosion at time of inspection.

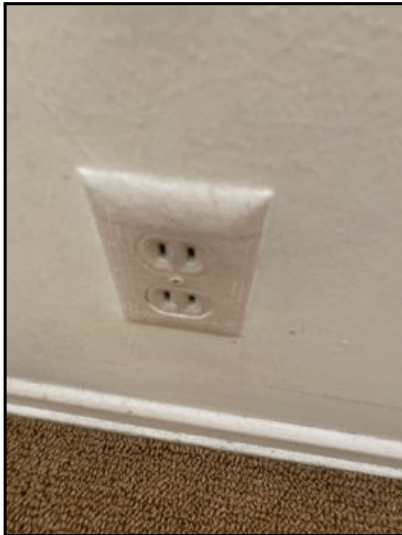
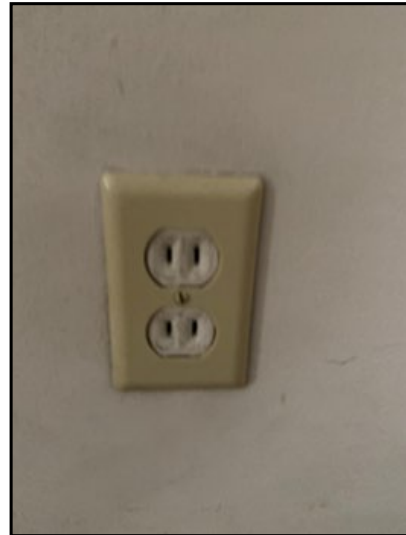
• 2-prong outlets -  
 The home contained outdated, ungrounded 2-prong electrical outlets. Although this condition may have been commonly considered safe or acceptable at the time the home was originally constructed, as general knowledge of safe building practices has improved with the passage of time, building standards have changed to reflect current understanding. Consider updating the existing condition to meet generally-accepted current standards.

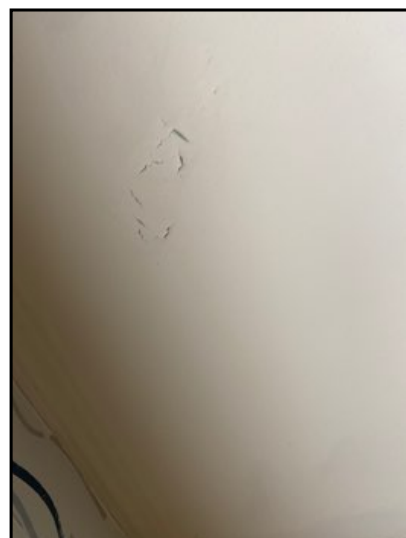
- Paint deterioration noted on bedroom ceilings at time of inspection. Recommend repair.

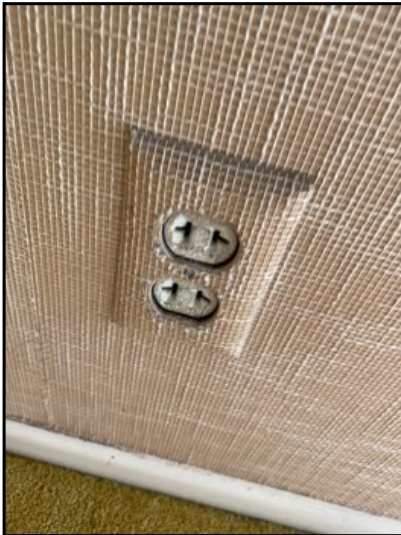
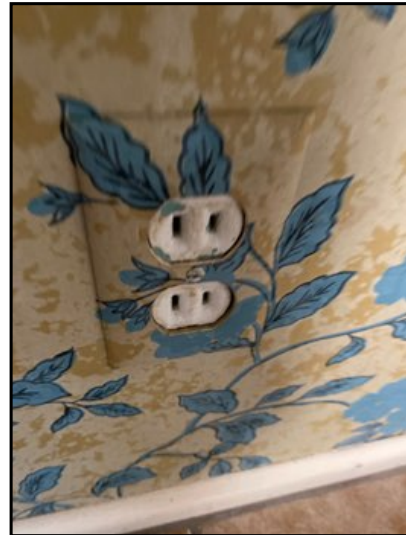
7. Electrical

• 2-prong outlets -  
 The home contained outdated, ungrounded 2-prong electrical outlets. Although this condition may have been commonly considered safe or acceptable at the time the home was originally constructed, as general knowledge of safe building practices has improved with the passage of time, building standards have changed to reflect current understanding. Consider updating the existing condition to meet generally-accepted current standards.

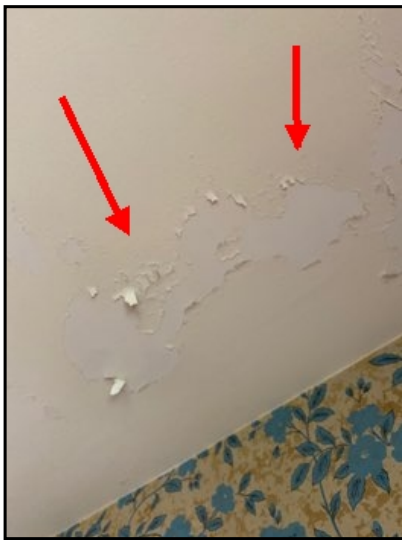
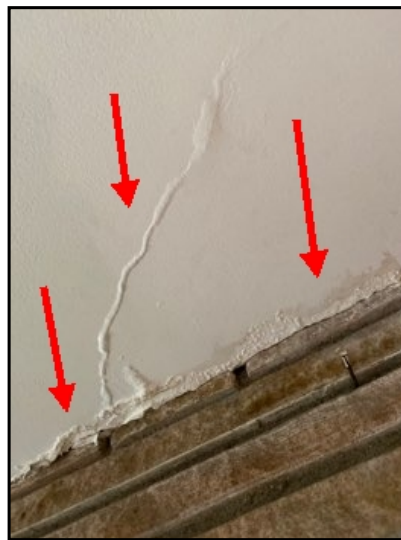
12. Ceiling Condition

- Small stains noted on the ceiling near fireplace. They tested dry at the time of the inspection.
  - Evidence of past leaking was noted.
  - Paint deterioration noted on some areas of ceiling at time of inspection.
- Recommend repair.

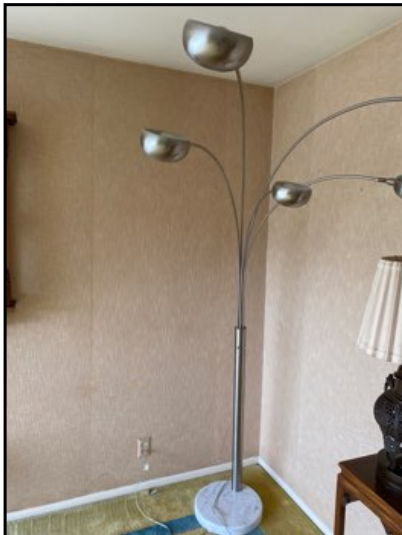
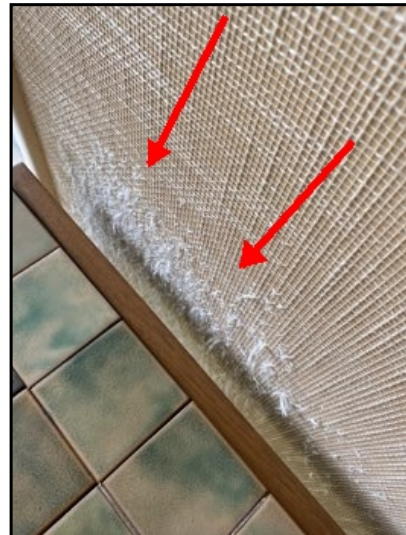
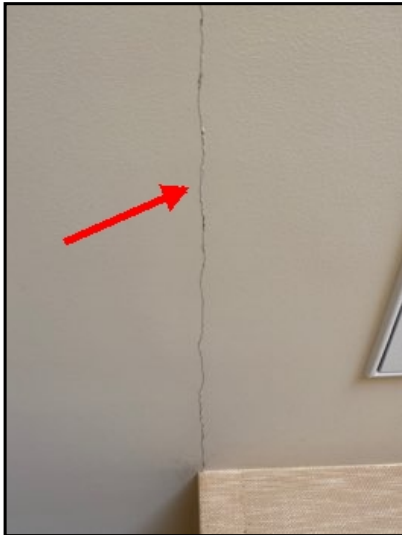
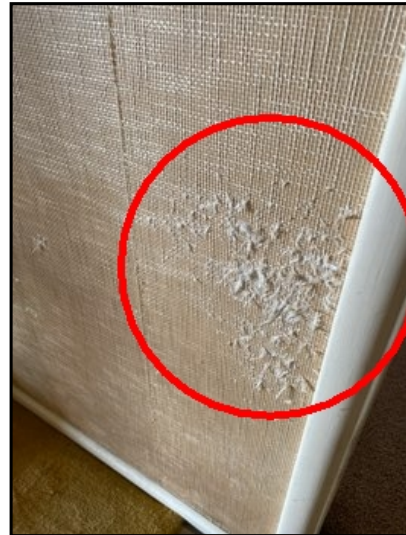
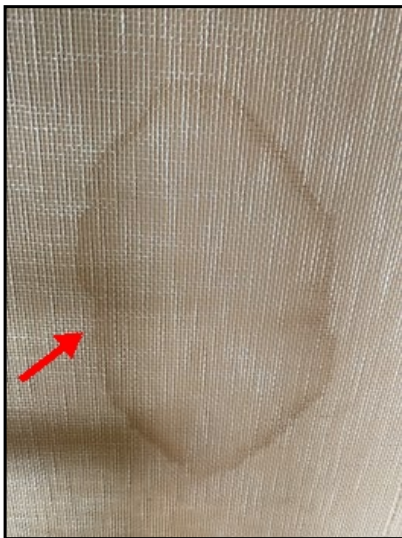
### 15. Wall Condition

- Some sections of walls showed signs of damage and moisture stains. Recommend licensed contractor inspect and evaluate further for repairs.

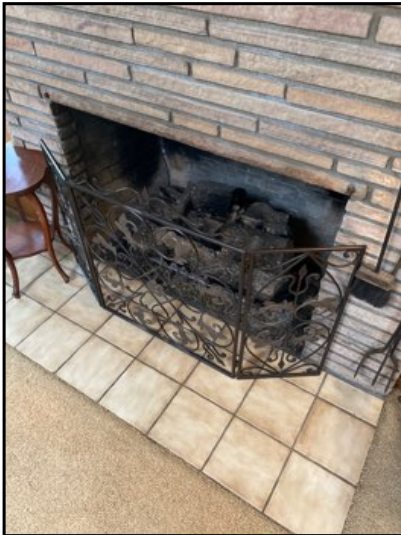
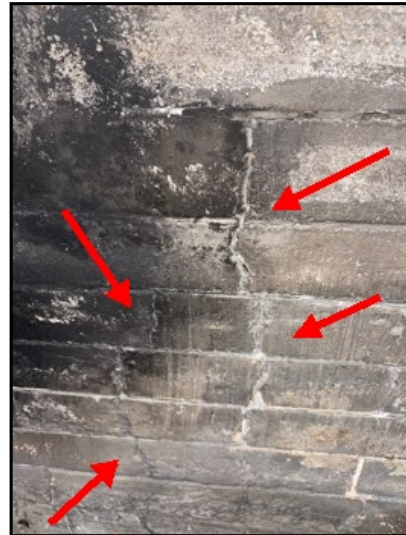
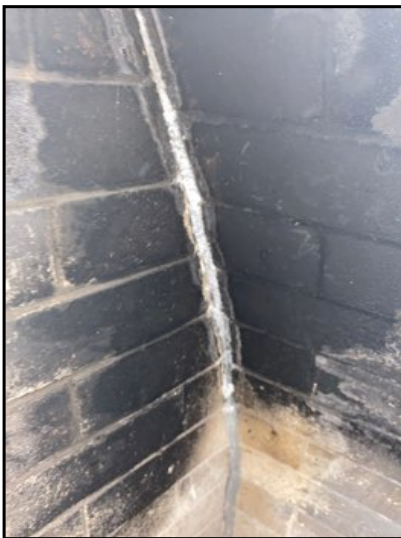
16. Fireplace

- Some cracks present in firebrick at time of inspection. Recommend licensed fireplace specialist inspect and evaluate further fore repairs.

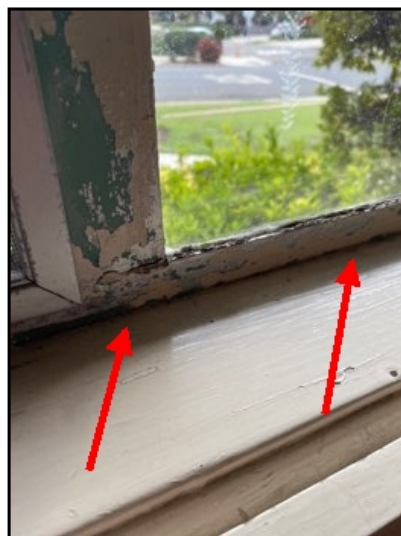
17. Window Condition

- Deterioration noted due to contact with moisture, repairs needed.

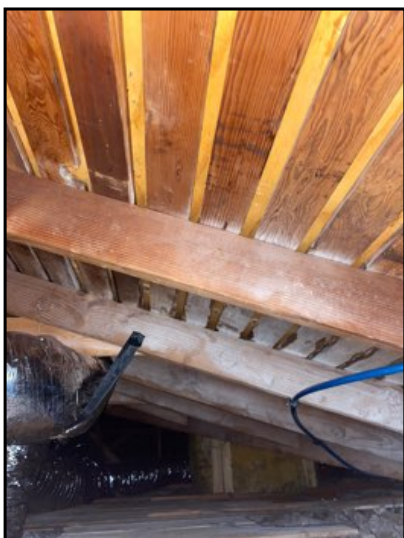
- Hornet/wasp nest found in attic at time of inspection. Recommend licensed pest control specialist inspect and evaluate further for repairs.

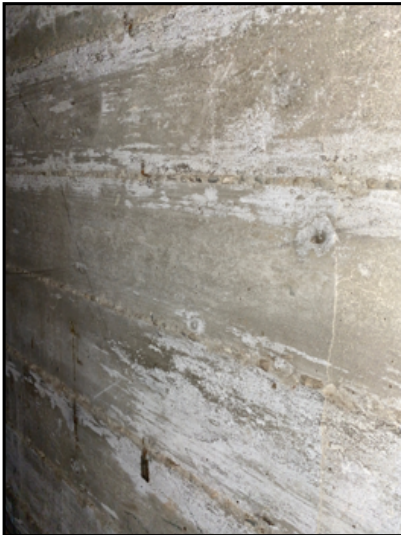
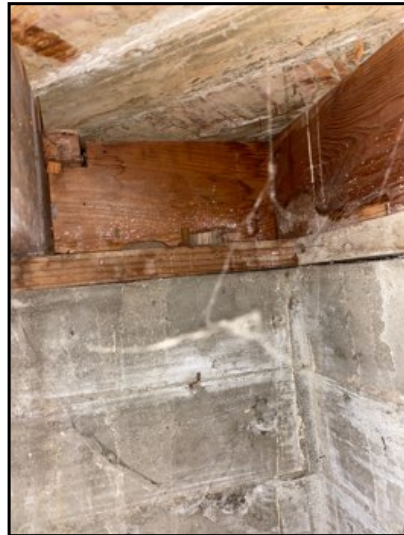
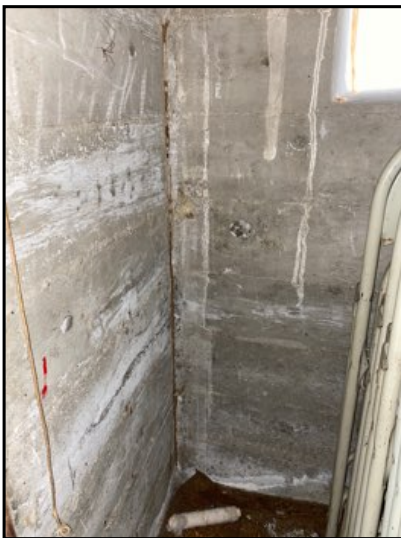
## 3. Foundation Walls

Observations:  
 • Normal settlement.  
 • Moisture intrusion was observed in numerous areas of the foundation floor and at the base of foundation walls. Moisture can create high humidity, mold & can damage stored items & finishing materials. It is recommended to have a foundation specialist review the foundation for correcting the water intrusion and advise as needed before closing.

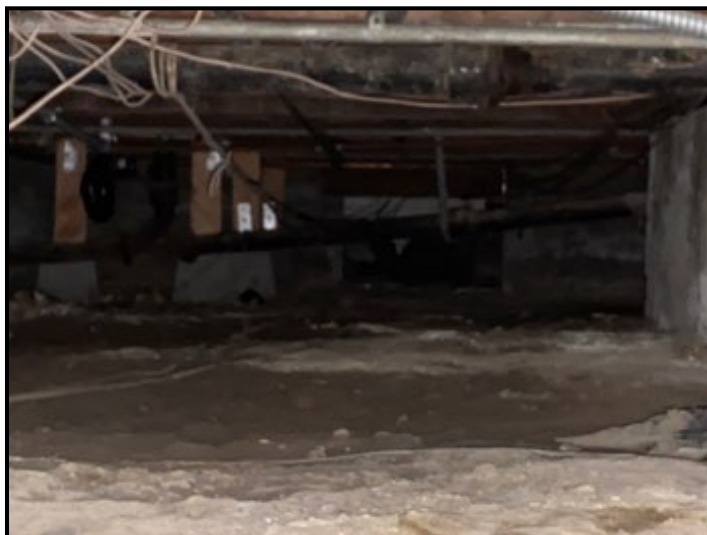
- Concrete block/wood piers support floor above.
- Foundation systems had been retrofitted in some sections.

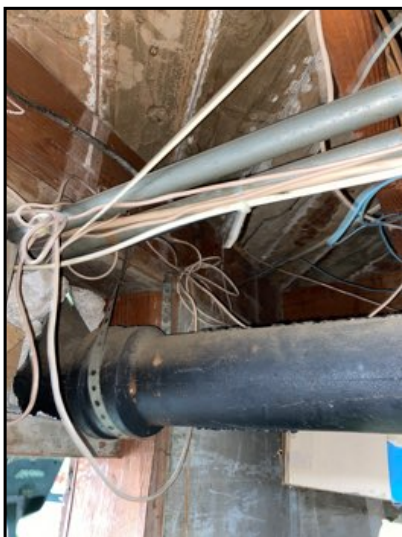
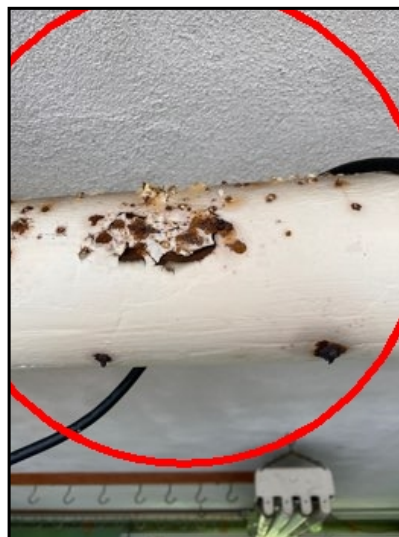
### 12. Foundation Plumbing

- Cast iron waste and vent pipe noted.
- Acrylonitrile-Butadiene-Stryrene "**ABS**" waste and vent pipes noted.
- Corrosion/cysts were noted as one or more locations of the metal drain lines. Repairs recommended to be performed by a Qualified Licensed Plumber.

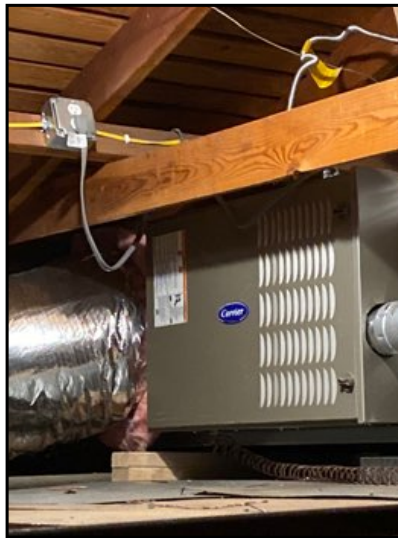
## 1. Heater Condition

- Furnace was in overall satisfactory condition at time of inspection.

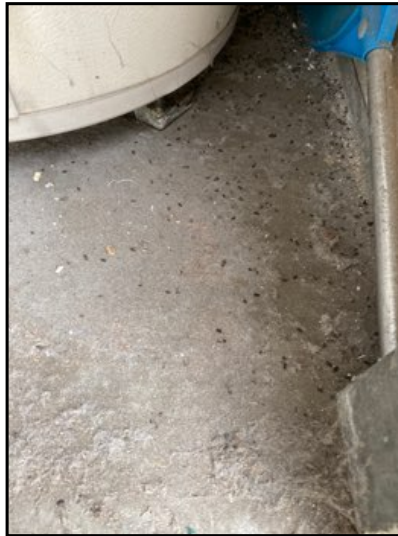
- The water heater base is functional.
- Evidence of possible rodent droppings found in water heat closet at time of inspection. Recommend licensed pest control specialist inspect and evaluate further.

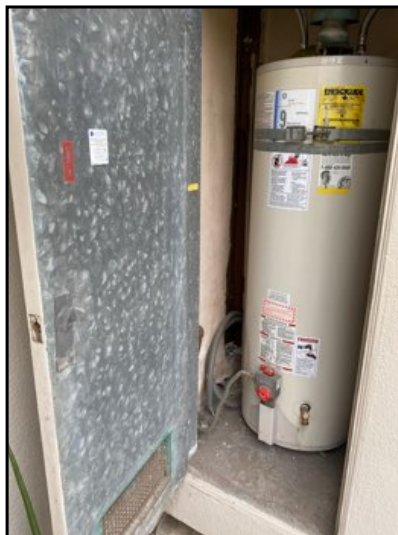
## 2. Heater Enclosure

- The water heater enclosure is functional.

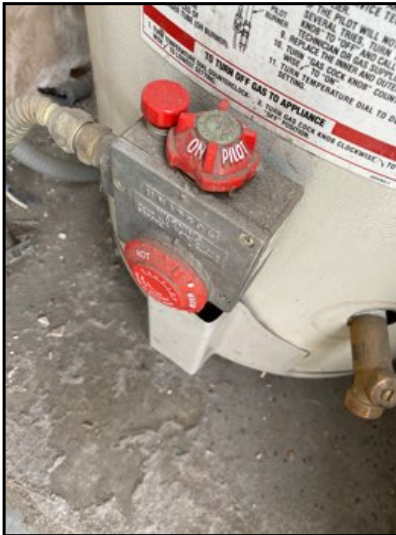
## 3. Combustion

- The combustion chamber appears to in functional condition.

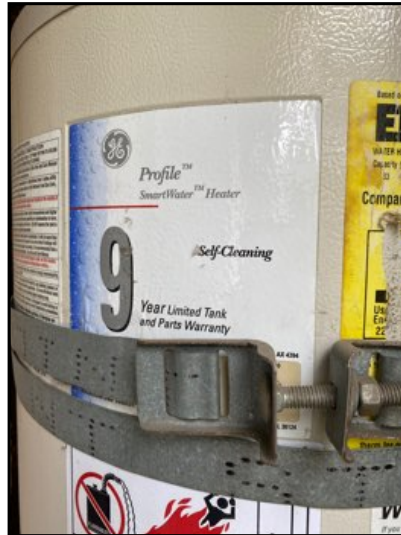
#### 5. Water Heater Condition

- Tank appears to be in satisfactory condition -- no concerns.

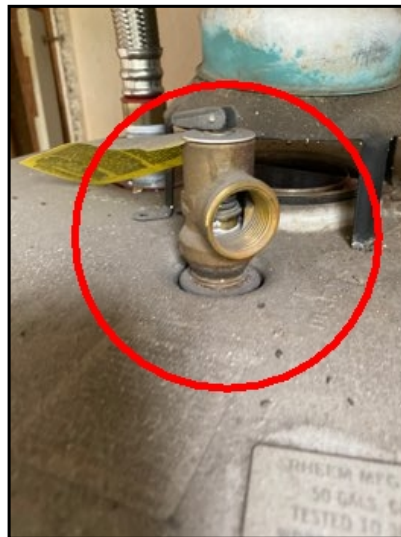
6. TPRV

- **IPR valve** extension piping missing at time of inspection. Recommend licensed plumber inspect and evaluate further for repairs.

- The extension at the water heater relief valve is missing. This is a potential scalding concern as water can discharge improperly. Recommend installing the proper type of relief extension to discharge within 6 to 8" from the floor.
