# *Coggeshall Home Inspections*

## **Home Inspection Report**

5459 4th St. , Long Beach, CA 90814

Date of Inspection: 10/24/2020

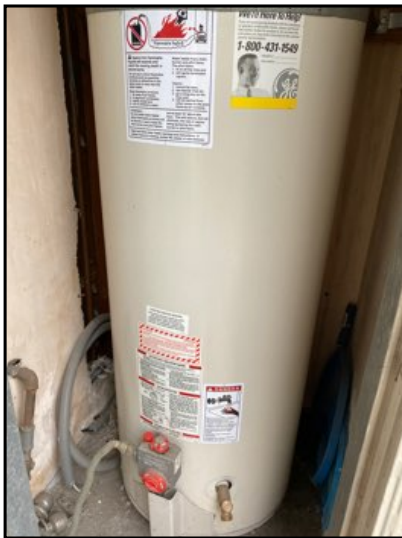
- The water heater is partially strapped. Potential safety hazard. Recommend licensed plumber inspect and evaluate further for repairs.

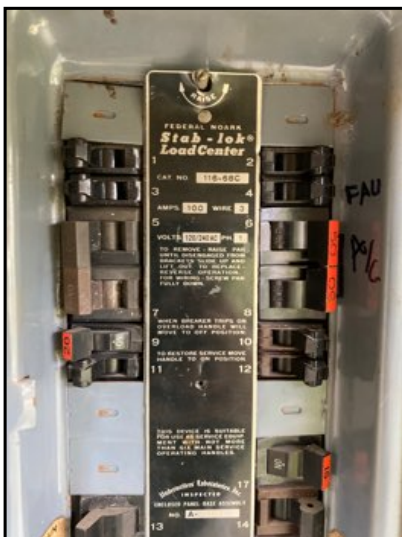
- Panel cover missing on sub panel in garage, exposing live electrical wires/breakers as an electrocution hazard.
- Panel cover screw(s) missing.

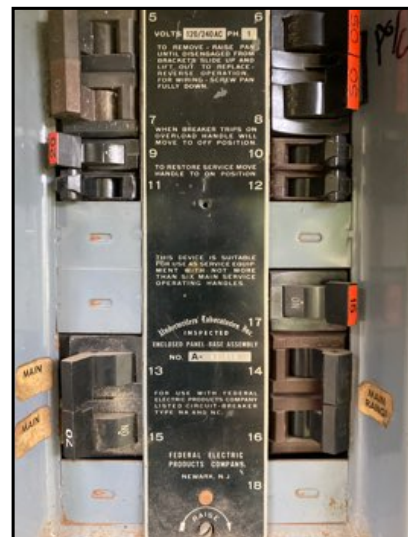
- There is a Federal Pacific Electric service panel in the house. There are studies that show that some FPE circuit breakers are prone to problems that can lead to failures, lack of proper protection of circuits and other serious issues, including fire and electrocution. Although the Consumer Products Safety Commission has not issued a formal product recall, the panel is old and the company is now out of business. We cannot definitively call this panel defective, but recommend, for your peace of mind, to consult a qualified electrical contractor to get their opinion on this matter. You can learn more about this issue at: <http://www.codecheck.com/pdf/electri...%20Nov2003.pdf>, [www.inspect-ny.com/fpe/fpepanel.htm](http://www.inspect-ny.com/fpe/fpepanel.htm), and <http://www.inspect-ny.com/fpe/CPSCsummary.htm>.
