Uniform Mitigation Verification Inspection FormMaintain a copy of this form and any documentation provided with the insurance policy

Inspection Date: 05/03/2023		
Owner Information		
Owner Name: Fairwinds Cove		Contact Person: Kristen Decesare
Address: 3452 NE Causeway Boulevard		Home Phone:
City: Jensen Beach	Zip: 34957	Work Phone:
County: Martin		Cell Phone: 772-334-8900
Insurance Company:		Policy #:
Year of Home: 1978	# of Stories: 4	Email: kristend@advpropmgt.com

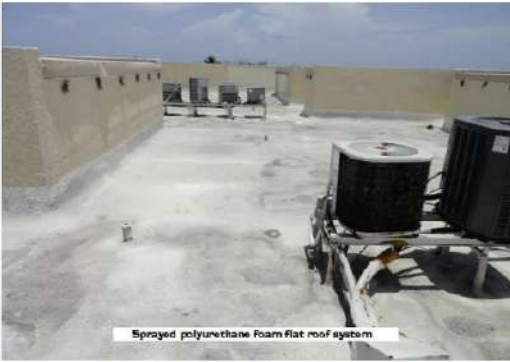
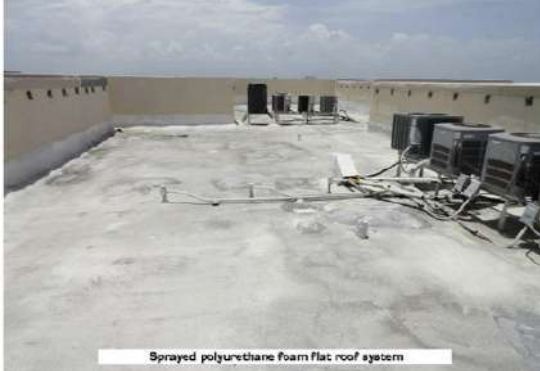
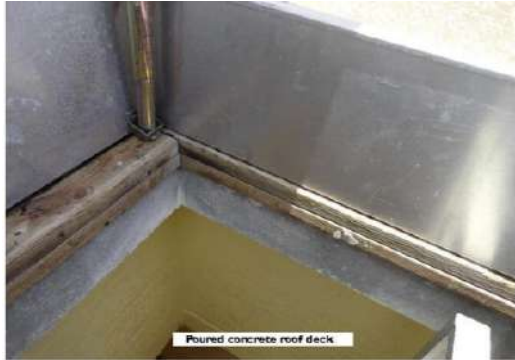
ROOF

2.1 Roof Covering Type:	Permit Application Date	FBC or MDC Product Approval #	Year of Original Installation or Replacement	No Information Provided for Compliance
<input type="checkbox"/> 1. Asphalt/Fiberglass Shingle	____/____/____	_____	_____	<input type="checkbox"/>
<input type="checkbox"/> 2. Concrete/Clay Tile	____/____/____	_____	_____	<input type="checkbox"/>
<input type="checkbox"/> 3. Metal	____/____/____	_____	_____	<input type="checkbox"/>
<input type="checkbox"/> 4. Built Up	____/____/____	_____	_____	<input type="checkbox"/>
<input type="checkbox"/> 5. Membrane	____/____/____	_____	_____	<input type="checkbox"/>
<input checked="" type="checkbox"/> 6. Other <u>Polyurethane</u>	<u>01/13/2005</u>	<u>BRR2005010917</u>	<u>2005</u>	<input type="checkbox"/>

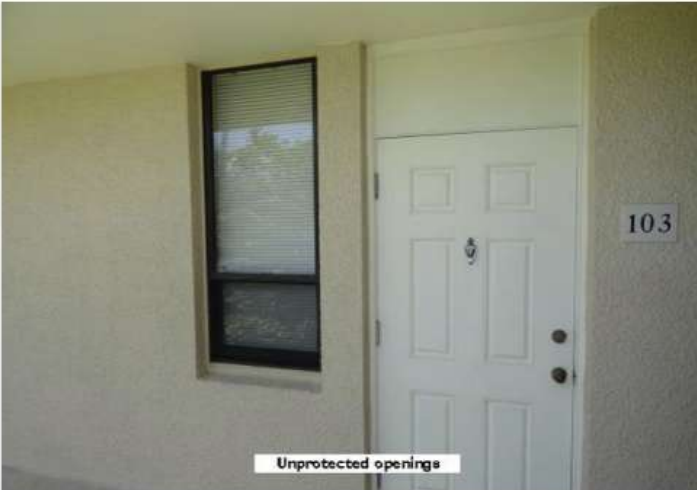
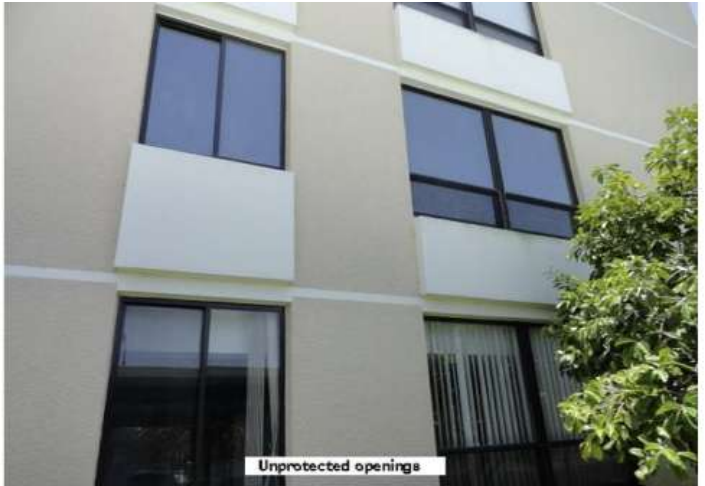
DOOR / WINDOWS: NOT PROTECTED
