FISHER HOME INSPECTIONS, LLC

TREC REI 7-6

1234 Main Street
Keller TX 76244

PROPERTY INSPECTION REPORT FORM

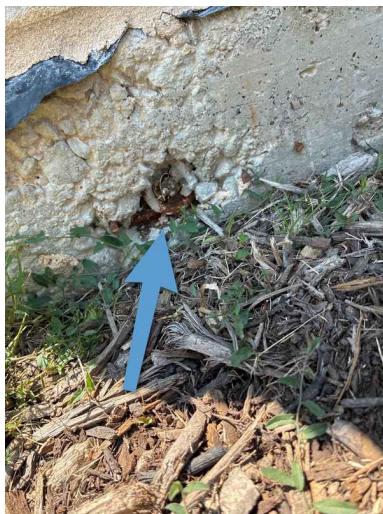
Southeast

1: Post tension exposed

One or more of the post tension cables ends are exposed and need to be properly sealed.

Recommendation: Contact a qualified professional.

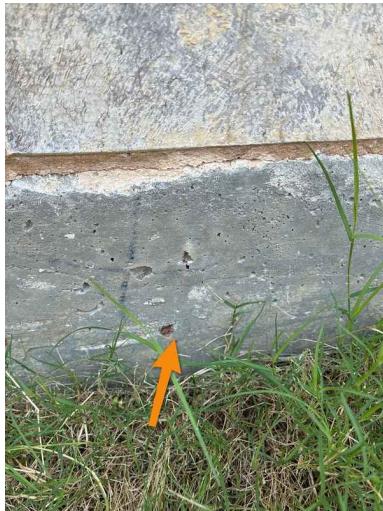
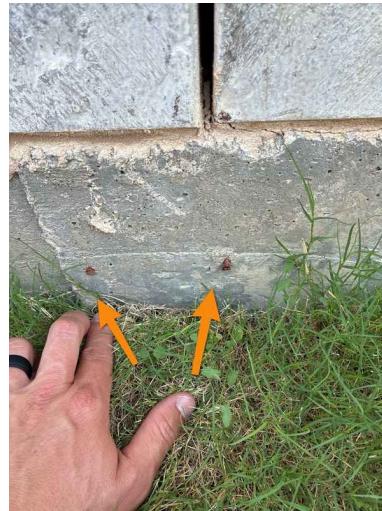
2: Post tension nails

All exposed post tension nails should be trimmed.

Recommendation: Contact a qualified professional.

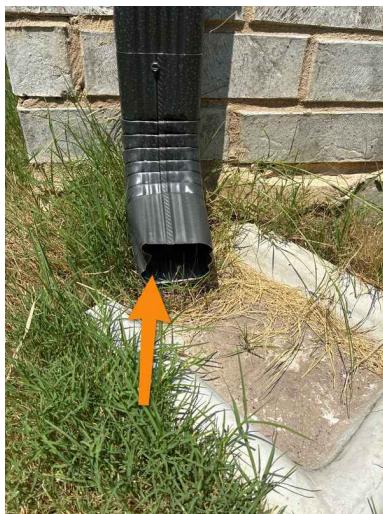
South

1: Downspout Damage

The gutter system downspout is damaged.

Recommendation: Contact a qualified professional.

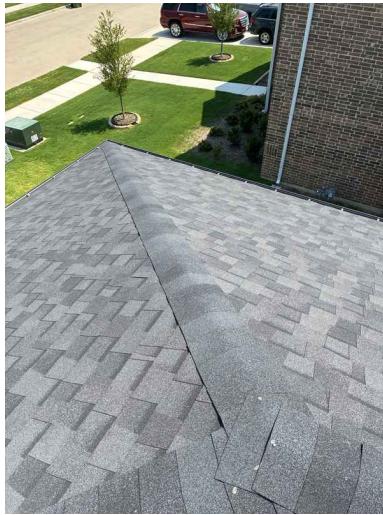
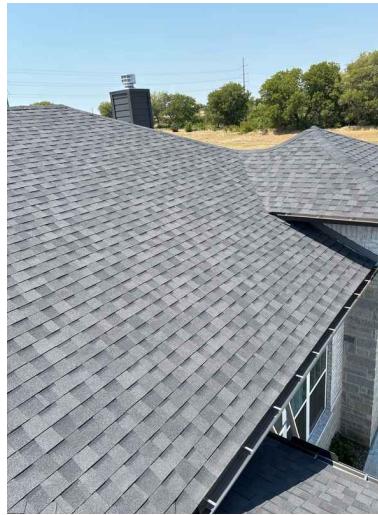
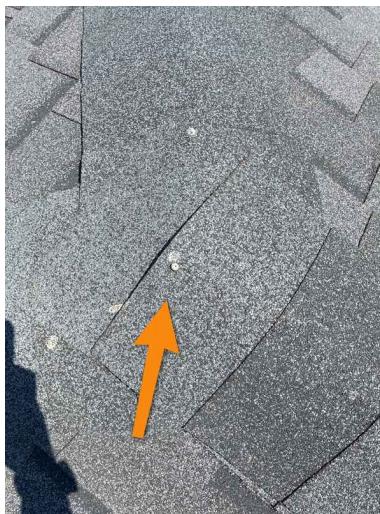
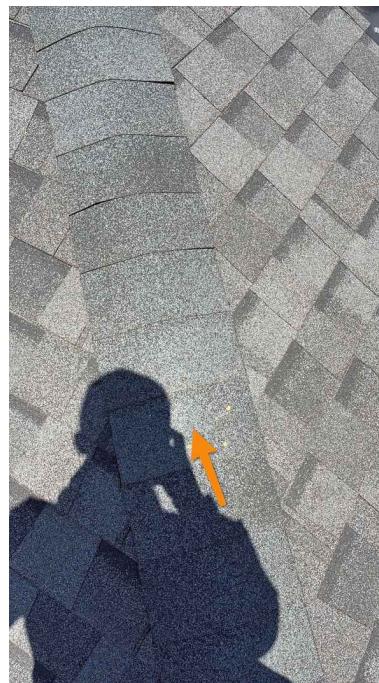
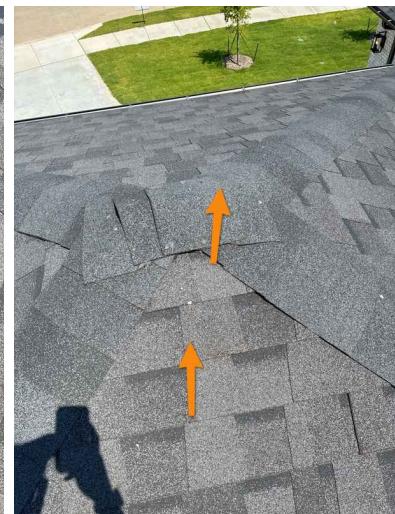
*Comments:***1: Exposed Nails****Recommendation**

Under-driven or exposed nails were found in one or more roof coverings. Recommend a qualified roofer evaluate and correct.

Recommendation: Contact a qualified roofing professional.

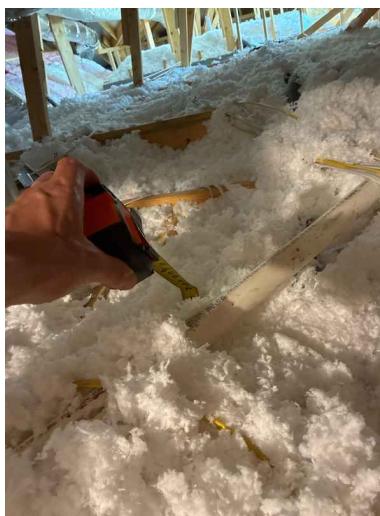
9" here

The attic insulation is lower than typical and it is recommended to add additional insulation to achieve at least a R-30 value.

Recommendation: Contact a qualified professional.

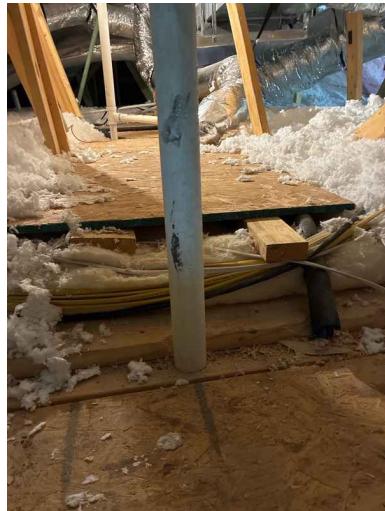
2: Tripping hazard**● Recommendation**

Decking not completed and wires are exposed near the attic opening . Could cause a tripping hazard.

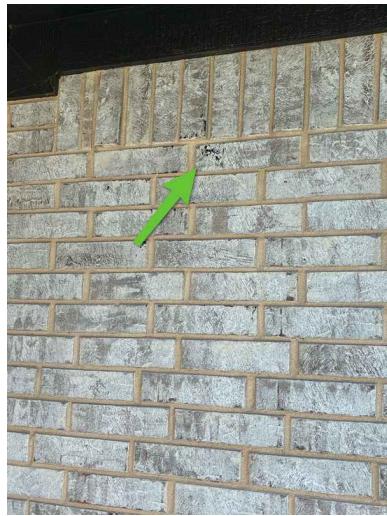
Patio

Paint on Bricks:

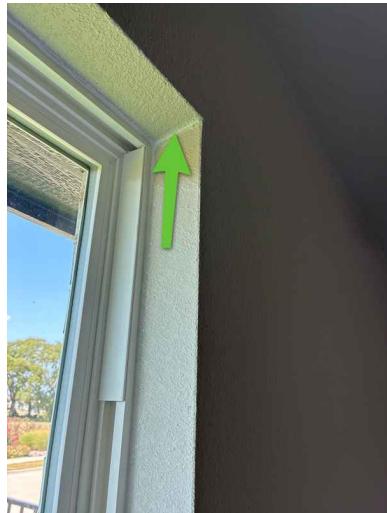
Front bedroom

Touch up Paint needed:

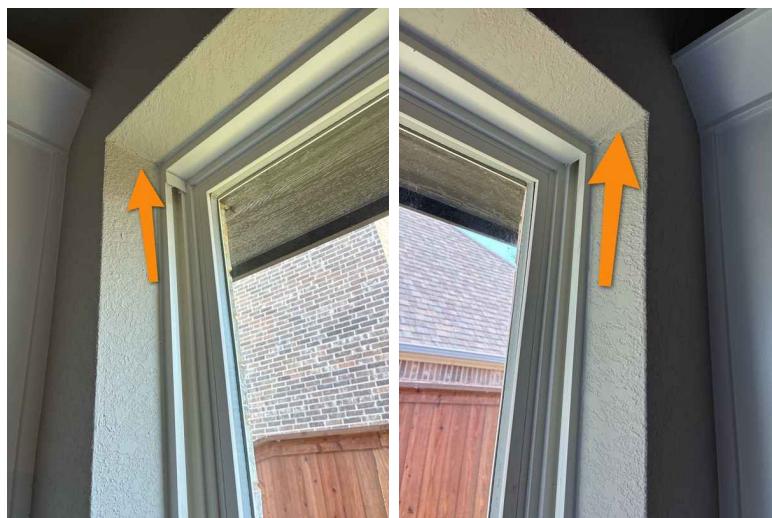
1: Cracks - Minor

Minor cracking was observed in wall structure. This is common in homes this age. Recommend monitoring.

Recommendation: Recommended DIY Project

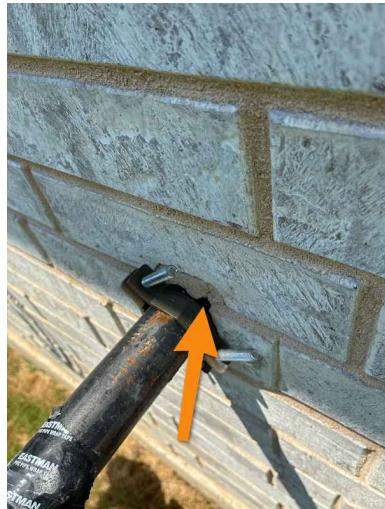
Gas meter

**2: Exterior Wall Penetrations Need Sealant****Recommendation**

The area between the exterior cladding / veneer and all of the wall penetrations / openings need to be properly sealed. Areas such as utility connections, downspouts, hose bibbs, lighting fixtures, receptacles etc. It is recommended to use an elastomeric caulking / sealant.

Recommendation: Contact a handyman or DIY project

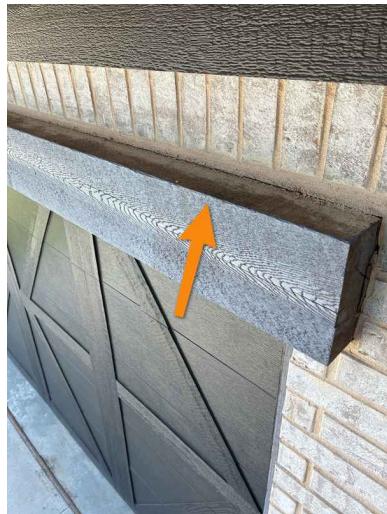
3: Trim needs painting**Recommendation**

The top of the trim above the garage door needs to be painted.

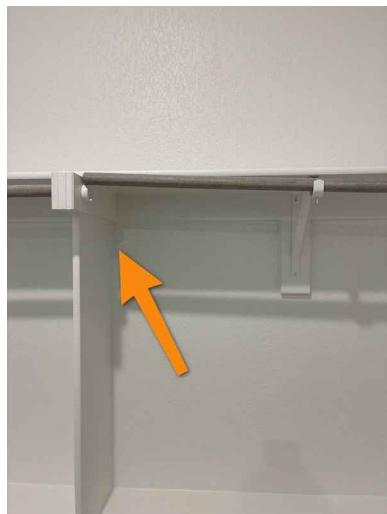
4: Clothes rod does not fit

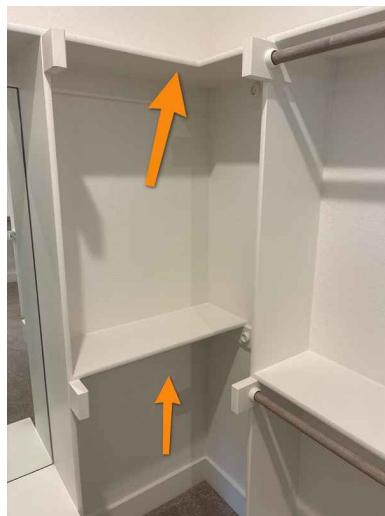
5: Clothes rod missing

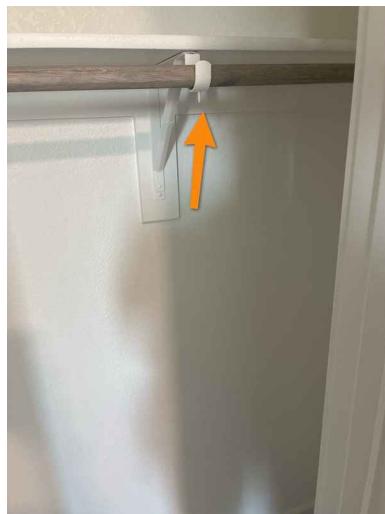
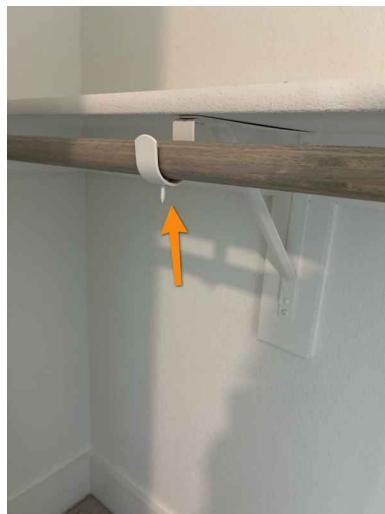
Front bedroom

**6: Clothes Rod Not screwed in**

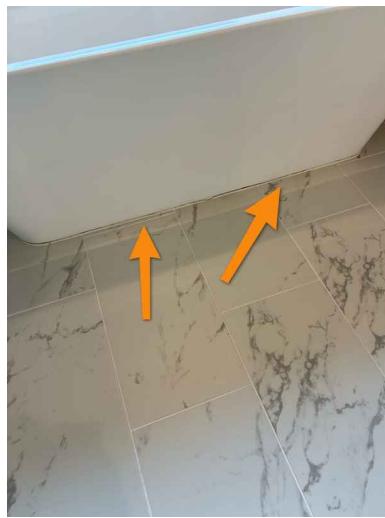
Master

F. Ceilings and Floors*Comments:***1: Tile Caulking Damage**

The caulking between the tile and tub is cracking and needs to be re-caulked.

Recommendation: Contact a qualified professional.

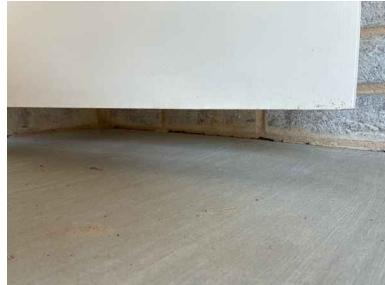
Hall Patio Door

1: Weather-Stripping Improvements Needed

Weather-stripping improvements are recommended.

Recommendation: Contact a qualified professional.

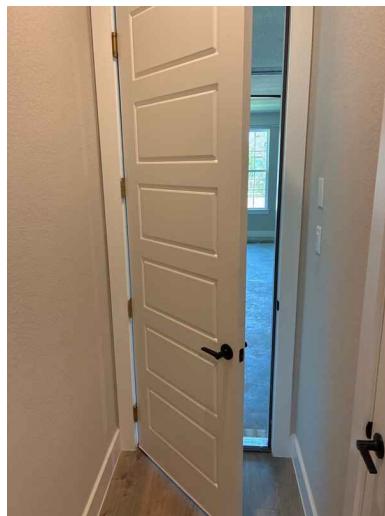
2: Garage Door Not Self-Closing

The garage entry door is not equipped with a self-closing device.

Recommendation: Contact a qualified professional.

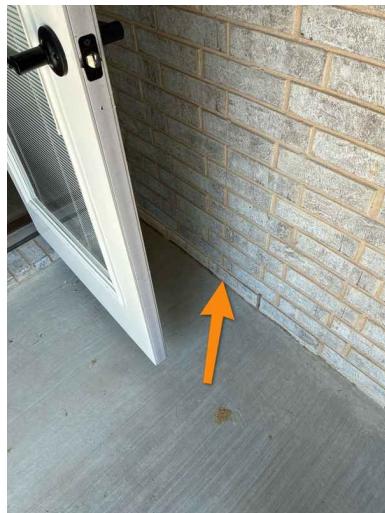
Hall Patio Door

3: Door Stop Missing

One or more of the door stops are missing/damaged. This can cause wall damage if the door is swung open

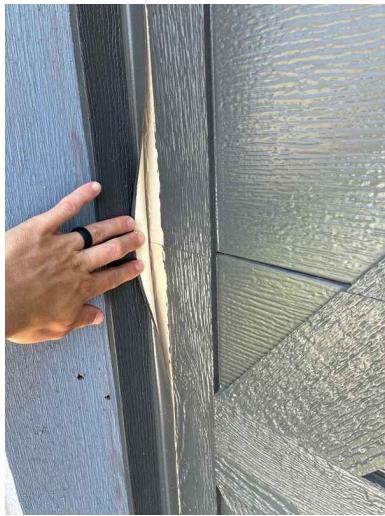
4: Garage door needs touch up Paint

The edges of the garage door need to be painted.

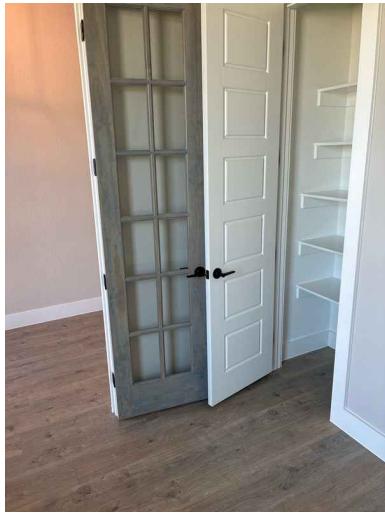
5: Doors Overlap

Doors are overlapping. This could cause future door damage when opening.

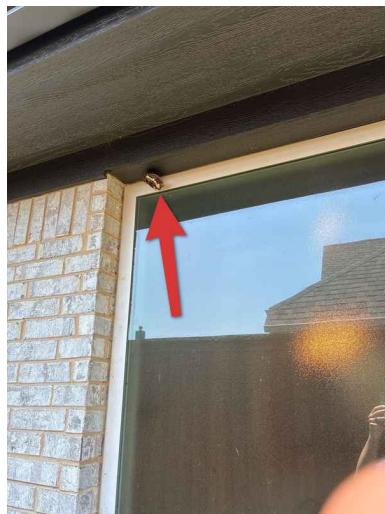
South

Wasp nest:

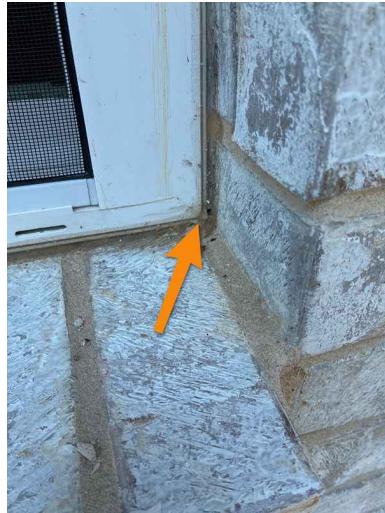
1: Caulking needed

Caulking needed to complete the seal around windows

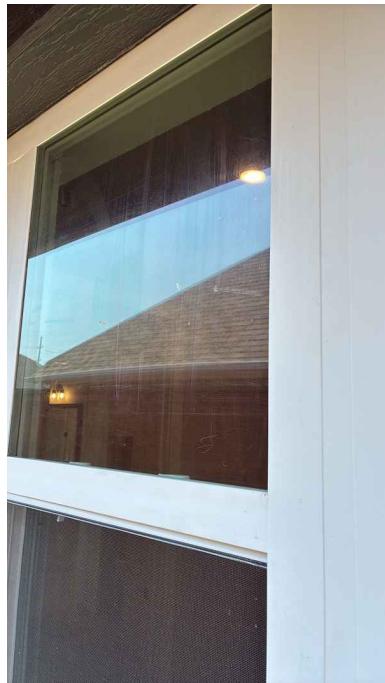
2: Window Scratched

A window appears to be scratched and should be further investigated.

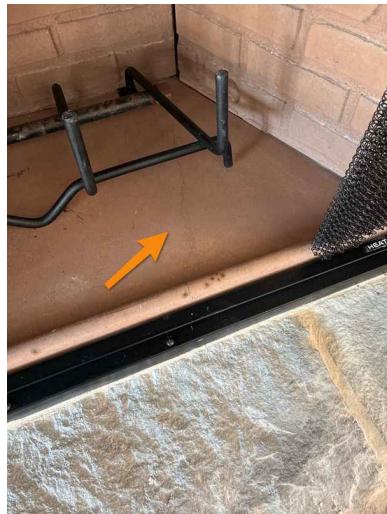
1: Firebox floor cracked

The firebox floor is cracked and should be repaired.

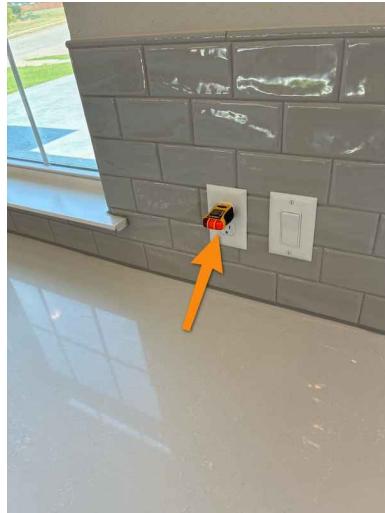
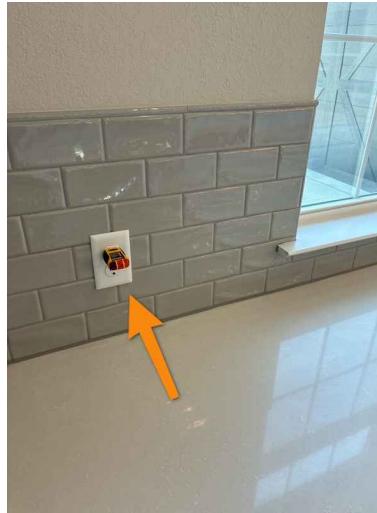
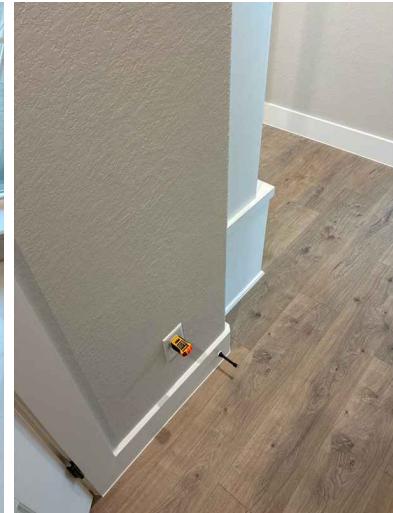
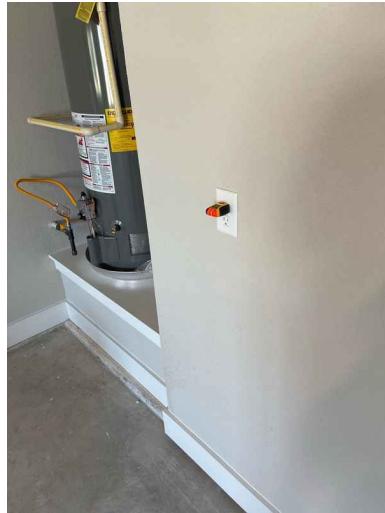
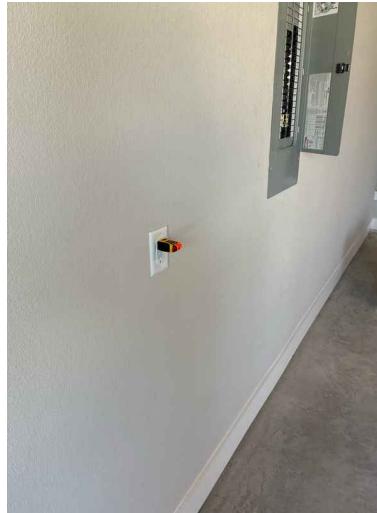
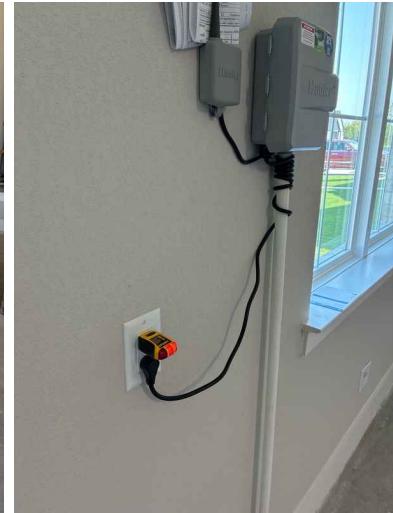
2: Receptacle Loose

One or more of the receptacles were observed to be loose at the wall mount.

Recommendation: Contact a qualified electrical contractor.

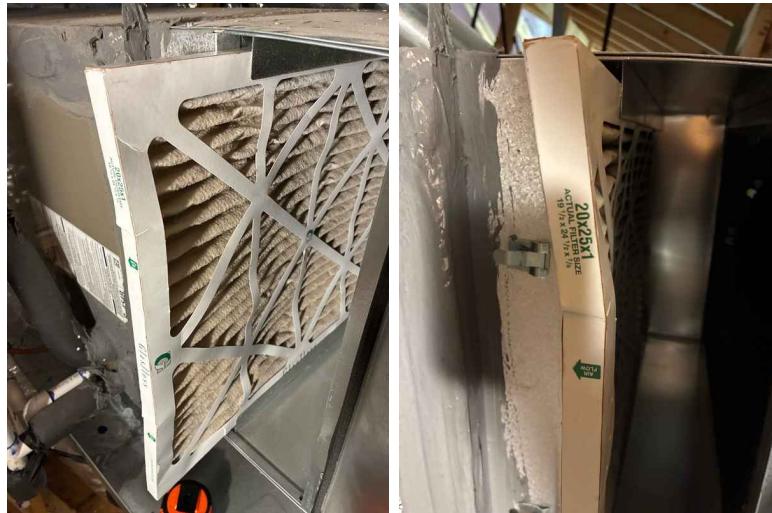
1: Filter requires replacement**⊖ Recommendation**

The dirty air filter should be replaced.

Recommendation: Recommended DIY Project

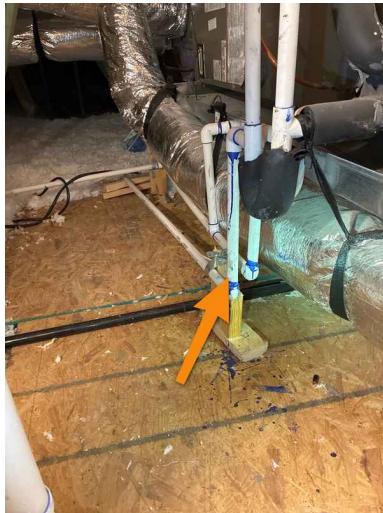
1: Drain Line Not Properly Insulated**⊖ Recommendation**

The primary drain line is not properly insulated in the attic at the time of inspection. It is recommended to add insulation to prevent condensation build up and moisture damage.

Recommendation: Recommended DIY Project

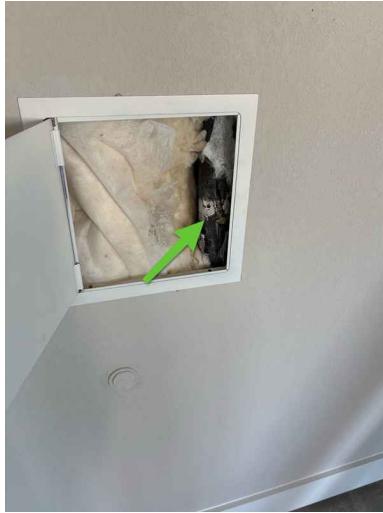
Missing Handle

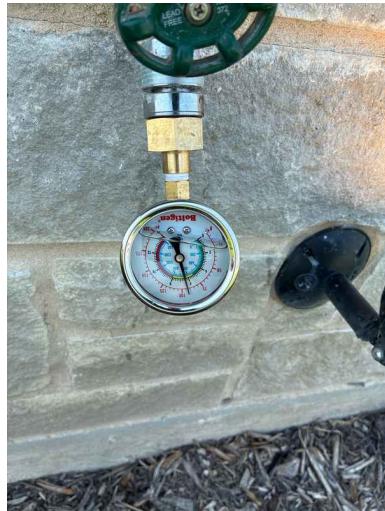
1: High Water Pressure

The water pressure was observed to be above 80 psi at the time of this inspection. Under current plumbing standards the maximum water pressure should be 80 psi. This condition should be further evaluated and corrected as necessary.

Recommendation: Contact a qualified plumbing contractor.

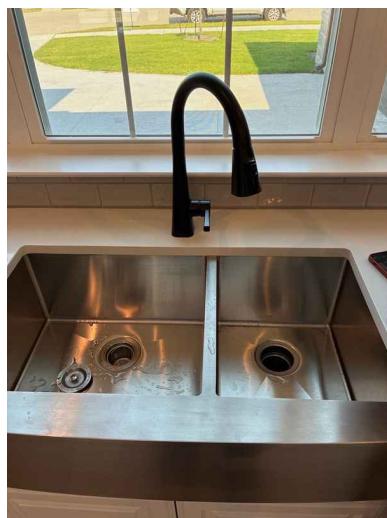
2: Faucet Hot/Cold Reversed

The faucet hot/cold water orientation is reversed.

Hot is down, cold is up

Recommendation: Contact a handyman or DIY project

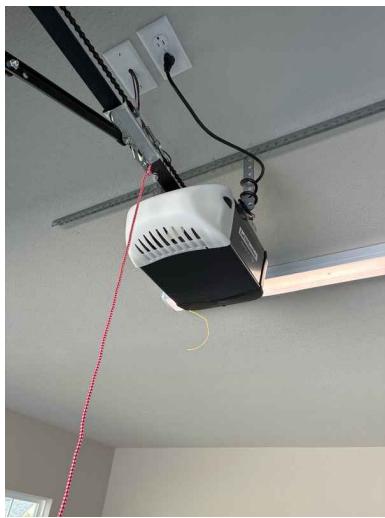
1: Light Not Functioning

The garage door light bulb was missing at the time of inspection.

Recommendation: Contact a qualified professional.

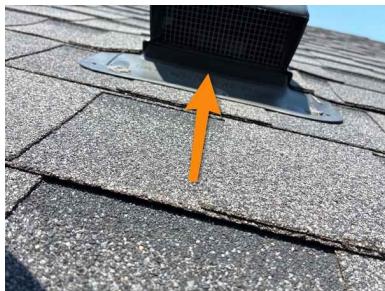
1: Vent Termination Screened

The dryer duct termination was observed to be screened. Screening the termination is not permitted under current installation standards. Note: Screening the dryer termination will cause the dryer duct to clog and will not allow the dryer to operate efficiently.

Recommendation: Contact a qualified professional.
