FISHER HOME INSPECTIONS, LLC

1234 Main Street
Keller TX 76244

PROPERTY INSPECTION REPORT FORM

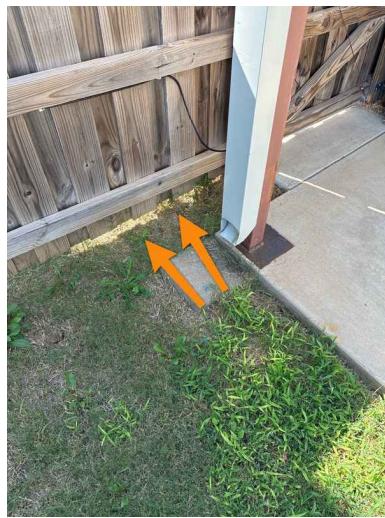
B. Grading and Drainage*Comments:***1: Negative Grading****➡Recommendation**

Grading is sloping towards the home in some areas. This could lead to water intrusion and foundation issues. Recommend qualified landscaper or foundation contractor regrade so water flows away from home.

Divert water away

Recommendation: Contact a qualified landscaping contractor

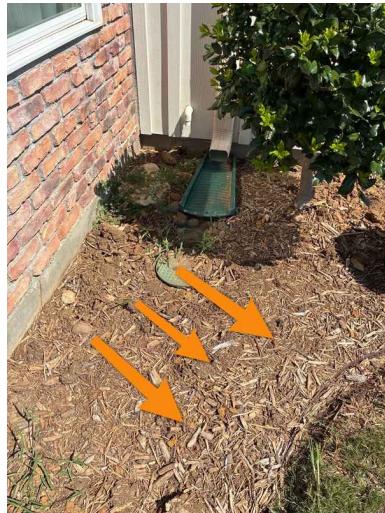
2: Marginal Site Drainage**◐ Recommendation**

Marginal site drainage was observed. Proper drainage is needed to help prevent water from standing and/or ponding next to the foundation beam. Corrective measures may be needed if the water stands within 10-feet of the foundation perimeter beam for more than 24-hours.

Direct Water Away

Recommendation: Recommend monitoring.

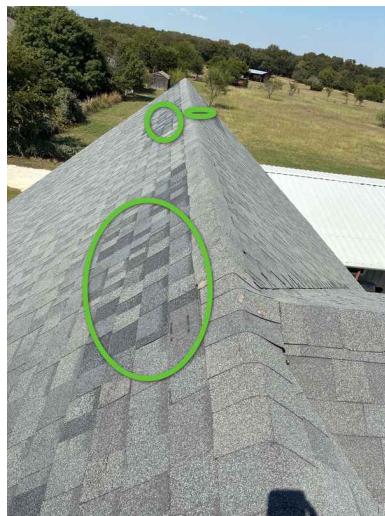
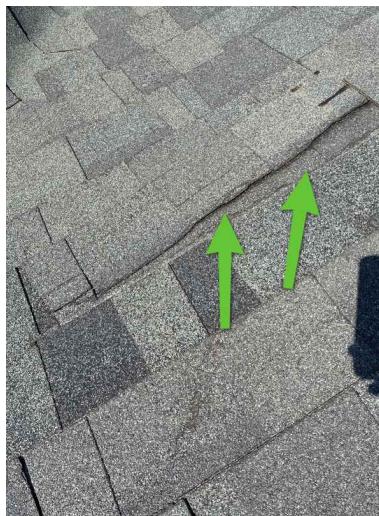
Previous Repair:

Prior repairs to the roofing material and/or flashing were observed in one or more locations.

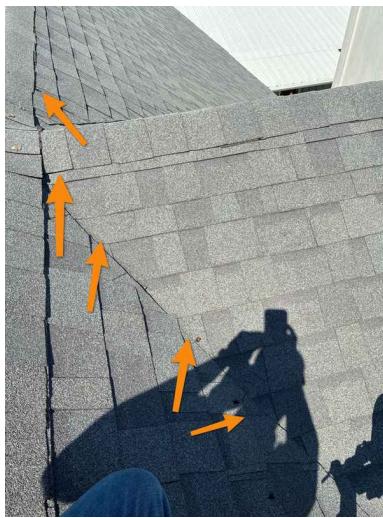
1: Exposed Nails

Under-driven or exposed nails were found in one or more roof coverings. Recommend a qualified roofer evaluate and correct.

Recommendation: Contact a qualified roofing professional.

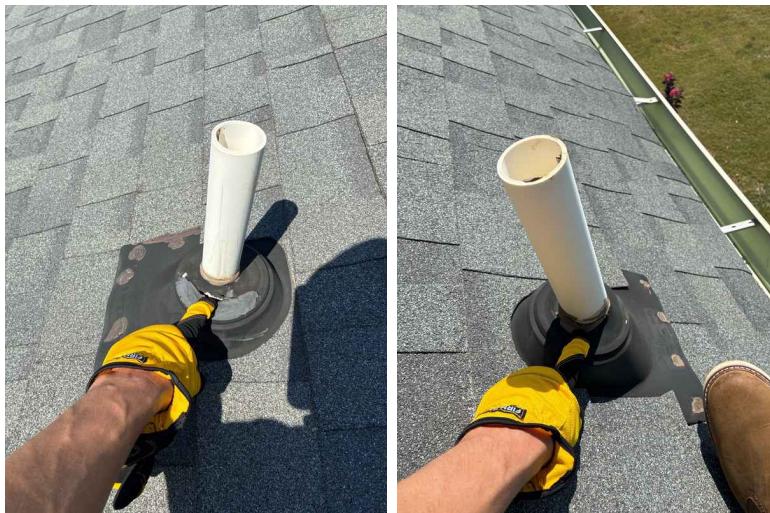
2: Plumbing Vent Seal Damaged

One or more of the roof level plumbing vent stack flashing details have some damage to the rubber seal around the stack. This condition could allow water penetration at this point.

Recommendation: Contact a qualified professional.

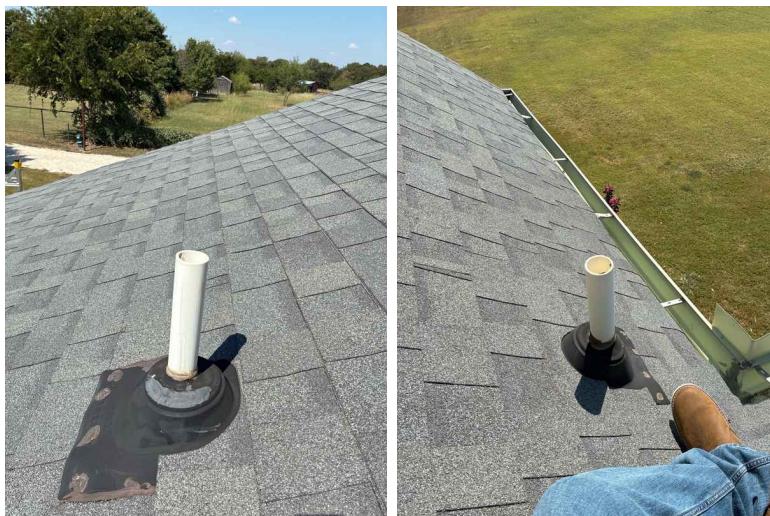
3: Plumbing Jacks Need Painted

The plumbing jacks need to be painted to protect the PVC from future UV damage.

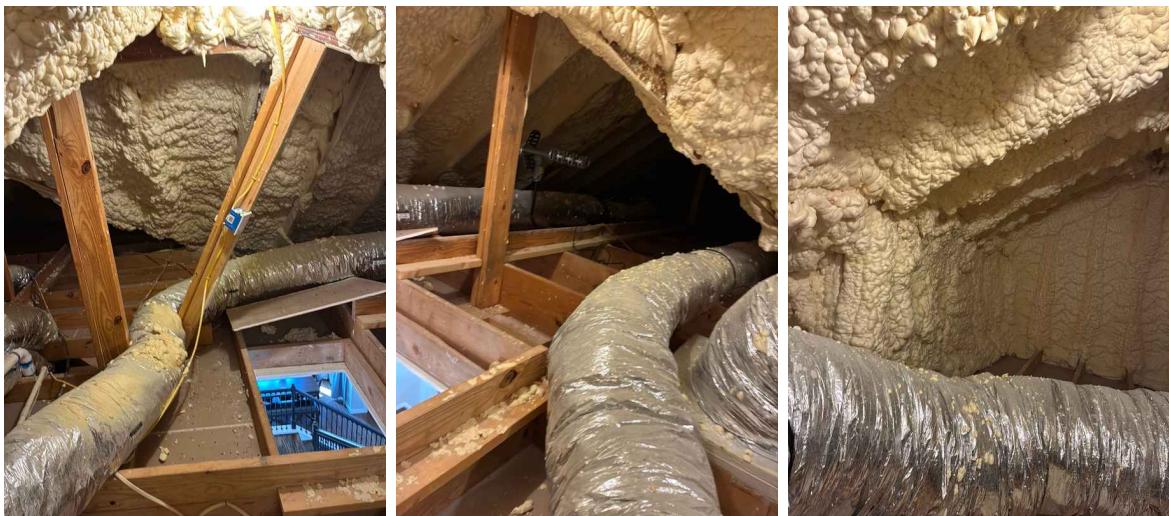
No Venting in Attic Space Above Back Porch

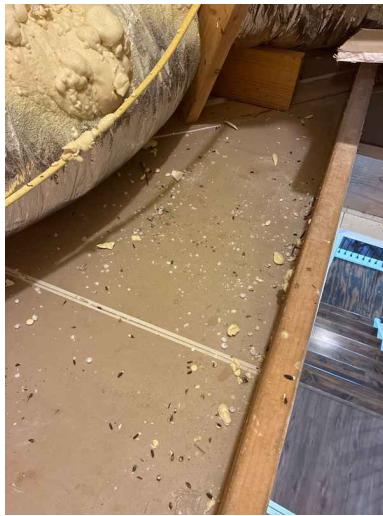
Rodent Activity:

Visible evidence of rodent activity was observed in the attic area. I did not see anything active.

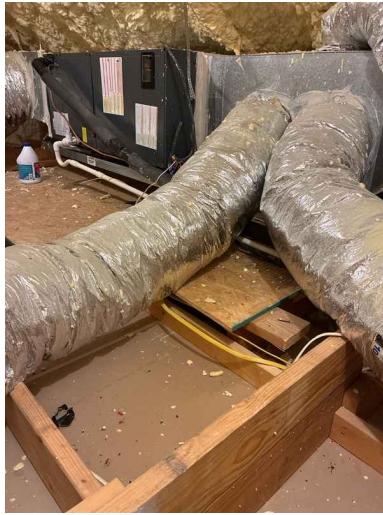
1: Attic Decking Missing

There is no attic decking for easy access to the equipment service. There should be at least a 30 x 30 inch floored service space in front of the service side of the equipment and a path to access the equipment.

Recommendation: Contact a qualified professional.

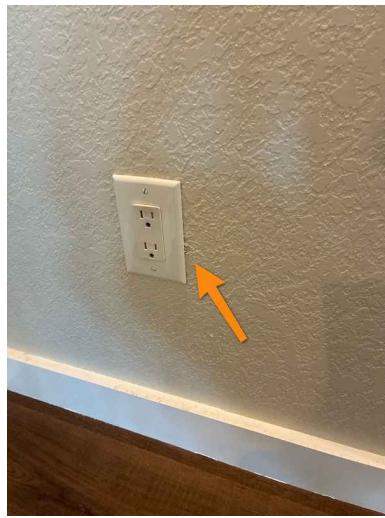
1: Wall Damage

Wall surface damage was observed.

Recommendation: Contact a qualified professional.

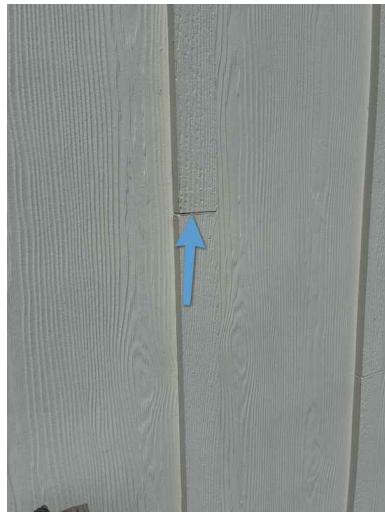
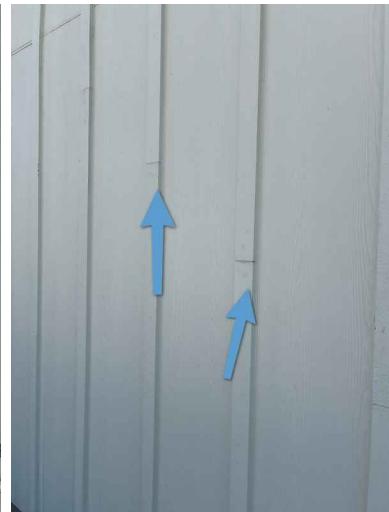
2: Caulking Improvement needed

Some caulking is needed on the exterior of the house. Caulking is a necessary routine maintenance item every 3-5 years.

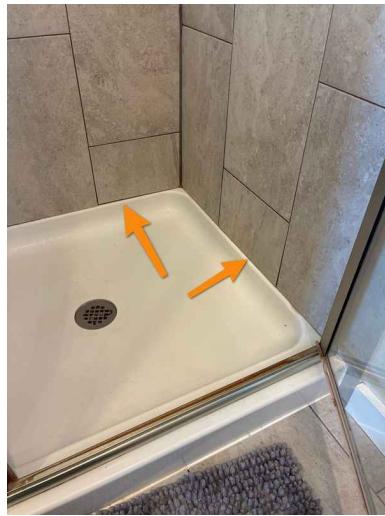
3: Caulking Needed in Shower

Caulking is needed to seal the shower wall.

Recommendation: Contact a qualified professional.

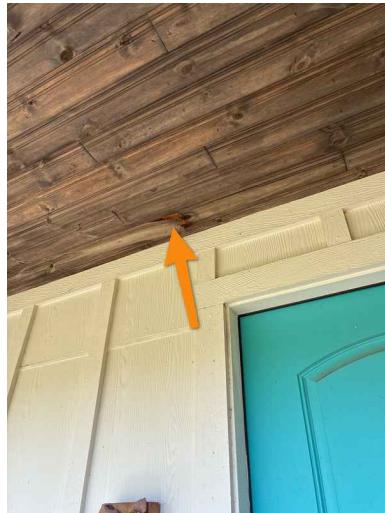
1: Ceiling Damage

The ceiling was observed to be damaged.

Recommendation: Contact a qualified professional.

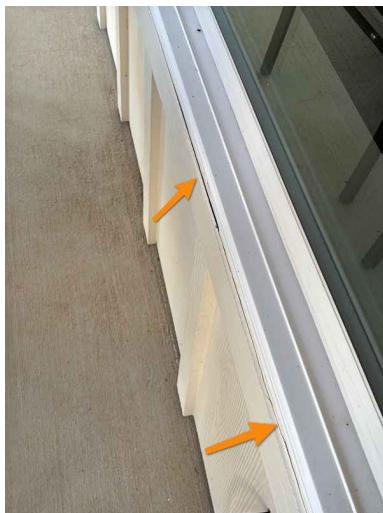
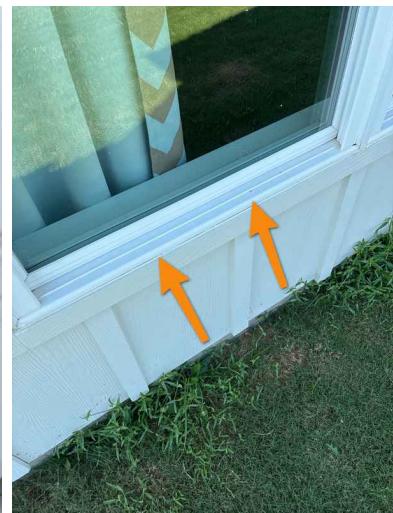
Back Porch

2: Caulking needed**⊖ Recommendation**

Caulking needed to complete the seal around windows

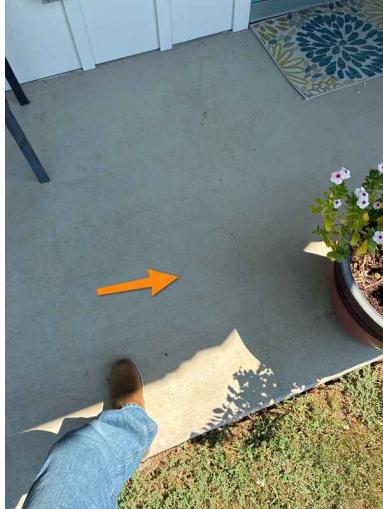
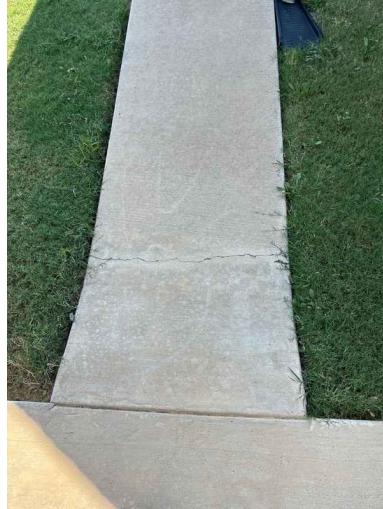
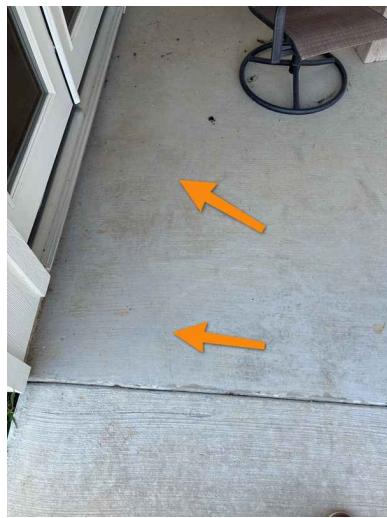
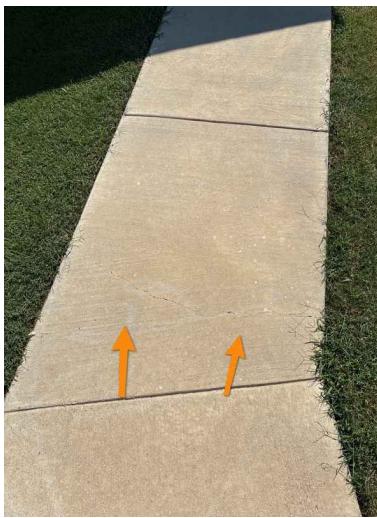
*Comments:***1: Minor Cracked Exterior Floor****● Recommendation**

Minor cracks and/or deficiencies were observed in the patio.

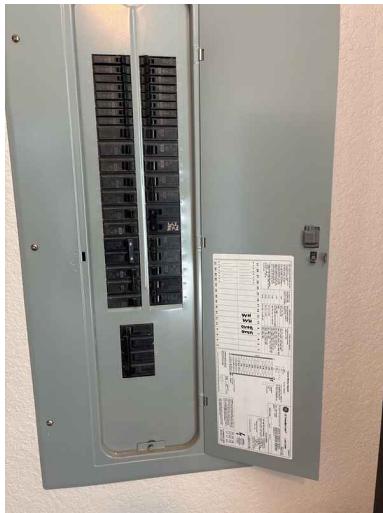
1: Panel Missing Labels**● Recommendation**

The breakers (overcurrent devices) in the electrical panel are not properly labeled.

Recommendation: Contact a qualified electrical contractor.

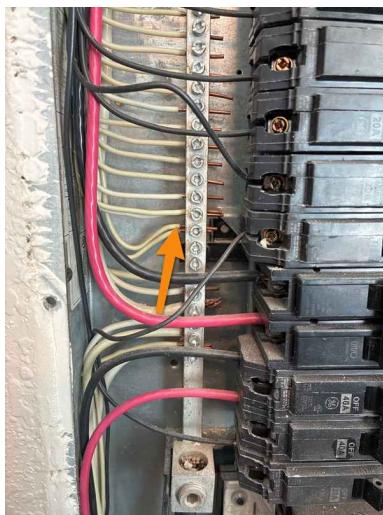
**2: Neutral Wires Double Lugged****● Recommendation**

There are multiple neutral wires secured under one lug/screw on the neutral bus bar. This type of installation does not meet current electrical standards. These conditions may not have violated building codes or common practices at the time of the construction of the home, or they may have been “grandfathered” because they were present prior to the adoption of codes prohibiting such conditions.

Recommendation: Contact a qualified professional.

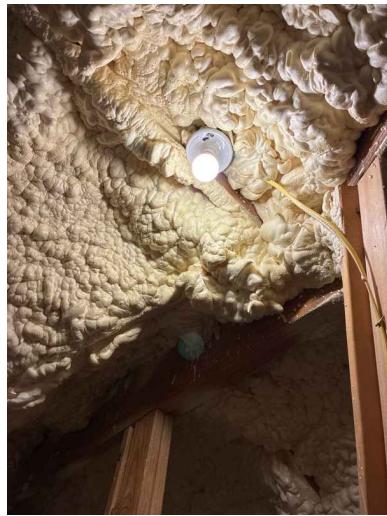
1: Light Fixture Cover(s) Missing**⊖ Recommendation**

One or more of the light fixture globes and/or covers are missing.

Recommendation: Contact a qualified professional.

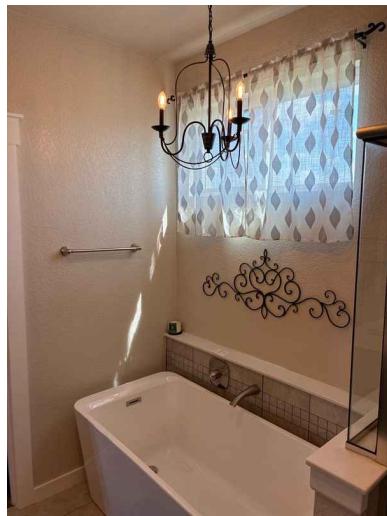
2: Light Fixture Over Tub/Shower

Light fixtures should be at least 8 feet above tub/shower. This is a safety hazard.

Recommendation: Contact a qualified professional.

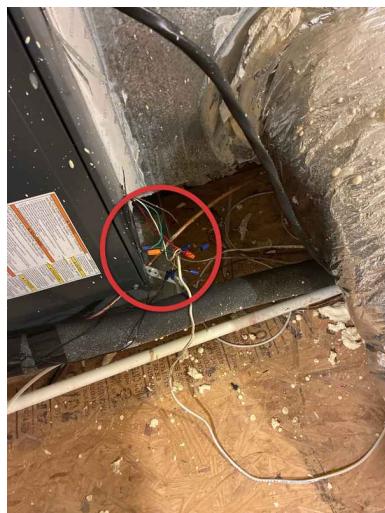
1: Exposed Electrical Wires

The exposed electrical service wires to the heating equipment should be enclosed in conduit.

Recommendation: Contact a qualified professional.

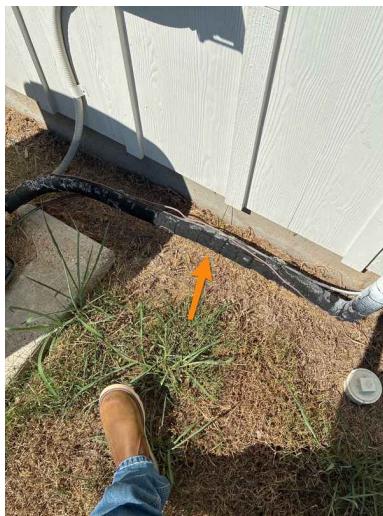
1: Refrigerant Line Insulation Ageing**● Recommendation**

Ageing insulation on the refrigerant lines should be repaired or replaced as necessary.

Recommendation: Contact a qualified professional.

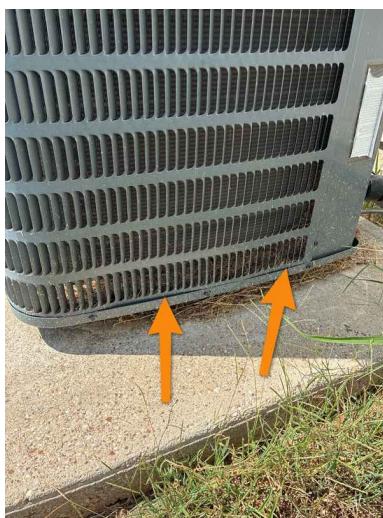
2: Condenser Dirty

The outdoor unit of the air conditioning system requires cleaning.

Recommendation: Recommended DIY Project

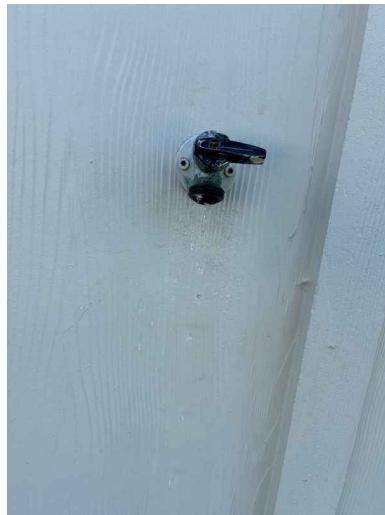
North

1: Faucet Leaks

A faucet is leaking. Recommend qualified handyman or plumber evaluate and repair.

Recommendation: Contact a qualified plumbing contractor.

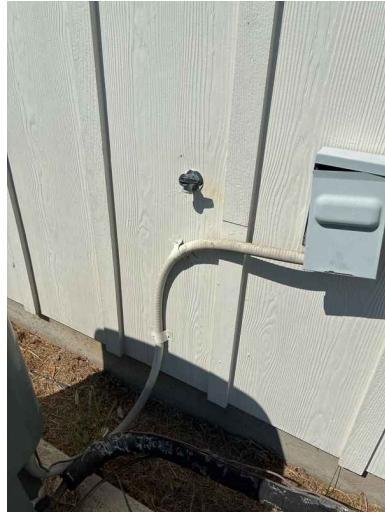
South

2: Faucet Not Working

The faucet is inoperative. The cause and remedy should be further evaluated.

Recommendation: Contact a qualified plumbing contractor.

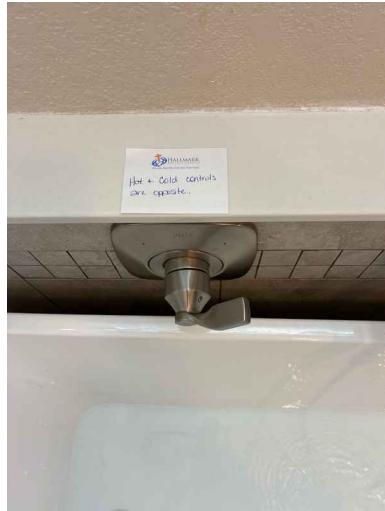
Master

3: Faucet Hot/Cold Reversed

The faucet hot/cold water orientation is reversed.

Recommendation: Contact a handyman or DIY project

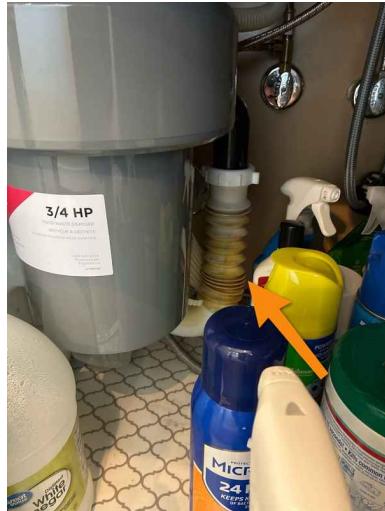
4: Corrugated Drain Under Sink

The drain line is made of corrugated material. It is recommended to use smooth wall/PVC type material to prevent blockage.

Recommendation: Contact a handyman or DIY project

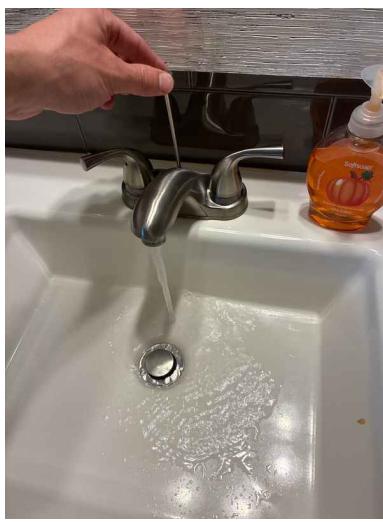
Stopper Not Connected Hallway
