RE: Drinking Water Sampling – Northeast Nodaway School District

126 South High School Avenue Ravenwood, MO 64479

Project Number: 923222

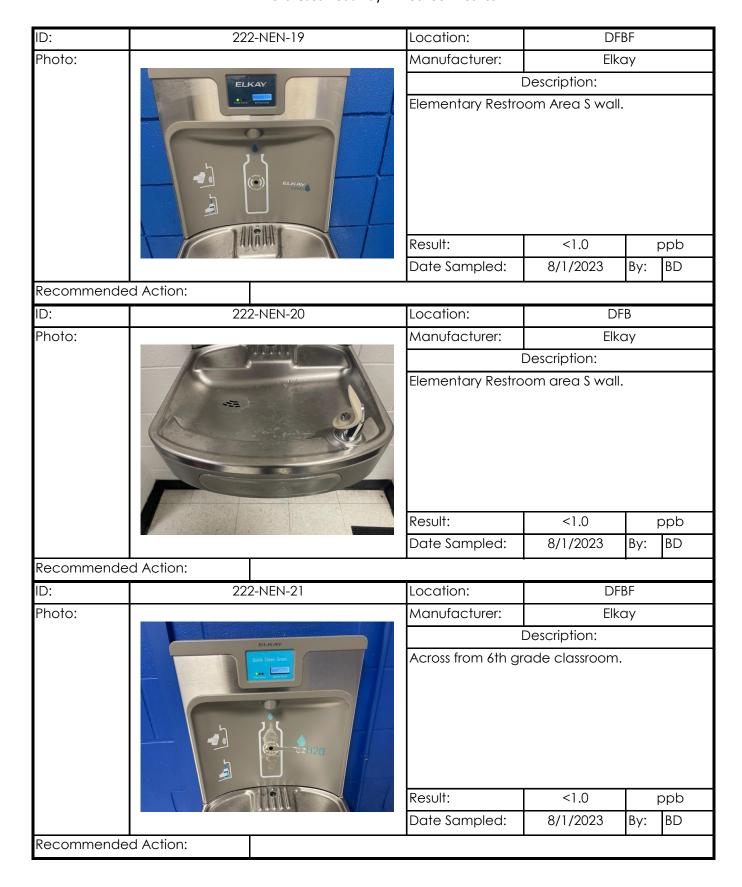
ID:	222-NEN-22	Location:	DFB				
Photo:		Manufacturer:	Elk	ay			
	Think The state of		Description:				
		Across from 6th gr	aae classroom				
		Result:	<1.0	ppb			
		Date Sampled:	8/1/2023	By: BD			
Recommende	d Action:			l l			
ID:	222-NEN-23	Location:	12	٧K			
Photo:		Manufacturer:	De	elta			
			Description:				
		Junior high math/s Sink on E side.					
		Result:	<1.0	ppb			
		Date Sampled:	8/1/2023	By: BD			
Recommende	d Action:	-		•			
ID:	222-NEN-24	Location:	12	٧K			
Photo:		Manufacturer:	De	elta			
			Description:				
		Junior high math/s on W side.	science room s	sink			
		Result:	<1.0	ppb			
		Date Sampled:	8/1/2023	By: BD			
Recommende	d Action:	!		<u> </u>
