CLARITY HOME INSPECTIONS LLC

RESIDENTIAL REPORT

1234 Main St.
Mount Washington, KY 40047

10/01/2019 9:00AM

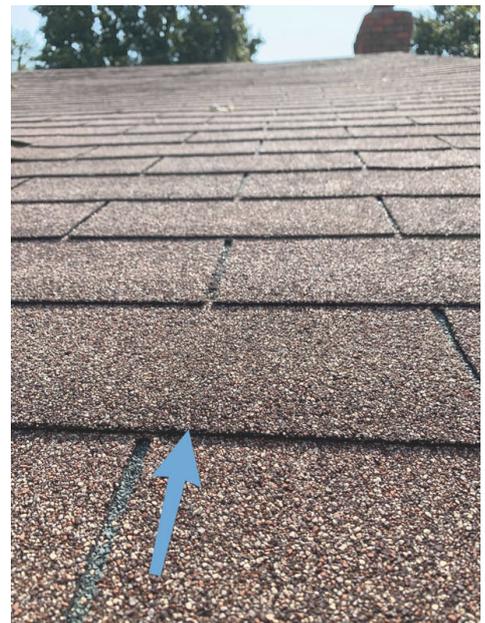
Racking is an improper installation method for many shingle types. It is acceptable for some shingle types, and it is the required method for a few shingle types.

Recommend that the roof examined by a qualified roofing contractor to determine whether the shingles on your roof have been improperly installed.

Contact a qualified roofing professional.

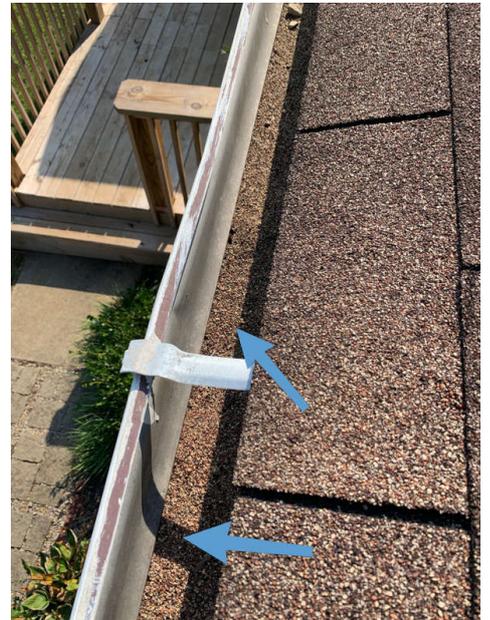
2.1.2 Coverings

Recommend cleaning gutters and monitoring shingles for delamination or cracking.

Recommend monitoring.

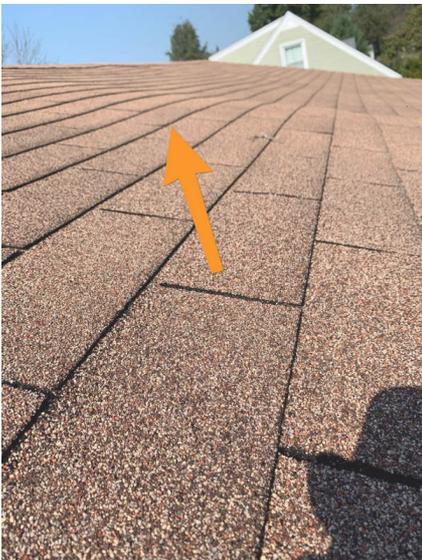
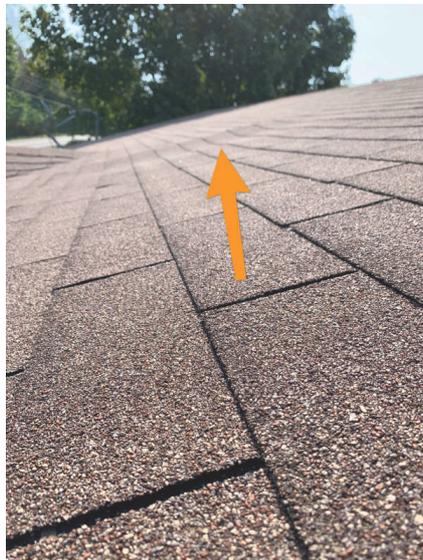
2.1.3 Coverings

WARPING

The roof was warping/sagging in one area of the roof. This could be due to improper decking techniques under the shingles. Recommend evaluation by a qualified roofing contractor.

Contact a qualified roofing professional.

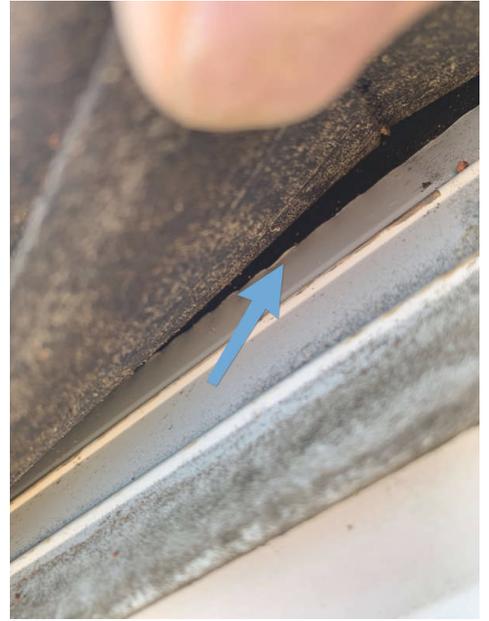
2.1.4 Coverings

IMPROPER DRIP EDGE FLASHING

Drip edge flashing is installed over the underlayment. This should be reversed to where the underlayment is installed over the drip edge to prevent any possibility of water intrusion. This should not be an issue unless the roof covering materials are damaged and allowing water underneath. Recommend monitoring shingles for cracking or deterioration in the future.

Recommend monitoring.

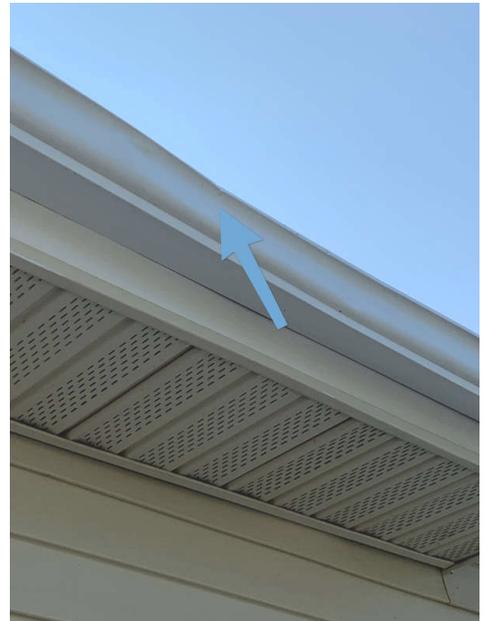
2.2.1 Roof Drainage Systems

MINOR DAMAGE

RIGHT SIDE GUTTERS

Minor damage was observed at one or more gutters. The gutters were still operating as designed. Repair as desired.

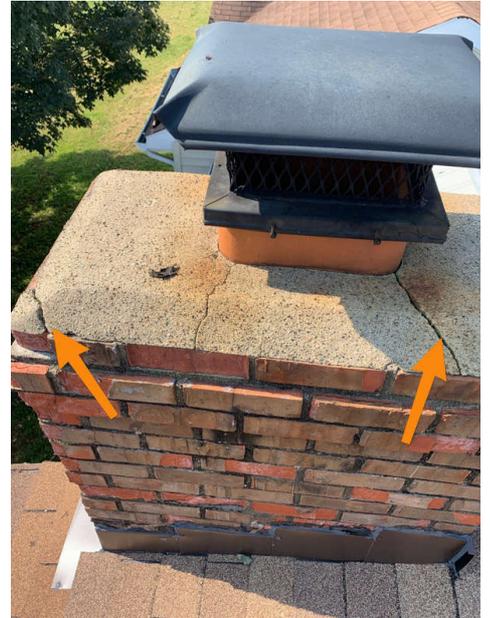
2.4.1 Skylights, Chimneys & Other Roof Penetrations

SPALLING/CRACKED CHIMNEY CAP

Evidence of spalling in the chimney cap. Recommend monitoring for future deterioration or water penetration. If water penetration is observed recommend repair by a licensed mason.

Recommend monitoring.

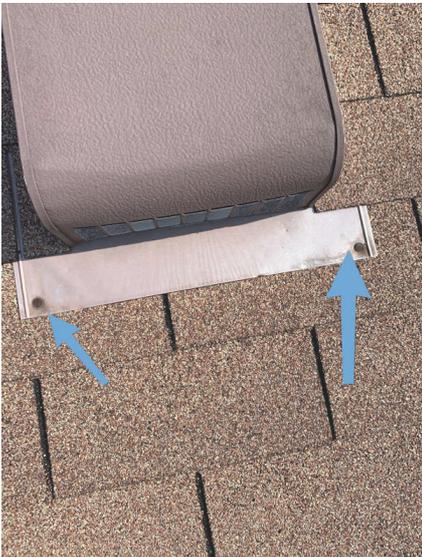
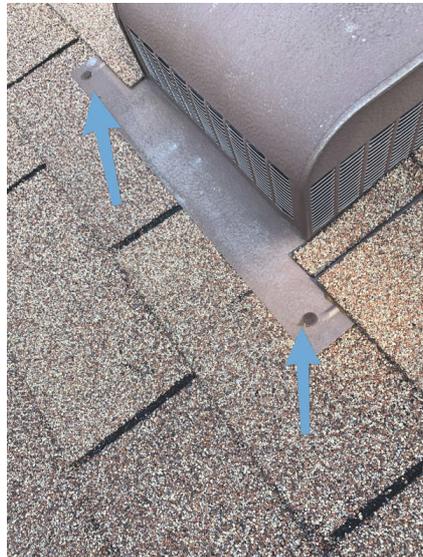
2.4.2 Skylights, Chimneys & Other Roof Penetrations

RUST RESISTANT NAILS

The flashings in one or more areas were nailed properly but did not have a sealant to protect against rust. This could cause the nails to rust and let the boot or flashing become loose from the roof. Recommend repair by a qualified individual.

Contact a handyman or DIY project

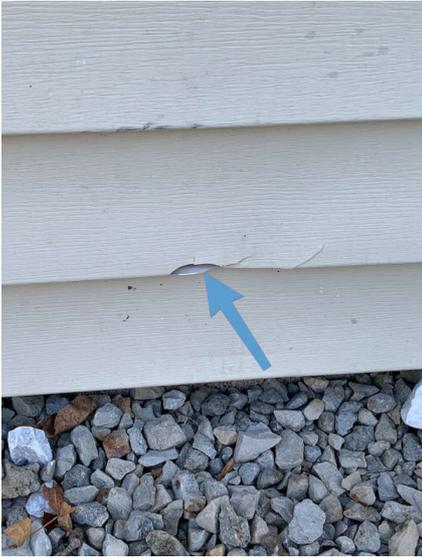
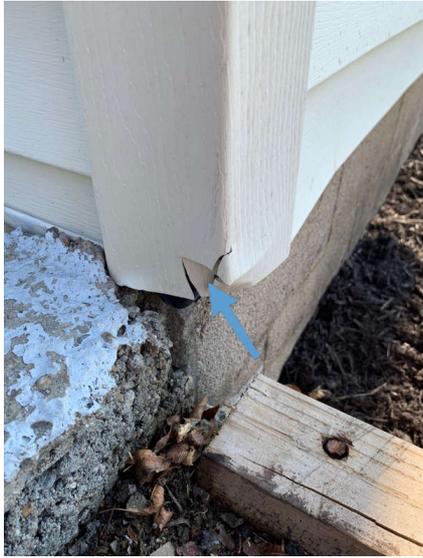
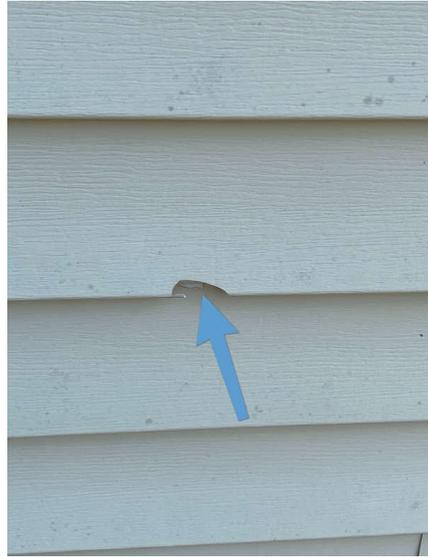
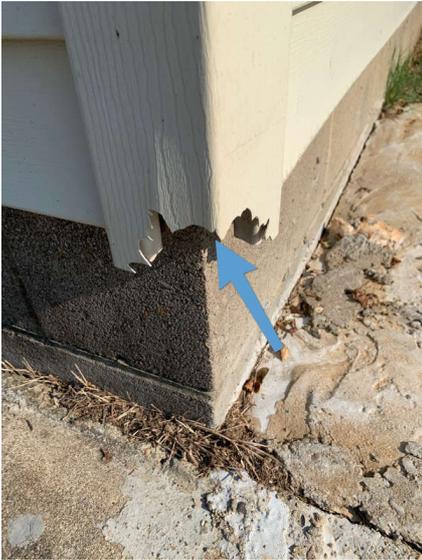
CRACKING - MINOR

Siding showed cracking in one or more places. This is a result of temperature changes or thrown material from a lawn mower and typical as homes with siding age. Recommend monitoring and/or repair as desired.

Recommend monitoring.

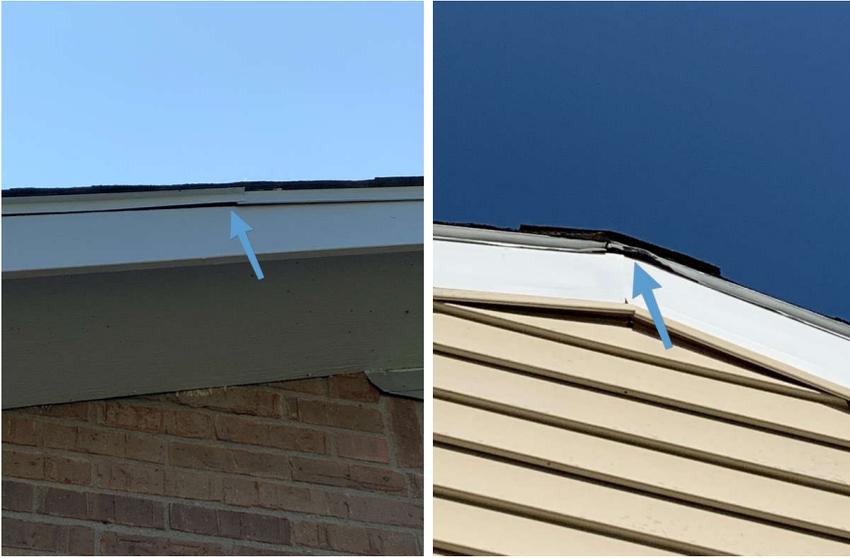
3.1.2 Siding, Flashing & Trim

FASCIA TRIM LOOSE

The trim/flashing for the fascia of the home was loose in one or more areas. This is still functioning as designed. Repair as desired by a qualified individual

Contact a qualified professional.

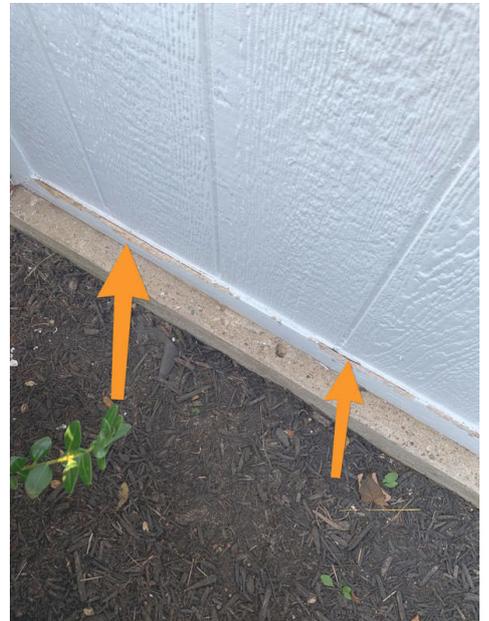
3.1.3 Siding, Flashing & Trim

One or more areas of paint/refinishing needed to maximize the service life. Recommend repair by a qualified individual.

Contact a qualified professional.

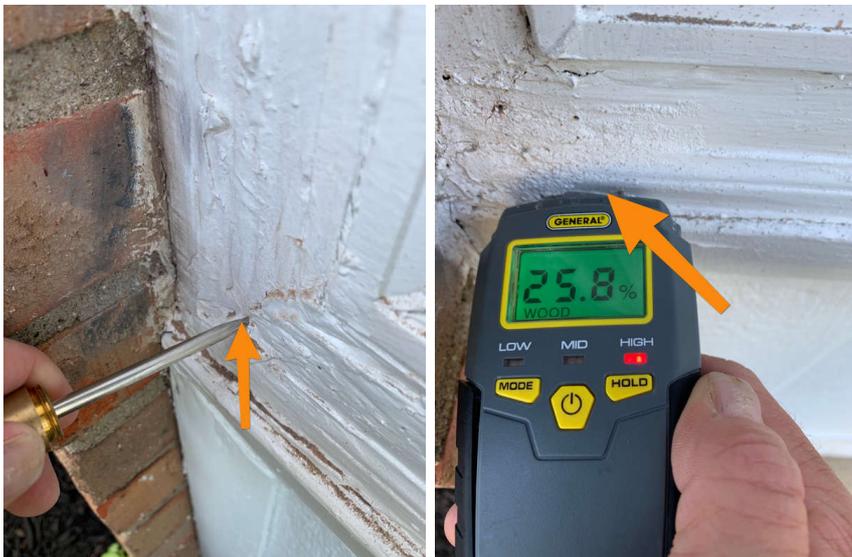
3.1.4 Siding, Flashing & Trim

WINDOW SILL DETERIORATION

The window sill/trim showed signs of deterioration. Recommend monitoring for water intrusion and repair if water intrusion is noted by a licensed contractor.

Contact a qualified general contractor.

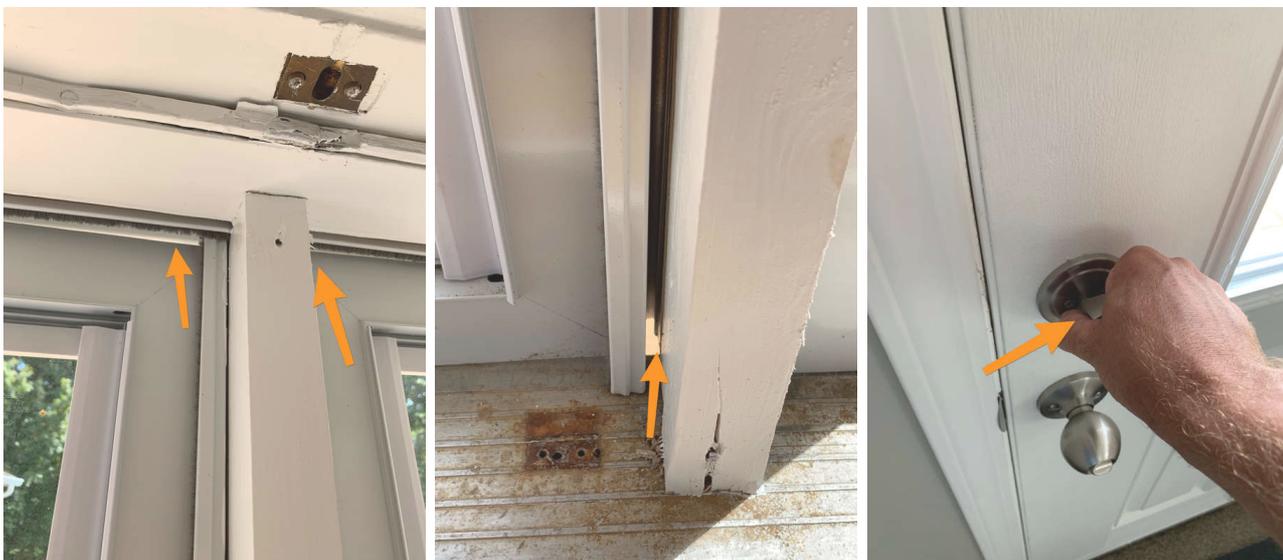
3.2.1 Exterior Doors

Door does not close or latch properly. Recommend qualified handyman adjust strike plate and/or lock.

Contact a qualified door repair/installation contractor.

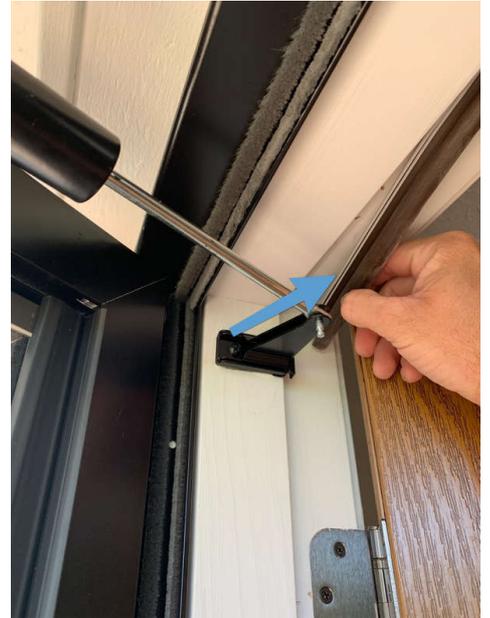
3.2.2 Exterior Doors

DAMAGED WEATHERSTRIPPING

One or more exterior doors had damage to the weatherstripping. This can result in energy loss and an entry point for pests. Recommend weatherstripping be repaired.

Contact a handyman or DIY project

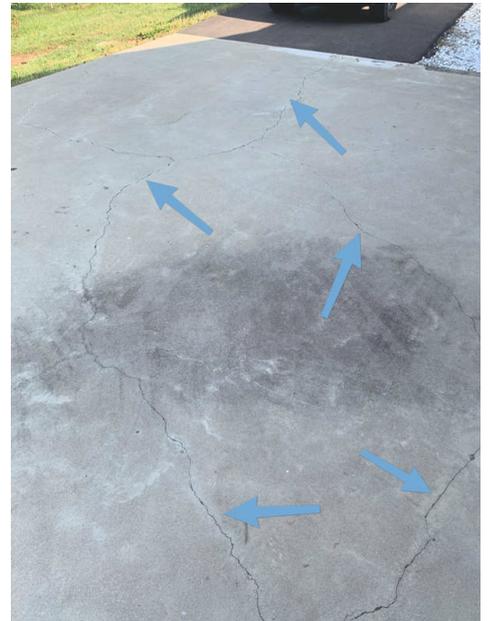
3.3.1 Walkways, Patios & Driveways

DRIVEWAY CRACKING - MINOR

Minor cosmetic cracks observed, which may indicate movement in the soil. Recommend monitor and/or have concrete contractor patch/seal.

Recommend monitoring.

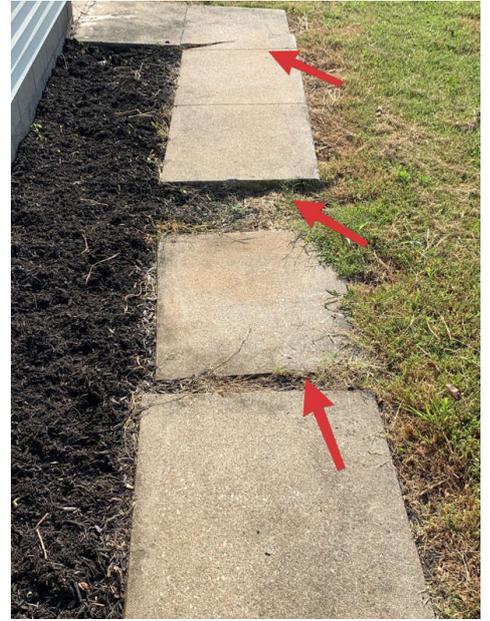
3.3.2 Walkways, Patios & Driveways

WALKWAY TRIP HAZARD

Trip hazard observed at the homes rear walkway. Recommend repair by a qualified individual.

Contact a qualified professional.

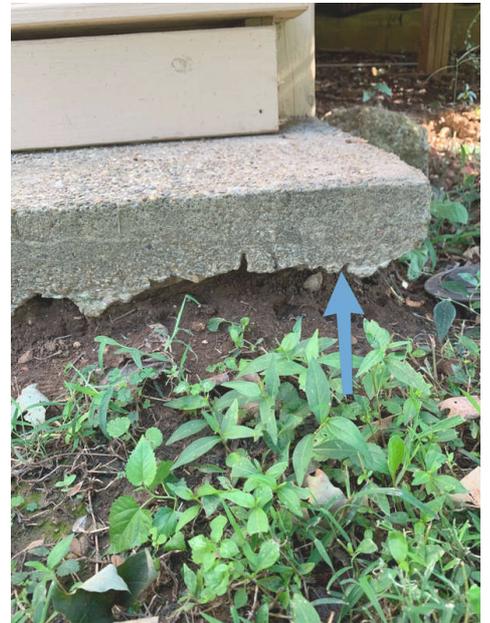
3.4.1 Decks, Balconies, Porches & Steps

PORCH/DECK LANDING DETERIORATION

Spalling and Deterioration noticed at front landing. This is due to typical settlement. Recommend monitoring for further deterioration.

Recommend monitoring.

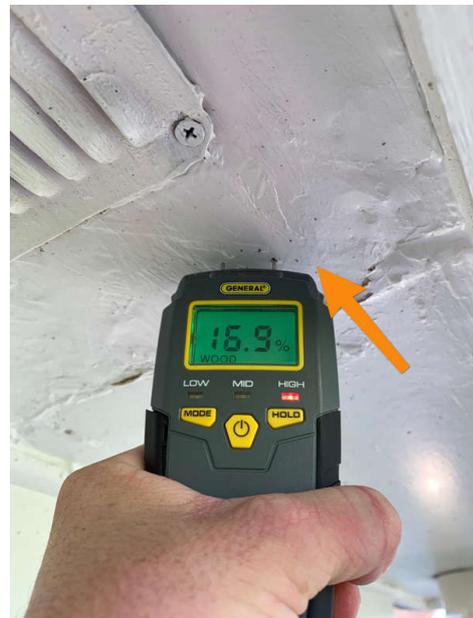
3.5.1 Eaves, Soffits & Fascia

EAVES - WATER STAINS

Water stains were observed under the roof eaves. This may indicate an active leak. Recommend qualified roofer evaluate & repair.

Contact a qualified roofing professional.

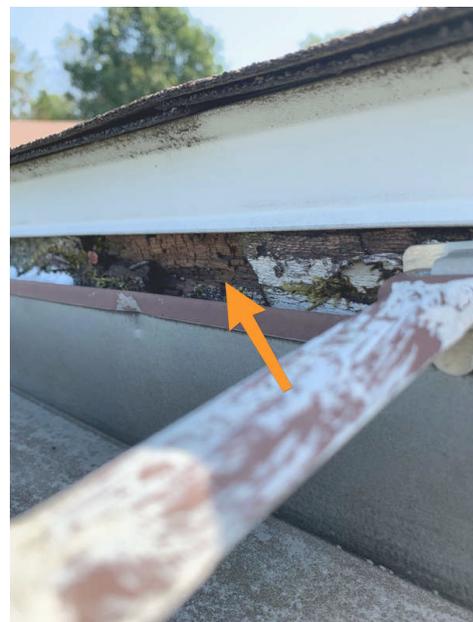
3.5.2 Eaves, Soffits & Fascia

One or more sections of the fascia are rotted. Recommend qualified roofer evaluate & repair.

Contact a qualified roofing professional.

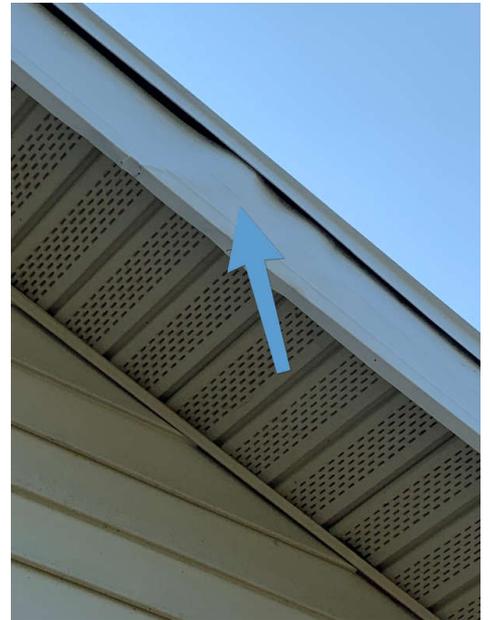
3.5.3 Eaves, Soffits & Fascia

MINOR DAMAGE

Minor damage was observed to the eaves, soffit or fascia. They are still operating as designed in these areas. Recommend monitoring for further damage as to not allow water intrusion.

Recommend monitoring.

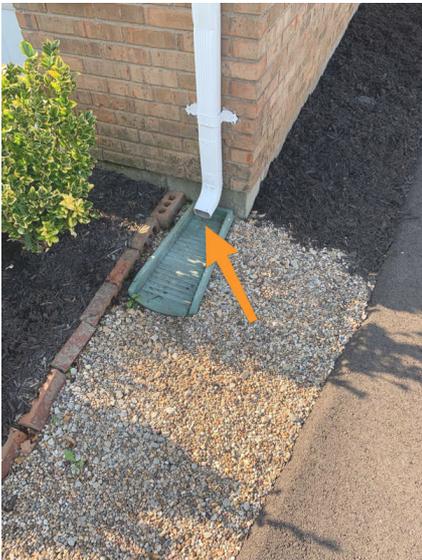
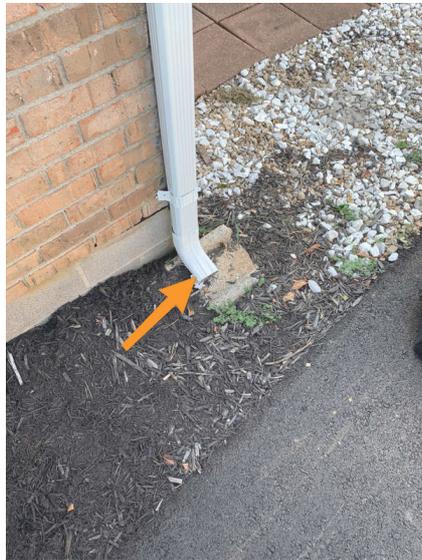
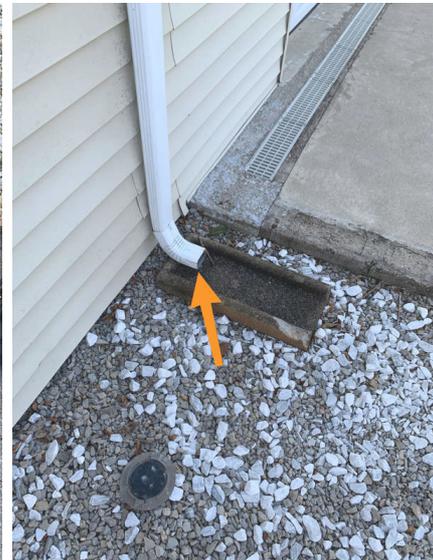
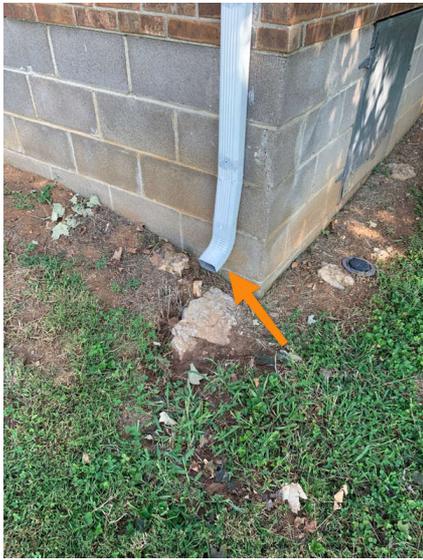
3.6.1 Vegetation, Grading, Drainage & Retaining Walls

DOWNSPOUTS DISCHARGING NEAR FOUNDATION

Gutter drainage near foundation noted in one or more areas below gutter downspout. This can cause water to deteriorate ground beneath and cause moisture intrusion. Recommend having drainage water discharge approximately 5 ft from foundation with splash blocks beneath to prevent future problems.

Recommended DIY Project

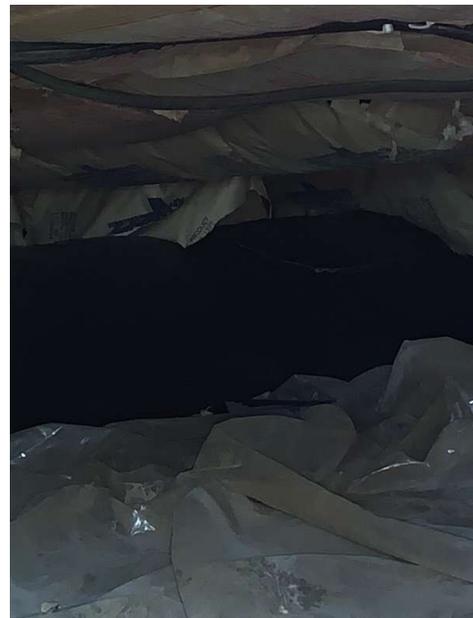
DUCT WORK BLOCKING

The HVAC ductwork was blocking one or more areas of the crawlspace preventing access to all parts.

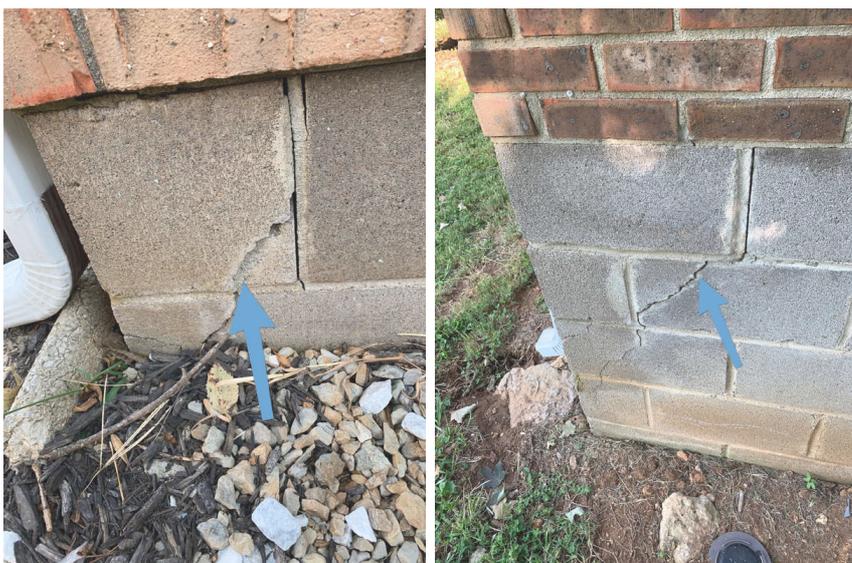
4.1.1 Foundation

CORNER CRACK

Corner cracks were noticed in the foundation. Most of the time, a cracked corner is not caused by foundation movement. The most common cause is temperature changes. In the summer, the ground is cooler than the air. Because your foundation sits on the ground (and because you air condition our home) your foundation tends to stay much cooler than the air. The difference between the air temperature and the temperature of your foundation will be greatest on hot summer days. Recommend monitoring for further separation. If further separation is observed recommend repair by a foundation specialist.

Recommend monitoring.

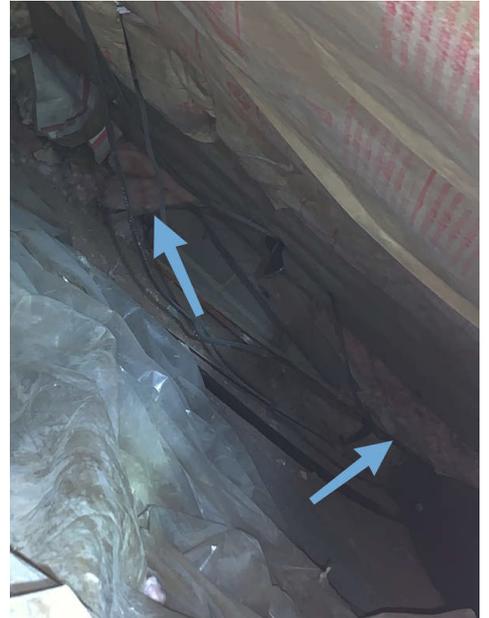
4.2.1 Basements & Crawlspace

The flooring insulation in the crawlspace has fallen down in one or more areas. Recommend the insulation be reattached by a qualified individual.

Contact a qualified professional.

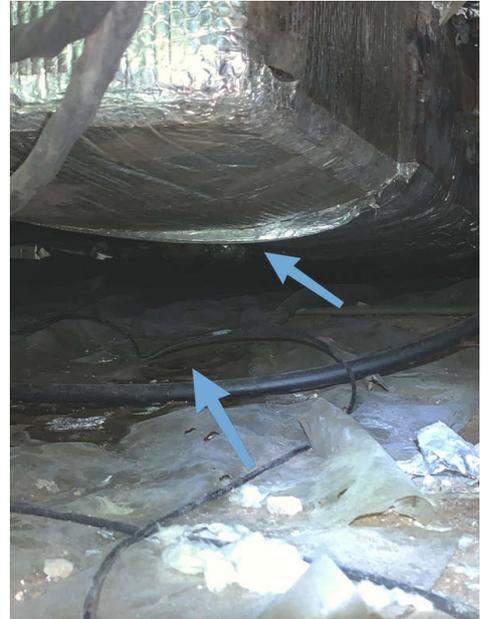
4.2.2 Basements & Crawlspace

One or more ducts were creating excessive condensation and dripping. Recommend monitoring area for excessive moisture.

Recommend monitoring.

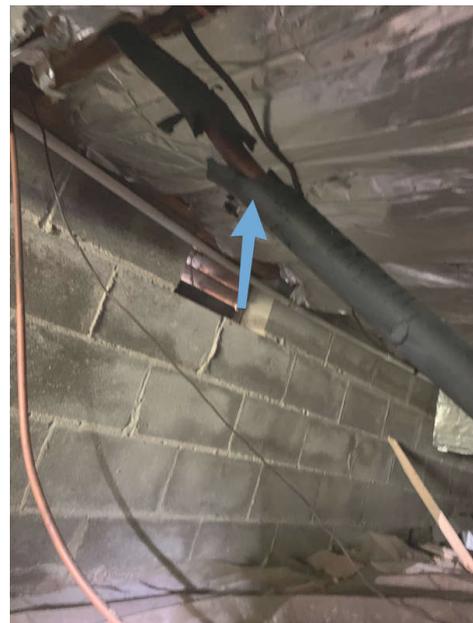
6.1.1 Cooling Equipment

INSULATION MISSING OR DAMAGED

Missing or damaged insulation on refrigerant line can cause energy loss and condensation.

Contact a qualified HVAC professional.

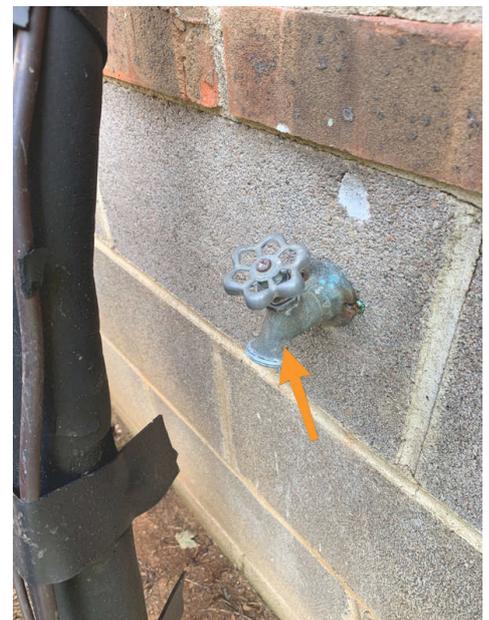
HOSE BIB DEFICIENT

One or more hose bibs were not in working condition at time of inspection. Recommend repair or replacement by a qualified individual.

Contact a qualified professional.

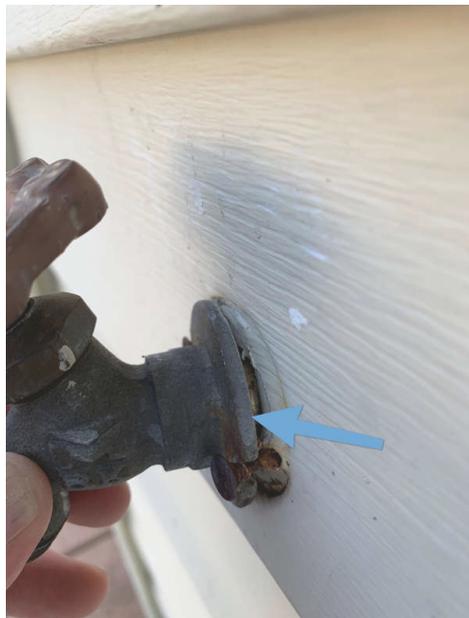
7.3.2 Water Supply, Distribution Systems & Fixtures

One or more hose bibs were not secured to the wall materials. Recommend repair by a qualified individual.

Contact a qualified professional.

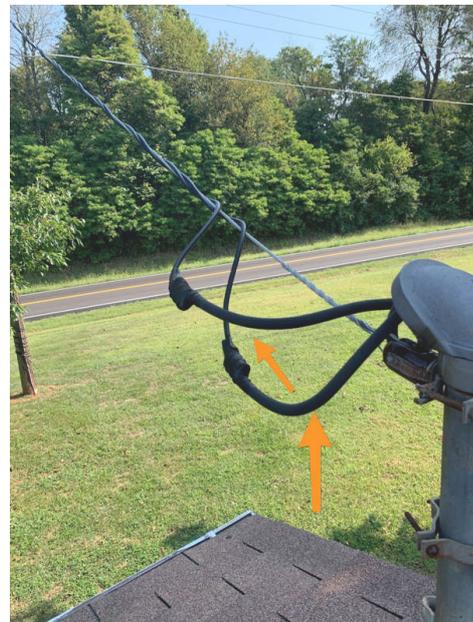
The drip loop for the service entrance conductors may not be operating as designed based on the slope from the pole. Recommend evaluation by utility company or licensed electrician.

Contact your local utility company

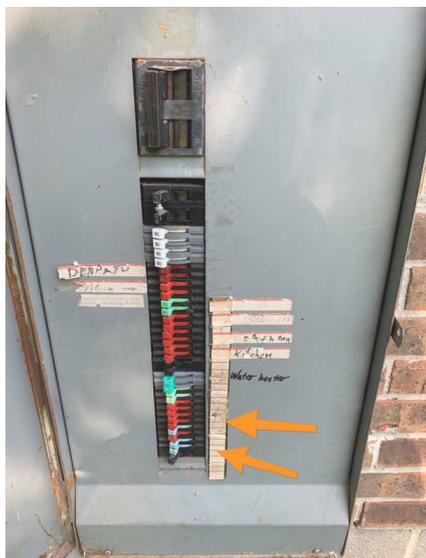
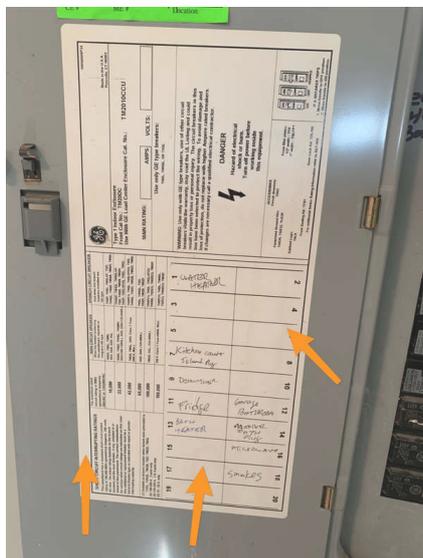
8.2.1 Main & Subpanels, Service & Grounding, Main Overcurrent Device

MISSING LABELS ON PANEL

At the time of inspection, panel was missing labeling. Recommend a qualified electrician or person identify and map out locations.

Contact a qualified electrical contractor.

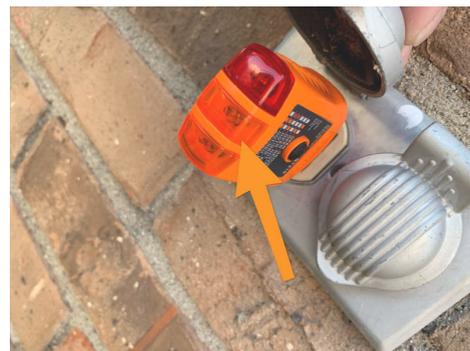
8.4.2 Lighting Fixtures, Switches & Receptacles

DEFECTIVE RECEPTACLE

One or more receptacles were not operating as designed at time of inspection. Recommend evaluation and/or replacement by a qualified electrician. Also each outdoor receptacle should be covered by rain box.

Contact a qualified electrical contractor.

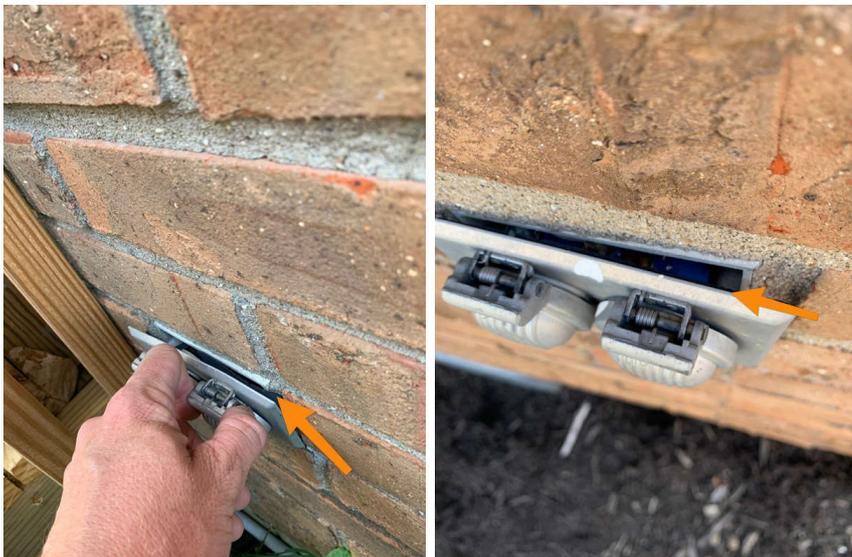
8.4.3 Lighting Fixtures, Switches & Receptacles

LOOSE RECEPTACLE/SWITCH

One or more receptacles/light switches were not secured properly to the wall. This could pose an electrical hazard. Recommend proper installation by a qualified individual

Contact a qualified electrical contractor.

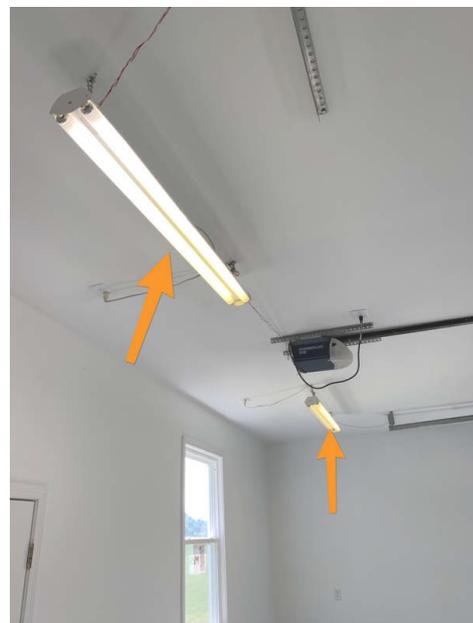
8.4.4 Lighting Fixtures, Switches & Receptacles

One or more fixtures in the home were flickering when powered on. This happens when shutting the occupant door in the garage. This could be a loose bulb or loose wiring. Recommend evaluation and repair by a qualified individual.

Contact a qualified professional.

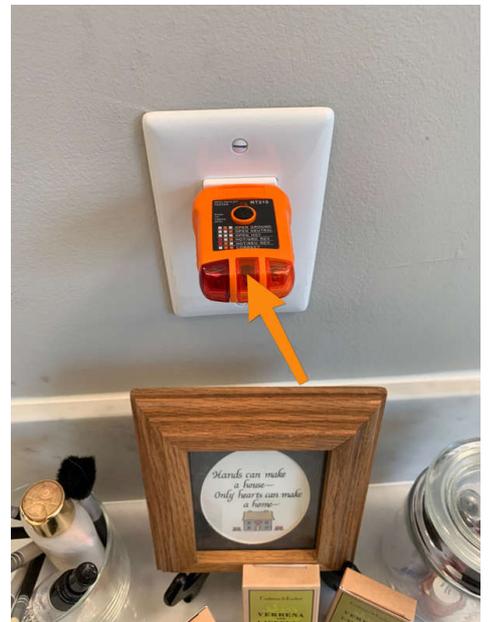
8.5.1 GFCI & AFCI

IMPROPER INSTALLATION

The GFCI receptacle was installed incorrectly. Recommend repair by a licensed electrician.

Contact a qualified electrical contractor.

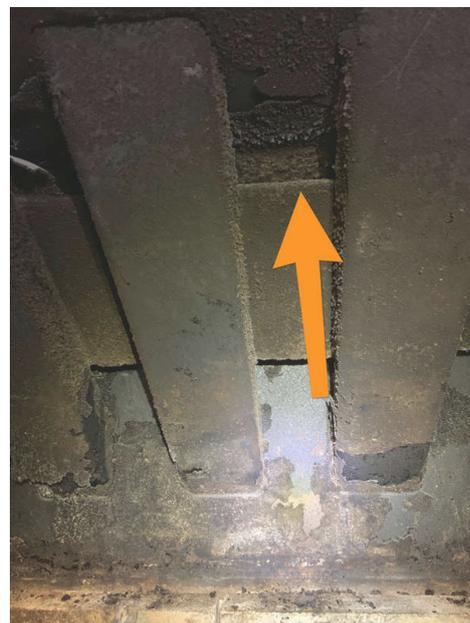
Chimney liner had layer of creosote dust, so underlying structure couldn't be inspected for cracks. Recommend qualified chimney sweep company inspect and/or clean.

Contact a qualified chimney sweep.

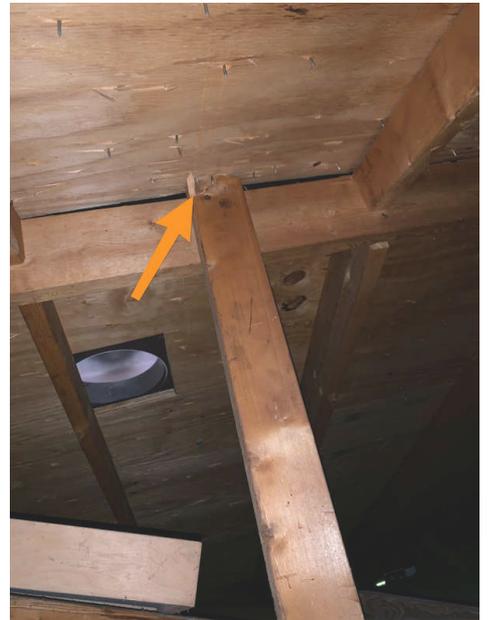
ROOF DECKING DAMAGE

The decking for the roof was damaged in one or more areas of the attic space. Recommend monitoring areas for leaks and if leaks are observed, have a qualified individual repair or replace damaged boards.

Contact a qualified professional.

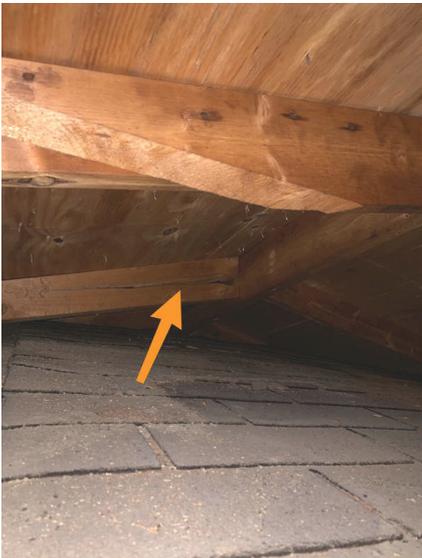
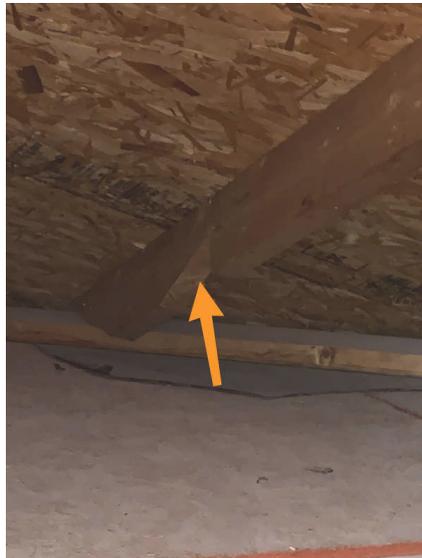
10.5.2 Roof Structure

DAMAGED SUPPORTS

The roof structure supports were damaged in one or more areas. This can cause the roof to sag and possibly leak. Recommend evaluation and repair by a licensed contractor.

Contact a qualified general contractor.

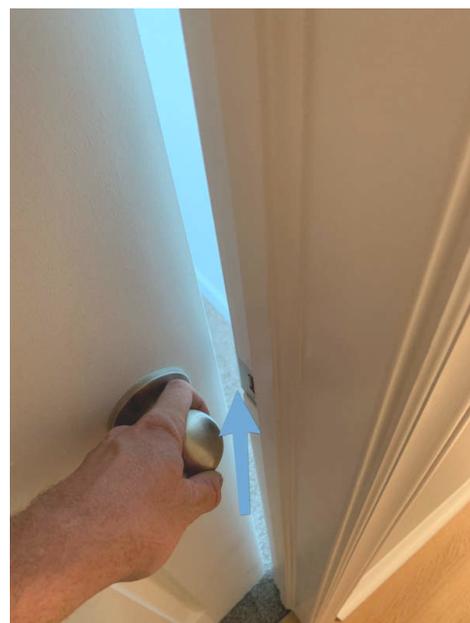
Door latch and/or strike plate is out of alignment. Recommend a handyman repair.

Contact a qualified handyman.

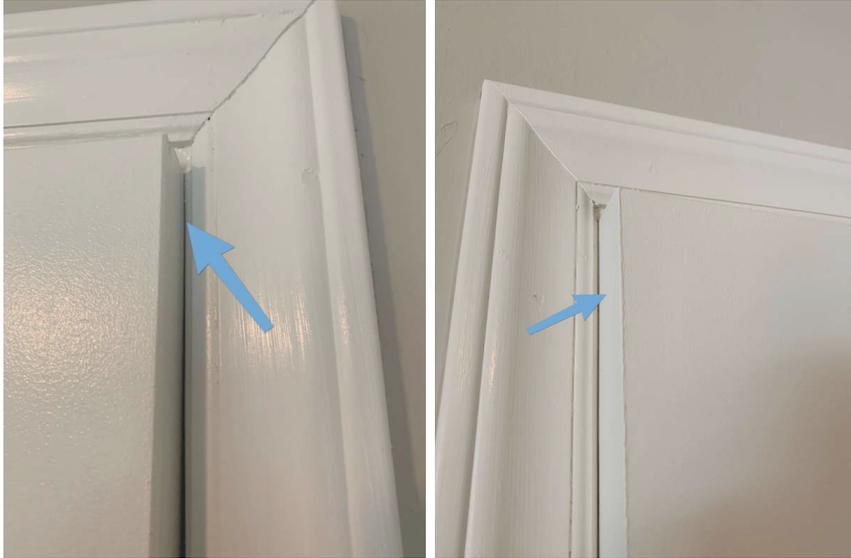
11.1.2 Doors

DOOR STICKS

Door sticks and is tough to open. Recommend sanding down offending sides.

Recommended DIY Project

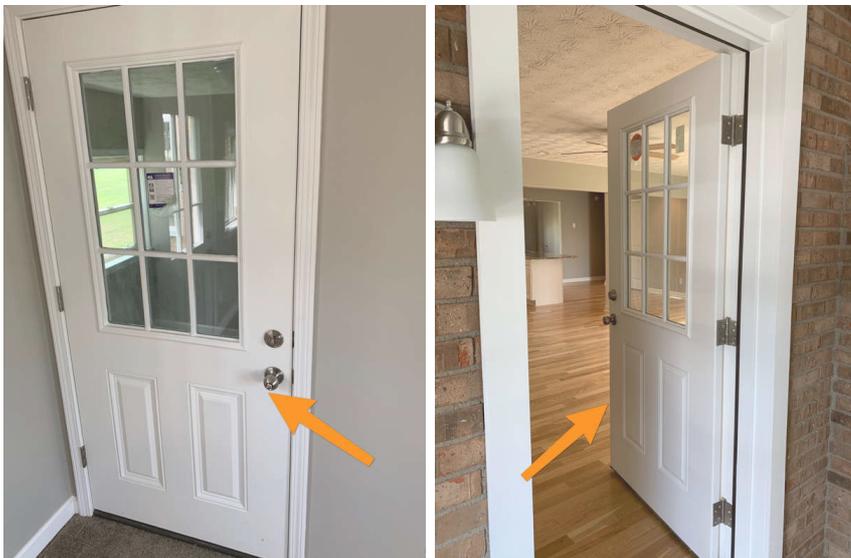
11.1.3 Doors

EXTERIOR DOOR ON INTERIOR

An exterior hollow core metal door was observed at sunroom and mud room. The use of this door prevents airflow and ventilation into the bonus room when closed. Recommend replacement with an interior door.

Contact a qualified professional.

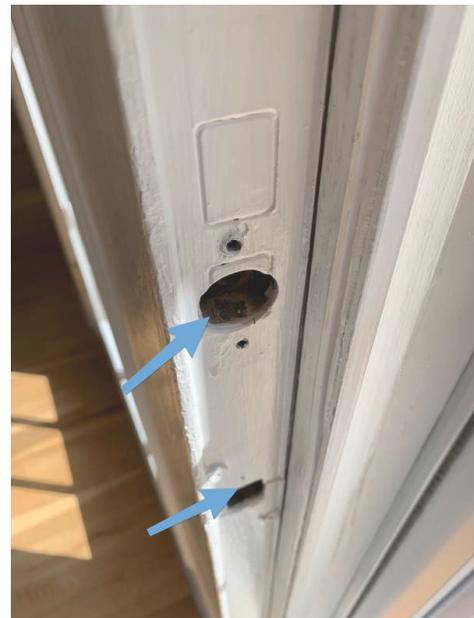
11.1.4 Doors

DAMAGED HARDWARE

The hardware was broken and/or missing on one or more doors. Recommend repair as desired.

Contact a qualified professional.

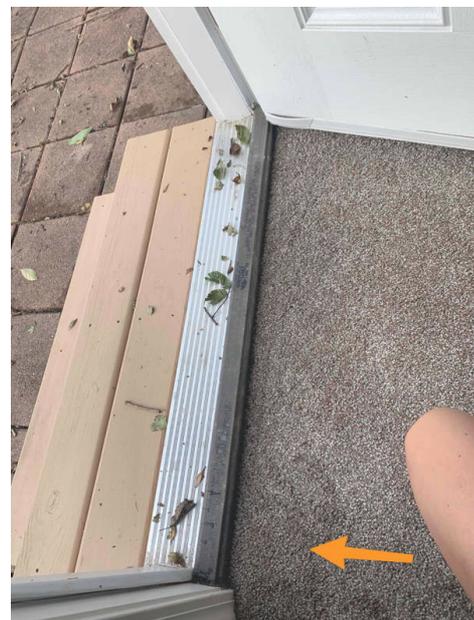
11.3.1 Floors

MOISTURE INTRUSION

Floors had areas of visible moisture intrusion. This is likely due to the fact that both of the sunroom exterior doors do not have a storm door installed. Recommend evaluation of moisture intrusion by a qualified individual and/or installation of storm doors.

Contact a qualified professional.

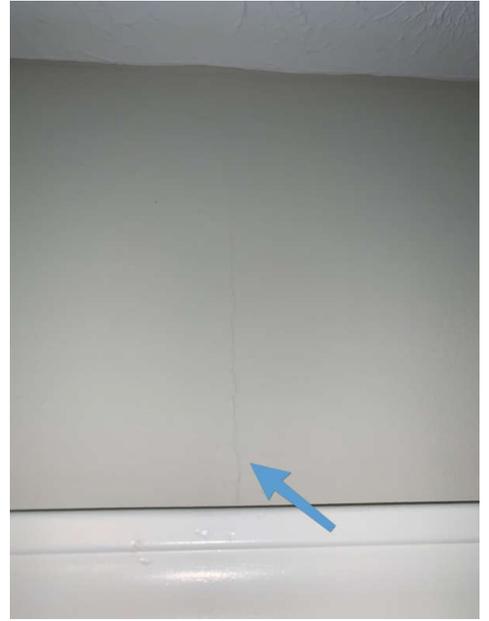
11.4.1 Walls

MINOR CORNER CRACKS

Minor cracks at the corners of doors and windows in walls. Appeared to be the result of long-term settling. Some settling is not unusual in a home of this age and these cracks are not a structural concern.

Recommend monitoring.

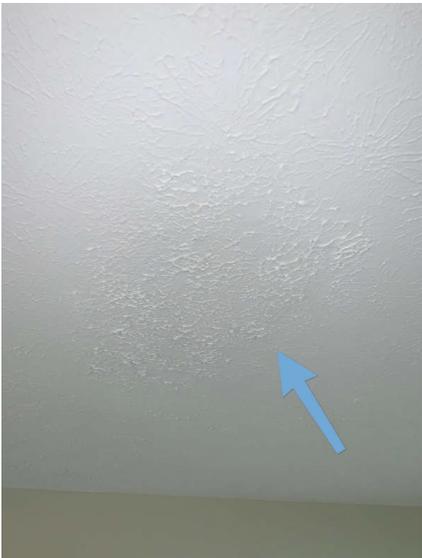
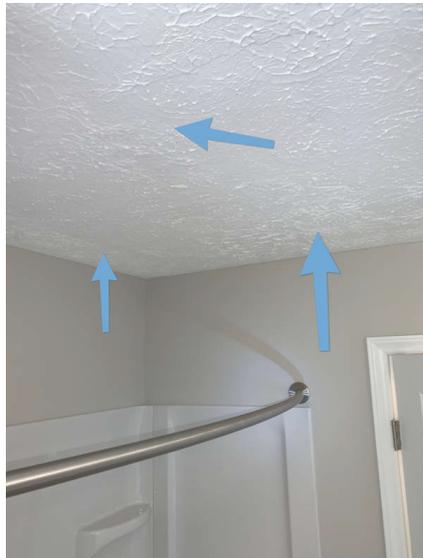
11.5.1 Ceilings

CEILING REPAIR

Repairs were noted in one or more areas of the home. This could have been due to a previous leak. Recommend conversation with homeowner as to why the ceiling has been repaired in areas.

Recommended DIY Project

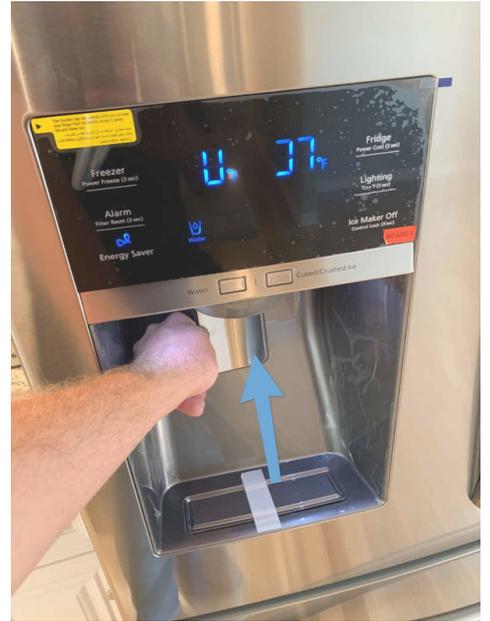
The water has not been run to the refrigerator preventing the water and ice dispenser from working. Recommend repair by a qualified individual.

Contact a qualified professional.

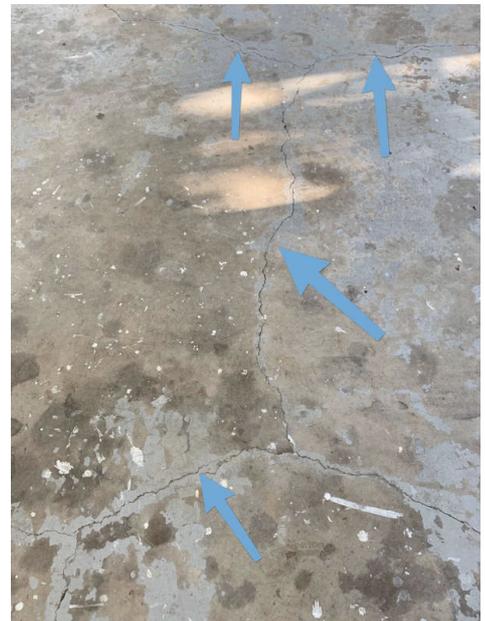
MINOR CRACKING

Minor garage floor cracking observed. This is from normal settlement, expansion and contraction. Recommend monitoring and if cracking becomes displaced repair as desired.

Contact a qualified professional.

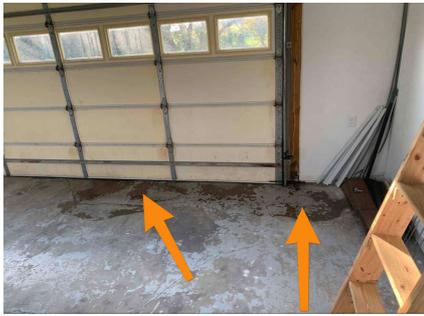
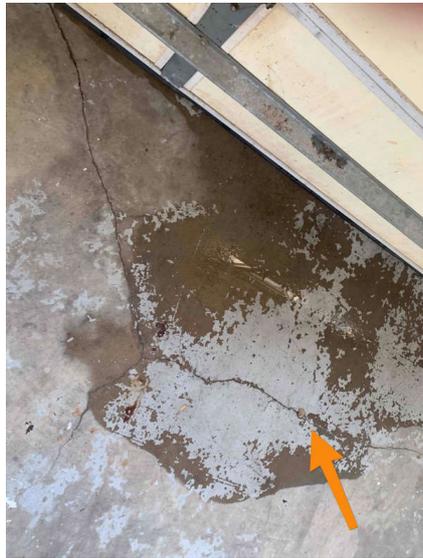
13.2.2 Floor

Evidence of water intrusion under the garage door and occupant exterior door in garage. Recommend evaluation and repair by a qualified individual.

Contact a qualified professional.

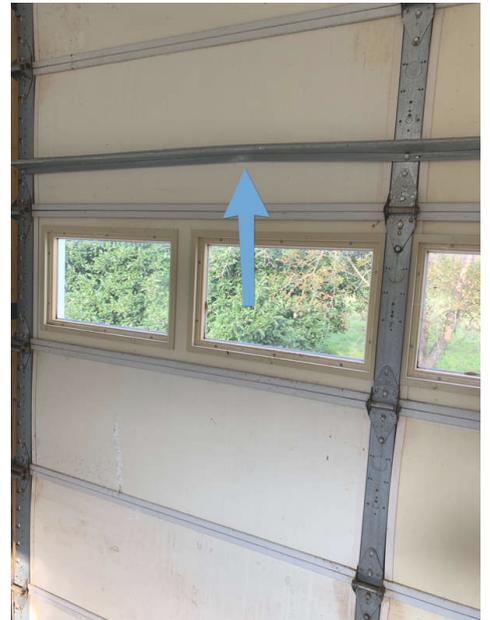
The garage door showed signs of minor damage. Recommend repair as desired.
