75A-1 Cabinet and Speaker

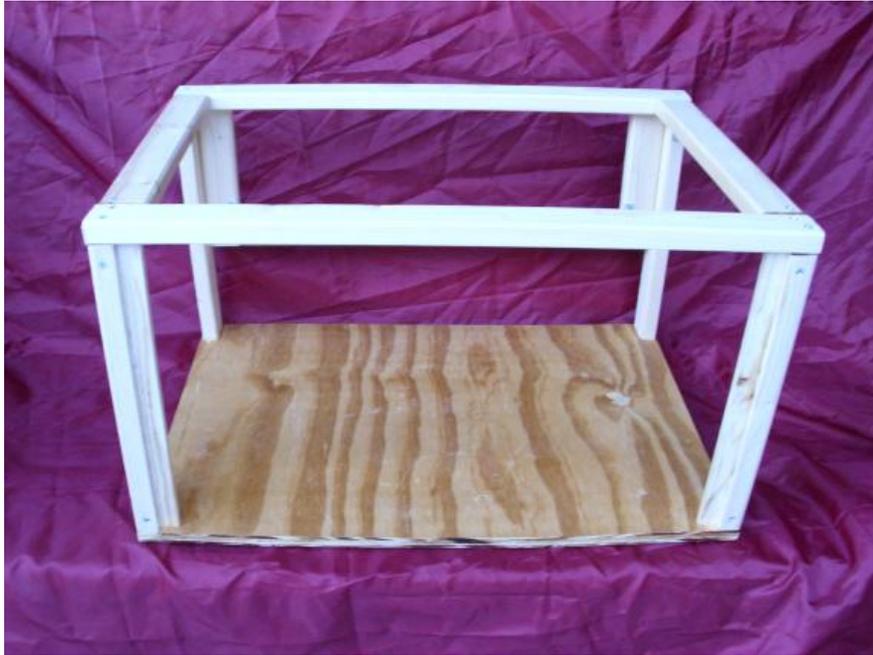
Basic Frame, viewed from the front

“1 X 2” lumber, which is now .75 inch by 1.5 inches was used to form the basic frame of the 75A-1 cabinet and half-inch thick plywood for the base of the receiver cabinet and for the sides, top, and bottom of the speaker cabinet. Wood screws were used to hold everything together and a lot of “L” brackets used as well. For the top, back, and sides of the 75A-1 cabinet, “hardboard” (Masonite) was chosen. The particular hardboard chosen had a smooth side and a rough side. The texture of the rough side was not that far from resembling the finish on the “regular” “A” Line cabinets. So, the rough side was put on the outside of the cabinet.

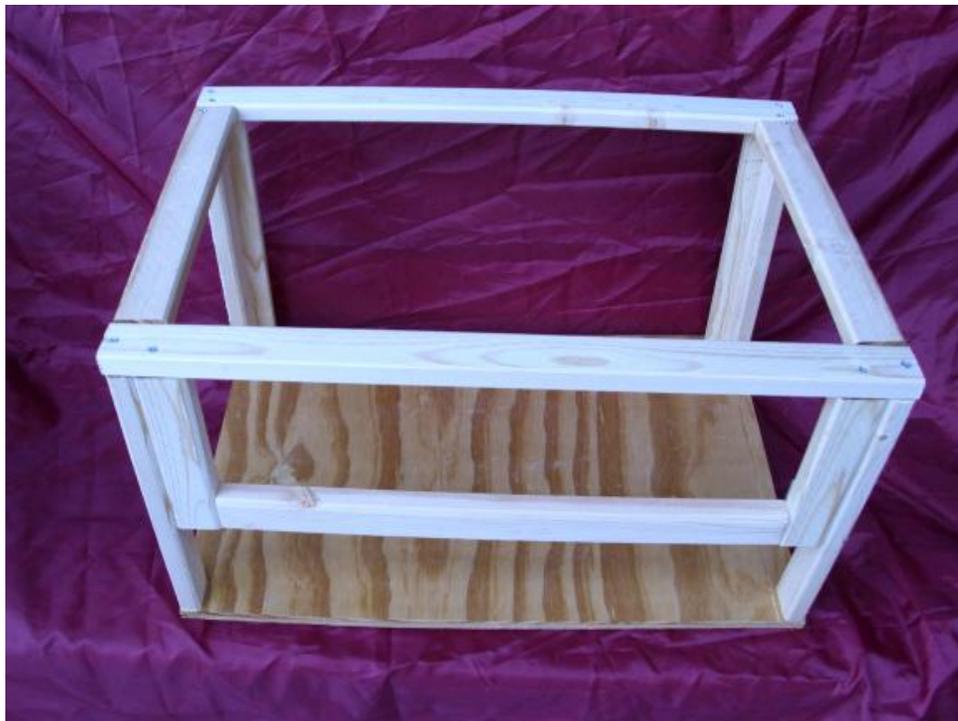
Basic Frame, viewed from the rear

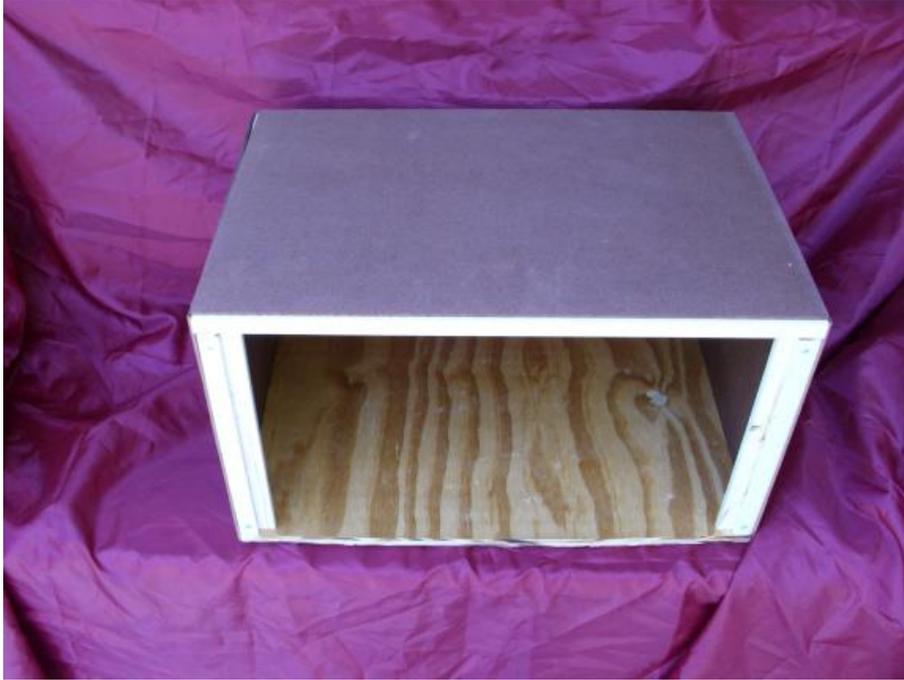
Cabinet with "hardboard" installed, viewed from front

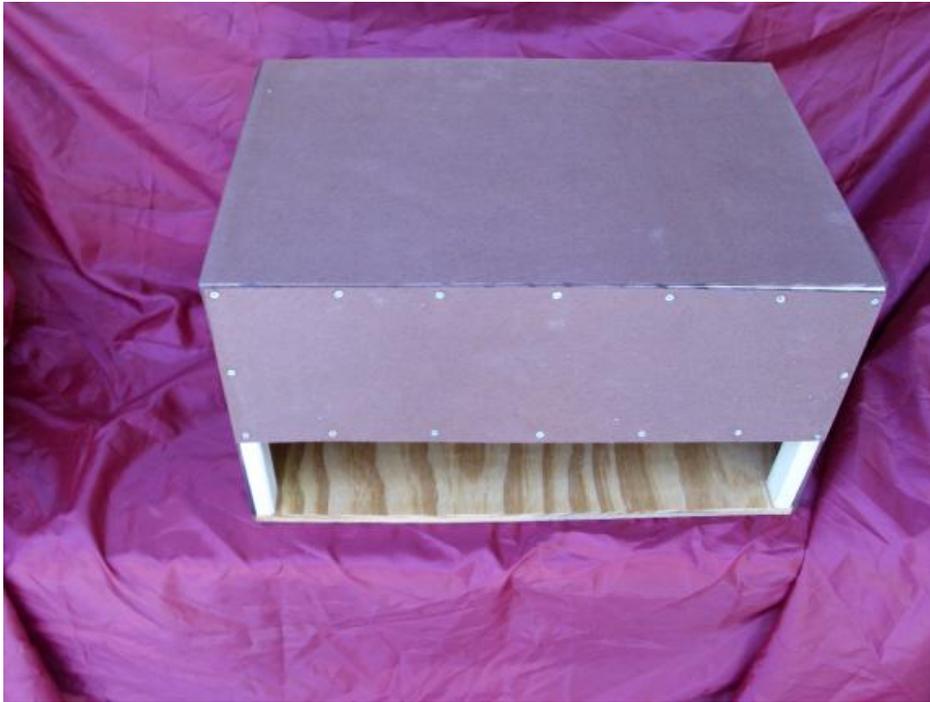
Cabinet with "hardboard" installed, viewed from back

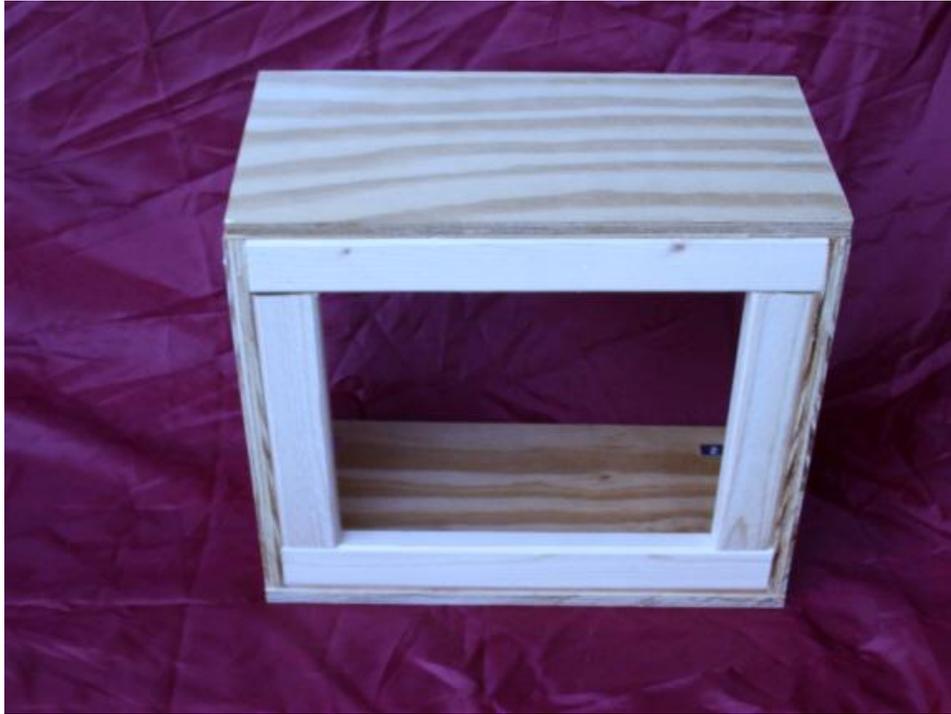
Basic Speaker, viewed from front

The speaker cabinet is basically the same size as the original Collins speaker. “1 X 2” lumber was placed on the inside of the plywood to form the front of the speaker to resemble the original speaker. There is room for a 10 inch diameter speaker in the cabinet and when one arrives from being ordered, it will be installed. For the meantime, an 8 inch speaker is installed.

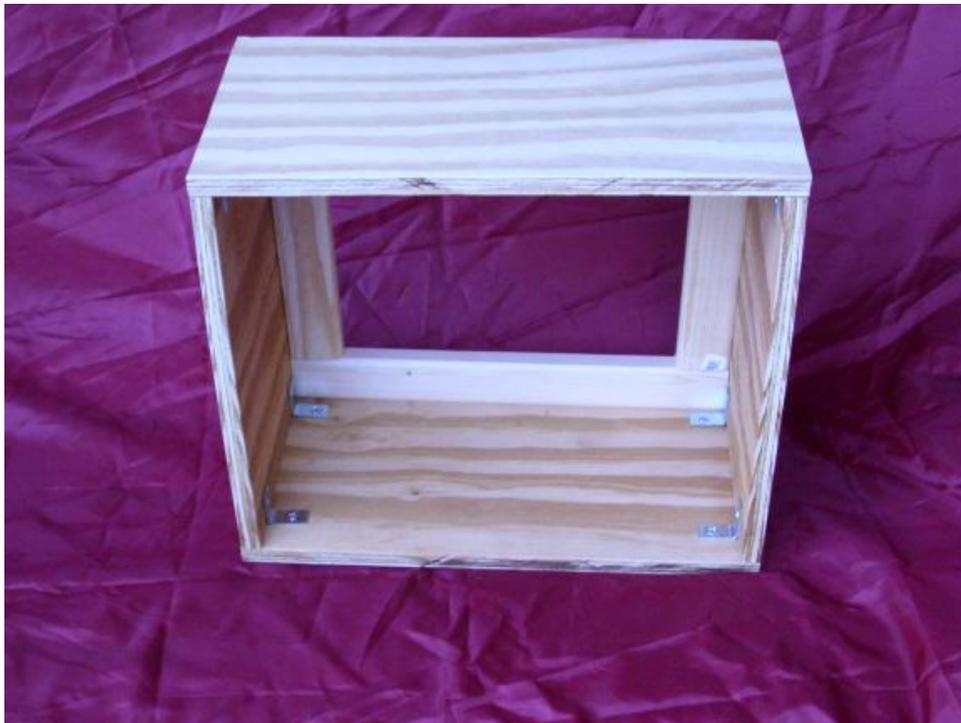
Basic Speaker, viewed from back

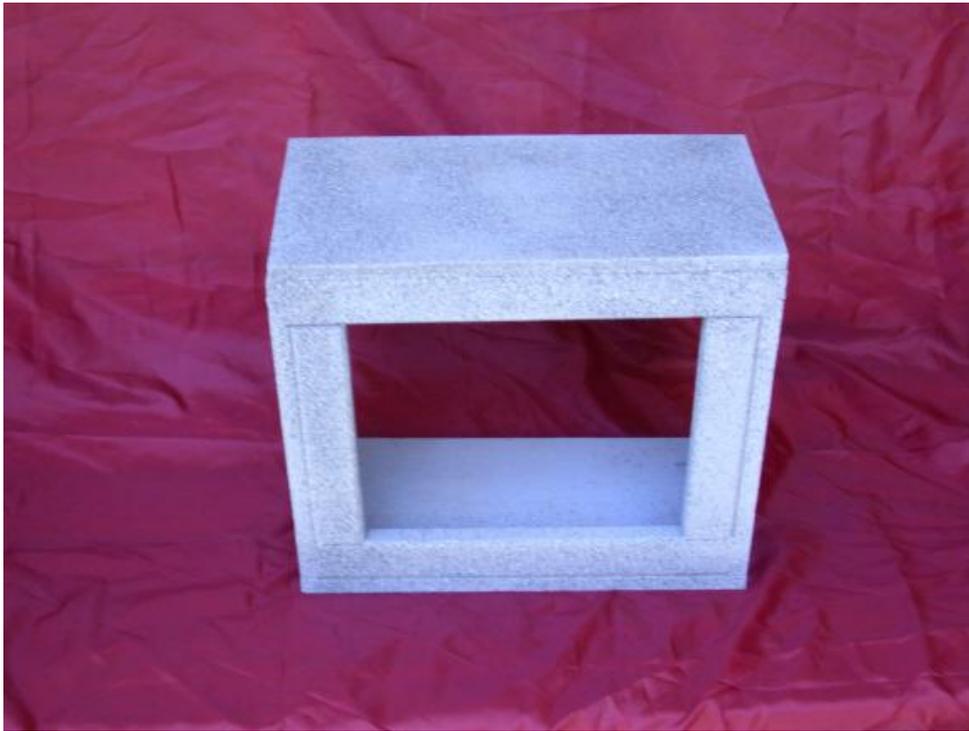
Speaker after prime and "crackle" applied

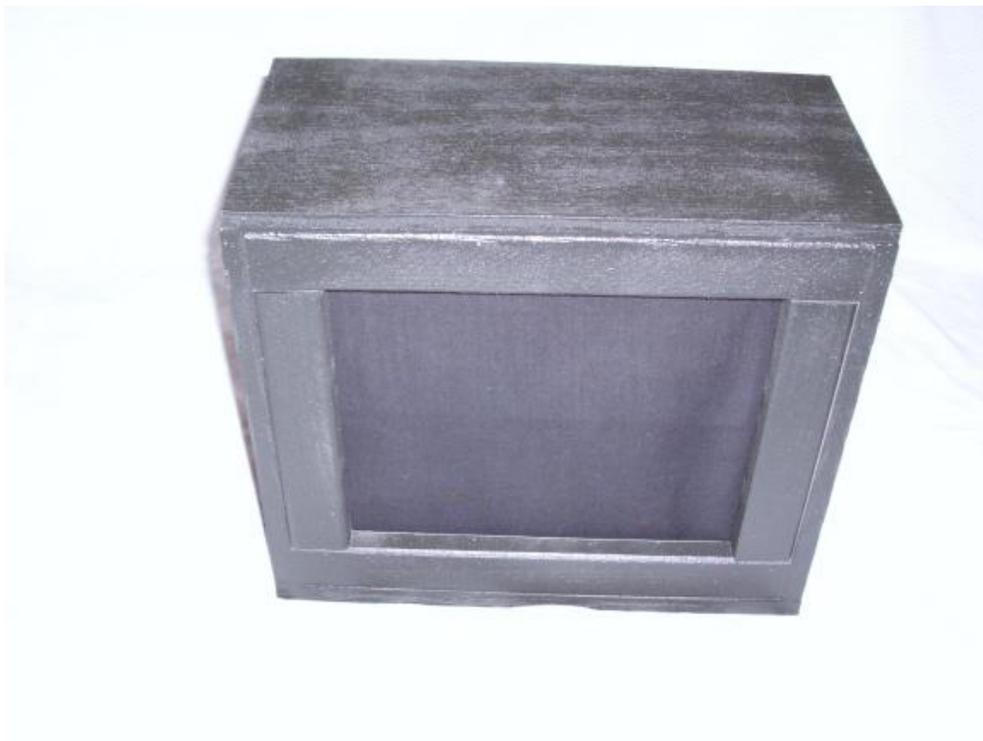
Speaker after painting and grill cloth installed

After completion, both the cabinet and the speaker cabinet were painted with St. James gray paint. Black cloth was put across the front opening of the speaker cabinet.

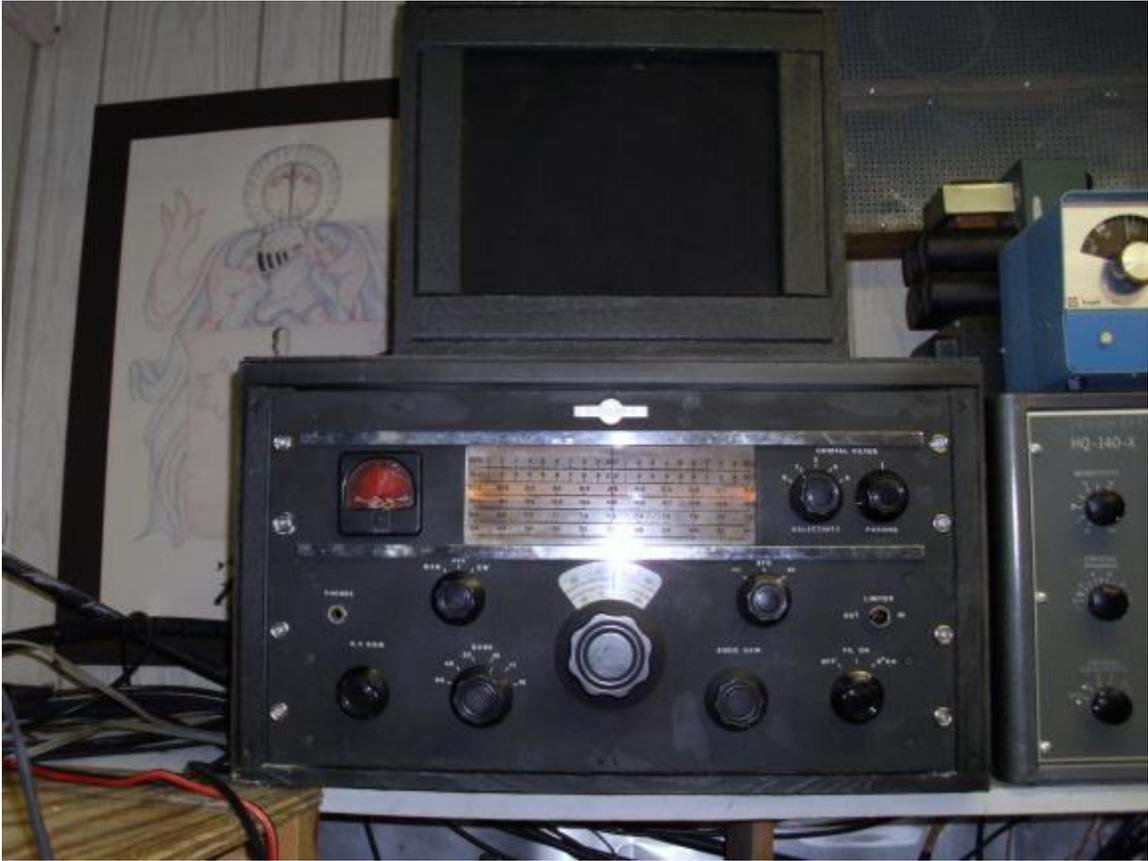
75A-1 and speaker on main console at K9STH

The completed project doesn’t look bad. Of course, the cabinet and speaker are not “Collins”. However, considering the alternative (no cabinet), this alternative works out very well.
