Heathkit AR-3 Restoration

Glen E. Zook, K9STH

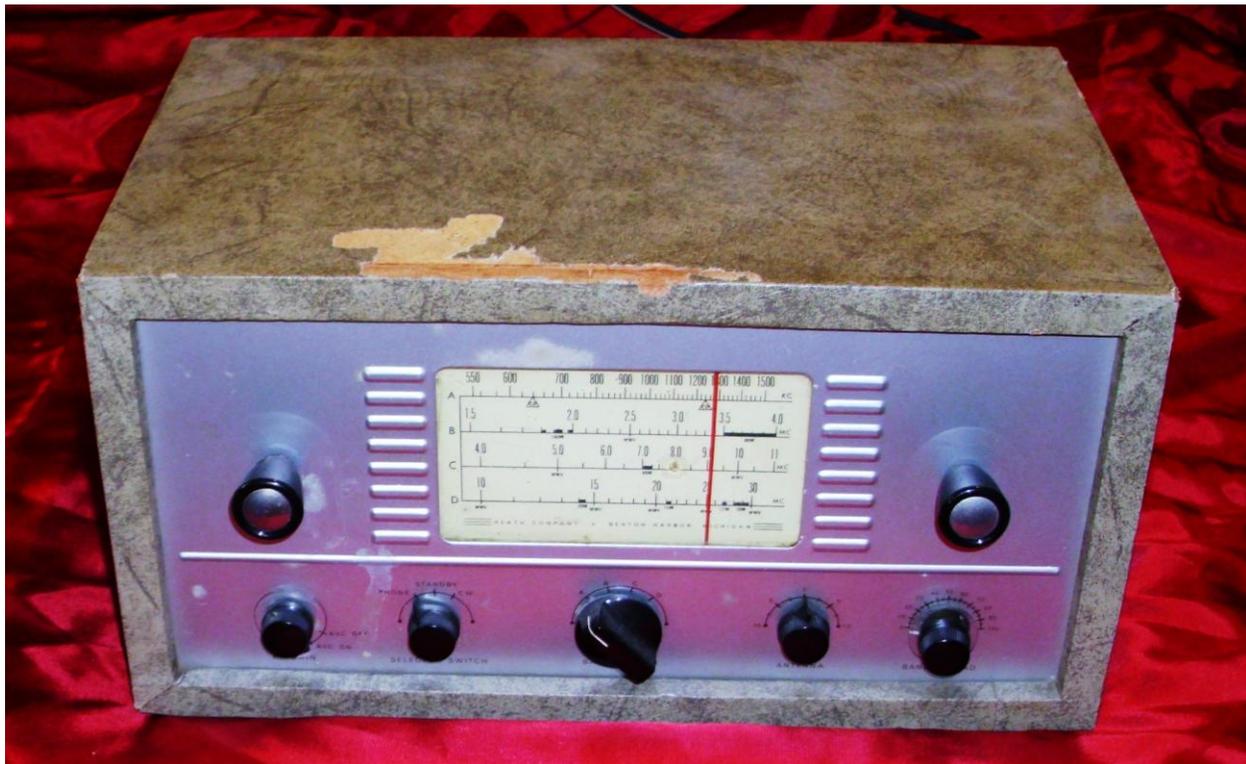
Receiver Before Restoration

As can be seen from the photograph, the receiver cabinet was badly in need of recovering and the front panel showed a number of stains and slight corrosion. After removing the receiver from the cabinet, all the old fabric was removed from the cabinet.

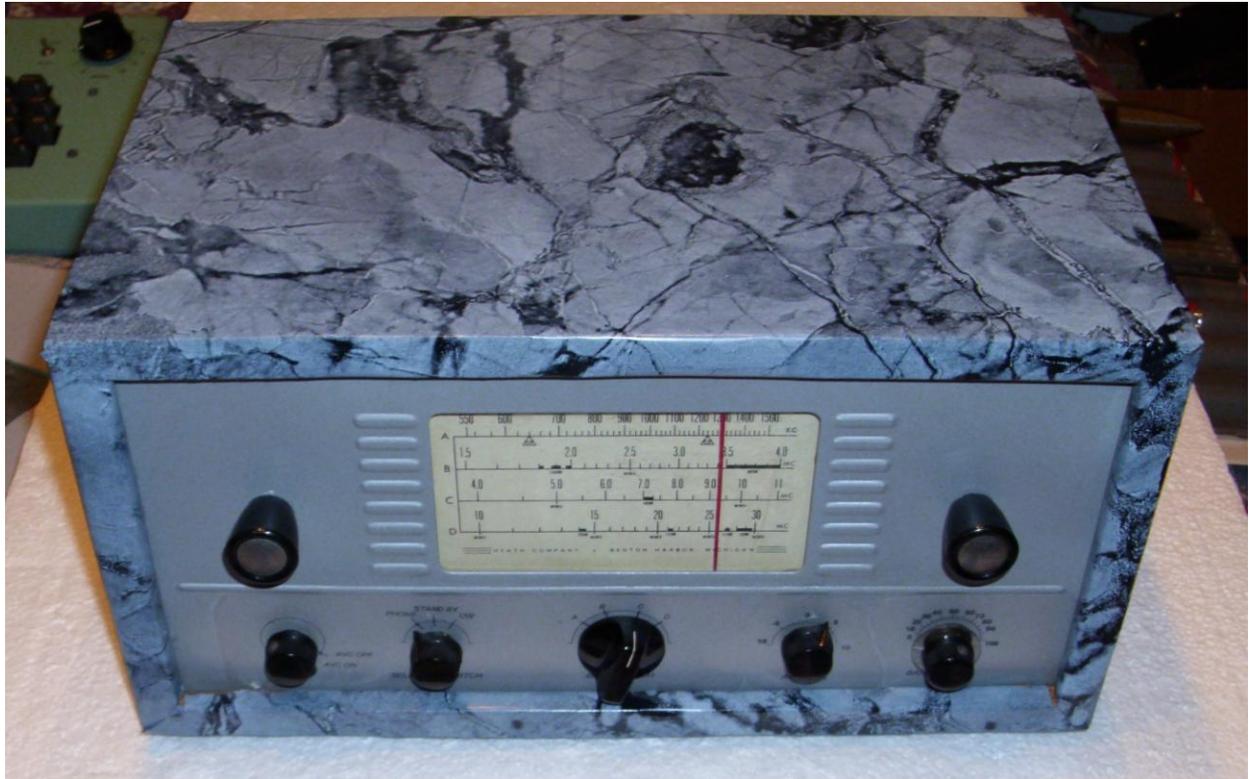
The Restored Heathkit AR-3

The front panel required complete repainting. Of course, this eliminated the lettering on the panel which, in turn, required creation of new artwork. Fortunately, I do have a couple of programs, on my computers, to generate reasonable reproductions of the layout of the panel. Using "cut and paste" methods, I was able to create a "master" which was then scanned. After scanning, various imperfections in the artwork were eliminated and, finally, a decal was printed to be applied to the panel.

In addition, the clear plastic covering the opening, in the panel, for the dial, was badly yellowed. This was removed and a new cover was made using the plastic from a "blister pack". The new cover was secured to the back of the panel using packing tape.

Originally, the AR-3 used small rubber coated "tacks" for the feet. These were destroyed when removing the original covering from the cabinet. Instead of trying to find new "tacks", I decided to use "real" low profile gray colored rubber feet. The chassis is secured in the cabinet by 4-machine screws through the cabinet into the bottom the receiver. By using slightly longer machine screws, the new rubber feet were installed.

After installing the chassis, the knobs were replaced and the receiver "checked out". It works fine and the receiver definitely does not "look bad"!
