## Restoration of BC-312M

*In late June, 2012, a derelict military receiver, model BC-312M, was acquired at K9STH. The condition of the receiver was such that even thinking of returning it to its original state was not possible. As such, it was decided to first get the receiver in operation and then to get the receiver into a respectable physical condition even though that condition was far removed from the original design of the receiver.*

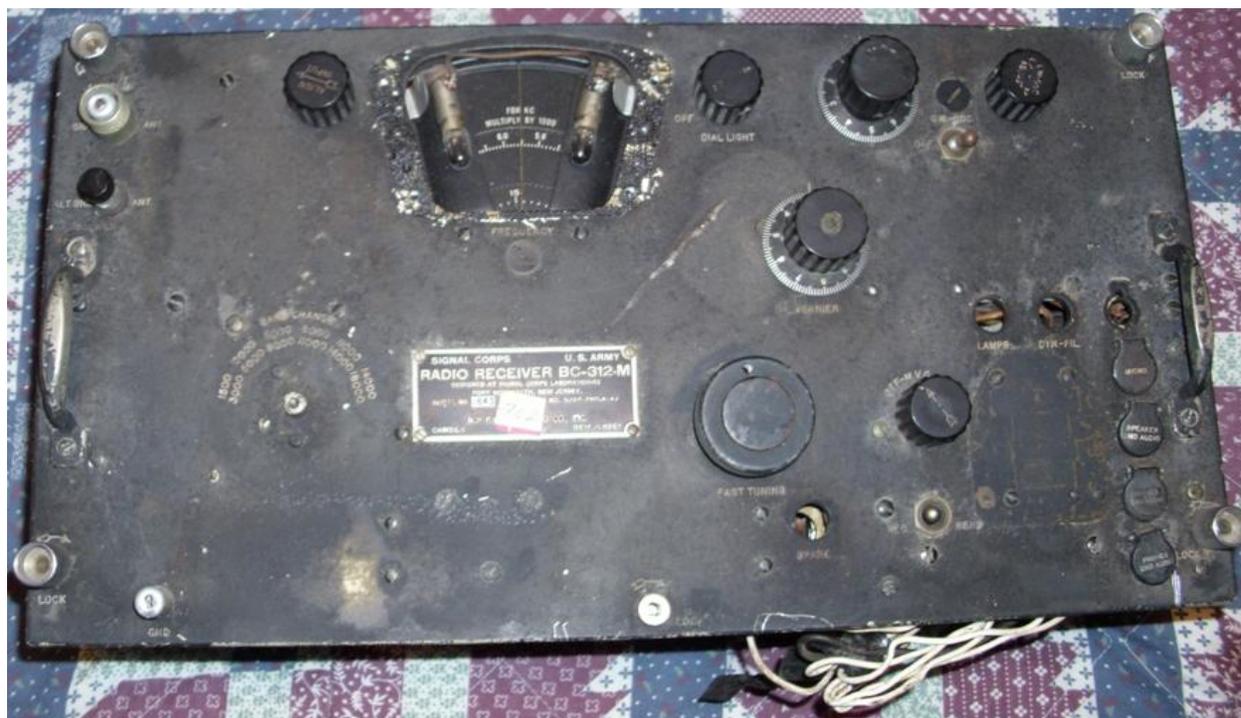
Front panel of BC-312M when acquired

When acquired, the BC-312M was missing the band switch knob, the escutcheon around the frequency dial, and quite a number of other parts including the accessory connection assembly. The decision was made to make an "overlay" for the front panel and to replace all of the knobs.

Since the "overlay" is primarily cosmetic, aluminum "flashing", available from just about any home improvement center, was used. This relatively thin aluminum is easier to drill and cut as well as being considerably lower in cost than aluminum sheets. The "overlay" was cut from the flashing, holes were drilled for the various controls and mounting screws, and then attached to the existing front panel. A new escutcheon was made for the frequency dial. This was made in 2-pieces because it is much easier to get a good looking cutout for the dial rather than trying to use a single piece of aluminum.

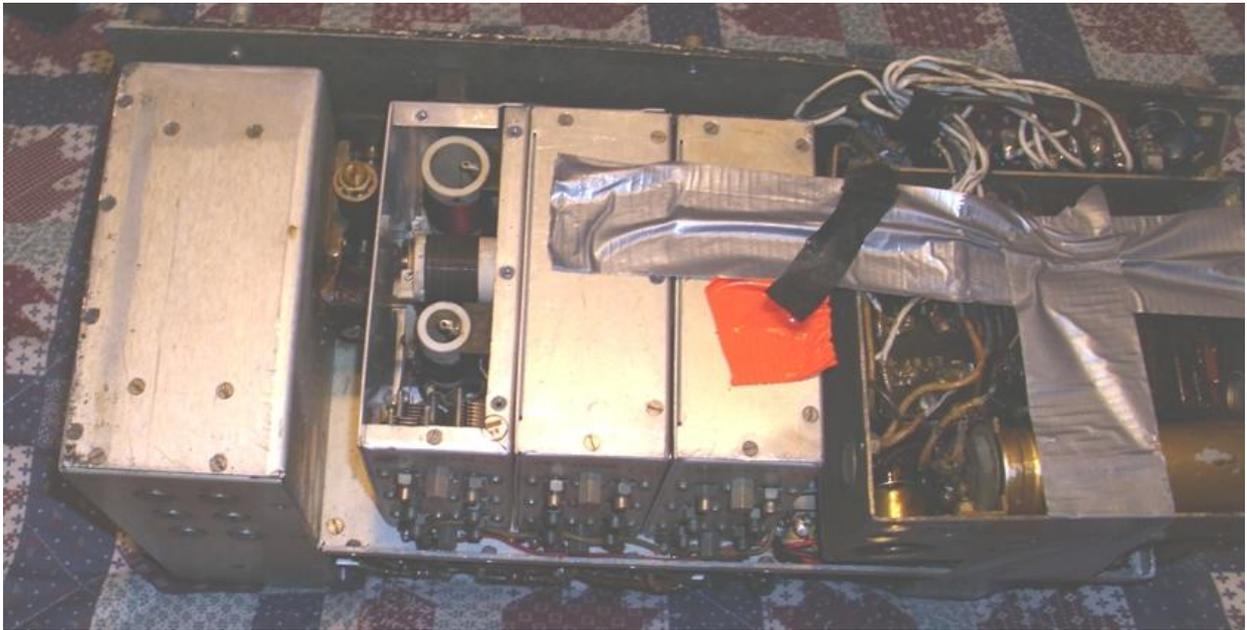
*Underside of receiver as acquired*

*After trying to get the receiver at least partially operating, it was decided to basically rewire the receiver, except for the high frequency oscillator circuitry, and to replace all resistors and capacitors in the radio frequency, intermediate frequency, and audio circuits. Also, several parts in the BFO assembly were replaced. New resistors and capacitors were obtained from Mouser at a cost of just over \$20.00. Other parts were already "in stock" which helped keep down the cost of the restoration.*

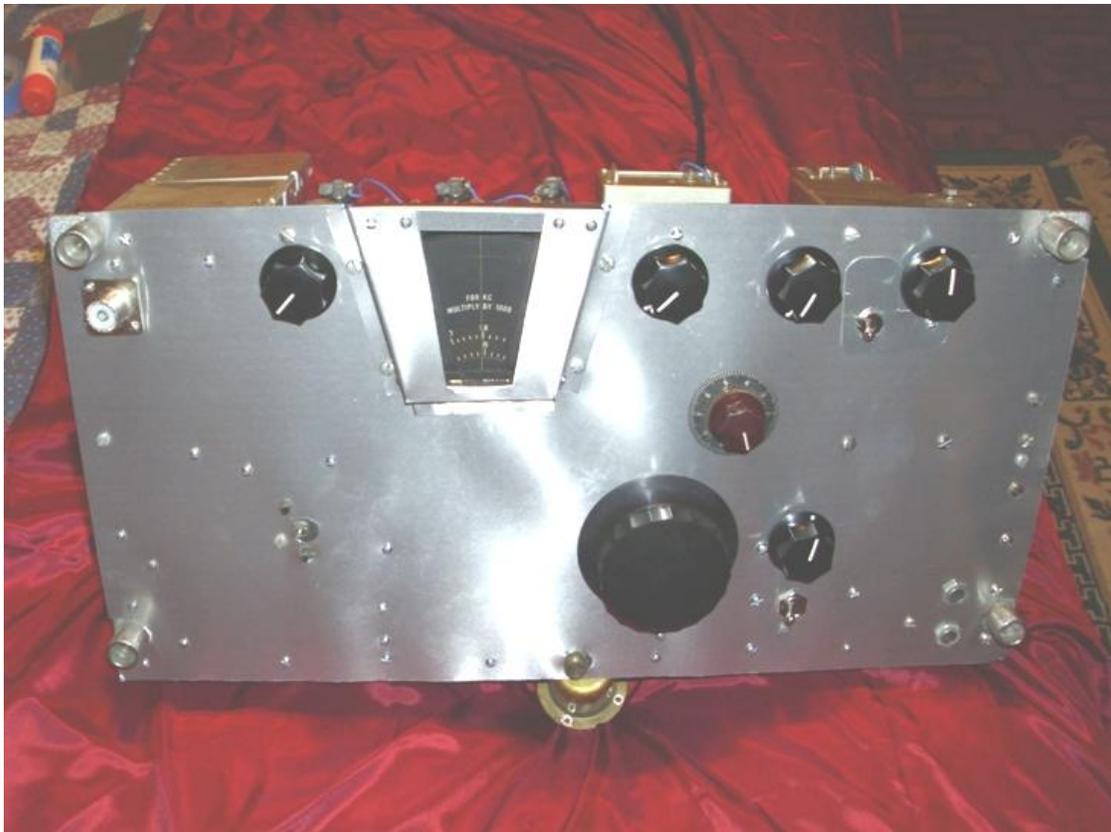
*First try with "modern" knobs*

Originally, the intention was to use "modern" knobs for the controls. However, after trying some, it was decided that "Daka-Ware" knobs, which were very common in the 1940s and well into the 1950s, "looked" much better on the receiver. In addition, the original aluminum surface was just too reflective and it was decided to paint the "overlay" with a blue-gray paint. Also, the original control labels were cut from paper and applied to the "overlay". Frankly, this was not very attractive! Therefore, decal material, which can be used with ink jet printers, was obtained from a company called Micro Mark. After printing, the decals were applied to the "overlay".

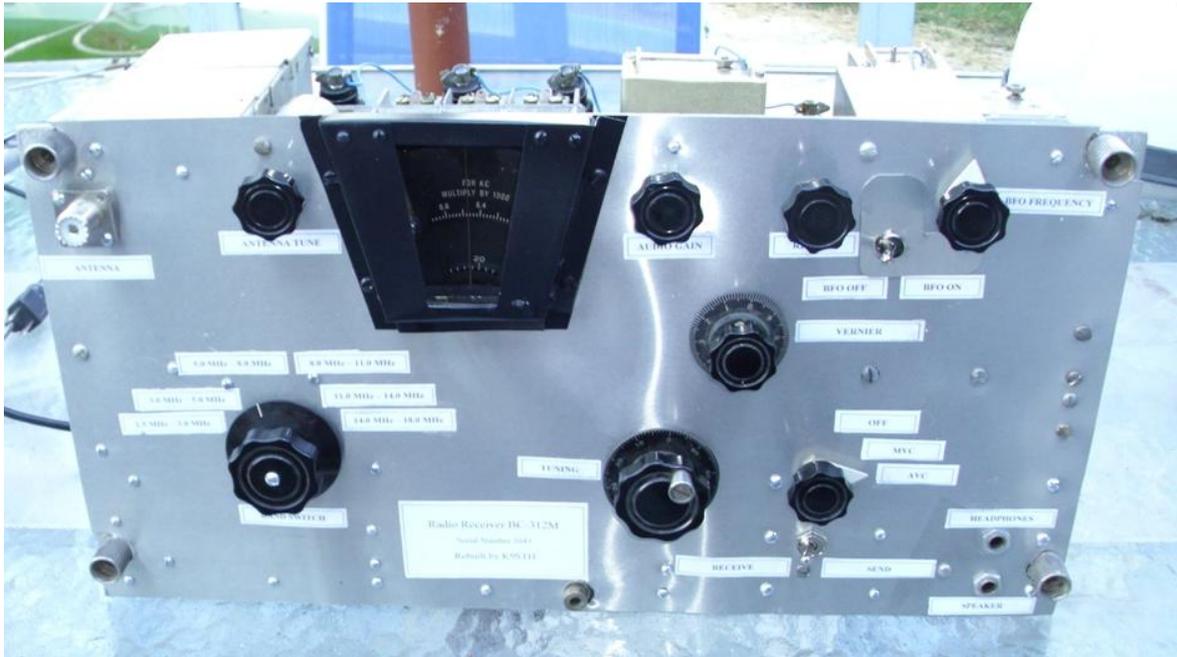
*Receiver with "Daka-Ware" knobs and paper labels*

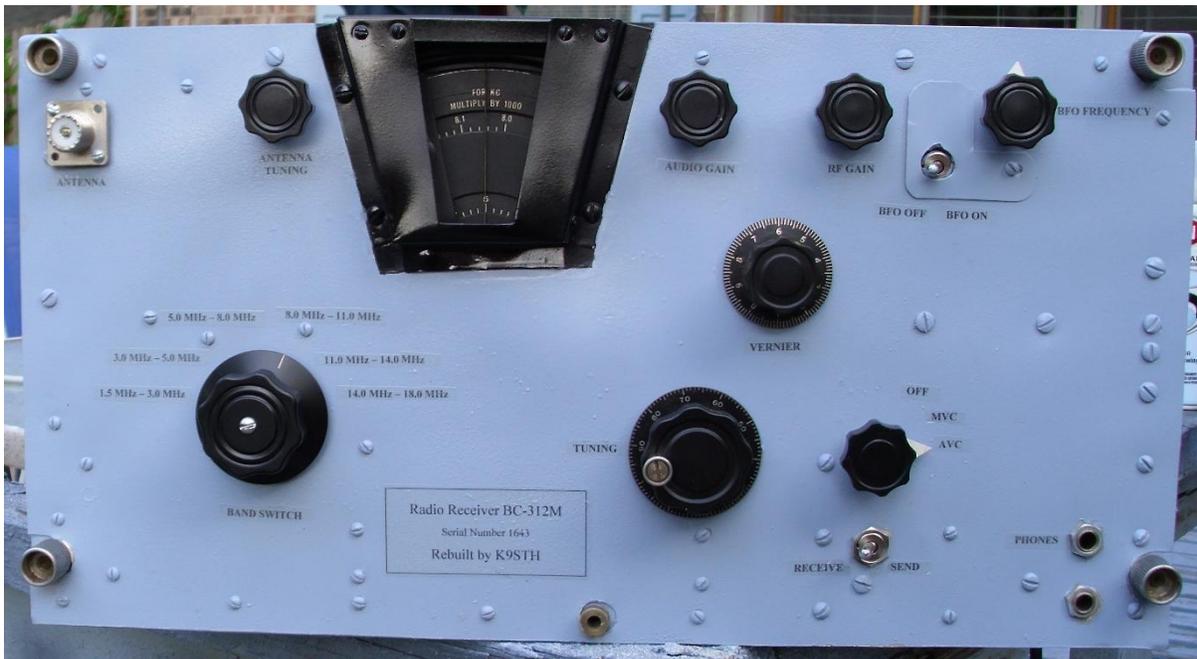
*Final receiver*

The end result is a well working receiver which also is fairly attractive!
