Repairing Frozen Ceramic Trimmers In Collins S-Line / KWM-2

Glen E. Zook, K9STH

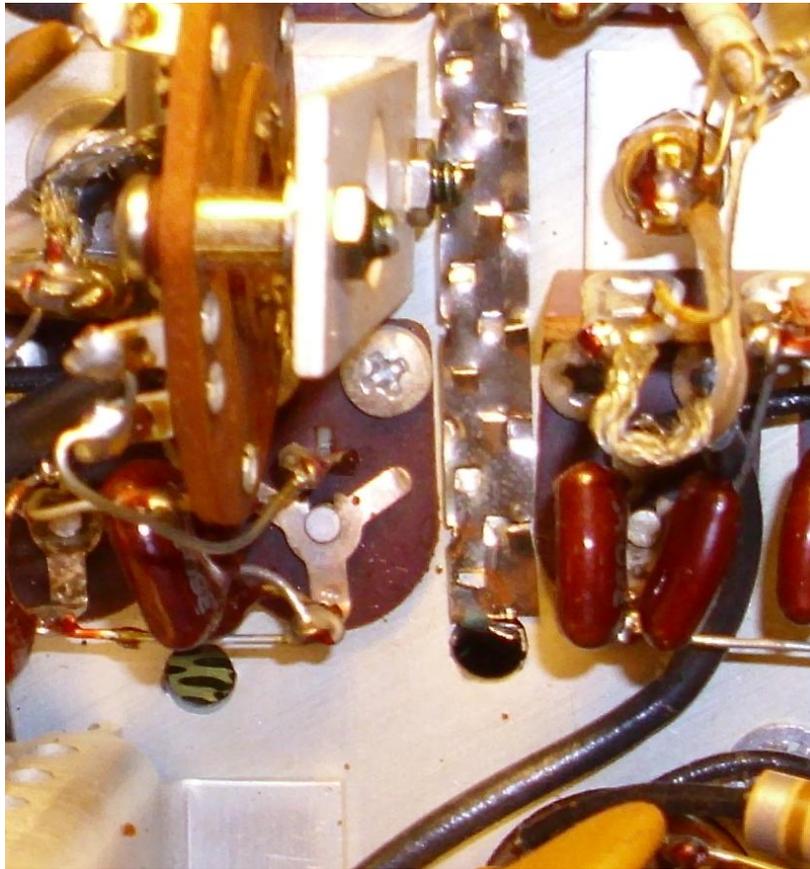
This is the "clip" that needs to be loosened

The rotating portion of the ceramic trimmers is secured on the underside by a "clip" to which various components are attached. It is NOT necessary to unsolder any components. This "clip" can be slid from the center post of the trimmer using a pair of needle nosed pliers. Just slide this clip only far enough that the center post comes free. Push the center post through the hole in the fiber portion of the capacitor that is secured to the chassis with two screws.

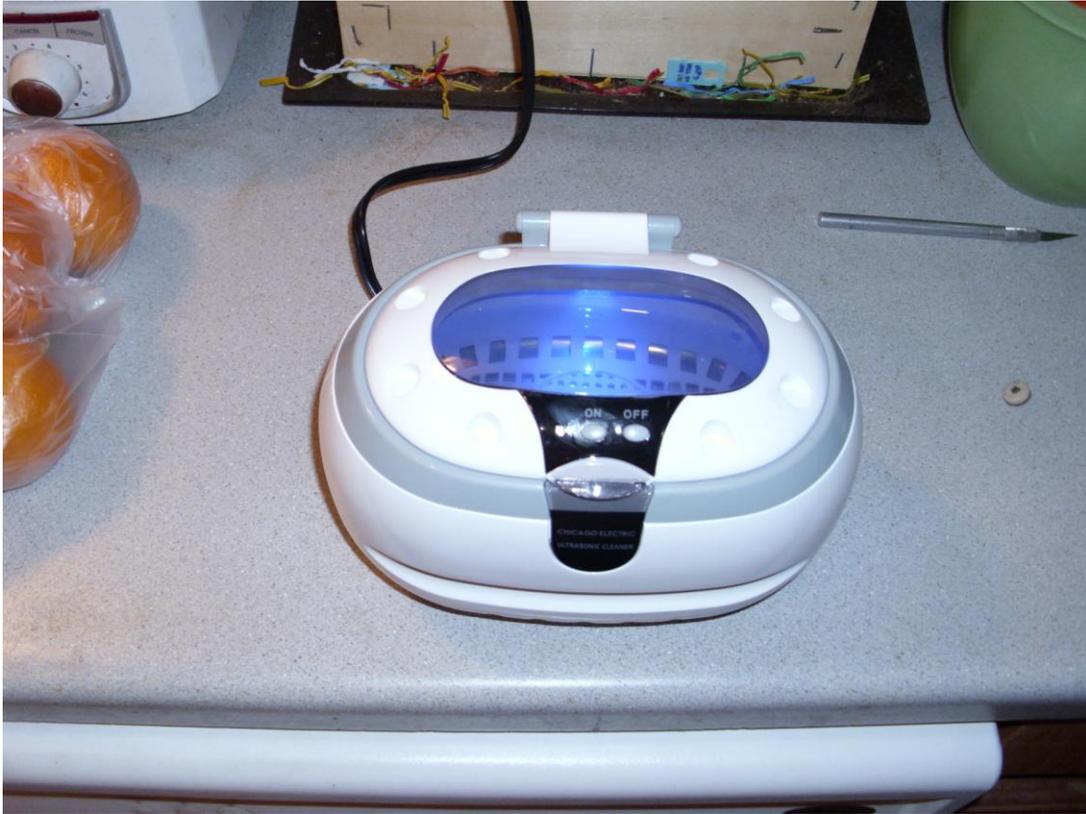
The ultrasonic cleaner

I was fortunate in that Harbor Freight was having a sale on their small ultrasonic cleaner at basically 25% off. That is, it was on sale for \$29.99 instead of the regular \$39.99. Since there is a Harbor Freight outlet just a few miles from me, I purchased a unit along with a bottle of cleaning agent.

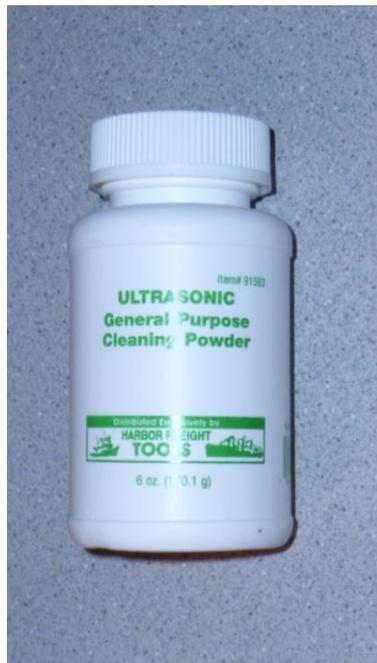
The cleaning agent

This ultrasonic cleaner requires two cups (one pint) of water and one-fourth of a teaspoon of cleaning agent.

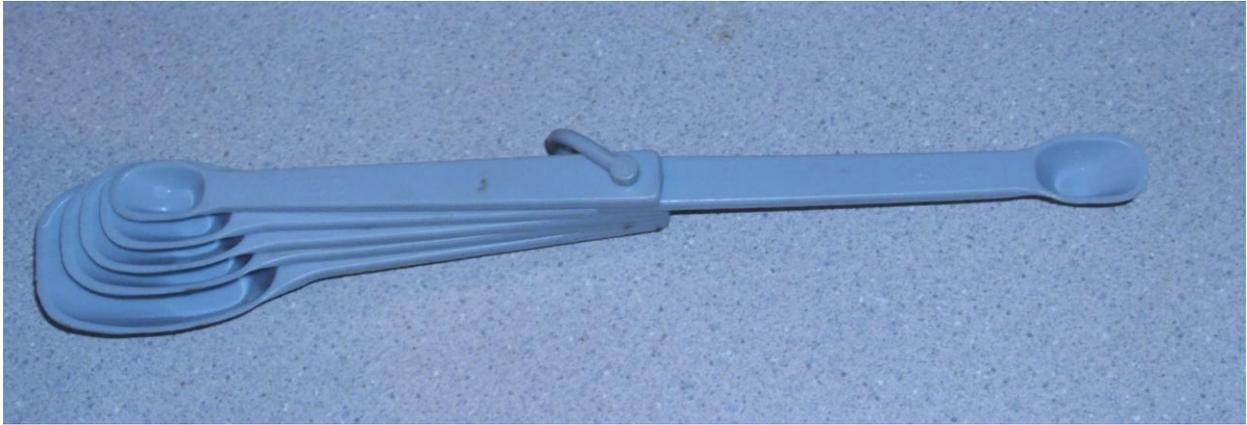
Measuring spoons

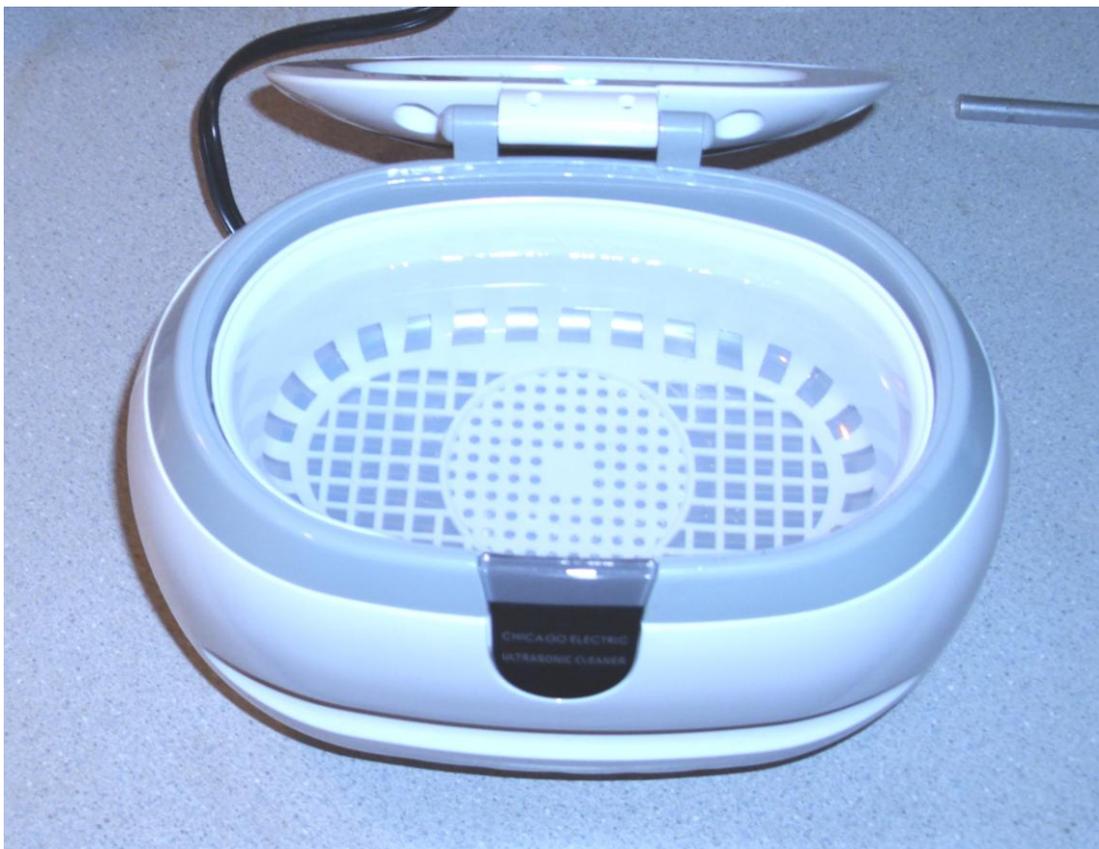
Inside of ultrasonic cleaner

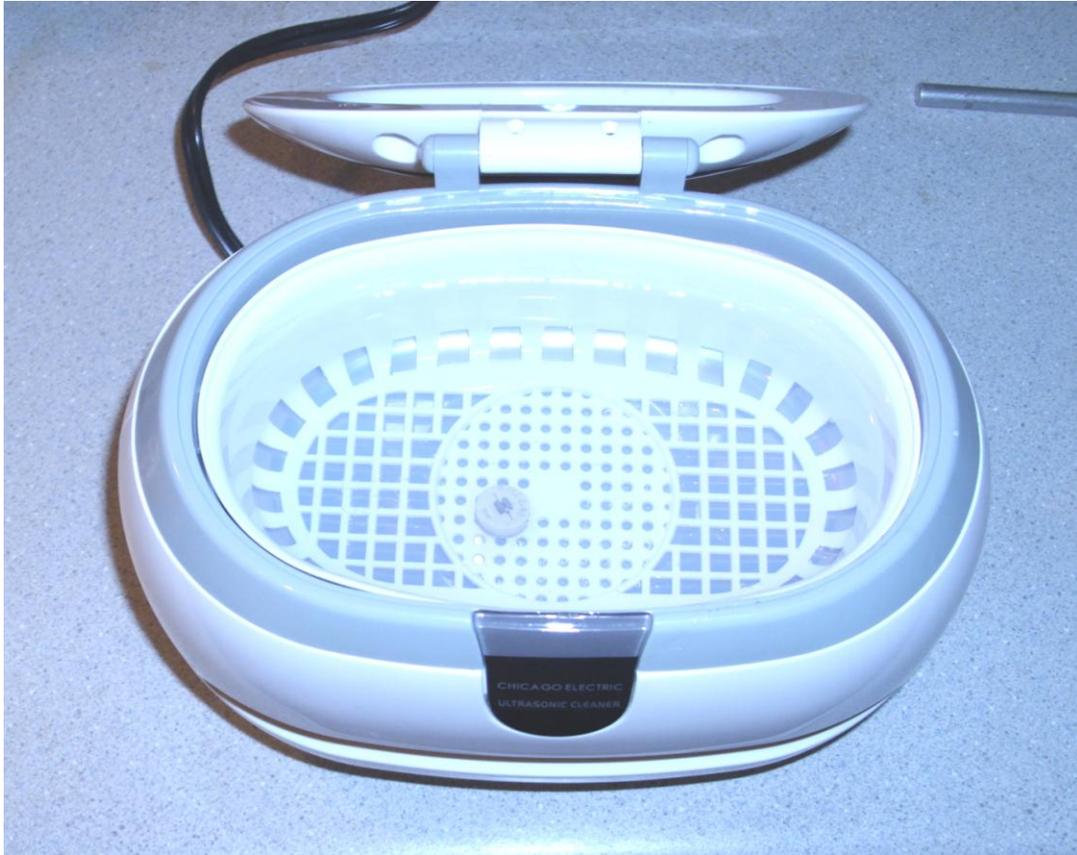
Parts in ultrasonic cleaner

The “frozen” parts of the ceramic trimmer are placed in the ultrasonic cleaner and the cleaner is activated. This particular machine runs for three minutes and then automatically shuts down.

Usually, the parts will separate making restoration of the ceramic trimmer easy. If the parts are not actually separated, use an Xacto knife with a #11 blade (or new single edged razor blade) and barely touch between the rotating portion and the disc. The parts should then separate. If not, run the parts through another cleaning cycle.

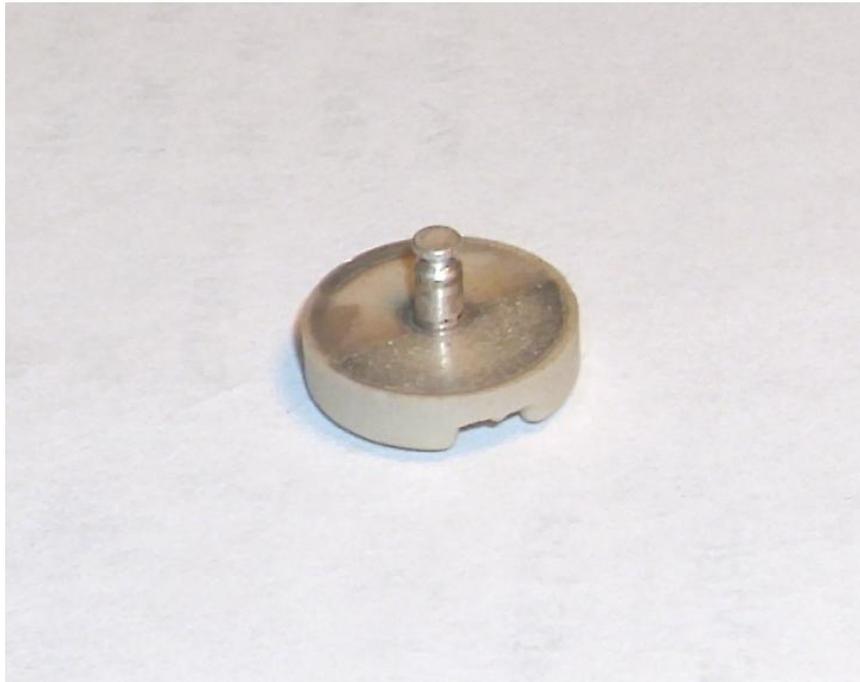
Close up of rotating portion
