# Case Study #1 Creek Crossing

## **Integrated intervention**

## High Performance Landscapes

NSF Design & Implementation  
Case Studies

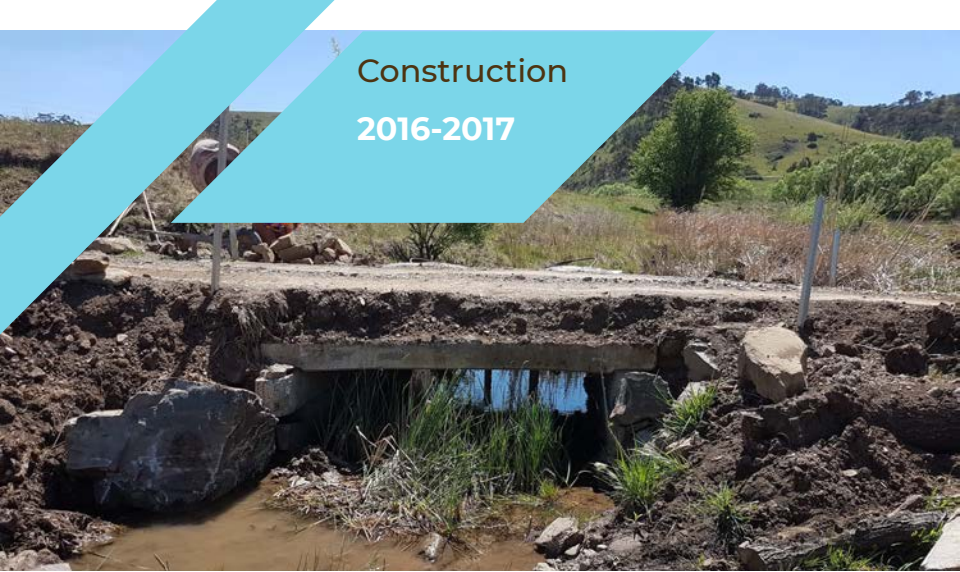
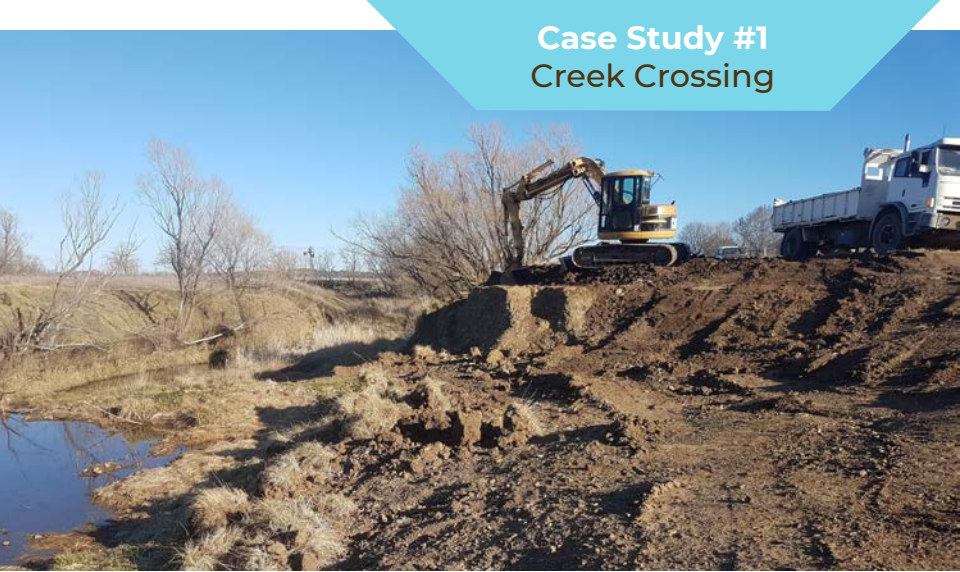
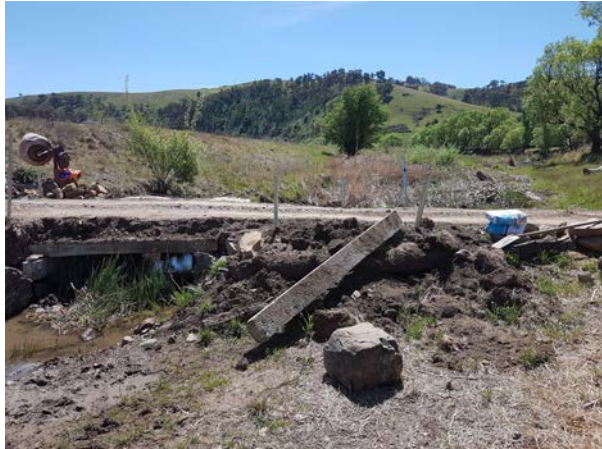
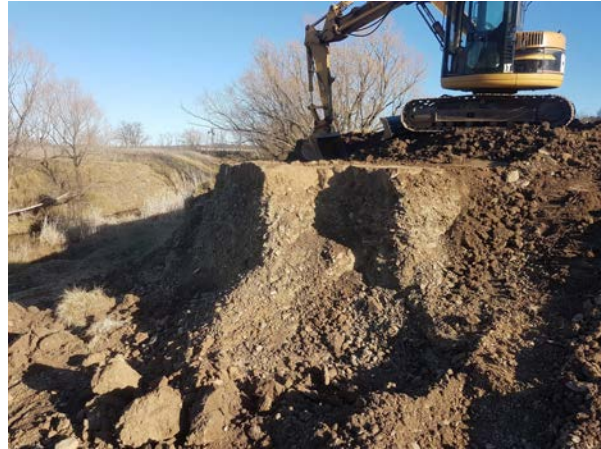
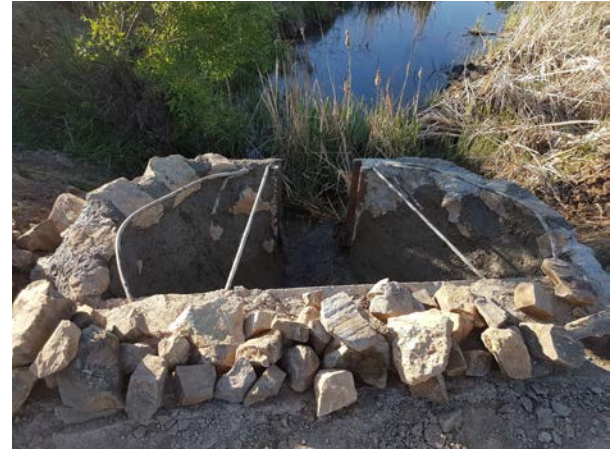
The 800m long stream restoration created a pond sequence with a de-energising bowl and flow control upstream of the crossing, modification of the stream bank and stream flow, reed re-location, and a building a bespoke culvert. The process included battering and terracing the bank to reduce the slope, revegetation of the bank, repurposing of living materials from the bank into the crossing for the culvert approach.

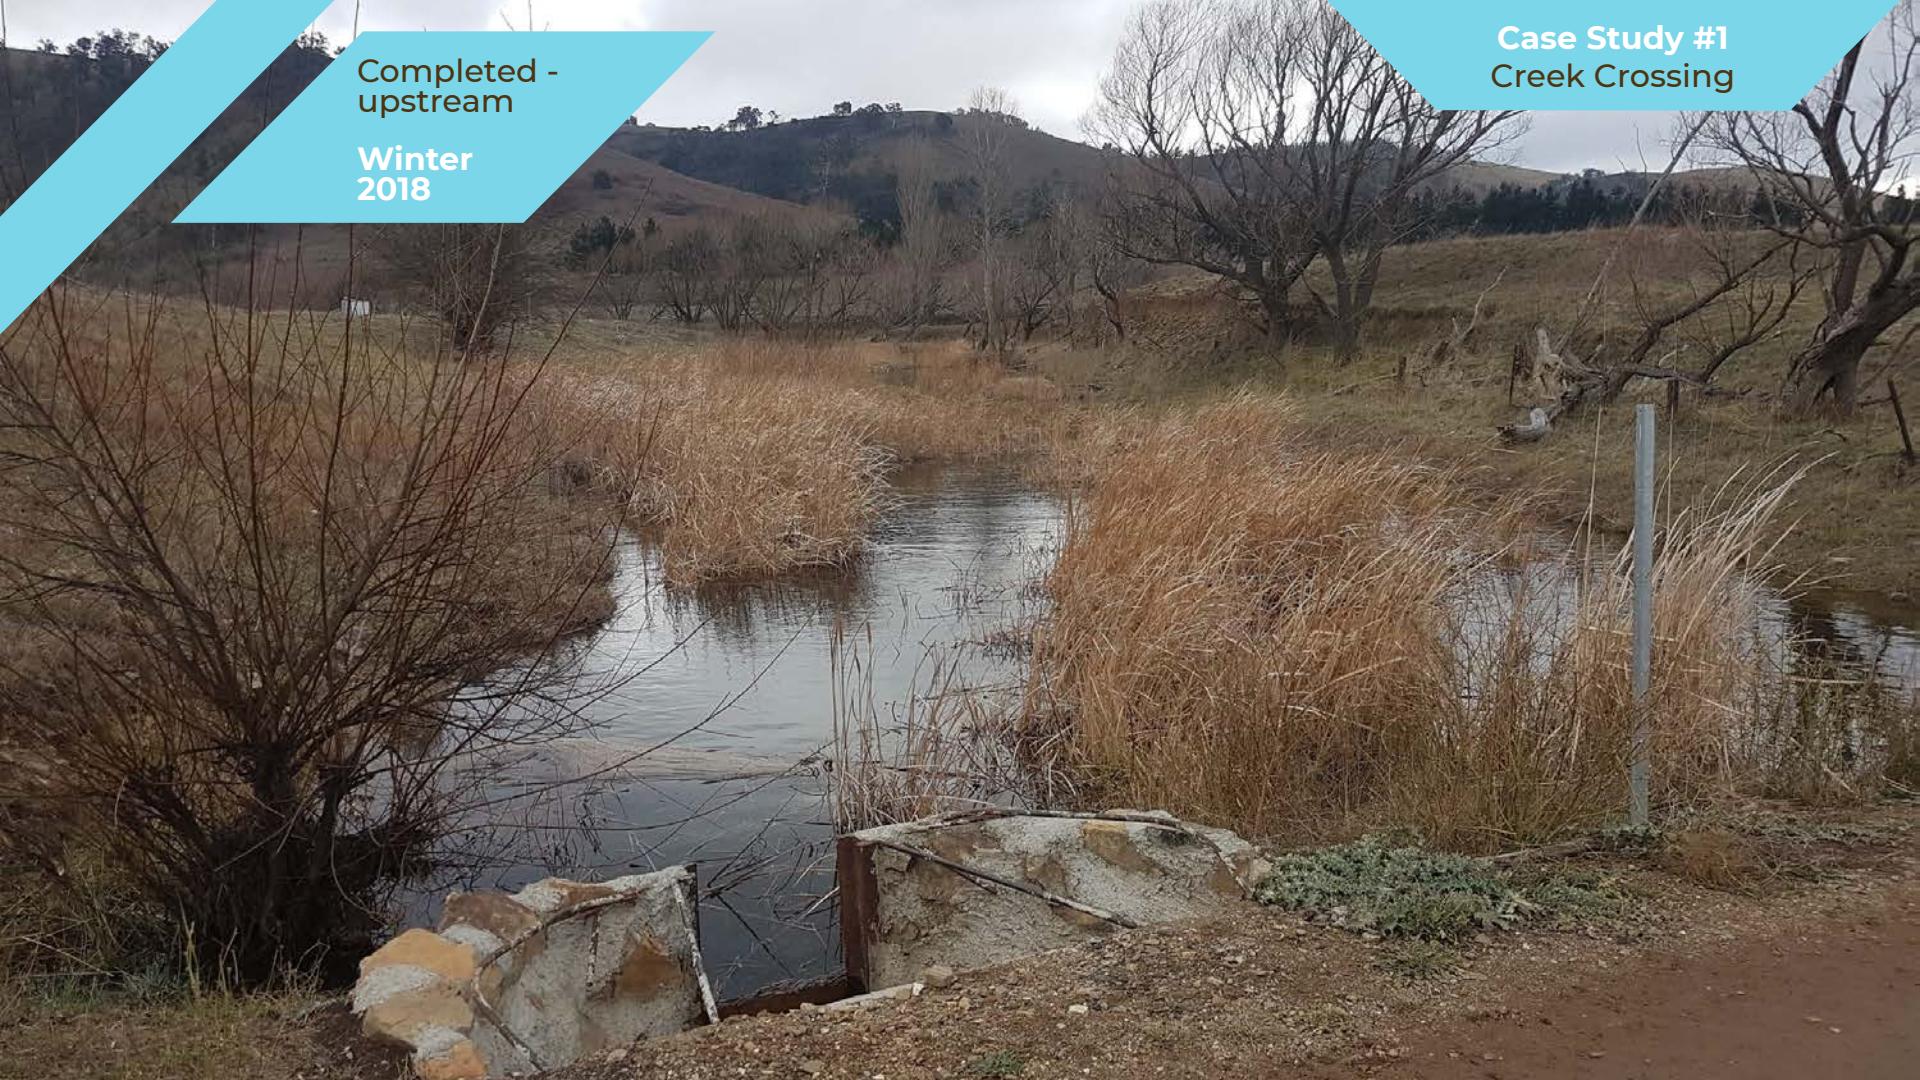
Winter  
2018

Completed -  
upstream

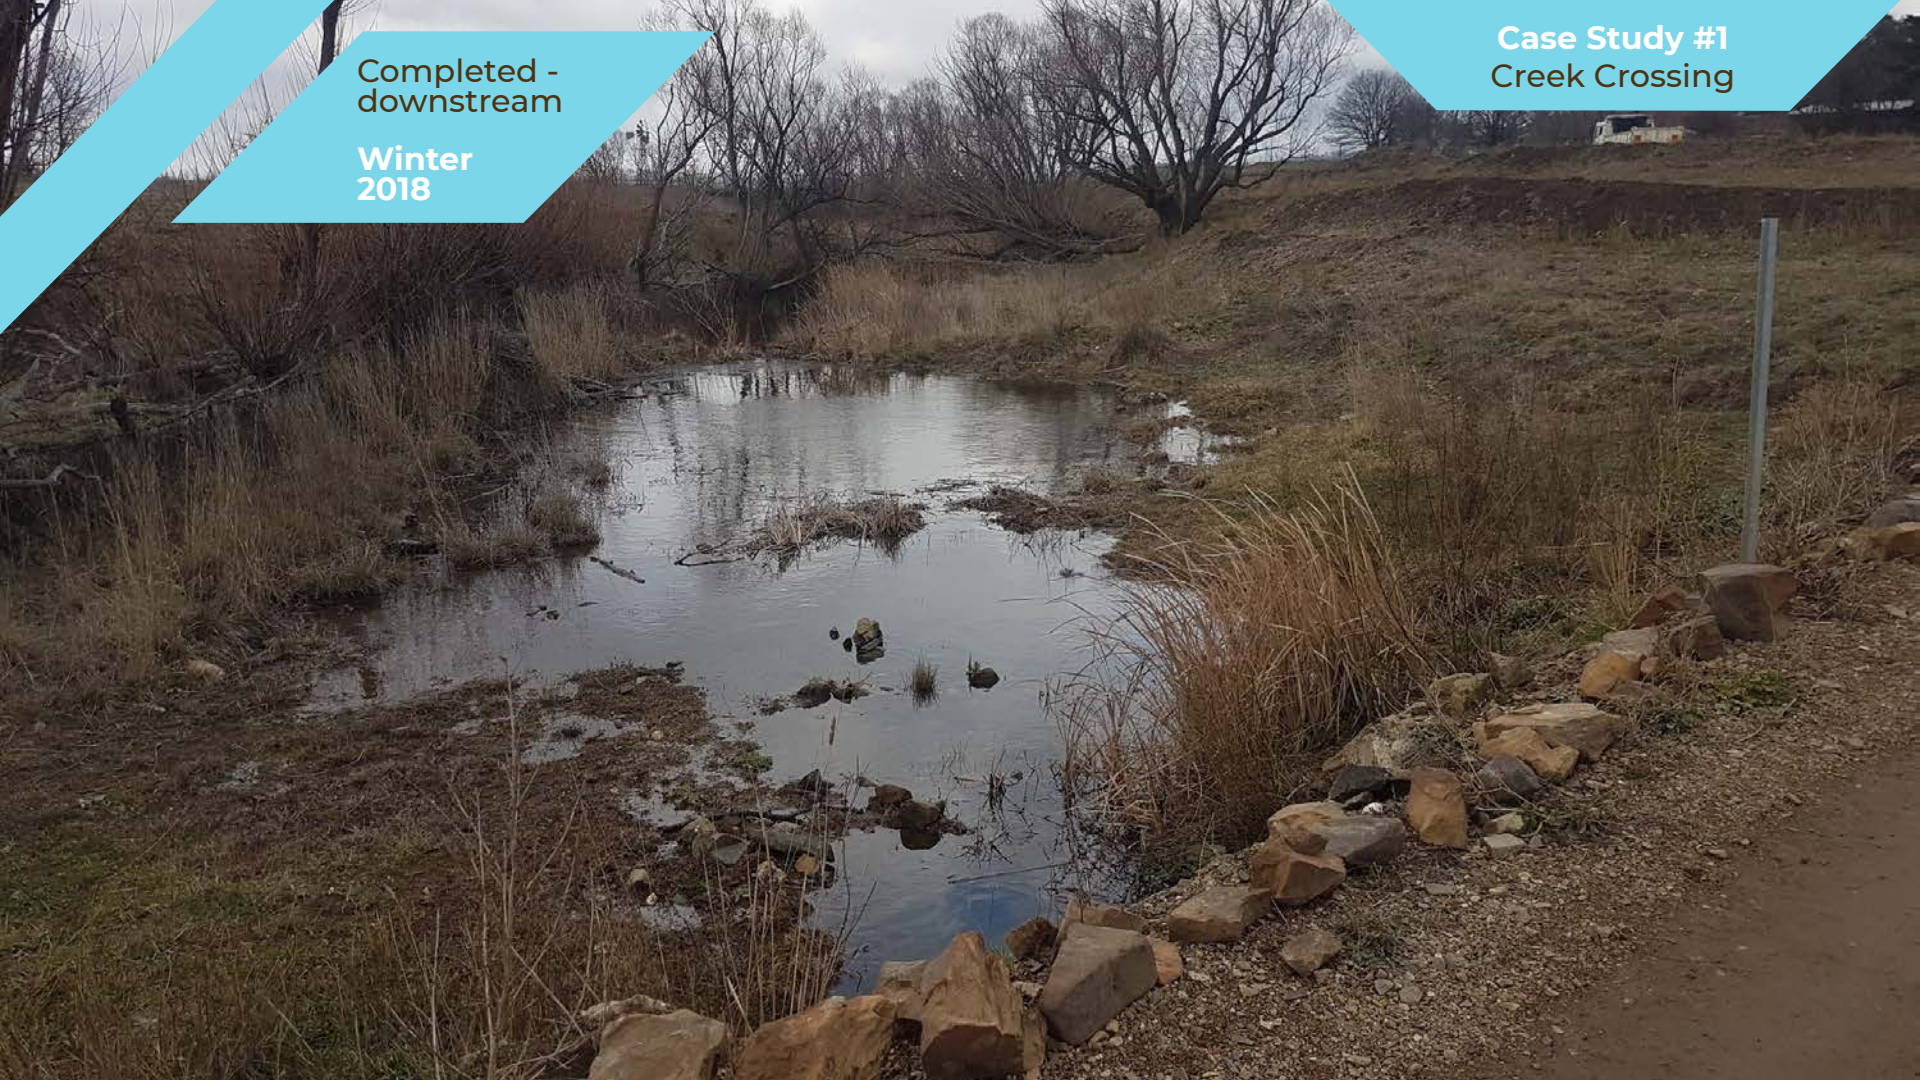
Winter  
2018

Completed -  
downstream

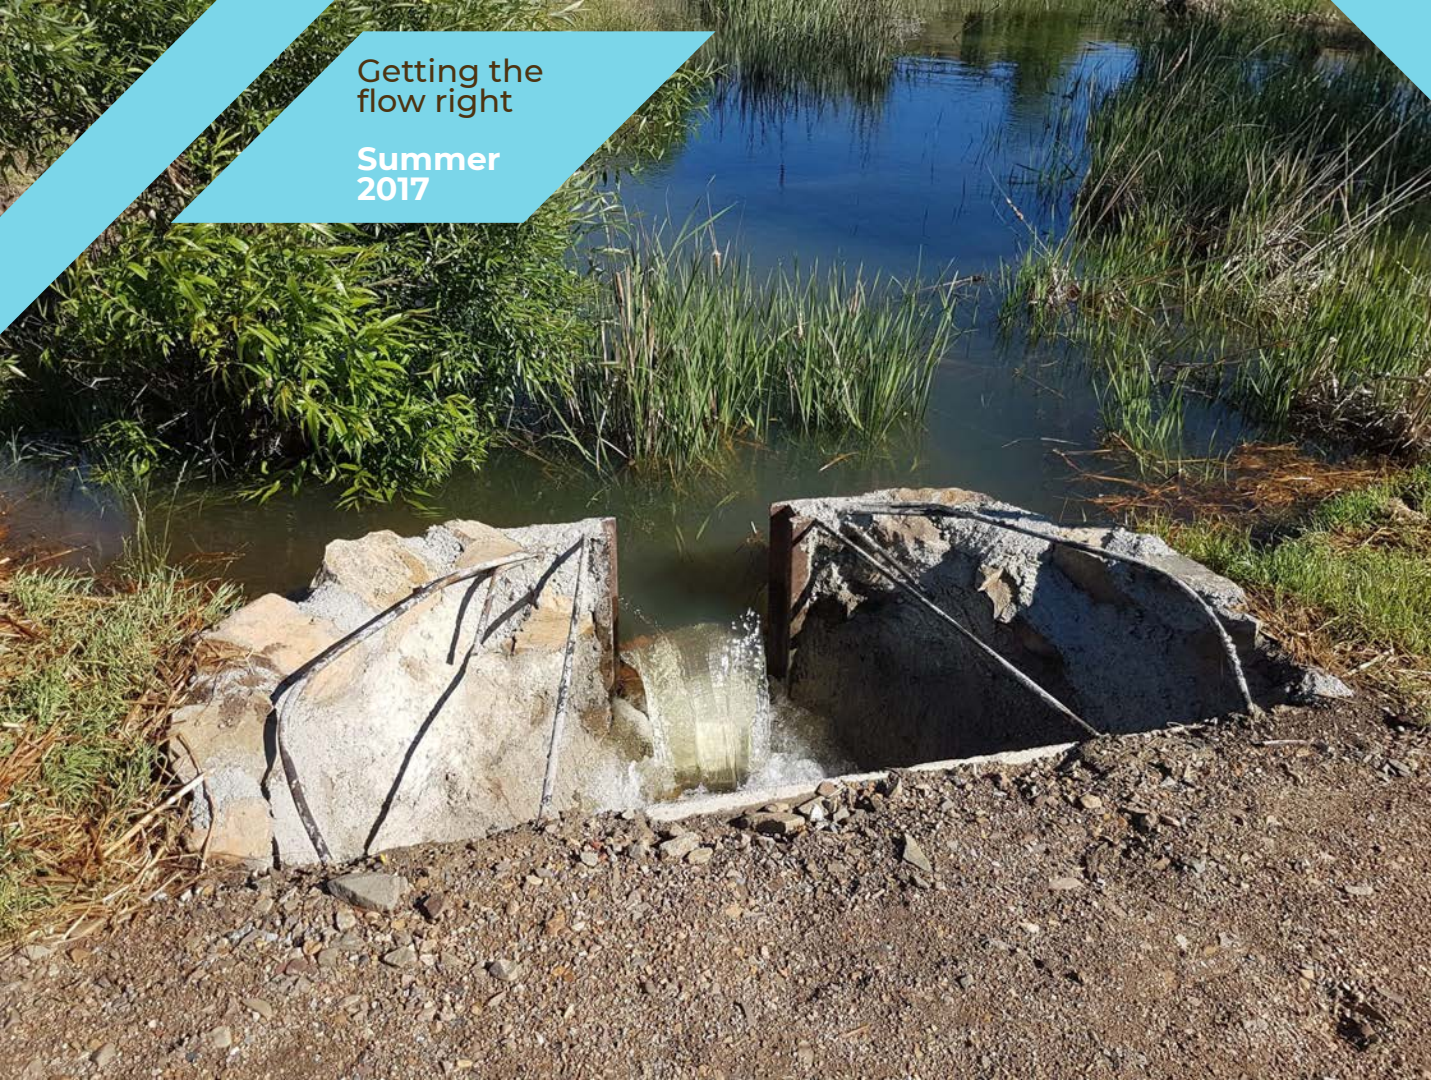
Summer  
2017

Getting the  
flow right

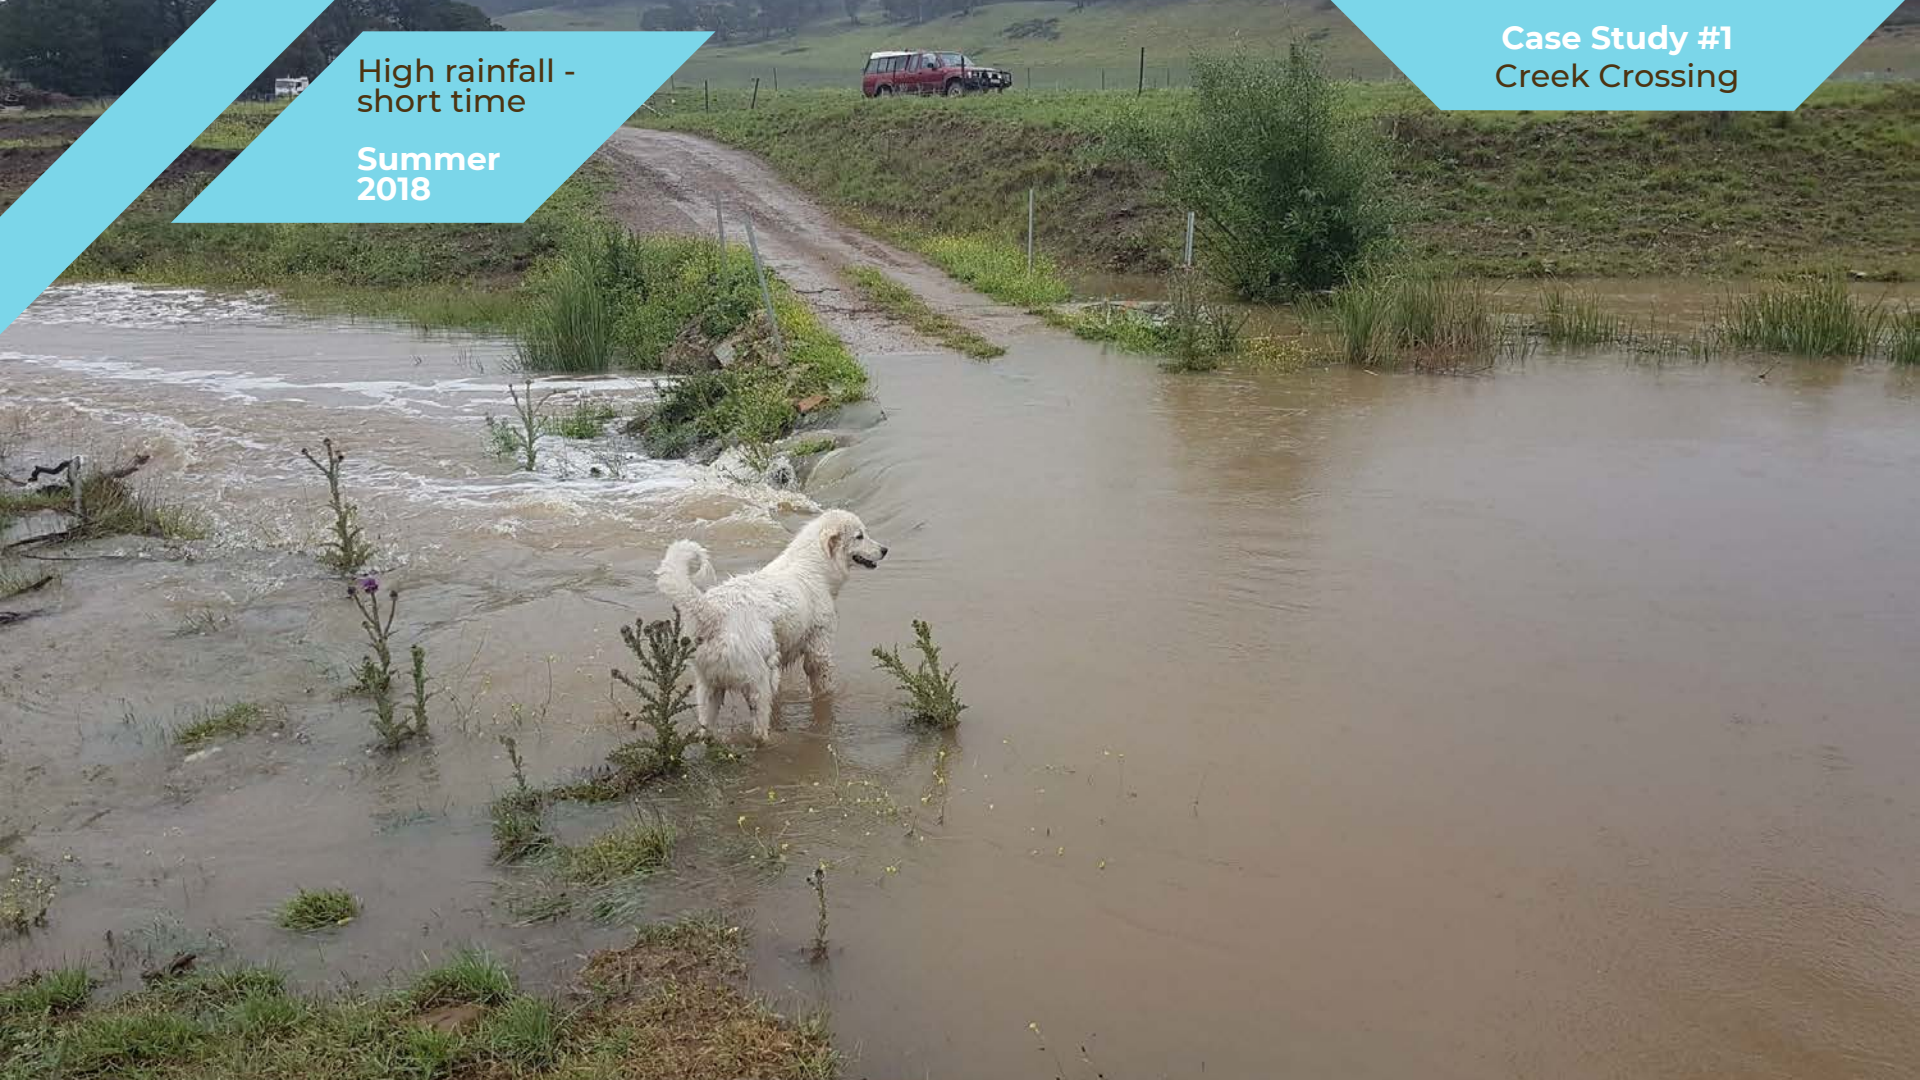
Summer  
2018

High rainfall -  
short time
