## Drews Creek Irrigation Diversion Dam

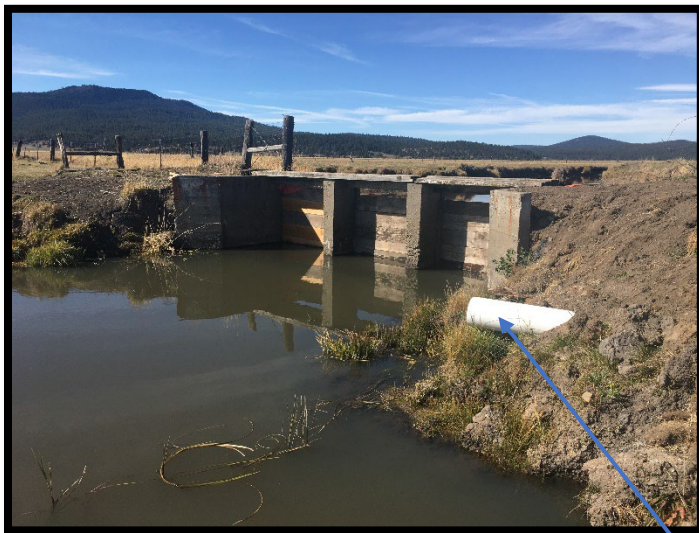
Exhibit 1: October 2019 – Irrigation Diversion looking upstream to the northwest. Boards are in place to divert water to meadow. White tube is a fish return pipe connected to fish screen.

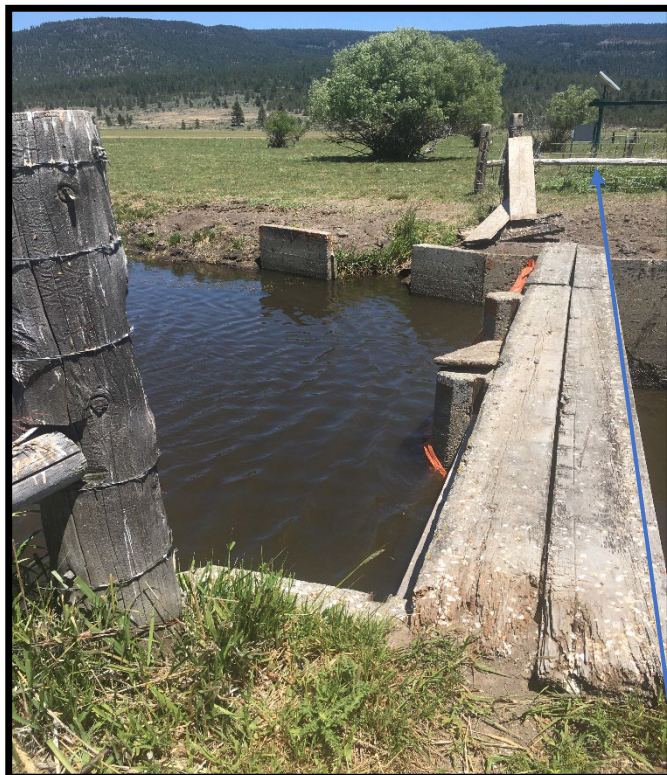
Exhibit 4: June 2020 – Photo showing irrigation water intake and fish screen.

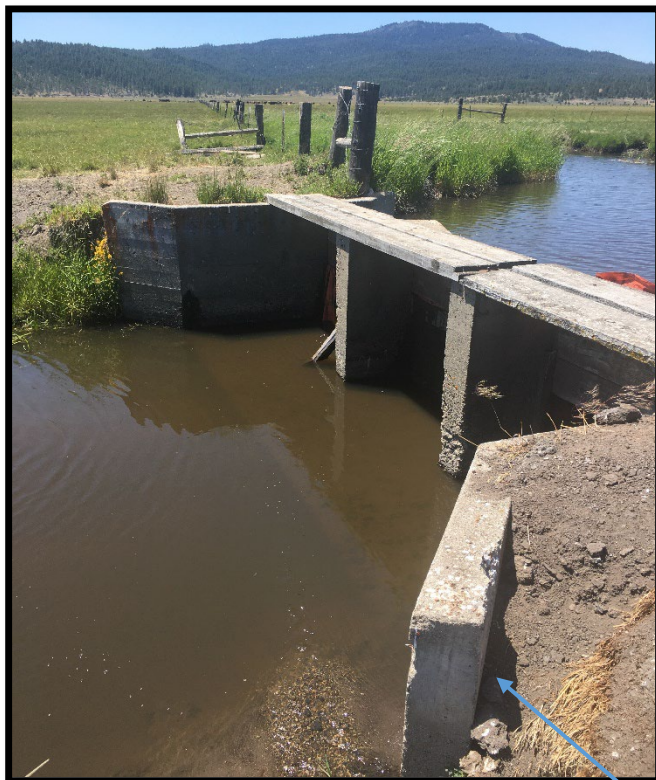
Exhibit 3: June 2020 – Irrigation Diversion looking to the northwest as drop boards are in place diverting water to the east ditch system. Erosion around structure as high spring flows overtop dam.

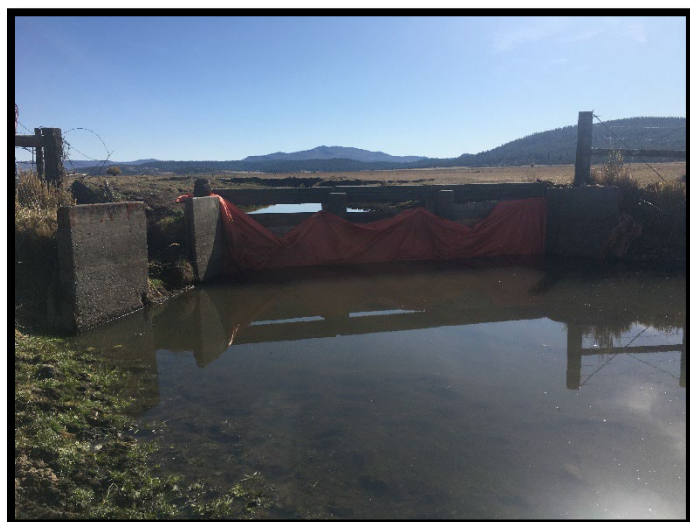
Exhibit 2: October 2019 – Irrigation Diversion looking downstream to the south. Tarp is used to support leaky drop boards. Structure will be replaced with a fish ladder constructed west side of diversion.
