Level I – FULL Reserve Study Report For Fiscal Year Beginning January 1, 2022

Sample HOA

Reserve Study Summary for Sample HOA

Sample HOA consists of 50 single family homes located in Your Town, WA. It was constructed in approximately 2008.

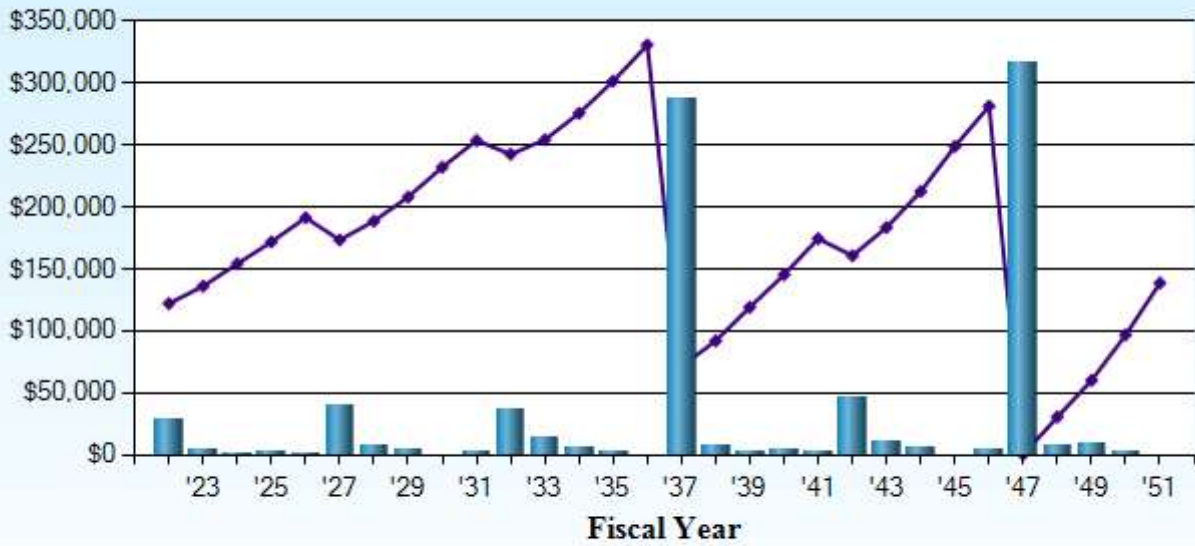
Annual Expenditures Compared to Baseline Funding Model

This chart compares the projected yearly reserve balance within the Baseline Funding model against the cumulative expenses anticipated within that year.

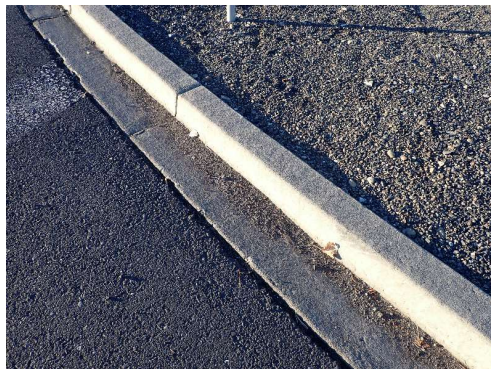
Concrete - Repair - 2023

Concrete appeared generally intact, with no major damage or deterioration observed.

Inspect and repair concrete as needed through annual operating budget. Clean periodically to remove stains and organic debris, and repair any trip hazards (defined as ¼" or more of vertical change at any joint or crack by the 1990 Americans with Disabilities Act) immediately.

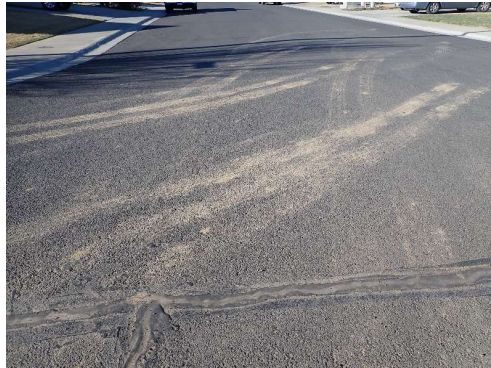
Asphalt - Repair & Sealcoat - 2022

Asphalt seal coat appeared generally deteriorated, with peeling and flaking observed in areas.

Regular cycles of seal coating are recommended to prevent water from penetrating the asphalt surface. We typically recommend that asphalt seal coat is applied at 5 year intervals, however areas of high traffic or water movement (such as on a slope) may require more frequent applications. Failure to regularly apply asphalt seal coat is likely to reduce the overall useful life of asphalt. Repairing asphalt and sealing cracks prior to seal coat application is imperative, and an allowance for repairs is included within the funding in this report. Repair costs can vary significantly based on scope, therefore costs may vary from the allowances included herein. Costs also factor re-stripping asphalt following seal coat application.

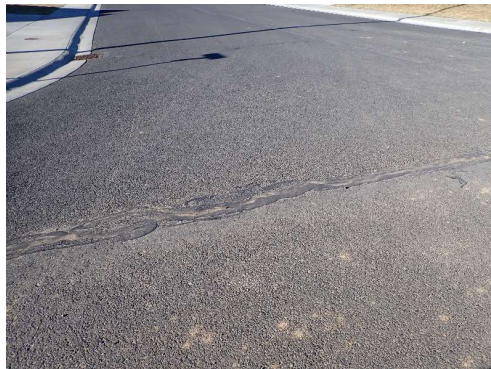
Asphalt - Overlay - 2037

Asphalt appeared generally intact, with local cracks and tree root uplift observed in areas.

The average useful life of asphalt can range significantly based on several factors including, but not limited to, quality of initial installation, traffic levels and type, proximity of tree roots, frequency of proactive repairs and frequency of seal coat or chip seal application. Typically asphalt is initially installed 2-4 inches in depth and resurfacing involves grinding down the top 1-2 inches and overlaying a new layer of asphalt. This is typically performed at 20-40 year intervals depending on the unique site conditions of the property and levels of proactive maintenance. Asphalt resurfacing is often one of the larger expenses experienced by an association, especially if the association is responsible for private roads, therefore proactive maintenance and sealing to prolong the useful life of the asphalt is a best practice.

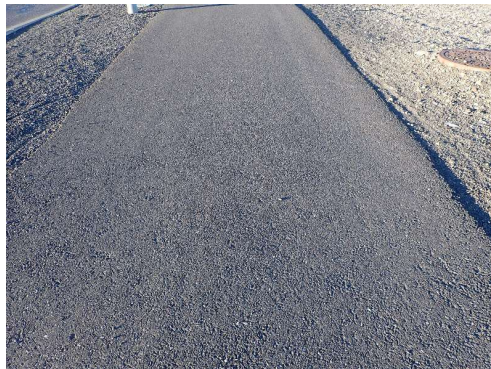
Asphalt Path - Overlay - 2047

Asphalt path appeared generally intact, with no major damage or deterioration observed.

The average useful life of asphalt can range significantly based on several factors including, but not limited to, quality of initial installation, proximity of tree roots, frequency of proactive repairs and frequency of seal coat or chip seal application. Typically, resurfacing involves grinding down the top 1-2 inches and overlaying a new layer of asphalt. This is generally performed at 20-40 year intervals depending on the unique site conditions of the property and levels of proactive maintenance. Resurfacing asphalt paths is typically more expensive than resurfacing roadways and parking areas due to more difficult access, etc., therefore proactively maintaining asphalt through regular cycles of seal coat to prolong the useful life is a best practice.

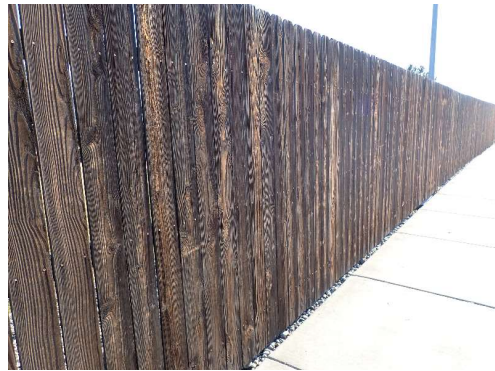
Wood Fence - Replace - 2027

Wood fence appeared intact, with no major damage or deterioration observed.

Inspect and repair fence through the annual operating budget in between larger replacement cycles. It is strongly recommended that wood fences are regularly stained to prolong the useful life of the fencing, and for the aesthetic benefits that stain affords.

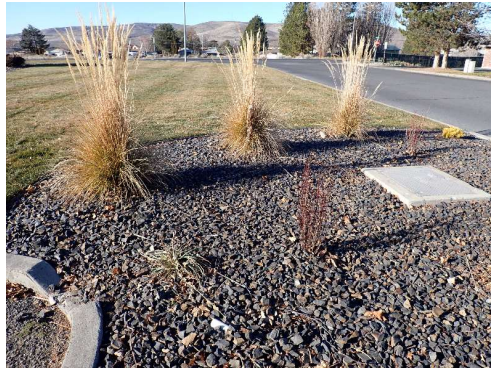
Landscape - Refurbish - 2022

1 Allowance	@ \$2,575.00
Asset ID	1135		Asset Actual Cost	\$2,575.00
			Percent Replacement	100%
	Grounds		Future Cost	\$2,575.00
Placed in Service	January 2019			
Useful Life	3			
Replacement Year	2022			
Remaining Life	0

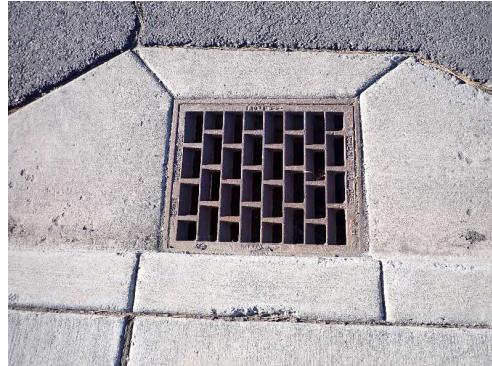
Drainage System - Maintain

It is beyond the scope of a reserve study to assess the design, quality and/or function of the stormwater drainage system, however no problems reported by client as of this report. When properly installed with no known defects or deficiencies, there is no predictable basis to expect maintenance, repair or replacement of the drainage system within the scope of this report, therefore no reserve funding included.

Common stormwater system components include gutters, ditches, catch basins and control facilities. Catch basins are the drains commonly found in asphalt or concrete surfaces and consist of a metal grate with a compartment below ground. Water gathers inside the compartment and is then drained through an outlet pipe. Often, sediment removal is required within the compartment structure. This is typically done using a vactor truck. The frequency at which sediment removal is required varies by location and is dependent on numerous factors. We recommend assessing the sediment levels in your catch basins every 1-2 years and cleaning as-needed through the annual operating budget.

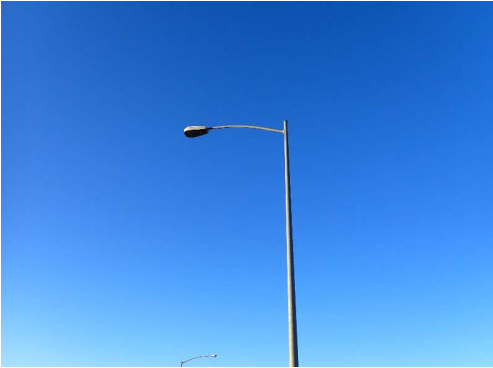
Pole Lights - Replace

Location: Adjacent to private roadways

Component History: Original to ~ 2008 construction
