## **Level I – FULL Reserve Study Report**

For Fiscal Year Beginning January 1, 2023

### **Sample HOA**

**Your Town, WA**  
**January 4, 2023**

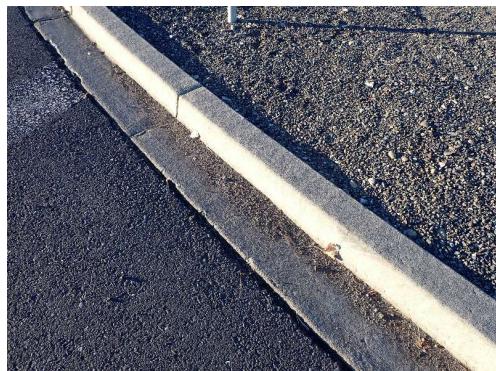
**Concrete - Repair - 2027**

Concrete appeared generally intact, with no major damage or deterioration observed.

Typically, concrete surfaces have a predictable useful life which exceeds the scope of this report, however we have included a rotating funding allowance for periodic repairs and spot replacements. Because this is a rotating component, the date in service represents the approximate last repair date.

Inspect and repair concrete as needed through annual operating budget. Clean periodically to remove stains and organic debris, and repair any trip hazards (defined as  $\frac{1}{4}$ " or more of vertical change at any joint or crack by the 1990 Americans with Disabilities Act) immediately.

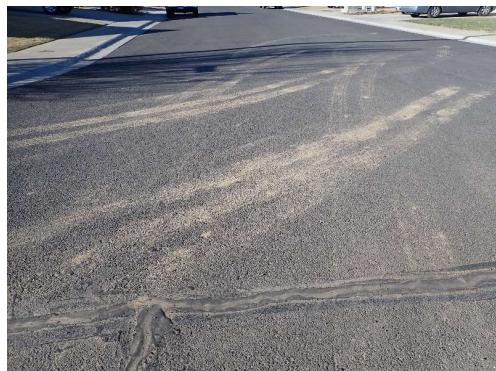
**Asphalt - Repair & Sealcoat - 2023**

Asphalt seal coat appeared generally deteriorated, with peeling and flaking observed in areas.

Regular cycles of seal coating are recommended to prevent water from penetrating the asphalt surface. We typically recommend that asphalt seal coat is applied at 5 year intervals, however areas of high traffic or water movement (such as on a slope) may require more frequent applications. Failure to regularly apply asphalt seal coat is likely to reduce the overall useful life of asphalt. Repairing asphalt and sealing cracks prior to seal coat application is imperative, and an allowance for repairs is included within the funding in this report. Repair costs can vary significantly based on scope, therefore costs may vary from the allowances included herein. Costs also factor re-striping asphalt following seal coat application.

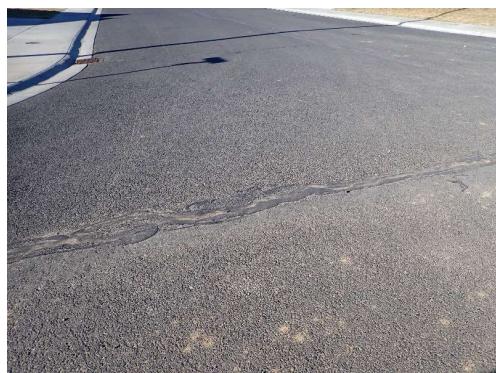
**Asphalt - Overlay - 2048**

Asphalt appeared generally intact, with local cracks and tree root uplift observed in areas.

The average useful life of asphalt can range significantly based on several factors including, but not limited to, quality of initial installation, traffic levels and type, proximity of tree roots, frequency of proactive repairs and frequency of seal coat or chip seal application. Typically asphalt is initially installed 2-4 inches in depth and resurfacing involves grinding down the top 1-2 inches and overlaying a new layer of asphalt. This is typically performed at 20-40 year intervals depending on the unique site conditions of the property and levels of proactive maintenance. Asphalt resurfacing is often one of the larger expenses experienced by an association, especially if the association is responsible for private roads, therefore proactive maintenance and sealing to prolong the useful life of the asphalt is a best practice.

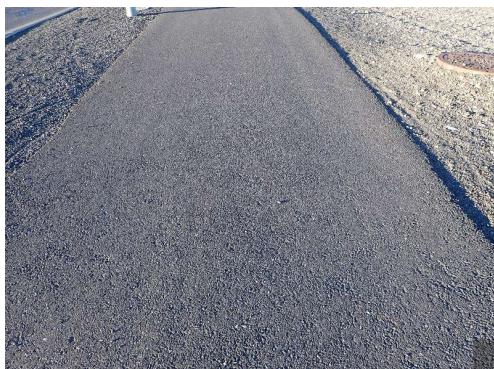
**Asphalt Path - Overlay - 2058**

Asphalt path appeared generally intact, with no major damage or deterioration observed.

The average useful life of asphalt can range significantly based on several factors including, but not limited to, quality of initial installation, proximity of tree roots, frequency of proactive repairs and frequency of seal coat or chip seal application. Typically, resurfacing involves grinding down the top 1-2 inches and overlaying a new layer of asphalt. This is generally performed at 20-40 year intervals depending on the unique site conditions of the property and levels of proactive maintenance. Resurfacing asphalt paths is typically more expensive than resurfacing roadways and parking areas due to more difficult access, etc., therefore proactively maintaining asphalt through regular cycles of seal coat to prolong the useful life is a best practice.

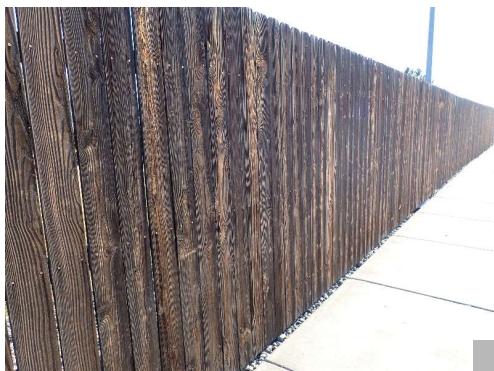
**Wood Fence - Replace - 2027**

Wood fence appeared intact, with no major damage or deterioration observed.

The typical useful life of wood fence ranges from 15 to 25 years depending on multiple factors including, but not limited to, the thickness and quality of wood at the time of installation, exposure to the elements and regular cycles of paint/stain. According to the American Fence Association, cedar posts should be inserted directly into the ground and not mounted in concrete to avoid premature decay. Pressure treated pine posts may be set in concrete as the chemical treatment will help prevent decay. Ensure that vegetation is trimmed back from fencing and that soil does not touch the bottom of the fence to prevent premature decay. Adjust irrigation systems as needed to limit contact with fence.

Inspect and repair fence through the annual operating budget in between larger replacement cycles. It is strongly recommended that wood fences are regularly stained to prolong the useful life of the fencing, and for the aesthetic benefits that stain affords.

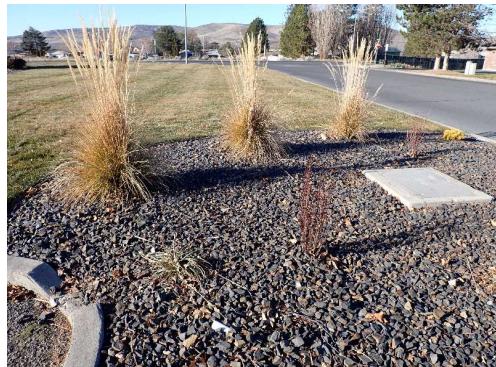
Landscape - Refurbish - 2023		1 Allowance	@ \$2,500.00
Asset ID	1135	Asset Actual Cost	\$2,500.00
		Percent Replacement	100%
	Grounds	Future Cost	\$2,500.00
Placed in Service	January 2019		
Useful Life	3		
Replacement Year	2023		
Remaining Life	0

Typically, landscape maintenance is handled through the operating budget however this component factors an allowance for larger periodic landscaping projects outside the scope of the annual maintenance contract. Actual costs may vary significantly based on scope of work, therefore track actual expenses, as well as frequency, and update future reserve studies as needed. Irrigation work, tree trimming and bark/mulch replacement are handled as separate components within this report, if applicable.

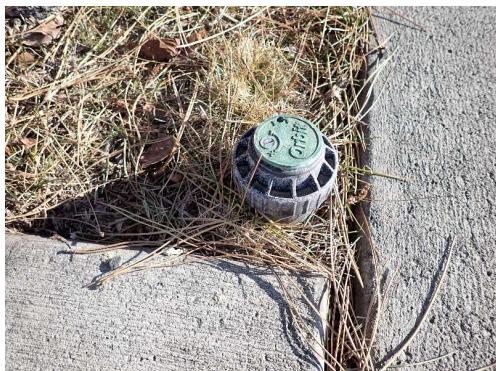
**Irrigation System - Repair - 2024**

It is beyond the scope of a reserve study to assess the design, quality and/or function of an irrigation system, however no problems related to irrigation system reported at the time of this report. Irrigation systems typically consist of three main components; timer(s), underground water distribution lines (generally constructed of PVC) and spray heads. The United States Golf Association suggests complete replacement of irrigation systems at 25-30 years of age, as lines can become brittle over time and parts obsolete.

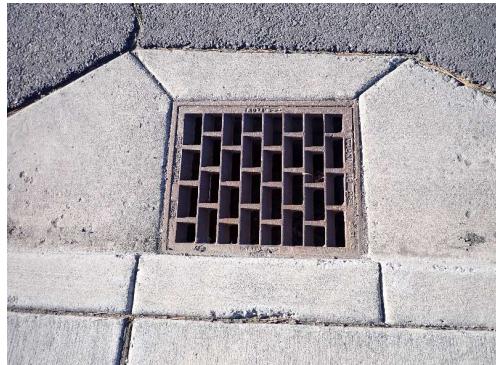
**Drainage System - Maintain**

Location: Throughout common area roads and landscaping

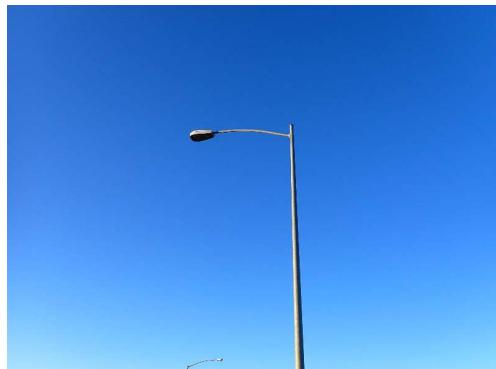
**Pole Lights - Replace**

Location: Adjacent to private roadways

Component History: Original to ~ 2008 construction
