Level I – FULL Reserve Study Report

For Fiscal Year Beginning January 1, 2024

Sample HOA

Your Town, WA
January 18, 2024

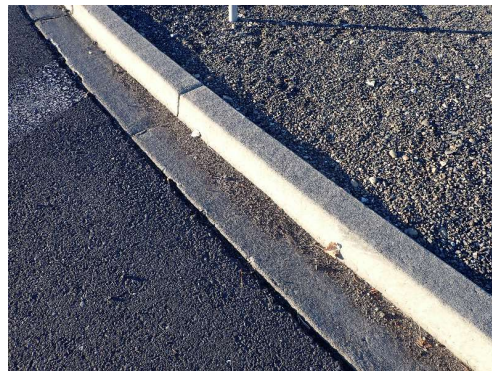
Concrete - Repair - 2028

Concrete appeared generally intact, with no major damage or deterioration observed.

Typically, concrete surfaces have a predictable useful life which exceeds the scope of this report however we have included a rotating funding allowance for periodic repairs and spot replacements.

Inspect and repair concrete as needed through annual operating budget. Clean periodically to remove stains and organic debris, and repair any trip hazards (defined as ¼" or more of vertical change at any joint or crack by the 1990 Americans with Disabilities Act) immediately.

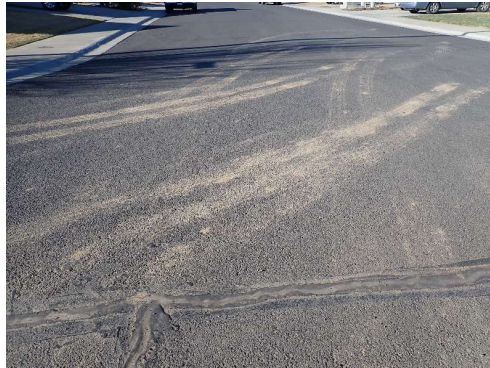
Asphalt - Repair & Sealcoat - 2024

Asphalt seal coat appeared generally deteriorated, with peeling and flaking observed in areas. Regular cycles of seal coating are recommended to prevent water from penetrating the asphalt surface. We typically recommend that asphalt seal coat is applied at 5 year intervals, however areas of high traffic or water movement (such as on a slope) may require more frequent applications. Failure to regularly apply asphalt seal coat is likely to reduce the overall useful life of asphalt. Repairing asphalt and sealing cracks prior to seal coat application is imperative, and an allowance for repairs is included within the funding in this report. Repair costs can vary significantly based on scope, therefore costs may vary from the allowances included herein. Costs also factor re-stripping asphalt following seal coat application, if applicable.

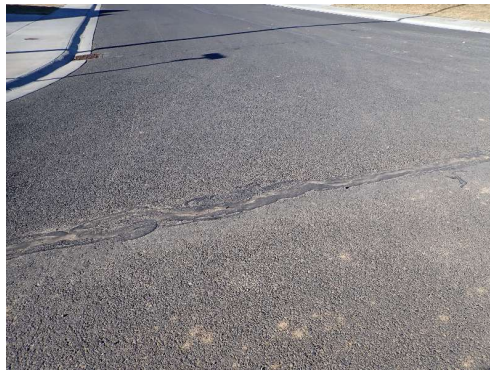
Asphalt - Overlay - 2049		55,000 GSF	@ \$3.00
Asset ID	1015	Asset Actual Cost	\$165,000.00
		Percent Replacement	100%
Category	Grounds	Future Cost	\$345,473.36
Placed in Service	January 2008		
Useful Life	40		
Adjustment	1		
Replacement Year	2049		
Remaining Life	25

Asphalt appeared generally intact, with local cracks and tree root uplift observed in areas. The average useful life of asphalt can range significantly based on several factors including, but not limited to, quality of initial installation, traffic levels and type, proximity of tree roots, frequency of proactive repairs and frequency of seal coat or chip seal application. Typically asphalt is initially installed 2-4 inches in depth and resurfacing involves grinding down the top 1-2 inches and overlaying a new layer of asphalt. This is typically performed at 20-40 year intervals depending on the unique site conditions of the property and levels of proactive maintenance. Asphalt resurfacing is often one of the larger expenses experienced by an association, especially if the association is responsible for private roads, therefore proactive maintenance and sealing to prolong the useful life of the asphalt is a best practice.

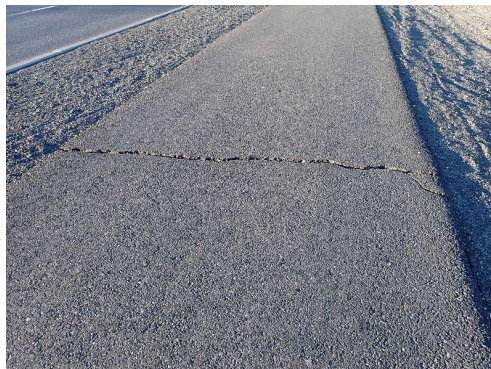
Asphalt Path - Repair & Seal - 2024			
Asset ID	1035	15,000 GSF	@ \$0.60
		Asset Actual Cost	\$9,000.00
		Percent Replacement	100%
		Future Cost	\$9,000.00
Category	Grounds		
Placed in Service	January 2016		
Useful Life	5		
Replacement Year	2024		
Remaining Life	0

Regular cycles of seal coat application are recommended at asphalt pathways to prevent water from penetrating the asphalt surface. We typically recommend that asphalt seal coat is applied at 5 year intervals. Failure to regularly apply asphalt seal coat is likely to reduce the overall useful life of asphalt. Repairing asphalt and sealing cracks prior to seal coat application is imperative, and an allowance for repairs is included within the funding in this report. Repair costs can vary significantly based on scope, therefore costs may vary from the allowances included herein.

Inspect and clean periodically to remove stains and organic debris through the annual operating budget, and repair any trip hazards (defined as ¼" or more of vertical change at any joint or crack by the 1990 Americans with Disabilities Act) immediately.

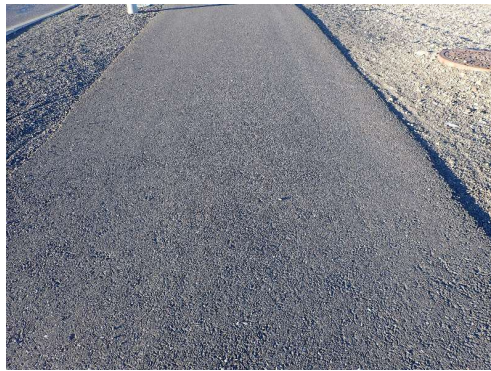
Asphalt Path - Overlay - 2059

Asphalt path appeared generally intact, with no major damage or deterioration observed.

The average useful life of asphalt can range significantly based on several factors including, but not limited to, quality of initial installation, proximity of tree roots, frequency of proactive repairs and frequency of seal coat application. Typically, resurfacing involves grinding down the top 1-2 inches and overlaying a new layer of asphalt. This is generally performed at 20-40 year intervals depending on the unique site conditions of the property and levels of proactive maintenance. Resurfacing asphalt paths is typically more expensive than resurfacing roadways and parking areas due to more difficult access, etc., therefore proactively maintaining asphalt through regular cycles of seal coat to prolong the useful life is a best practice.

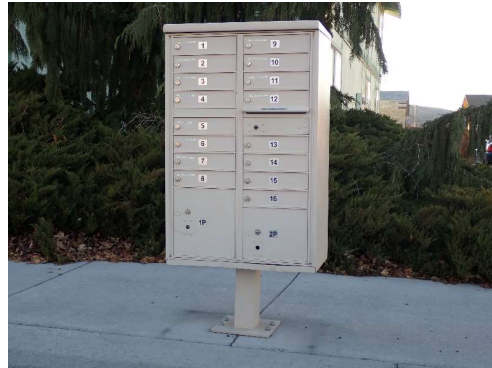
Mailboxes - Replace - 2033

Plan to replace mailboxes at roughly 20-25 year cycles. Inspect, clean and repair as needed utilizing operating funds. The most common causes for premature replacement are damage caused by a vehicle and/or vandalism. Contact your local post office prior to replacement of mailboxes to ensure new boxes are installed according to post office guidelines and to coordinate installation of the master lock.

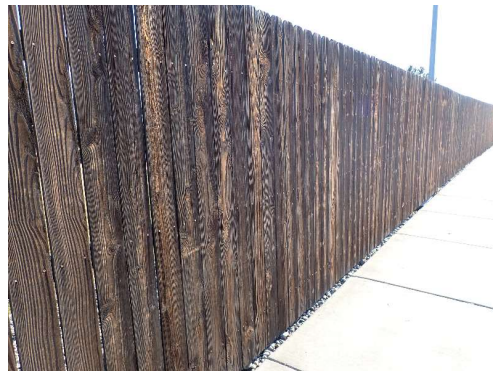
Wood Fence - Replace - 2028

Wood fence appeared intact, with no major damage or deterioration observed. The typical useful life of a wood fence ranges from 15 to 25 years depending on multiple factors including, but not limited to, the thickness and quality of wood at the time of installation, exposure to the elements and regular cycles of paint/stain. According to the American Fence Association, cedar posts should be inserted directly into the ground and not mounted in concrete to avoid premature decay. Pressure treated pine posts may be set in concrete as the chemical treatment will help prevent decay. Ensure that vegetation is trimmed back from fencing and that soil does not touch the bottom of the fence to prevent premature decay. Adjust irrigation systems as needed to limit contact with fence.

Inspect and repair fence through the annual operating budget in between larger replacement cycles. It is strongly recommended that wood fences are regularly stained to prolong the useful life of the fencing, and for the aesthetic benefits that stain affords.

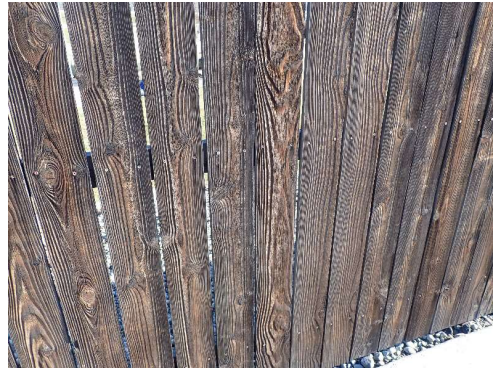
Wood Fence - Repair & Stain - 2028

Component History: Stained 2023 \$2,800

Regular cycles of staining of wood fencing are recommended, typically at 5 year intervals. A semi-transparent or solid bodied stain typically yield the best results aesthetically as paint is prone to peel over time and may require additional prep work prior to each paint cycle, resulting in increased costs. In addition to the aesthetic benefit of staining the fence, stain also provides water repellency and may help extend the useful life of the fence. Ensure that fence is adequately cleaned prior to stain application and adjust irrigation systems as needed to limit contact with fence, as direct contact will result in deterioration and discoloration of stain in those areas.

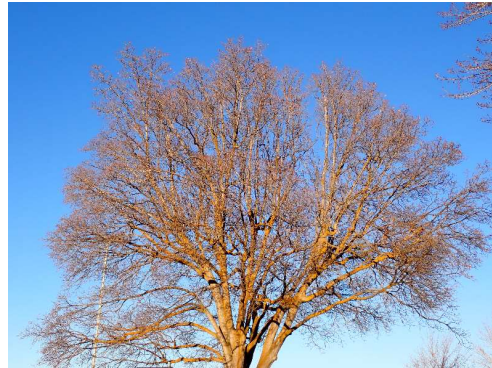
Trees - Trim/Remove - 2025

Prior to performing any tree trimming, removal or replacement, we strongly urge the association to consult with an arborist to assess the condition of the trees and to assist the association in formulating a tree maintenance plan. Typically, some minor tree work is included within an annual landscape maintenance contract however many communities require a rotating allowance for larger tree projects. Cost may vary significantly from the allowance included here depending on the scope of work.

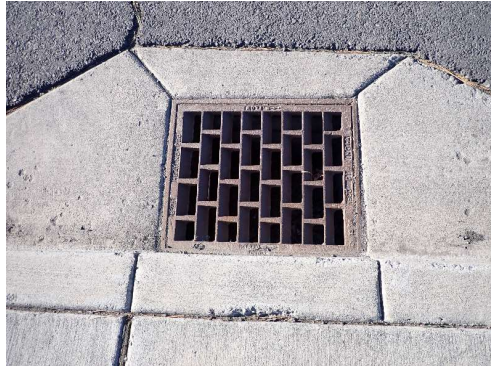
Drainage System - Maintain

Location: Throughout common area roads and landscaping

Component History: No major projects known

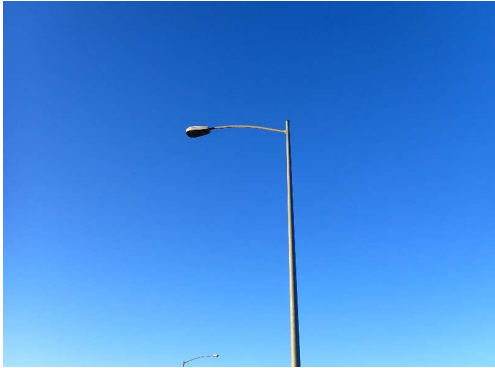
Pole Lights - Replace			5 Each	
Asset ID	1175	Asset Actual Cost		
		Percent Replacement		100%
Category	Grounds	Future Cost		
Placed in Service	January 2008			
No Useful Life

Location: Adjacent to private roadways

Component History: Original to ~ 2008 construction
