SANTA ROSA CREEK STEELHEAD HABITAT AND POPULATION SURVEY

Prepared by:
Jennifer Nelson, DFG
Assisted by:
Eileen Baglivio and Tim Kahles,
CA Conservation Corps
2005

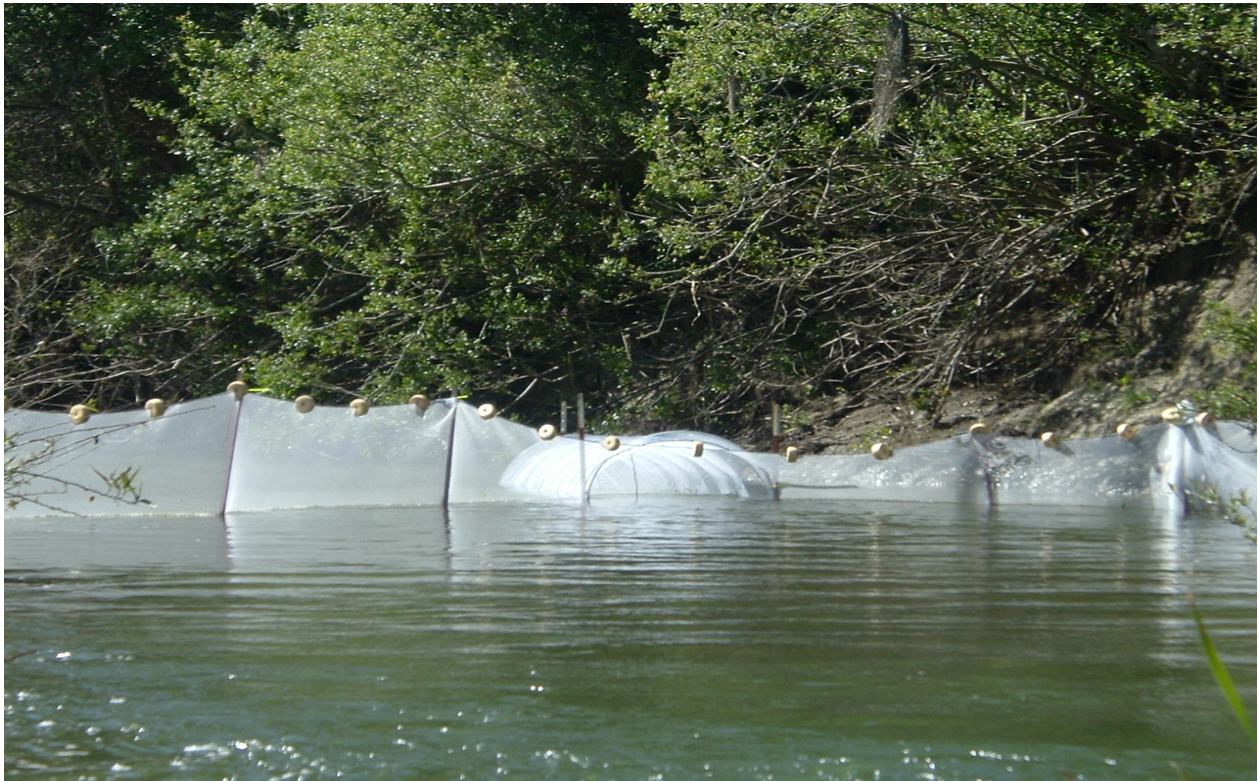
Figure 5. Hoop trap and weir on Santa Rosa Creek, 2005.

In order to determine the timing and general morphological characteristics of steelhead smolts moving downstream, an out-migrant trap and attached weir were placed in Santa Rosa Creek from April 18, 2005 through May 25, 2005 at stream mile 0.35. The trap was a twelve foot long seven hoop trap constructed of treated quarter inch mesh. The attached weir was also constructed of treated quarter inch mesh with floats along the top edge at one foot intervals. The weir extended slightly upstream to the stream banks to form a V-shape that would facilitate fish movement into the trap (Figure 5). The weir was secured by fastening it to fence posts at two to three foot intervals depending on water velocities. The bottom of the weir was lined with rock in order to prevent fish from swimming underneath.

The trap was operational from Monday afternoon through Friday afternoon (four nights) with one side of the weir folded back into the trap during the weekends to allow unimpeded fish movement.

On the days when the trap was operational, the trap and weir were cleared of debris and checked to assure that it remained secure and that it was fishing effectively. Trap and weir conditions, air temperature, water temperature, weather conditions, and sandbar condition were recorded daily.

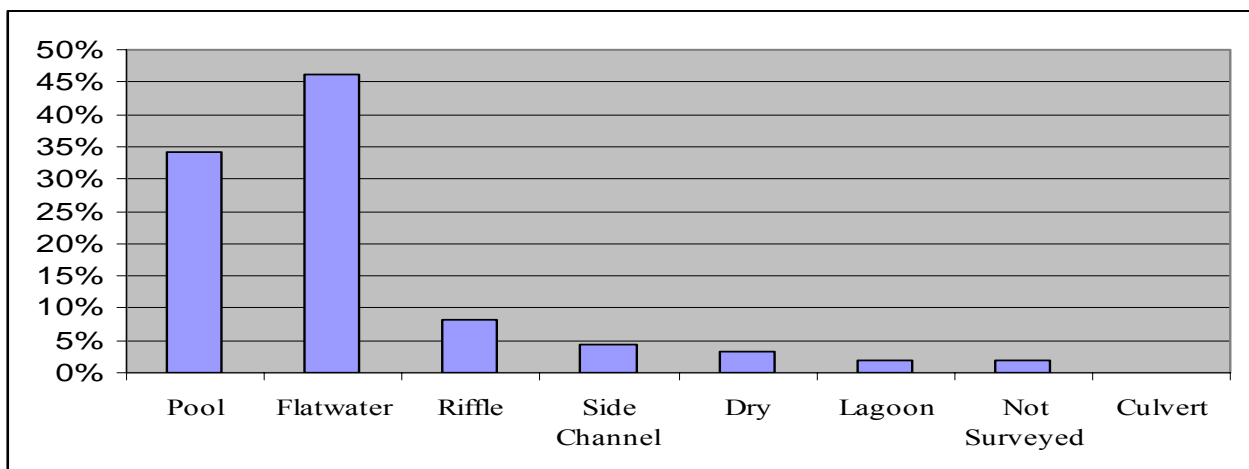
Figure 7. Percent total length of each category of habitat, Santa Rosa Creek, 2005.

Based on total stream length, 34.1% (27,238 feet) was pool habitat, 46.2% (36,924 feet) was flatwater, 8.2% (6,546 feet) were riffles, 3.3% (2,625 feet) was dry, 1.8% (1,452 feet) was not surveyed, 1.9% (1,548 feet) was lagoon habitat, 0.06% (50 feet) of the creek went through a culvert and 4.3% (3,370 feet) were side channel units (Table 1 and Figure 7).

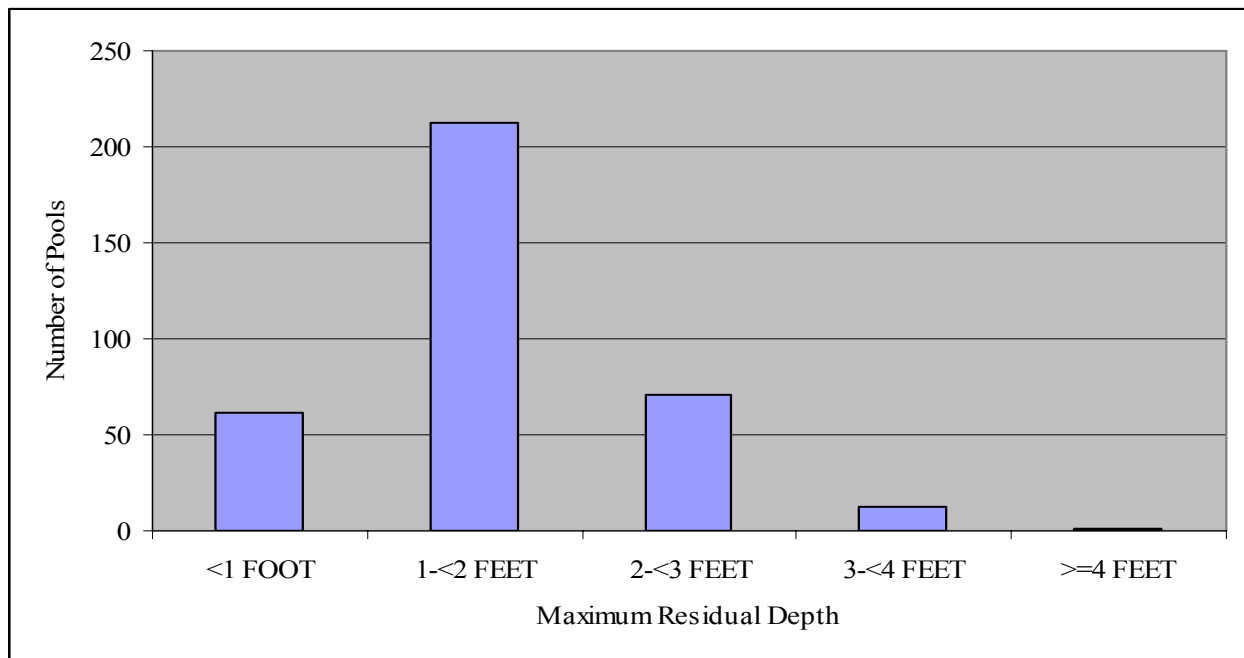
Figure 8. Distribution of maximum residual depths in measured pools, Santa Rosa Creek, 2005.

Average lengths, widths, and depths of each of these pools types can be found in Table 2. Maximum depths of all pool types measured ranged from less than one foot (61 pools) to over 4 feet (1 pool). An additional 212 pools ranged between 1 and 2 feet maximum depth, 71 pools ranged between 2 and 3 feet, and 13 pools ranged between 3 and 4 feet deep (Table 3 and Figure 8). Pools upstream of the dry reach had a slightly higher average maximum depth of 1.92 feet while downstream of the dry reach the average maximum depth of pools was 1.88 feet.

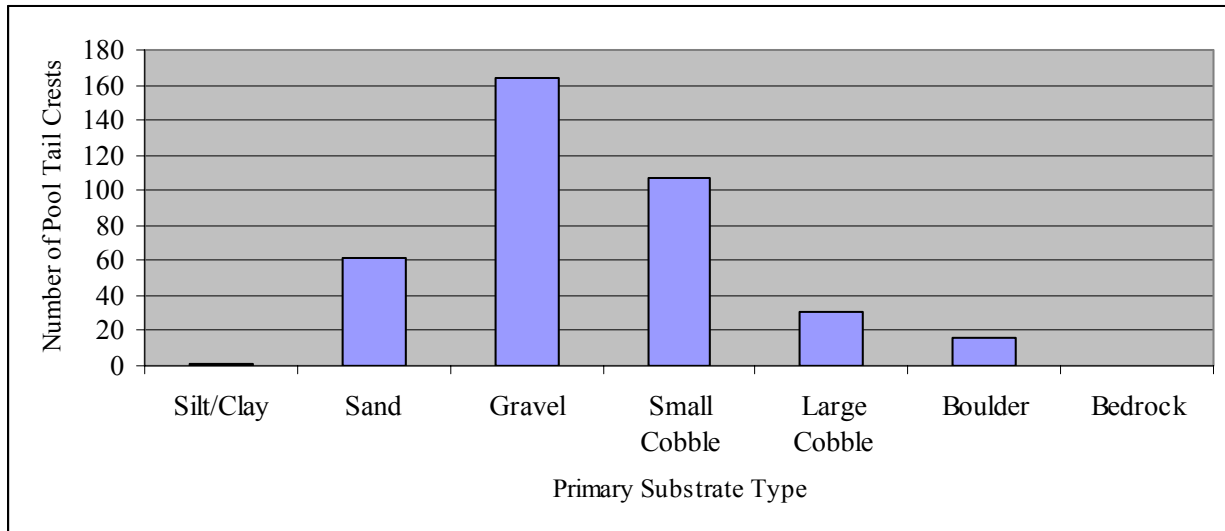
Figure 10. Distribution of the primary substrate at 381 of the pool tail crests, Santa Rosa Creek.

Of the 381 pool tail crests measured, 79 consisted of silt/clay, sand, or boulders and since these substrate types could not be used for spawning, they had a rating of 5. The remaining 302 pool tail crests consisted of gravel (164 pools), small cobble (107 pools), or large cobble (31 pools) (Figure10). Gravel (0.08 – 2.5 inches in diameter) and small cobble (2.5 – 5.0 inches in

diameter) can be used for spawning, however the large cobble (5 – 10 inches in diameter) would most likely need to be mixed with smaller sized substrate in order to be used for spawning.

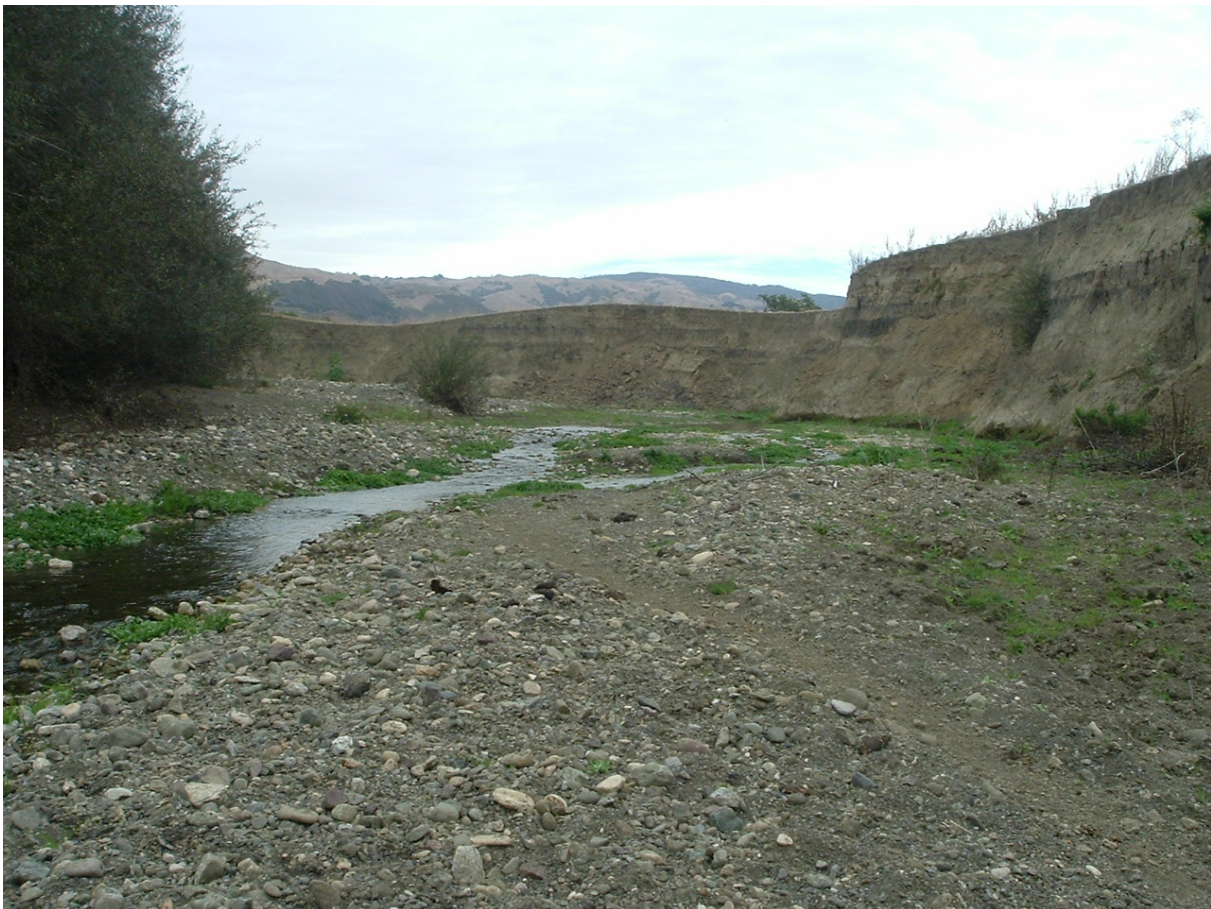
Although stream banks were relatively well vegetated in those units that were fully measured, vertical denuded banks were common in certain reaches of the stream (Figure 11). Downstream of stream 7.9, approximately 6,040 feet of the left bank and 7,770 feet of the right bank were denuded and actively eroding. Upstream of stream mile 7.9, approximately 8,353 feet of the left bank and 5,760 feet of the right bank were eroding. Only those sites greater than 50 feet in length were included in these measurements.

Figure 11. One of several vertical denuded banks observed along Santa Rosa Creek, 2005.

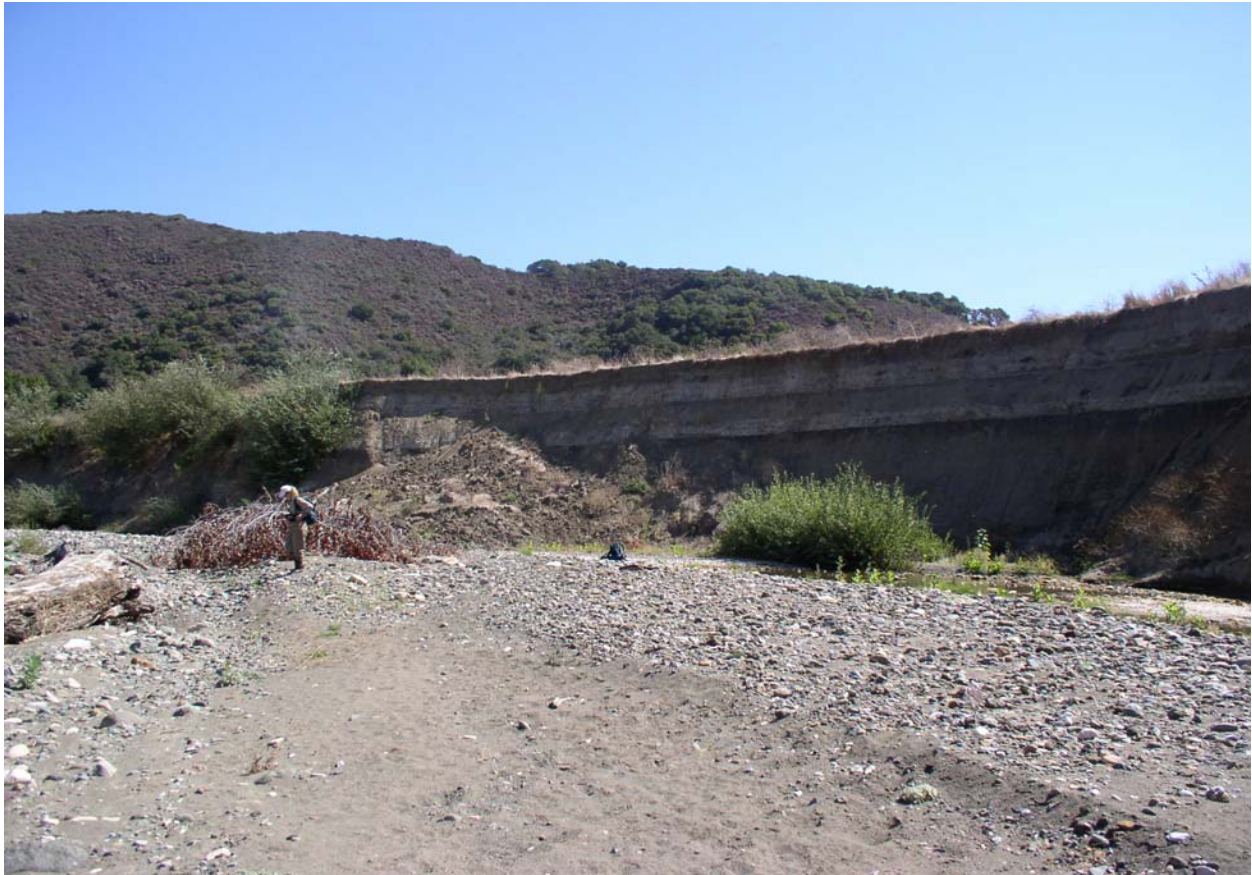
During the summer and fall months, stream flow at approximately stream mile 6.7 (unit 363) goes subsurface leaving a portion of Santa Rosa Creek dry for a part of the year. The dry unit was 2,625 feet long at the time of the survey (Sept. 21, 2005) although that distance and the length of the dry period may vary from year to year depending on the amount of rainfall the previous winter. The flood plain width in this section ranges from 250 to 350 feet with the potential wetted channel being 70 to 100 feet wide. These channel characteristics extend 3,304 feet upstream of the current dry channel. The stream banks throughout the dry reach and extending to stream mile 7.9 are 15 to 20 feet high, vertical, denuded, and are actively eroding in many areas (Figure 12). This section of dry creek severs the upper watershed from the lower watershed and can delay or prevent upstream migration of adult steelhead and downstream migration of smolts during drier years.

Figure 12. A portion of the dry section in Santa Rosa Creek, 2005.

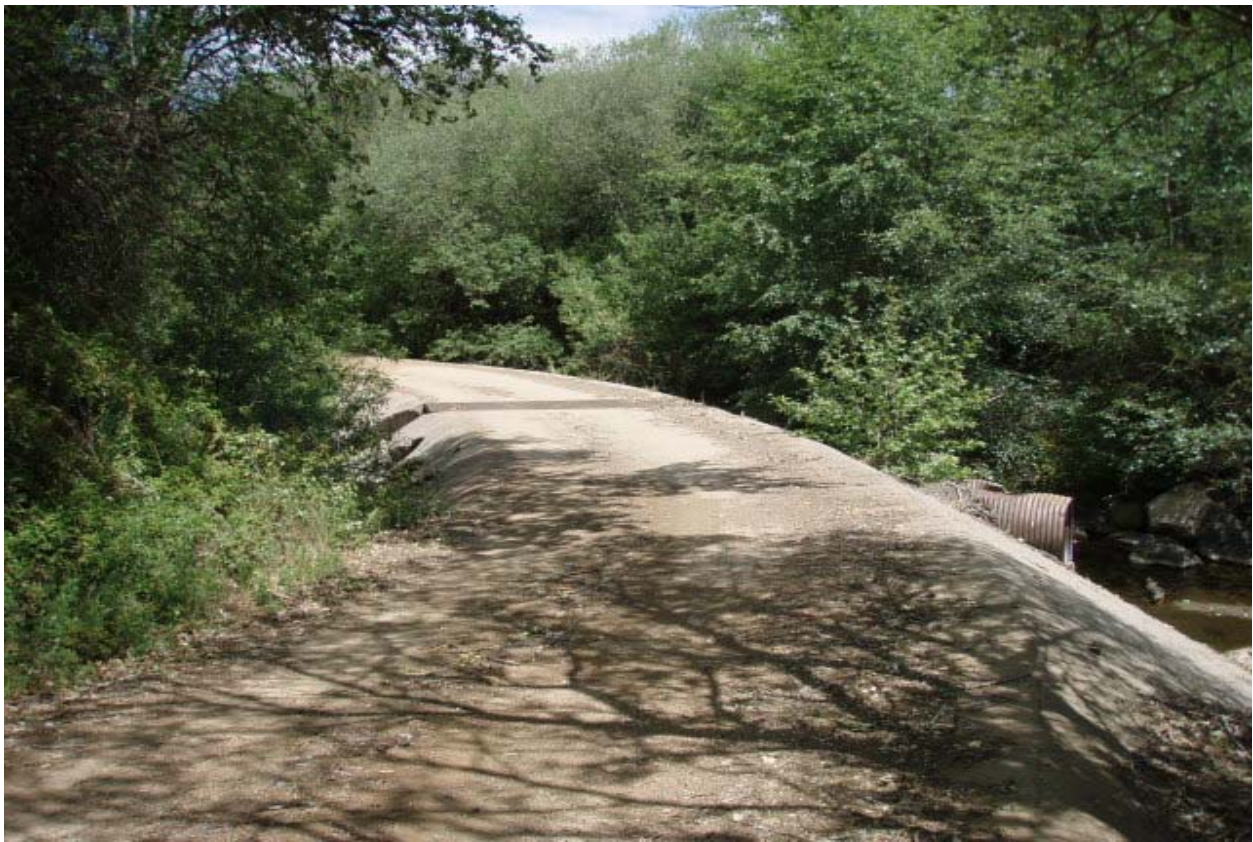
Another impediment and occasional barrier to upstream adult and juvenile migration is Ferrasci Road crossing located at stream mile 3.4 (N35° 24' 05.0" W121° 03' 55.3"). The crossing is a 10 foot high concrete ford that spans the 45 foot wide channel at an angle and has three culverts and a fish ladder through the center (Figure 13). The culverts are 4 feet in diameter and are perched approximately five feet above the pool at the base of the structure (Figures 14 and 15). The fish ladder is 4 feet in width and the flow is run-like through the ladder during the low flow season. During high flow events, water flows completely over the structure (Figure 16).

Figure 13. Ferrasci Road crossing at stream mile 3.4.

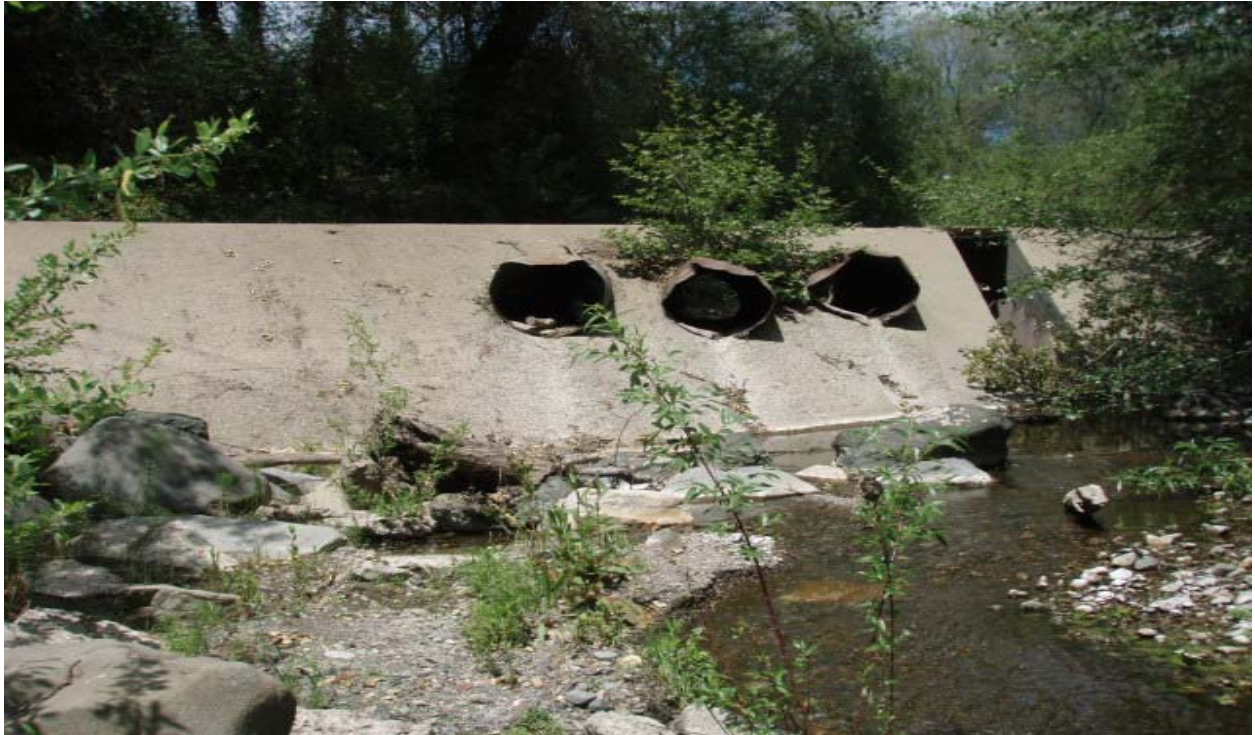
Figure 14. Looking upstream to Ferrasci Road crossing, Santa Rosa Creek.

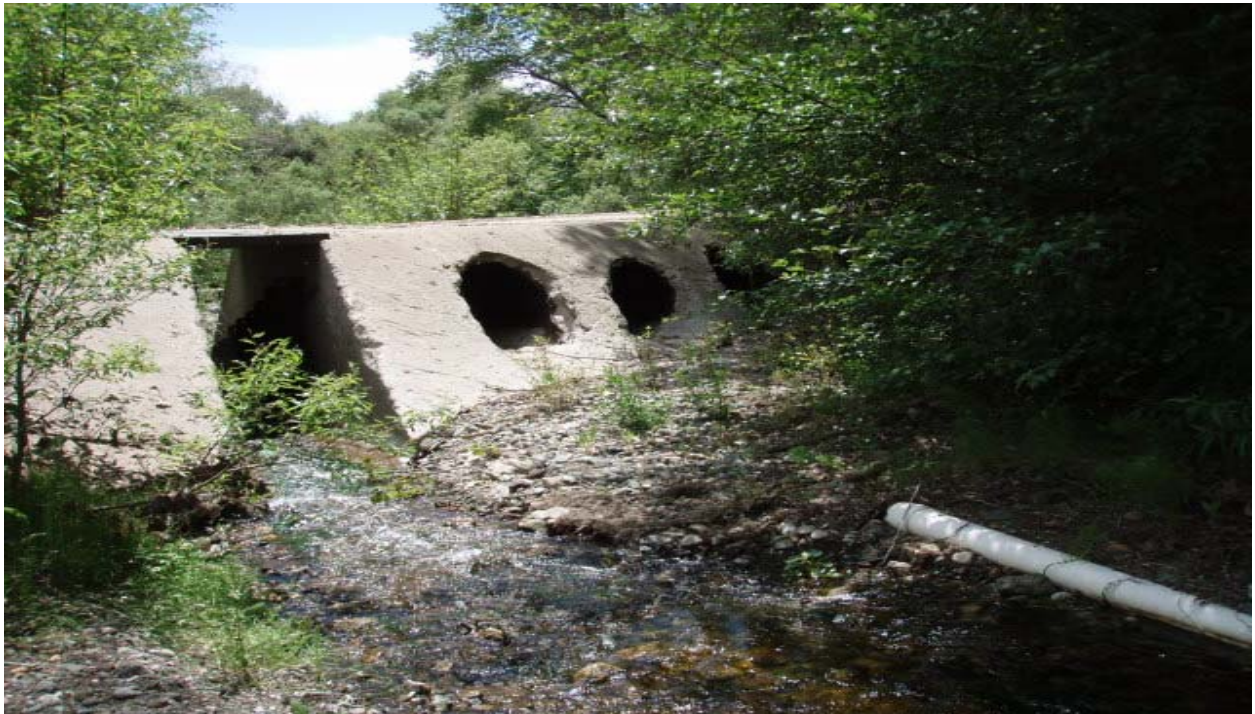
Figure 15. Looking downstream to Ferrasci Road crossing, Santa Rosa Creek

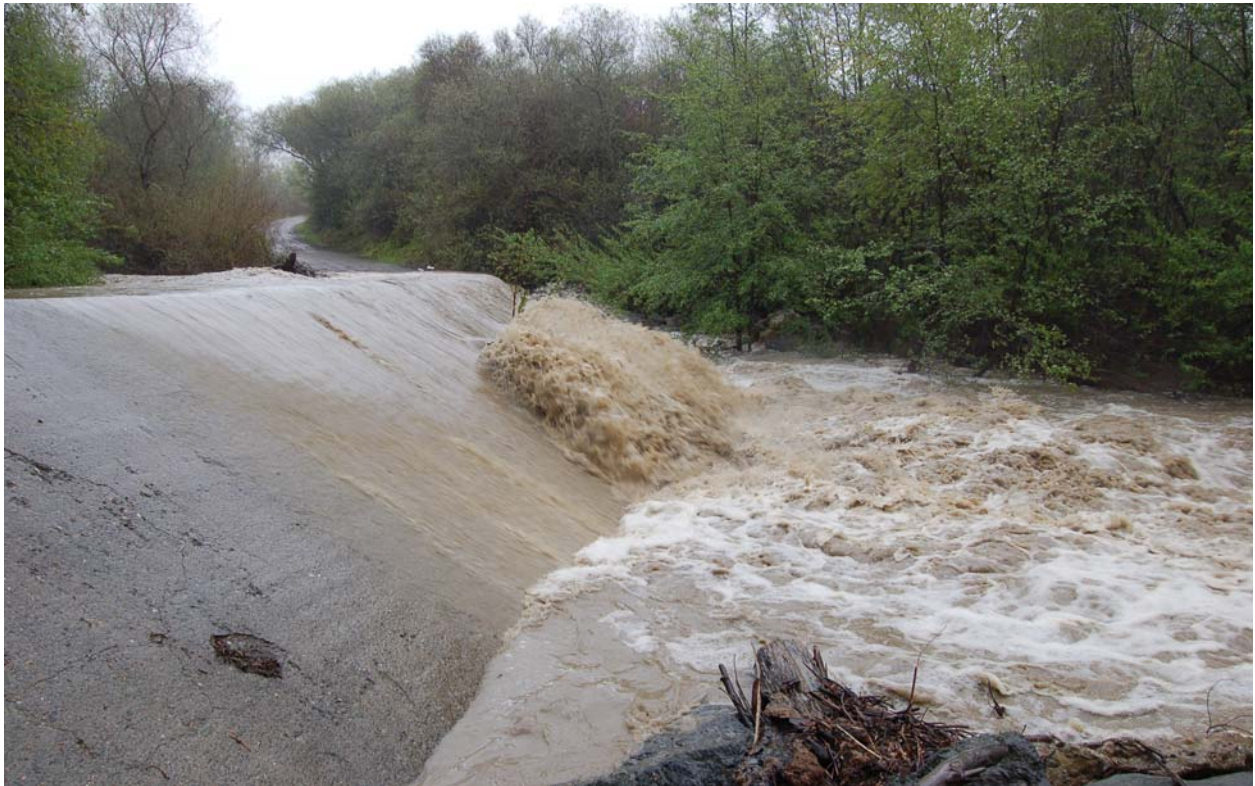
Figure 16. Ferrasci Road crossing during high flows in the spring of 2005.
