Santa Rosa Creek Watershed Management Plan

February 2012

Stillwater Sciences, Central Coast Salmon Enhancement, and Greenspace – The Cambria Land Trust. 2012. Santa Rosa Creek watershed management plan. Prepared for the California Department of Fish and Game, under a grant for the Fisheries Restoration Grant Program (P0740401).

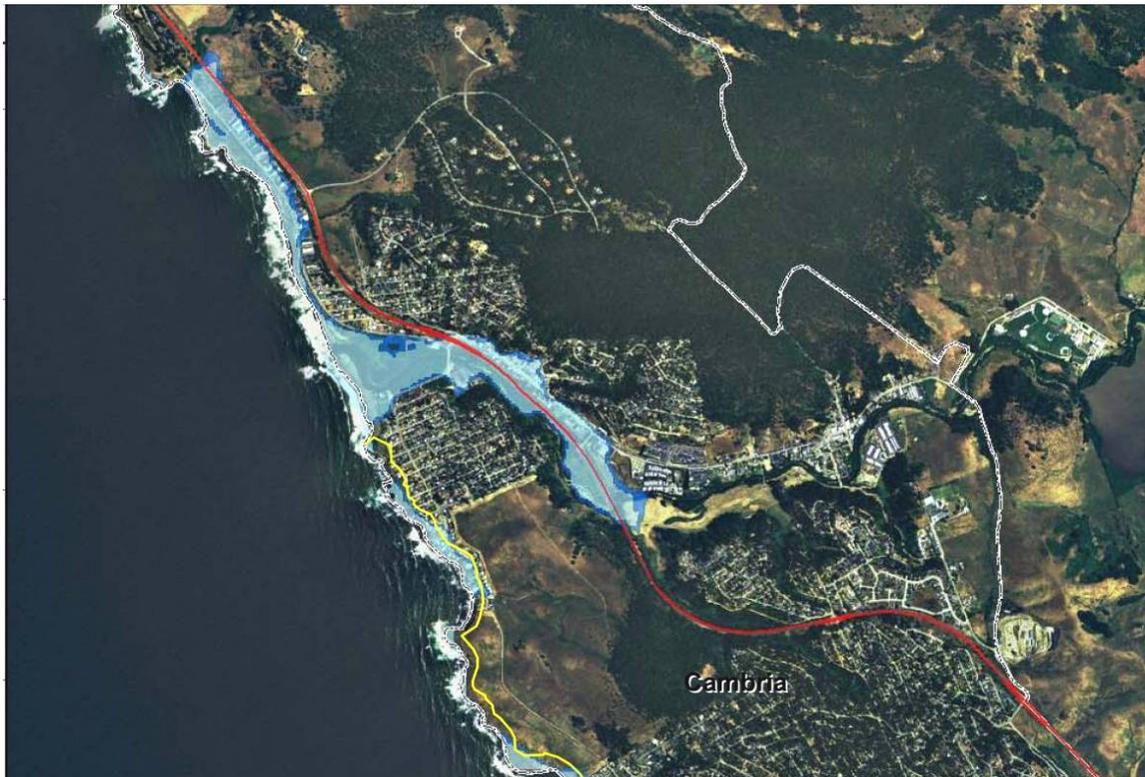
Figure 2-6. Predicted flood risk in 2100 in the Cambria area under a 1.4-m sea-level rise scenario. Light blue area is the current coastal base flood (approximate 100-year flood extent), dark blue area is the predicted coastal base flood under sea-level rise (current plus 1.4 m), yellow line is the predicted landward limit of erosion high hazard zone in 2100, and red line is Highway 1. Map used with permission from the Pacific Institute, Oakland, California.

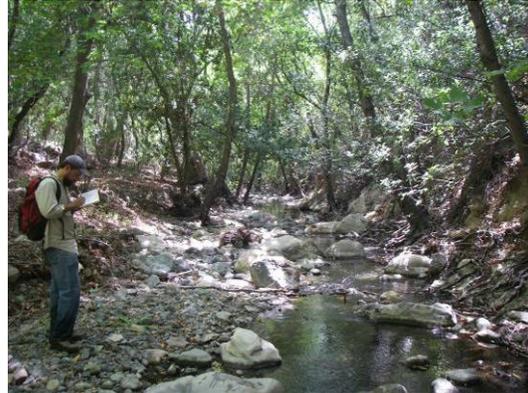
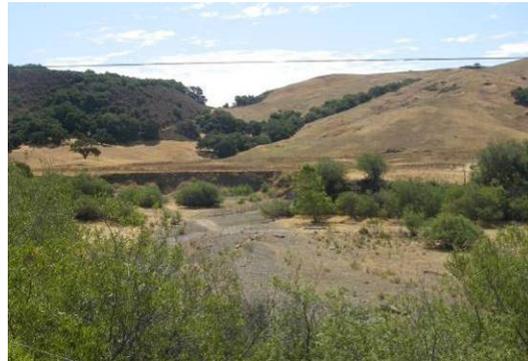
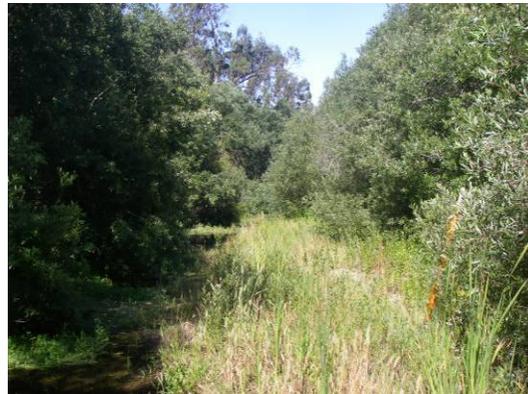
Examples of conditions in the upper, middle, and lower reaches of Santa Rosa Creek

The middle reaches display the features of a classic alluvial channel, with a sinuous channel that meanders through deposited alluvium, and a cobble-gravel bed characterized by pool-riffle bedforms. The middle reaches transition from a highly incised reach with active bank erosion and high sediment input at its upstream extent, to a moderately incised and apparently less dynamic reach as the degree of channel confinement increases and bedrock control once again becomes an influence near the confluence with Perry Creek. Comparing aerial photographs from 1937 to 2007, there has been a significant increase in the sinuosity of the middle reaches (Figure 2-8). The increase in sinuosity of this incised reach is evidence that the channel is still recovering from the impact of land use change in the mid-19th century. Land clearing for lumber and agriculture changed rainfall-runoff dynamics by decreasing landscape surface roughness (i.e., vegetation removal), thereby increasing the stream power in the creek for a given rainfall intensity and duration (i.e., increased hydrograph “flashiness”). Stream bank erosion in the middle reaches is one of the primary sources of fine sediment in Santa Rosa Creek.

Bedrock control returns at the junction with the lower reaches which have a sand-gravel bed and are moderately confined by terrain and development and show signs of aggradation before becoming tidally influenced near the low-gradient creek mouth (described in more detail below). Sediment delivered to the lower reaches from upstream Santa Rosa Creek, Perry Creek, and from local tributaries has resulted in a large amount of stored sediment in the reach. Banks are relatively stable, not least where extensive riprap protection exists.

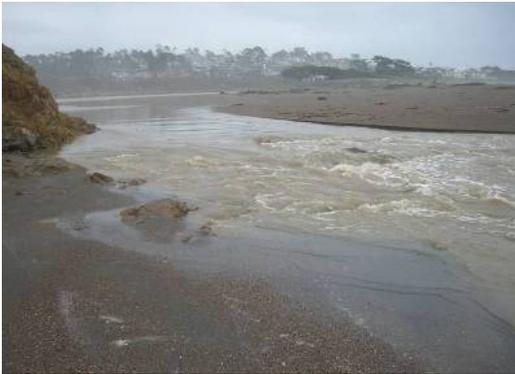
Open sandbar at the lagoon

The sandbar typically breaches after high rainfall and remains open for a week or more depending on streamflows; then the sandbar reforms to create the lagoon (M. Walgren, pers. comm., 2010). Often, high wave energy can also contribute to sandbar breaching. Reformation of the sandbar and closure of the lagoon occurs when lower stream discharges and lower-intensity wave action

facilitate onshore sediment transport and deposition at the mouth. Lagoon closure can take weeks to months, depending on the stream discharge and wave conditions. While the sandbar is open, the lagoon drains and is subject to the tides. From 1993–2007 the median date of sandbar closure was May 27, with the earliest closure on March 15 in 2007, and the latest closure on July 13 in 1998 (D. W. Alley & Associates 2008). During these years, date of sandbar closure was positively and significantly related to rainfall in the preceding water year, although the relationship was not strong ($r^2 = 0.347$; $P = 0.0209$; $n = 15$).

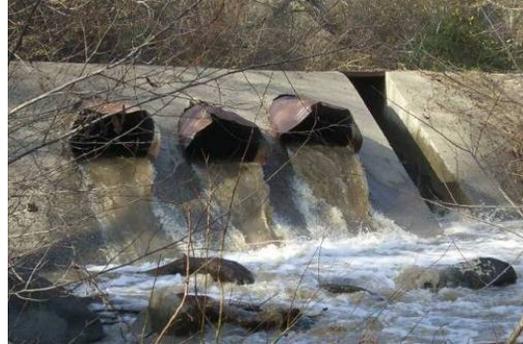
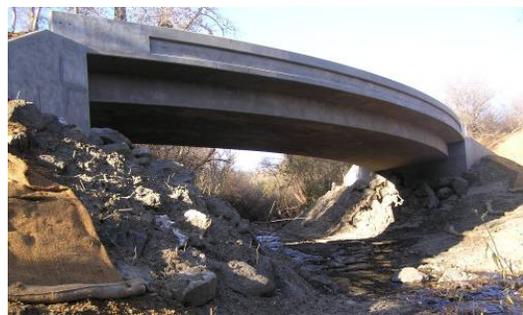
Ferrasci Road crossing before (above) and after (below) replacement

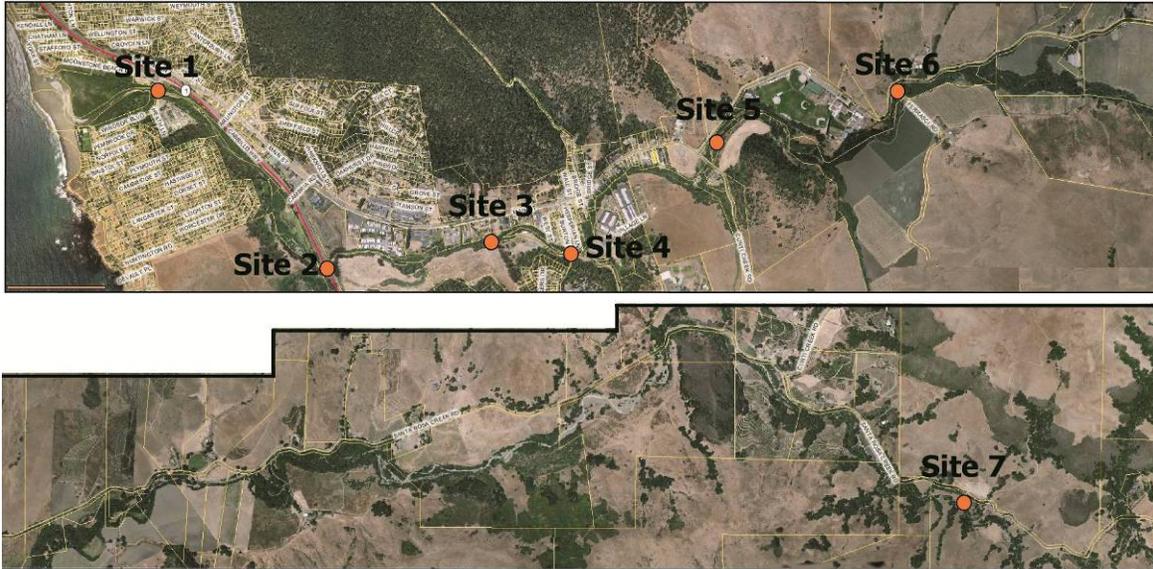
Figure 2-14. Benthic macroinvertebrate sampling sites on Santa Rosa Creek.

On May 5, 6, and 7 of 2010, benthic macroinvertebrates were collected using an abridged version of the State Water Resource Control Board's (SWRCB) Surface Water Ambient Monitoring Program (SWAMP) bioassessment protocol (Ode 2007) at seven sites along Santa Rosa Creek (Figure 2-14):

- Site 1 (stream mile 0.3)
- Site 2 (stream mile 1.0)
- Site 3 (stream mile 1.5)
- Site 4 (stream mile 1.8)
- Site 5 (stream mile 2.8)
- Site 6 (stream mile 3.3)
- Site 7 (stream mile 5.0)

Sampling sites were selected in part based on personal communications with Mary Adams of CCAMP and Jennifer Nelson of CDFG, both of whom have experience on Santa Rosa Creek. Physical accessibility and permission for access from landowners also played a role in site selection. Selected sampling sites reflect a variety of land uses and human influences, including urbanization, agriculture, and ranching. The four downstream-most sites are located within the town of Cambria.

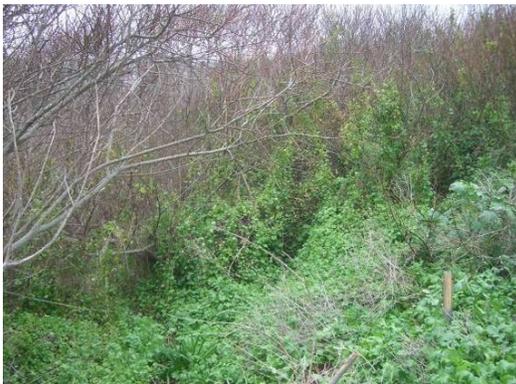
Cape ivy infestation near the lagoon

CDFG noted that “cape ivy was found from stream mile 10 downstream, but was most extensive in stream miles 5 and 6” (Nelson et al. 2009). In some areas, cape ivy was found to completely cover the streambank. In these and other cases, the extent of cape ivy is likely sufficient to preclude the establishment of native plants that would better shade the creek and help moderate stream temperatures as well as provide habitat for native wildlife species. Although Nelson et al. (2009) noted pampas grass in several areas in the lower 6 mi (9 km) of the creek, this was most likely jubata grass, which is easily confused with pampas grass but is more prevalent along the San Luis Obispo

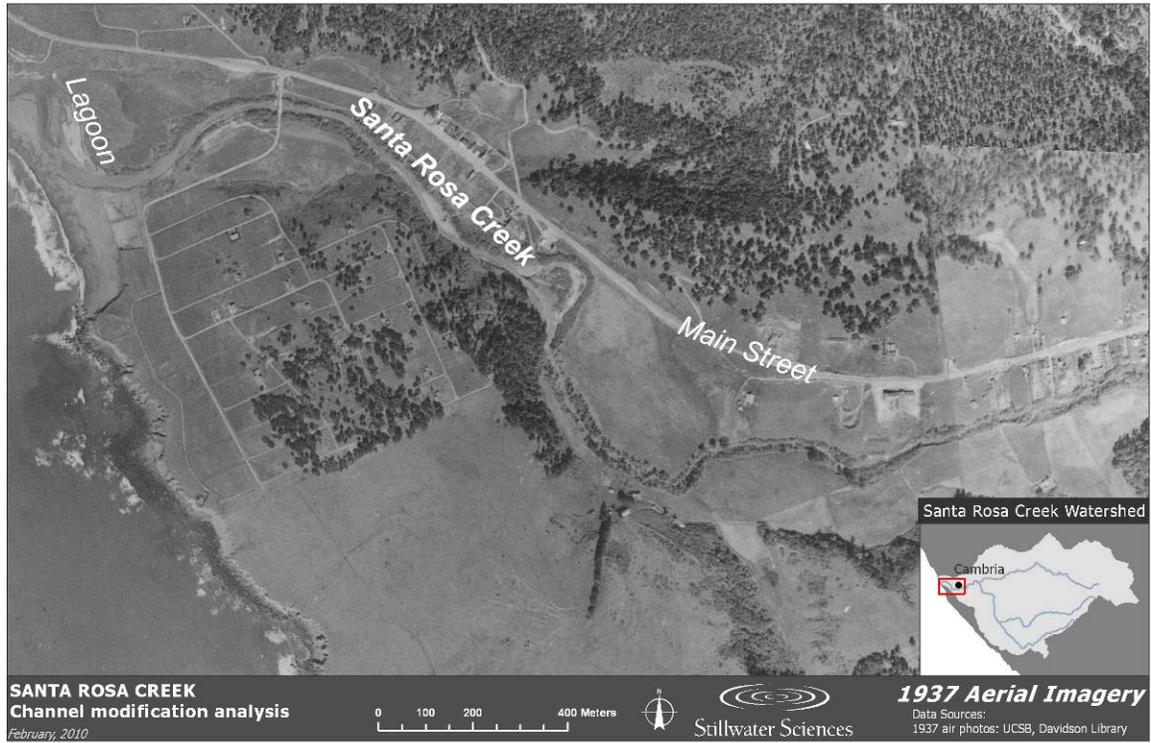
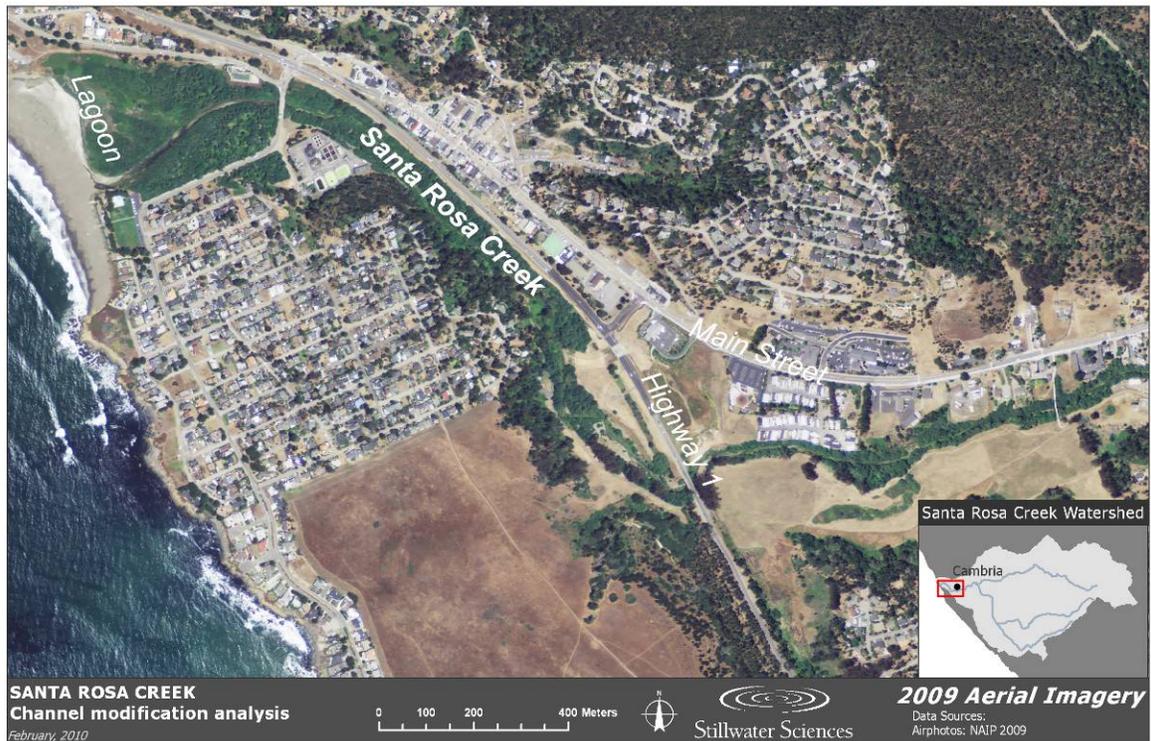
Figure 2-25. Historical (1937) and current (2009) aerial photographs of riparian corridor conditions in the lower reach of Santa Rosa Creek and near the town of Cambria.

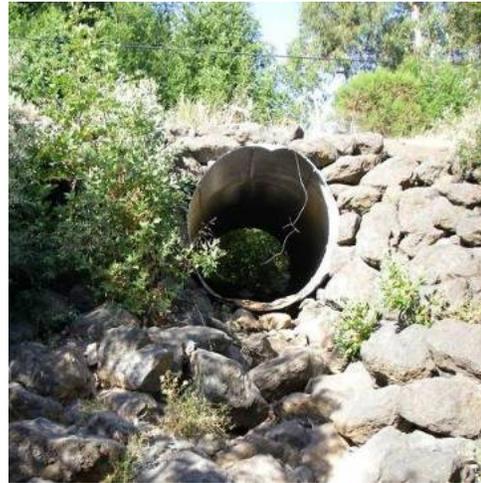
Culvert on Curti Creek

Although the two downstream-most barriers to fish migration and movement (i.e., Burton Street Bridge and Ferrasci Road crossing) have been corrected, close to 20 man-made (i.e., bridges and culverts) barriers have been identified in the watershed. Barriers that may impede access to potential steelhead spawning and rearing areas include several stream crossings on Perry and lower Green Valley creeks.

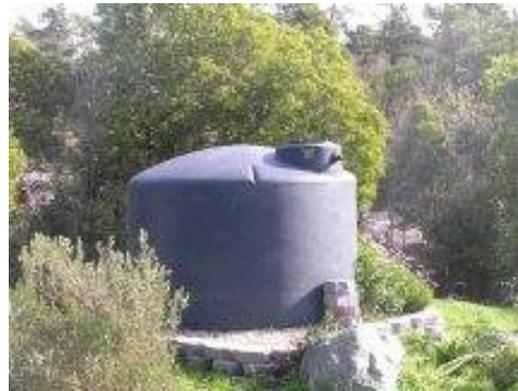
Storage tank in Santa Rosa Creek watershed

Off-stream water storage of extracted groundwater and riparian diversions for domestic and agricultural uses, which would divert water during higher instream flow conditions in the winter and store it for use in the summer and fall, is one way of achieving additional instream flows for steelhead rearing and fall migration during dry water years. Water for off-stream storage would be diverted in winter only, with an elimination of spring, summer, and/or fall water rights. Off-stream closed water storage facilities (e.g., above-ground water tanks, cisterns, etc.) are maintained along several tributaries in the watershed; it is recommended that opportunities to increase their efficiency as well as to increase the number of facilities in strategic locations be pursued.

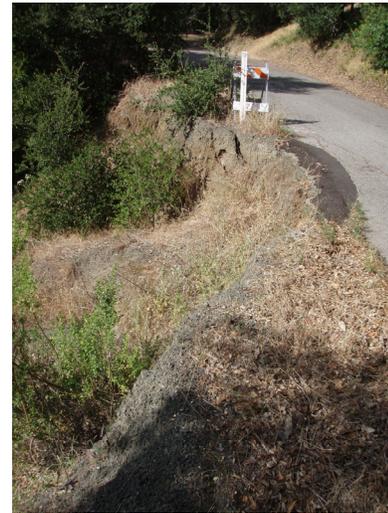
Erosion at Santa Rosa Creek Road
