**Santa Rosa Creek  
Watershed Geomorphology Assessment,  
San Luis Obispo County, CA**

**FINAL TECHNICAL REPORT  
May 2010**

*Prepared by*  
Stillwater Sciences  
2855 Telegraph Avenue, Suite 400  
Berkeley, CA 94705

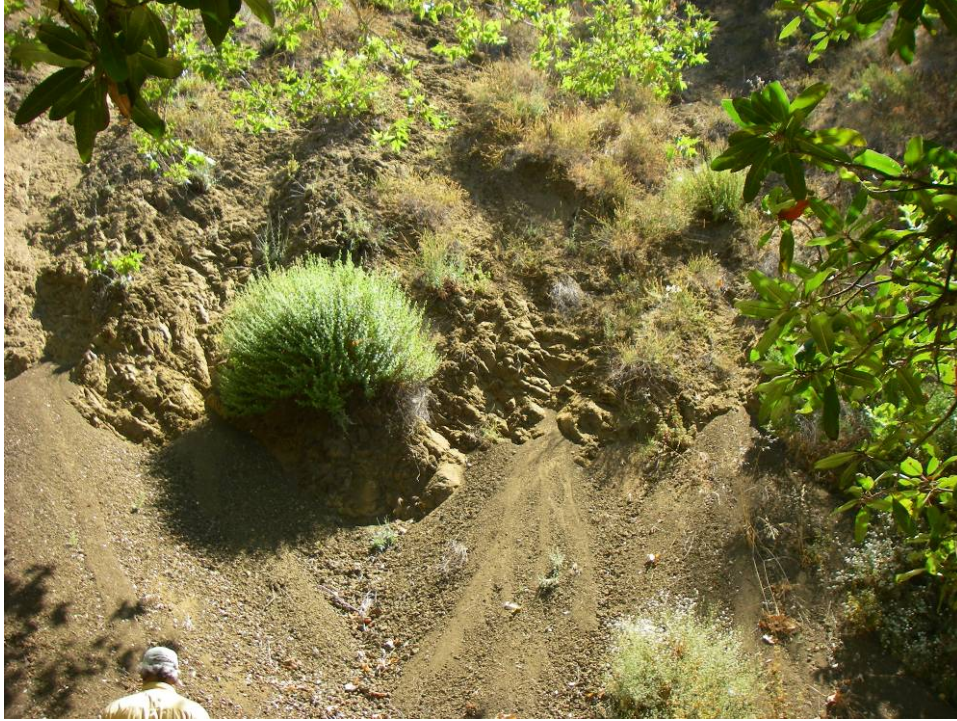
Figure 3-4. An exposure of fine-grained, weak shale of the Monterey Formation in the Curti Creek subwatershed (note person in foreground for scale).

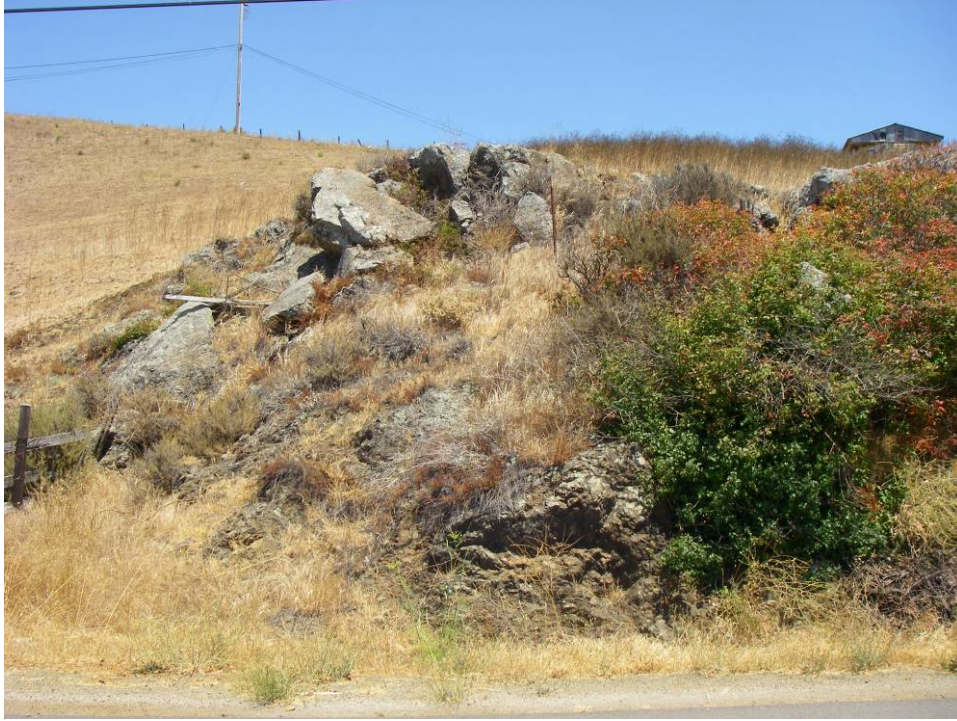
**Figure 3-5.** An exposure of coarse-grained, weak graywacke of the Franciscan mélangé along Santa Rosa Creek Road. Large fractured blocks of the rock unit lie upon the top of the outcrop.

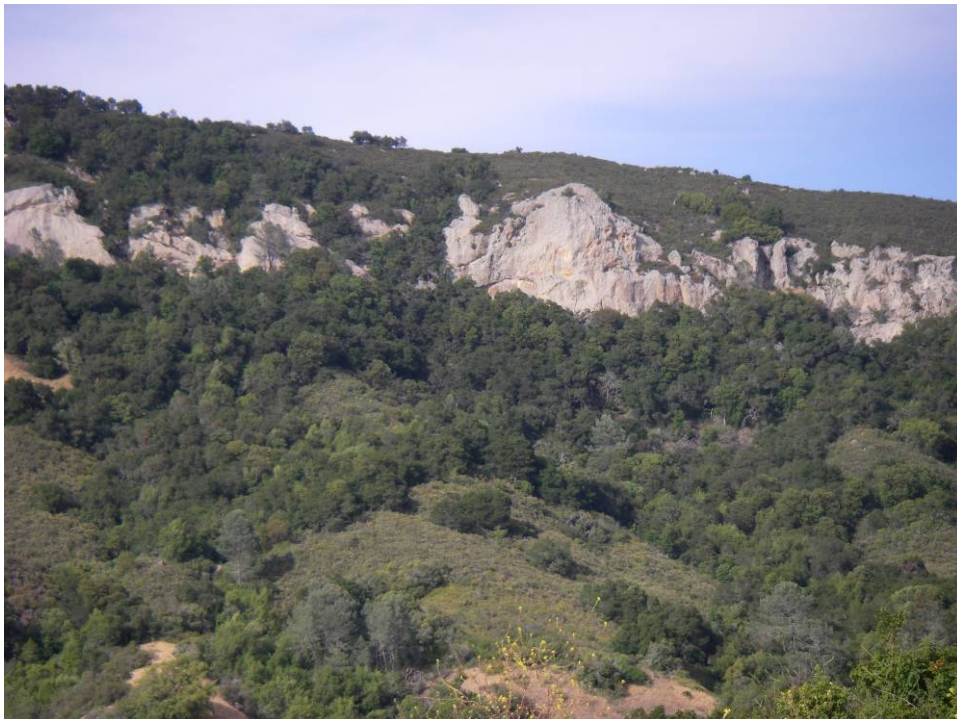
**Figure 3-6.** An exposure of coarse-grained, competent volcanic tuff of the Obispo Formation along Black Mountain.

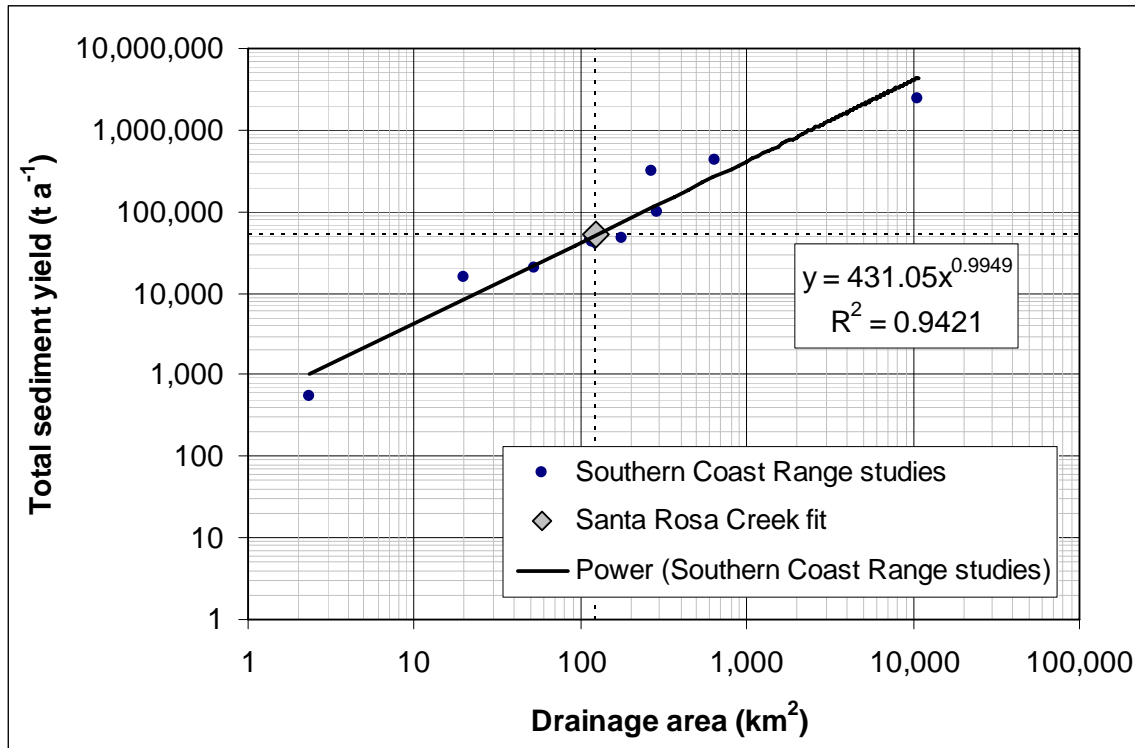
Figure 3-12. Correlation of estimated sediment yields from other watersheds in the southern Coast Range region with their drainage areas. Santa Rosa Creek watershed ( $123 km^2$ ) is shown by the gray diamond.

Plotting the average annual sediment yield ( $t a^{-1}$ ) data against drainage area from these other southern Coast Range watersheds shows a strong correlation—the coefficient of determination ( $R^2$ ) of 94% indicates that this model explains the variation well (Figure 3-12). This correlation is not surprising, since, generally, more sediment is produced from a larger watershed. Using the linear regression of the plotted data in Figure 3-12 with the drainage area of the Santa Rosa Creek watershed ( $123 km^2$ ), we can derive an estimated total sediment yield that amounts to approximately  $52,000 t a^{-1}$ , or a yield per unit area of  $420 t km^{-2} a^{-1}$ . This estimate corresponds to a uniform, watershed-wide denudation rate (i.e., landscape lowering rate) of  $0.3 mm/yr$ .

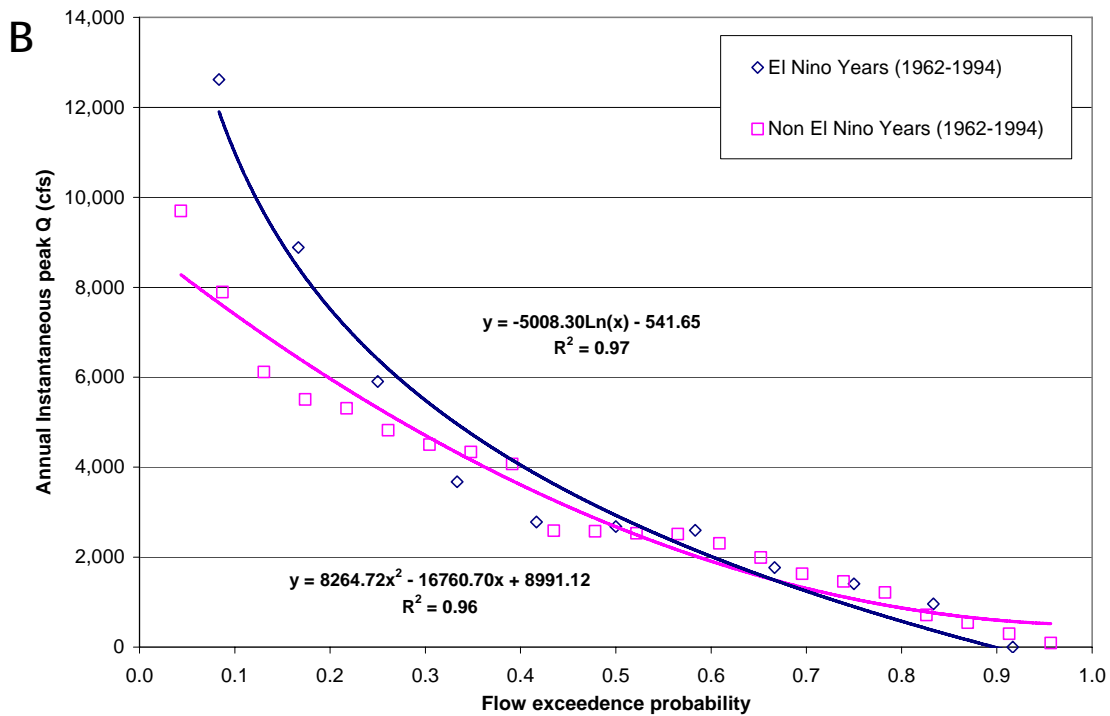
Figure 4-5. Flow exceedence in El Niño/non-El Niño years at (a) Santa Rosa Creek at Cambria (USGS gauge 11142200: WY 1958-1994) and (b) Santa Rosa Creek at Highway 1 bridge (SLO County Station 16: WY 1962-1994).

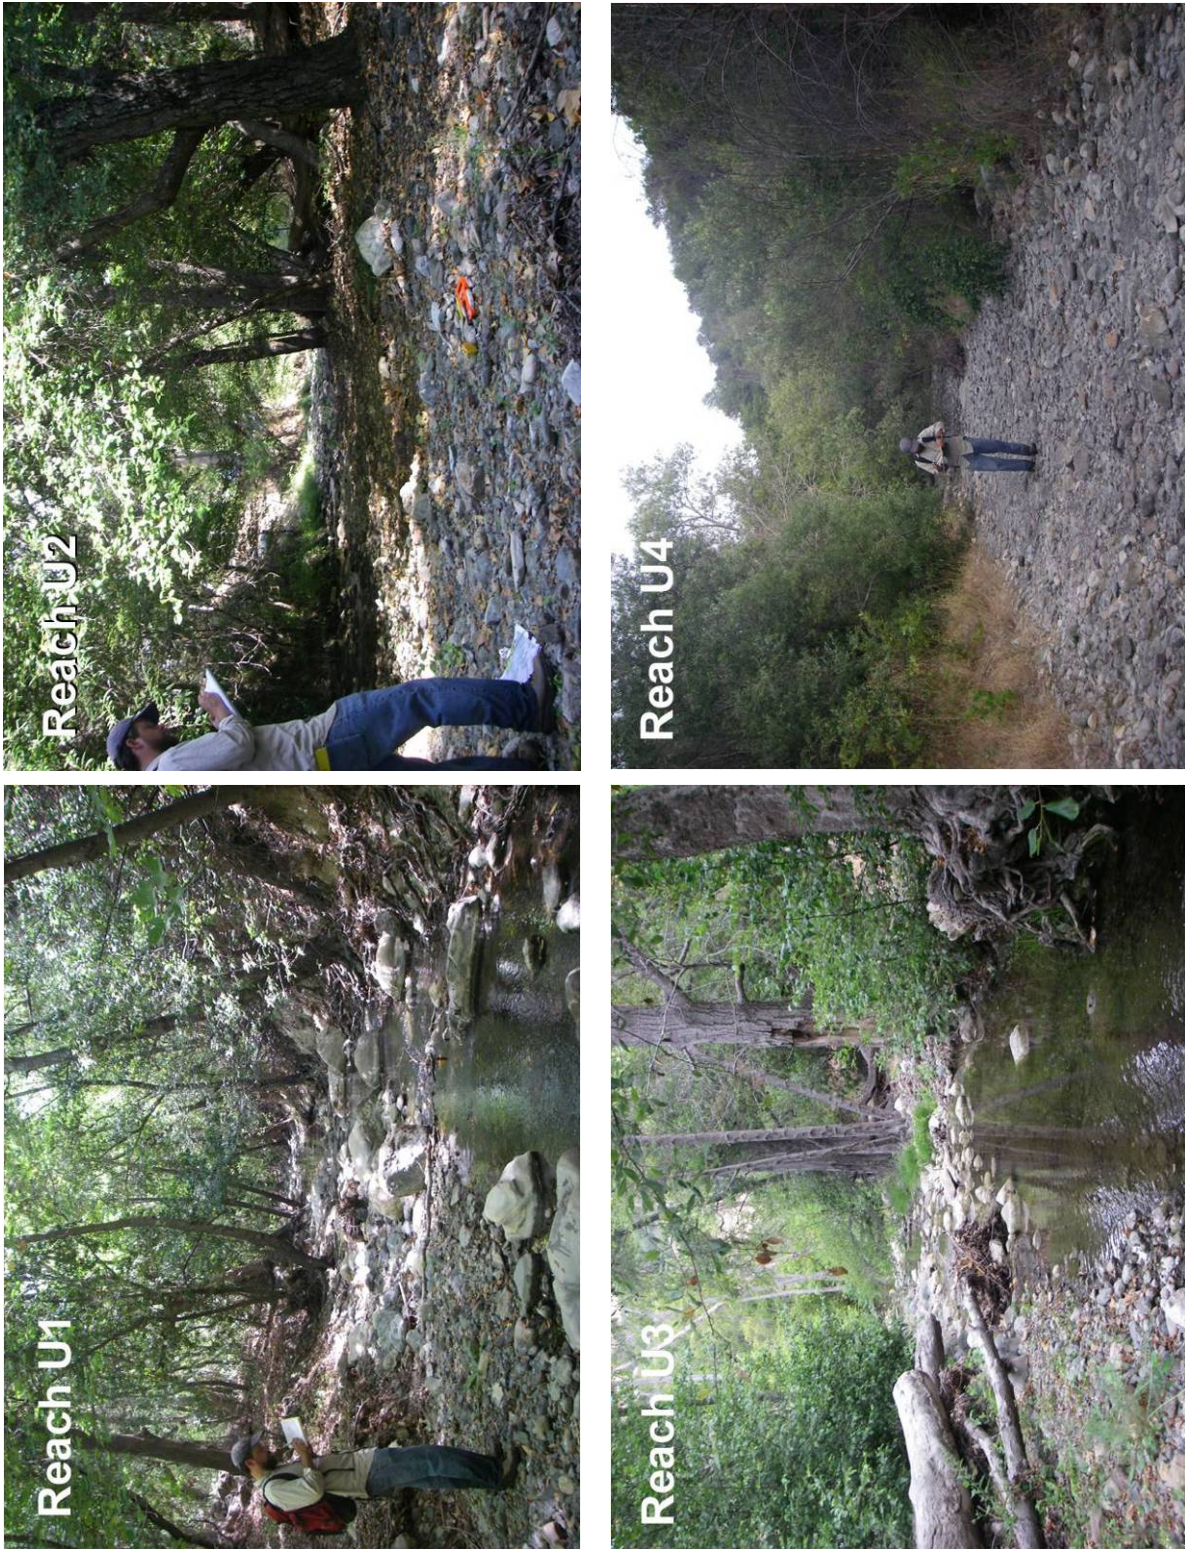
Figure 4-7a. Views of reaches U1, U2, U3, and U4 along upper Santa Rosa Creek.

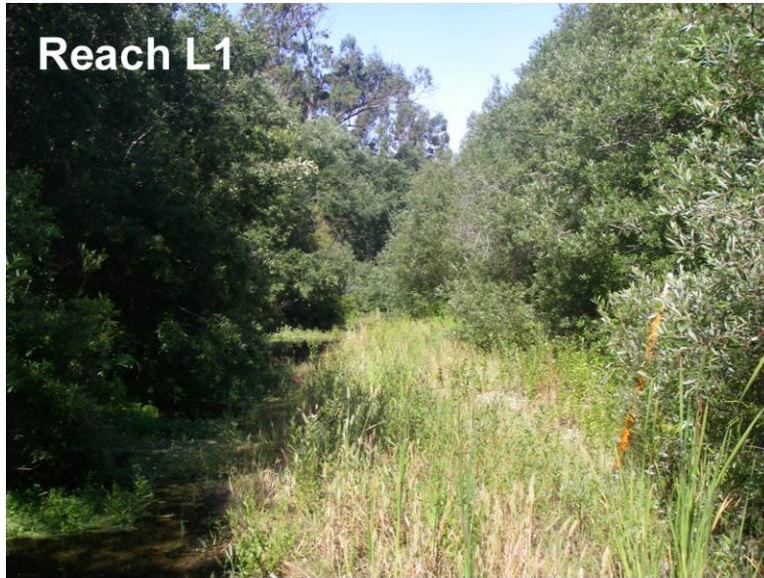
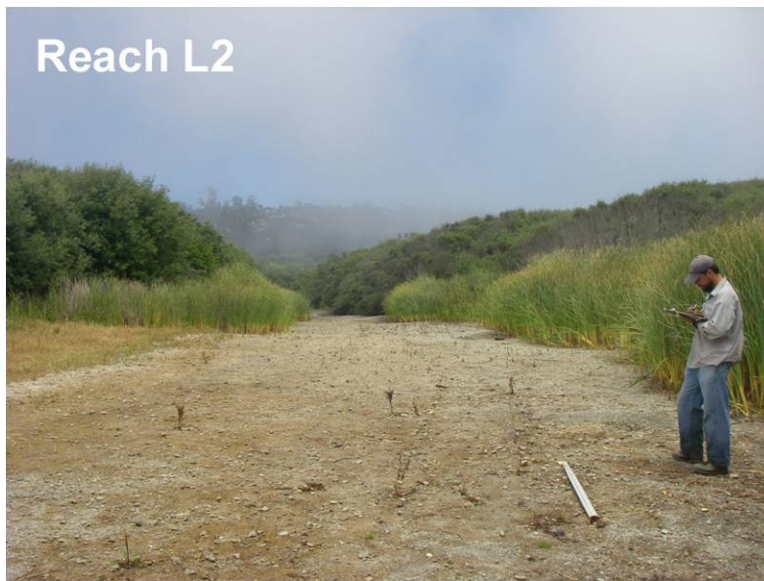
Figure 4-7c. Views of reaches L1 and L2 along lower Santa Rosa Creek.

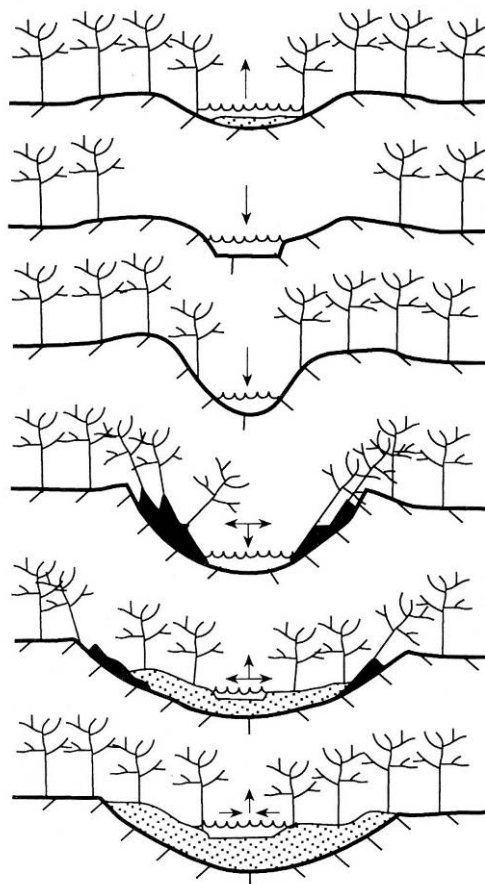
Figure 4-11. Conceptual model of channel evolution following watershed disturbances, such as channelization or incision. Arrows indicate the direction of degradation or aggradation (reprinted from Simon and Hupp [1986] and Hupp and Simon [1991], Copyright ©1991, Elsevier Science).

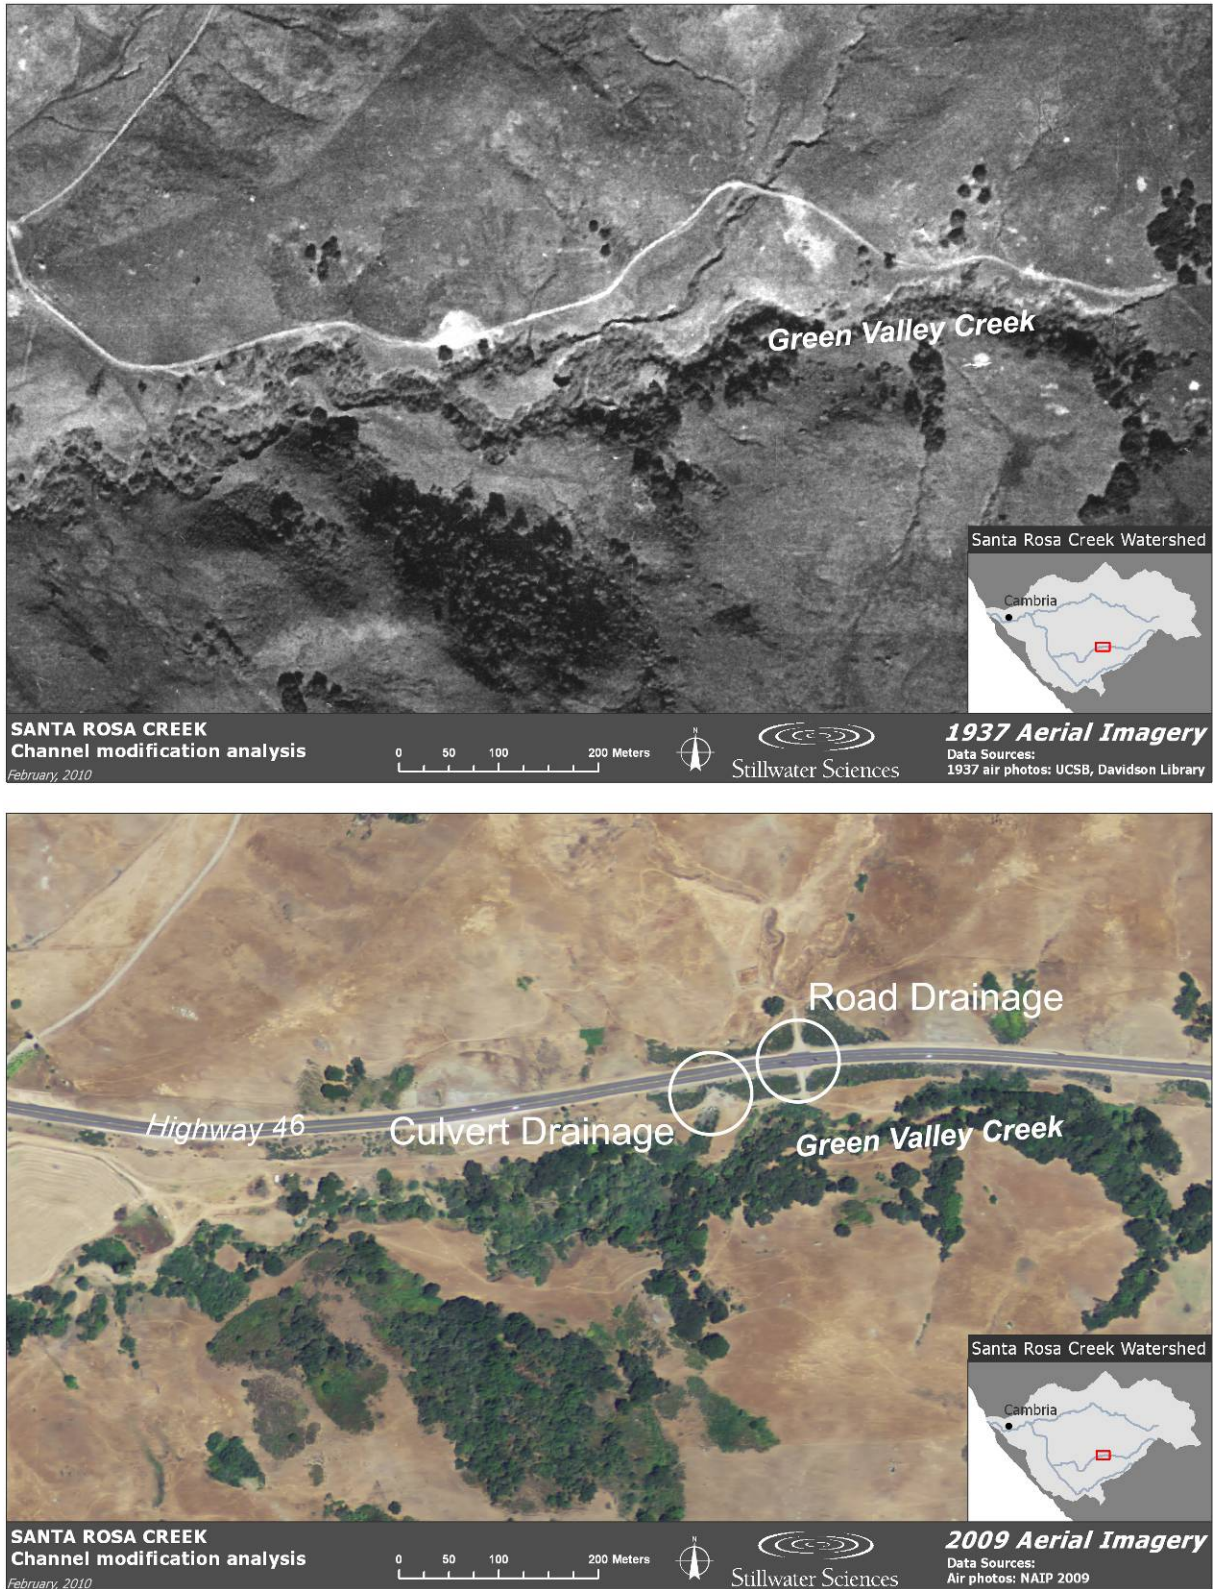
Figure 4-13. Historical (1937) and current (2009) aerial photographs showing the reach of Green Valley Creek with the large culvert drainage adjacent to Highway 46.

In Santa Rosa Creek watershed, there is a concentration of road drainage and crossing-related impacts along Green Valley Creek as part of the Highway 46 construction in 1970s. Perhaps the greatest geomorphic impact has come from drainage modification approximately 5 km from the junction of Highways 1 and 46. At this location, road drainage is directed towards Green Valley Creek (outboard side of Highway 46) and towards a south-facing tributary (inboard side of Highway 46) (Figure 4-13). The south-facing tributary flow (including the inboard road drainage) is now diverted through a 7-ft culvert under Highway 46 near the historic tributary confluence (Figure 4-14). The increase in flow to Green Valley Creek at this location appears to have, at least in part, caused substantial downstream channel enlargement (i.e., bed incision and channel widening) in Green Valley Creek and erosion of the tributary channel downstream of the culvert. The impact appears to extend approximately 2 km downstream to where the channel gradient decreases, the channel width increases, and sediment deposition is observed to occur. Upstream of the road drainage and culvert, exposed bedrock and coarse bed material seem to be controlling the channel grade, thereby inhibiting channel enlargement due to the flow increase.

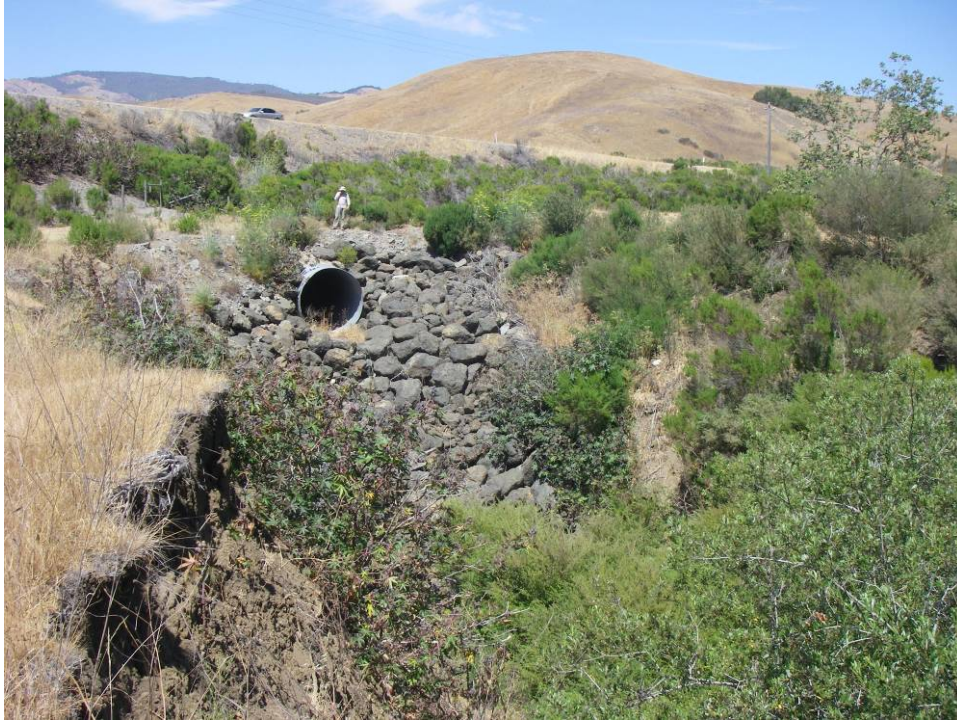
**Figure 4-14.** View looking upstream at a large, 7-ft diameter culvert that passes beneath Highway 46 and drains into Green Valley Creek.

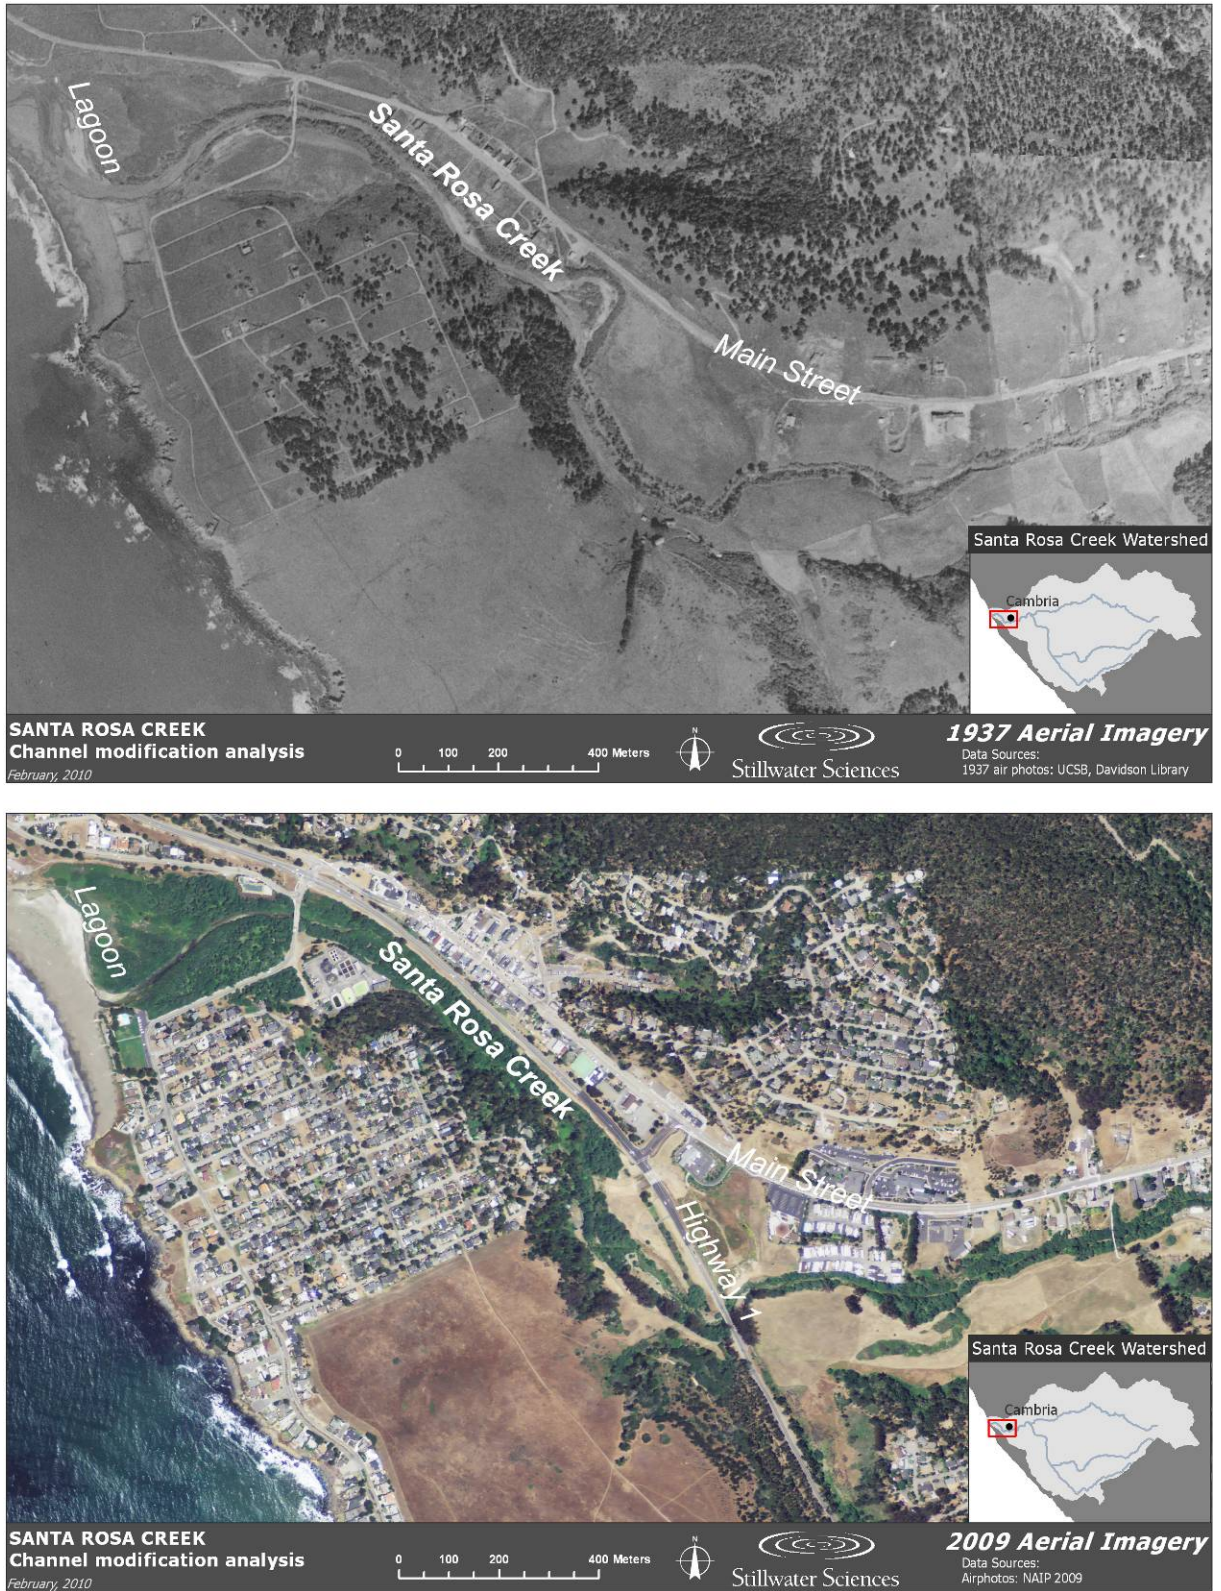
Figure 4-16. Historical (1937) and current (2009) aerial photographs showing the Lower reach of Santa Rosa Creek near the town of Cambria.

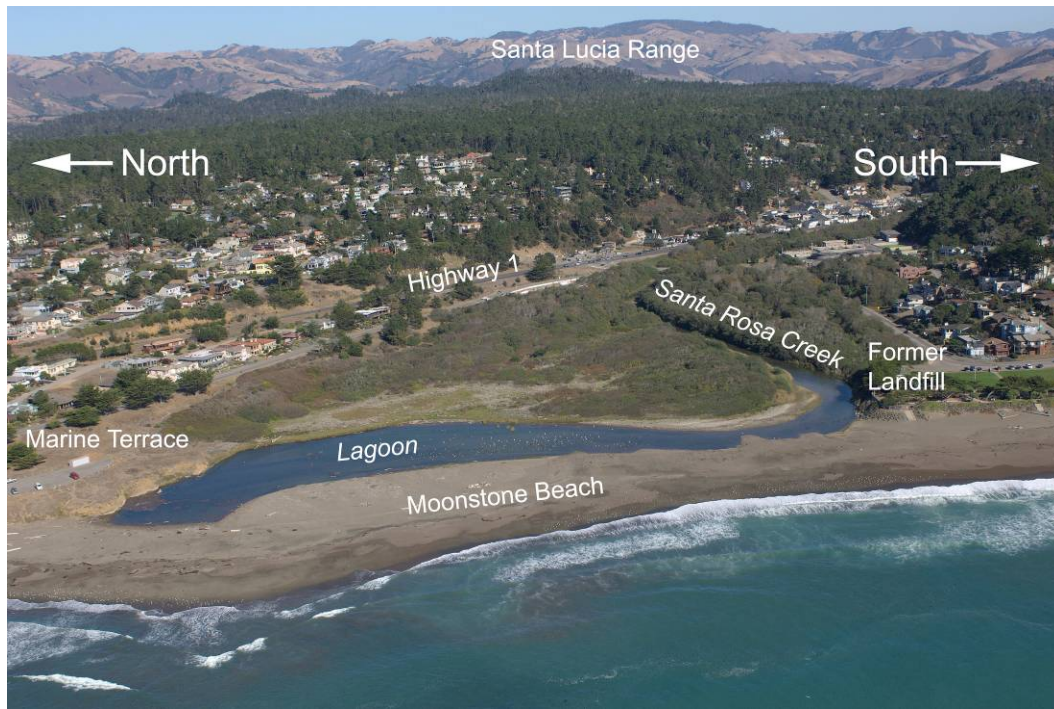
**Figure 4-17.** Oblique view of the Santa Rosa Creek lagoon looking east toward Cambria and the watershed with the Santa Lucia Mountain Range in the background (Photo taken October 28, 2005, Copyright © 2002-2009 Kenneth & Gabrielle Adelman, California Coastal Records Project, [www.californiacoastline.org](http://www.californiacoastline.org)).

Similar to other lagoons along the California coast, the Santa Rosa Creek lagoon exhibits a “wet” and “dry” state during any given year, whereby winter and spring flows fill up the lagoon and the lack of flows during late summer and early fall often result in a dry lagoon. During the relatively wet year of 2005, D. W. Alley & Associates (2006) reported that the lagoon remained full throughout the monitoring they conducted during the dry months. They also reported that lagoon water depth was predominantly controlled by streamflow and that tidal overwashes and throughflow (i.e., subsurface flow through the sandbar) had a minimal effect. Sandbar breaching typically occur in the winter when high streamflows rapidly fill the lagoon and cause the natural barrier to fail. Often, high wave energy can also contribute to sandbar breaching. Reformation of the sandbar and closure of the lagoon occurs when lower stream discharges and lower-intensity wave action facilitate onshore sediment transport and deposition at the mouth. Lagoon closure can take weeks to months, depending on the stream discharge and wave conditions.

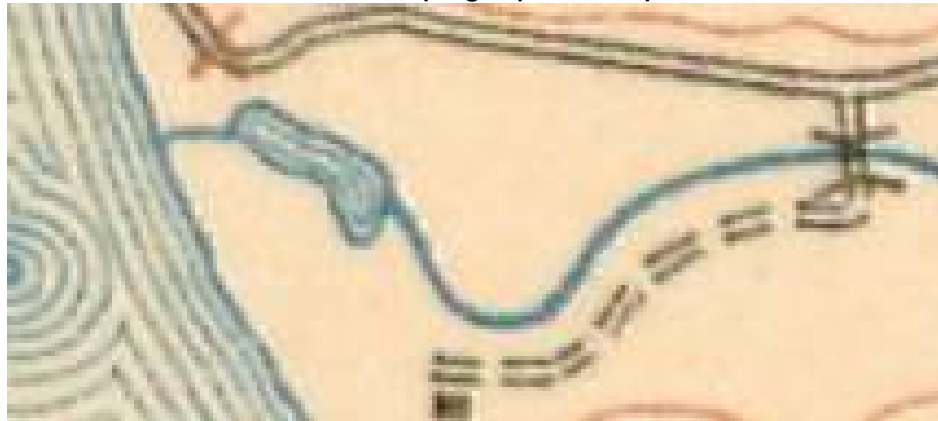
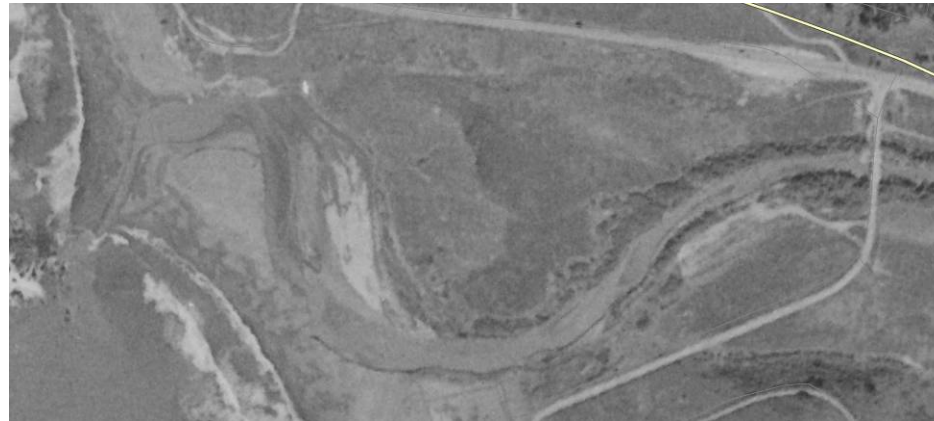
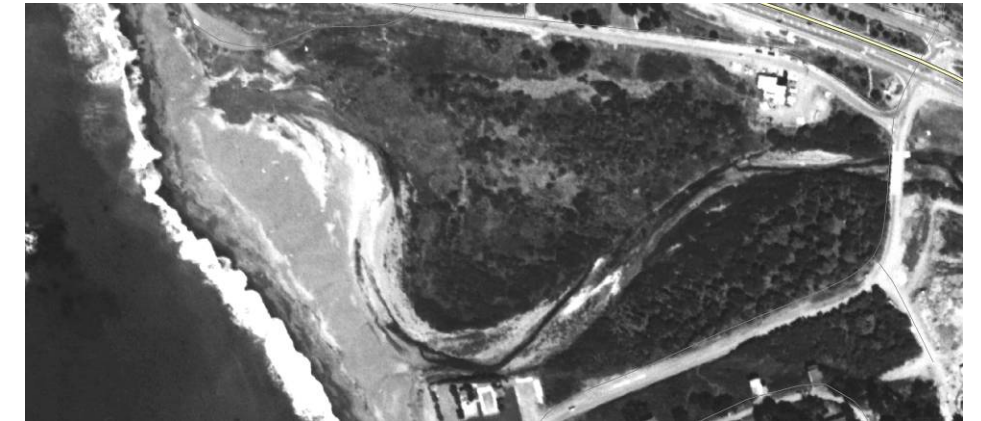
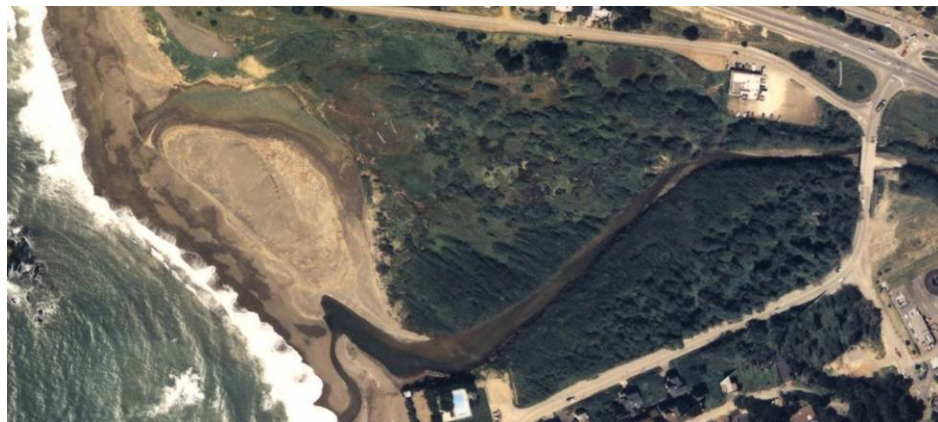
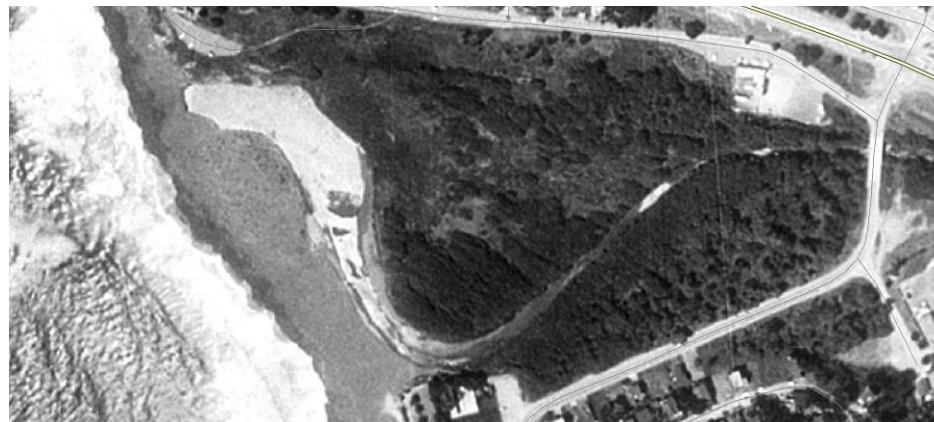
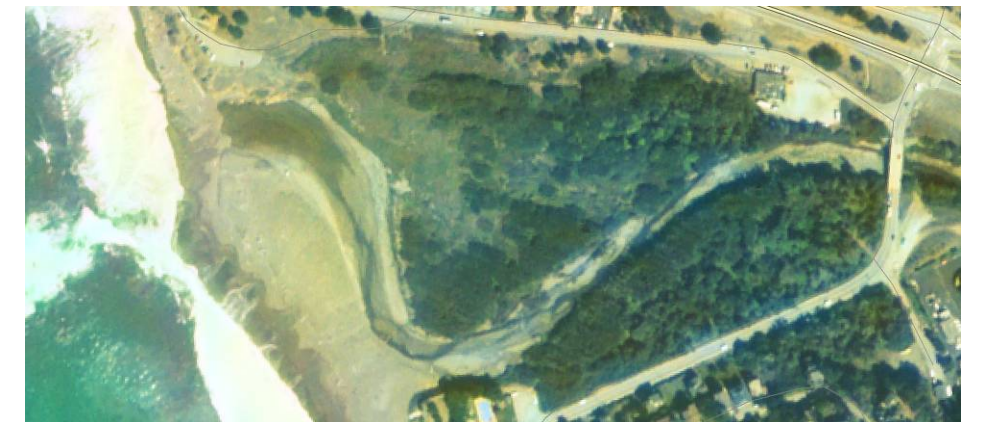
Figure 4-18. Historical topographic map and aerial views of the Santa Rosa Creek lagoon. The lagoon has generally maintained a similar planform shape since the early 1900s, with few exceptions (e.g., 1986). Also shown are examples of a breached sandbar during higher stream flow conditions (e.g., 2005) and a closed sandbar during lower flow conditions (e.g., 2009).
